Profile/Photo Observation Report

Date:	11/11/2021	Weather:		Coding:	PACP 7.0
Pipe Length (ft):	175.7	Owner:	City of Hobart	Pre Clean:	Heavy Cleaning
P.O.#:	YES502259	Surveyor:	Steven Bucklin	PSR:	P-605-023-021
Customer:	City of Hobart, IN (Red	Clean Date:	11/10/2021	Shape:	C

Street:	Henry Street	Flow Control:	Not Controlled
City:	City of Hobart	Year Renewed:	
Location:	Local rural streets with light traffic, t	Tape/Media #:	
Purpose:	Routine Assessment	Dia/Height:	12"
Use:	Sanitary Sewage Pipe	Material:	VCP
Drain Area:		Lining:	None
Category:	NA		
Comment:			
Location Details:		Direction of Survey:	Downstream
US MH:	M-605-021	DS MH:	M-605-023
		Total Length Surveyed (ft):	175.7

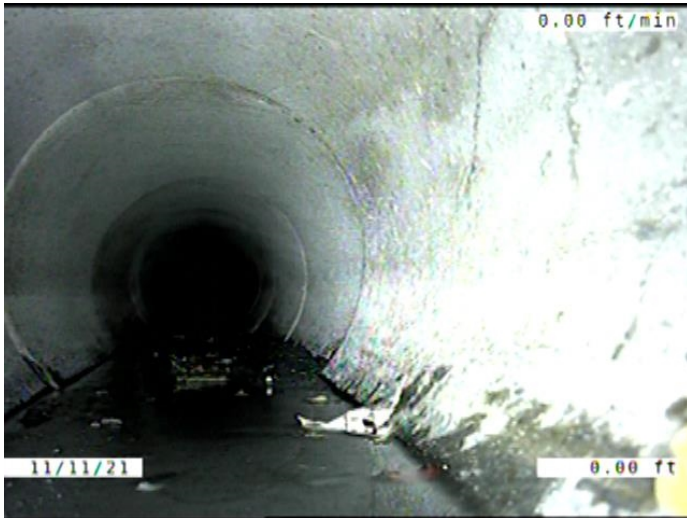
Code: **DSF**
Description: **Deposits Settled Fine**

Distance (ft): **.0**
Structural Grade: **0**
O&M Grade: **2**
Clock Start/From: **5**
Clock To: **7**
1st Value:
2nd Value:
Value Percent: **5.000**
Continuous Index: **S01**
Within 8" of Joint: **YES**
Remarks:

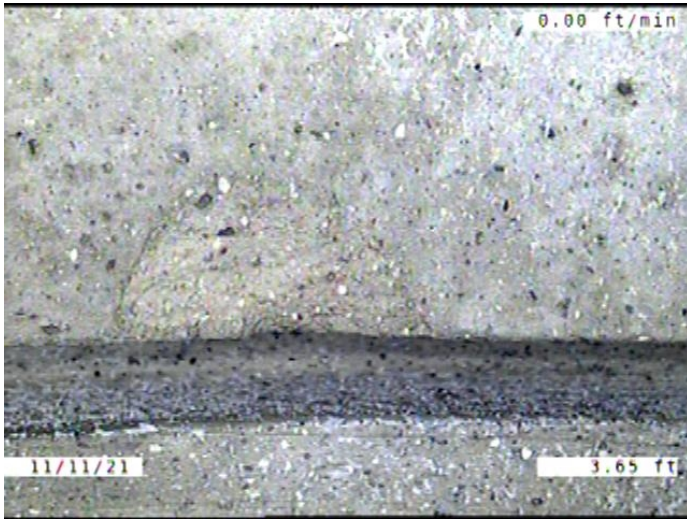
Code: **SSS**
 Description: **Surface Damage Surface Spalling**

Distance (ft): **3.6**
 Structural Grade: **2**
 O&M Grade: **0**
 Clock Start/From: **10**
 Clock To: **11**
 1st Value:
 2nd Value:
 Value Percent:
 Continuous Index:
 Within 8" of Joint: **YES**
 Remarks:

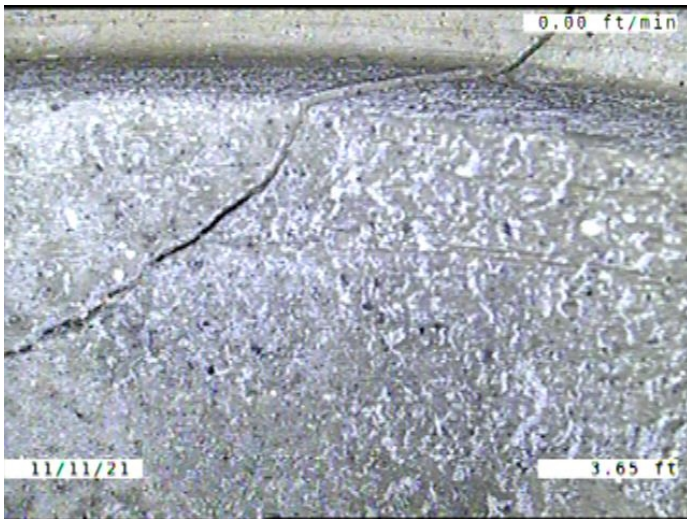
Code: **FM**
 Description: **Fracture Multiple**

Distance (ft): **3.7**
 Structural Grade: **4**
 O&M Grade: **0**
 Clock Start/From: **8**
 Clock To: **3**
 1st Value:
 2nd Value:
 Value Percent:
 Continuous Index:
 Within 8" of Joint: **YES**
 Remarks:

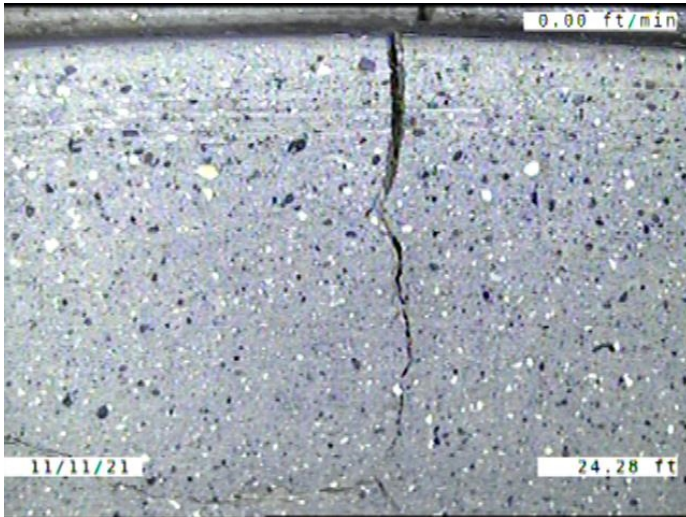
Code: **FM**
 Description: **Fracture Multiple**

Distance (ft): **24.3**
 Structural Grade: **4**
 O&M Grade: **0**
 Clock Start/From: **10**
 Clock To: **1**
 1st Value:
 2nd Value:
 Value Percent:
 Continuous Index:
 Within 8" of Joint: **YES**
 Remarks:

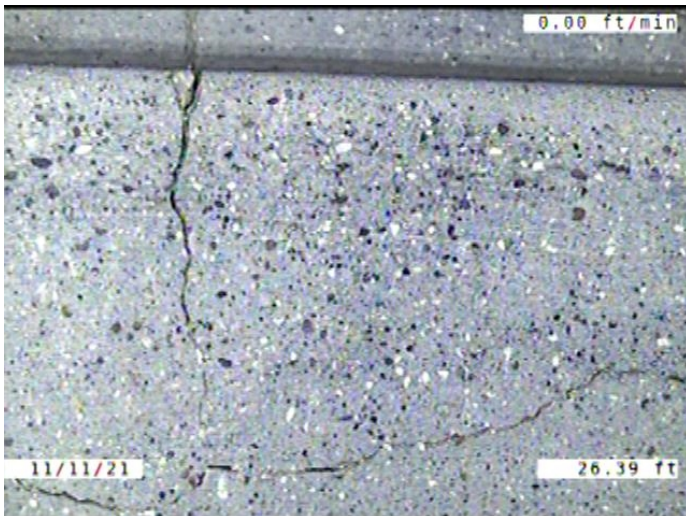
Code: **CM**
 Description: **Crack Multiple**

Distance (ft): **26.4**
 Structural Grade: **3**
 O&M Grade: **0**
 Clock Start/From: **9**
 Clock To: **3**
 1st Value:
 2nd Value:
 Value Percent:
 Continuous Index:
 Within 8" of Joint: **YES**
 Remarks:

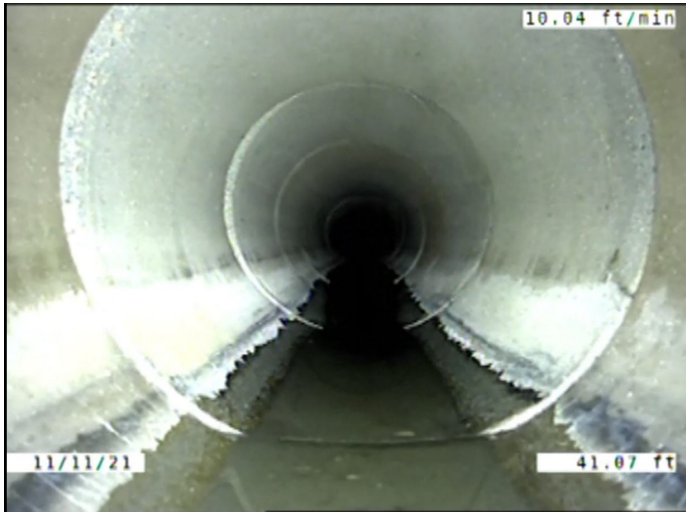
Code: **CL**
Description: **Crack Longitudinal**

Distance (ft): **41.1**
Structural Grade: **2**
O&M Grade: **0**
Clock Start/From: **4**
Clock To:
1st Value:
2nd Value:
Value Percent:
Continuous Index:
Within 8" of Joint: **YES**
Remarks:

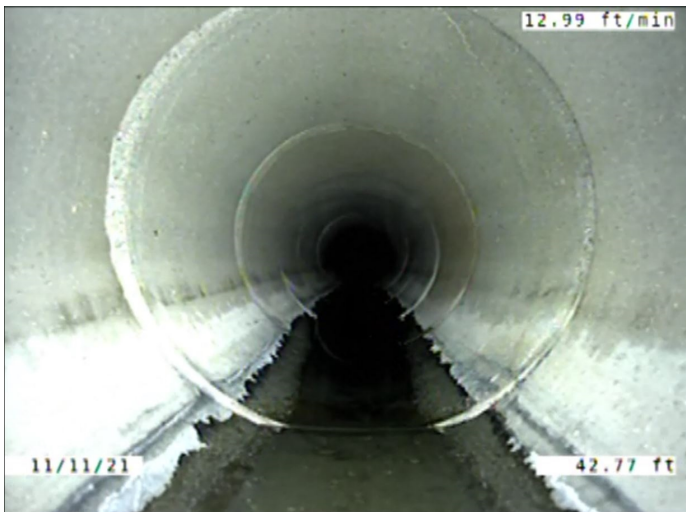
Code: **CC**
Description: **Crack Circumferential**

Distance (ft): **42.8**
Structural Grade: **1**
O&M Grade: **0**
Clock Start/From: **1**
Clock To: **3**
1st Value:
2nd Value:
Value Percent:
Continuous Index:
Within 8" of Joint: **YES**
Remarks:

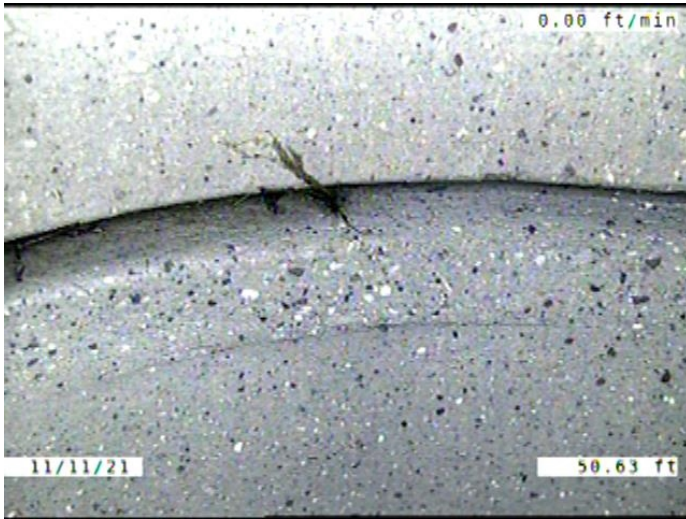
Code: **RFJ**
Description: **Roots Fine Joint**

Distance (ft): **50.6**
Structural Grade: **0**
O&M Grade: **1**
Clock Start/From: **10**
Clock To:
1st Value:
2nd Value:
Value Percent:
Continuous Index:
Within 8" of Joint: **YES**
Remarks:

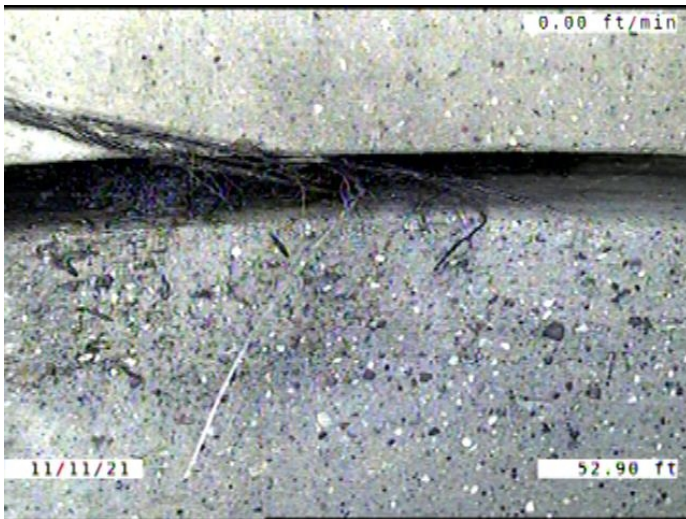
Code: **RFJ**
Description: **Roots Fine Joint**

Distance (ft): **52.9**
Structural Grade: **0**
O&M Grade: **1**
Clock Start/From: **8**
Clock To: **9**
1st Value:
2nd Value:
Value Percent:
Continuous Index:
Within 8" of Joint: **YES**
Remarks:

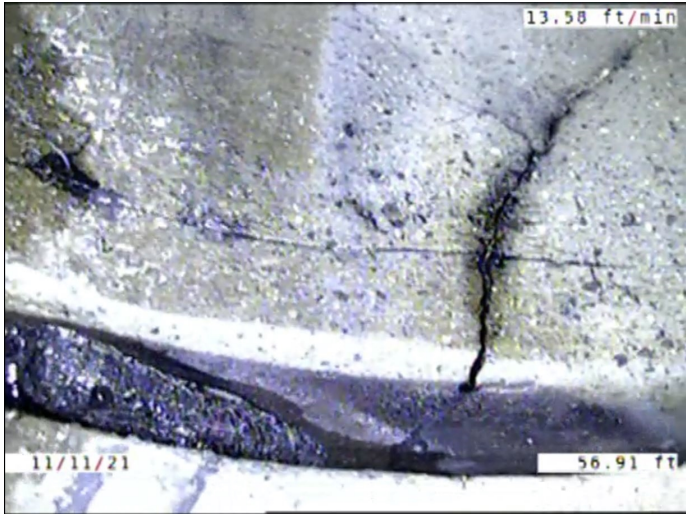
Code: **FM**
Description: **Fracture Multiple**

Distance (ft): **56.9**
Structural Grade: **4**
O&M Grade: **0**
Clock Start/From: **4**
Clock To: **5**
1st Value:
2nd Value:
Value Percent:
Continuous Index:
Within 8" of Joint: **YES**
Remarks:

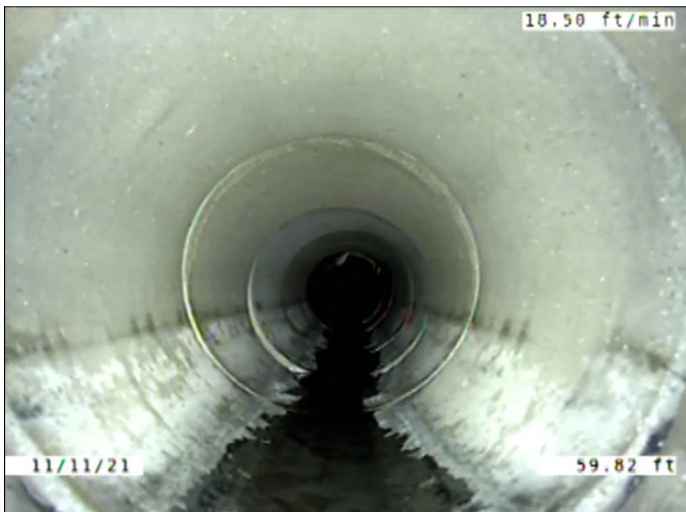
Code: **CL**
Description: **Crack Longitudinal**

Distance (ft): **59.8**
Structural Grade: **2**
O&M Grade: **0**
Clock Start/From: **3**
Clock To:
1st Value:
2nd Value:
Value Percent:
Continuous Index:
Within 8" of Joint: **YES**
Remarks:

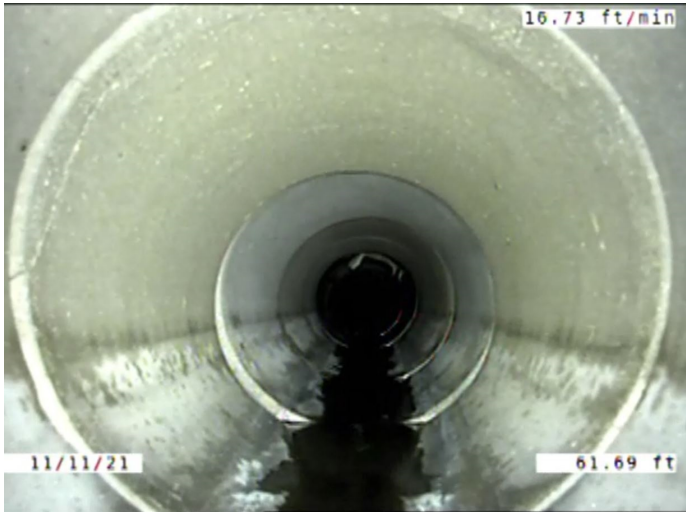
Code: **CC**
 Description: **Crack Circumferential**

Distance (ft): **61.7**
 Structural Grade: **1**
 O&M Grade: **0**
 Clock Start/From: **9**
 Clock To: **12**
 1st Value:
 2nd Value:
 Value Percent:
 Continuous Index:
 Within 8" of Joint: **YES**
 Remarks:

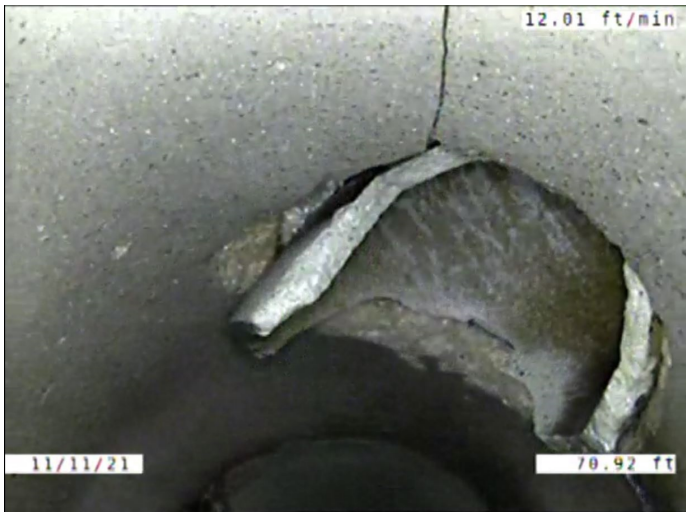
Code: **FM**
 Description: **Fracture Multiple**

Distance (ft): **70.9**
 Structural Grade: **4**
 O&M Grade: **0**
 Clock Start/From: **12**
 Clock To: **2**
 1st Value:
 2nd Value:
 Value Percent:
 Continuous Index:
 Within 8" of Joint: **YES**
 Remarks:

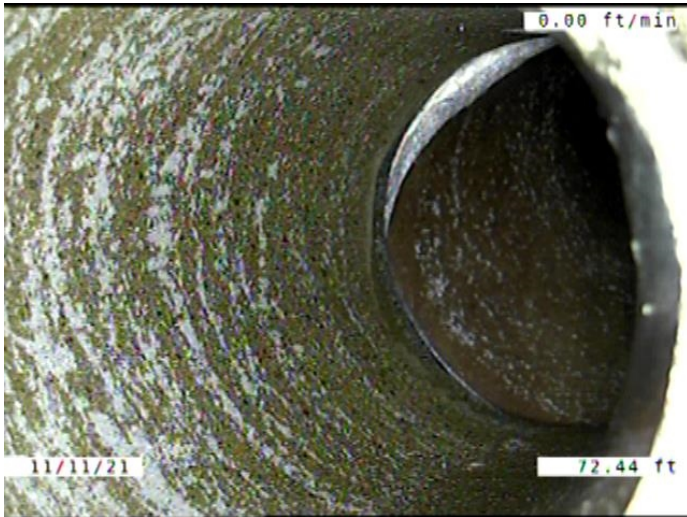
Code: **TBI**
 Description: **Tap Break-in Intruding**

Distance (ft): **72.4**
 Structural Grade: **0**
 O&M Grade: **2**
 Clock Start/From: **1**
 Clock To:
 1st Value: **4.000**
 2nd Value: **2.000**
 Value Percent:
 Continuous Index:
 Within 8" of Joint: **YES**
 Remarks:

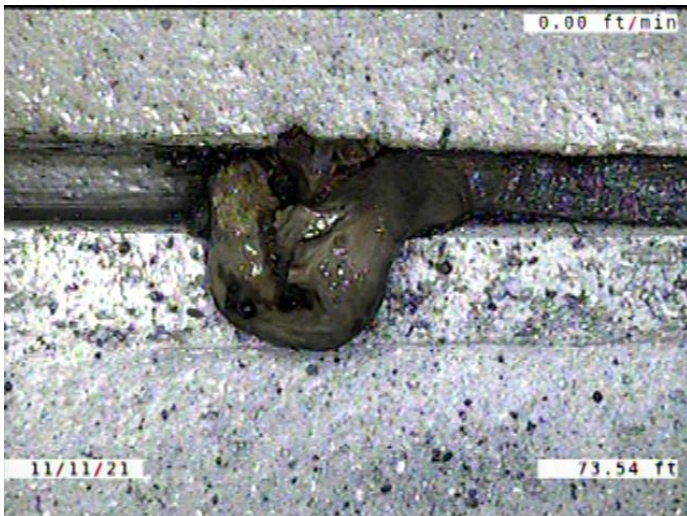
Code: **RTJ**
 Description: **Roots Tap Joint**

Distance (ft): **73.5**
 Structural Grade: **0**
 O&M Grade: **2**
 Clock Start/From: **10**
 Clock To: **1**
 1st Value:
 2nd Value:
 Value Percent: **5.000**
 Continuous Index:
 Within 8" of Joint: **YES**
 Remarks:

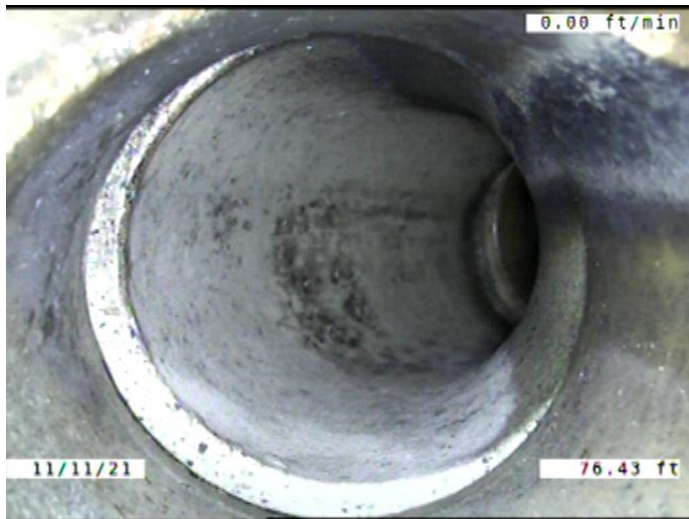
Code: **TFD**
 Description: **Tap Factory Defective**

Distance (ft): **76.4**
 Structural Grade: **0**
 O&M Grade: **3**
 Clock Start/From: **1**
 Clock To:
 1st Value: **4.000**
 2nd Value:
 Value Percent:
 Continuous Index:
 Within 8" of Joint: **YES**
 Remarks: **Cracked**

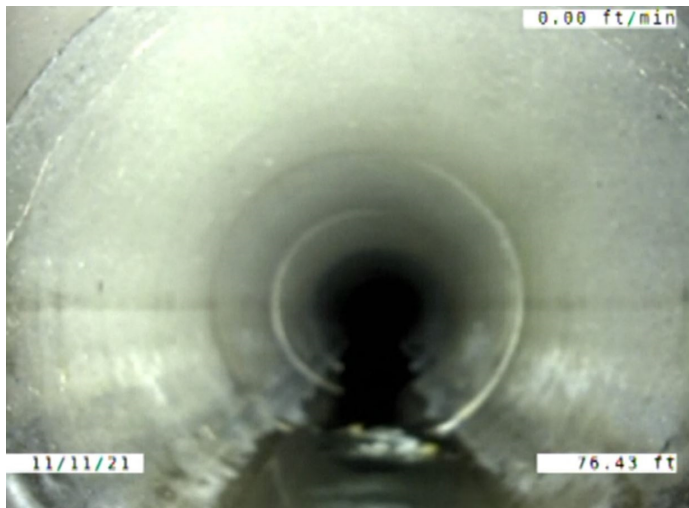
Code: **CC**
 Description: **Crack Circumferential**

Distance (ft): **76.4**
 Structural Grade: **1**
 O&M Grade: **0**
 Clock Start/From: **10**
 Clock To: **2**
 1st Value:
 2nd Value:
 Value Percent:
 Continuous Index:
 Within 8" of Joint: **YES**
 Remarks:

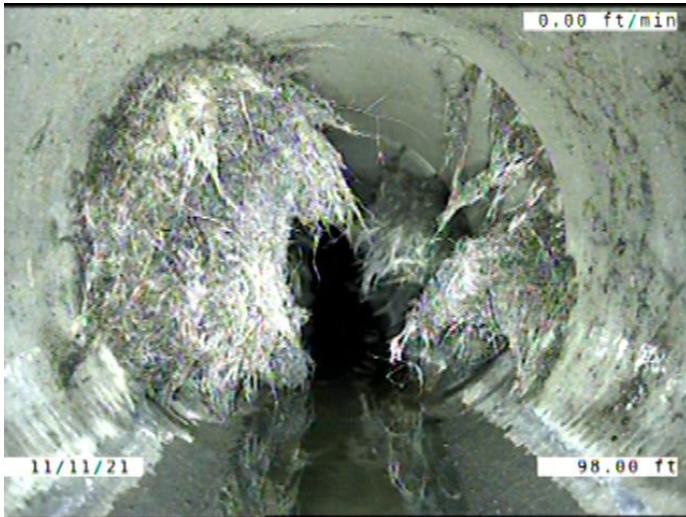
Code: **RMJ**
 Description: **Roots Medium Joint**

Distance (ft): **98.0**
 Structural Grade: **0**
 O&M Grade: **3**
 Clock Start/From: **7**
 Clock To: **4**
 1st Value:
 2nd Value:
 Value Percent: **50.000**
 Continuous Index:
 Within 8" of Joint: **YES**
 Remarks:

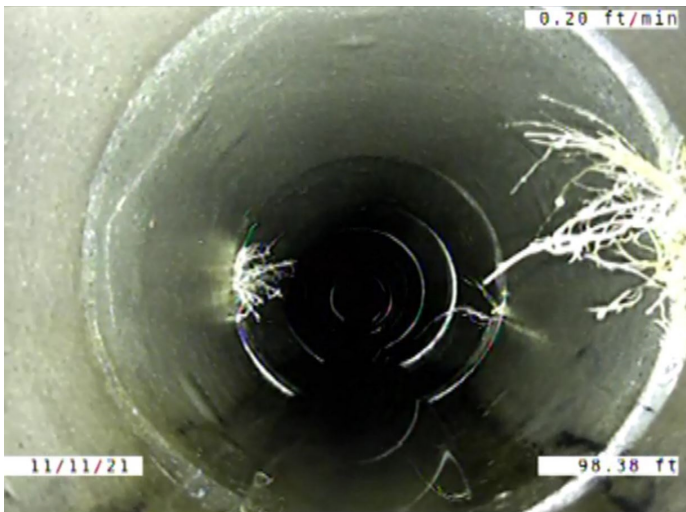
Code: **CC**
 Description: **Crack Circumferential**

Distance (ft): **98.4**
 Structural Grade: **1**
 O&M Grade: **0**
 Clock Start/From: **9**
 Clock To: **12**
 1st Value:
 2nd Value:
 Value Percent:
 Continuous Index:
 Within 8" of Joint: **YES**
 Remarks:

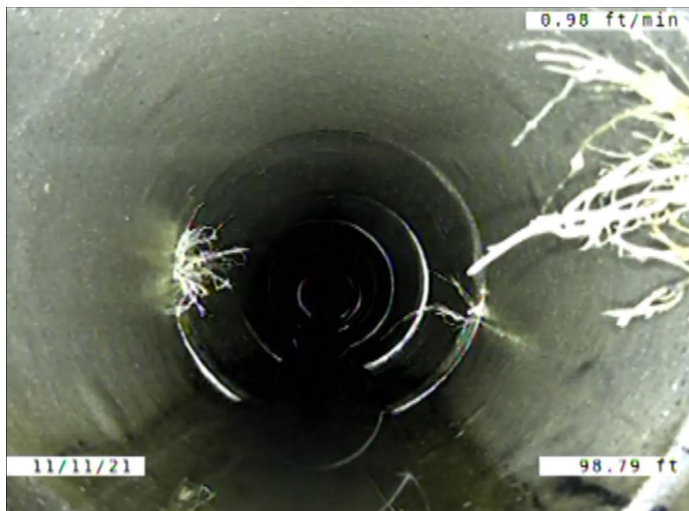
Code: **CL**
 Description: **Crack Longitudinal**

Distance (ft): **98.8**
 Structural Grade: **2**
 O&M Grade: **0**
 Clock Start/From: **4**
 Clock To:
 1st Value:
 2nd Value:
 Value Percent:
 Continuous Index:
 Within 8" of Joint: **YES**
 Remarks:

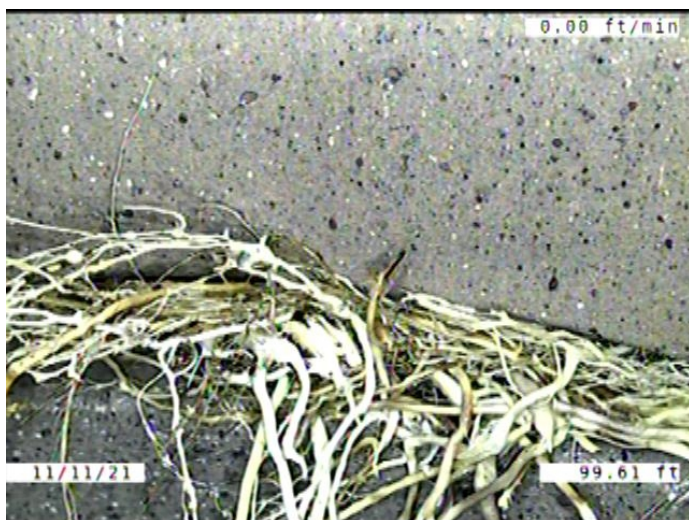
Code: **RMJ**
 Description: **Roots Medium Joint**

Distance (ft): **99.6**
 Structural Grade: **0**
 O&M Grade: **3**
 Clock Start/From: **1**
 Clock To: **4**
 1st Value:
 2nd Value:
 Value Percent: **5.000**
 Continuous Index:
 Within 8" of Joint: **YES**
 Remarks:

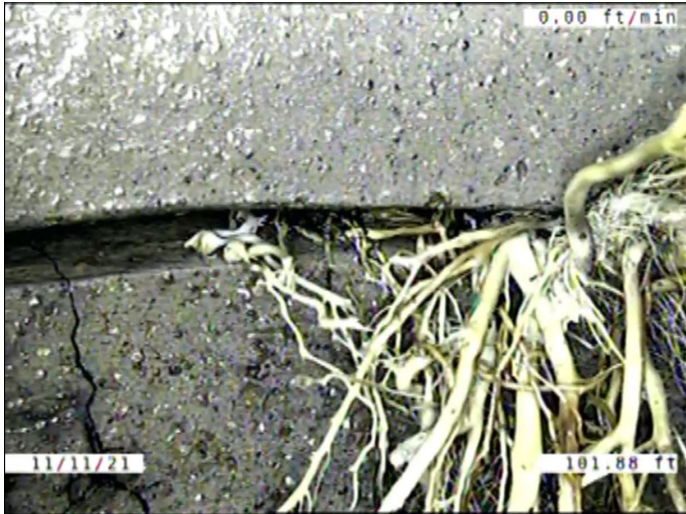
Code: **CL**
 Description: **Crack Longitudinal**

Distance (ft): **101.9**
 Structural Grade: **2**
 O&M Grade: **0**
 Clock Start/From: **8**
 Clock To:
 1st Value:
 2nd Value:
 Value Percent:
 Continuous Index:
 Within 8" of Joint: **NO**
 Remarks:

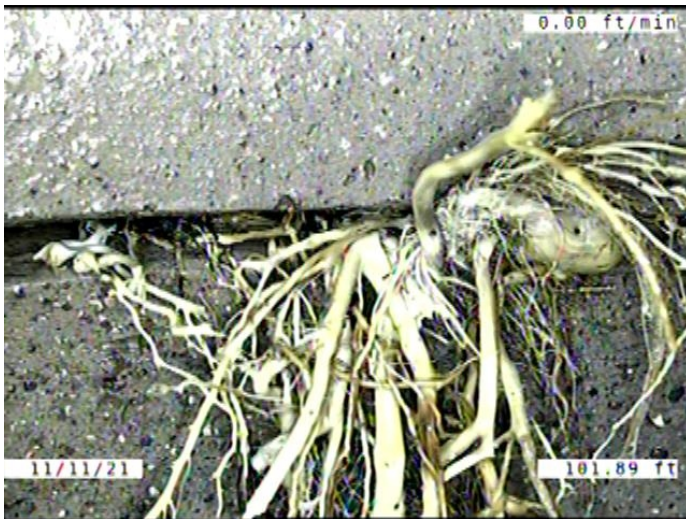
Code: **RMJ**
 Description: **Roots Medium Joint**

Distance (ft): **101.9**
 Structural Grade: **0**
 O&M Grade: **3**
 Clock Start/From: **9**
 Clock To: **10**
 1st Value:
 2nd Value:
 Value Percent: **5.000**
 Continuous Index:
 Within 8" of Joint: **YES**
 Remarks:

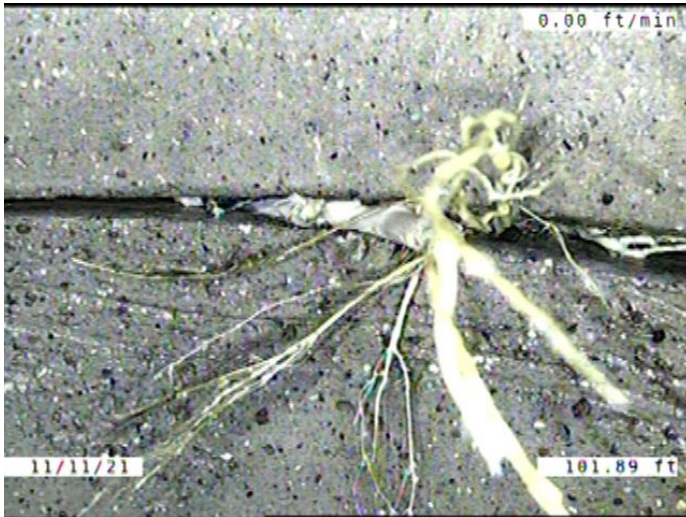
Code: **RFJ**
 Description: **Roots Fine Joint**

Distance (ft): **101.9**
 Structural Grade: **0**
 O&M Grade: **1**
 Clock Start/From: **2**
 Clock To: **3**
 1st Value:
 2nd Value:
 Value Percent:
 Continuous Index:
 Within 8" of Joint: **YES**
 Remarks:

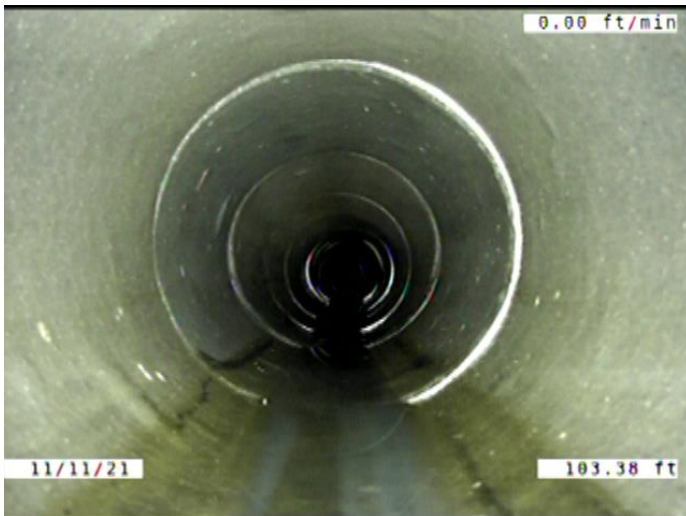
Code: **DSF**
 Description: **Deposits Settled Fine**

Distance (ft): **103.4**
 Structural Grade: **0**
 O&M Grade: **2**
 Clock Start/From: **5**
 Clock To: **7**
 1st Value:
 2nd Value:
 Value Percent: **5.000**
 Continuous Index: **F01**
 Within 8" of Joint: **YES**
 Remarks:

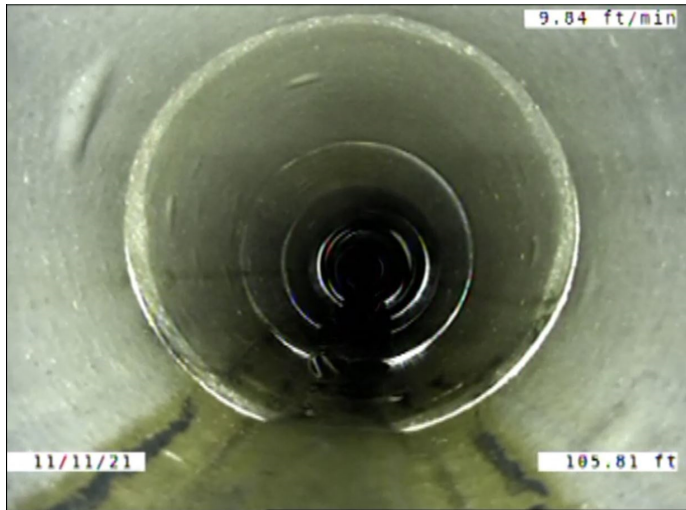
Code: **SZ**
Description: **Surface Damage Other**

Distance (ft): **105.8**
Structural Grade: **0**
O&M Grade: **0**
Clock Start/From: **9**
Clock To: **3**
1st Value:
2nd Value:
Value Percent:
Continuous Index: **S04**
Within 8" of Joint: **NO**
Remarks: **Indentations. Factory defect.**

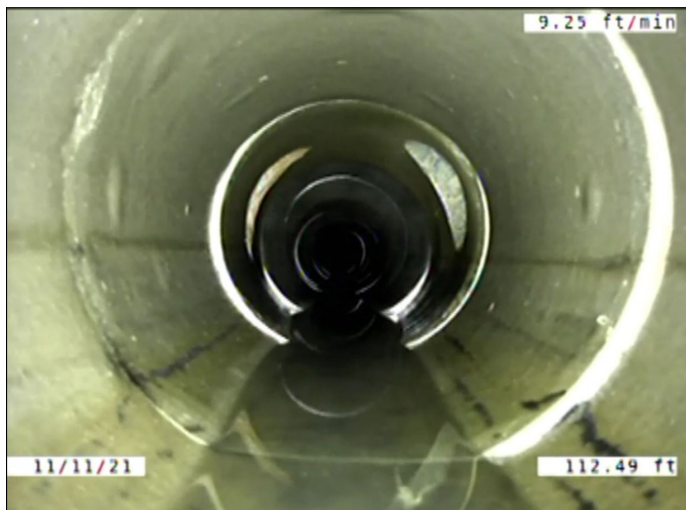
Code: **SZ**
Description: **Surface Damage Other**

Distance (ft): **112.5**
Structural Grade: **0**
O&M Grade: **0**
Clock Start/From: **9**
Clock To: **3**
1st Value:
2nd Value:
Value Percent:
Continuous Index: **F04**
Within 8" of Joint: **NO**
Remarks: **Indentations. Factory defect.**

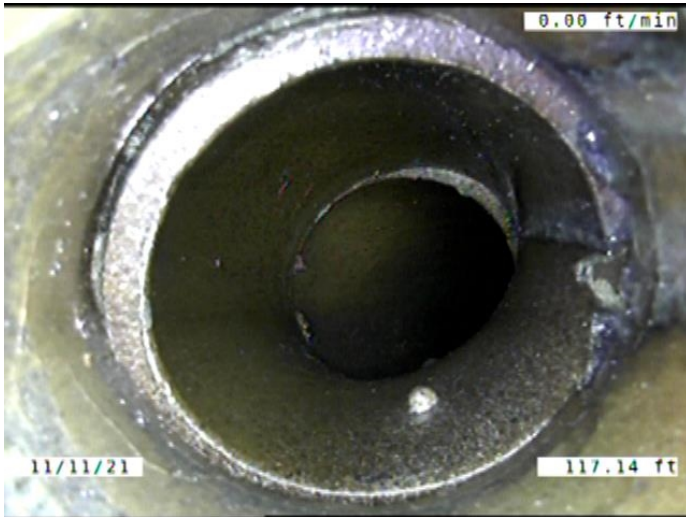
Code: **TFD**
 Description: **Tap Factory Defective**

Distance (ft): **117.1**
 Structural Grade: **0**
 O&M Grade: **3**
 Clock Start/From: **2**
 Clock To:
 1st Value: **4.000**
 2nd Value:
 Value Percent:
 Continuous Index:
 Within 8" of Joint: **YES**
 Remarks: **BROKEN. OFFSET.**

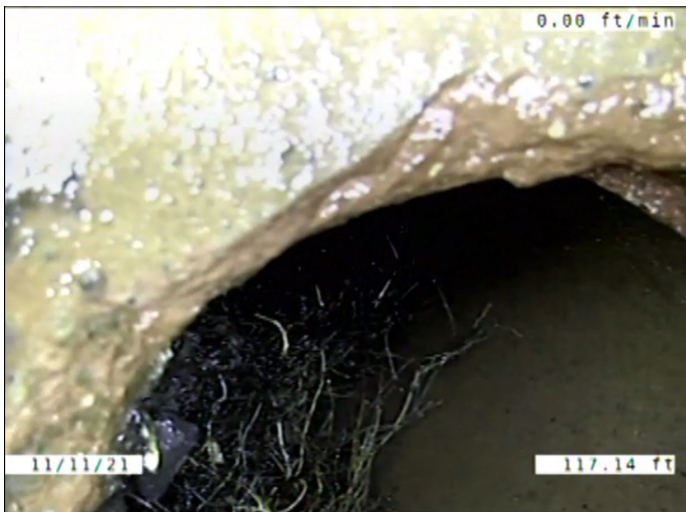
Code: **SSS**
 Description: **Surface Damage Surface Spalling**

Distance (ft): **117.4**
 Structural Grade: **2**
 O&M Grade: **0**
 Clock Start/From: **9**
 Clock To: **11**
 1st Value:
 2nd Value:
 Value Percent:
 Continuous Index:
 Within 8" of Joint: **NO**
 Remarks:

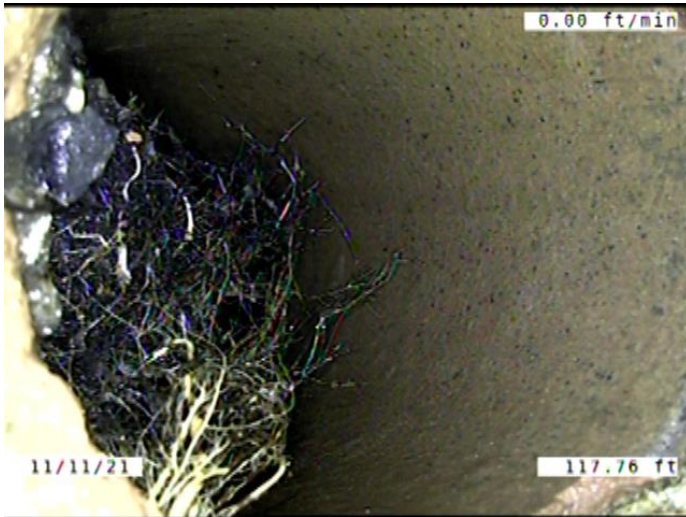
Code:	TBD
Description:	Tap Break-in/Hammer Defective
Distance (ft):	117.8
Structural Grade:	0
O&M Grade:	3
Clock Start/From:	10
Clock To:	
1st Value:	4.000
2nd Value:	
Value Percent:	
Continuous Index:	
Within 8" of Joint:	YES
Remarks:	ROOTS GROWING FROM THE CONNECTION

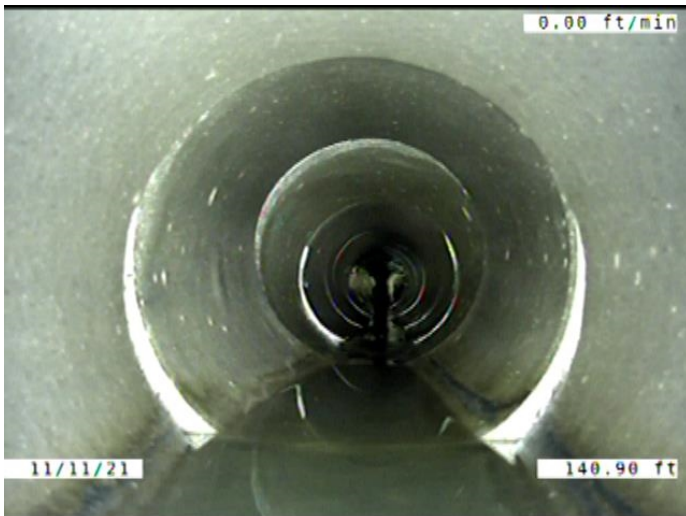
Code:	MWLS
Description:	Miscellaneous Water Level Sag
Distance (ft):	140.9
Structural Grade:	2
O&M Grade:	0
Clock Start/From:	
Clock To:	
1st Value:	
2nd Value:	
Value Percent:	5.000
Continuous Index:	
Within 8" of Joint:	NO
Remarks:

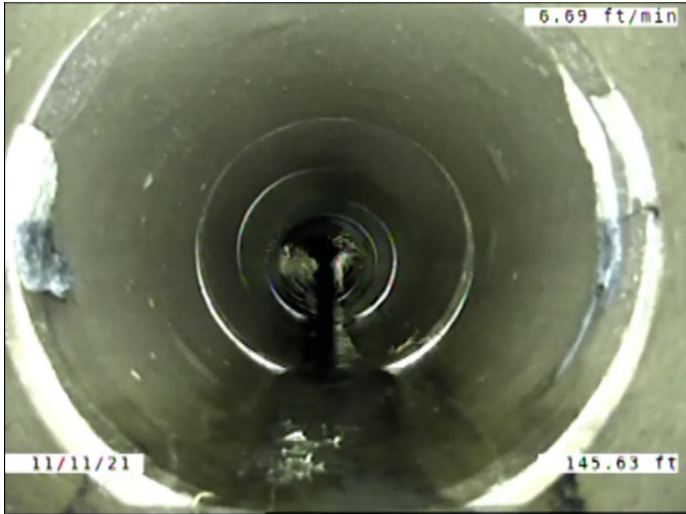
Code: **FM**
Description: **Fracture Multiple**

Distance (ft): **145.6**
Structural Grade: **4**
O&M Grade: **0**
Clock Start/From: **8**
Clock To: **4**
1st Value:
2nd Value:
Value Percent:
Continuous Index:
Within 8" of Joint: **YES**
Remarks:

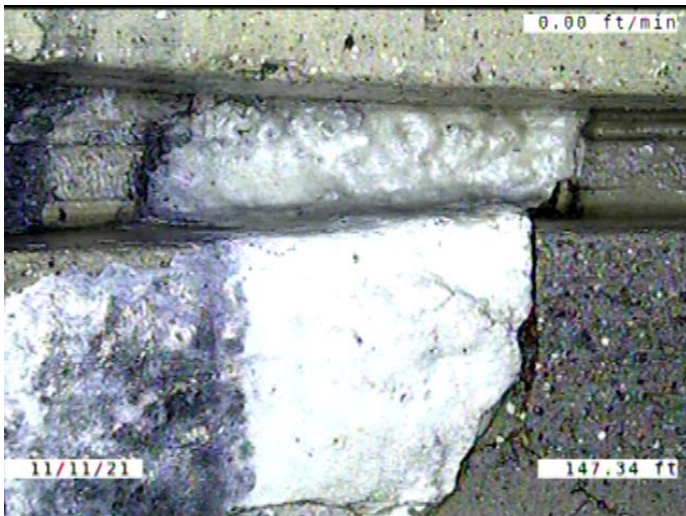
Code: **DAE**
Description: **Deposits Attached Encrustation**

Distance (ft): **147.3**
Structural Grade: **0**
O&M Grade: **2**
Clock Start/From: **9**
Clock To: **10**
1st Value:
2nd Value:
Value Percent: **5.000**
Continuous Index:
Within 8" of Joint: **YES**
Remarks:

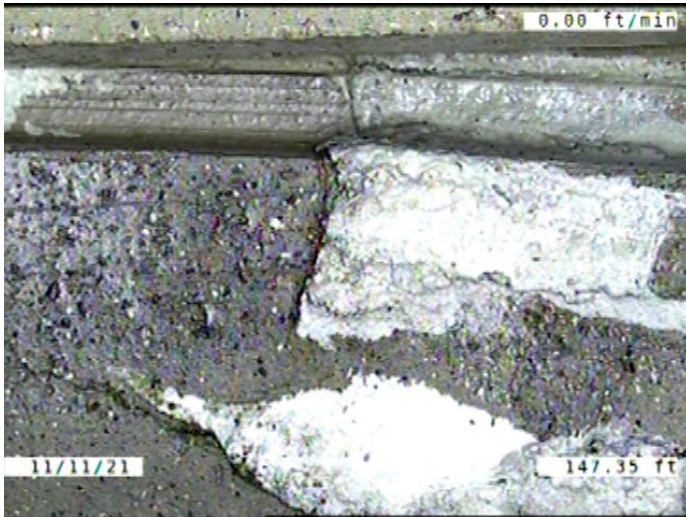
Code: **DAE**
 Description: **Deposits Attached Encrustation**

Distance (ft): **147.3**
 Structural Grade: **0**
 O&M Grade: **2**
 Clock Start/From: **1**
 Clock To: **3**
 1st Value:
 2nd Value:
 Value Percent: **5.000**
 Continuous Index:
 Within 8" of Joint: **YES**
 Remarks:

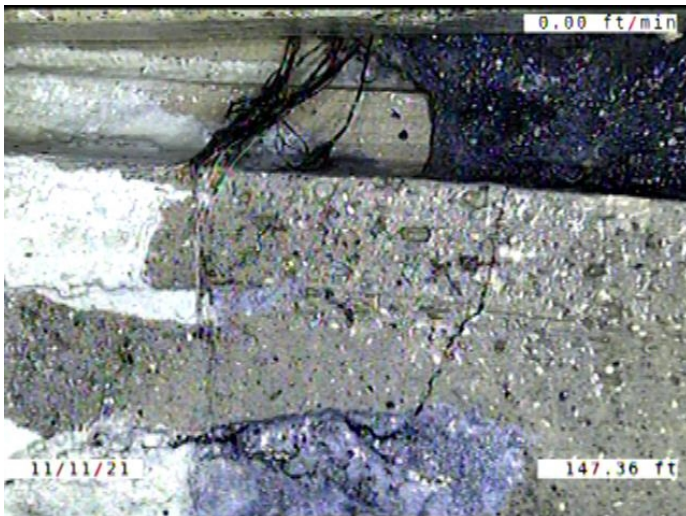
Code: **RFJ**
 Description: **Roots Fine Joint**

Distance (ft): **147.4**
 Structural Grade: **0**
 O&M Grade: **1**
 Clock Start/From: **3**
 Clock To:
 1st Value:
 2nd Value:
 Value Percent:
 Continuous Index:
 Within 8" of Joint: **YES**
 Remarks:

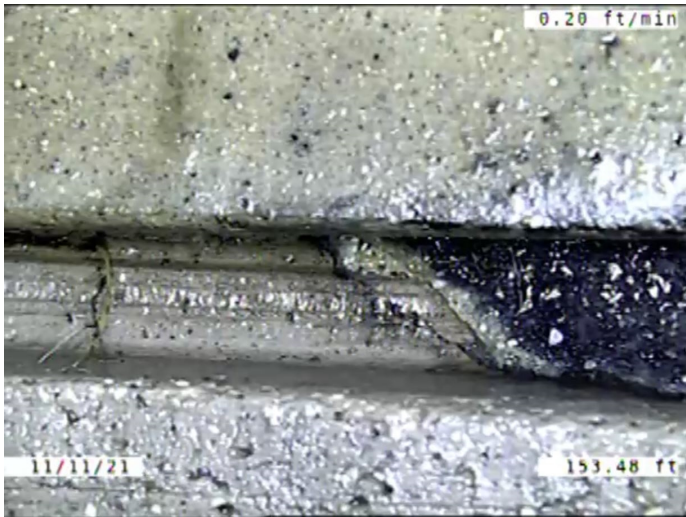
Code: **CM**
Description: **Crack Multiple**

Distance (ft): **153.5**
Structural Grade: **3**
O&M Grade: **0**
Clock Start/From: **7**
Clock To: **5**
1st Value:
2nd Value:
Value Percent:
Continuous Index:
Within 8" of Joint: **YES**
Remarks:

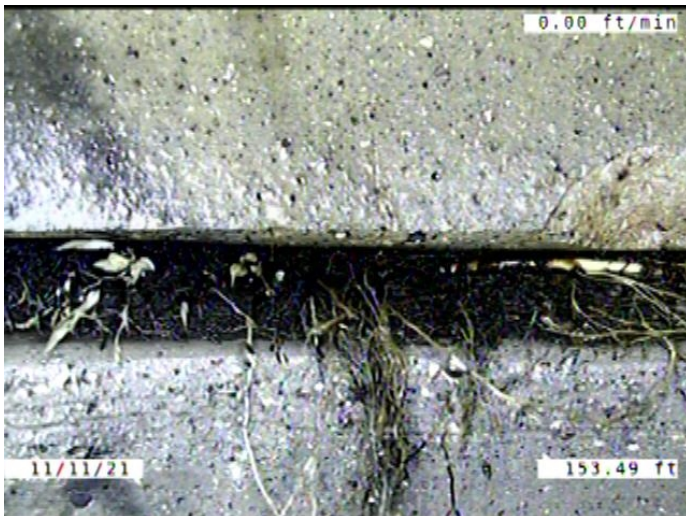
Code: **RFJ**
Description: **Roots Fine Joint**

Distance (ft): **153.5**
Structural Grade: **0**
O&M Grade: **1**
Clock Start/From: **9**
Clock To: **2**
1st Value:
2nd Value:
Value Percent:
Continuous Index:
Within 8" of Joint: **YES**
Remarks:

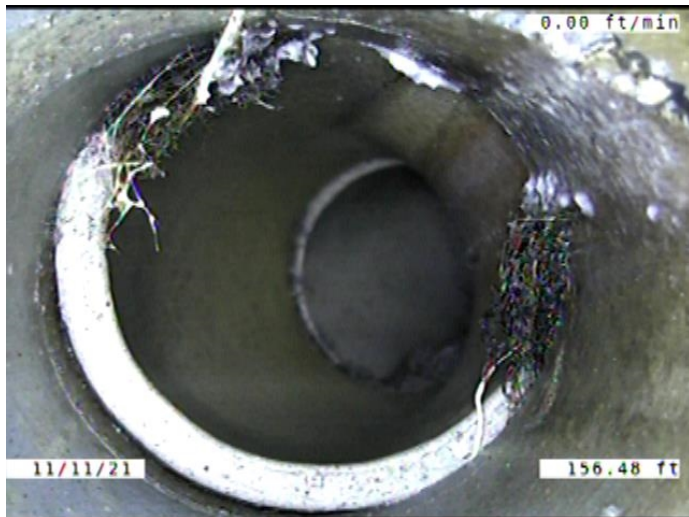
Code:	TF
Description:	Tap Factory
Distance (ft):	156.5
Structural Grade:	0
O&M Grade:	0
Clock Start/From:	1
Clock To:	
1st Value:	4.000
2nd Value:	
Value Percent:	
Continuous Index:	
Within 8" of Joint:	YES
Remarks:	ROOTS GROWING THROUGH THE JOINTS

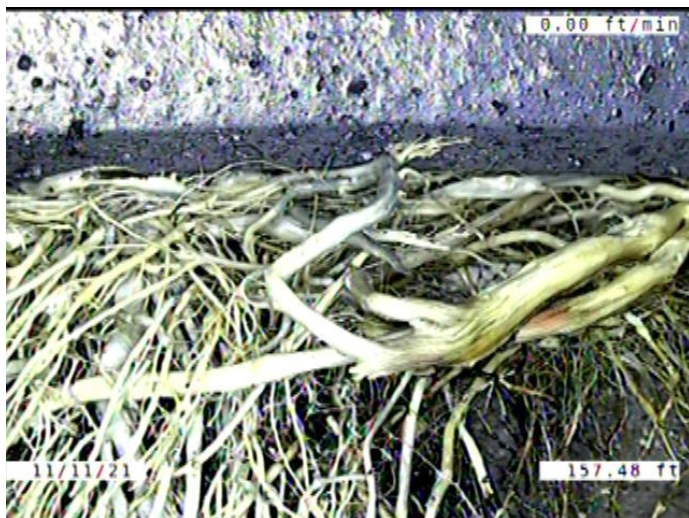
Code:	RMJ
Description:	Roots Medium Joint
Distance (ft):	157.5
Structural Grade:	0
O&M Grade:	3
Clock Start/From:	9
Clock To:	3
1st Value:	
2nd Value:	
Value Percent:	10.000
Continuous Index:	S03
Within 8" of Joint:	YES
Remarks:

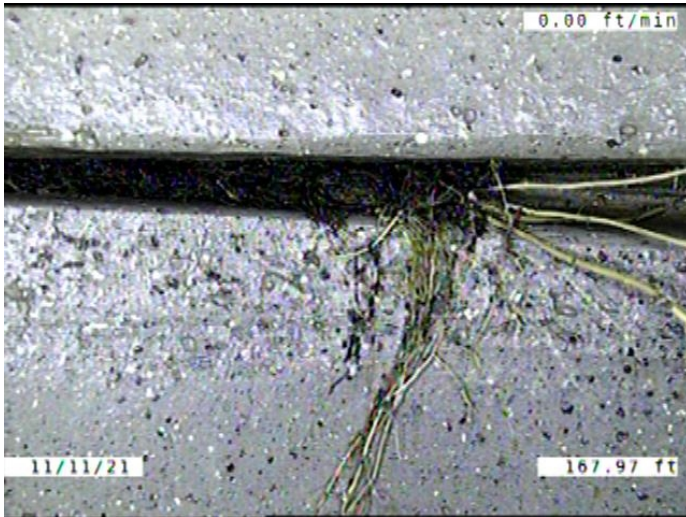
Code: **RFJ**
Description: **Roots Fine Joint**

Distance (ft): **168.0**
Structural Grade: **0**
O&M Grade: **1**
Clock Start/From: **10**
Clock To: **11**
1st Value:
2nd Value:
Value Percent:
Continuous Index:
Within 8" of Joint: **YES**
Remarks:

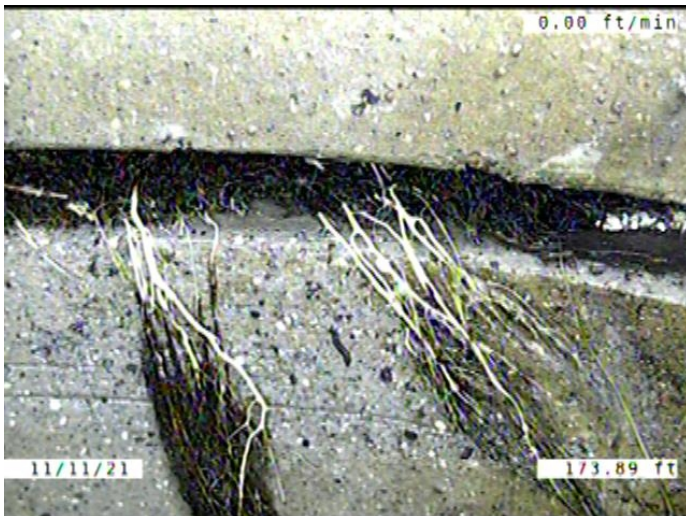
Code: **RFJ**
Description: **Roots Fine Joint**

Distance (ft): **173.9**
Structural Grade: **0**
O&M Grade: **1**
Clock Start/From: **2**
Clock To: **4**
1st Value:
2nd Value:
Value Percent:
Continuous Index:
Within 8" of Joint: **YES**
Remarks:

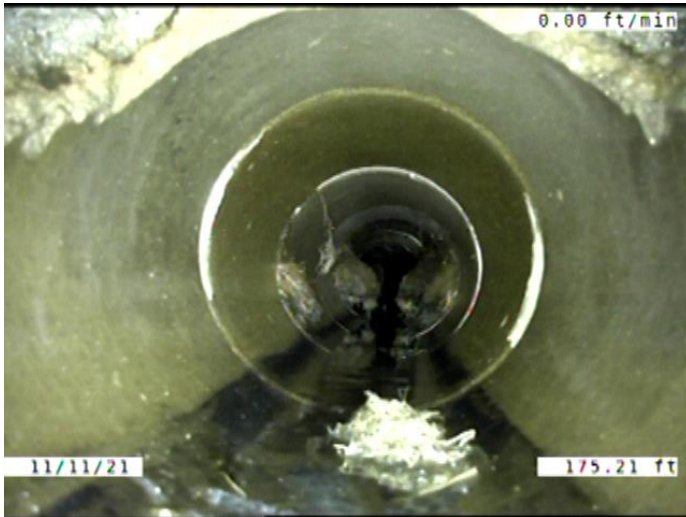
Code: **RMJ**
 Description: **Roots Medium Joint**

Distance (ft): **175.2**
 Structural Grade: **0**
 O&M Grade: **3**
 Clock Start/From: **9**
 Clock To: **3**
 1st Value:
 2nd Value:
 Value Percent: **10.000**
 Continuous Index: **F03**
 Within 8" of Joint: **YES**
 Remarks:
