Profile/Photo Observation Report

Date:	11/11/2021	Weather:		Coding:	PACP 7.0
Pipe Length (ft):	141.6	Owner:	City of Hobart	Pre Clean:	Heavy Cleaning
P.O.#:	YES502259	Surveyor:	Steven Bucklin	PSR:	P-605-022-023
Customer:	City of Hobart, IN (Red	Clean Date:	11/10/2021	Shape:	C

Street:	West 2nd Street	Flow Control:	Not Controlled
City:	City of Hobart	Year Renewed:	
Location:	Local rural streets with light traffic, t	Tape/Media #:	
Purpose:	Routine Assessment	Dia/Height:	10"
Use:	Sanitary Sewage Pipe	Material:	VCP
Drain Area:		Lining:	None
Category:	NA		
Comment:			
Location Details:		Direction of Survey:	Upstream
US MH:	M-605-023	DS MH:	M-605-022
		Total Length Surveyed (ft):	141.5

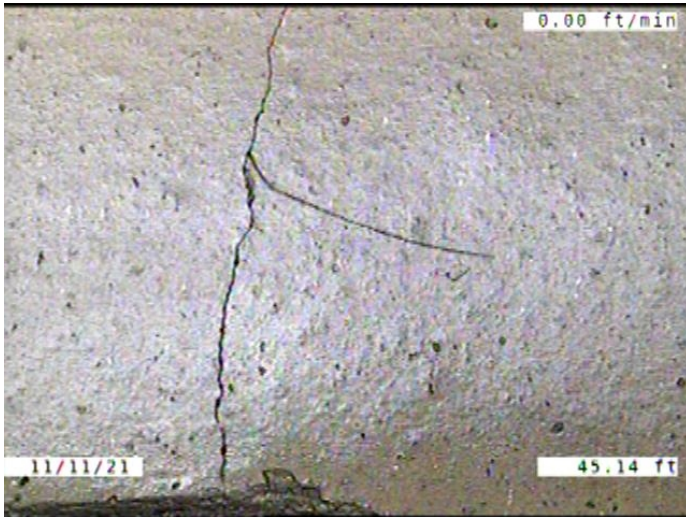
Code: **CM**
Description: **Crack Multiple**

Distance (ft): **45.1**
Structural Grade: **3**
O&M Grade: **0**
Clock Start/From: **8**
Clock To: **1**
1st Value:
2nd Value:
Value Percent:
Continuous Index:
Within 8" of Joint: **YES**
Remarks:

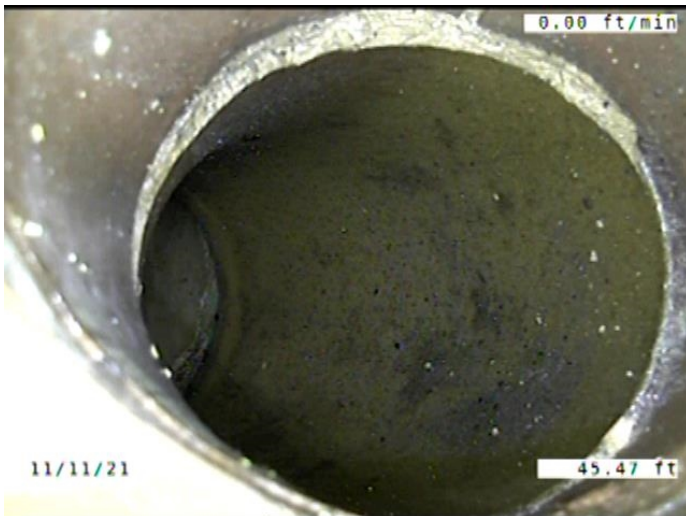
Code: **TFD**
Description: **Tap Factory Defective**

Distance (ft): **45.5**
Structural Grade: **0**
O&M Grade: **3**
Clock Start/From: **11**
Clock To:
1st Value: **4.000**
2nd Value:
Value Percent:
Continuous Index:
Within 8" of Joint: **YES**
Remarks: **BROKEN. SOIL VISIBLE**

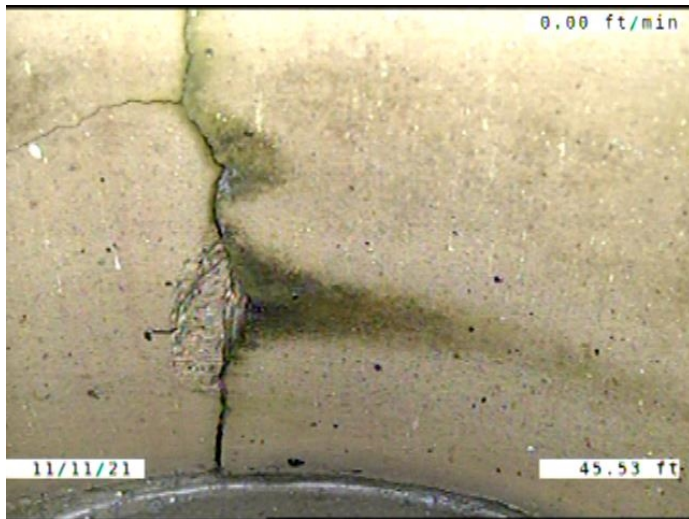
Code: **ISB**
Description: **Infiltration Stain Barrel**

Distance (ft): **45.5**
Structural Grade: **0**
O&M Grade: **1**
Clock Start/From: **1**
Clock To: **2**
1st Value:
2nd Value:
Value Percent:
Continuous Index:
Within 8" of Joint: **YES**
Remarks:

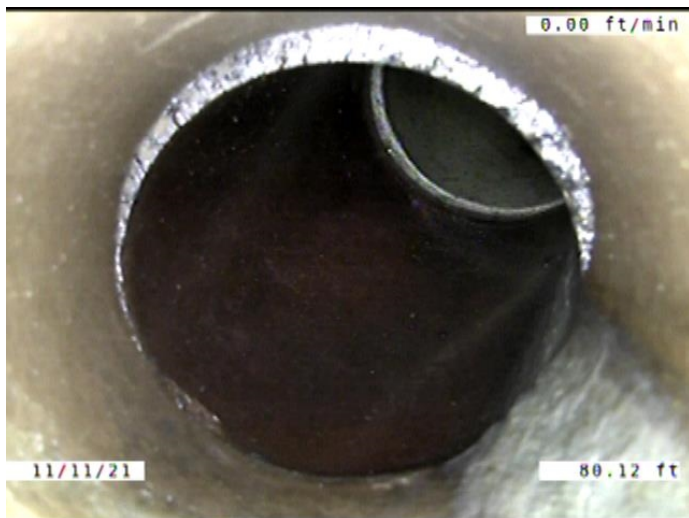
Code: **TF**
Description: **Tap Factory**

Distance (ft): **80.1**
Structural Grade: **0**
O&M Grade: **0**
Clock Start/From: **1**
Clock To:
1st Value: **4.000**
2nd Value:
Value Percent:
Continuous Index:
Within 8" of Joint: **YES**
Remarks: **CONSTANTLY RUNNING WATER**

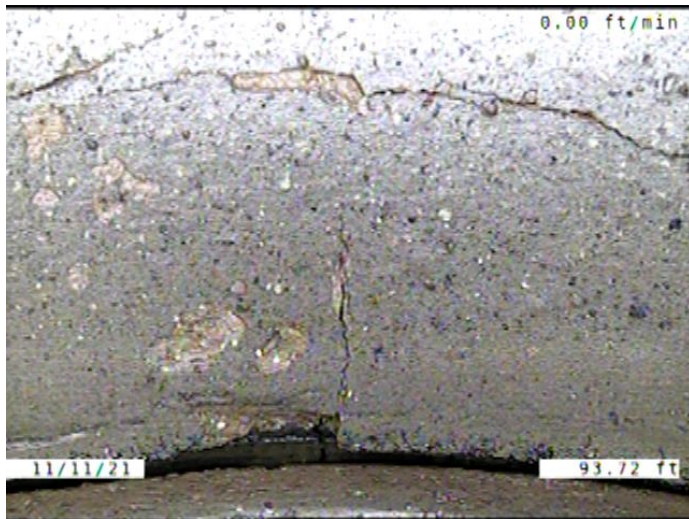
Code: **FM**
 Description: **Fracture Multiple**

Distance (ft): **93.7**
 Structural Grade: **4**
 O&M Grade: **0**
 Clock Start/From: **10**
 Clock To: **1**
 1st Value:
 2nd Value:
 Value Percent:
 Continuous Index:
 Within 8" of Joint: **YES**
 Remarks:

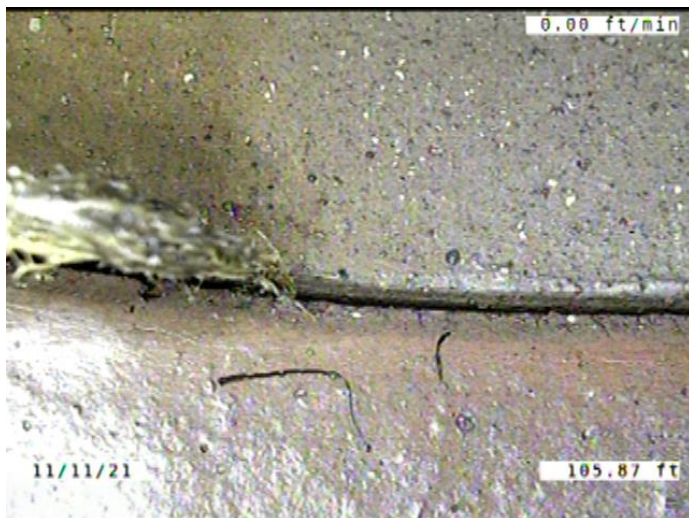
Code: **RFJ**
 Description: **Roots Fine Joint**

Distance (ft): **105.9**
 Structural Grade: **0**
 O&M Grade: **1**
 Clock Start/From: **2**
 Clock To: **3**
 1st Value:
 2nd Value:
 Value Percent:
 Continuous Index:
 Within 8" of Joint: **YES**
 Remarks:

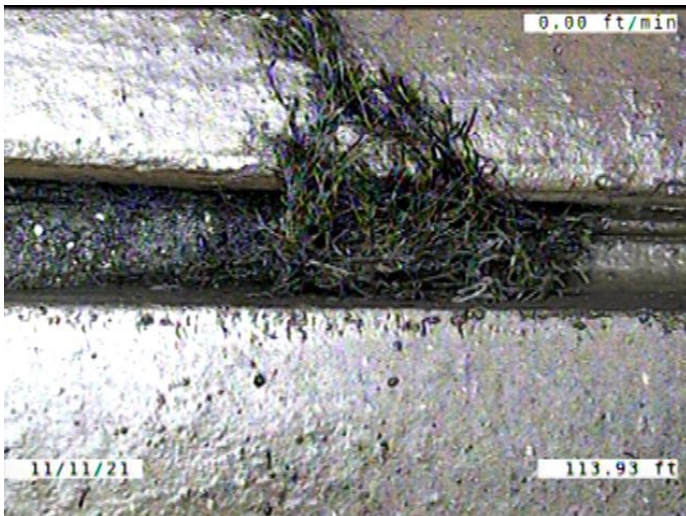
Code: **RFJ**
Description: **Roots Fine Joint**

Distance (ft): **113.9**
Structural Grade: **0**
O&M Grade: **1**
Clock Start/From: **3**
Clock To:
1st Value:
2nd Value:
Value Percent:
Continuous Index:
Within 8" of Joint: **YES**
Remarks:

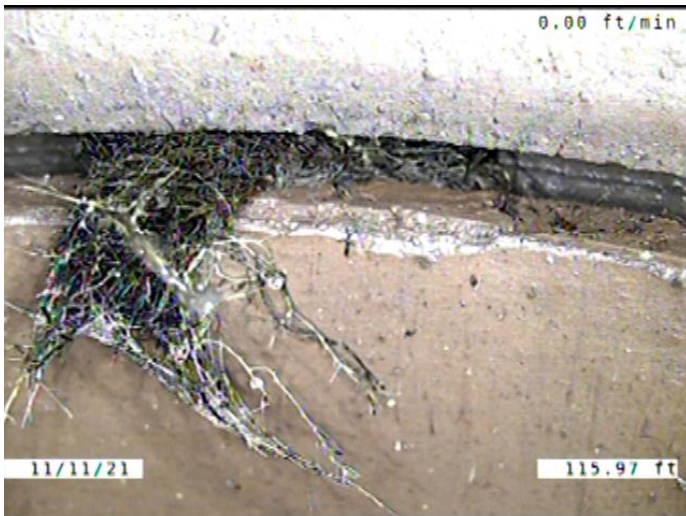
Code: **RFJ**
 Description: **Roots Fine Joint**

Distance (ft): **116.0**
 Structural Grade: **0**
 O&M Grade: **1**
 Clock Start/From: **2**
 Clock To: **3**
 1st Value:
 2nd Value:
 Value Percent:
 Continuous Index:
 Within 8" of Joint: **YES**
 Remarks:

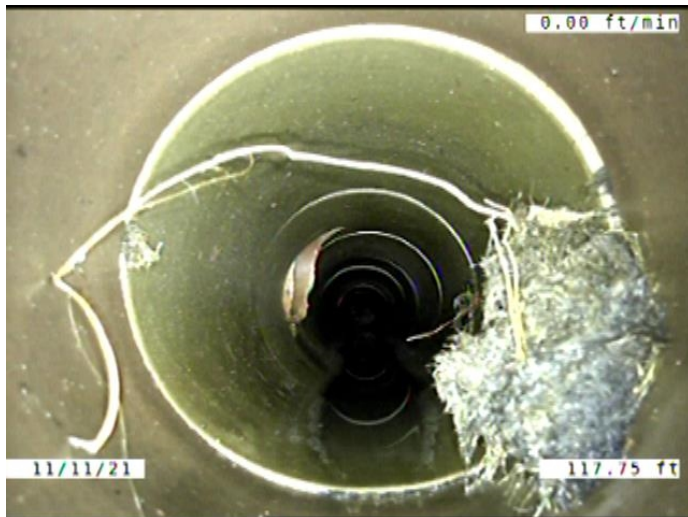
Code: **RMJ**
 Description: **Roots Medium Joint**

Distance (ft): **117.7**
 Structural Grade: **0**
 O&M Grade: **3**
 Clock Start/From: **10**
 Clock To: **5**
 1st Value:
 2nd Value:
 Value Percent: **15.000**
 Continuous Index:
 Within 8" of Joint: **YES**
 Remarks:

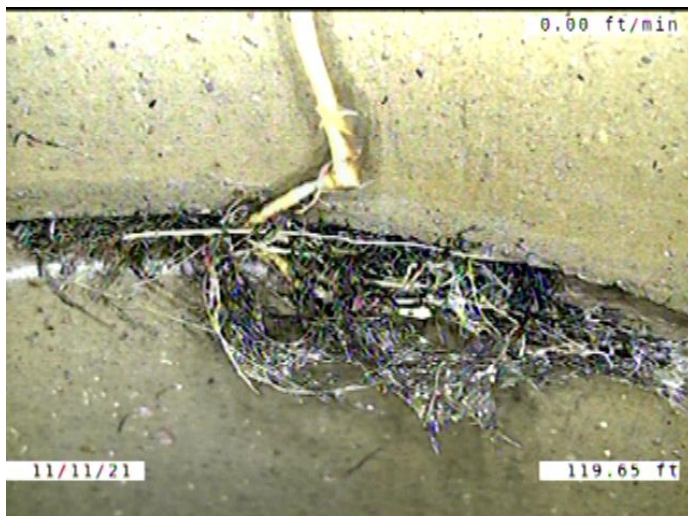
Code: **RFJ**
 Description: **Roots Fine Joint**

Distance (ft): **119.7**
 Structural Grade: **0**
 O&M Grade: **1**
 Clock Start/From: **2**
 Clock To: **4**
 1st Value:
 2nd Value:
 Value Percent:
 Continuous Index:
 Within 8" of Joint: **YES**
 Remarks:

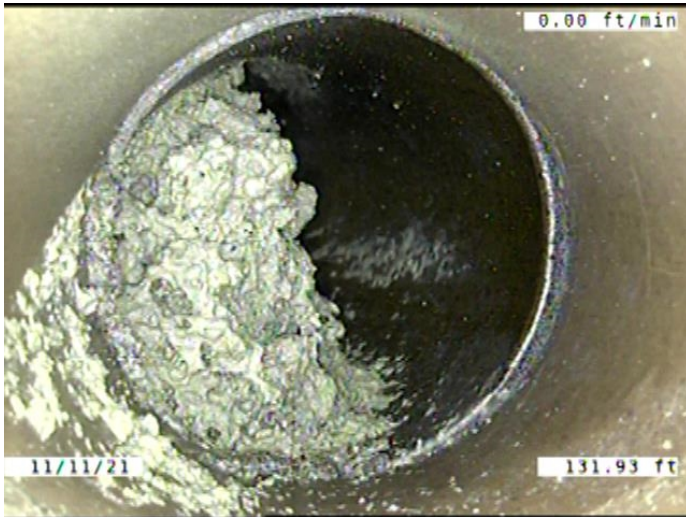
Code: **TFD**
Description: **Tap Factory Defective**

Distance (ft): **131.9**
Structural Grade: **0**
O&M Grade: **3**
Clock Start/From: **11**
Clock To:
1st Value: **4.000**
2nd Value:
Value Percent:
Continuous Index:
Within 8" of Joint: **YES**
Remarks: **LOOKS TO BE 50% PLUGGED WITH SOIL.**

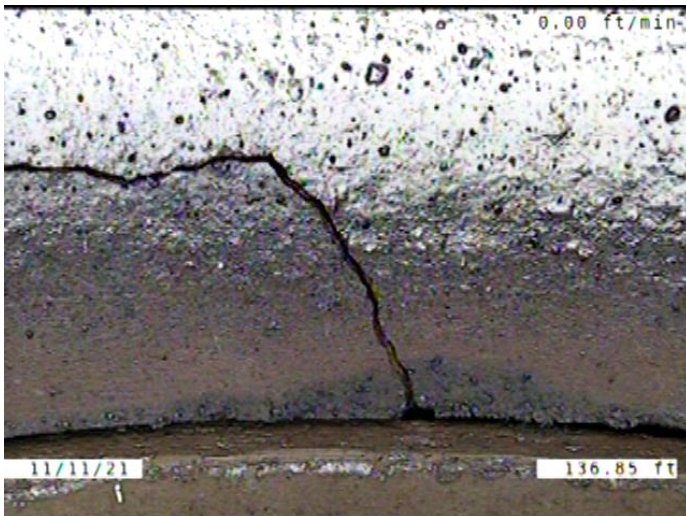
Code: **B**
Description: **Broken**

Distance (ft): **136.8**
Structural Grade: **4**
O&M Grade: **0**
Clock Start/From: **10**
Clock To: **12**
1st Value:
2nd Value:
Value Percent:
Continuous Index:
Within 8" of Joint: **YES**
Remarks:
