## Profile/Photo Observation Report

Date:	11/11/2021	Weather:		Coding:	PACP 7.0
Pipe Length (ft):	141.6	Owner:	City of Hobart	Pre Clean:	Heavy Cleaning
P.O.#:	YES502259	Surveyor:	Steven Bucklin	PSR:	P-605-022-023
Customer:	City of Hobart, IN (Red	Clean Date:	11/10/2021	Shape:	C

Street:	West 2nd Street	Flow Control:	Not Controlled
City:	City of Hobart	Year Renewed:	
Location:	Local rural streets with light traffic, t	Tape/Media #:	
Purpose:	Routine Assessment	Dia/Height:	10"
Use:	Sanitary Sewage Pipe	Material:	VCP
Drain Area:		Lining:	None
Category:	NA		
Comment:			
Location Details:		Direction of Survey:	Upstream
US MH:	M-605-023	DS MH:	M-605-022
		Total Length Surveyed (ft):	141.5

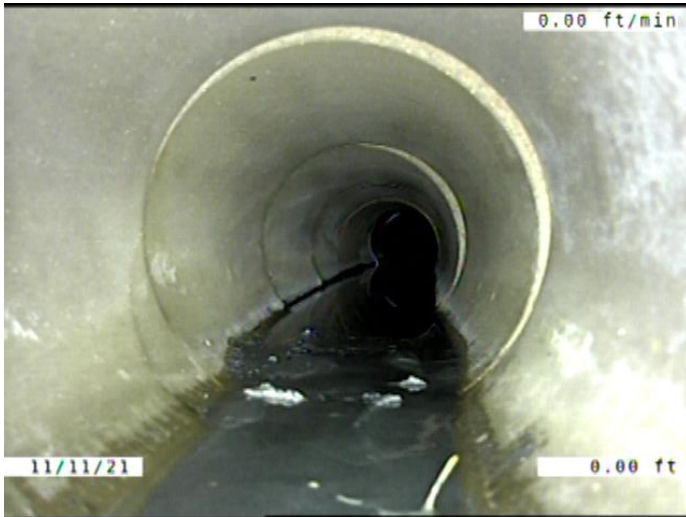
Code: **DSF**  
 Description: **Deposits Settled Fine**

Distance (ft): **.0**  
 Structural Grade: **0**  
 O&M Grade: **2**  
 Clock Start/From: **5**  
 Clock To: **7**  
 1st Value:  
 2nd Value:  
 Value Percent: **5.000**  
 Continuous Index: **S01**  
 Within 8" of Joint: **YES**  
 Remarks:

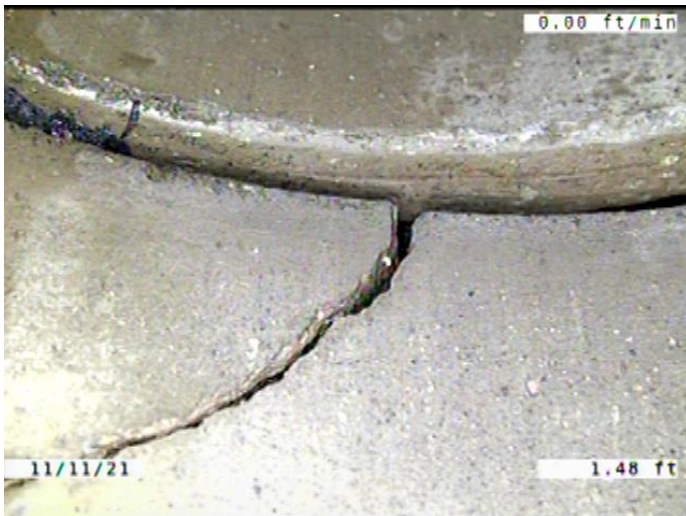
Code: **B**  
 Description: **Broken**

Distance (ft): **1.5**  
 Structural Grade: **4**  
 O&M Grade: **0**  
 Clock Start/From: **3**  
 Clock To: **9**  
 1st Value:  
 2nd Value:  
 Value Percent:  
 Continuous Index:  
 Within 8" of Joint: **YES**  
 Remarks:

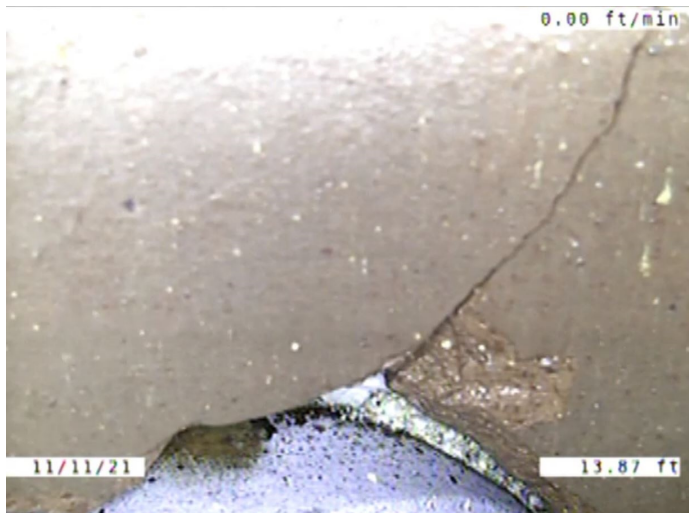
Code: **CL**  
 Description: **Crack Longitudinal**

Distance (ft): **13.9**  
 Structural Grade: **2**  
 O&M Grade: **0**  
 Clock Start/From: **12**  
 Clock To:  
 1st Value:  
 2nd Value:  
 Value Percent:  
 Continuous Index:  
 Within 8" of Joint: **NO**  
 Remarks:

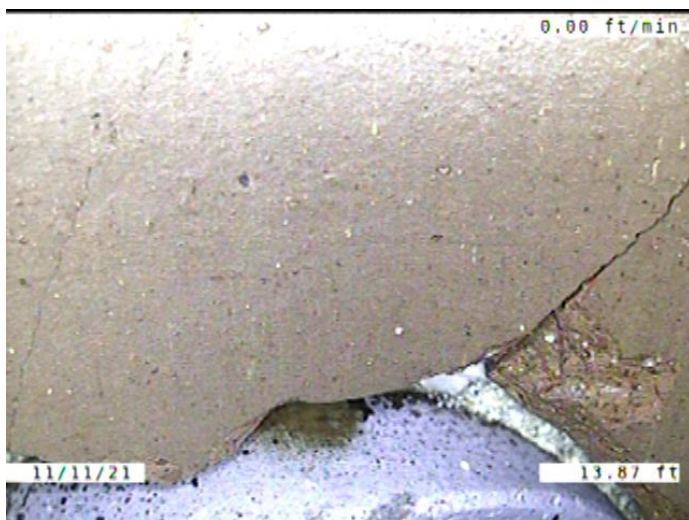
Code: **SSS**  
 Description: **Surface Damage Surface Spalling**

Distance (ft): **13.9**  
 Structural Grade: **2**  
 O&M Grade: **0**  
 Clock Start/From: **10**  
 Clock To: **1**  
 1st Value:  
 2nd Value:  
 Value Percent:  
 Continuous Index:  
 Within 8" of Joint: **YES**  
 Remarks:

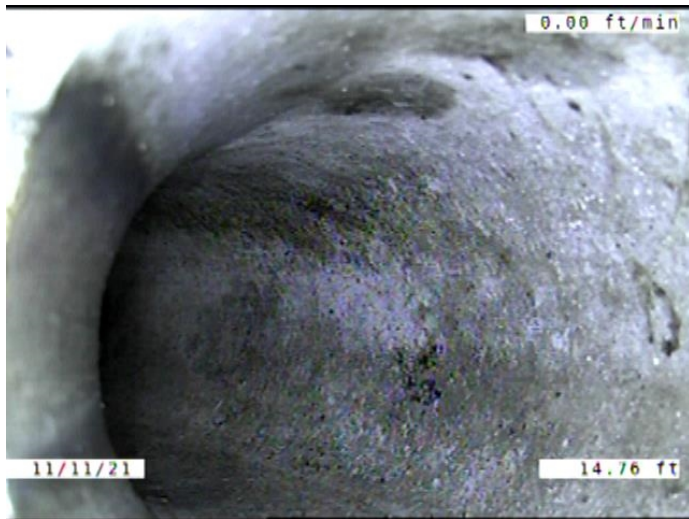
Code: **TBI**  
 Description: **Tap Break-in Intruding**

Distance (ft): **14.8**  
 Structural Grade: **0**  
 O&M Grade: **2**  
 Clock Start/From: **11**  
 Clock To:  
 1st Value: **4.000**  
 2nd Value: **1.000**  
 Value Percent:  
 Continuous Index:  
 Within 8" of Joint: **YES**  
 Remarks:

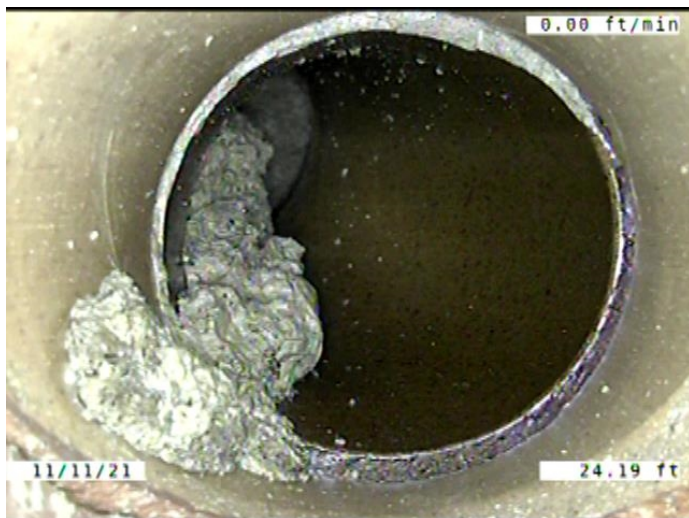
Code: **TFD**  
 Description: **Tap Factory Defective**

Distance (ft): **24.2**  
 Structural Grade: **0**  
 O&M Grade: **3**  
 Clock Start/From: **11**  
 Clock To:  
 1st Value: **4.000**  
 2nd Value:  
 Value Percent:  
 Continuous Index:  
 Within 8" of Joint: **YES**  
 Remarks: **SOIL VISIBLE. LOOKS LIKE IT COULD BE PLUGGED**

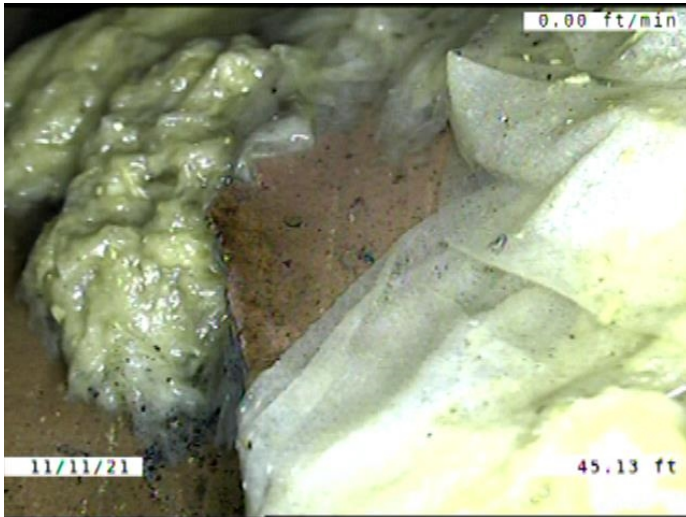
Code:	<b>OBM</b>
Description:	<b>Obstruction Pipe Material in Invert</b>
Distance (ft):	<b>45.1</b>
Structural Grade:	<b>0</b>
O&M Grade:	<b>2</b>
Clock Start/From:	<b>5</b>
Clock To:	<b>7</b>
1st Value:	
2nd Value:	
Value Percent:	<b>5.000</b>
Continuous Index:	
Within 8" of Joint:	<b>YES</b>
Remarks:

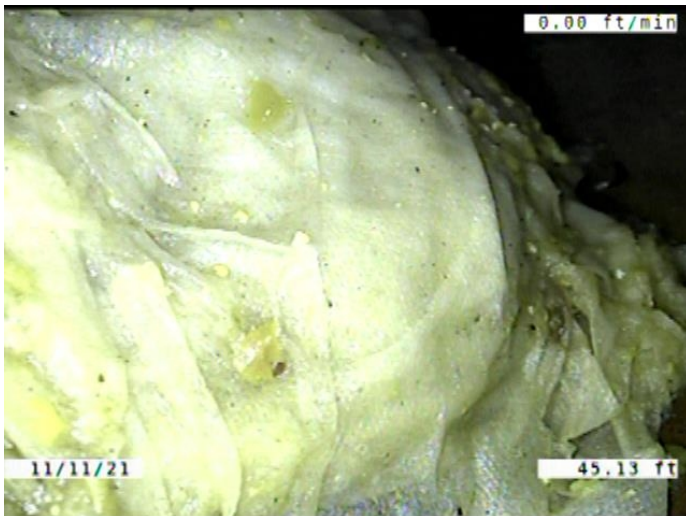
Code:	<b>DAR</b>
Description:	<b>Deposits Attached Ragging</b>
Distance (ft):	<b>45.1</b>
Structural Grade:	<b>0</b>
O&M Grade:	<b>2</b>
Clock Start/From:	<b>5</b>
Clock To:	<b>7</b>
1st Value:	
2nd Value:	
Value Percent:	<b>5.000</b>
Continuous Index:	
Within 8" of Joint:	<b>YES</b>
Remarks:

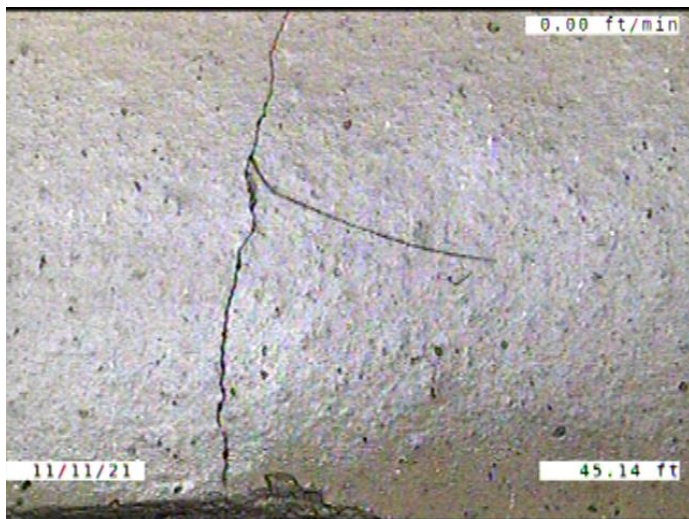
Code: **CM**  
Description: **Crack Multiple**

Distance (ft): **45.1**  
Structural Grade: **3**  
O&M Grade: **0**  
Clock Start/From: **8**  
Clock To: **1**  
1st Value:  
2nd Value:  
Value Percent:  
Continuous Index:  
Within 8" of Joint: **YES**  
Remarks:

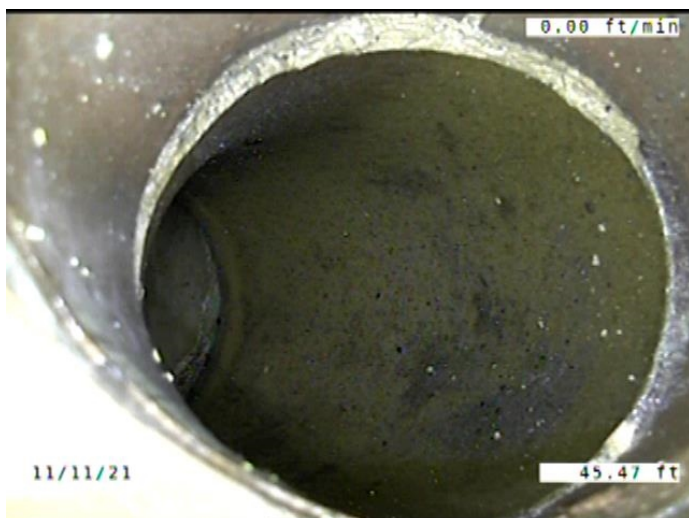
Code: **TFD**  
Description: **Tap Factory Defective**

Distance (ft): **45.5**  
Structural Grade: **0**  
O&M Grade: **3**  
Clock Start/From: **11**  
Clock To:  
1st Value: **4.000**  
2nd Value:  
Value Percent:  
Continuous Index:  
Within 8" of Joint: **YES**  
Remarks: **BROKEN. SOIL VISIBLE**

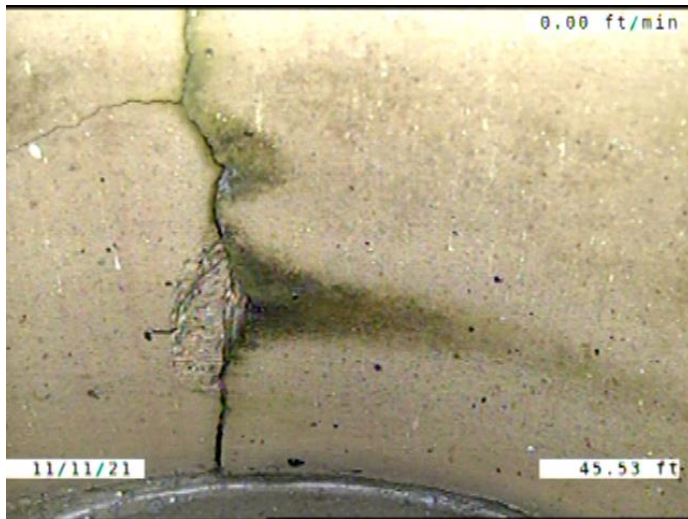
Code: **ISB**  
Description: **Infiltration Stain Barrel**

Distance (ft): **45.5**  
Structural Grade: **0**  
O&M Grade: **1**  
Clock Start/From: **1**  
Clock To: **2**  
1st Value:  
2nd Value:  
Value Percent:  
Continuous Index:  
Within 8" of Joint: **YES**  
Remarks:

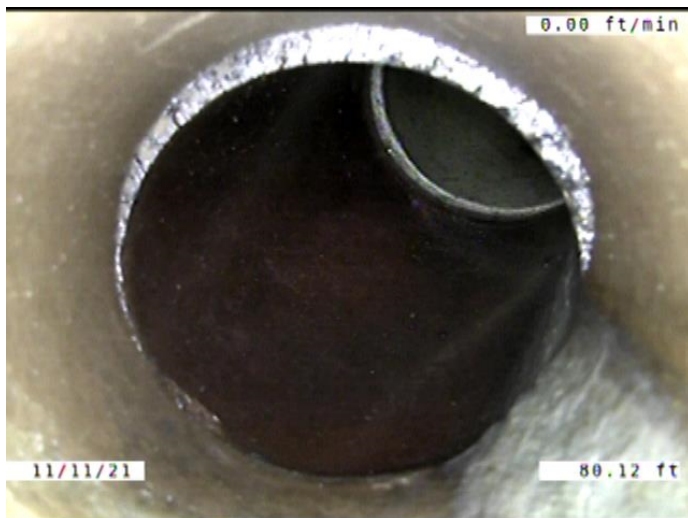
Code: **TF**  
Description: **Tap Factory**

Distance (ft): **80.1**  
Structural Grade: **0**  
O&M Grade: **0**  
Clock Start/From: **1**  
Clock To:  
1st Value: **4.000**  
2nd Value:  
Value Percent:  
Continuous Index:  
Within 8" of Joint: **YES**  
Remarks: **CONSTANTLY RUNNING WATER**

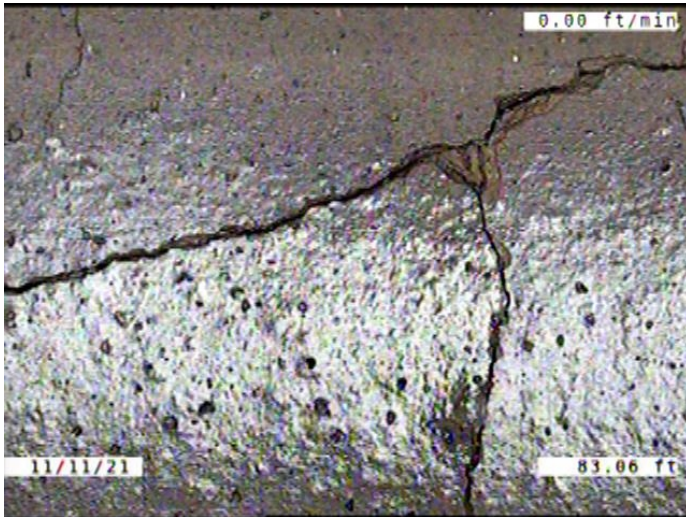
Code: **FM**  
Description: **Fracture Multiple**

Distance (ft): **83.1**  
Structural Grade: **4**  
O&M Grade: **0**  
Clock Start/From: **11**  
Clock To: **5**  
1st Value:  
2nd Value:  
Value Percent:  
Continuous Index:  
Within 8" of Joint: **YES**  
Remarks:

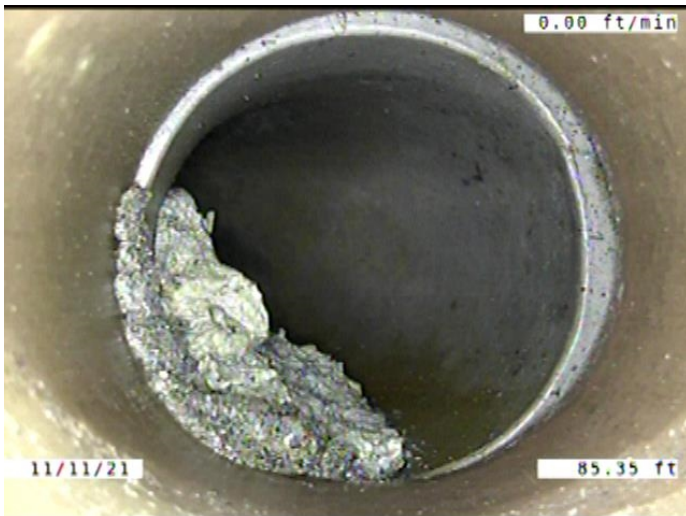
Code: **TF**  
Description: **Tap Factory**

Distance (ft): **85.4**  
Structural Grade: **0**  
O&M Grade: **0**  
Clock Start/From: **11**  
Clock To:  
1st Value: **4.000**  
2nd Value:  
Value Percent:  
Continuous Index:  
Within 8" of Joint: **YES**  
Remarks: **LOOKS TO HAVE SOIL IN THE TAP**

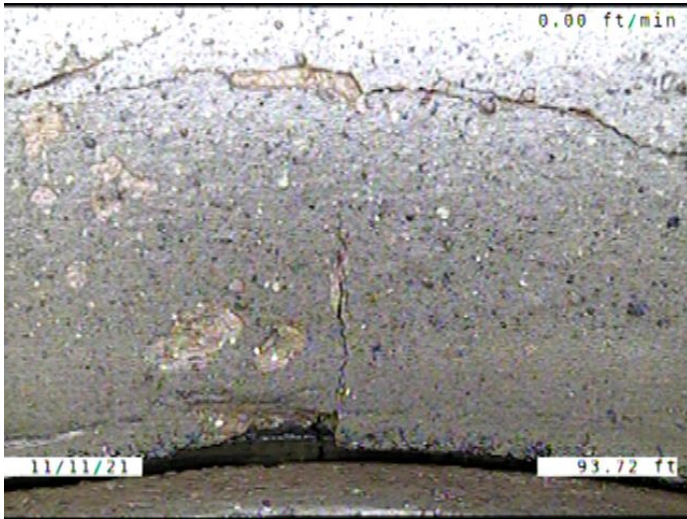
Code: **FM**  
 Description: **Fracture Multiple**

Distance (ft): **93.7**  
 Structural Grade: **4**  
 O&M Grade: **0**  
 Clock Start/From: **10**  
 Clock To: **1**  
 1st Value:  
 2nd Value:  
 Value Percent:  
 Continuous Index:  
 Within 8" of Joint: **YES**  
 Remarks:

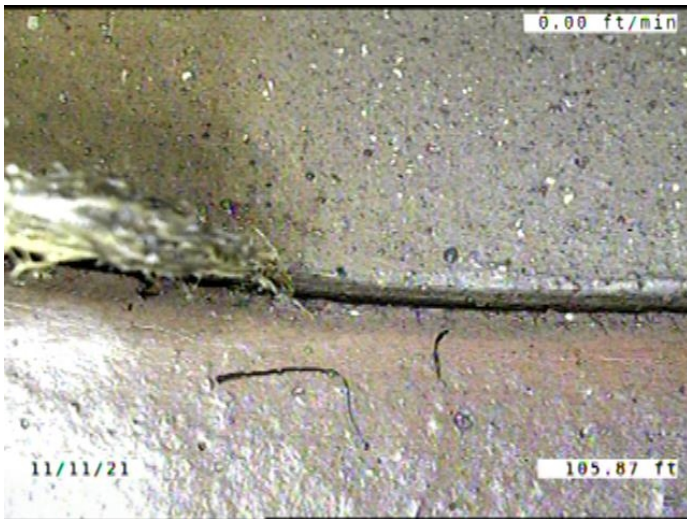
Code: **RFJ**  
 Description: **Roots Fine Joint**

Distance (ft): **105.9**  
 Structural Grade: **0**  
 O&M Grade: **1**  
 Clock Start/From: **2**  
 Clock To: **3**  
 1st Value:  
 2nd Value:  
 Value Percent:  
 Continuous Index:  
 Within 8" of Joint: **YES**  
 Remarks:

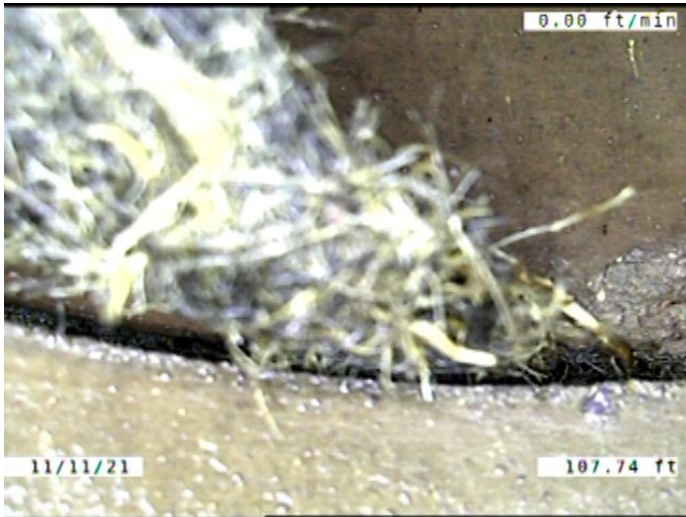
Code: **RFJ**  
Description: **Roots Fine Joint**

Distance (ft): **107.7**  
Structural Grade: **0**  
O&M Grade: **1**  
Clock Start/From: **8**  
Clock To: **3**  
1st Value:  
2nd Value:  
Value Percent:  
Continuous Index:  
Within 8" of Joint: **YES**  
Remarks:

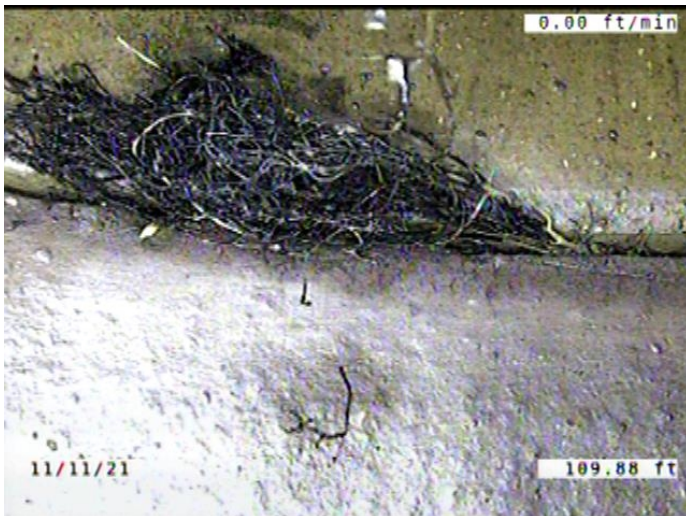
Code: **RFJ**  
Description: **Roots Fine Joint**

Distance (ft): **109.9**  
Structural Grade: **0**  
O&M Grade: **1**  
Clock Start/From: **3**  
Clock To: **4**  
1st Value:  
2nd Value:  
Value Percent:  
Continuous Index:  
Within 8" of Joint: **YES**  
Remarks:

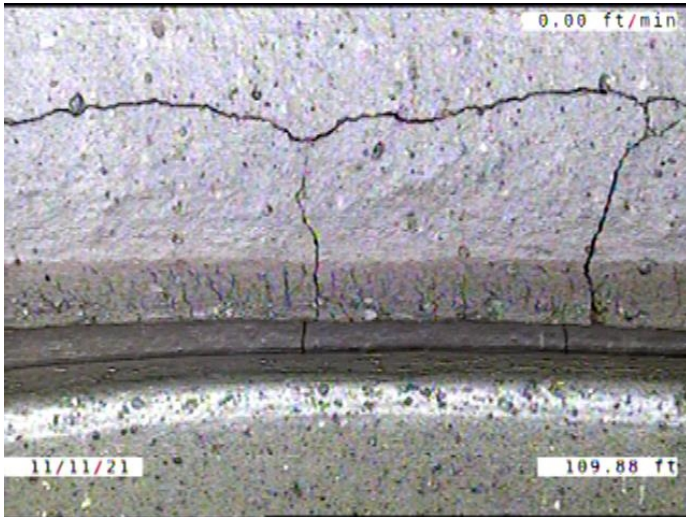
Code: **FM**  
 Description: **Fracture Multiple**

Distance (ft): **109.9**  
 Structural Grade: **4**  
 O&M Grade: **0**  
 Clock Start/From: **10**  
 Clock To: **3**  
 1st Value:  
 2nd Value:  
 Value Percent:  
 Continuous Index:  
 Within 8" of Joint: **YES**  
 Remarks:

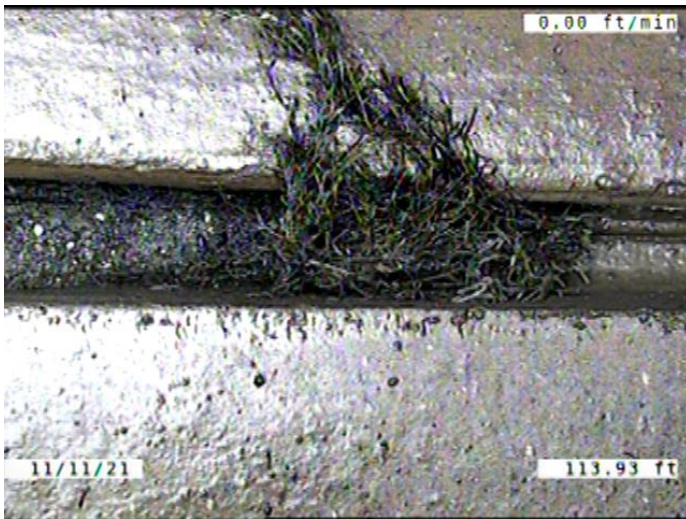
Code: **RFJ**  
 Description: **Roots Fine Joint**

Distance (ft): **113.9**  
 Structural Grade: **0**  
 O&M Grade: **1**  
 Clock Start/From: **3**  
 Clock To:  
 1st Value:  
 2nd Value:  
 Value Percent:  
 Continuous Index:  
 Within 8" of Joint: **YES**  
 Remarks:

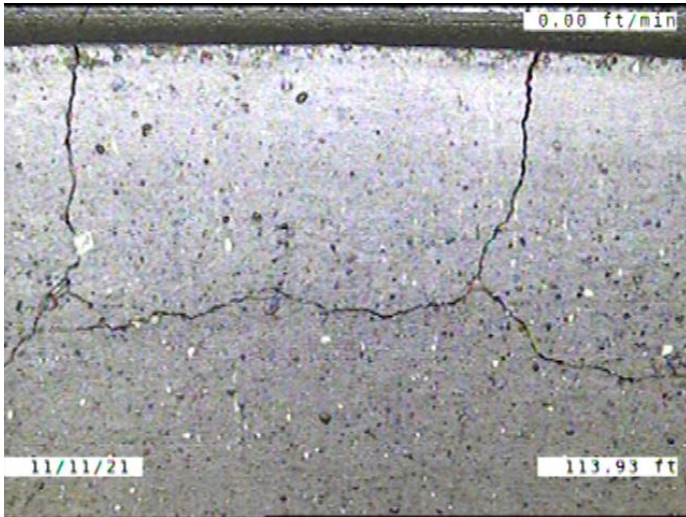
Code: **CM**  
 Description: **Crack Multiple**

Distance (ft): **113.9**  
 Structural Grade: **3**  
 O&M Grade: **0**  
 Clock Start/From: **9**  
 Clock To: **4**  
 1st Value:  
 2nd Value:  
 Value Percent:  
 Continuous Index:  
 Within 8" of Joint: **YES**  
 Remarks:

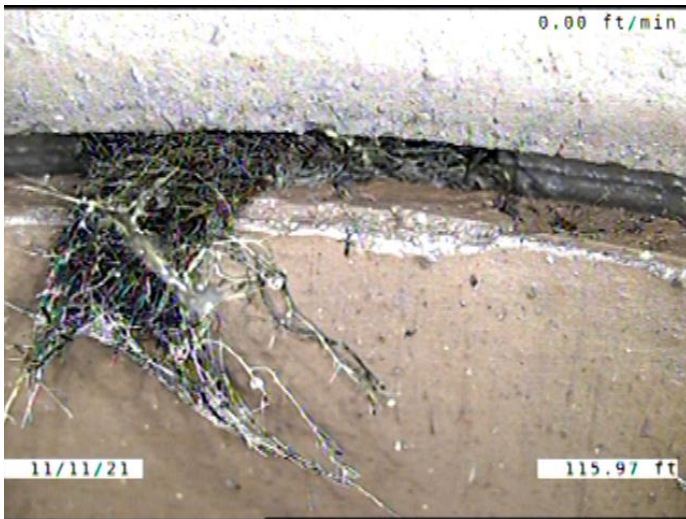
Code: **RFJ**  
 Description: **Roots Fine Joint**

Distance (ft): **116.0**  
 Structural Grade: **0**  
 O&M Grade: **1**  
 Clock Start/From: **2**  
 Clock To: **3**  
 1st Value:  
 2nd Value:  
 Value Percent:  
 Continuous Index:  
 Within 8" of Joint: **YES**  
 Remarks:

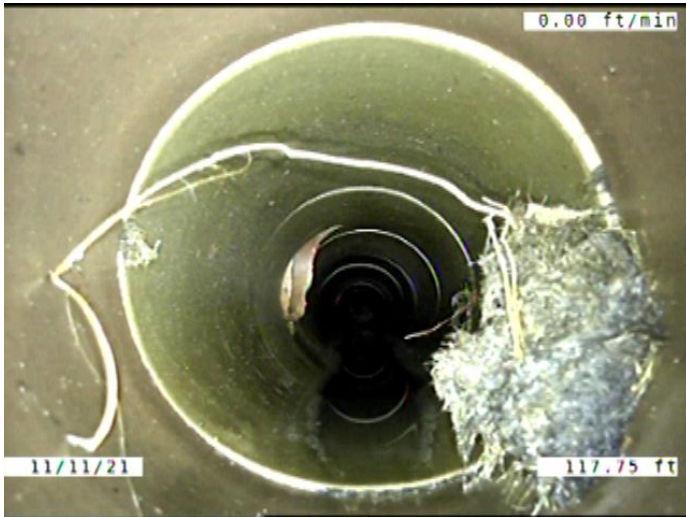
Code: **RMJ**  
 Description: **Roots Medium Joint**

Distance (ft): **117.7**  
 Structural Grade: **0**  
 O&M Grade: **3**  
 Clock Start/From: **10**  
 Clock To: **5**  
 1st Value:  
 2nd Value:  
 Value Percent: **15.000**  
 Continuous Index:  
 Within 8" of Joint: **YES**  
 Remarks:

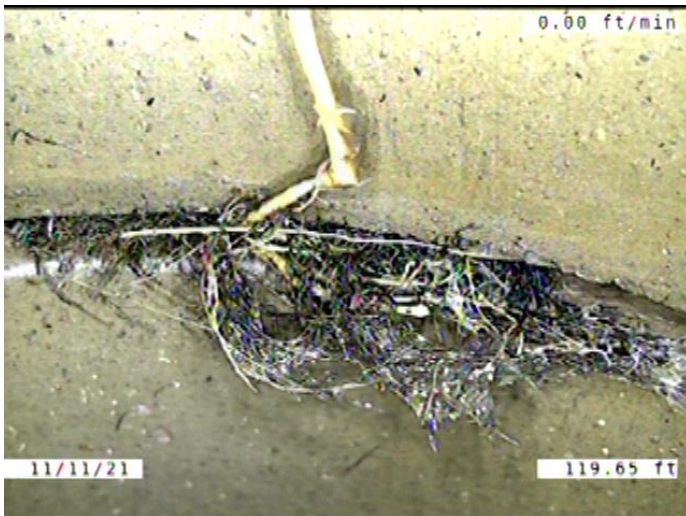
Code: **RFJ**  
 Description: **Roots Fine Joint**

Distance (ft): **119.7**  
 Structural Grade: **0**  
 O&M Grade: **1**  
 Clock Start/From: **2**  
 Clock To: **4**  
 1st Value:  
 2nd Value:  
 Value Percent:  
 Continuous Index:  
 Within 8" of Joint: **YES**  
 Remarks:

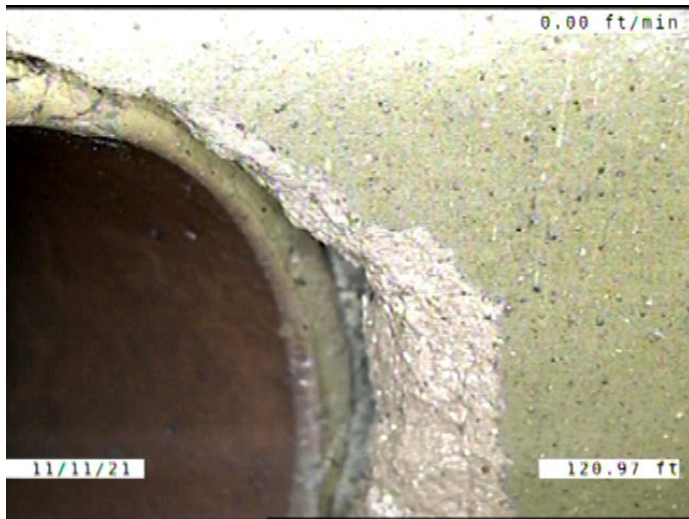
Code: **SSS**  
 Description: **Surface Damage Surface Spalling**

Distance (ft): **121.0**  
 Structural Grade: **2**  
 O&M Grade: **0**  
 Clock Start/From: **9**  
 Clock To: **1**  
 1st Value:  
 2nd Value:  
 Value Percent:  
 Continuous Index:  
 Within 8" of Joint: **YES**  
 Remarks:

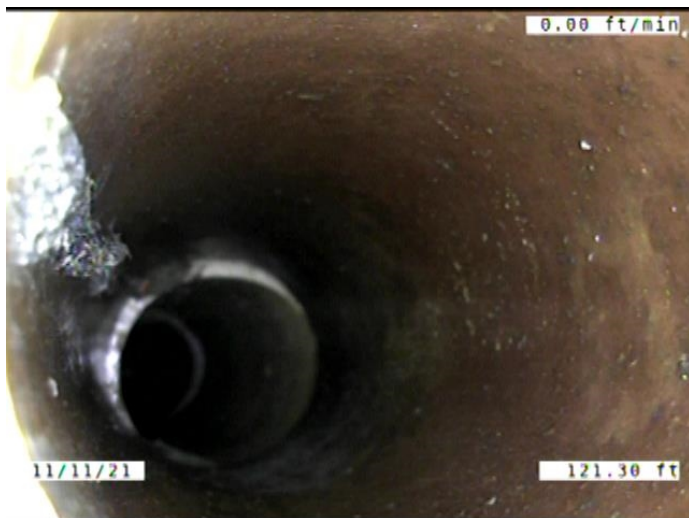
Code: **TBI**  
 Description: **Tap Break-in Intruding**

Distance (ft): **121.3**  
 Structural Grade: **0**  
 O&M Grade: **2**  
 Clock Start/From: **10**  
 Clock To:  
 1st Value: **4.000**  
 2nd Value: **1.000**  
 Value Percent:  
 Continuous Index:  
 Within 8" of Joint: **YES**  
 Remarks: **ROOTS GROWING FROM THE JOINTS**

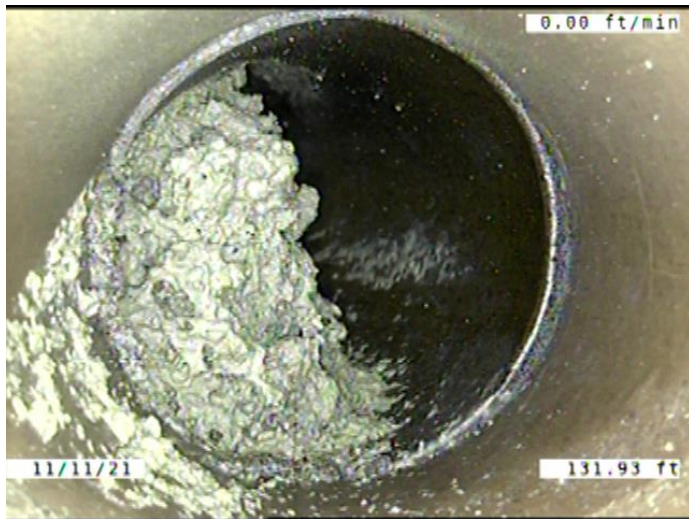
Code: **TFD**  
 Description: **Tap Factory Defective**

Distance (ft): **131.9**  
 Structural Grade: **0**  
 O&M Grade: **3**  
 Clock Start/From: **11**  
 Clock To:  
 1st Value: **4.000**  
 2nd Value:  
 Value Percent:  
 Continuous Index:  
 Within 8" of Joint: **YES**  
 Remarks: **LOOKS TO BE 50% PLUGGED WITH SOIL.**

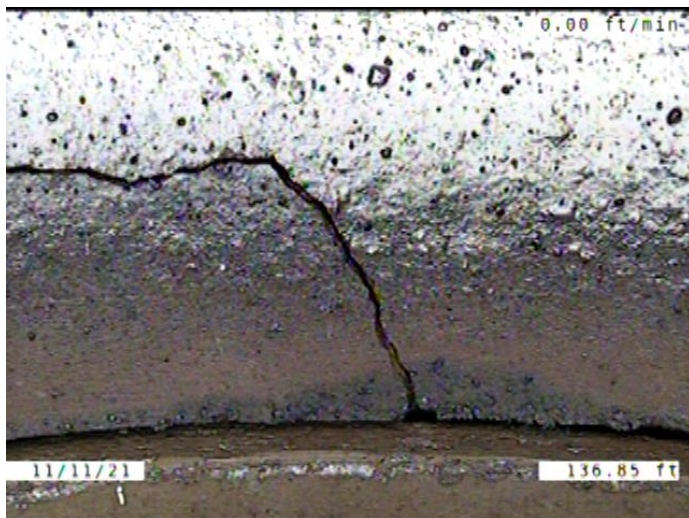
Code: **B**  
 Description: **Broken**

Distance (ft): **136.8**  
 Structural Grade: **4**  
 O&M Grade: **0**  
 Clock Start/From: **10**  
 Clock To: **12**  
 1st Value:  
 2nd Value:  
 Value Percent:  
 Continuous Index:  
 Within 8" of Joint: **YES**  
 Remarks:

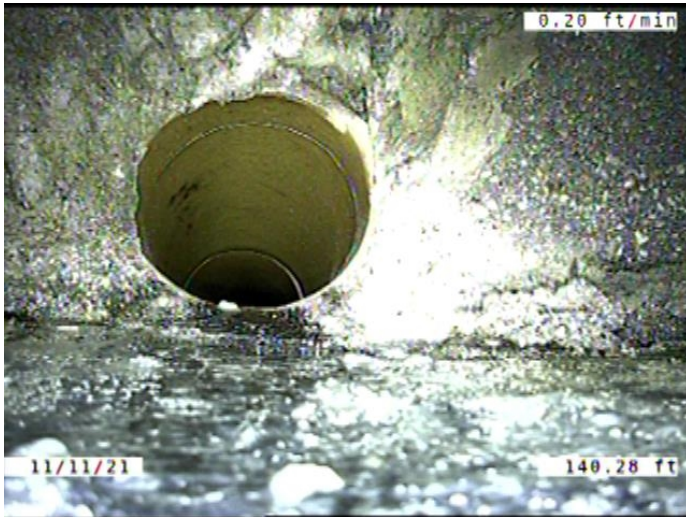
Code: **DSF**  
 Description: **Deposits Settled Fine**

Distance (ft): **140.3**  
 Structural Grade: **0**  
 O&M Grade: **2**  
 Clock Start/From: **5**  
 Clock To: **7**  
 1st Value:  
 2nd Value:  
 Value Percent: **5.000**  
 Continuous Index: **F01**  
 Within 8" of Joint: **YES**  
 Remarks:
