Street:	West 2nd Street		Flow Control:	Not Controlled	
City:	City of Hobart		Year Renewed:		
Location:	Local rural streets with light traffic, t		Tape/Media #:		
Purpose:	Routine Assessment		Dia/Height:	10"	
Use:	Sanitary Sewage Pipe		Material:	VCP	
Drain Area:			Lining:	None	
Category:	NA				
Comment:					
Location Details:			Direction of Survey:	Upstream	
US MH:	M-605-023	DS MH:	M-605-024	Total Length Surveyed (ft):	140.7

Tuesday, April 25, 2023

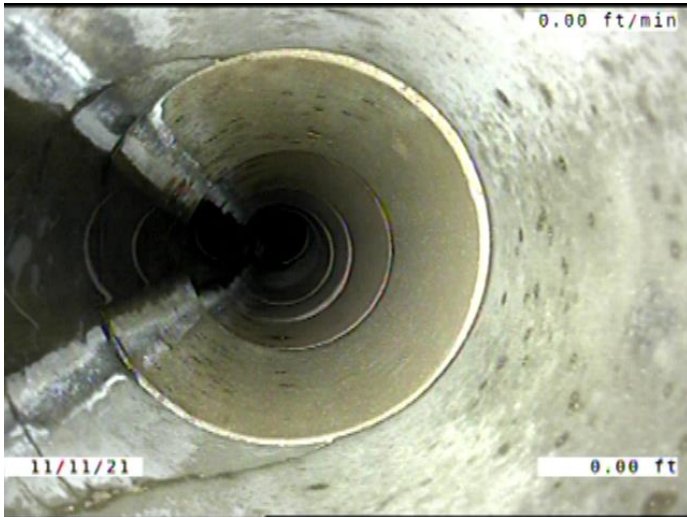
Code: **MWL**
 Description: **Miscellaneous Water Level**

Distance (ft): **.0**
 Structural Grade: **0**
 O&M Grade: **0**
 Clock Start/From:
 Clock To:
 1st Value:
 2nd Value:
 Value Percent: **5.000**
 Continuous Index:
 Within 8" of Joint: **NO**
 Remarks:

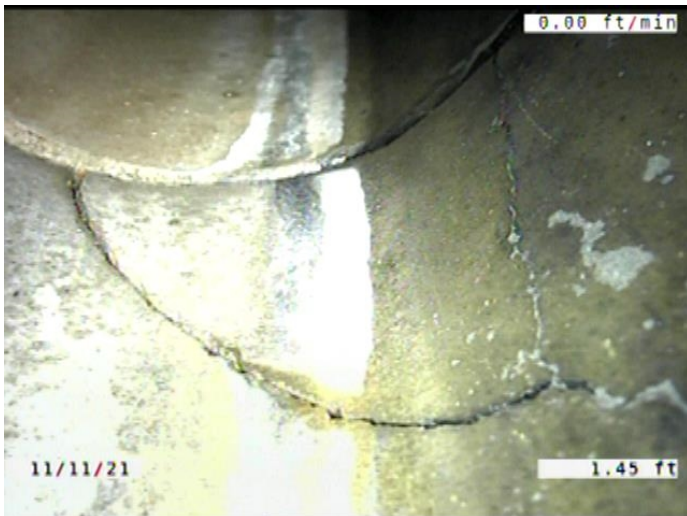
Code: **B**
 Description: **Broken**

Distance (ft): **1.4**
 Structural Grade: **4**
 O&M Grade: **0**
 Clock Start/From: **3**
 Clock To: **9**
 1st Value:
 2nd Value:
 Value Percent:
 Continuous Index:
 Within 8" of Joint: **YES**
 Remarks:

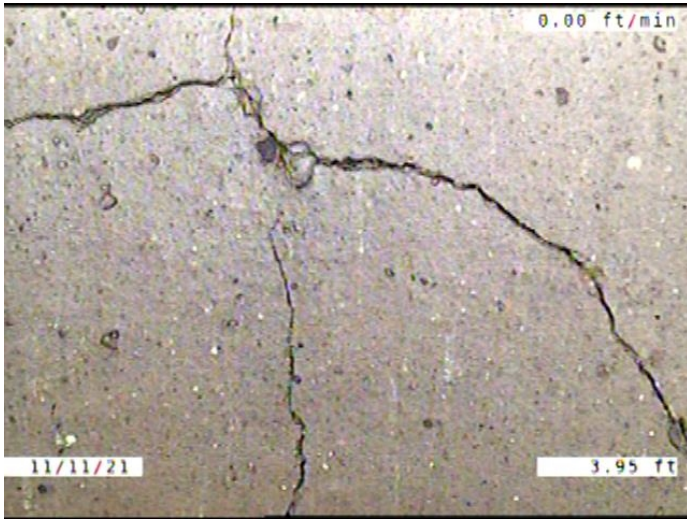
Code: **FM**
 Description: **Fracture Multiple**

Distance (ft): **4.0**
 Structural Grade: **4**
 O&M Grade: **0**
 Clock Start/From: **11**
 Clock To: **3**
 1st Value:
 2nd Value:
 Value Percent:
 Continuous Index:
 Within 8" of Joint: **YES**
 Remarks:

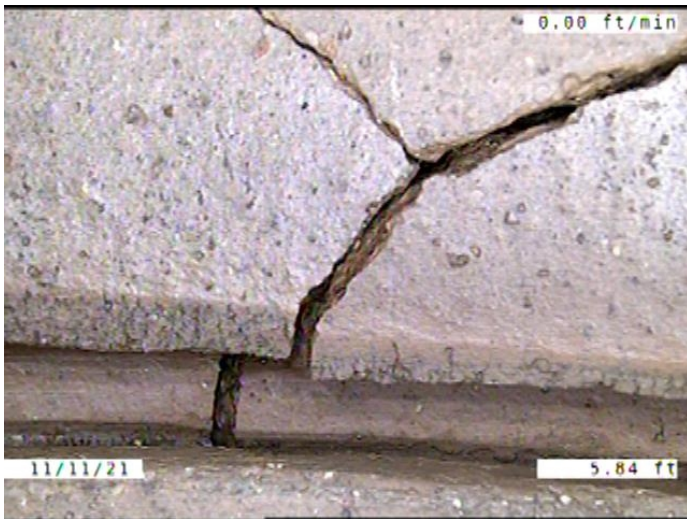
Code: **B**
 Description: **Broken**

Distance (ft): **5.8**
 Structural Grade: **4**
 O&M Grade: **0**
 Clock Start/From: **11**
 Clock To: **3**
 1st Value:
 2nd Value:
 Value Percent:
 Continuous Index:
 Within 8" of Joint: **YES**
 Remarks:

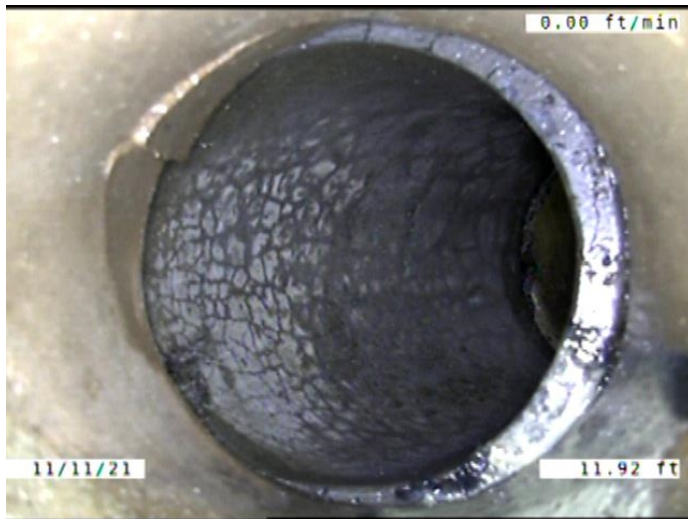
Code: **TFD**
 Description: **Tap Factory Defective**

Distance (ft): **11.9**
 Structural Grade: **0**
 O&M Grade: **3**
 Clock Start/From: **1**
 Clock To:
 1st Value: **4.000**
 2nd Value:
 Value Percent:
 Continuous Index:
 Within 8" of Joint: **YES**
 Remarks: **BROKEN. OFFSET.**

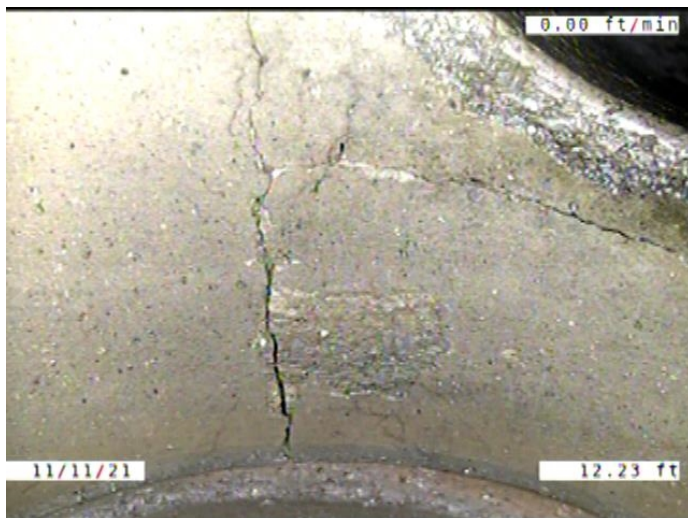
Code: **FM**
 Description: **Fracture Multiple**

Distance (ft): **12.2**
 Structural Grade: **4**
 O&M Grade: **0**
 Clock Start/From: **12**
 Clock To: **3**
 1st Value:
 2nd Value:
 Value Percent:
 Continuous Index:
 Within 8" of Joint: **YES**
 Remarks:

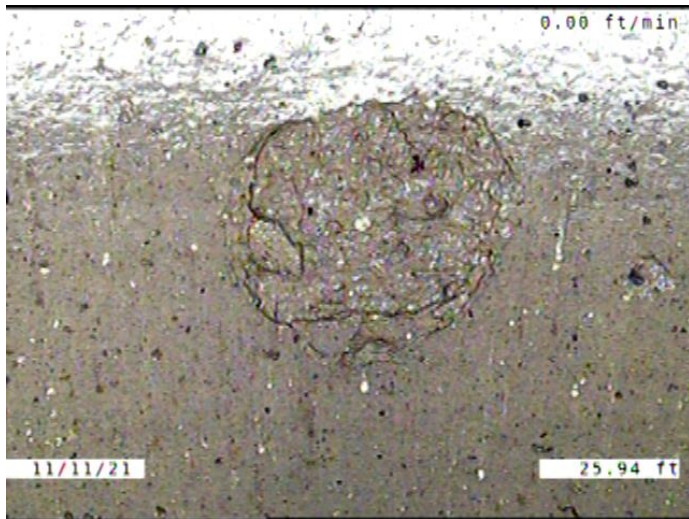
Code: **SSS**
Description: **Surface Damage Surface Spalling**

Distance (ft): **25.9**
Structural Grade: **2**
O&M Grade: **0**
Clock Start/From: **11**
Clock To: **12**
1st Value:
2nd Value:
Value Percent:
Continuous Index:
Within 8" of Joint: **NO**
Remarks:

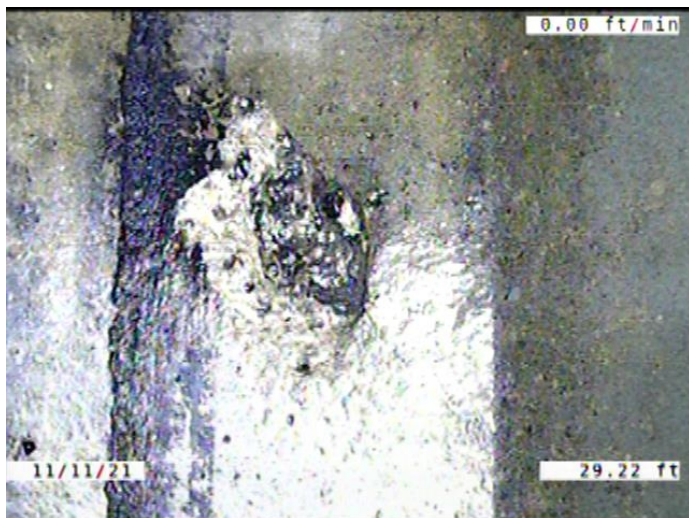
Code: **SSS**
Description: **Surface Damage Surface Spalling**

Distance (ft): **29.2**
Structural Grade: **2**
O&M Grade: **0**
Clock Start/From: **8**
Clock To:
1st Value:
2nd Value:
Value Percent:
Continuous Index:
Within 8" of Joint: **NO**
Remarks:

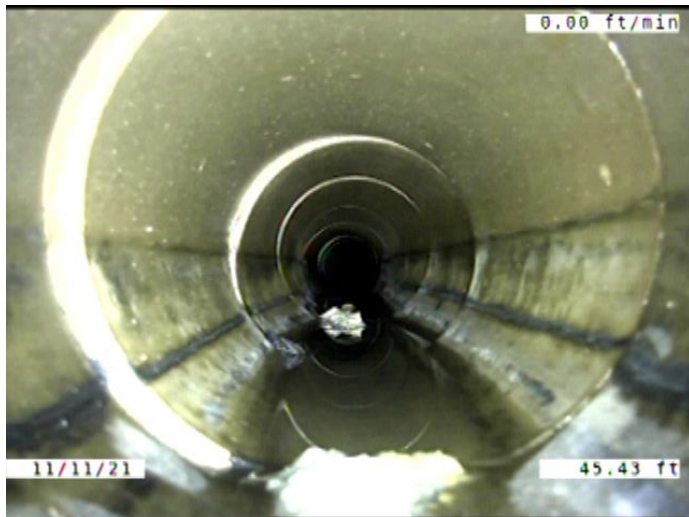
Code: **DSF**
 Description: **Deposits Settled Fine**

Distance (ft): **45.4**
 Structural Grade: **0**
 O&M Grade: **2**
 Clock Start/From: **6**
 Clock To:
 1st Value:
 2nd Value:
 Value Percent: **5.000**
 Continuous Index:
 Within 8" of Joint: **YES**
 Remarks:

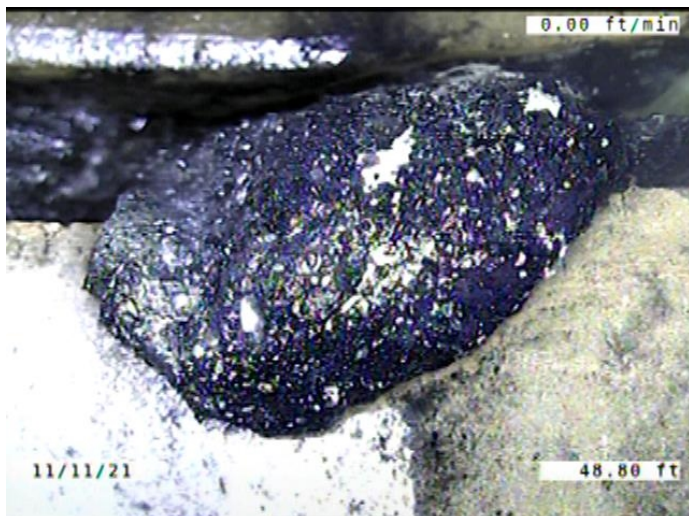
Code: **DAE**
 Description: **Deposits Attached Encrustation**

Distance (ft): **48.8**
 Structural Grade: **0**
 O&M Grade: **2**
 Clock Start/From: **7**
 Clock To:
 1st Value:
 2nd Value:
 Value Percent: **5.000**
 Continuous Index:
 Within 8" of Joint: **YES**
 Remarks:

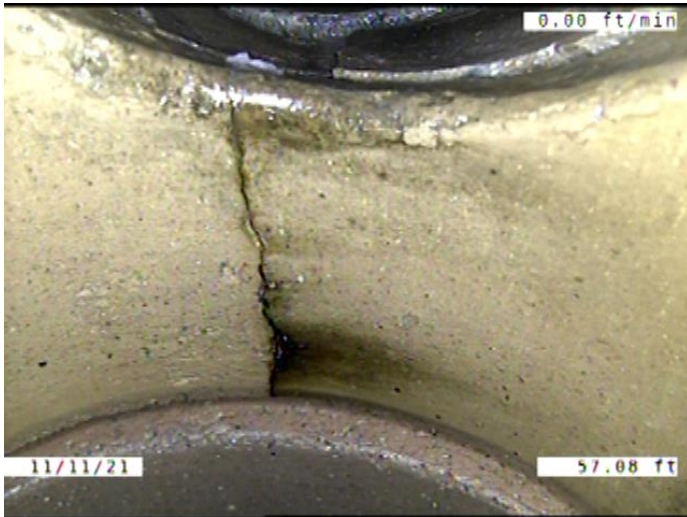
Code: **CM**
Description: **Crack Multiple**

Distance (ft): **57.1**
Structural Grade: **3**
O&M Grade: **0**
Clock Start/From: **1**
Clock To: **3**
1st Value:
2nd Value:
Value Percent:
Continuous Index:
Within 8" of Joint: **YES**
Remarks:

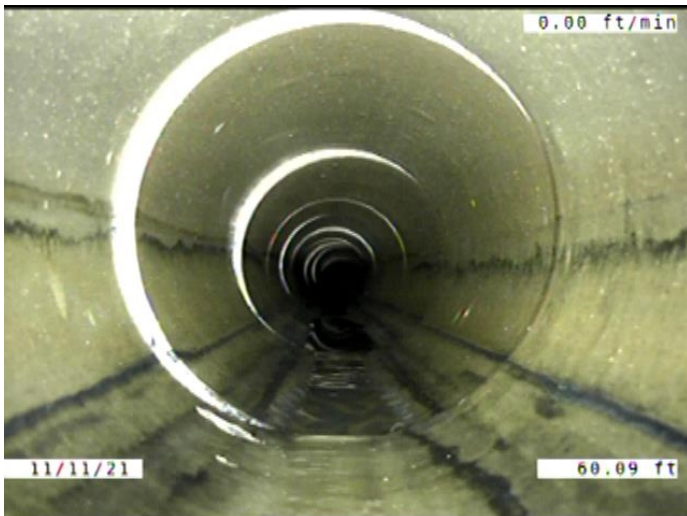
Code: **MWLS**
Description: **Miscellaneous Water Level Sag**

Distance (ft): **60.1**
Structural Grade: **2**
O&M Grade: **0**
Clock Start/From:
Clock To:
1st Value:
2nd Value:
Value Percent: **5.000**
Continuous Index: **F03**
Within 8" of Joint: **NO**
Remarks:
