Street:	West 2nd Street		Flow Control:	Not Controlled	
City:	City of Hobart		Year Renewed:		
Location:	Local rural streets with light traffic, t		Tape/Media #:		
Purpose:	Routine Assessment		Dia/Height:	10"	
Use:	Sanitary Sewage Pipe		Material:	VCP	
Drain Area:			Lining:	None	
Category:	NA				
Comment:					
Location Details:			Direction of Survey:	Upstream	
US MH:	M-605-023	DS MH:	M-605-024	Total Length Surveyed (ft):	140.7

**Wednesday, January 19, 2022**

**M-605-023**

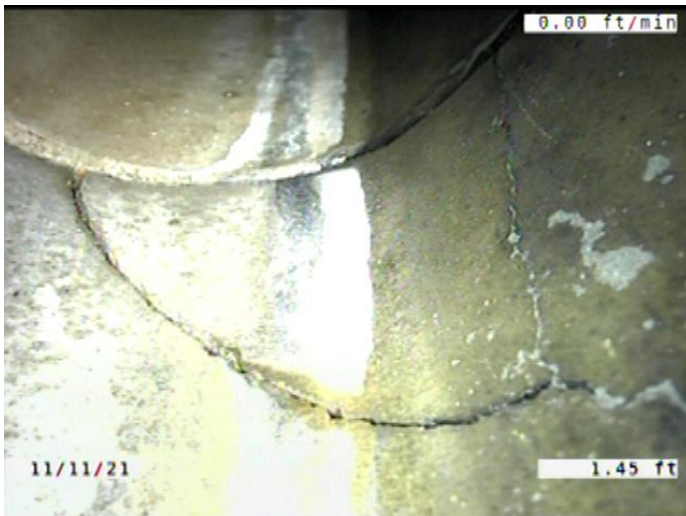
Code: **B**  
 Description: **Broken**

Distance (ft): **1.4**  
 Structural Grade: **4**  
 O&M Grade: **0**  
 Clock Start/From: **3**  
 Clock To: **9**  
 1st Value:  
 2nd Value:  
 Value Percent:  
 Continuous Index:  
 Within 8" of Joint: **YES**  
 Remarks:

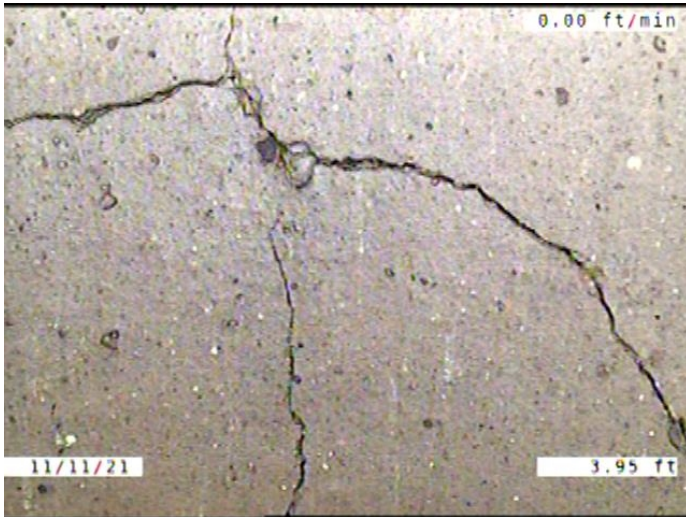
Code: **FM**  
Description: **Fracture Multiple**

Distance (ft): **4.0**  
Structural Grade: **4**  
O&M Grade: **0**  
Clock Start/From: **11**  
Clock To: **3**  
1st Value:  
2nd Value:  
Value Percent:  
Continuous Index:  
Within 8" of Joint: **YES**  
Remarks:

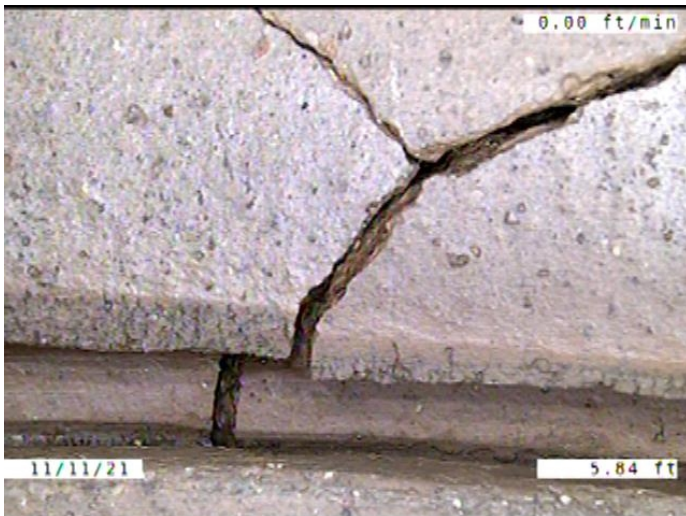
Code: **B**  
Description: **Broken**

Distance (ft): **5.8**  
Structural Grade: **4**  
O&M Grade: **0**  
Clock Start/From: **11**  
Clock To: **3**  
1st Value:  
2nd Value:  
Value Percent:  
Continuous Index:  
Within 8" of Joint: **YES**  
Remarks:

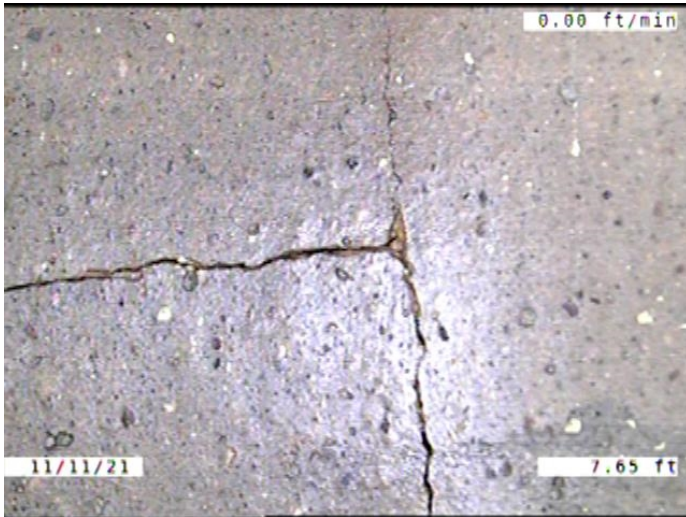
Code: **FM**  
 Description: **Fracture Multiple**

Distance (ft): **7.7**  
 Structural Grade: **4**  
 O&M Grade: **0**  
 Clock Start/From: **9**  
 Clock To: **4**  
 1st Value:  
 2nd Value:  
 Value Percent:  
 Continuous Index:  
 Within 8" of Joint: **YES**  
 Remarks:

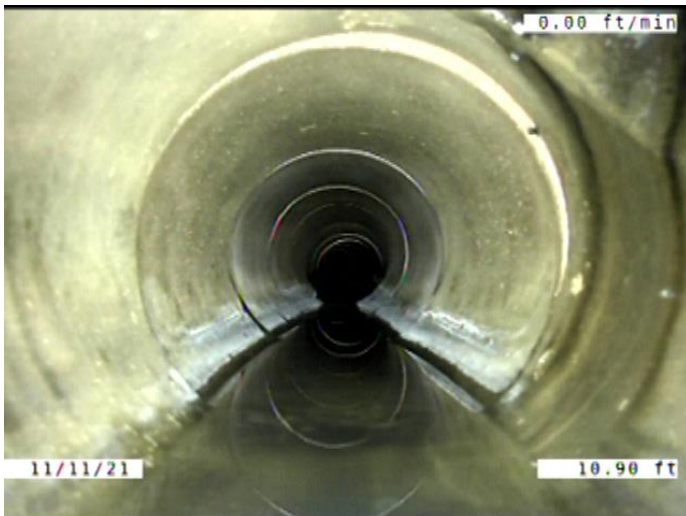
Code: **MWLS**  
 Description: **Miscellaneous Water Level Sag**

Distance (ft): **10.9**  
 Structural Grade: **2**  
 O&M Grade: **0**  
 Clock Start/From:  
 Clock To:  
 1st Value:  
 2nd Value:  
 Value Percent: **5.000**  
 Continuous Index: **S01**  
 Within 8" of Joint: **NO**  
 Remarks:

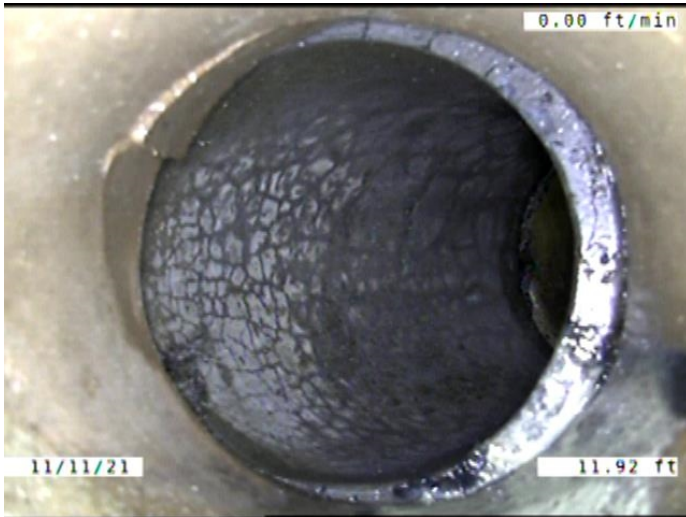
Code: **TFD**  
Description: **Tap Factory Defective**

Distance (ft): **11.9**  
Structural Grade: **0**  
O&M Grade: **3**  
Clock Start/From: **1**  
Clock To:  
1st Value: **4.000**  
2nd Value:  
Value Percent:  
Continuous Index:  
Within 8" of Joint: **YES**  
Remarks: **BROKEN. OFFSET.**

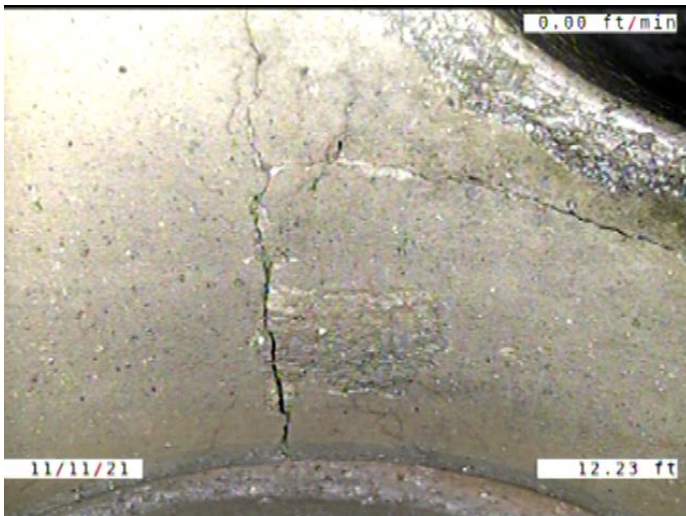
Code: **FM**  
Description: **Fracture Multiple**

Distance (ft): **12.2**  
Structural Grade: **4**  
O&M Grade: **0**  
Clock Start/From: **12**  
Clock To: **3**  
1st Value:  
2nd Value:  
Value Percent:  
Continuous Index:  
Within 8" of Joint: **YES**  
Remarks:

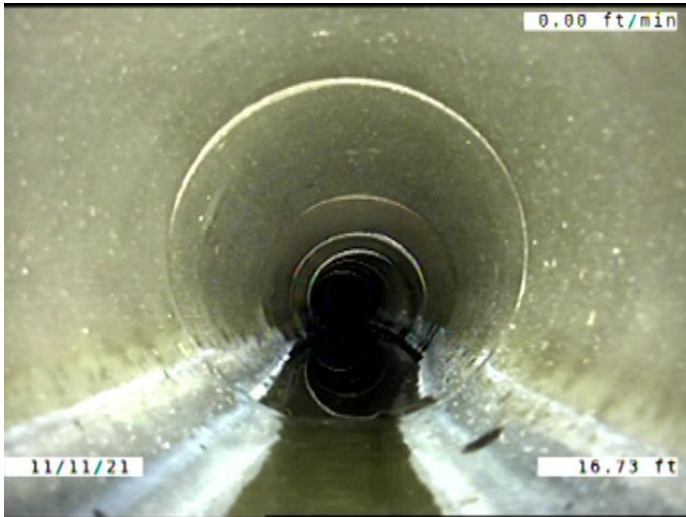
Code: **MWLS**  
Description: **Miscellaneous Water Level Sag**

Distance (ft): **16.7**  
Structural Grade: **2**  
O&M Grade: **0**  
Clock Start/From:  
Clock To:  
1st Value:  
2nd Value:  
Value Percent: **5.000**  
Continuous Index: **F01**  
Within 8" of Joint: **NO**  
Remarks:

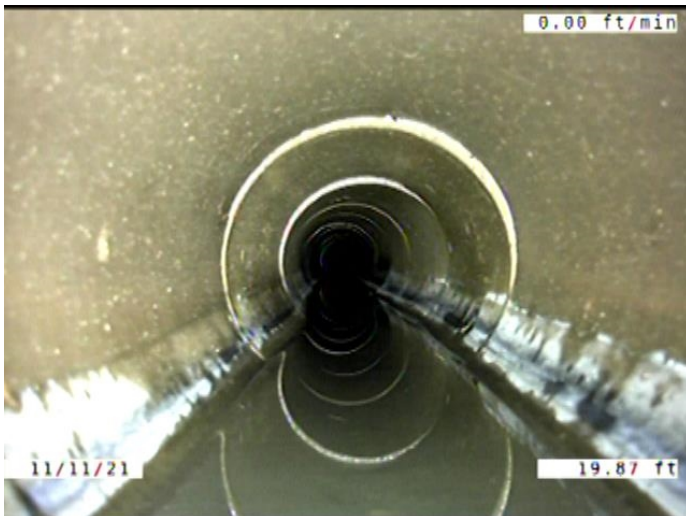
Code: **MWLS**  
Description: **Miscellaneous Water Level Sag**

Distance (ft): **19.9**  
Structural Grade: **2**  
O&M Grade: **0**  
Clock Start/From:  
Clock To:  
1st Value:  
2nd Value:  
Value Percent: **5.000**  
Continuous Index: **S02**  
Within 8" of Joint: **NO**  
Remarks:

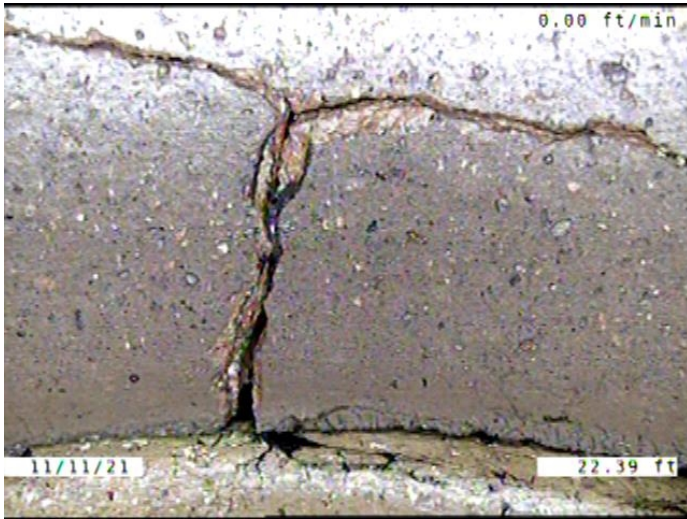
Code: **B**  
Description: **Broken**

Distance (ft): **22.4**  
Structural Grade: **4**  
O&M Grade: **0**  
Clock Start/From: **10**  
Clock To: **3**  
1st Value:  
2nd Value:  
Value Percent:  
Continuous Index:  
Within 8" of Joint: **YES**  
Remarks:

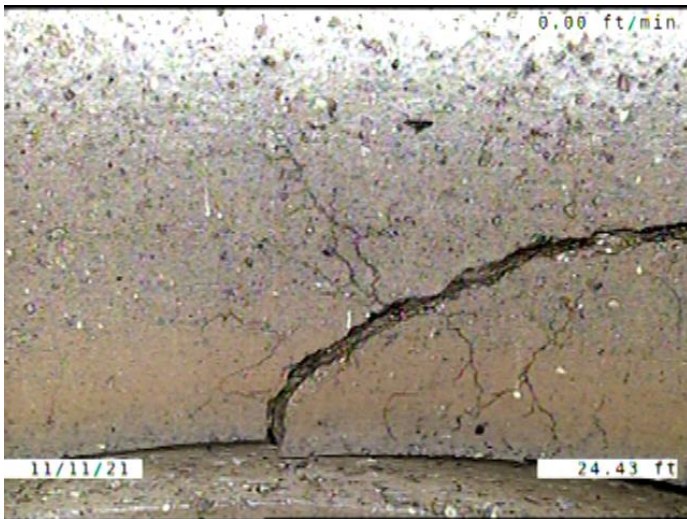
Code: **B**  
Description: **Broken**

Distance (ft): **24.4**  
Structural Grade: **4**  
O&M Grade: **0**  
Clock Start/From: **11**  
Clock To: **1**  
1st Value:  
2nd Value:  
Value Percent:  
Continuous Index:  
Within 8" of Joint: **YES**  
Remarks:

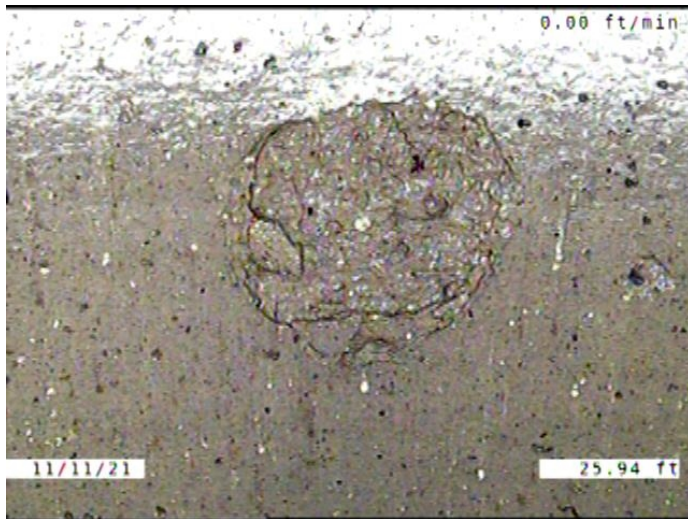
Code: **SSS**  
Description: **Surface Damage Surface Spalling**

Distance (ft): **25.9**  
Structural Grade: **2**  
O&M Grade: **0**  
Clock Start/From: **11**  
Clock To: **12**  
1st Value:  
2nd Value:  
Value Percent:  
Continuous Index:  
Within 8" of Joint: **NO**  
Remarks:

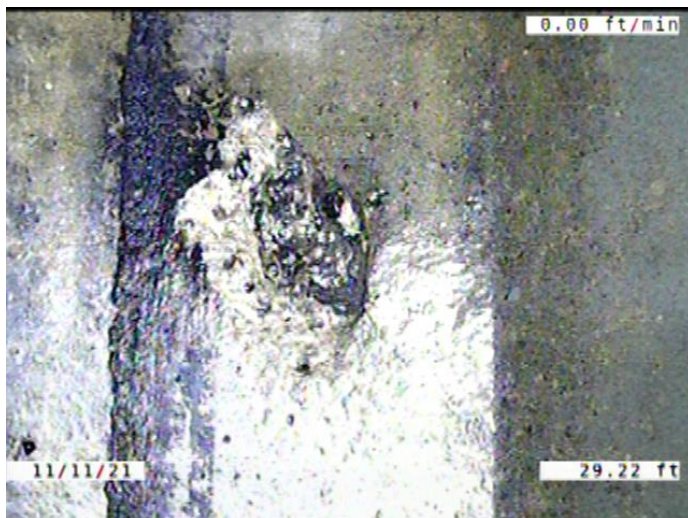
Code: **SSS**  
Description: **Surface Damage Surface Spalling**

Distance (ft): **29.2**  
Structural Grade: **2**  
O&M Grade: **0**  
Clock Start/From: **8**  
Clock To:  
1st Value:  
2nd Value:  
Value Percent:  
Continuous Index:  
Within 8" of Joint: **NO**  
Remarks:

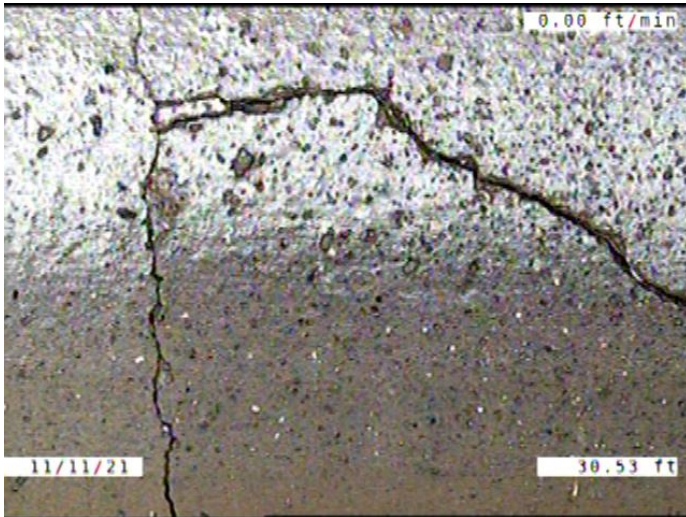
Code: **FM**  
 Description: **Fracture Multiple**

Distance (ft): **30.5**  
 Structural Grade: **4**  
 O&M Grade: **0**  
 Clock Start/From: **11**  
 Clock To: **12**  
 1st Value:  
 2nd Value:  
 Value Percent:  
 Continuous Index:  
 Within 8" of Joint: **YES**  
 Remarks:

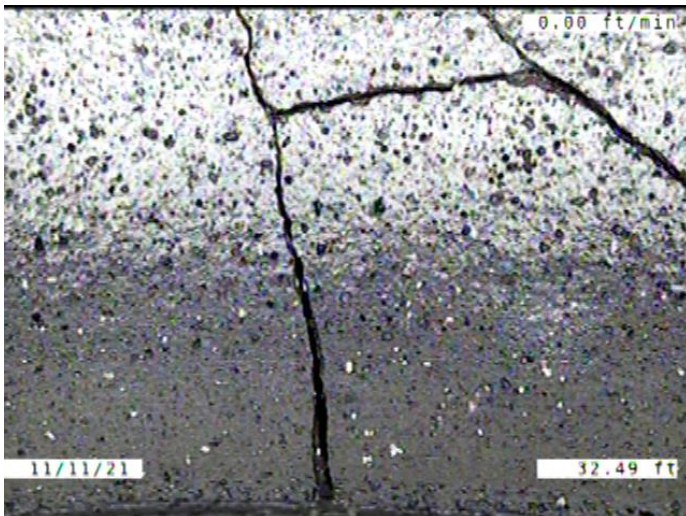
Code: **B**  
 Description: **Broken**

Distance (ft): **32.5**  
 Structural Grade: **4**  
 O&M Grade: **0**  
 Clock Start/From: **10**  
 Clock To: **2**  
 1st Value:  
 2nd Value:  
 Value Percent:  
 Continuous Index:  
 Within 8" of Joint: **YES**  
 Remarks:

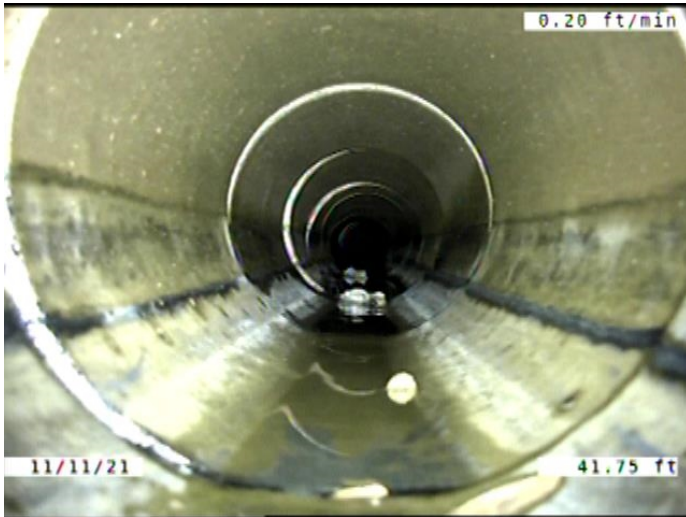
Code: **MWLS**  
 Description: **Miscellaneous Water Level Sag**

Distance (ft): **41.7**  
 Structural Grade: **2**  
 O&M Grade: **0**  
 Clock Start/From:  
 Clock To:  
 1st Value:  
 2nd Value:  
 Value Percent: **5.000**  
 Continuous Index: **F02**  
 Within 8" of Joint: **NO**  
 Remarks:

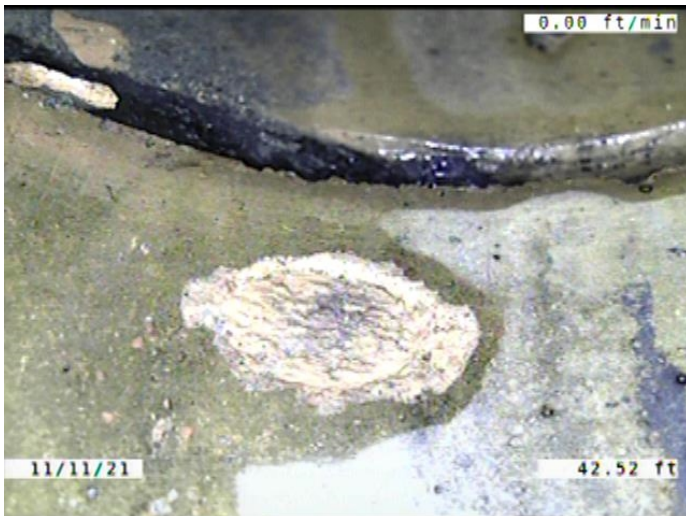
Code: **SSS**  
 Description: **Surface Damage Surface Spalling**

Distance (ft): **42.5**  
 Structural Grade: **2**  
 O&M Grade: **0**  
 Clock Start/From: **5**  
 Clock To:  
 1st Value:  
 2nd Value:  
 Value Percent:  
 Continuous Index:  
 Within 8" of Joint: **YES**  
 Remarks:

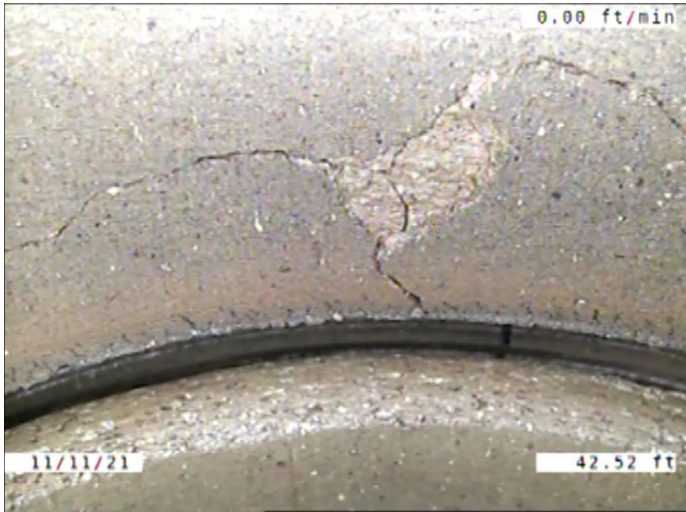
Code: **SSS**  
Description: **Surface Damage Surface Spalling**

Distance (ft): **42.5**  
Structural Grade: **2**  
O&M Grade: **0**  
Clock Start/From: **12**  
Clock To:  
1st Value:  
2nd Value:  
Value Percent:  
Continuous Index:  
Within 8" of Joint: **YES**  
Remarks:

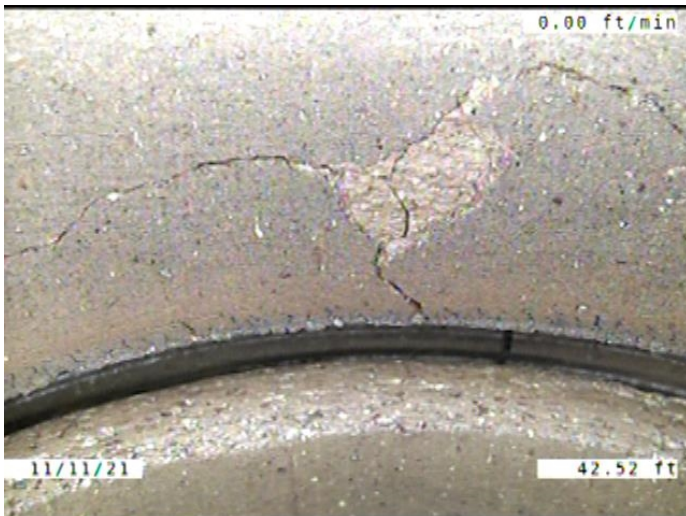
Code: **FM**  
Description: **Fracture Multiple**

Distance (ft): **42.5**  
Structural Grade: **4**  
O&M Grade: **0**  
Clock Start/From: **10**  
Clock To: **2**  
1st Value:  
2nd Value:  
Value Percent:  
Continuous Index:  
Within 8" of Joint: **YES**  
Remarks:

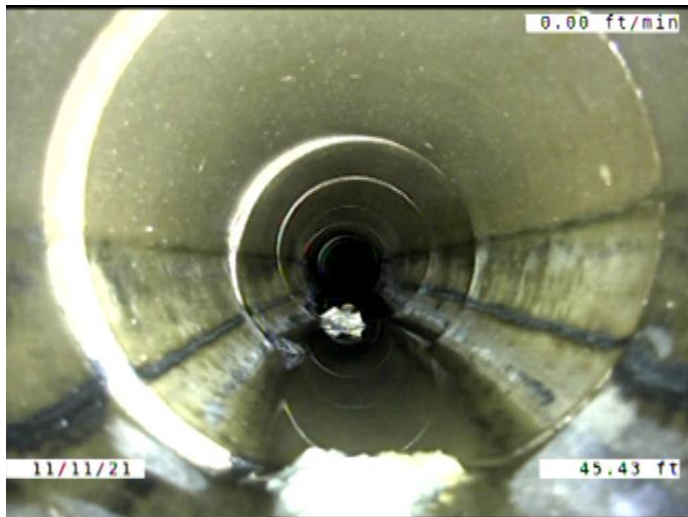
Code: **DSF**  
 Description: **Deposits Settled Fine**

Distance (ft): **45.4**  
 Structural Grade: **0**  
 O&M Grade: **2**  
 Clock Start/From: **6**  
 Clock To:  
 1st Value:  
 2nd Value:  
 Value Percent: **5.000**  
 Continuous Index:  
 Within 8" of Joint: **YES**  
 Remarks:

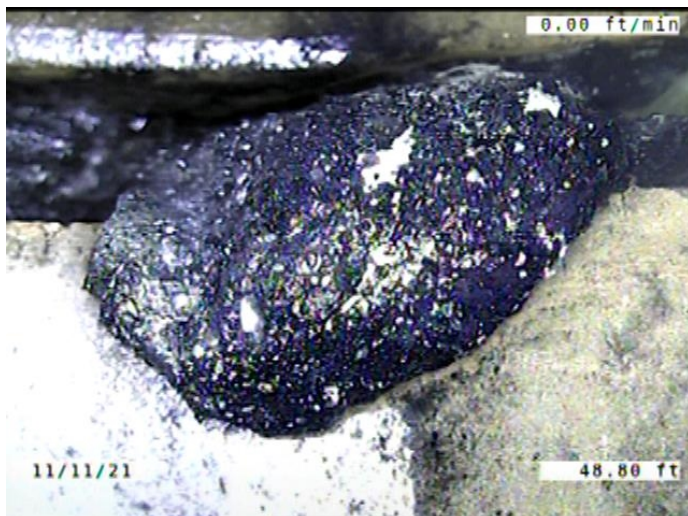
Code: **DAE**  
 Description: **Deposits Attached Encrustation**

Distance (ft): **48.8**  
 Structural Grade: **0**  
 O&M Grade: **2**  
 Clock Start/From: **7**  
 Clock To:  
 1st Value:  
 2nd Value:  
 Value Percent: **5.000**  
 Continuous Index:  
 Within 8" of Joint: **YES**  
 Remarks:

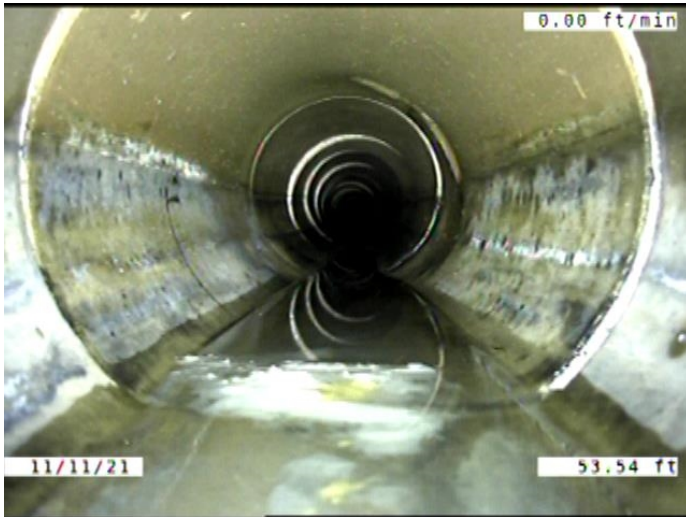
Code: **MWLS**  
 Description: **Miscellaneous Water Level Sag**

Distance (ft): **53.5**  
 Structural Grade: **2**  
 O&M Grade: **0**  
 Clock Start/From:  
 Clock To:  
 1st Value:  
 2nd Value:  
 Value Percent: **5.000**  
 Continuous Index: **S03**  
 Within 8" of Joint: **NO**  
 Remarks:

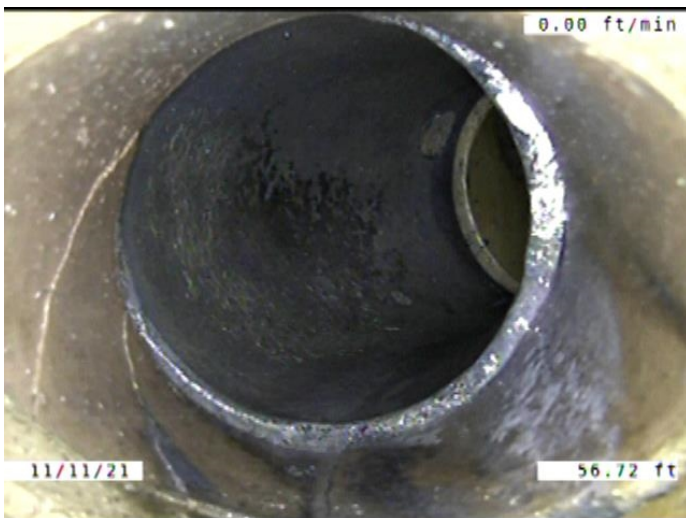
Code: **TFD**  
 Description: **Tap Factory Defective**

Distance (ft): **56.7**  
 Structural Grade: **0**  
 O&M Grade: **3**  
 Clock Start/From: **1**  
 Clock To:  
 1st Value: **4.000**  
 2nd Value:  
 Value Percent:  
 Continuous Index:  
 Within 8" of Joint: **YES**  
 Remarks: **BROKEN**

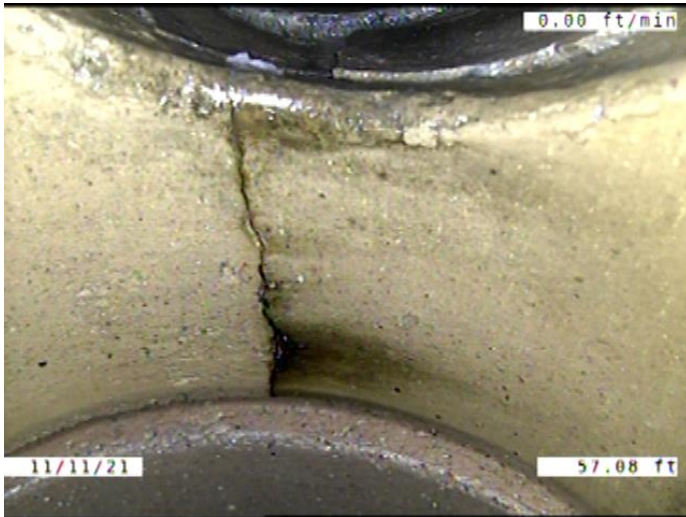
Code: **CM**  
 Description: **Crack Multiple**

Distance (ft): **57.1**  
 Structural Grade: **3**  
 O&M Grade: **0**  
 Clock Start/From: **1**  
 Clock To: **3**  
 1st Value:  
 2nd Value:  
 Value Percent:  
 Continuous Index:  
 Within 8" of Joint: **YES**  
 Remarks:

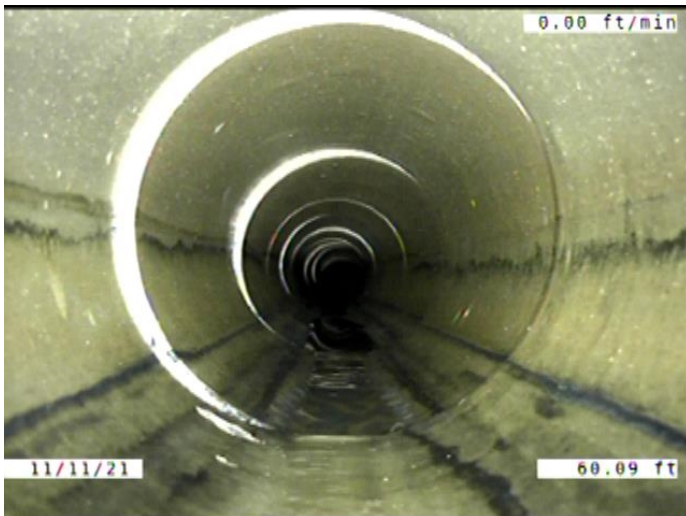
Code: **MWLS**  
 Description: **Miscellaneous Water Level Sag**

Distance (ft): **60.1**  
 Structural Grade: **2**  
 O&M Grade: **0**  
 Clock Start/From:  
 Clock To:  
 1st Value:  
 2nd Value:  
 Value Percent: **5.000**  
 Continuous Index: **F03**  
 Within 8" of Joint: **NO**  
 Remarks:

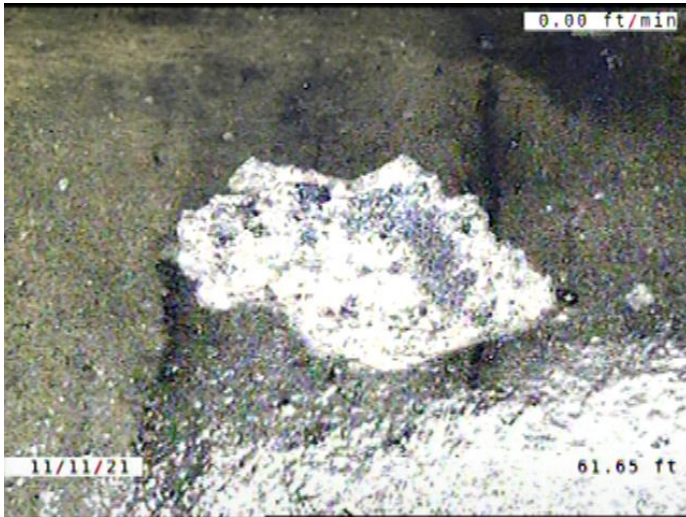
Code: **SSS**  
Description: **Surface Damage Surface Spalling**

Distance (ft): **61.7**  
Structural Grade: **2**  
O&M Grade: **0**  
Clock Start/From: **7**  
Clock To:  
1st Value:  
2nd Value:  
Value Percent:  
Continuous Index:  
Within 8" of Joint: **YES**  
Remarks:

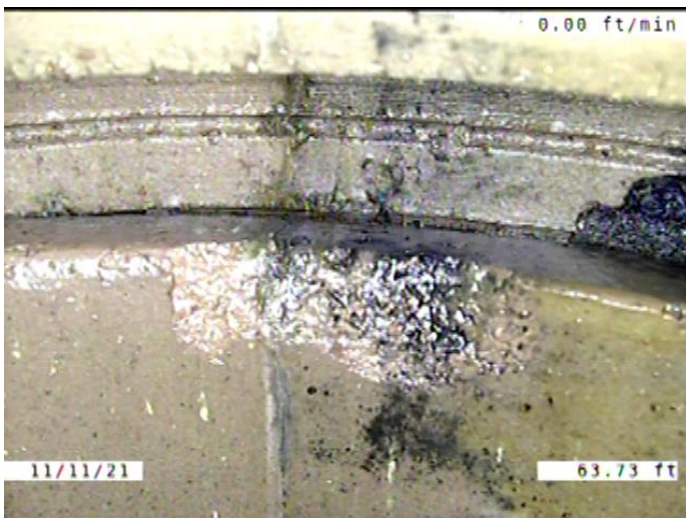
Code: **SSS**  
Description: **Surface Damage Surface Spalling**

Distance (ft): **63.7**  
Structural Grade: **2**  
O&M Grade: **0**  
Clock Start/From: **3**  
Clock To:  
1st Value:  
2nd Value:  
Value Percent:  
Continuous Index:  
Within 8" of Joint: **YES**  
Remarks:

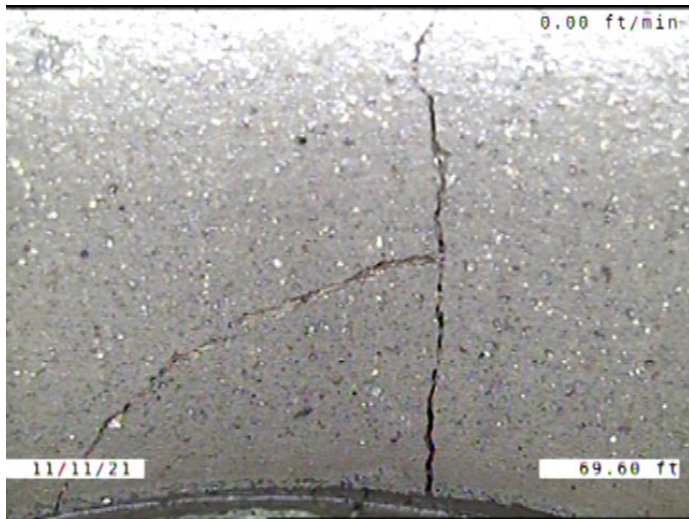
Code: **B**  
Description: **Broken**

Distance (ft): **69.6**  
Structural Grade: **4**  
O&M Grade: **0**  
Clock Start/From: **11**  
Clock To: **1**  
1st Value:  
2nd Value:  
Value Percent:  
Continuous Index:  
Within 8" of Joint: **YES**  
Remarks:

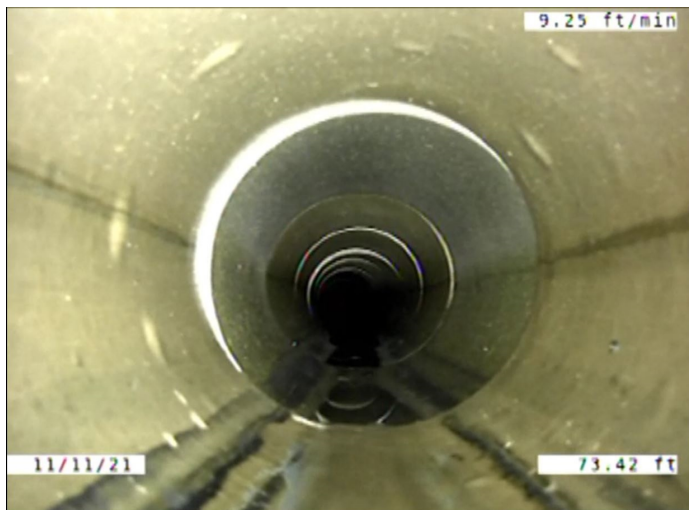
Code: **SZ**  
Description: **Surface Damage Other**

Distance (ft): **73.4**  
Structural Grade: **0**  
O&M Grade: **0**  
Clock Start/From: **8**  
Clock To: **3**  
1st Value:  
2nd Value:  
Value Percent:  
Continuous Index:  
Within 8" of Joint: **NO**  
Remarks: **Indentations. Factory defect.**

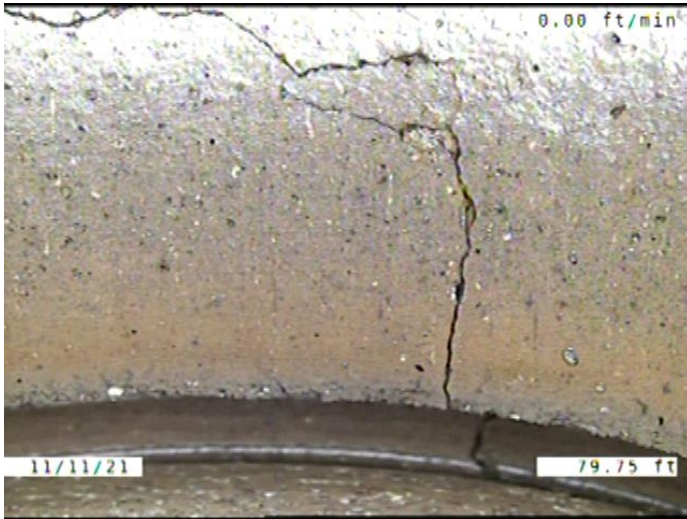
Code: **FM**  
 Description: **Fracture Multiple**

Distance (ft): **79.7**  
 Structural Grade: **4**  
 O&M Grade: **0**  
 Clock Start/From: **11**  
 Clock To: **1**  
 1st Value:  
 2nd Value:  
 Value Percent:  
 Continuous Index:  
 Within 8" of Joint: **YES**  
 Remarks:

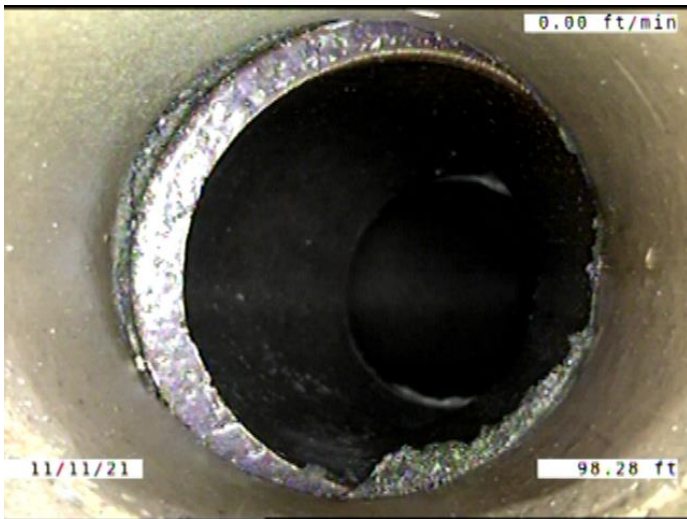
Code: **TFD**  
 Description: **Tap Factory Defective**

Distance (ft): **98.3**  
 Structural Grade: **0**  
 O&M Grade: **3**  
 Clock Start/From: **1**  
 Clock To:  
 1st Value: **4.000**  
 2nd Value:  
 Value Percent:  
 Continuous Index:  
 Within 8" of Joint: **YES**  
 Remarks: **OFFSET. SOIL VISIBLE.**

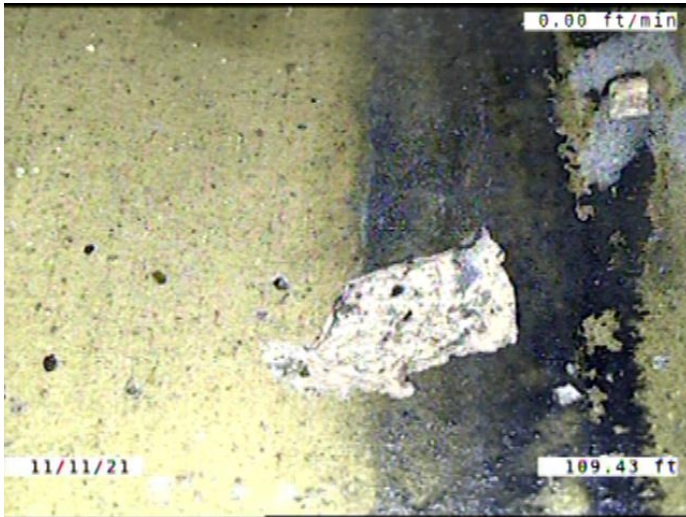
Code:	<b>SSS</b>
Description:	<b>Surface Damage Surface Spalling</b>
Distance (ft):	<b>109.4</b>
Structural Grade:	<b>2</b>
O&M Grade:	<b>0</b>
Clock Start/From:	<b>5</b>
Clock To:	<b>7</b>
1st Value:	
2nd Value:	
Value Percent:	
Continuous Index:	
Within 8" of Joint:	<b>YES</b>
Remarks:

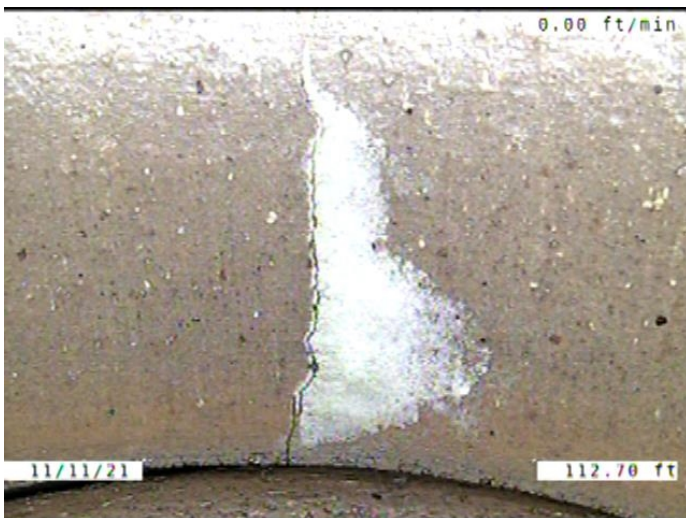
Code:	<b>CL</b>
Description:	<b>Crack Longitudinal</b>
Distance (ft):	<b>112.7</b>
Structural Grade:	<b>2</b>
O&M Grade:	<b>0</b>
Clock Start/From:	<b>1</b>
Clock To:	
1st Value:	
2nd Value:	
Value Percent:	
Continuous Index:	
Within 8" of Joint:	<b>YES</b>
Remarks:

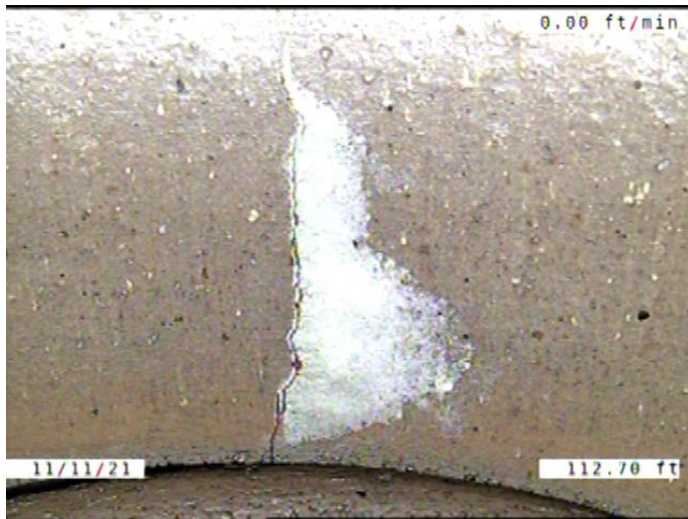
Code: **DAE**  
 Description: **Deposits Attached Encrustation**

Distance (ft): **112.7**  
 Structural Grade: **0**  
 O&M Grade: **2**  
 Clock Start/From: **1**  
 Clock To:  
 1st Value:  
 2nd Value:  
 Value Percent: **5.000**  
 Continuous Index:  
 Within 8" of Joint: **YES**  
 Remarks:
