Profile/Photo Observation Report

Date:	04/25/2018	Weather:		Coding:	PACP 6.0
Pipe Length (ft):	247.1	Owner:	NA	Pre Clean:	Not Known
P.O.#:		Surveyor:	Jen Costello	PSR:	P-605-026-025
Customer:		Clean Date:	01/01/1900	Shape:	C

Street:	Ash	Flow Control:	Not Controlled
City:	Hobart, IN	Year Renewed:	
Location:	Other	Tape/Media #:	
Purpose:	Not Known	Dia/Height:	12"
Use:	Sanitary	Material:	VCP
Drain Area:	NA	Lining:	
Category:	NA		
Comment:	Flow direction wrong.

Location Details:		Direction of Survey:	Downstream
US MH:	M-605-025	DS MH:	M-605-026
		Total Length Surveyed (ft):	248.5

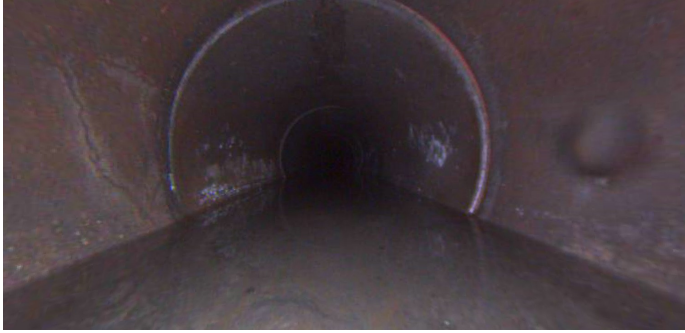
Code: **FM**
Description: **Fracture Multiple**

Distance (ft): **.0**
Structural Grade: **4**
O&M Grade: **0**
Clock Start/From: **8**
Clock To: **9**
1st Value:
2nd Value:
Value Percent:
Continuous Index:
Within 8" of Joint: **YES**
Remarks:

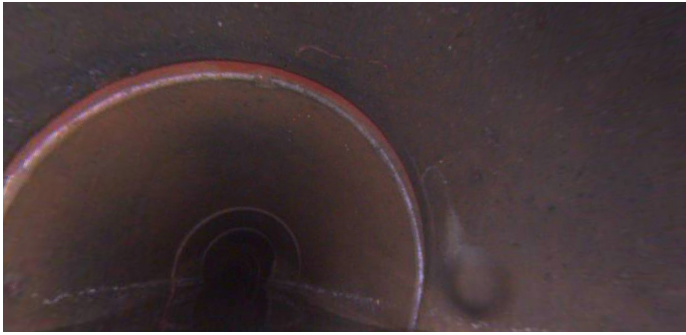
Code: **FM**
Description: **Fracture Multiple**

Distance (ft): **27.4**
Structural Grade: **4**
O&M Grade: **0**
Clock Start/From: **12**
Clock To: **4**
1st Value:
2nd Value:
Value Percent:
Continuous Index:
Within 8" of Joint: **YES**
Remarks:

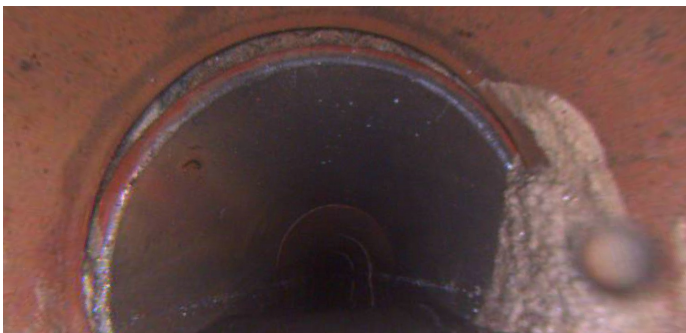
Code: **DAE**
Description: **Deposits Attached Encrustation**

Distance (ft): **31.6**
Structural Grade: **0**
O&M Grade: **2**
Clock Start/From: **1**
Clock To: **4**
1st Value:
2nd Value:
Value Percent: **5.000**
Continuous Index:
Within 8" of Joint: **YES**
Remarks:

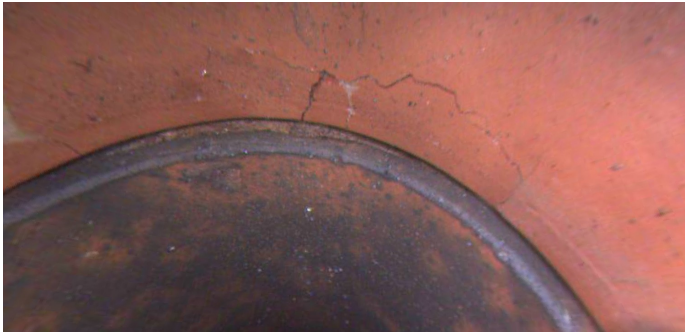
Code: **FM**
Description: **Fracture Multiple**

Distance (ft): **42.3**
Structural Grade: **4**
O&M Grade: **0**
Clock Start/From: **8**
Clock To: **4**
1st Value:
2nd Value:
Value Percent:
Continuous Index:
Within 8" of Joint: **YES**
Remarks:

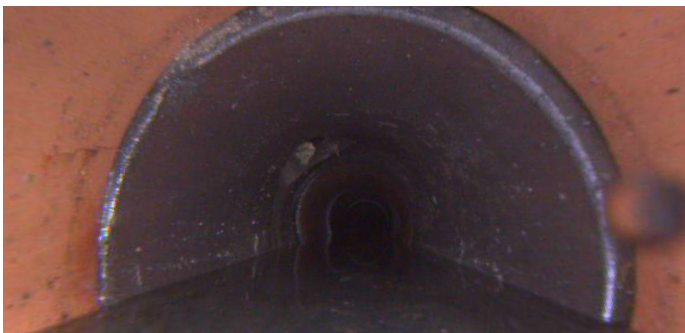
Code: **FL**
Description: **Fracture Longitudinal**

Distance (ft): **46.2**
Structural Grade: **3**
O&M Grade: **0**
Clock Start/From: **9**
Clock To:
1st Value:
2nd Value:
Value Percent:
Continuous Index:
Within 8" of Joint: **YES**
Remarks:

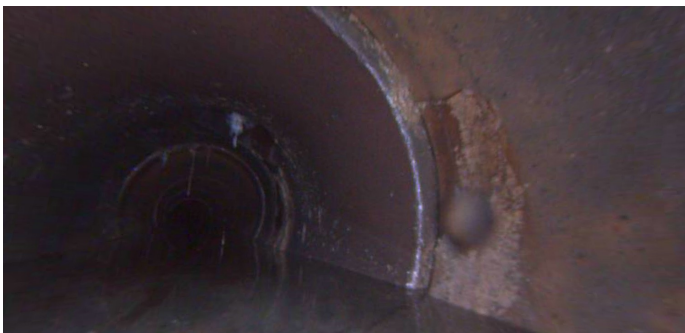
Code: **FM**
Description: **Fracture Multiple**

Distance (ft): **52.5**
Structural Grade: **4**
O&M Grade: **0**
Clock Start/From: **2**
Clock To: **4**
1st Value:
2nd Value:
Value Percent:
Continuous Index:
Within 8" of Joint: **YES**
Remarks:

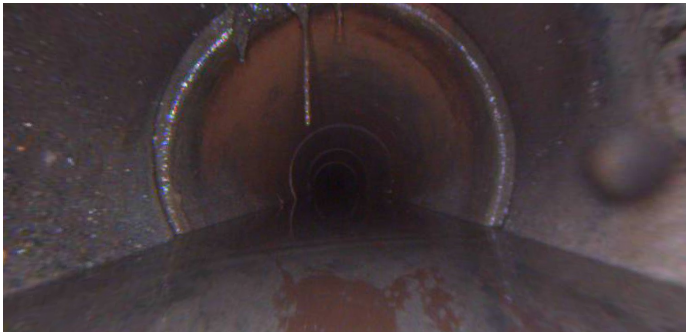
Code: **ID**
Description: **Infil Dripper**

Distance (ft): **54.4**
Structural Grade: **0**
O&M Grade: **3**
Clock Start/From: **12**
Clock To:
1st Value:
2nd Value:
Value Percent:
Continuous Index:
Within 8" of Joint: **YES**
Remarks:

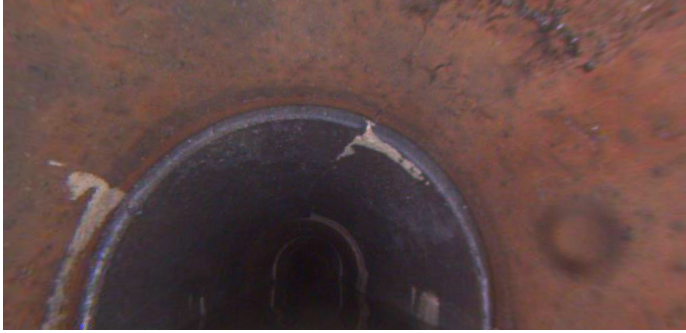
Code: **FM**
Description: **Fracture Multiple**

Distance (ft): **68.9**
Structural Grade: **4**
O&M Grade: **0**
Clock Start/From: **11**
Clock To: **12**
1st Value:
2nd Value:
Value Percent:
Continuous Index:
Within 8" of Joint: **YES**
Remarks:

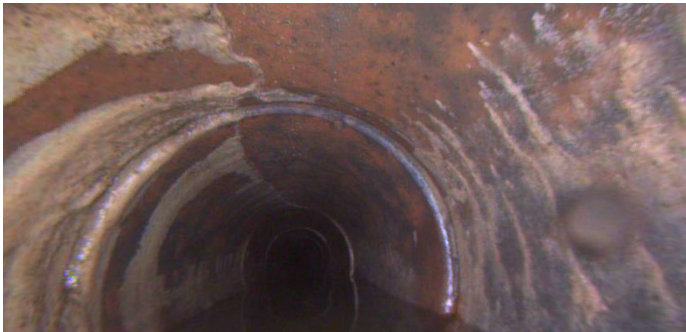
Code: **FL**
Description: **Fracture Longitudinal**

Distance (ft): **75.1**
Structural Grade: **3**
O&M Grade: **0**
Clock Start/From: **12**
Clock To:
1st Value:
2nd Value:
Value Percent:
Continuous Index:
Within 8" of Joint: **YES**
Remarks:

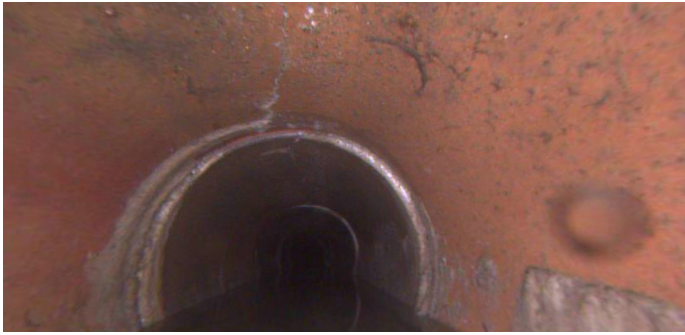
Code: **FM**
Description: **Fracture Multiple**

Distance (ft): **78.9**
Structural Grade: **4**
O&M Grade: **0**
Clock Start/From: **8**
Clock To: **4**
1st Value:
2nd Value:
Value Percent:
Continuous Index: **S01**
Within 8" of Joint: **YES**
Remarks:

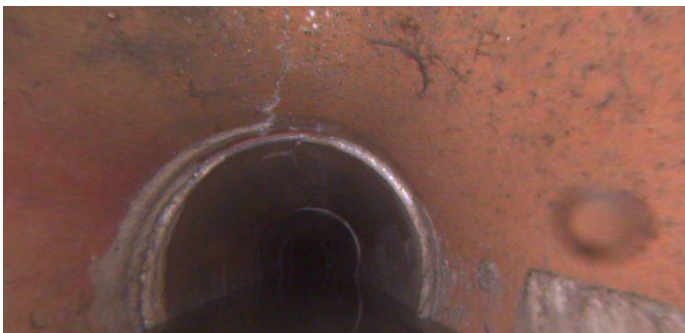
Code: **DAE**
Description: **Deposits Attached Encrustation**

Distance (ft): **78.9**
Structural Grade: **0**
O&M Grade: **2**
Clock Start/From: **8**
Clock To: **4**
1st Value:
2nd Value:
Value Percent: **5.000**
Continuous Index: **S02**
Within 8" of Joint: **YES**
Remarks:

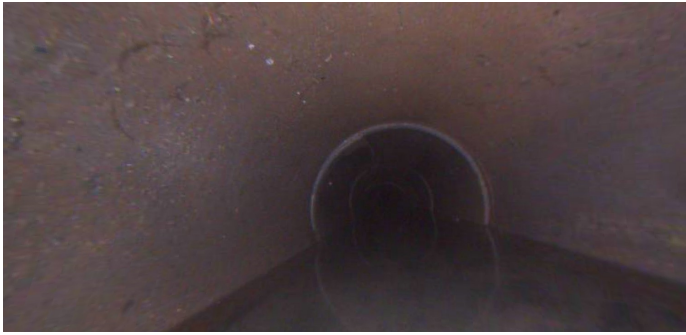
Code: **DAE**
Description: **Deposits Attached Encrustation**

Distance (ft): **162.6**
Structural Grade: **0**
O&M Grade: **2**
Clock Start/From: **8**
Clock To: **4**
1st Value:
2nd Value:
Value Percent: **5.000**
Continuous Index: **F02**
Within 8" of Joint: **YES**
Remarks:

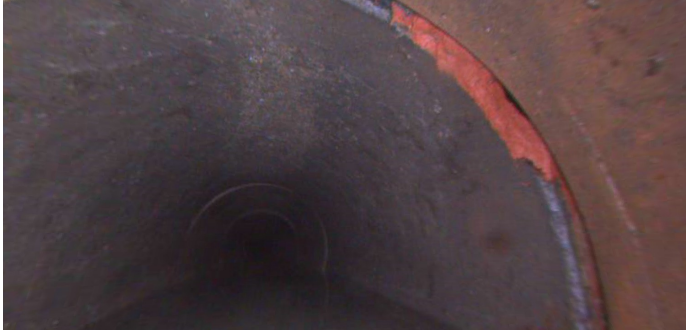
Code: **SSS**
Description: **Surface Spalling**

Distance (ft): **196.5**
Structural Grade: **2**
O&M Grade: **0**
Clock Start/From: **1**
Clock To: **3**
1st Value:
2nd Value:
Value Percent:
Continuous Index:
Within 8" of Joint: **YES**
Remarks:

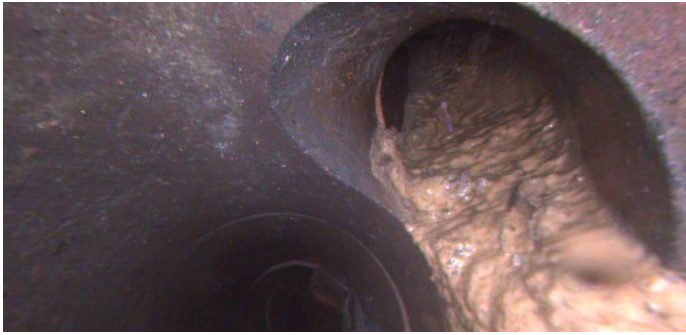
Code: **TFD**
Description: **Tap Factory Defective**

Distance (ft): **214.1**
Structural Grade: **0**
O&M Grade: **2**
Clock Start/From: **2**
Clock To:
1st Value: **4.000**
2nd Value:
Value Percent:
Continuous Index:
Within 8" of Joint:
Remarks: **dae**

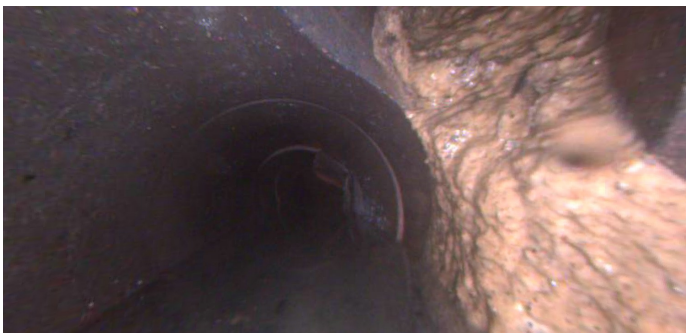
Code: **DAE**
Description: **Deposits Attached Encrustation**

Distance (ft): **214.1**
Structural Grade: **0**
O&M Grade: **2**
Clock Start/From: **1**
Clock To: **4**
1st Value:
2nd Value:
Value Percent: **5.000**
Continuous Index:
Within 8" of Joint: **NO**
Remarks:

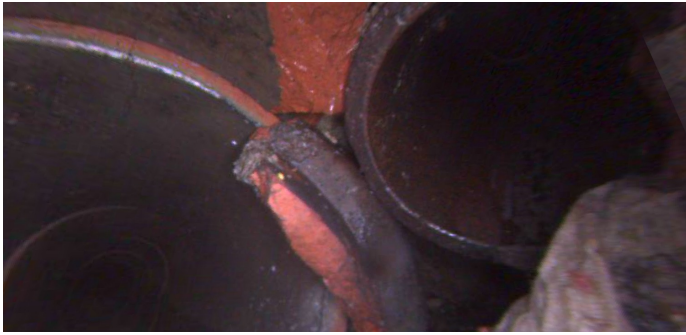
Code: **TBI**
Description: **Tap Break-in Intruding**

Distance (ft): **216.7**
Structural Grade: **0**
O&M Grade: **2**
Clock Start/From: **2**
Clock To:
1st Value: **4.000**
2nd Value: **1.000**
Value Percent:
Continuous Index:
Within 8" of Joint:
Remarks:

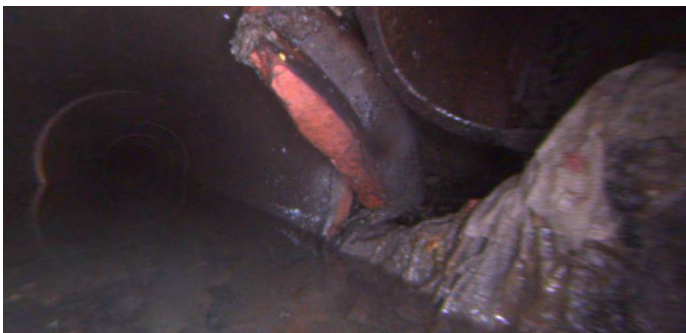
Code: **BVV**
Description: **Broken Void Visible**

Distance (ft): **216.7**
Structural Grade: **5**
O&M Grade: **0**
Clock Start/From: **1**
Clock To: **3**
1st Value:
2nd Value:
Value Percent:
Continuous Index:
Within 8" of Joint: **YES**
Remarks:

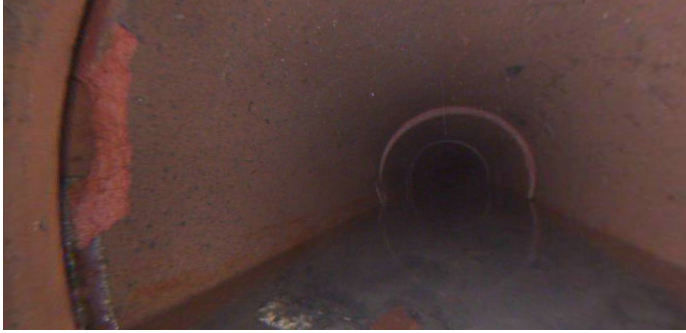
Code: **SSS**
Description: **Surface Spalling**

Distance (ft): **221.1**
Structural Grade: **2**
O&M Grade: **0**
Clock Start/From: **8**
Clock To: **9**
1st Value:
2nd Value:
Value Percent:
Continuous Index:
Within 8" of Joint: **YES**
Remarks:

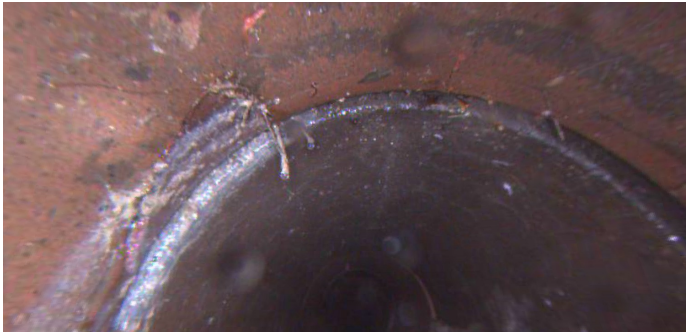
Code: **RFJ**
Description: **Roots Fine Joint**

Distance (ft): **241.4**
Structural Grade: **0**
O&M Grade: **1**
Clock Start/From: **9**
Clock To: **12**
1st Value:
2nd Value:
Value Percent:
Continuous Index:
Within 8" of Joint: **YES**
Remarks:

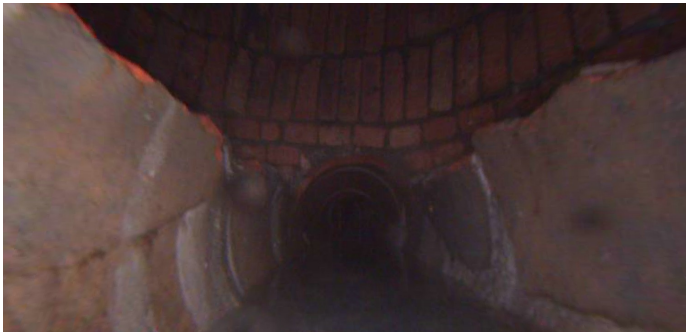
Code: **FM**
Description: **Fracture Multiple**

Distance (ft): **246.9**
Structural Grade: **4**
O&M Grade: **0**
Clock Start/From: **8**
Clock To: **4**
1st Value:
2nd Value:
Value Percent:
Continuous Index: **F01**
Within 8" of Joint: **YES**
Remarks:
