## Profile/Photo Observation Report

Street:	<b>W 2ND ST &amp; S ASH ST</b>	Flow Control:	<b>Not Controlled</b>
City:	<b>Hobart, IN</b>	Year Renewed:	
Location:	<b>Other</b>	Tape/Media #:	
Purpose:	<b>Not Known</b>	Dia/Height:	<b>12"</b>
Use:	<b>Sanitary</b>	Material:	<b>VCP</b>
Drain Area:	<b>NA</b>	Lining:	
Category:	<b>NA</b>		
Comment:

Location Details:		Direction of Survey:	<b>Downstream</b>
US MH:	<b>M-605-026</b>	DS MH:	<b>M-605-027</b>
		Total Length Surveyed (ft):	<b>48.0</b>

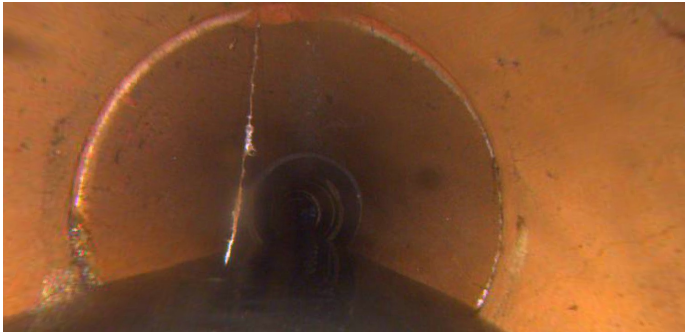
Code: **RFJ**  
Description: **Roots Fine Joint**

Distance (ft): **.0**  
Structural Grade: **0**  
O&M Grade: **1**  
Clock Start/From: **12**  
Clock To:  
1st Value:  
2nd Value:  
Value Percent:  
Continuous Index:  
Within 8" of Joint: **YES**  
Remarks:

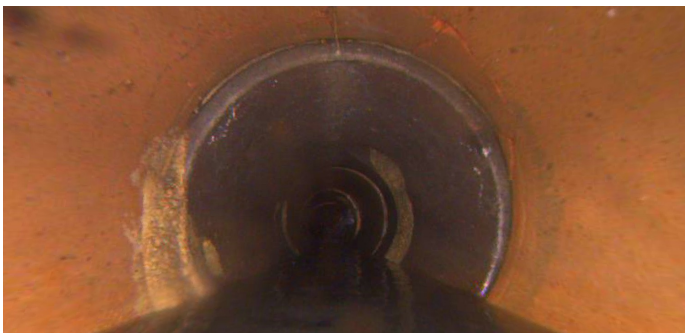
Code: **FM**  
Description: **Fracture Multiple**

Distance (ft): **3.0**  
Structural Grade: **4**  
O&M Grade: **0**  
Clock Start/From: **1**  
Clock To: **3**  
1st Value:  
2nd Value:  
Value Percent:  
Continuous Index:  
Within 8" of Joint: **YES**  
Remarks:

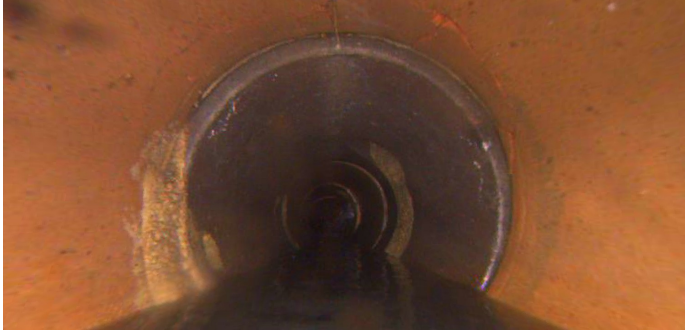
Code: **DAE**  
Description: **Deposits Attached Encrustation**

Distance (ft): **3.0**  
Structural Grade: **0**  
O&M Grade: **2**  
Clock Start/From: **8**  
Clock To: **10**  
1st Value:  
2nd Value:  
Value Percent: **5.000**  
Continuous Index:  
Within 8" of Joint: **YES**  
Remarks:

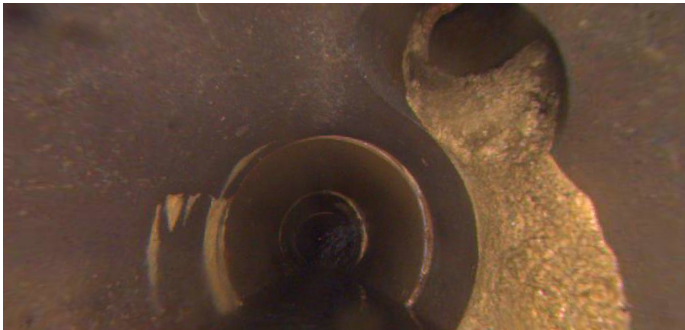
Code: **TFD**  
Description: **Tap Factory Defective**

Distance (ft): **4.4**  
Structural Grade: **0**  
O&M Grade: **2**  
Clock Start/From: **2**  
Clock To:  
1st Value: **4.000**  
2nd Value:  
Value Percent:  
Continuous Index:  
Within 8" of Joint:  
Remarks: **DAE**

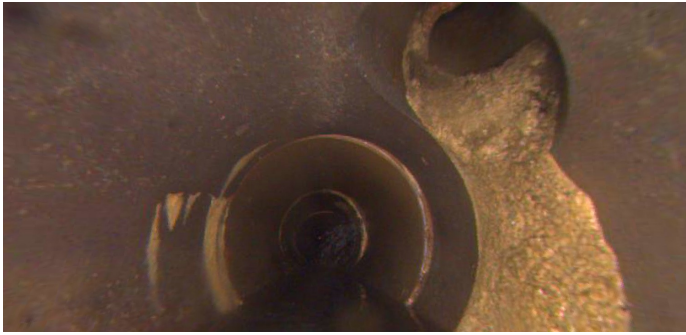
Code: **DAE**  
Description: **Deposits Attached Encrustation**

Distance (ft): **4.4**  
Structural Grade: **0**  
O&M Grade: **2**  
Clock Start/From: **1**  
Clock To: **4**  
1st Value:  
2nd Value:  
Value Percent: **5.000**  
Continuous Index:  
Within 8" of Joint: **NO**  
Remarks:

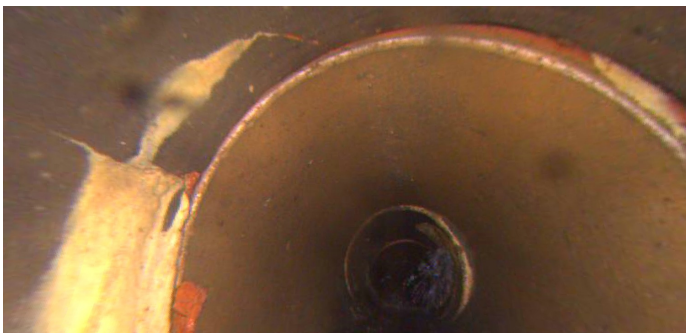
Code: **FM**  
Description: **Fracture Multiple**

Distance (ft): **5.3**  
Structural Grade: **4**  
O&M Grade: **0**  
Clock Start/From: **10**  
Clock To: **12**  
1st Value:  
2nd Value:  
Value Percent:  
Continuous Index:  
Within 8" of Joint: **YES**  
Remarks:

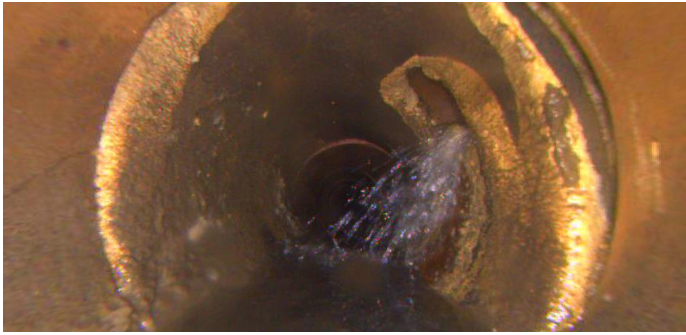
Code: **DAE**  
Description: **Deposits Attached Encrustation**

Distance (ft): **7.2**  
Structural Grade: **0**  
O&M Grade: **2**  
Clock Start/From: **8**  
Clock To: **4**  
1st Value:  
2nd Value:  
Value Percent: **5.000**  
Continuous Index:  
Within 8" of Joint: **YES**  
Remarks:

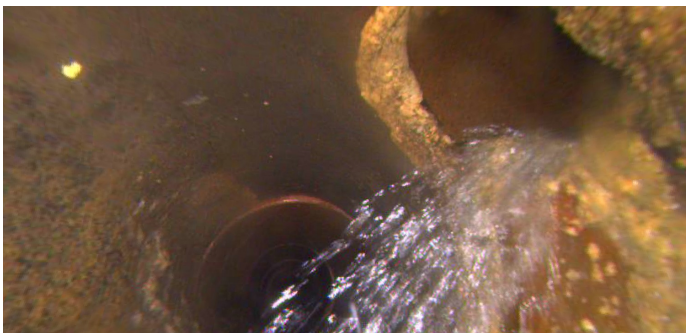
Code: **TBA**  
Description: **Tap Break-in Active**

Distance (ft): **8.1**  
Structural Grade: **0**  
O&M Grade: **0**  
Clock Start/From: **2**  
Clock To:  
1st Value: **4.000**  
2nd Value:  
Value Percent:  
Continuous Index:  
Within 8" of Joint:  
Remarks:

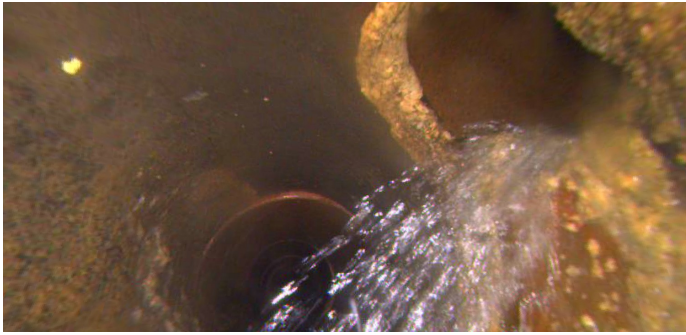
Code: **DAE**  
Description: **Deposits Attached Encrustation**

Distance (ft): **8.1**  
Structural Grade: **0**  
O&M Grade: **2**  
Clock Start/From: **1**  
Clock To: **4**  
1st Value:  
2nd Value:  
Value Percent: **10.000**  
Continuous Index:  
Within 8" of Joint: **NO**  
Remarks:

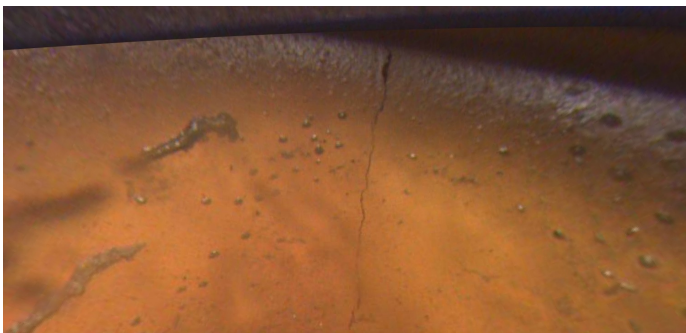
Code: **FL**  
Description: **Fracture Longitudinal**

Distance (ft): **9.9**  
Structural Grade: **3**  
O&M Grade: **0**  
Clock Start/From: **12**  
Clock To:  
1st Value:  
2nd Value:  
Value Percent:  
Continuous Index: **S01**  
Within 8" of Joint: **YES**  
Remarks:

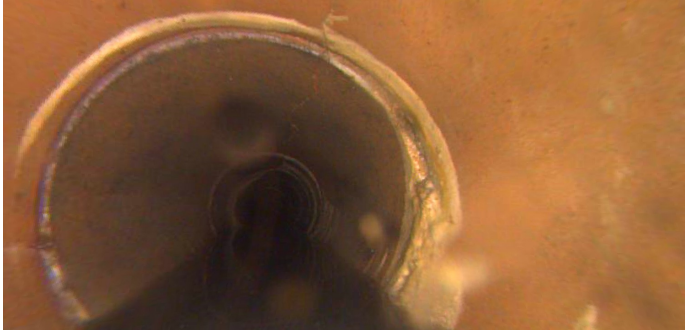
Code: **DAE**  
Description: **Deposits Attached Encrustation**

Distance (ft): **11.0**  
Structural Grade: **0**  
O&M Grade: **2**  
Clock Start/From: **8**  
Clock To: **4**  
1st Value:  
2nd Value:  
Value Percent: **5.000**  
Continuous Index:  
Within 8" of Joint: **YES**  
Remarks:

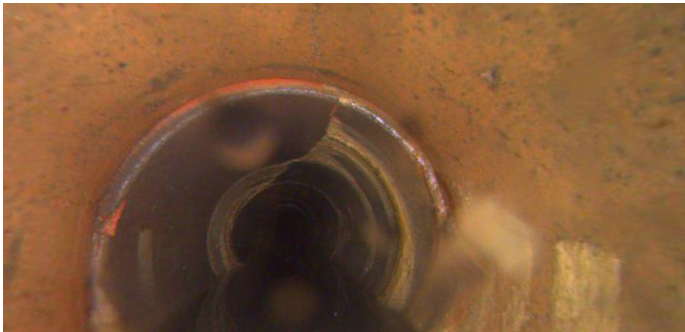
Code: **FM**  
Description: **Fracture Multiple**

Distance (ft): **13.0**  
Structural Grade: **4**  
O&M Grade: **0**  
Clock Start/From: **12**  
Clock To: **4**  
1st Value:  
2nd Value:  
Value Percent:  
Continuous Index: **S02**  
Within 8" of Joint: **YES**  
Remarks:

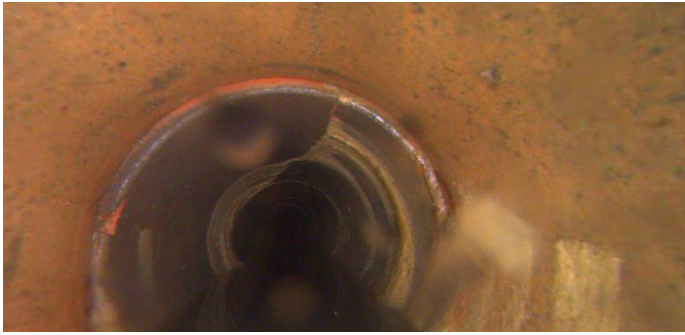
Code: **FL**  
Description: **Fracture Longitudinal**

Distance (ft): **13.0**  
Structural Grade: **3**  
O&M Grade: **0**  
Clock Start/From: **12**  
Clock To:  
1st Value:  
2nd Value:  
Value Percent:  
Continuous Index: **F01**  
Within 8" of Joint: **YES**  
Remarks:

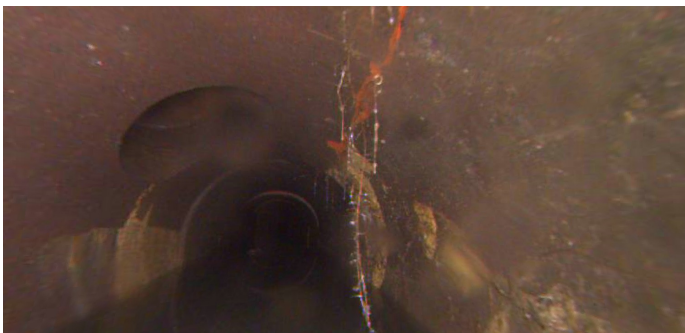
Code: **RFB**  
Description: **Roots Fine Barrel**

Distance (ft): **26.0**  
Structural Grade: **0**  
O&M Grade: **2**  
Clock Start/From: **1**  
Clock To:  
1st Value:  
2nd Value:  
Value Percent:  
Continuous Index:  
Within 8" of Joint: **NO**  
Remarks:

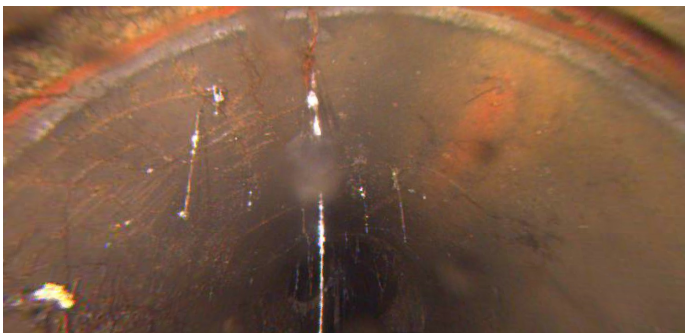
Code: **RFB**  
Description: **Roots Fine Barrel**

Distance (ft): **33.8**  
Structural Grade: **0**  
O&M Grade: **2**  
Clock Start/From: **9**  
Clock To: **12**  
1st Value:  
2nd Value:  
Value Percent:  
Continuous Index:  
Within 8" of Joint: **NO**  
Remarks:

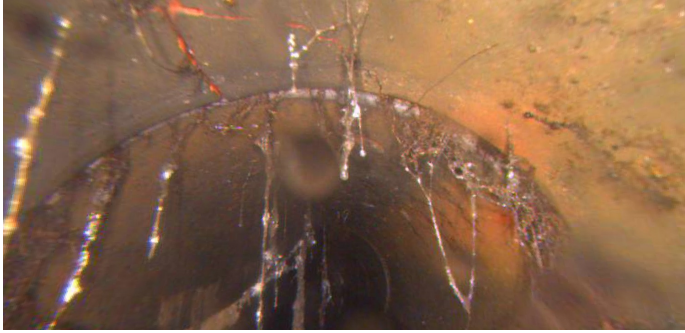
Code: **RMJ**  
Description: **Roots Medium Joint**

Distance (ft): **35.6**  
Structural Grade: **0**  
O&M Grade: **3**  
Clock Start/From: **8**  
Clock To: **4**  
1st Value:  
2nd Value:  
Value Percent: **10.000**  
Continuous Index:  
Within 8" of Joint: **YES**  
Remarks:

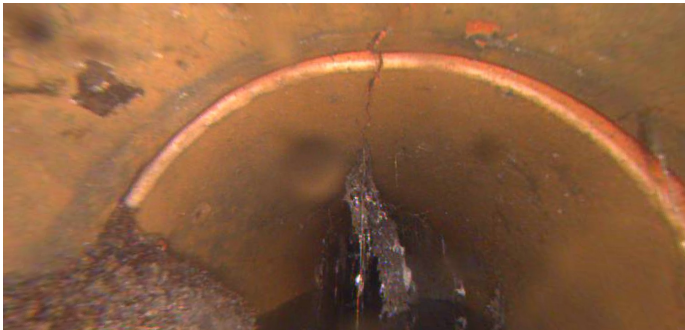
Code: **RMJ**  
Description: **Roots Medium Joint**

Distance (ft): **39.6**  
Structural Grade: **0**  
O&M Grade: **3**  
Clock Start/From: **8**  
Clock To: **4**  
1st Value:  
2nd Value:  
Value Percent: **20.000**  
Continuous Index:  
Within 8" of Joint: **YES**  
Remarks:

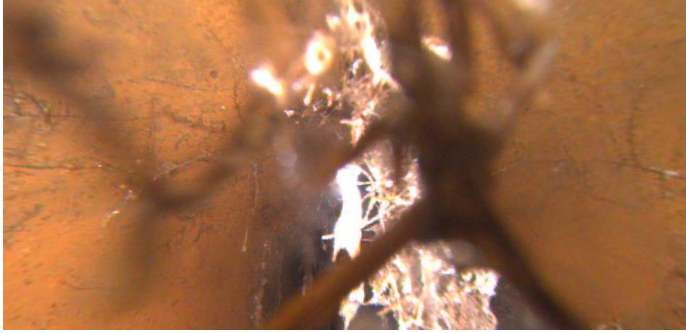
Code: **RMB**  
Description: **Roots Medium Barrel**

Distance (ft): **40.7**  
Structural Grade: **0**  
O&M Grade: **4**  
Clock Start/From: **12**  
Clock To:  
1st Value:  
2nd Value:  
Value Percent: **10.000**  
Continuous Index:  
Within 8" of Joint: **NO**  
Remarks:

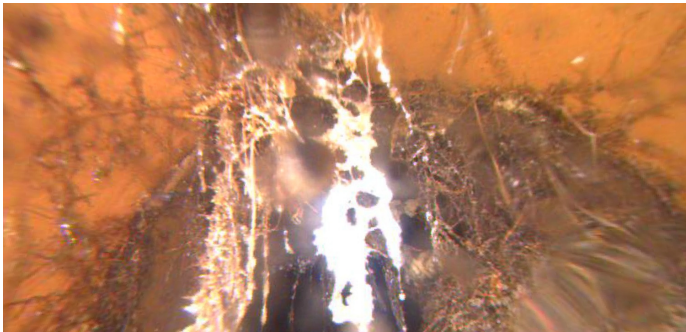
Code: **RMJ**  
Description: **Roots Medium Joint**

Distance (ft): **41.4**  
Structural Grade: **0**  
O&M Grade: **3**  
Clock Start/From: **8**  
Clock To: **4**  
1st Value:  
2nd Value:  
Value Percent: **40.000**  
Continuous Index:  
Within 8" of Joint: **YES**  
Remarks:

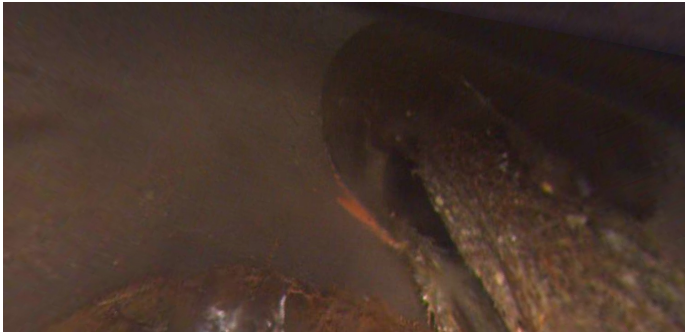
Code: **TFD**  
Description: **Tap Factory Defective**

Distance (ft): **45.1**  
Structural Grade: **0**  
O&M Grade: **2**  
Clock Start/From: **1**  
Clock To:  
1st Value: **4.000**  
2nd Value:  
Value Percent:  
Continuous Index:  
Within 8" of Joint:  
Remarks: **ROOTS**

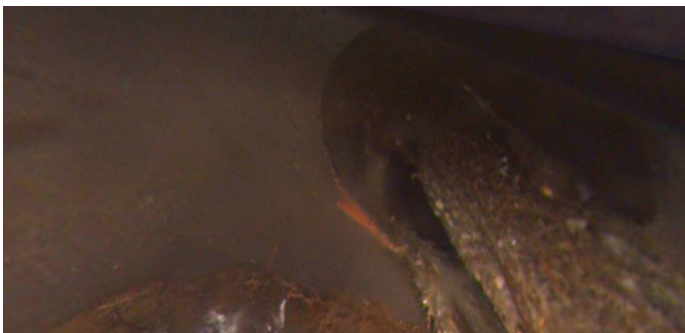
Code: **RML**  
Description: **Roots Medium Lateral**

Distance (ft): **45.1**  
Structural Grade: **0**  
O&M Grade: **3**  
Clock Start/From: **1**  
Clock To:  
1st Value:  
2nd Value:  
Value Percent: **10.000**  
Continuous Index:  
Within 8" of Joint: **NO**  
Remarks:

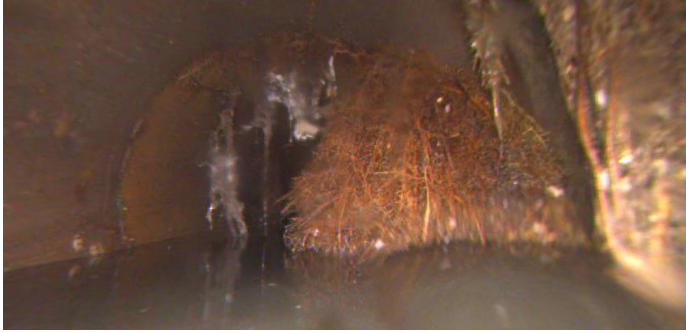
Code: **RBJ**  
Description: **Roots Ball Joint**

Distance (ft): **45.1**  
Structural Grade: **0**  
O&M Grade: **4**  
Clock Start/From: **8**  
Clock To: **4**  
1st Value:  
2nd Value:  
Value Percent: **70.000**  
Continuous Index:  
Within 8" of Joint: **YES**  
Remarks:

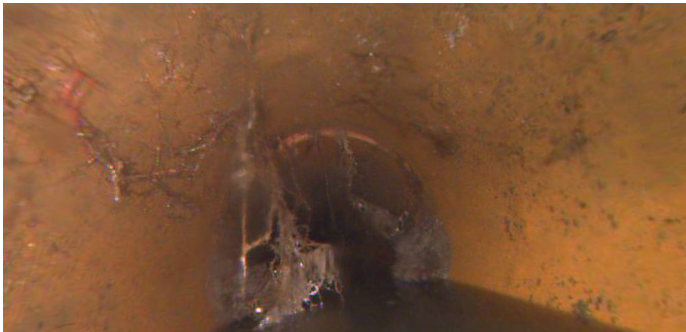
Code: **FM**  
Description: **Fracture Multiple**

Distance (ft): **48.0**  
Structural Grade: **4**  
O&M Grade: **0**  
Clock Start/From: **12**  
Clock To: **4**  
1st Value:  
2nd Value:  
Value Percent:  
Continuous Index: **F02**  
Within 8" of Joint: **YES**  
Remarks:

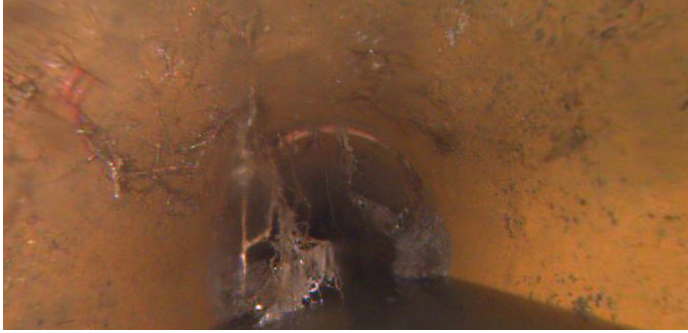
Code:	<b>MSA</b>
Description:	<b>Abandoned Survey</b>
Distance (ft):	<b>48.0</b>
Structural Grade:	<b>0</b>
O&M Grade:	<b>0</b>
Clock Start/From:	
Clock To:	
1st Value:	
2nd Value:	
Value Percent:	
Continuous Index:	
Within 8" of Joint:	<b>NO</b>
Remarks:	<b>ROOTS</b>
