Profile/Photo Observation Report

Date:	04/25/2018	Weather:		Coding:	PACP 6.0
Pipe Length (ft):	235.5	Owner:	NA	Pre Clean:	Not Known
P.O.#:		Surveyor:	Jen Costello	PSR:	P-605-027-026
Customer:		Clean Date:	01/01/1900	Shape:	C

Street:	S Ash St.	Flow Control:	Not Controlled
City:	Hobart, IN	Year Renewed:	
Location:	Other	Tape/Media #:	
Purpose:	Not Known	Dia/Height:	12"
Use:	Sanitary	Material:	VCP
Drain Area:	NA	Lining:	
Category:	NA		
Comment:

Location Details:		Direction of Survey:	Downstream
US MH:	M-605-026	DS MH:	M-605-027
		Total Length Surveyed (ft):	48.0

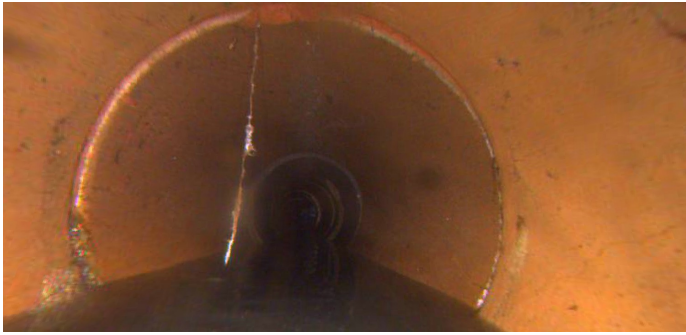
Code: **AMH**
Description: **Manhole**

Distance (ft): **.0**
Structural Grade: **0**
O&M Grade: **0**
Clock Start/From:
Clock To:
1st Value:
2nd Value:
Value Percent:
Continuous Index:
Within 8" of Joint: **NO**
Remarks: **M-605-026**

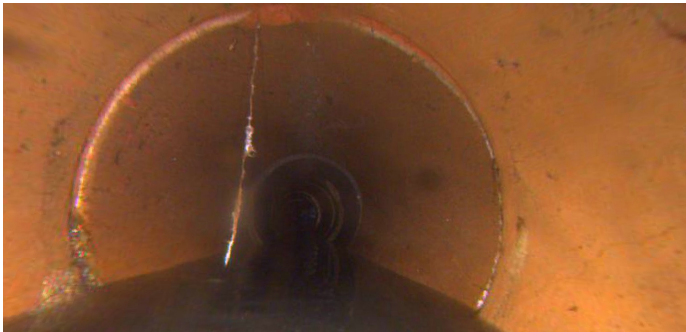
Code: **MWL**
Description: **Water Level**

Distance (ft): **.0**
Structural Grade: **0**
O&M Grade: **0**
Clock Start/From:
Clock To:
1st Value:
2nd Value:
Value Percent: **20.000**
Continuous Index:
Within 8" of Joint: **NO**
Remarks:

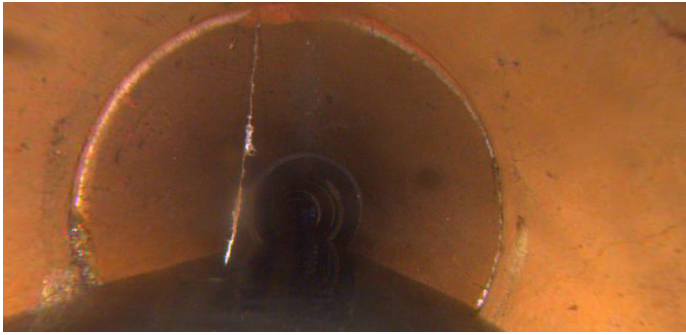
Code: **RFJ**
Description: **Roots Fine Joint**

Distance (ft): **.0**
Structural Grade: **0**
O&M Grade: **1**
Clock Start/From: **12**
Clock To:
1st Value:
2nd Value:
Value Percent:
Continuous Index:
Within 8" of Joint: **YES**
Remarks:

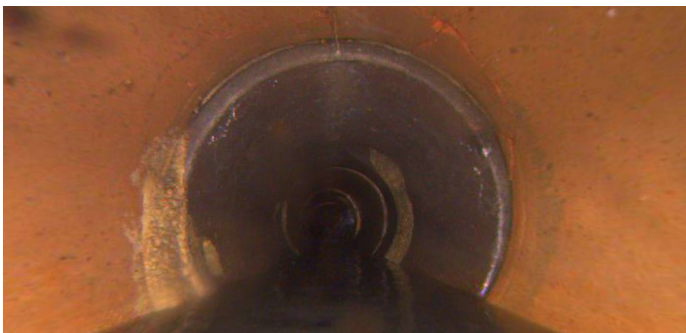
Code: **FM**
Description: **Fracture Multiple**

Distance (ft): **3.0**
Structural Grade: **4**
O&M Grade: **0**
Clock Start/From: **1**
Clock To: **3**
1st Value:
2nd Value:
Value Percent:
Continuous Index:
Within 8" of Joint: **YES**
Remarks:

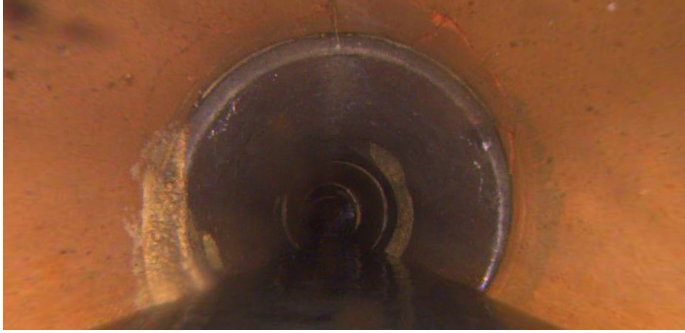
Code: **DAE**
Description: **Deposits Attached Encrustation**

Distance (ft): **3.0**
Structural Grade: **0**
O&M Grade: **2**
Clock Start/From: **8**
Clock To: **10**
1st Value:
2nd Value:
Value Percent: **5.000**
Continuous Index:
Within 8" of Joint: **YES**
Remarks:

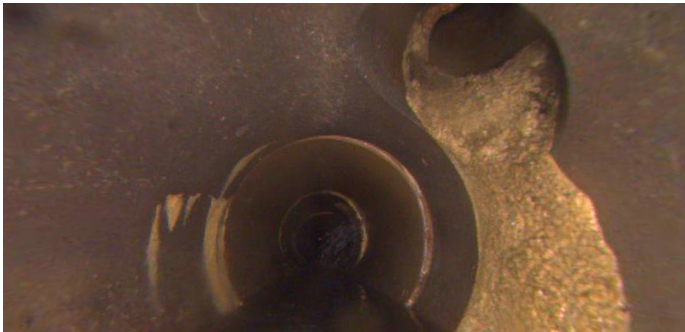
Code: **TFD**
Description: **Tap Factory Defective**

Distance (ft): **4.4**
Structural Grade: **0**
O&M Grade: **2**
Clock Start/From: **2**
Clock To:
1st Value: **4.000**
2nd Value:
Value Percent:
Continuous Index:
Within 8" of Joint:
Remarks: **DAE**

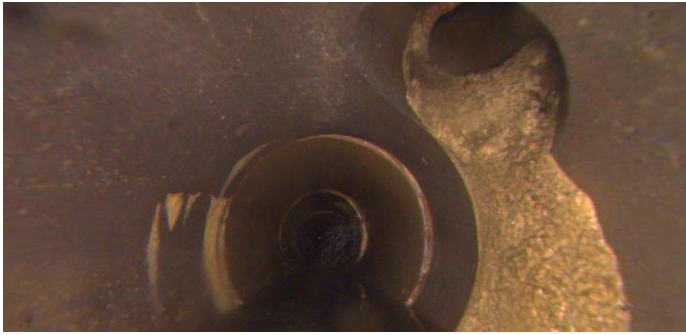
Code: **DAE**
Description: **Deposits Attached Encrustation**

Distance (ft): **4.4**
Structural Grade: **0**
O&M Grade: **2**
Clock Start/From: **1**
Clock To: **4**
1st Value:
2nd Value:
Value Percent: **5.000**
Continuous Index:
Within 8" of Joint: **NO**
Remarks:

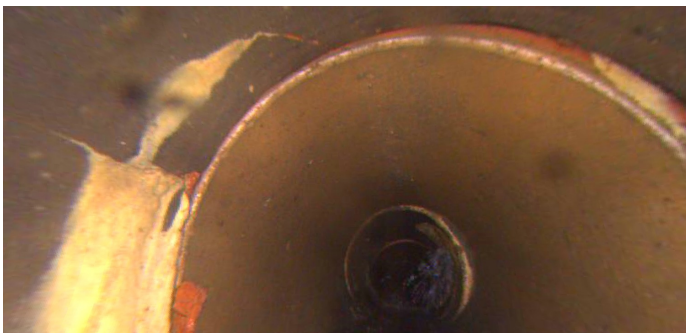
Code: **FM**
Description: **Fracture Multiple**

Distance (ft): **5.3**
Structural Grade: **4**
O&M Grade: **0**
Clock Start/From: **10**
Clock To: **12**
1st Value:
2nd Value:
Value Percent:
Continuous Index:
Within 8" of Joint: **YES**
Remarks:

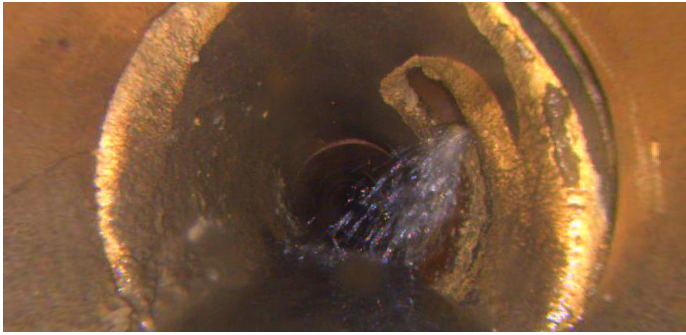
Code: **DAE**
Description: **Deposits Attached Encrustation**

Distance (ft): **7.2**
Structural Grade: **0**
O&M Grade: **2**
Clock Start/From: **8**
Clock To: **4**
1st Value:
2nd Value:
Value Percent: **5.000**
Continuous Index:
Within 8" of Joint: **YES**
Remarks:

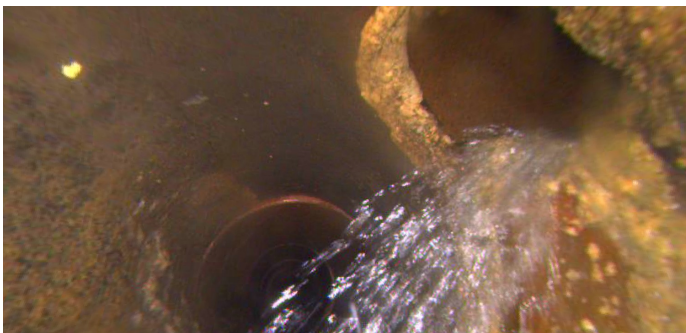
Code: **TBA**
Description: **Tap Break-in Active**

Distance (ft): **8.1**
Structural Grade: **0**
O&M Grade: **0**
Clock Start/From: **2**
Clock To:
1st Value: **4.000**
2nd Value:
Value Percent:
Continuous Index:
Within 8" of Joint:
Remarks:

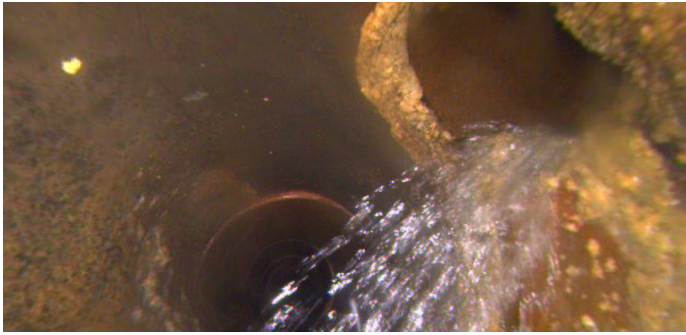
Code: **DAE**
Description: **Deposits Attached Encrustation**

Distance (ft): **8.1**
Structural Grade: **0**
O&M Grade: **2**
Clock Start/From: **1**
Clock To: **4**
1st Value:
2nd Value:
Value Percent: **10.000**
Continuous Index:
Within 8" of Joint: **NO**
Remarks:

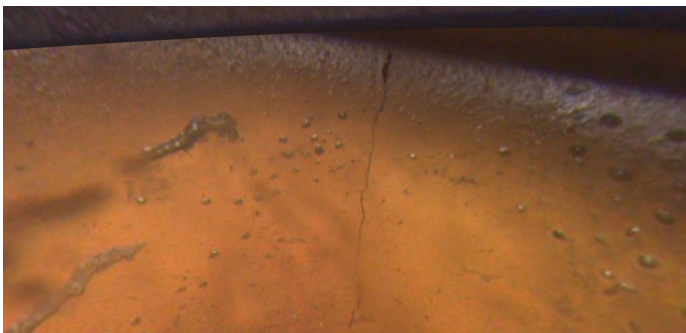
Code: **FL**
Description: **Fracture Longitudinal**

Distance (ft): **9.9**
Structural Grade: **3**
O&M Grade: **0**
Clock Start/From: **12**
Clock To:
1st Value:
2nd Value:
Value Percent:
Continuous Index: **S01**
Within 8" of Joint: **YES**
Remarks:

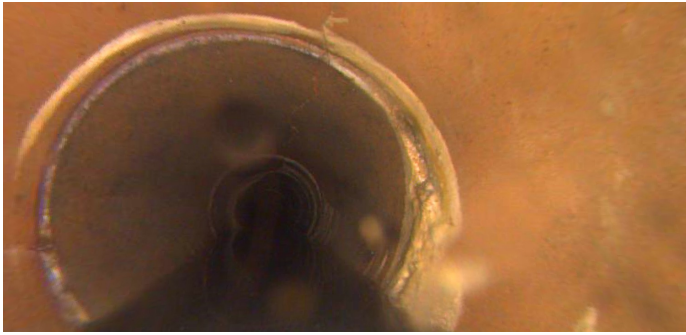
Code: **DAE**
Description: **Deposits Attached Encrustation**

Distance (ft): **11.0**
Structural Grade: **0**
O&M Grade: **2**
Clock Start/From: **8**
Clock To: **4**
1st Value:
2nd Value:
Value Percent: **5.000**
Continuous Index:
Within 8" of Joint: **YES**
Remarks:

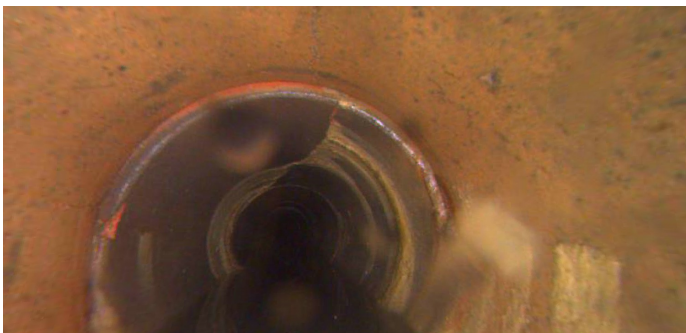
Code: **FM**
Description: **Fracture Multiple**

Distance (ft): **13.0**
Structural Grade: **4**
O&M Grade: **0**
Clock Start/From: **12**
Clock To: **4**
1st Value:
2nd Value:
Value Percent:
Continuous Index: **S02**
Within 8" of Joint: **YES**
Remarks:

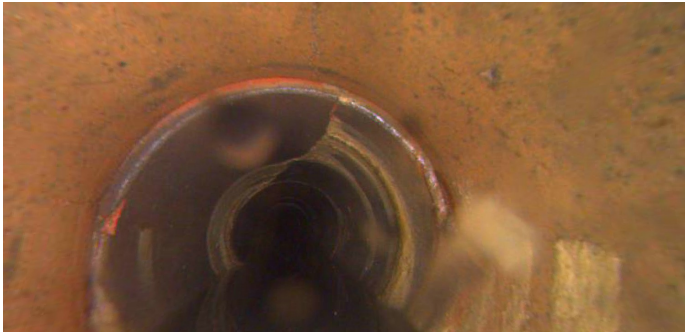
Code: **FL**
Description: **Fracture Longitudinal**

Distance (ft): **13.0**
Structural Grade: **3**
O&M Grade: **0**
Clock Start/From: **12**
Clock To:
1st Value:
2nd Value:
Value Percent:
Continuous Index: **F01**
Within 8" of Joint: **YES**
Remarks:

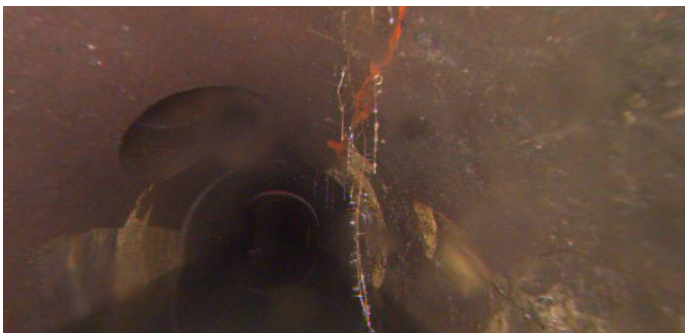
Code: **RFB**
Description: **Roots Fine Barrel**

Distance (ft): **26.0**
Structural Grade: **0**
O&M Grade: **2**
Clock Start/From: **1**
Clock To:
1st Value:
2nd Value:
Value Percent:
Continuous Index:
Within 8" of Joint: **NO**
Remarks:

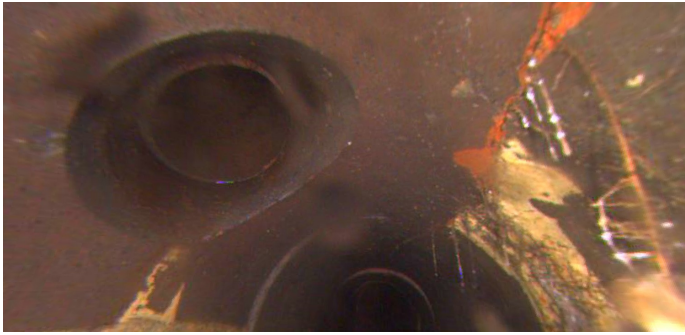
Code: **TF**
Description: **Tap Factory**

Distance (ft): **26.7**
Structural Grade: **0**
O&M Grade: **0**
Clock Start/From: **11**
Clock To:
1st Value: **4.000**
2nd Value:
Value Percent:
Continuous Index:
Within 8" of Joint:
Remarks:

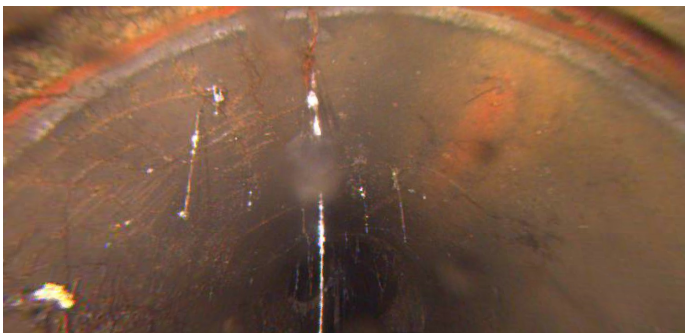
Code: **RFB**
Description: **Roots Fine Barrel**

Distance (ft): **33.8**
Structural Grade: **0**
O&M Grade: **2**
Clock Start/From: **9**
Clock To: **12**
1st Value:
2nd Value:
Value Percent:
Continuous Index:
Within 8" of Joint: **NO**
Remarks:

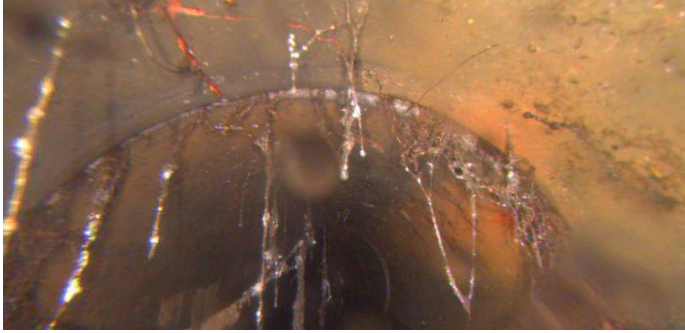
Code: **RMJ**
Description: **Roots Medium Joint**

Distance (ft): **35.6**
Structural Grade: **0**
O&M Grade: **3**
Clock Start/From: **8**
Clock To: **4**
1st Value:
2nd Value:
Value Percent: **10.000**
Continuous Index:
Within 8" of Joint: **YES**
Remarks:

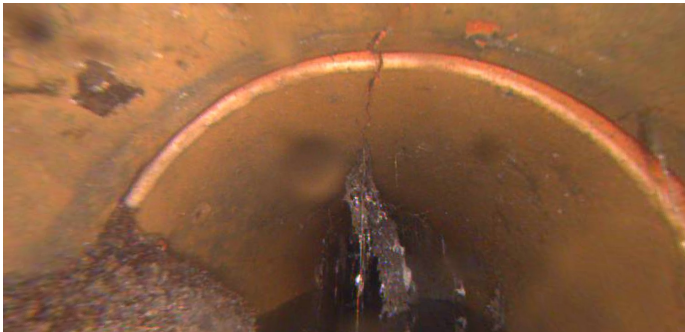
Code: **RMJ**
Description: **Roots Medium Joint**

Distance (ft): **39.6**
Structural Grade: **0**
O&M Grade: **3**
Clock Start/From: **8**
Clock To: **4**
1st Value:
2nd Value:
Value Percent: **20.000**
Continuous Index:
Within 8" of Joint: **YES**
Remarks:

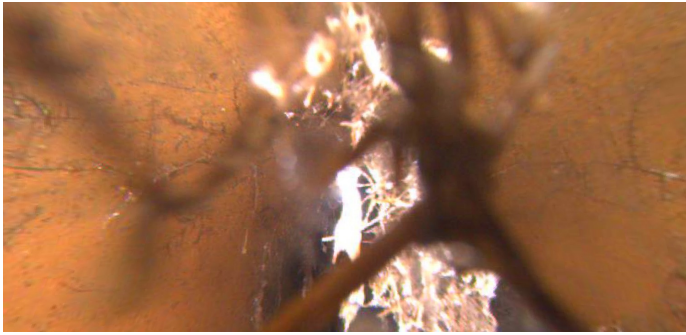
Code: **RMB**
Description: **Roots Medium Barrel**

Distance (ft): **40.7**
Structural Grade: **0**
O&M Grade: **4**
Clock Start/From: **12**
Clock To:
1st Value:
2nd Value:
Value Percent: **10.000**
Continuous Index:
Within 8" of Joint: **NO**
Remarks:

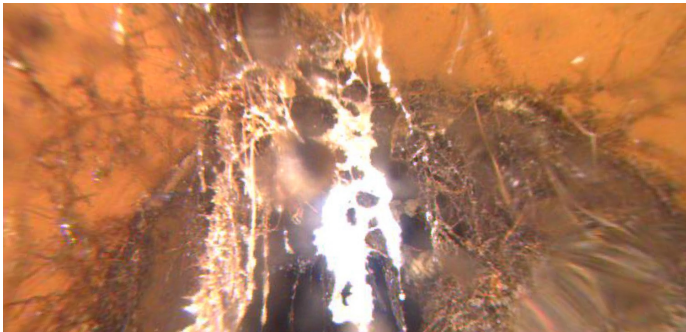
Code: **RMJ**
Description: **Roots Medium Joint**

Distance (ft): **41.4**
Structural Grade: **0**
O&M Grade: **3**
Clock Start/From: **8**
Clock To: **4**
1st Value:
2nd Value:
Value Percent: **40.000**
Continuous Index:
Within 8" of Joint: **YES**
Remarks:

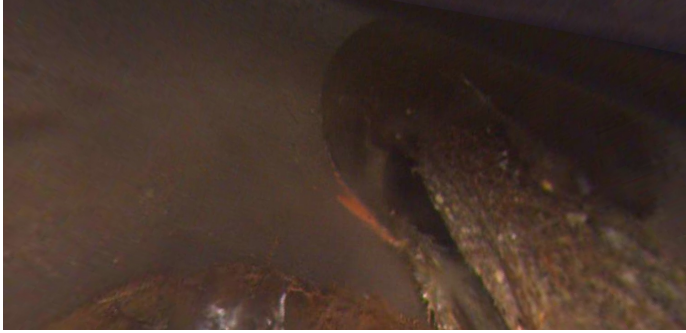
Code: **TFD**
Description: **Tap Factory Defective**

Distance (ft): **45.1**
Structural Grade: **0**
O&M Grade: **2**
Clock Start/From: **1**
Clock To:
1st Value: **4.000**
2nd Value:
Value Percent:
Continuous Index:
Within 8" of Joint:
Remarks: **ROOTS**

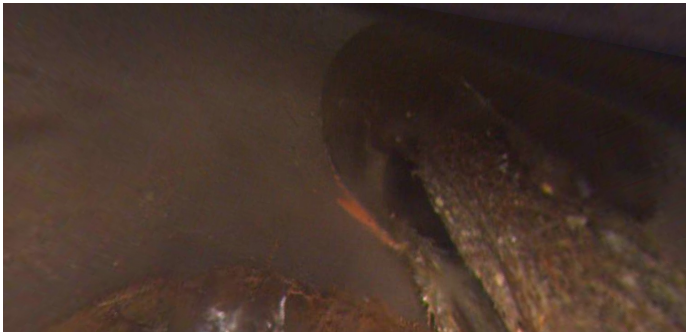
Code: **RML**
Description: **Roots Medium Lateral**

Distance (ft): **45.1**
Structural Grade: **0**
O&M Grade: **3**
Clock Start/From: **1**
Clock To:
1st Value:
2nd Value:
Value Percent: **10.000**
Continuous Index:
Within 8" of Joint: **NO**
Remarks:

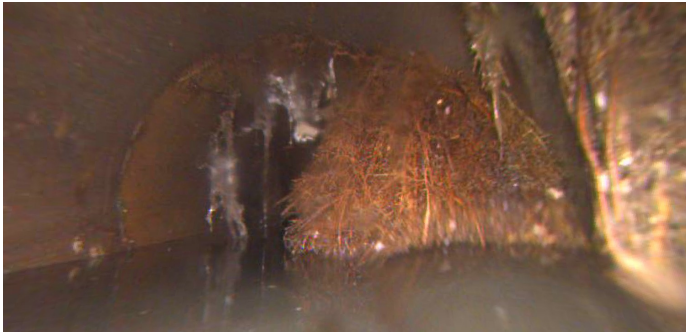
Code: **RBJ**
Description: **Roots Ball Joint**

Distance (ft): **45.1**
Structural Grade: **0**
O&M Grade: **4**
Clock Start/From: **8**
Clock To: **4**
1st Value:
2nd Value:
Value Percent: **70.000**
Continuous Index:
Within 8" of Joint: **YES**
Remarks:

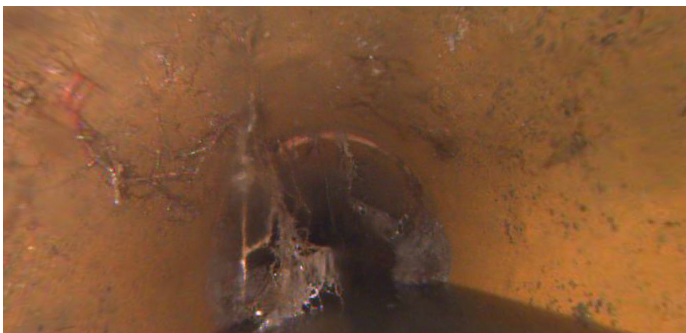
Code: **FM**
Description: **Fracture Multiple**

Distance (ft): **48.0**
Structural Grade: **4**
O&M Grade: **0**
Clock Start/From: **12**
Clock To: **4**
1st Value:
2nd Value:
Value Percent:
Continuous Index: **F02**
Within 8" of Joint: **YES**
Remarks:

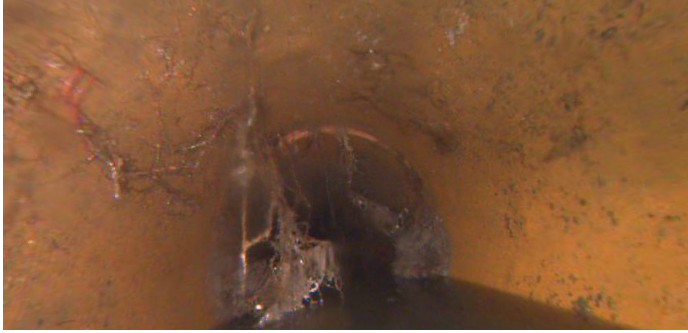
Code:	MSA
Description:	Abandoned Survey
Distance (ft):	48.0
Structural Grade:	0
O&M Grade:	0
Clock Start/From:	
Clock To:	
1st Value:	
2nd Value:	
Value Percent:	
Continuous Index:	
Within 8" of Joint:	NO
Remarks:	ROOTS
