## Profile/Photo Observation Report

Date:	<b>04/25/2018</b>	Weather:		Coding:	<b>PACP 6.0</b>
Pipe Length (ft):	<b>167.9</b>	Owner:	<b>NA</b>	Pre Clean:	<b>Not Known</b>
P.O.#:		Surveyor:	<b>Jen Costello</b>	PSR:	<b>P-605-028-027</b>
Customer:		Clean Date:	<b>01/01/1900</b>	Shape:	<b>C</b>

Street:	<b>W 2ND ST &amp; S ASH ST</b>	Flow Control:	<b>Not Controlled</b>
City:	<b>Hobart, IN</b>	Year Renewed:	
Location:	<b>Other</b>	Tape/Media #:	
Purpose:	<b>Not Known</b>	Dia/Height:	<b>12"</b>
Use:	<b>Sanitary</b>	Material:	<b>VCP</b>
Drain Area:	<b>NA</b>	Lining:	
Category:	<b>NA</b>		
Comment:

Location Details:		Direction of Survey:	<b>Downstream</b>
US MH:	<b>M-605-027</b>	DS MH:	<b>M-605-028</b>
		Total Length Surveyed (ft):	<b>67.9</b>

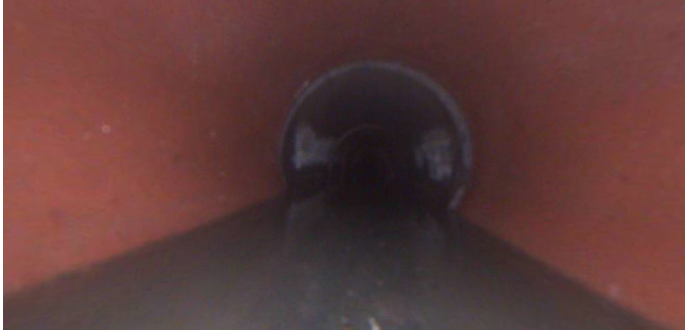
Code: **AMH**  
Description: **Manhole**

Distance (ft): **.0**  
Structural Grade: **0**  
O&M Grade: **0**  
Clock Start/From:  
Clock To:  
1st Value:  
2nd Value:  
Value Percent:  
Continuous Index:  
Within 8" of Joint: **NO**  
Remarks: **M-605-027**

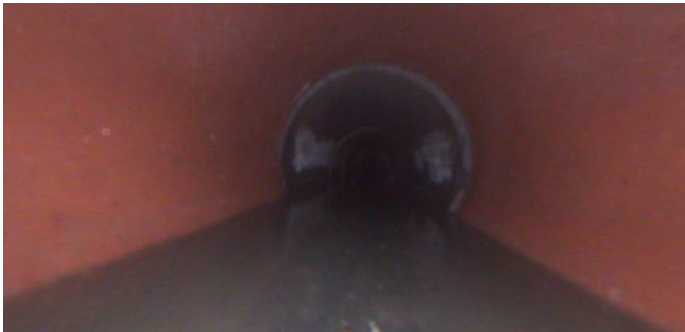
Code: **MWL**  
Description: **Water Level**

Distance (ft): **.0**  
Structural Grade: **0**  
O&M Grade: **0**  
Clock Start/From:  
Clock To:  
1st Value:  
2nd Value:  
Value Percent: **30.000**  
Continuous Index:  
Within 8" of Joint: **NO**  
Remarks:

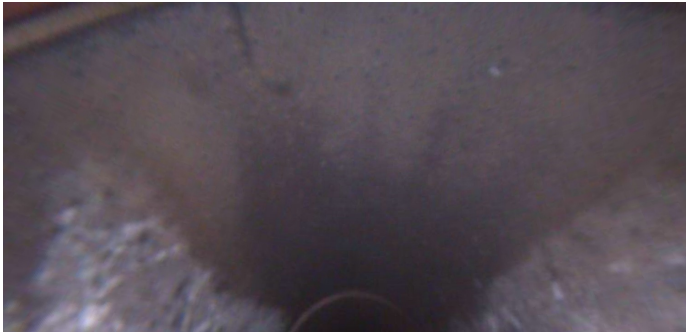
Code: **FL**  
Description: **Fracture Longitudinal**

Distance (ft): **2.4**  
Structural Grade: **3**  
O&M Grade: **0**  
Clock Start/From: **11**  
Clock To:  
1st Value:  
2nd Value:  
Value Percent:  
Continuous Index:  
Within 8" of Joint: **YES**  
Remarks:

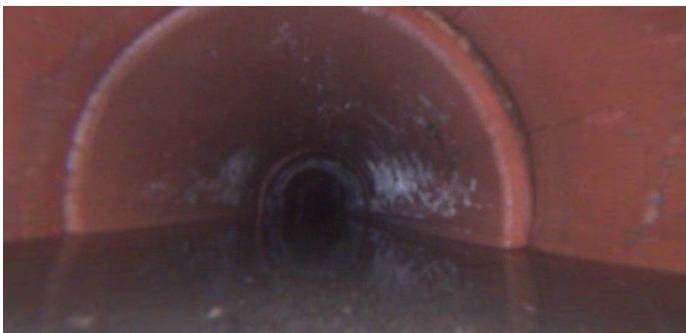
Code: **FL**  
Description: **Fracture Longitudinal**

Distance (ft): **12.2**  
Structural Grade: **3**  
O&M Grade: **0**  
Clock Start/From: **3**  
Clock To:  
1st Value:  
2nd Value:  
Value Percent:  
Continuous Index:  
Within 8" of Joint: **YES**  
Remarks:

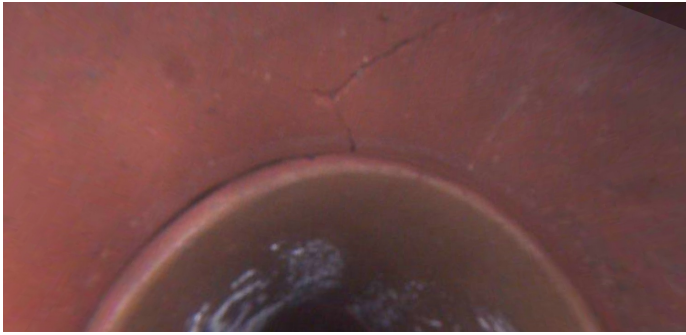
Code: **FS**  
Description: **Fracture Spiral**

Distance (ft): **18.2**  
Structural Grade: **3**  
O&M Grade: **0**  
Clock Start/From: **11**  
Clock To: **12**  
1st Value:  
2nd Value:  
Value Percent:  
Continuous Index:  
Within 8" of Joint: **YES**  
Remarks:

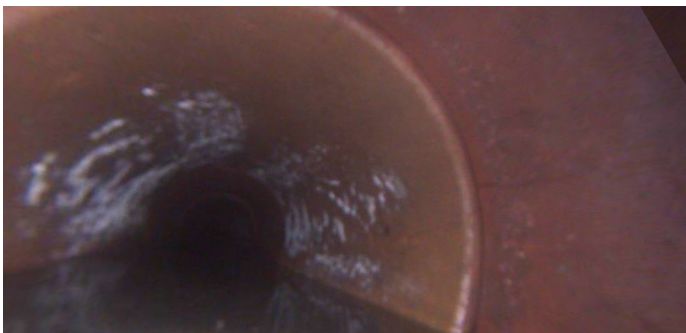
Code: **FL**  
Description: **Fracture Longitudinal**

Distance (ft): **18.4**  
Structural Grade: **3**  
O&M Grade: **0**  
Clock Start/From: **3**  
Clock To:  
1st Value:  
2nd Value:  
Value Percent:  
Continuous Index:  
Within 8" of Joint: **YES**  
Remarks:

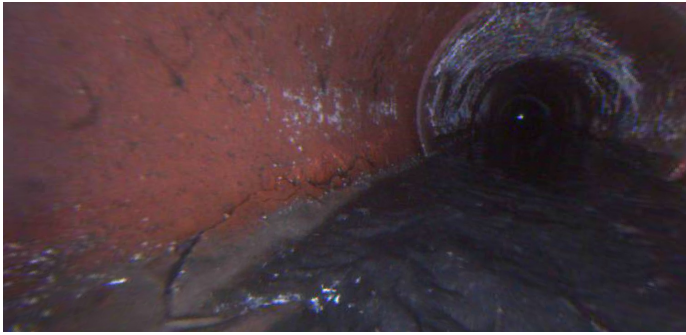
Code: **FS**  
Description: **Fracture Spiral**

Distance (ft): **18.4**  
Structural Grade: **3**  
O&M Grade: **0**  
Clock Start/From: **3**  
Clock To: **4**  
1st Value:  
2nd Value:  
Value Percent:  
Continuous Index:  
Within 8" of Joint:  
Remarks:

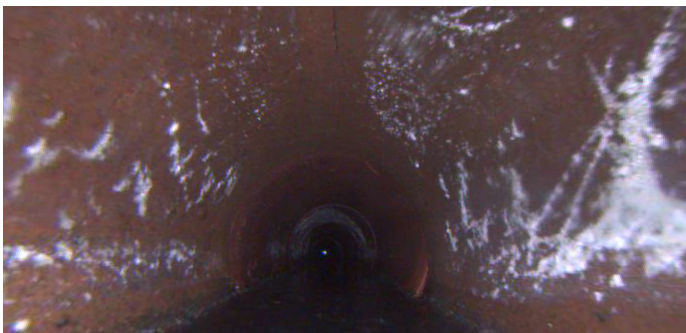
Code: **MGO**  
Description: **General Observation**

Distance (ft): **20.6**  
Structural Grade: **0**  
O&M Grade: **0**  
Clock Start/From:  
Clock To:  
1st Value:  
2nd Value:  
Value Percent:  
Continuous Index:  
Within 8" of Joint: **NO**  
Remarks: **rear camera**

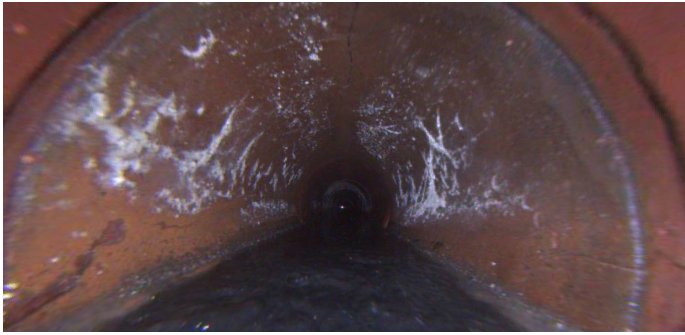
Code: **FM**  
Description: **Fracture Multiple**

Distance (ft): **21.3**  
Structural Grade: **4**  
O&M Grade: **0**  
Clock Start/From: **8**  
Clock To: **4**  
1st Value:  
2nd Value:  
Value Percent:  
Continuous Index: **S01**  
Within 8" of Joint: **YES**  
Remarks:

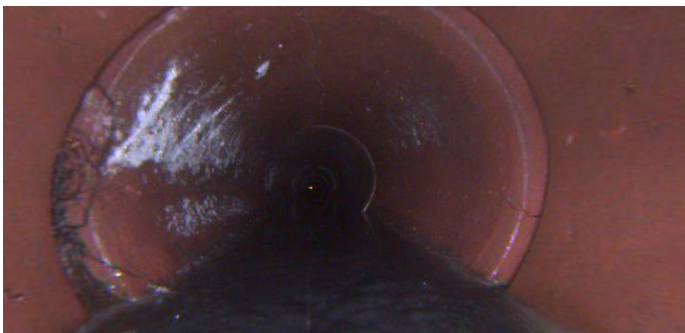
Code: **RFJ**  
Description: **Roots Fine Joint**

Distance (ft): **27.7**  
Structural Grade: **0**  
O&M Grade: **1**  
Clock Start/From: **8**  
Clock To: **4**  
1st Value:  
2nd Value:  
Value Percent:  
Continuous Index: **S02**  
Within 8" of Joint: **YES**  
Remarks:

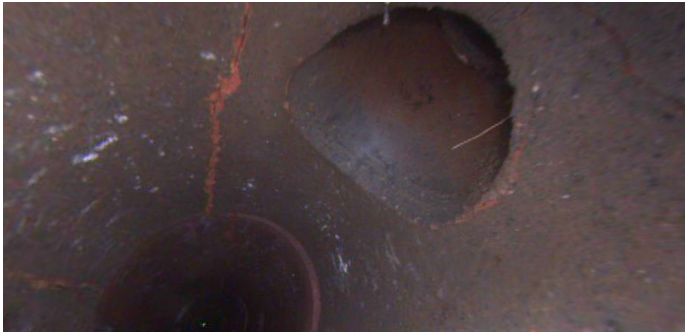
Code: **TFD**  
Description: **Tap Factory Defective**

Distance (ft): **33.0**  
Structural Grade: **0**  
O&M Grade: **2**  
Clock Start/From: **10**  
Clock To:  
1st Value: **4.000**  
2nd Value:  
Value Percent:  
Continuous Index:  
Within 8" of Joint:  
Remarks: **roots**

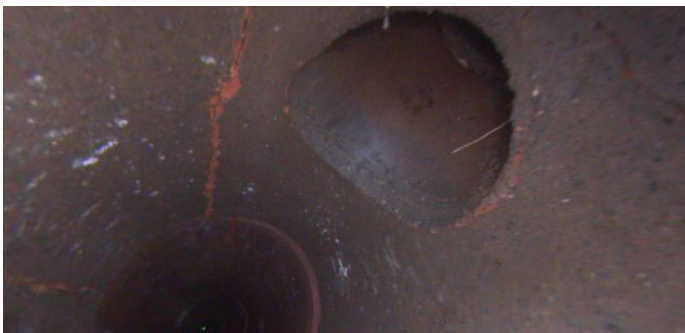
Code: **RFL**  
Description: **Roots Fine Lateral**

Distance (ft): **33.0**  
Structural Grade: **0**  
O&M Grade: **1**  
Clock Start/From: **10**  
Clock To:  
1st Value:  
2nd Value:  
Value Percent:  
Continuous Index:  
Within 8" of Joint: **NO**  
Remarks:

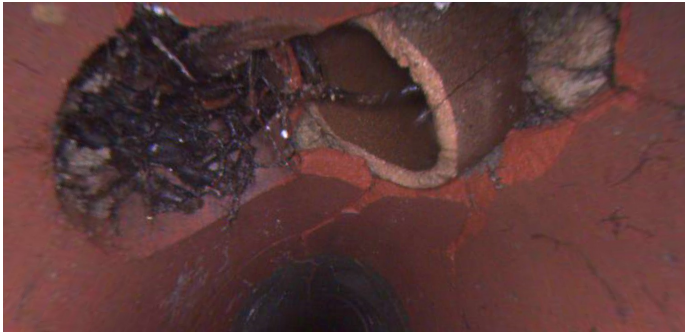
Code: **TBI**  
Description: **Tap Break-in Intruding**

Distance (ft): **35.3**  
Structural Grade: **0**  
O&M Grade: **2**  
Clock Start/From: **12**  
Clock To:  
1st Value: **4.000**  
2nd Value: **1.000**  
Value Percent:  
Continuous Index:  
Within 8" of Joint:  
Remarks:

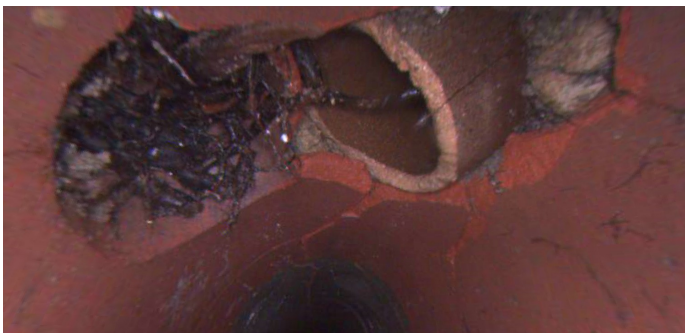
Code: **TFD**  
Description: **Tap Factory Defective**

Distance (ft): **35.3**  
Structural Grade: **0**  
O&M Grade: **2**  
Clock Start/From: **1**  
Clock To:  
1st Value: **4.000**  
2nd Value:  
Value Percent:  
Continuous Index:  
Within 8" of Joint: **NO**  
Remarks: **roots**

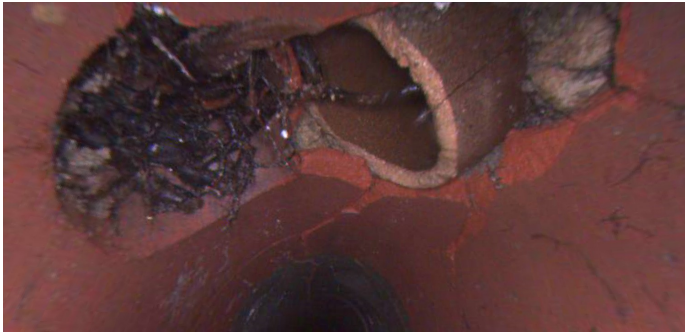
Code: **RFL**  
Description: **Roots Fine Lateral**

Distance (ft): **35.3**  
Structural Grade: **0**  
O&M Grade: **1**  
Clock Start/From: **12**  
Clock To: **1**  
1st Value:  
2nd Value:  
Value Percent:  
Continuous Index:  
Within 8" of Joint: **NO**  
Remarks:

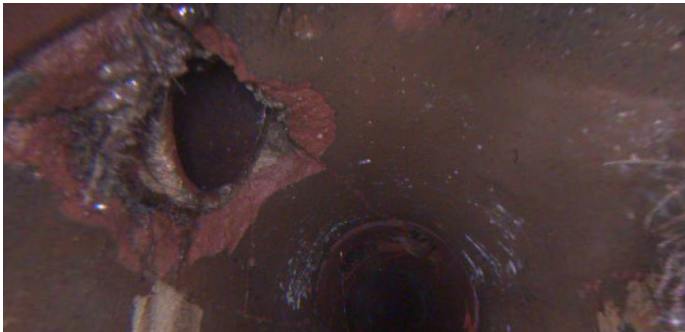
Code: **TBI**  
Description: **Tap Break-in Intruding**

Distance (ft): **37.6**  
Structural Grade: **0**  
O&M Grade: **2**  
Clock Start/From: **2**  
Clock To:  
1st Value: **4.000**  
2nd Value: **1.000**  
Value Percent:  
Continuous Index:  
Within 8" of Joint:  
Remarks:

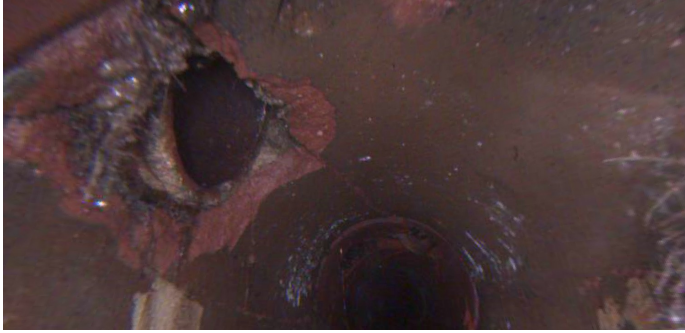
Code: **RFC**  
Description: **Roots Fine Connection**

Distance (ft): **37.6**  
Structural Grade: **0**  
O&M Grade: **1**  
Clock Start/From: **1**  
Clock To:  
1st Value:  
2nd Value:  
Value Percent:  
Continuous Index:  
Within 8" of Joint: **NO**  
Remarks:

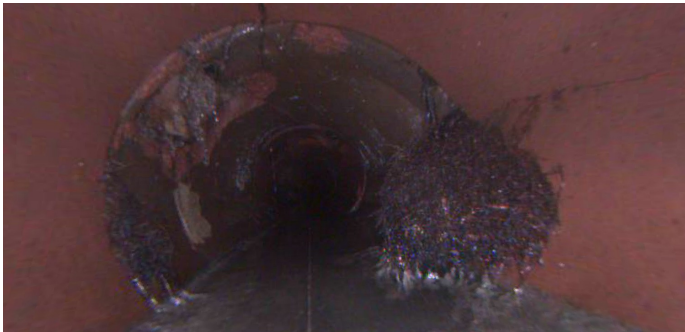
Code: **RMJ**  
Description: **Roots Medium Joint**

Distance (ft): **38.2**  
Structural Grade: **0**  
O&M Grade: **3**  
Clock Start/From: **8**  
Clock To: **4**  
1st Value:  
2nd Value:  
Value Percent: **15.000**  
Continuous Index:  
Within 8" of Joint: **YES**  
Remarks:

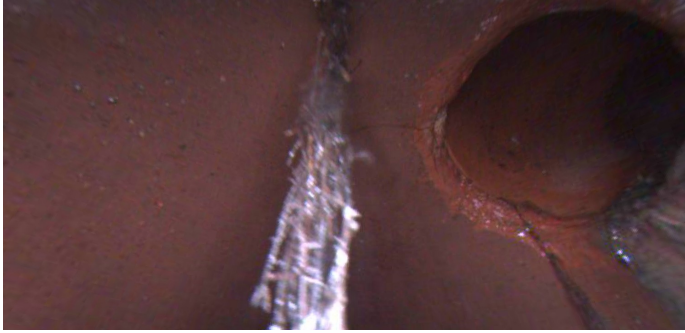
Code: **RMB**  
Description: **Roots Medium Barrel**

Distance (ft): **38.9**  
Structural Grade: **0**  
O&M Grade: **4**  
Clock Start/From: **12**  
Clock To:  
1st Value:  
2nd Value:  
Value Percent: **5.000**  
Continuous Index:  
Within 8" of Joint: **NO**  
Remarks:

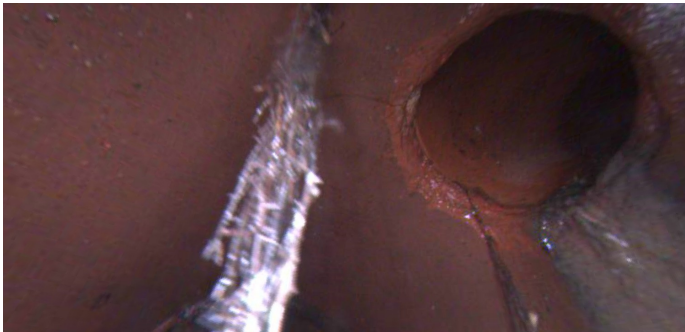
Code: **TBD**  
Description: **Tap Break-in Defective**

Distance (ft): **38.9**  
Structural Grade: **0**  
O&M Grade: **3**  
Clock Start/From: **11**  
Clock To:  
1st Value: **4.000**  
2nd Value:  
Value Percent:  
Continuous Index:  
Within 8" of Joint:  
Remarks: **roots**

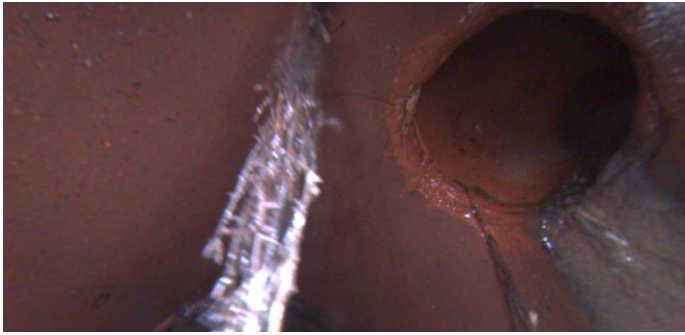
Code: **RFC**  
Description: **Roots Fine Connection**

Distance (ft): **38.9**  
Structural Grade: **0**  
O&M Grade: **1**  
Clock Start/From: **11**  
Clock To:  
1st Value:  
2nd Value:  
Value Percent:  
Continuous Index:  
Within 8" of Joint: **NO**  
Remarks:

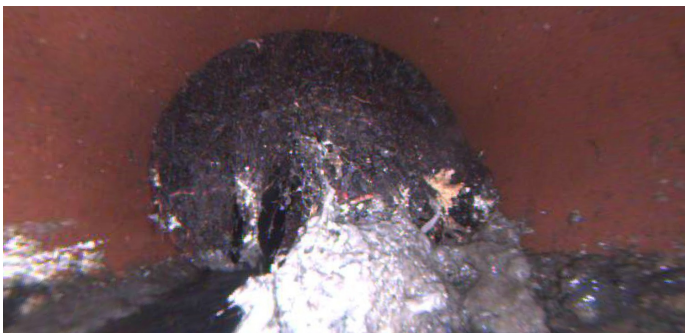
Code: **RBJ**  
Description: **Roots Ball Joint**

Distance (ft): **40.5**  
Structural Grade: **0**  
O&M Grade: **4**  
Clock Start/From: **12**  
Clock To: **12**  
1st Value:  
2nd Value:  
Value Percent: **90.000**  
Continuous Index:  
Within 8" of Joint: **YES**  
Remarks:

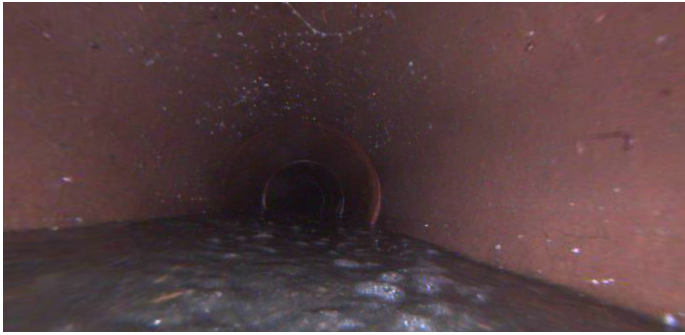
Code: **RFJ**  
Description: **Roots Fine Joint**

Distance (ft): **63.5**  
Structural Grade: **0**  
O&M Grade: **1**  
Clock Start/From: **8**  
Clock To: **4**  
1st Value:  
2nd Value:  
Value Percent:  
Continuous Index: **F02**  
Within 8" of Joint: **YES**  
Remarks:

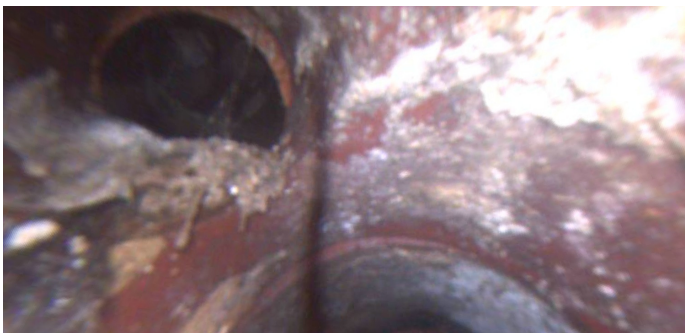
Code: **TFD**  
Description: **Tap Factory Defective**

Distance (ft): **66.5**  
Structural Grade: **0**  
O&M Grade: **2**  
Clock Start/From: **10**  
Clock To:  
1st Value: **4.000**  
2nd Value:  
Value Percent:  
Continuous Index:  
Within 8" of Joint:  
Remarks: **roots**

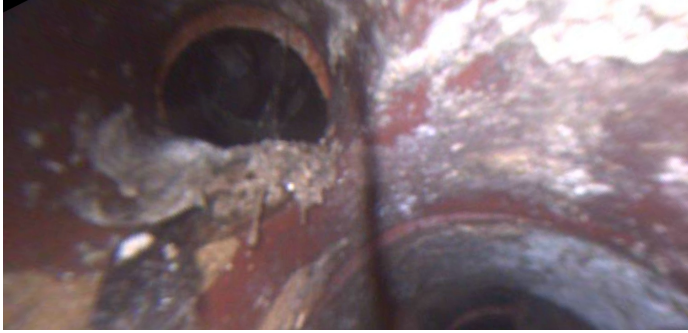
Code: **TFD**  
Description: **Tap Factory Defective**

Distance (ft): **66.5**  
Structural Grade: **0**  
O&M Grade: **2**  
Clock Start/From: **11**  
Clock To:  
1st Value: **4.000**  
2nd Value:  
Value Percent:  
Continuous Index:  
Within 8" of Joint:  
Remarks: **roots**

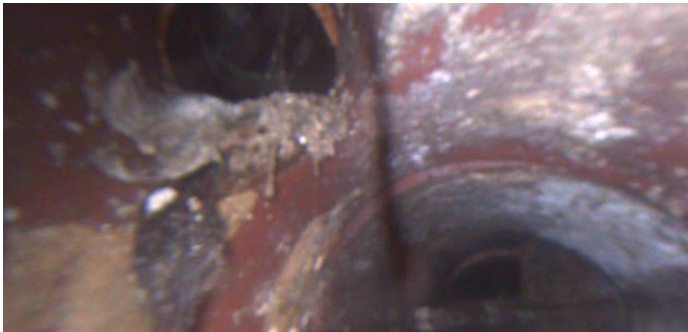
Code: **RFL**  
Description: **Roots Fine Lateral**

Distance (ft): **66.5**  
Structural Grade: **0**  
O&M Grade: **1**  
Clock Start/From: **10**  
Clock To:  
1st Value:  
2nd Value:  
Value Percent:  
Continuous Index:  
Within 8" of Joint: **NO**  
Remarks:

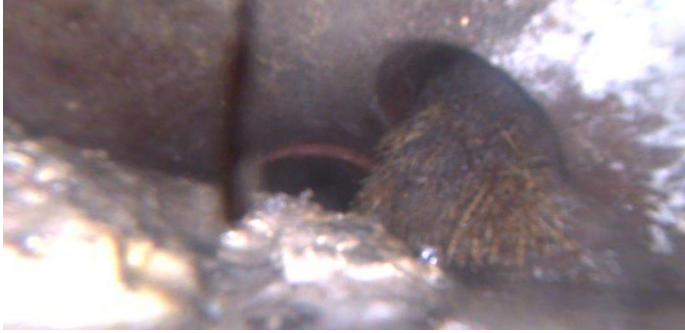
Code: **TFD**  
Description: **Tap Factory Defective**

Distance (ft): **67.5**  
Structural Grade: **0**  
O&M Grade: **2**  
Clock Start/From: **2**  
Clock To:  
1st Value: **4.000**  
2nd Value:  
Value Percent:  
Continuous Index:  
Within 8" of Joint:  
Remarks: **roots**

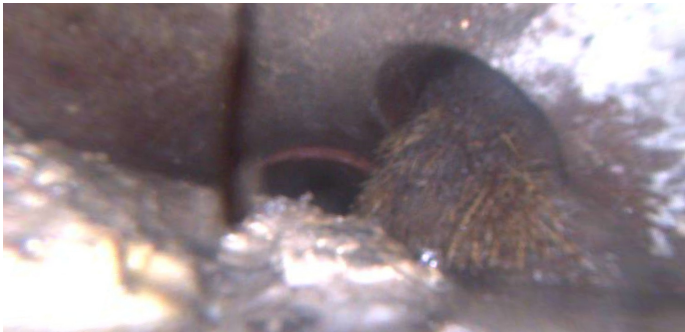
Code: **RML**  
Description: **Roots Medium Lateral**

Distance (ft): **67.5**  
Structural Grade: **0**  
O&M Grade: **3**  
Clock Start/From: **1**  
Clock To: **4**  
1st Value:  
2nd Value:  
Value Percent: **20.000**  
Continuous Index:  
Within 8" of Joint: **NO**  
Remarks:
