## Profile/Photo Observation Report

Street:	<b>S Ash St.</b>	Flow Control:	<b>Not Controlled</b>
City:	<b>Hobart, IN</b>	Year Renewed:	
Location:	<b>Other</b>	Tape/Media #:	
Purpose:	<b>Not Known</b>	Dia/Height:	<b>12"</b>
Use:	<b>Sanitary</b>	Material:	<b>VCP</b>
Drain Area:	<b>NA</b>	Lining:	
Category:	<b>NA</b>		
Comment:

Location Details:		Direction of Survey:	<b>Downstream</b>
US MH:	<b>M-605-027</b>	DS MH:	<b>M-605-028</b>
		Total Length Surveyed (ft):	<b>67.9</b>

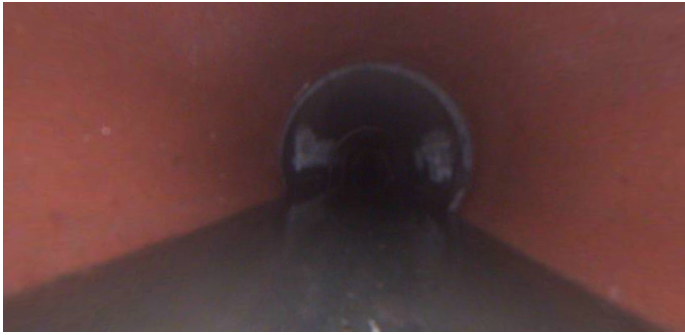
Code: **AMH**  
Description: **Manhole**

Distance (ft): **.0**  
Structural Grade: **0**  
O&M Grade: **0**  
Clock Start/From:  
Clock To:  
1st Value:  
2nd Value:  
Value Percent:  
Continuous Index:  
Within 8" of Joint: **NO**  
Remarks: **M-605-027**

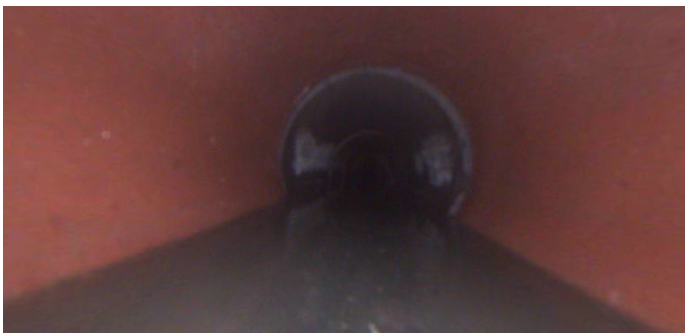
Code: **MWL**  
Description: **Water Level**

Distance (ft): **.0**  
Structural Grade: **0**  
O&M Grade: **0**  
Clock Start/From:  
Clock To:  
1st Value:  
2nd Value:  
Value Percent: **30.000**  
Continuous Index:  
Within 8" of Joint: **NO**  
Remarks:

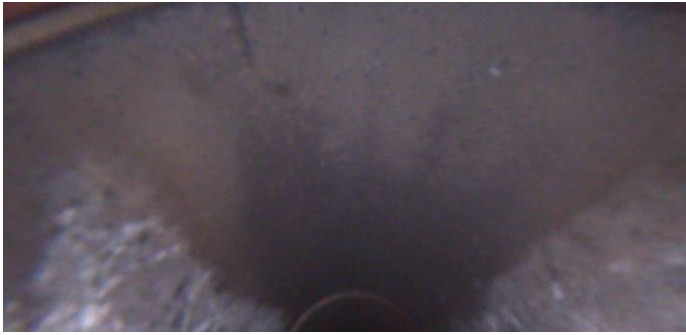
Code: **FL**  
Description: **Fracture Longitudinal**

Distance (ft): **2.4**  
Structural Grade: **3**  
O&M Grade: **0**  
Clock Start/From: **11**  
Clock To:  
1st Value:  
2nd Value:  
Value Percent:  
Continuous Index:  
Within 8" of Joint: **YES**  
Remarks:

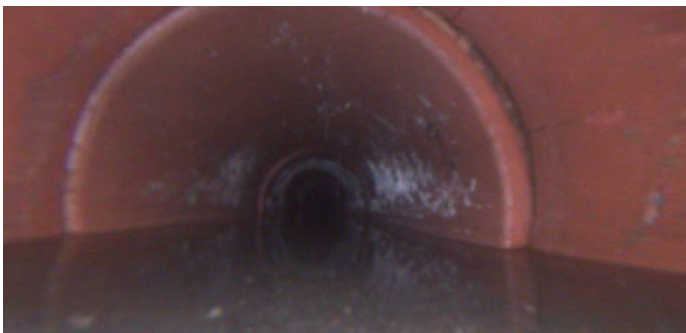
Code: **FL**  
Description: **Fracture Longitudinal**

Distance (ft): **12.2**  
Structural Grade: **3**  
O&M Grade: **0**  
Clock Start/From: **3**  
Clock To:  
1st Value:  
2nd Value:  
Value Percent:  
Continuous Index:  
Within 8" of Joint: **YES**  
Remarks:

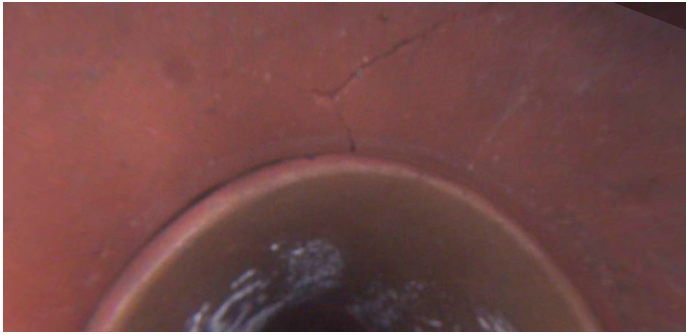
Code: **FS**  
Description: **Fracture Spiral**

Distance (ft): **18.2**  
Structural Grade: **3**  
O&M Grade: **0**  
Clock Start/From: **11**  
Clock To: **12**  
1st Value:  
2nd Value:  
Value Percent:  
Continuous Index:  
Within 8" of Joint: **YES**  
Remarks:

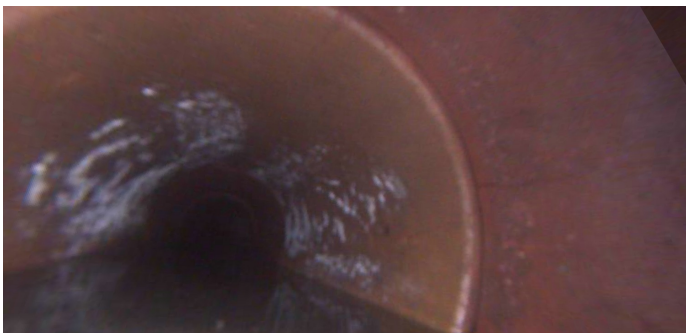
Code: **FL**  
Description: **Fracture Longitudinal**

Distance (ft): **18.4**  
Structural Grade: **3**  
O&M Grade: **0**  
Clock Start/From: **3**  
Clock To:  
1st Value:  
2nd Value:  
Value Percent:  
Continuous Index:  
Within 8" of Joint: **YES**  
Remarks:

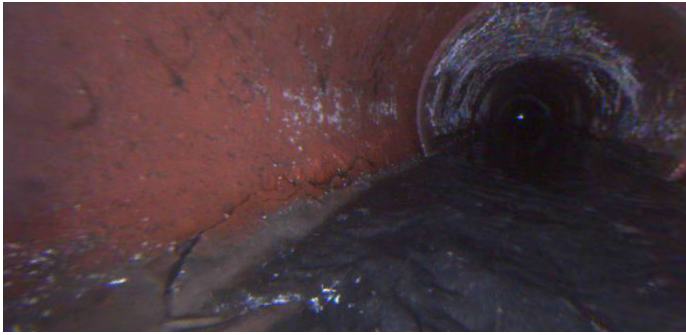
Code: **FS**  
Description: **Fracture Spiral**

Distance (ft): **18.4**  
Structural Grade: **3**  
O&M Grade: **0**  
Clock Start/From: **3**  
Clock To: **4**  
1st Value:  
2nd Value:  
Value Percent:  
Continuous Index:  
Within 8" of Joint:  
Remarks:

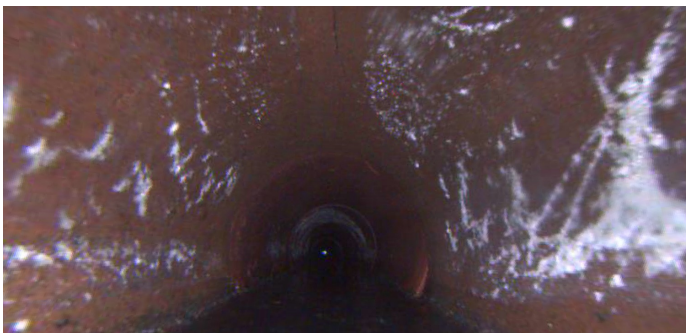
Code: **MGO**  
Description: **General Observation**

Distance (ft): **20.6**  
Structural Grade: **0**  
O&M Grade: **0**  
Clock Start/From:  
Clock To:  
1st Value:  
2nd Value:  
Value Percent:  
Continuous Index:  
Within 8" of Joint: **NO**  
Remarks: **rear camera**

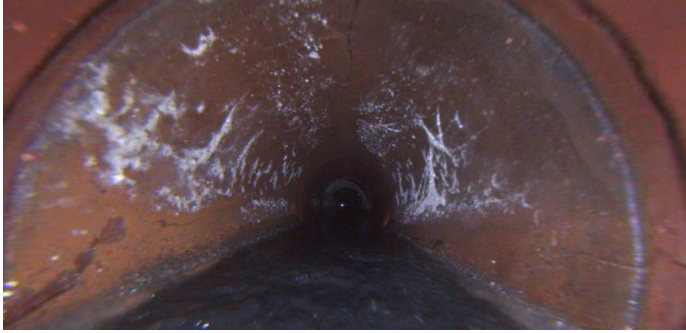
Code: **FM**  
Description: **Fracture Multiple**

Distance (ft): **21.3**  
Structural Grade: **4**  
O&M Grade: **0**  
Clock Start/From: **8**  
Clock To: **4**  
1st Value:  
2nd Value:  
Value Percent:  
Continuous Index: **S01**  
Within 8" of Joint: **YES**  
Remarks:

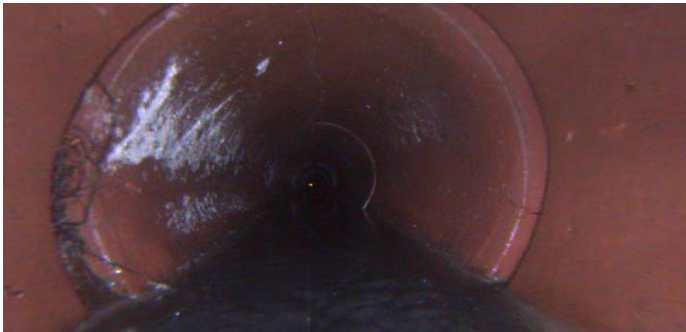
Code: **RFJ**  
Description: **Roots Fine Joint**

Distance (ft): **27.7**  
Structural Grade: **0**  
O&M Grade: **1**  
Clock Start/From: **8**  
Clock To: **4**  
1st Value:  
2nd Value:  
Value Percent:  
Continuous Index: **S02**  
Within 8" of Joint: **YES**  
Remarks:

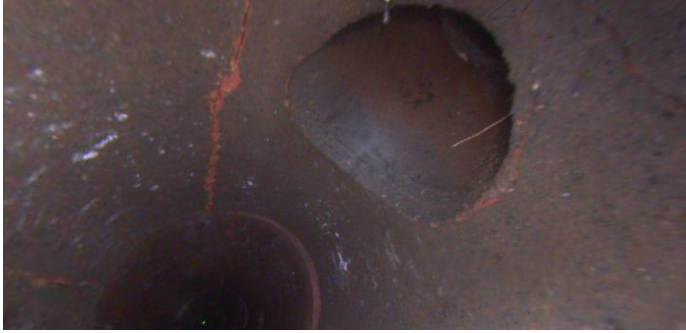
Code: **TFD**  
Description: **Tap Factory Defective**

Distance (ft): **33.0**  
Structural Grade: **0**  
O&M Grade: **2**  
Clock Start/From: **10**  
Clock To:  
1st Value: **4.000**  
2nd Value:  
Value Percent:  
Continuous Index:  
Within 8" of Joint:  
Remarks: **roots**

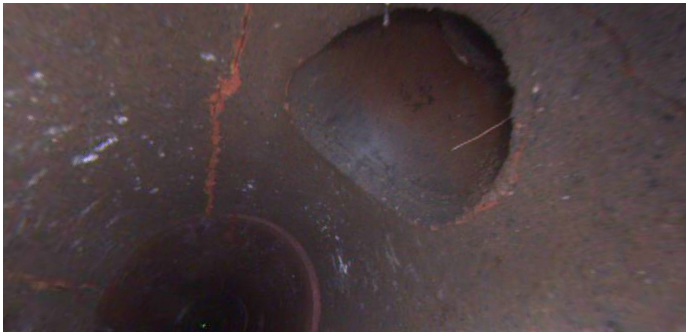
Code: **RFL**  
Description: **Roots Fine Lateral**

Distance (ft): **33.0**  
Structural Grade: **0**  
O&M Grade: **1**  
Clock Start/From: **10**  
Clock To:  
1st Value:  
2nd Value:  
Value Percent:  
Continuous Index:  
Within 8" of Joint: **NO**  
Remarks:

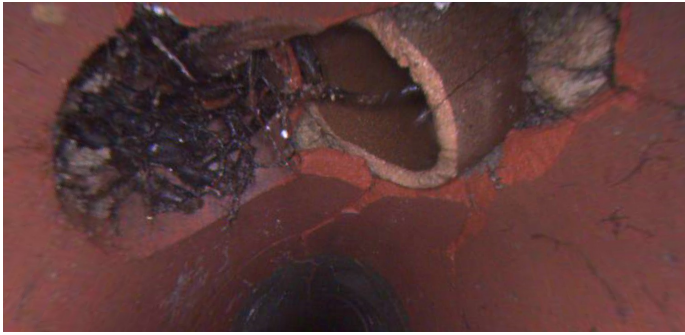
Code: **TBI**  
Description: **Tap Break-in Intruding**

Distance (ft): **35.3**  
Structural Grade: **0**  
O&M Grade: **2**  
Clock Start/From: **12**  
Clock To:  
1st Value: **4.000**  
2nd Value: **1.000**  
Value Percent:  
Continuous Index:  
Within 8" of Joint:  
Remarks:

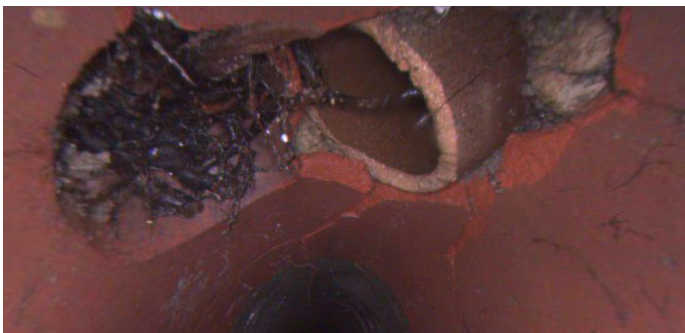
Code: **TFD**  
Description: **Tap Factory Defective**

Distance (ft): **35.3**  
Structural Grade: **0**  
O&M Grade: **2**  
Clock Start/From: **1**  
Clock To:  
1st Value: **4.000**  
2nd Value:  
Value Percent:  
Continuous Index:  
Within 8" of Joint: **NO**  
Remarks: **roots**

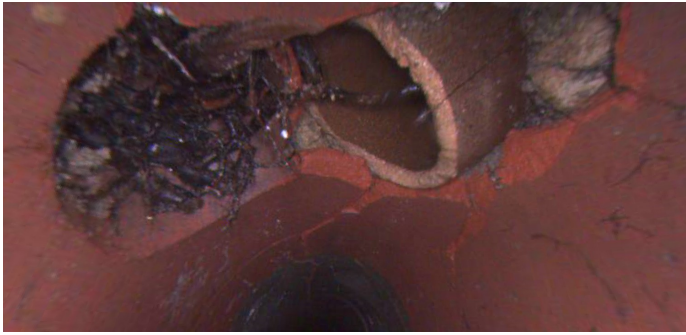
Code: **RFL**  
Description: **Roots Fine Lateral**

Distance (ft): **35.3**  
Structural Grade: **0**  
O&M Grade: **1**  
Clock Start/From: **12**  
Clock To: **1**  
1st Value:  
2nd Value:  
Value Percent:  
Continuous Index:  
Within 8" of Joint: **NO**  
Remarks:

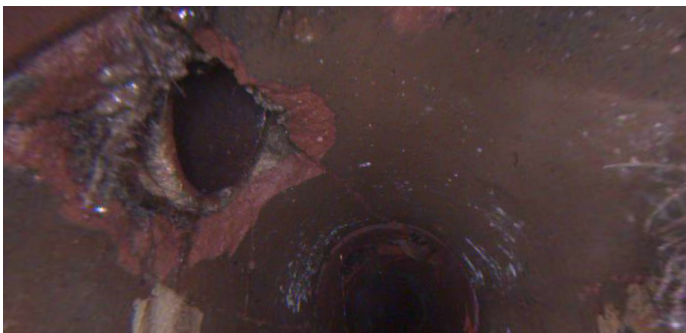
Code: **TBI**  
Description: **Tap Break-in Intruding**

Distance (ft): **37.6**  
Structural Grade: **0**  
O&M Grade: **2**  
Clock Start/From: **2**  
Clock To:  
1st Value: **4.000**  
2nd Value: **1.000**  
Value Percent:  
Continuous Index:  
Within 8" of Joint:  
Remarks:

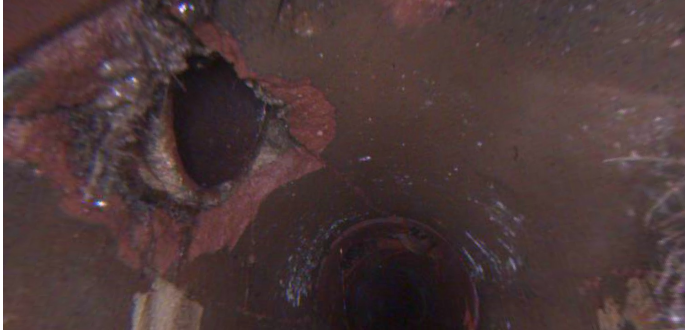
Code: **RFC**  
Description: **Roots Fine Connection**

Distance (ft): **37.6**  
Structural Grade: **0**  
O&M Grade: **1**  
Clock Start/From: **1**  
Clock To:  
1st Value:  
2nd Value:  
Value Percent:  
Continuous Index:  
Within 8" of Joint: **NO**  
Remarks:

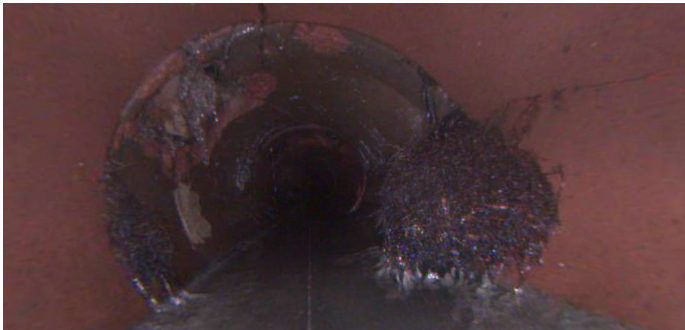
Code: **RMJ**  
Description: **Roots Medium Joint**

Distance (ft): **38.2**  
Structural Grade: **0**  
O&M Grade: **3**  
Clock Start/From: **8**  
Clock To: **4**  
1st Value:  
2nd Value:  
Value Percent: **15.000**  
Continuous Index:  
Within 8" of Joint: **YES**  
Remarks:

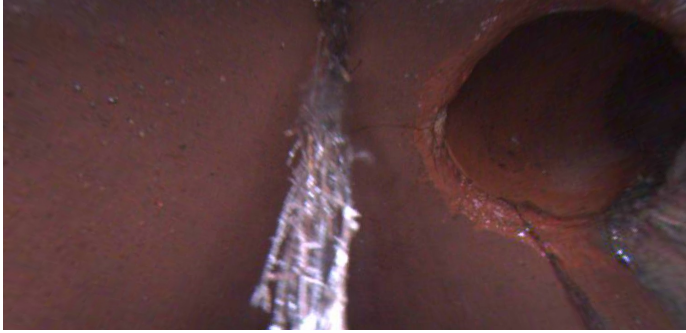
Code: **RMB**  
Description: **Roots Medium Barrel**

Distance (ft): **38.9**  
Structural Grade: **0**  
O&M Grade: **4**  
Clock Start/From: **12**  
Clock To:  
1st Value:  
2nd Value:  
Value Percent: **5.000**  
Continuous Index:  
Within 8" of Joint: **NO**  
Remarks:

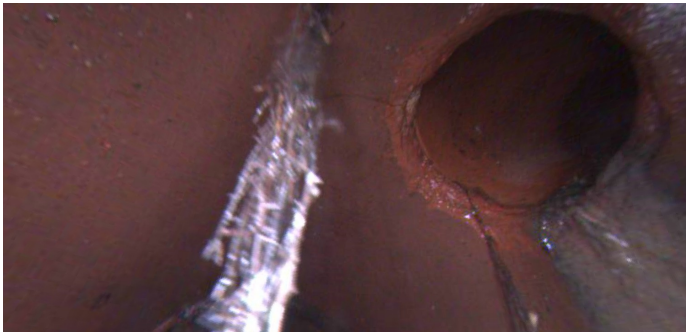
Code: **TBD**  
Description: **Tap Break-in Defective**

Distance (ft): **38.9**  
Structural Grade: **0**  
O&M Grade: **3**  
Clock Start/From: **11**  
Clock To:  
1st Value: **4.000**  
2nd Value:  
Value Percent:  
Continuous Index:  
Within 8" of Joint:  
Remarks: **roots**

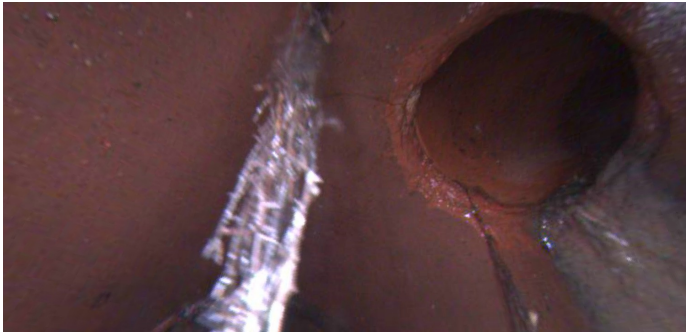
Code: **RFC**  
Description: **Roots Fine Connection**

Distance (ft): **38.9**  
Structural Grade: **0**  
O&M Grade: **1**  
Clock Start/From: **11**  
Clock To:  
1st Value:  
2nd Value:  
Value Percent:  
Continuous Index:  
Within 8" of Joint: **NO**  
Remarks:

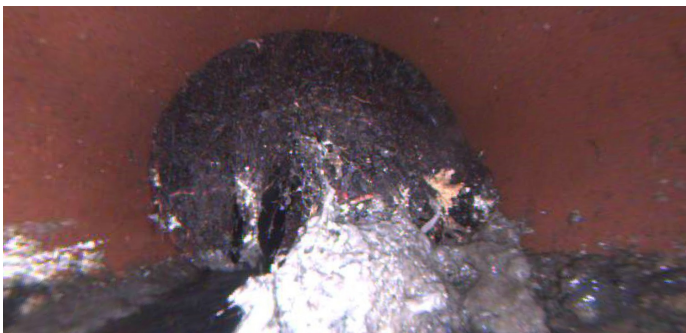
Code: **RBJ**  
Description: **Roots Ball Joint**

Distance (ft): **40.5**  
Structural Grade: **0**  
O&M Grade: **4**  
Clock Start/From: **12**  
Clock To: **12**  
1st Value:  
2nd Value:  
Value Percent: **90.000**  
Continuous Index:  
Within 8" of Joint: **YES**  
Remarks:

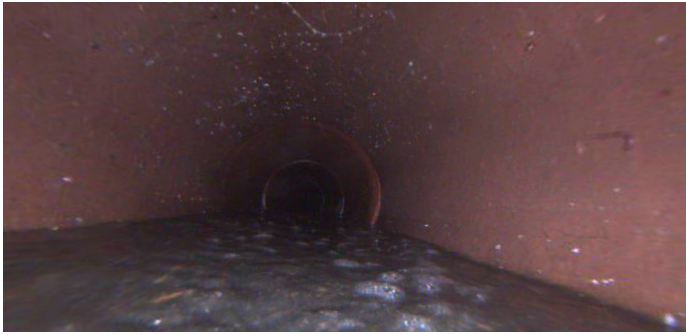
Code: **RFJ**  
Description: **Roots Fine Joint**

Distance (ft): **63.5**  
Structural Grade: **0**  
O&M Grade: **1**  
Clock Start/From: **8**  
Clock To: **4**  
1st Value:  
2nd Value:  
Value Percent:  
Continuous Index: **F02**  
Within 8" of Joint: **YES**  
Remarks:

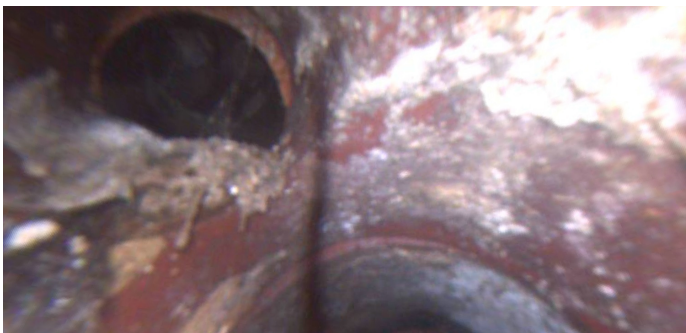
Code: **TFD**  
Description: **Tap Factory Defective**

Distance (ft): **66.5**  
Structural Grade: **0**  
O&M Grade: **2**  
Clock Start/From: **10**  
Clock To:  
1st Value: **4.000**  
2nd Value:  
Value Percent:  
Continuous Index:  
Within 8" of Joint:  
Remarks: **roots**

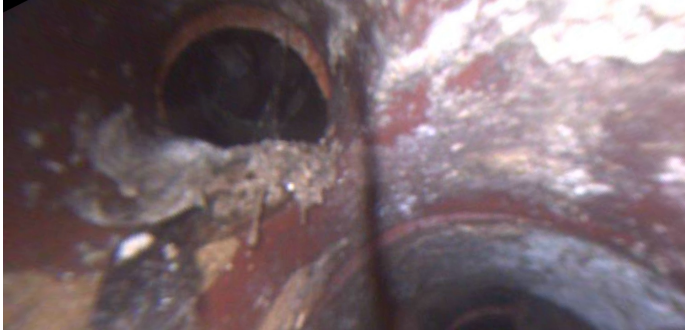
Code: **TFD**  
Description: **Tap Factory Defective**

Distance (ft): **66.5**  
Structural Grade: **0**  
O&M Grade: **2**  
Clock Start/From: **11**  
Clock To:  
1st Value: **4.000**  
2nd Value:  
Value Percent:  
Continuous Index:  
Within 8" of Joint:  
Remarks: **roots**

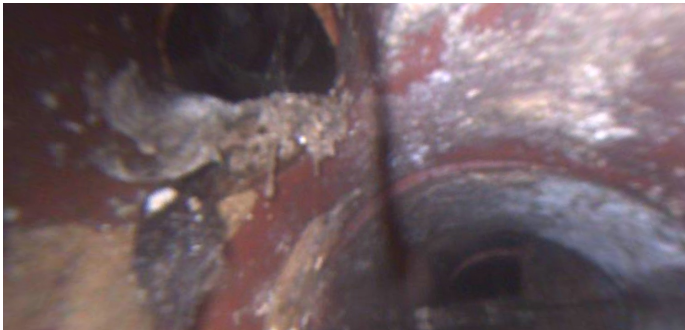
Code: **RFL**  
Description: **Roots Fine Lateral**

Distance (ft): **66.5**  
Structural Grade: **0**  
O&M Grade: **1**  
Clock Start/From: **10**  
Clock To:  
1st Value:  
2nd Value:  
Value Percent:  
Continuous Index:  
Within 8" of Joint: **NO**  
Remarks:

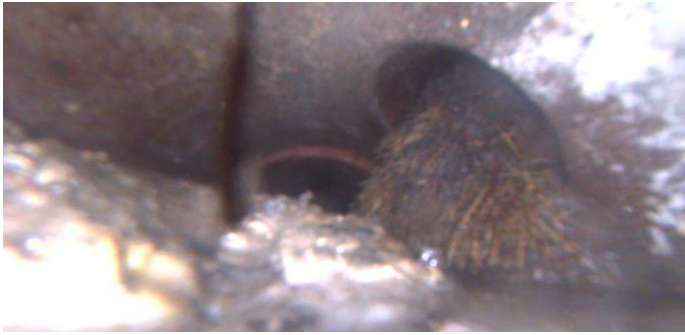
Code: **TFD**  
Description: **Tap Factory Defective**

Distance (ft): **67.5**  
Structural Grade: **0**  
O&M Grade: **2**  
Clock Start/From: **2**  
Clock To:  
1st Value: **4.000**  
2nd Value:  
Value Percent:  
Continuous Index:  
Within 8" of Joint:  
Remarks: **roots**

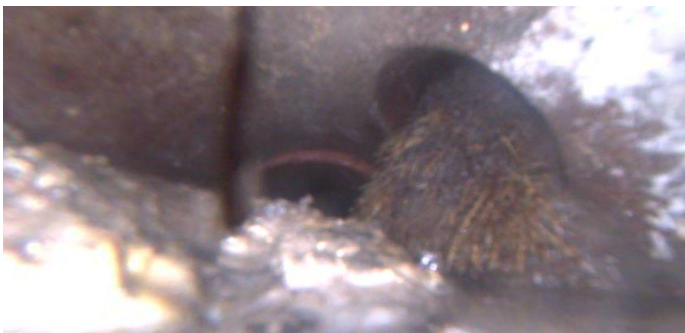
Code: **RML**  
Description: **Roots Medium Lateral**

Distance (ft): **67.5**  
Structural Grade: **0**  
O&M Grade: **3**  
Clock Start/From: **1**  
Clock To: **4**  
1st Value:  
2nd Value:  
Value Percent: **20.000**  
Continuous Index:  
Within 8" of Joint: **NO**  
Remarks:
