Profile/Photo Observation Report

Date: 11/11/2021 **PACP 7.0** Weather: Coding: **City of Hobart** Pipe Length (ft): 175.9 Owner: Pre Clean: **Heavy Cleaning** P.O.#: Surveyor: Steven Bucklin P-605-028-027 YES502259 PSR:

Street: South Ash Street Flow Control: Not Controlled

US MH: M-605-027 DS MH: M-605-028 Total Length Surveyed (ft): 175.9

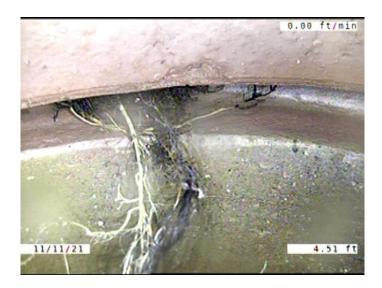
Code: RFJ

Description: **Roots Fine Joint**

Distance (ft): 4.5 Structural Grade: 0 O&M Grade: 1 Clock Start/From: 9 Clock To: 10

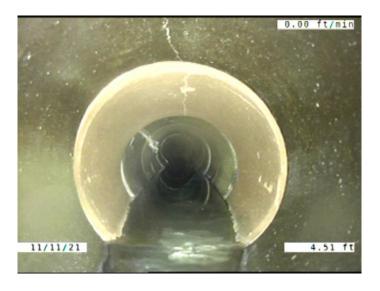
Code: **MWLS**

Description: **Miscellaneous Water Level Sag**

4.5 Distance (ft): Structural Grade: 2 O&M Grade: 0

Value Percent: 10.000 Continuous Index: **S01** Within 8" of Joint: NO

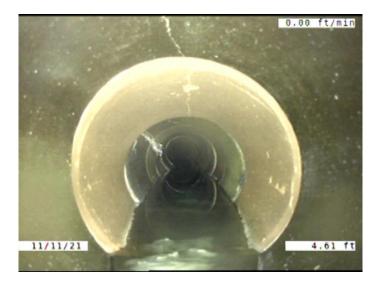
Code: B
Description: Broken

Distance (ft): 4.6
Structural Grade: 4

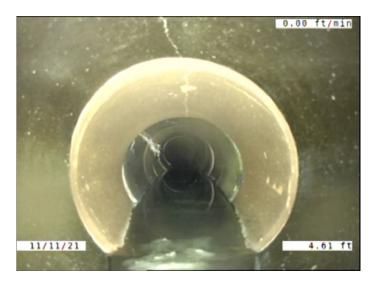
Code: **FM**

Description: Fracture Multiple

Distance (ft): 4.6
Structural Grade: 4

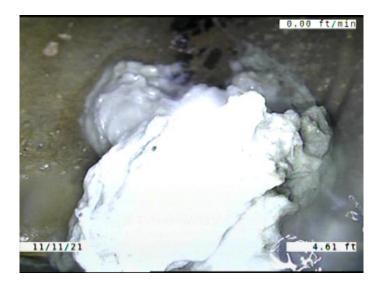
Code: **DSF**

Description: Deposits Settled Fine

Distance (ft): 4.6
Structural Grade: 0
O&M Grade: 2
Clock Start/From: 5
Clock To: 7

Remarks: ALSO RAGS

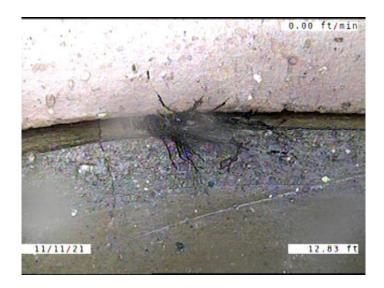
Code: RFJ

Description: Roots Fine Joint

Distance (ft): 12.8
Structural Grade: 0

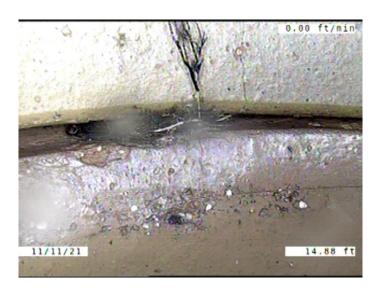
Code: RFJ

Description: Roots Fine Joint

Distance (ft): 14.9
Structural Grade: 0
O&M Grade: 1
Clock Start/From: 9
Clock To:
1st Value:
2nd Value:

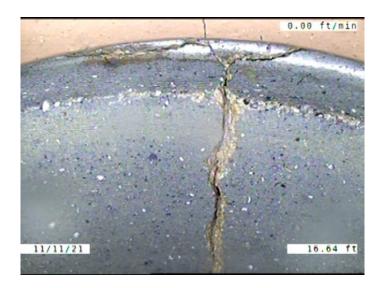
Code: DR

Description: Deformed Rigid

Distance (ft): 16.6
Structural Grade: 4
O&M Grade: 0

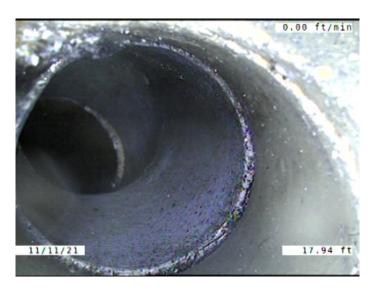
Code: **TFD**

Description: Tap Factory Defective

Distance (ft): 17.9
Structural Grade: 0
O&M Grade: 3
Clock Start/From: 10

Remarks: CONSTANTLY RUNNING WATER.
BROKEN. ROOTS GROWING FROM T

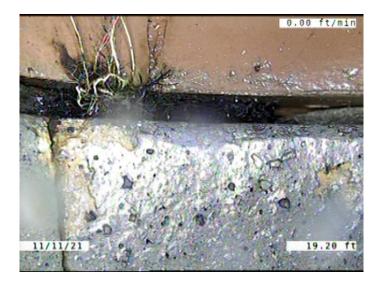
Code: RFJ

Description: Roots Fine Joint

Distance (ft): 19.2
Structural Grade: 0
O&M Grade: 1
Clock Start/From: 3
Clock To: 4

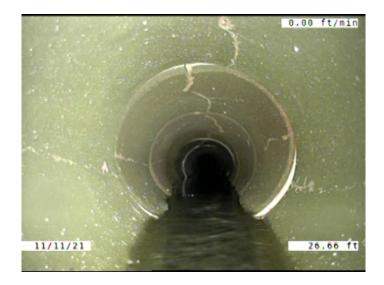
Code: MWLS

Description: Miscellaneous Water Level Sag

Distance (ft): 26.7
Structural Grade: 2
O&M Grade: 0

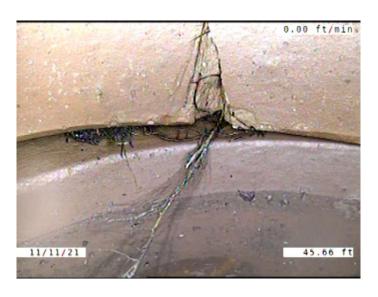
Code: RFJ

Description: Roots Fine Joint

Distance (ft): 45.7
Structural Grade: 0

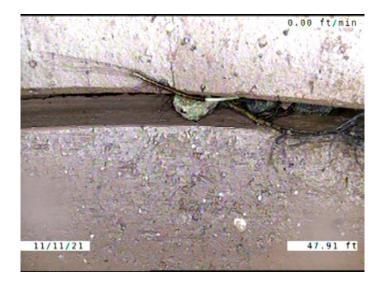
Code: RFJ
Description: Roots Fine Joint

Distance (ft): 47.9
Structural Grade: 0
O&M Grade: 1
Clock Start/From: 2
Clock To: 3
1st Value:
2nd Value:
Value Percent:
Continuous Index:

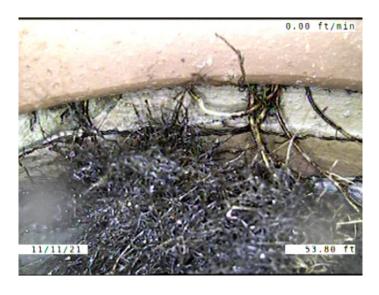
Code: RMJ

Description: Roots Medium Joint

Distance (ft): 53.8
Structural Grade: 0
O&M Grade: 3
Clock Start/From: 8
Clock To: 4
1st Value:
2nd Value:

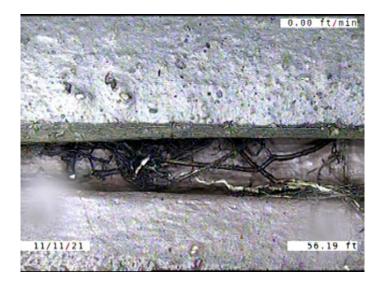
Code: RFJ

Description: Roots Fine Joint

Distance (ft): 56.2
Structural Grade: 0
O&M Grade: 1
Clock Start/From: 9
Clock To: 3

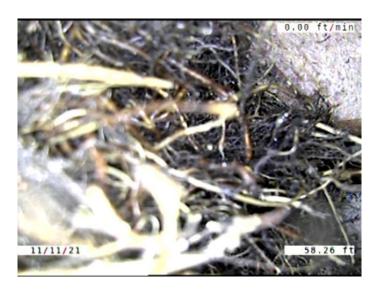
Code: RMJ

Description: Roots Medium Joint

Distance (ft): 58.3
Structural Grade: 0

O&M Grade: 3

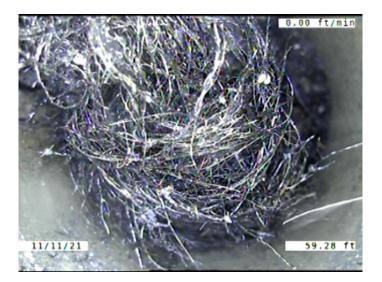
Code: **TFD**

Description: Tap Factory Defective

Distance (ft): 59.3
Structural Grade: 0
O&M Grade: 3
Clock Start/From: 10

Remarks: LOOKS TO BE 100% PLUGGED WITH

ROOTS.

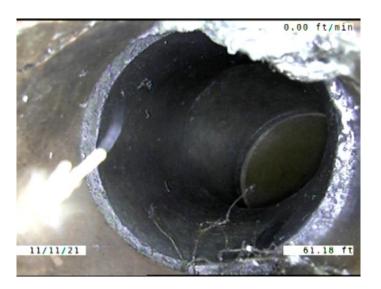
Code: **TFD**

Description: Tap Factory Defective

Distance (ft): 61.2
Structural Grade: 0

Remarks: BROKEN. ROOTS GROWING OUT OF

THE JOINTS

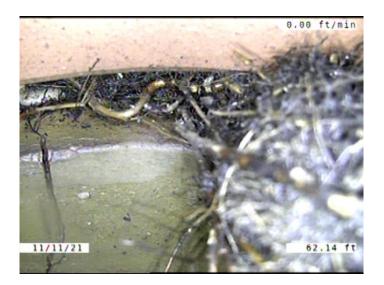
Code: RMJ

Description: **Roots Medium Joint**

Distance (ft): 62.1 Structural Grade: 0 3 O&M Grade: Clock Start/From: 8 Clock To: 4

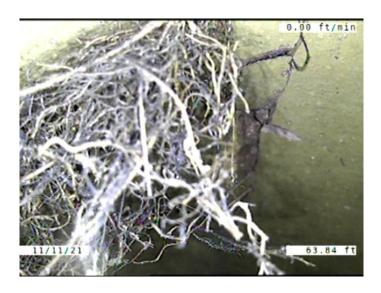
Code: RMJ

Description: **Roots Medium Joint**

Distance (ft): 63.8 Structural Grade: 0 O&M Grade: 3 Clock Start/From: 8 Clock To: 1st Value:

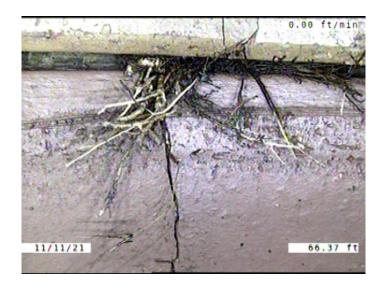
Code: RFJ

Description: **Roots Fine Joint**

Distance (ft): 66.4 Structural Grade: 0 O&M Grade: 1 Clock Start/From: 8 Clock To: 4

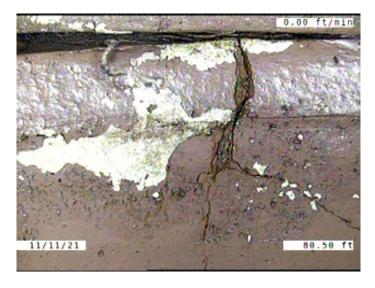
Code: DAE

Description: **Deposits Attached Encrustation**

Distance (ft): 80.5 Structural Grade: 0 O&M Grade: 2 Clock Start/From: 8 Clock To: 12 1st Value:

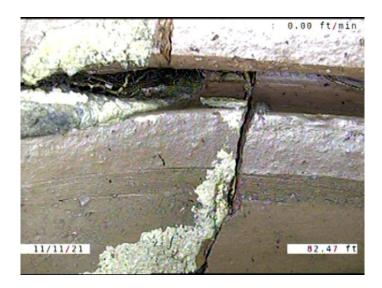
Code: DAE

Description: **Deposits Attached Encrustation**

Distance (ft): 82.5 Structural Grade: 0 2 O&M Grade: Clock Start/From: 8 Clock To: 10

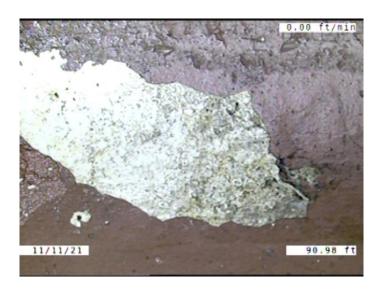
Code: DAE

Description: **Deposits Attached Encrustation**

Distance (ft): 91.0 Structural Grade: 0 O&M Grade: 2 Clock Start/From: 8 Clock To: 10 1st Value:

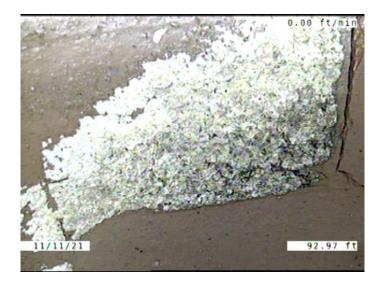
Code: DAE

Description: **Deposits Attached Encrustation**

Distance (ft): 93.0 Structural Grade: 0 2 O&M Grade: Clock Start/From: 9 Clock To: 11

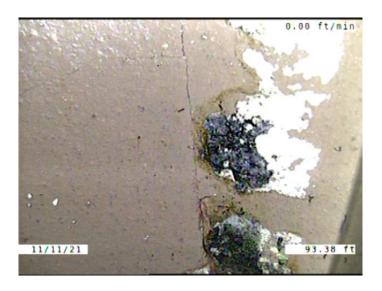
Code: DAE

Description: **Deposits Attached Encrustation**

Distance (ft): 93.4 Structural Grade: 0 O&M Grade: 2 Clock Start/From: 2 3 Clock To: 1st Value: 2nd Value:

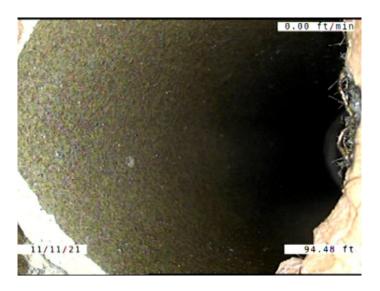
Code: TB

Description: Tap Break-in/Hammer

Distance (ft): 94.5
Structural Grade: 0

Remarks: ROOTS GROWING AROUND THE

CONNECTION

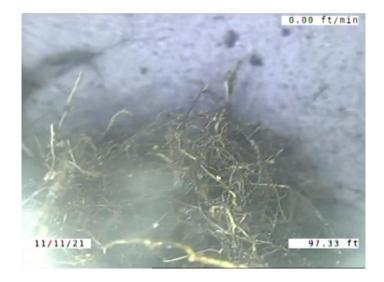
Code: **FM**

Description: Fracture Multiple

Distance (ft): 97.3
Structural Grade: 4
O&M Grade: 0
Clock Start/From: 8
Clock To: 4

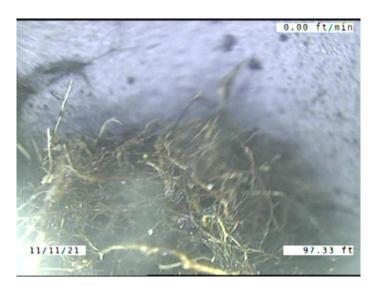
Code: MCU

Description: Miscellaneous Camera Underwater

Distance (ft): 97.3
Structural Grade: 0
O&M Grade: 4

Remarks: Out at 98.1

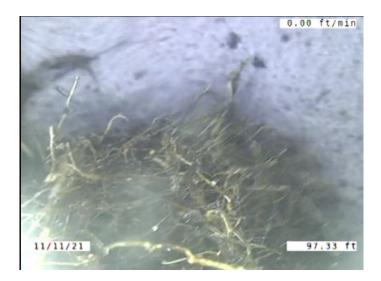
Code: DR

Description: **Deformed Rigid**

Distance (ft): 97.3 Structural Grade: O&M Grade: 0

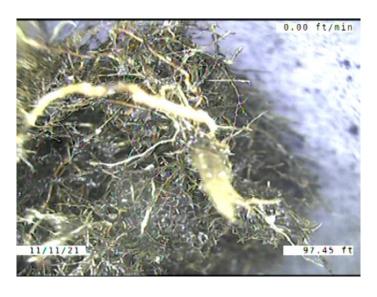
Code: **RMB**

Description: **Roots Medium Barrel**

97.4 Distance (ft): Structural Grade: 0 O&M Grade: Clock Start/From: 9 Clock To: 1 1st Value:

Value Percent: 30.000

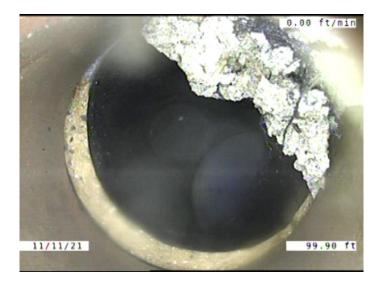
Code: **TFD**

Description: Tap Factory Defective

Distance (ft): 99.9
Structural Grade: 0
O&M Grade: 3
Clock Start/From: 1

Remarks: CAPPED. OFFSET. ROOTS GROWING

OUT OF THE JOINT

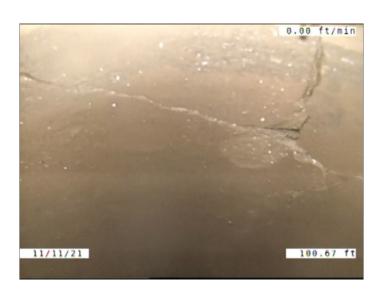
Code: FM

Description: Fracture Multiple

Distance (ft): 100.7
Structural Grade: 4
O&M Grade: 0
Clock Start/From: 8
Clock To: 4
1st Value:
2nd Value:
Value Percent:

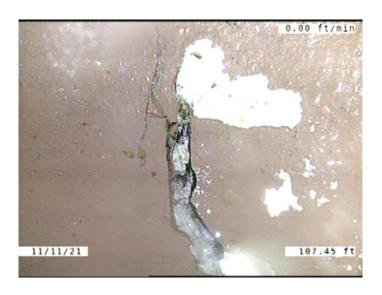
Code: DAE

Description: **Deposits Attached Encrustation**

Distance (ft): 107.5 Structural Grade: 0 O&M Grade: 2 Clock Start/From: 2 Clock To: 4 1st Value: 2nd Value:

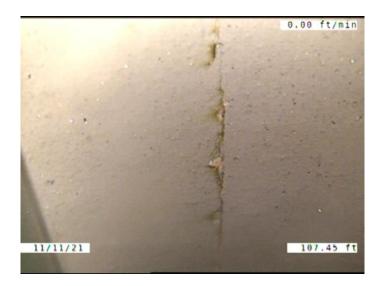
Code: DAE

Description: **Deposits Attached Encrustation**

Distance (ft): 107.5 Structural Grade: 0 O&M Grade: 2 Clock Start/From: 8 Clock To: 10

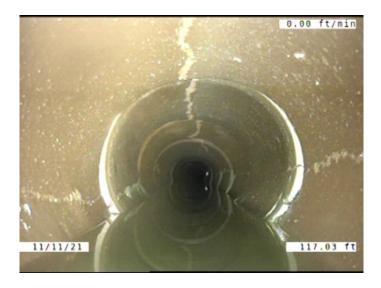
Code: RFJ

Description: Roots Fine Joint

Distance (ft): 117.0
Structural Grade: 0
O&M Grade: 1
Clock Start/From: 8

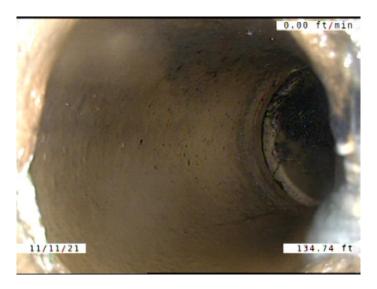
Code: TBD

Description: Tap Break-in/Hammer Defective

Distance (ft): 134.7
Structural Grade: 0
O&M Grade: 3
Clock Start/From: 2

Remarks: CONSTANTLY RUNNING WATER.
ROOTS GROWING FROM THE JOINT

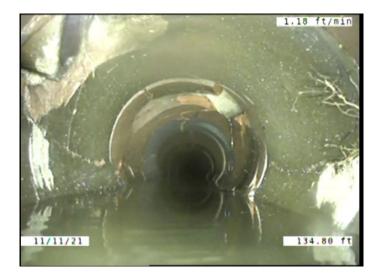
Code: B
Description: Broken

Distance (ft): 134.8
Structural Grade: 4

O&M Grade: 0
Clock Start/From: 10
Clock To: 2

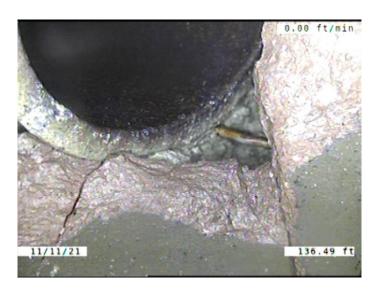
Code: BSV

Description: Broken Soil Visible

Distance (ft): 136.5
Structural Grade: 5
O&M Grade: 0
Clock Start/From: 8
Clock To: 11
1st Value:
2nd Value:
Value Percent:

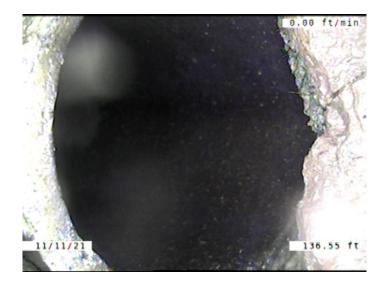
Code: **TFD**

Description: Tap Factory Defective

Distance (ft): 136.5
Structural Grade: 0
O&M Grade: 3
Clock Start/From: 11

Remarks: **Defective**

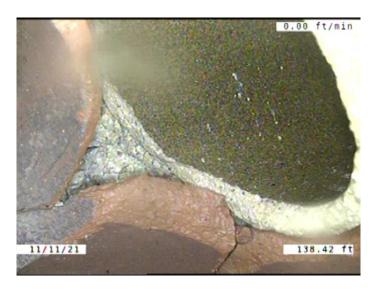
Code: BSV

Description: Broken Soil Visible

Distance (ft): 138.4
Structural Grade: 5
O&M Grade: 0
Clock Start/From: 12
Clock To: 2
1st Value:
2nd Value:
Value Percent:
Continuous Index:

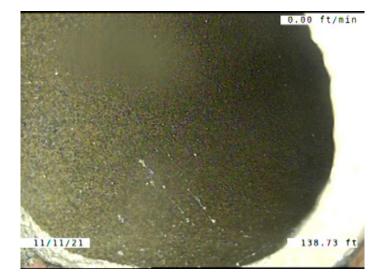
Code: **TBI**

Description: Tap Break-in Intruding

Distance (ft): 138.7
Structural Grade: 0
O&M Grade: 2
Clock Start/From: 1

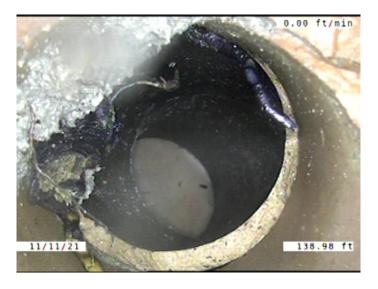
Code: **TFD**

Description: Tap Factory Defective

Distance (ft): 139.0
Structural Grade: 0
O&M Grade: 3
Clock Start/From: 11

Remarks: BROKEN. SOIL VISIBLE. ROOTS

GROWING OUT OF THE OFFSET AND

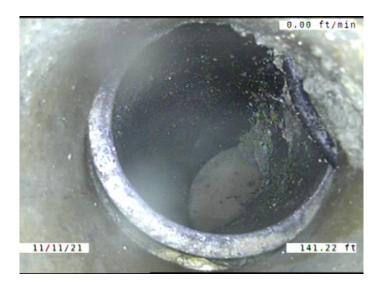
Code: TFC

Description: Tap Factory Capped

Remarks: BROKEN. OFFSET. SOIL VISIBLE.
ROOTS GROWING FROM THE JOINT

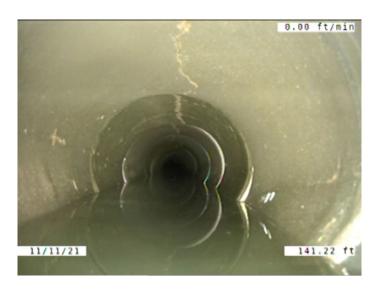
Code: **B**

Description: Broken

Distance (ft): 141.2
Structural Grade: 4

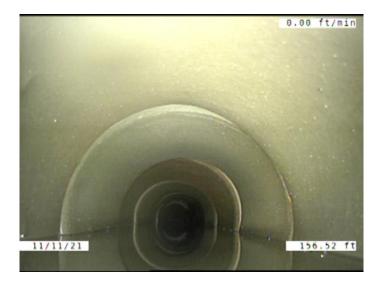
Code: DAE

Description: Deposits Attached Encrustation

Distance (ft): 156.5
Structural Grade: 0
O&M Grade: 2
Clock Start/From: 8
Clock To: 10

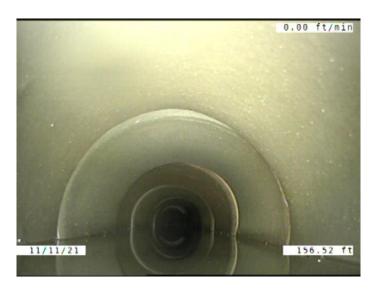
Code: DAE

Description: Deposits Attached Encrustation

Distance (ft): 156.5
Structural Grade: 0
O&M Grade: 2
Clock Start/From: 2
Clock To: 4
1st Value:
2nd Value:

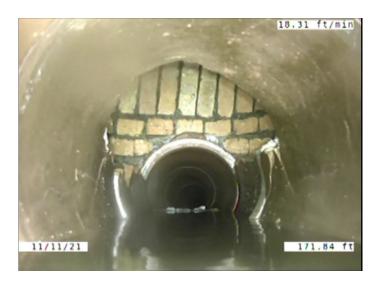
Code: FM

Description: Fracture Multiple

Distance (ft): 171.8

Structural Grade: 4

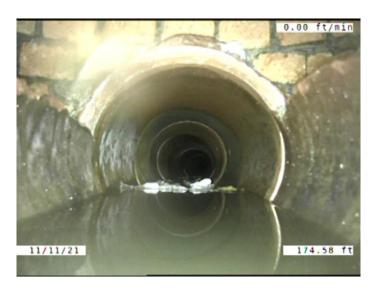
Code: **DSF**

Description: Deposits Settled Fine

Distance (ft): 174.6
Structural Grade: 0
O&M Grade: 2
Clock Start/From: 5
Clock To: 7
1st Value:

Remarks: ALSO RAGS
