RedZone  
ROBOTICS

Street:	South Ash Street		Flow Control:	Not Controlled	
City:	City of Hobart		Year Renewed:		
Location:	Local rural streets with light traffic, t		Tape/Media #:		
Purpose:	Routine Assessment		Dia/Height:	12"	
Use:	Sanitary Sewage Pipe		Material:	VCP	
Drain Area:			Lining:	None	
Category:	NA				
Comment:					
Location Details:			Direction of Survey:	Downstream	
US MH:	M-605-027	DS MH:	M-605-028	Total Length Surveyed (ft):	175.9

O&M Index:	<b>1.97</b>	O&M Quick:	<b>423A</b>	O&M Rating:	<b>179.00</b>
Structural Index:	<b>3.86</b>	Structural Quick:	<b>524I</b>	Structural Rating:	<b>224.00</b>
Overall Index:	<b>2.70</b>	Overall Quick:	<b>524I</b>	Overall Rating:	<b>403.00</b>

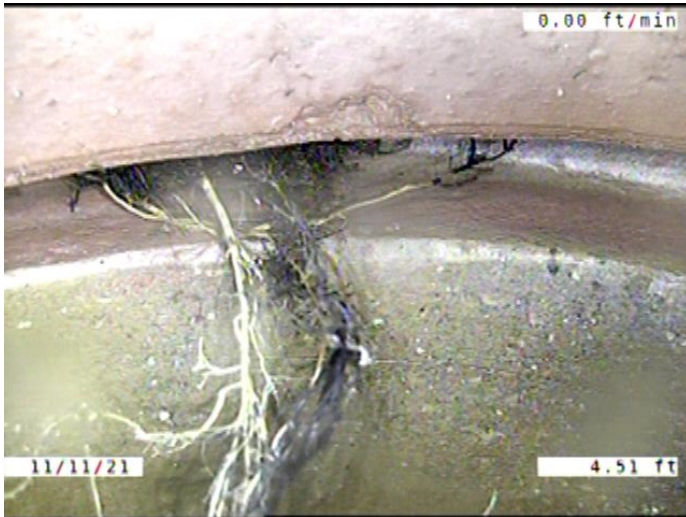
Code: **RFJ**  
 Description: **Roots Fine Joint**

Distance (ft): **4.5**  
 Structural Grade: **0**  
 O&M Grade: **1**  
 Clock Start/From: **9**  
 Clock To: **10**  
 1st Value:  
 2nd Value:  
 Value Percent:  
 Continuous Index:  
 Within 8" of Joint: **YES**  
 Remarks:

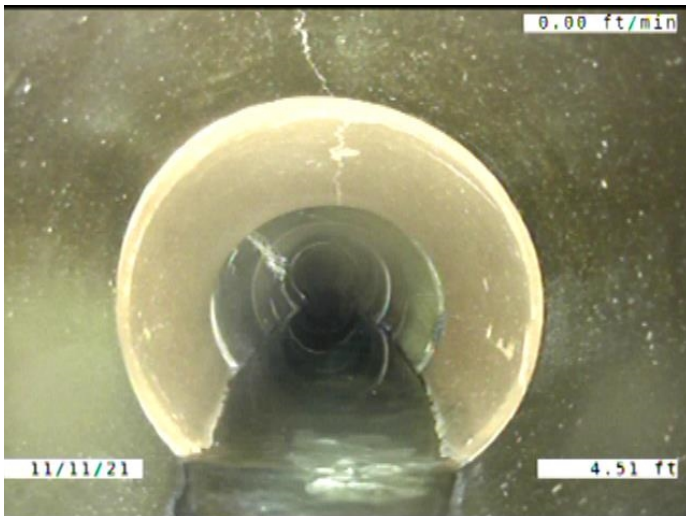
Code: **MWLS**  
 Description: **Miscellaneous Water Level Sag**

Distance (ft): **4.5**  
 Structural Grade: **2**  
 O&M Grade: **0**  
 Clock Start/From:  
 Clock To:  
 1st Value:  
 2nd Value:  
 Value Percent: **10.000**  
 Continuous Index: **S01**  
 Within 8" of Joint: **NO**  
 Remarks:

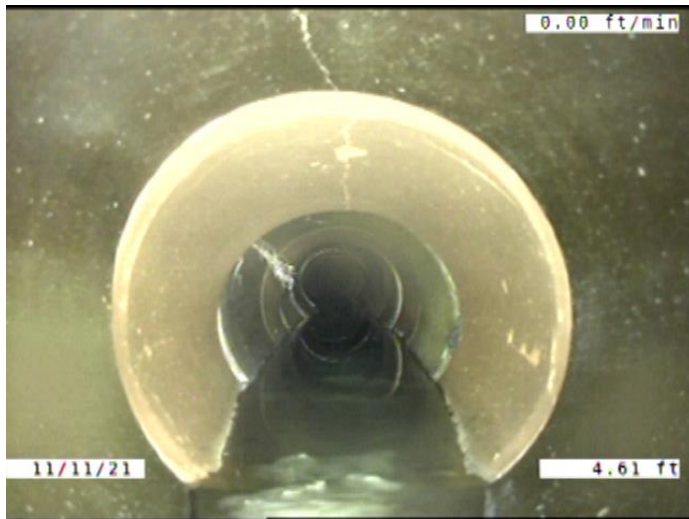
Code: **B**  
 Description: **Broken**

Distance (ft): **4.6**  
 Structural Grade: **4**  
 O&M Grade: **0**  
 Clock Start/From: **12**  
 Clock To: **12**  
 1st Value:  
 2nd Value:  
 Value Percent:  
 Continuous Index:  
 Within 8" of Joint: **YES**  
 Remarks:

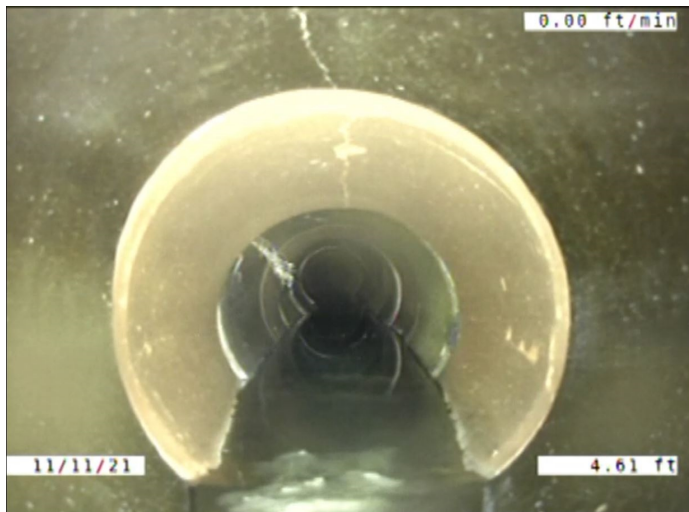
Code: **FM**  
 Description: **Fracture Multiple**

Distance (ft): **4.6**  
 Structural Grade: **4**  
 O&M Grade: **0**  
 Clock Start/From: **8**  
 Clock To: **4**  
 1st Value:  
 2nd Value:  
 Value Percent:  
 Continuous Index: **S08**  
 Within 8" of Joint: **YES**  
 Remarks:

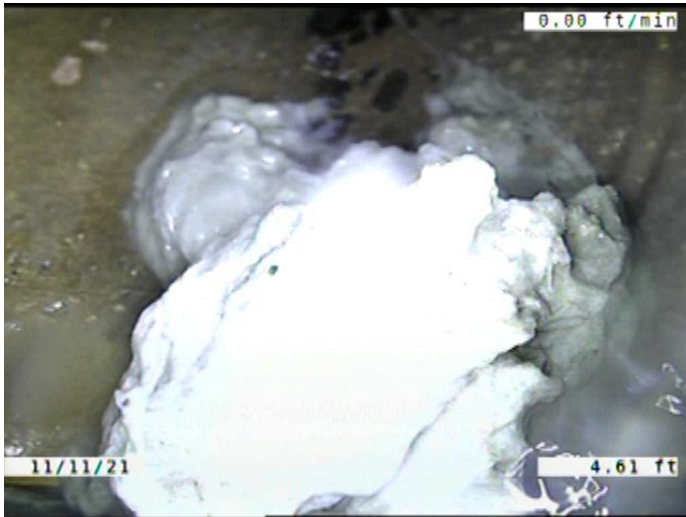
Code: **DSF**  
 Description: **Deposits Settled Fine**

Distance (ft): **4.6**  
 Structural Grade: **0**  
 O&M Grade: **2**  
 Clock Start/From: **5**  
 Clock To: **7**  
 1st Value:  
 2nd Value:  
 Value Percent: **5.000**  
 Continuous Index: **S03**  
 Within 8" of Joint: **YES**  
 Remarks: **ALSO RAGS**

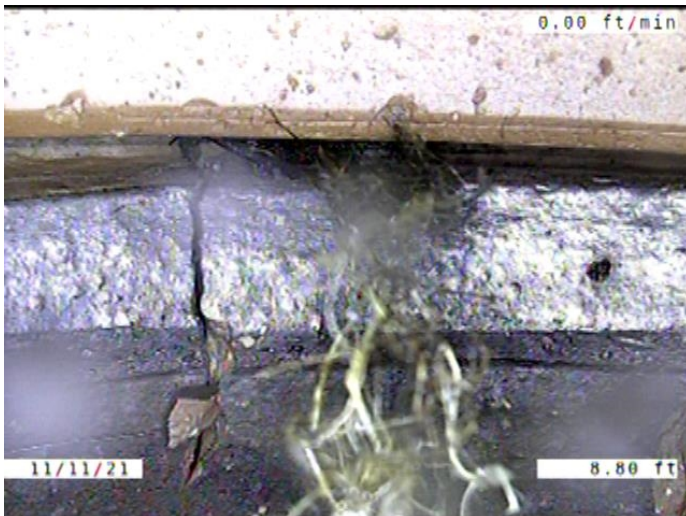
Code: **RFJ**  
 Description: **Roots Fine Joint**

Distance (ft): **8.8**  
 Structural Grade: **0**  
 O&M Grade: **1**  
 Clock Start/From: **10**  
 Clock To: **4**  
 1st Value:  
 2nd Value:  
 Value Percent:  
 Continuous Index:  
 Within 8" of Joint: **YES**  
 Remarks:

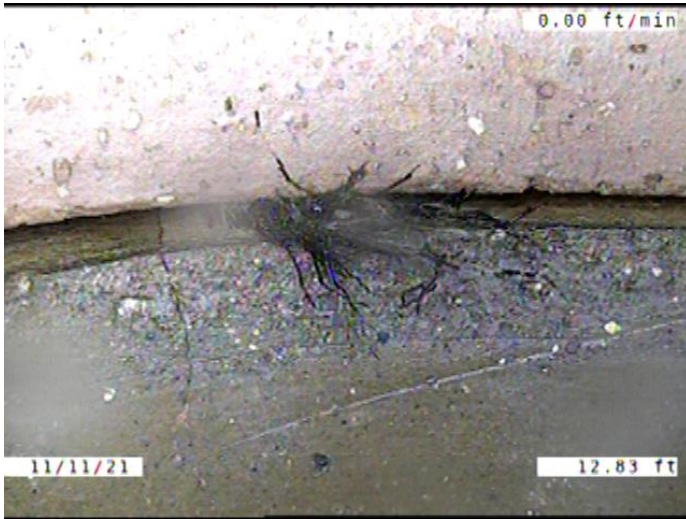
Code: **RFJ**  
Description: **Roots Fine Joint**

Distance (ft): **12.8**  
Structural Grade: **0**  
O&M Grade: **1**  
Clock Start/From: **10**  
Clock To:  
1st Value:  
2nd Value:  
Value Percent:  
Continuous Index:  
Within 8" of Joint: **YES**  
Remarks:

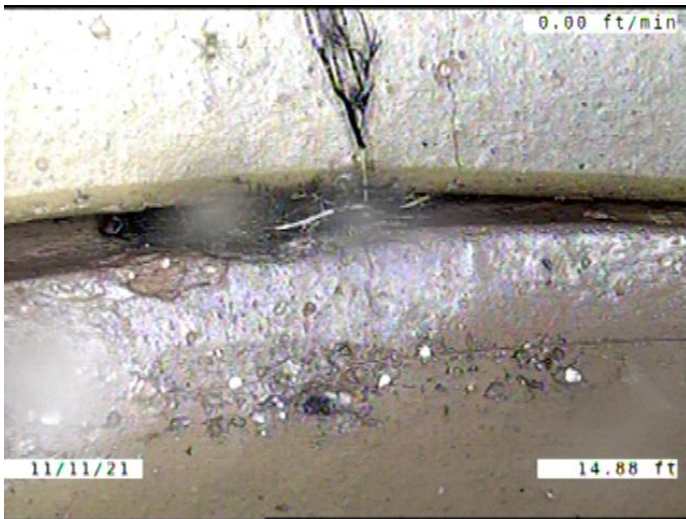
Code: **RFJ**  
Description: **Roots Fine Joint**

Distance (ft): **14.9**  
Structural Grade: **0**  
O&M Grade: **1**  
Clock Start/From: **9**  
Clock To:  
1st Value:  
2nd Value:  
Value Percent:  
Continuous Index:  
Within 8" of Joint: **YES**  
Remarks:

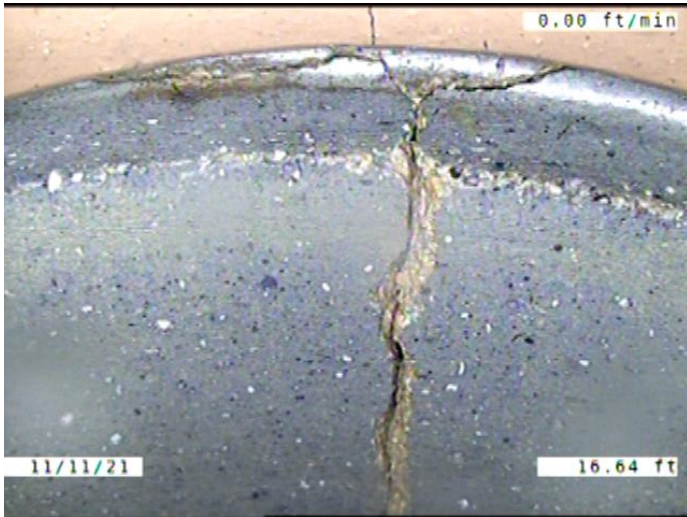
Code: **DR**  
 Description: **Deformed Rigid**

Distance (ft): **16.6**  
 Structural Grade: **4**  
 O&M Grade: **0**  
 Clock Start/From:  
 Clock To:  
 1st Value:  
 2nd Value:  
 Value Percent: **5.000**  
 Continuous Index: **S04**  
 Within 8" of Joint: **NO**  
 Remarks:

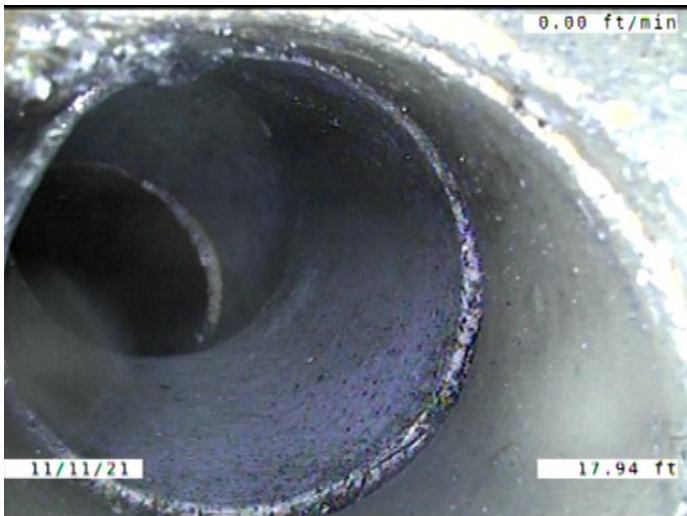
Code: **TFD**  
 Description: **Tap Factory Defective**

Distance (ft): **17.9**  
 Structural Grade: **0**  
 O&M Grade: **3**  
 Clock Start/From: **10**  
 Clock To:  
 1st Value: **4.000**  
 2nd Value:  
 Value Percent:  
 Continuous Index:  
 Within 8" of Joint: **YES**  
 Remarks: **CONSTANTLY RUNNING WATER. BROKEN. ROOTS GROWING FROM T**

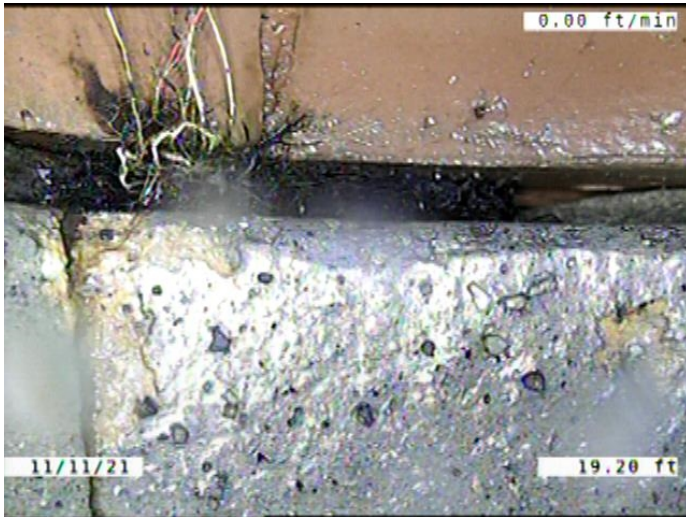
Code: **RFJ**  
 Description: **Roots Fine Joint**

Distance (ft): **19.2**  
 Structural Grade: **0**  
 O&M Grade: **1**  
 Clock Start/From: **3**  
 Clock To: **4**  
 1st Value:  
 2nd Value:  
 Value Percent:  
 Continuous Index:  
 Within 8" of Joint: **YES**  
 Remarks:

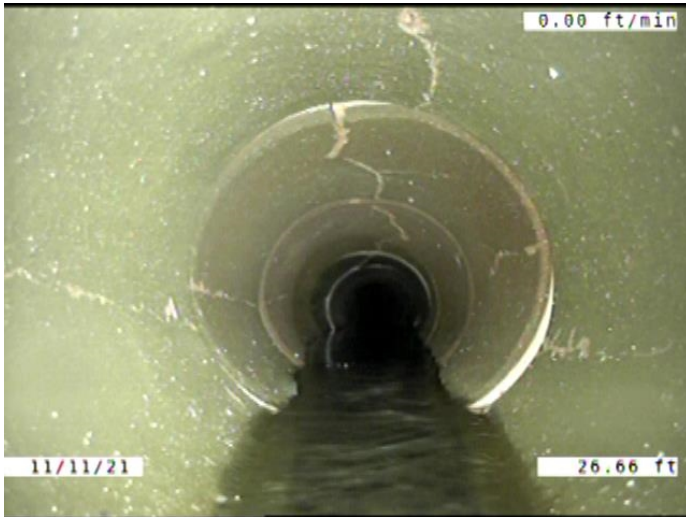
Code: **MWLS**  
 Description: **Miscellaneous Water Level Sag**

Distance (ft): **26.7**  
 Structural Grade: **2**  
 O&M Grade: **0**  
 Clock Start/From:  
 Clock To:  
 1st Value:  
 2nd Value:  
 Value Percent: **10.000**  
 Continuous Index: **F01**  
 Within 8" of Joint: **NO**  
 Remarks:

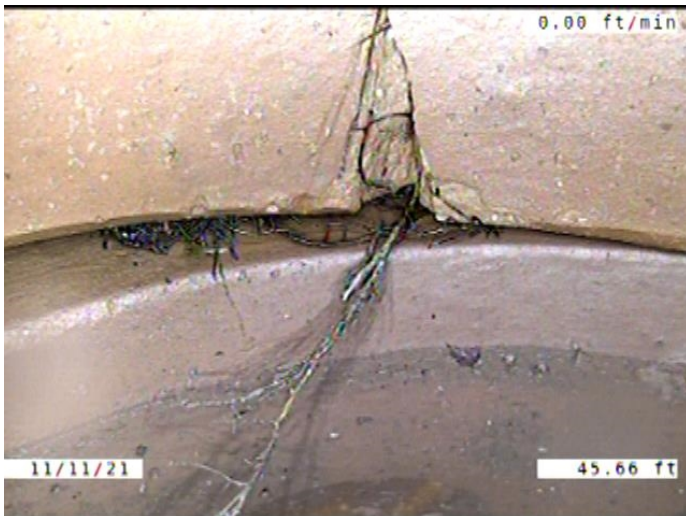
Code: **RFJ**  
 Description: **Roots Fine Joint**

Distance (ft): **45.7**  
 Structural Grade: **0**  
 O&M Grade: **1**  
 Clock Start/From: **10**  
 Clock To:  
 1st Value:  
 2nd Value:  
 Value Percent:  
 Continuous Index:  
 Within 8" of Joint: **YES**  
 Remarks:

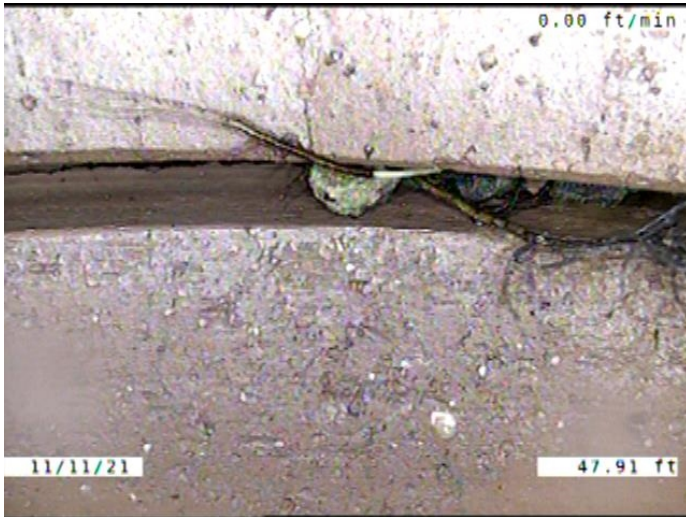
Code: **RFJ**  
 Description: **Roots Fine Joint**

Distance (ft): **47.9**  
 Structural Grade: **0**  
 O&M Grade: **1**  
 Clock Start/From: **2**  
 Clock To: **3**  
 1st Value:  
 2nd Value:  
 Value Percent:  
 Continuous Index:  
 Within 8" of Joint: **YES**  
 Remarks:

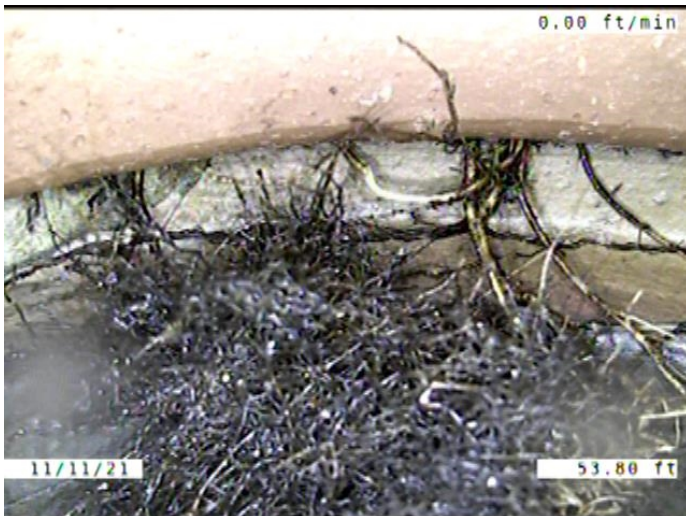
Code: **RMJ**  
 Description: **Roots Medium Joint**

Distance (ft): **53.8**  
 Structural Grade: **0**  
 O&M Grade: **3**  
 Clock Start/From: **8**  
 Clock To: **4**  
 1st Value:  
 2nd Value:  
 Value Percent: **5.000**  
 Continuous Index:  
 Within 8" of Joint: **YES**  
 Remarks:

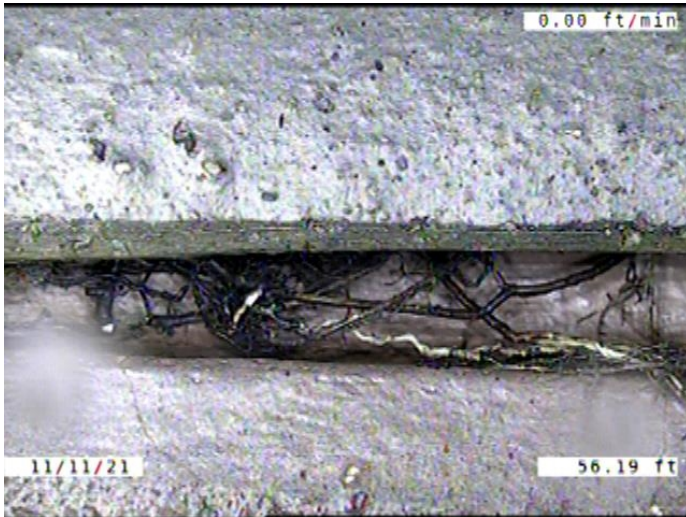
Code: **RFJ**  
 Description: **Roots Fine Joint**

Distance (ft): **56.2**  
 Structural Grade: **0**  
 O&M Grade: **1**  
 Clock Start/From: **9**  
 Clock To: **3**  
 1st Value:  
 2nd Value:  
 Value Percent:  
 Continuous Index:  
 Within 8" of Joint: **YES**  
 Remarks:

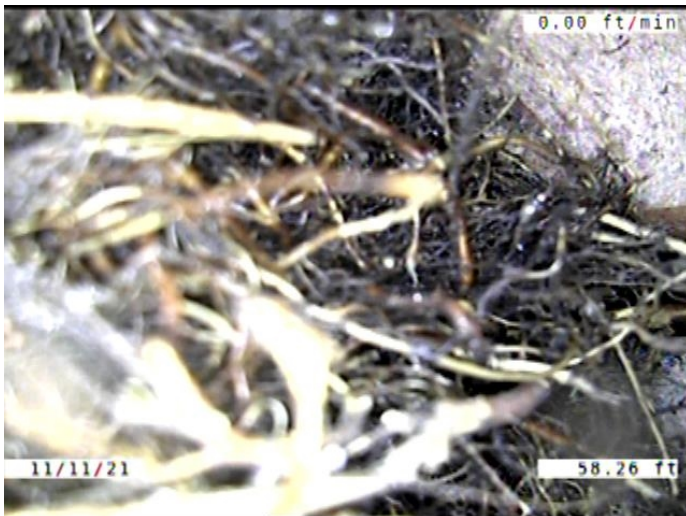
Code: **RMJ**  
 Description: **Roots Medium Joint**

Distance (ft): **58.3**  
 Structural Grade: **0**  
 O&M Grade: **3**  
 Clock Start/From: **8**  
 Clock To: **4**  
 1st Value:  
 2nd Value:  
 Value Percent: **15.000**  
 Continuous Index:  
 Within 8" of Joint: **YES**  
 Remarks:

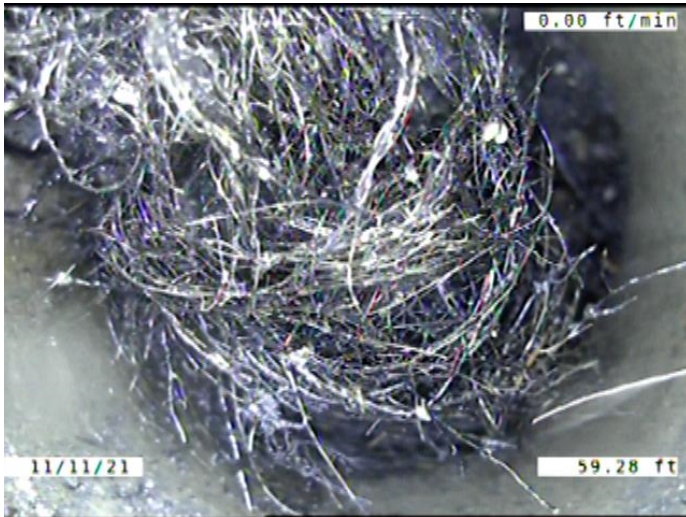
Code:	TFD
Description:	Tap Factory Defective
Distance (ft):	59.3
Structural Grade:	0
O&M Grade:	3
Clock Start/From:	10
Clock To:	
1st Value:	4.000
2nd Value:	
Value Percent:	
Continuous Index:	
Within 8" of Joint:	YES
Remarks:	LOOKS TO BE 100% PLUGGED WITH ROOTS.

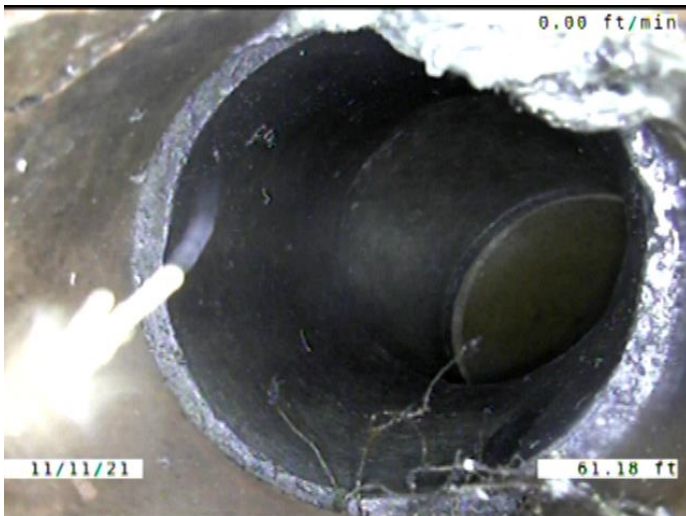
Code:	TFD
Description:	Tap Factory Defective
Distance (ft):	61.2
Structural Grade:	0
O&M Grade:	3
Clock Start/From:	2
Clock To:	
1st Value:	4.000
2nd Value:	
Value Percent:	
Continuous Index:	
Within 8" of Joint:	YES
Remarks:	BROKEN. ROOTS GROWING OUT OF THE JOINTS

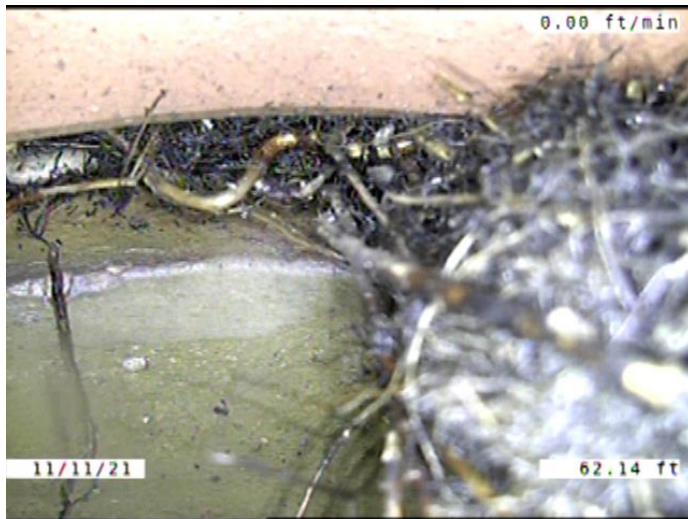
Code: **RMJ**  
 Description: **Roots Medium Joint**

Distance (ft): **62.1**  
 Structural Grade: **0**  
 O&M Grade: **3**  
 Clock Start/From: **8**  
 Clock To: **4**  
 1st Value:  
 2nd Value:  
 Value Percent: **15.000**  
 Continuous Index:  
 Within 8" of Joint: **YES**  
 Remarks:

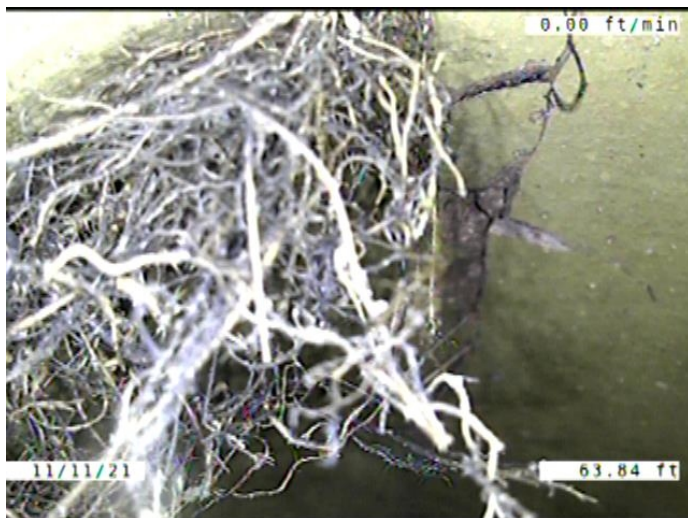
Code: **RMJ**  
 Description: **Roots Medium Joint**

Distance (ft): **63.8**  
 Structural Grade: **0**  
 O&M Grade: **3**  
 Clock Start/From: **8**  
 Clock To: **4**  
 1st Value:  
 2nd Value:  
 Value Percent: **5.000**  
 Continuous Index:  
 Within 8" of Joint: **YES**  
 Remarks:

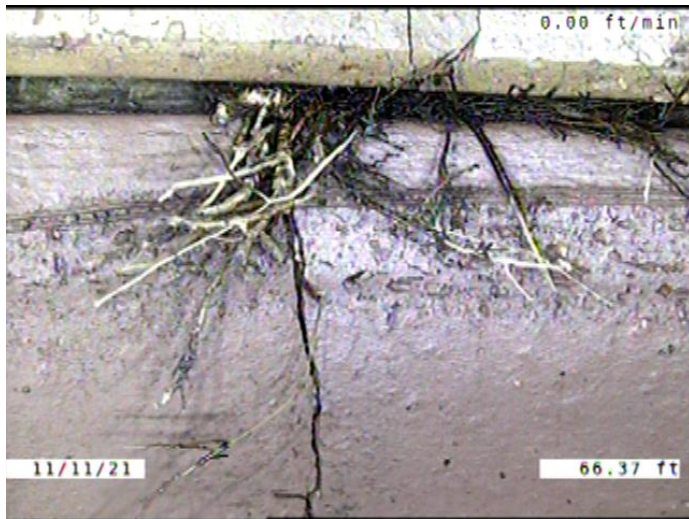
Code: **RFJ**  
 Description: **Roots Fine Joint**

Distance (ft): **66.4**  
 Structural Grade: **0**  
 O&M Grade: **1**  
 Clock Start/From: **8**  
 Clock To: **4**  
 1st Value:  
 2nd Value:  
 Value Percent:  
 Continuous Index: **S05**  
 Within 8" of Joint: **YES**  
 Remarks:

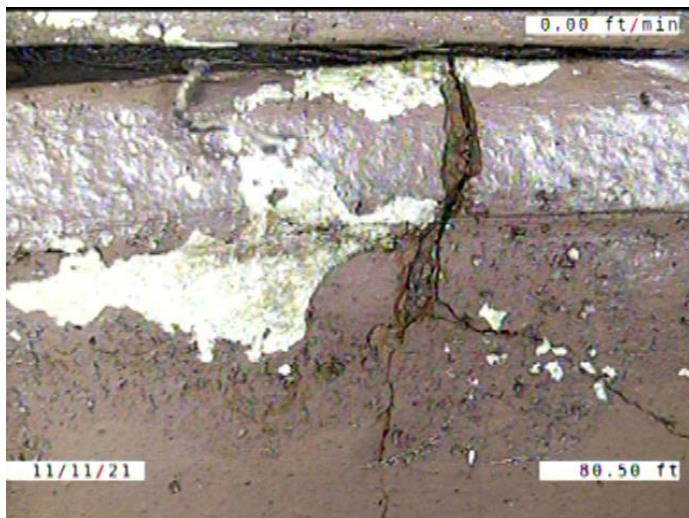
Code: **DAE**  
 Description: **Deposits Attached Encrustation**

Distance (ft): **80.5**  
 Structural Grade: **0**  
 O&M Grade: **2**  
 Clock Start/From: **8**  
 Clock To: **12**  
 1st Value:  
 2nd Value:  
 Value Percent: **5.000**  
 Continuous Index:  
 Within 8" of Joint: **YES**  
 Remarks:

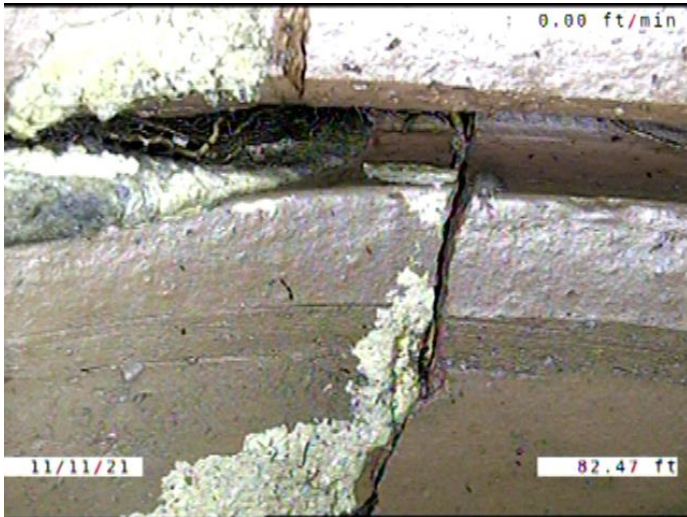
Code: **DAE**  
 Description: **Deposits Attached Encrustation**

Distance (ft): **82.5**  
 Structural Grade: **0**  
 O&M Grade: **2**  
 Clock Start/From: **8**  
 Clock To: **10**  
 1st Value:  
 2nd Value:  
 Value Percent: **5.000**  
 Continuous Index:  
 Within 8" of Joint: **YES**  
 Remarks:

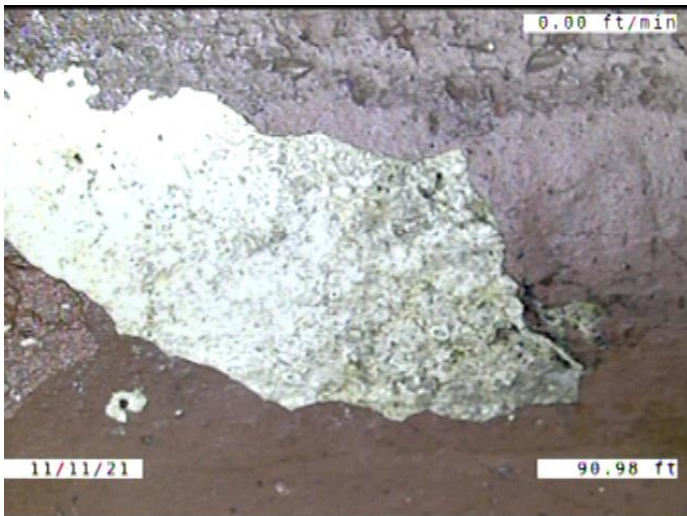
Code: **DAE**  
 Description: **Deposits Attached Encrustation**

Distance (ft): **91.0**  
 Structural Grade: **0**  
 O&M Grade: **2**  
 Clock Start/From: **8**  
 Clock To: **10**  
 1st Value:  
 2nd Value:  
 Value Percent: **5.000**  
 Continuous Index:  
 Within 8" of Joint: **YES**  
 Remarks:

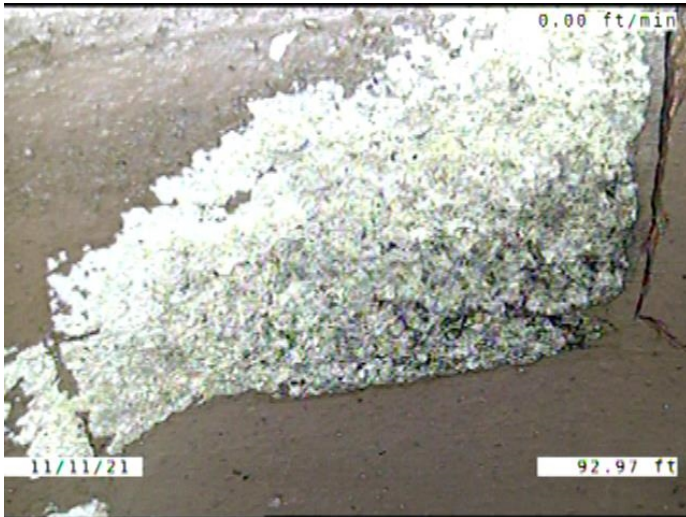
Code: **DAE**  
 Description: **Deposits Attached Encrustation**

Distance (ft): **93.0**  
 Structural Grade: **0**  
 O&M Grade: **2**  
 Clock Start/From: **9**  
 Clock To: **11**  
 1st Value:  
 2nd Value:  
 Value Percent: **5.000**  
 Continuous Index:  
 Within 8" of Joint: **YES**  
 Remarks:

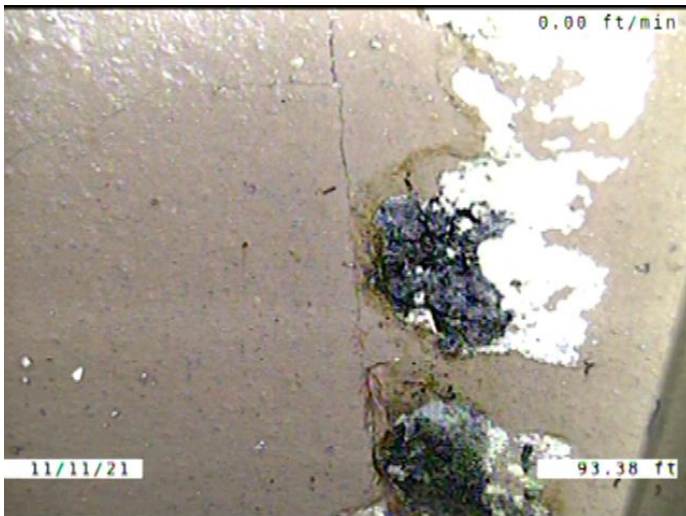
Code: **DAE**  
 Description: **Deposits Attached Encrustation**

Distance (ft): **93.4**  
 Structural Grade: **0**  
 O&M Grade: **2**  
 Clock Start/From: **2**  
 Clock To: **3**  
 1st Value:  
 2nd Value:  
 Value Percent: **5.000**  
 Continuous Index:  
 Within 8" of Joint: **YES**  
 Remarks:

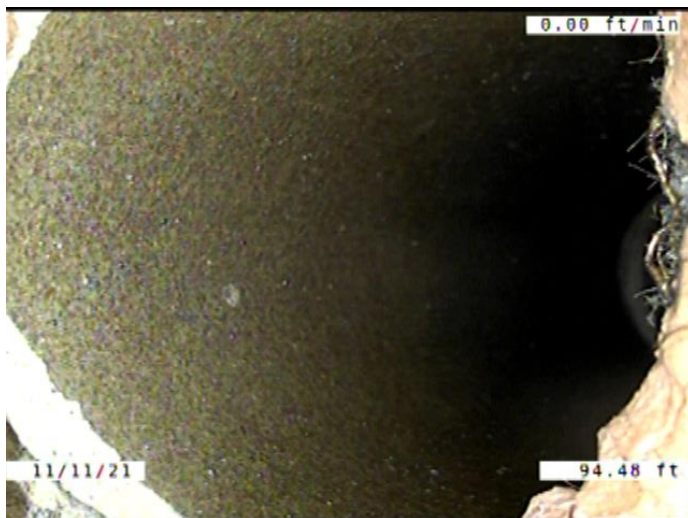
Code: **TB**  
 Description: **Tap Break-in/Hammer**

Distance (ft): **94.5**  
 Structural Grade: **0**  
 O&M Grade: **0**  
 Clock Start/From: **1**  
 Clock To:  
 1st Value: **4.000**  
 2nd Value:  
 Value Percent:  
 Continuous Index:  
 Within 8" of Joint: **YES**  
 Remarks: **ROOTS GROWING AROUND THE CONNECTION**

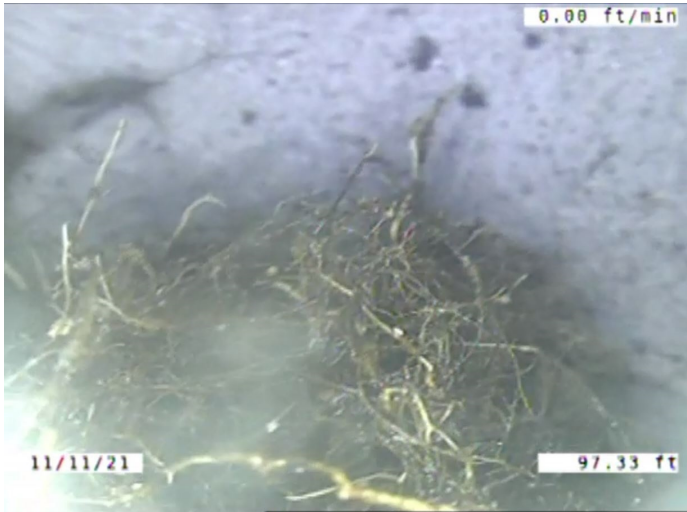
Code: **FM**  
 Description: **Fracture Multiple**

Distance (ft): **97.3**  
 Structural Grade: **4**  
 O&M Grade: **0**  
 Clock Start/From: **8**  
 Clock To: **4**  
 1st Value:  
 2nd Value:  
 Value Percent:  
 Continuous Index: **F08**  
 Within 8" of Joint: **YES**  
 Remarks:

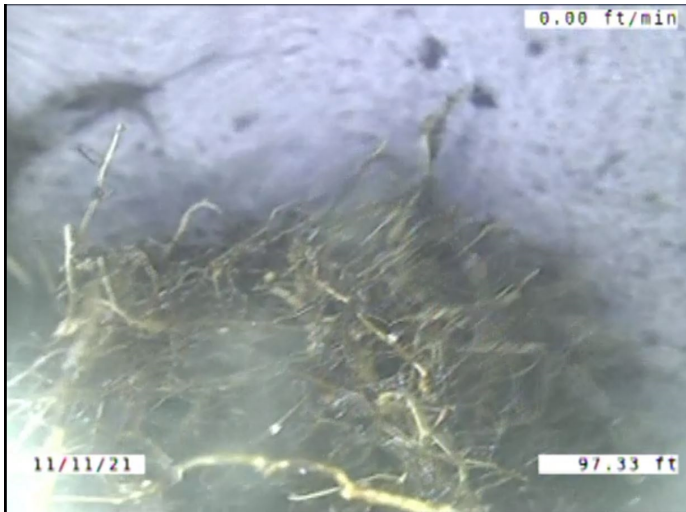
Code: **DR**  
Description: **Deformed Rigid**

Distance (ft): **97.3**  
Structural Grade: **4**  
O&M Grade: **0**  
Clock Start/From:  
Clock To:  
1st Value:  
2nd Value:  
Value Percent: **5.000**  
Continuous Index: **F04**  
Within 8" of Joint: **NO**  
Remarks:

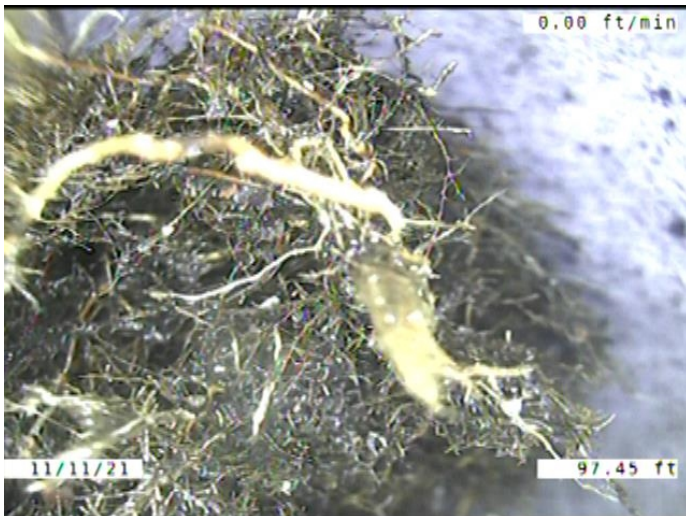
Code: **RMB**  
Description: **Roots Medium Barrel**

Distance (ft): **97.4**  
Structural Grade: **0**  
O&M Grade: **4**  
Clock Start/From: **9**  
Clock To: **1**  
1st Value:  
2nd Value:  
Value Percent: **30.000**  
Continuous Index:  
Within 8" of Joint: **NO**  
Remarks:

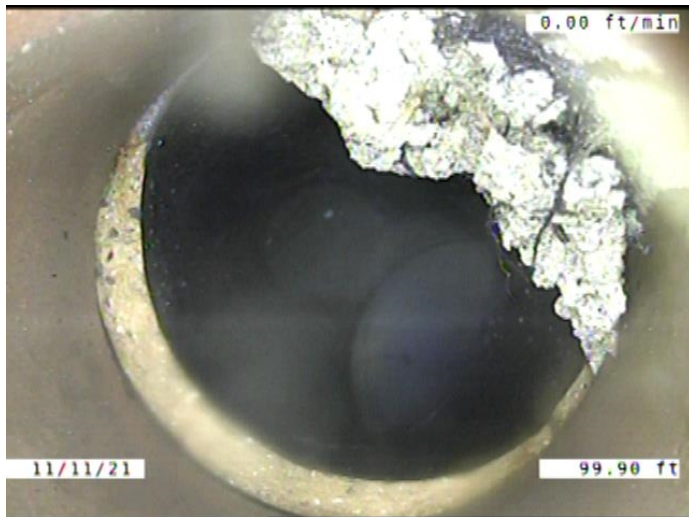
Code:	<b>TFD</b>
Description:	<b>Tap Factory Defective</b>
Distance (ft):	<b>99.9</b>
Structural Grade:	<b>0</b>
O&M Grade:	<b>3</b>
Clock Start/From:	<b>1</b>
Clock To:	
1st Value:	<b>4.000</b>
2nd Value:	
Value Percent:	
Continuous Index:	
Within 8" of Joint:	<b>YES</b>
Remarks:	<b>CAPPED. OFFSET. ROOTS GROWING OUT OF THE JOINT</b>

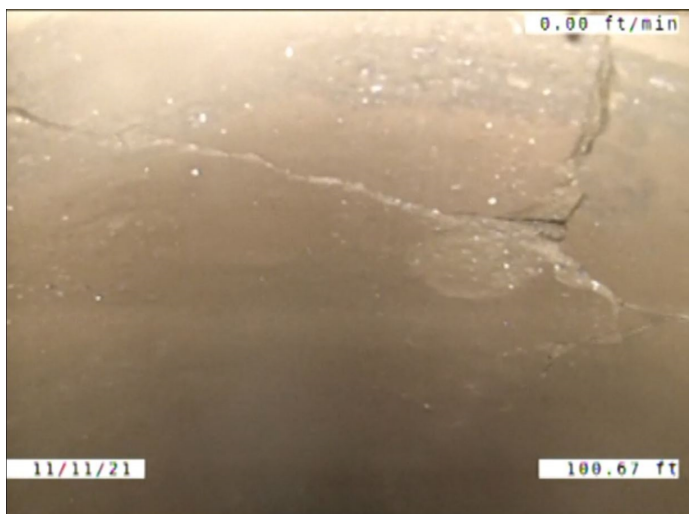
Code:	<b>FM</b>
Description:	<b>Fracture Multiple</b>
Distance (ft):	<b>100.7</b>
Structural Grade:	<b>4</b>
O&M Grade:	<b>0</b>
Clock Start/From:	<b>8</b>
Clock To:	<b>4</b>
1st Value:	
2nd Value:	
Value Percent:	
Continuous Index:	<b>S09</b>
Within 8" of Joint:	<b>YES</b>
Remarks:

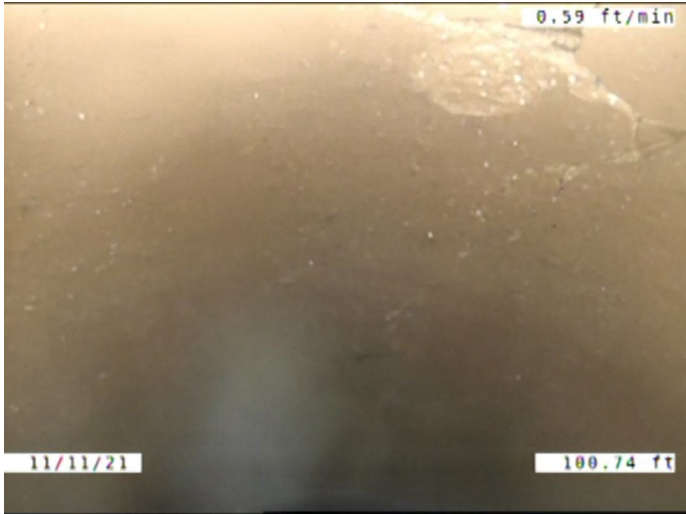
Code: **SSS**  
Description: **Surface Damage Surface Spalling**

Distance (ft): **100.7**  
Structural Grade: **2**  
O&M Grade: **0**  
Clock Start/From: **12**  
Clock To:  
1st Value:  
2nd Value:  
Value Percent:  
Continuous Index:  
Within 8" of Joint: **NO**  
Remarks:

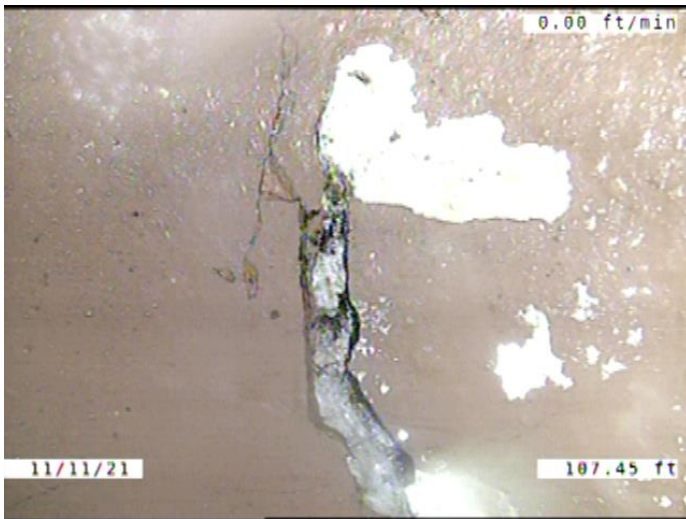
Code: **DAE**  
Description: **Deposits Attached Encrustation**

Distance (ft): **107.5**  
Structural Grade: **0**  
O&M Grade: **2**  
Clock Start/From: **2**  
Clock To: **4**  
1st Value:  
2nd Value:  
Value Percent: **5.000**  
Continuous Index: **S06**  
Within 8" of Joint: **YES**  
Remarks:

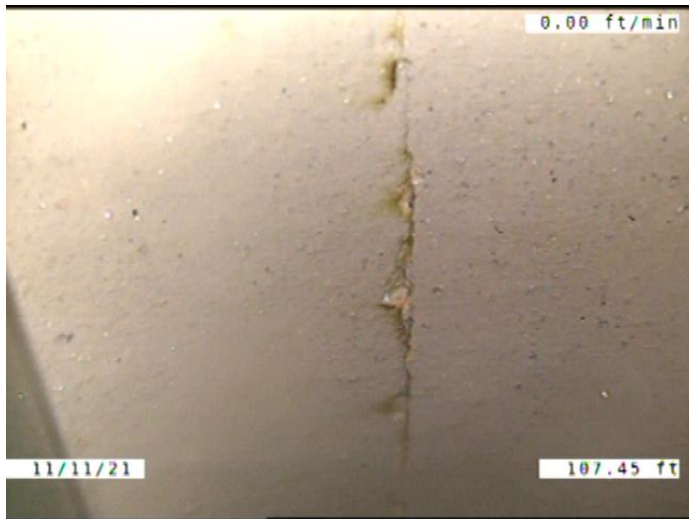
Code: **DAE**  
Description: **Deposits Attached Encrustation**

Distance (ft): **107.5**  
Structural Grade: **0**  
O&M Grade: **2**  
Clock Start/From: **8**  
Clock To: **10**  
1st Value:  
2nd Value:  
Value Percent: **5.000**  
Continuous Index: **S07**  
Within 8" of Joint: **YES**  
Remarks:

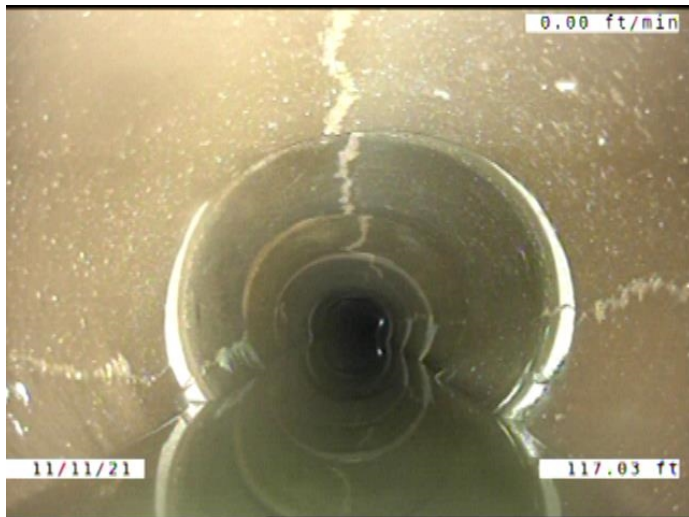
Code: **RFJ**  
 Description: **Roots Fine Joint**

Distance (ft): **117.0**  
 Structural Grade: **0**  
 O&M Grade: **1**  
 Clock Start/From: **8**  
 Clock To: **4**  
 1st Value:  
 2nd Value:  
 Value Percent:  
 Continuous Index: **F05**  
 Within 8" of Joint: **YES**  
 Remarks:

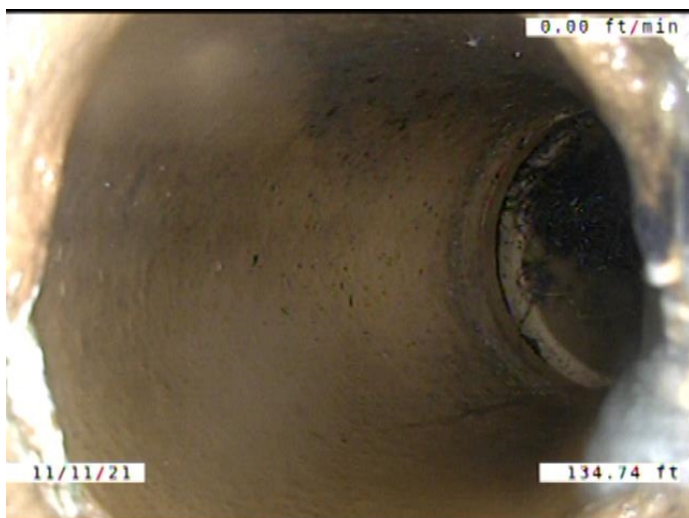
Code: **TBD**  
 Description: **Tap Break-in/Hammer Defective**

Distance (ft): **134.7**  
 Structural Grade: **0**  
 O&M Grade: **3**  
 Clock Start/From: **2**  
 Clock To:  
 1st Value: **4.000**  
 2nd Value:  
 Value Percent:  
 Continuous Index:  
 Within 8" of Joint: **YES**  
 Remarks: **CONSTANTLY RUNNING WATER.  
 ROOTS GROWING FROM THE JOINT**

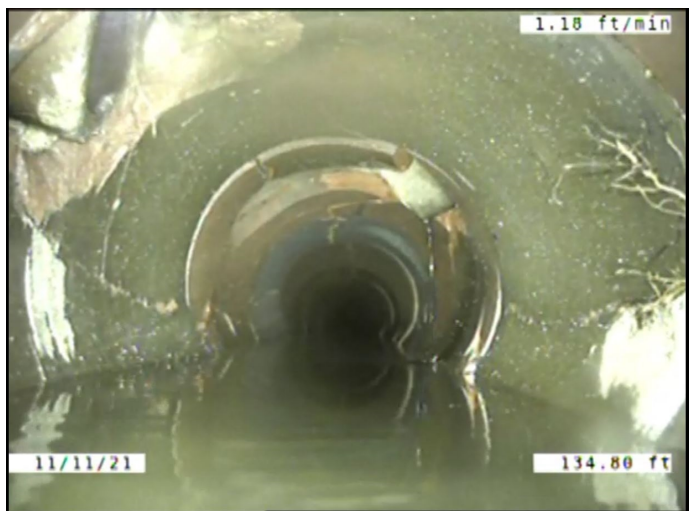
Code: **B**  
Description: **Broken**

Distance (ft): **134.8**  
Structural Grade: **4**  
O&M Grade: **0**  
Clock Start/From: **10**  
Clock To: **2**  
1st Value:  
2nd Value:  
Value Percent:  
Continuous Index: **S10**  
Within 8" of Joint: **YES**  
Remarks:

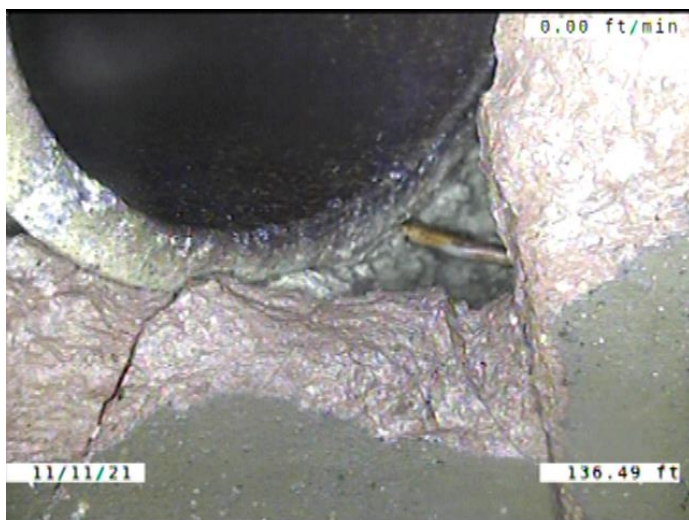
Code: **BSV**  
Description: **Broken Soil Visible**

Distance (ft): **136.5**  
Structural Grade: **5**  
O&M Grade: **0**  
Clock Start/From: **8**  
Clock To: **11**  
1st Value:  
2nd Value:  
Value Percent:  
Continuous Index:  
Within 8" of Joint: **YES**  
Remarks:

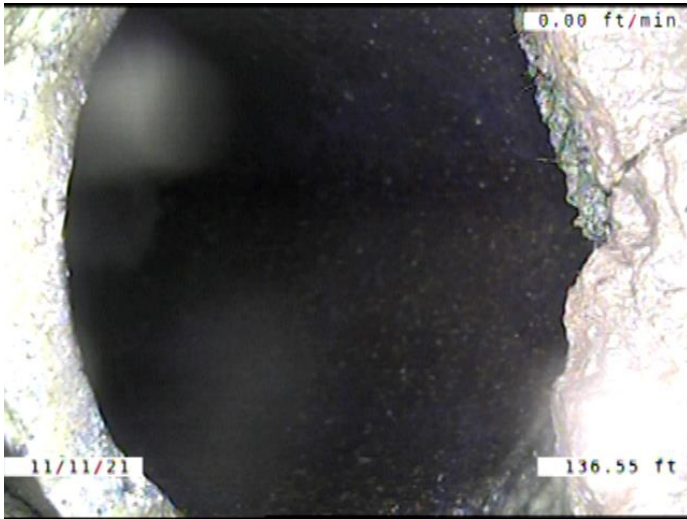
Code: **TFD**  
 Description: **Tap Factory Defective**

Distance (ft): **136.5**  
 Structural Grade: **0**  
 O&M Grade: **3**  
 Clock Start/From: **11**  
 Clock To:  
 1st Value: **4.000**  
 2nd Value:  
 Value Percent:  
 Continuous Index:  
 Within 8" of Joint: **YES**  
 Remarks: **Defective**

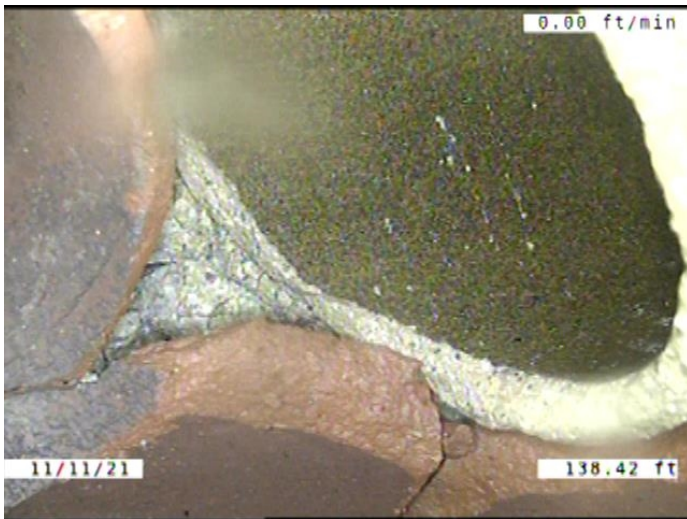
Code: **BSV**  
 Description: **Broken Soil Visible**

Distance (ft): **138.4**  
 Structural Grade: **5**  
 O&M Grade: **0**  
 Clock Start/From: **12**  
 Clock To: **2**  
 1st Value:  
 2nd Value:  
 Value Percent:  
 Continuous Index:  
 Within 8" of Joint: **YES**  
 Remarks:

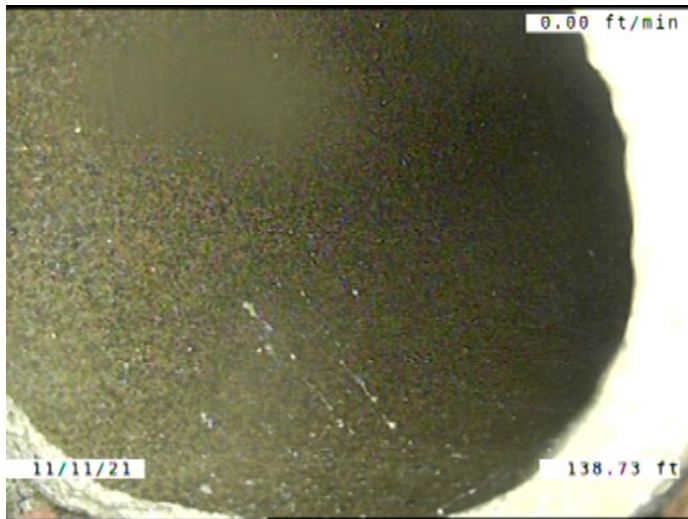
Code: **TBI**  
 Description: **Tap Break-in Intruding**

Distance (ft): **138.7**  
 Structural Grade: **0**  
 O&M Grade: **2**  
 Clock Start/From: **1**  
 Clock To:  
 1st Value: **4.000**  
 2nd Value: **2.000**  
 Value Percent:  
 Continuous Index:  
 Within 8" of Joint: **YES**  
 Remarks:

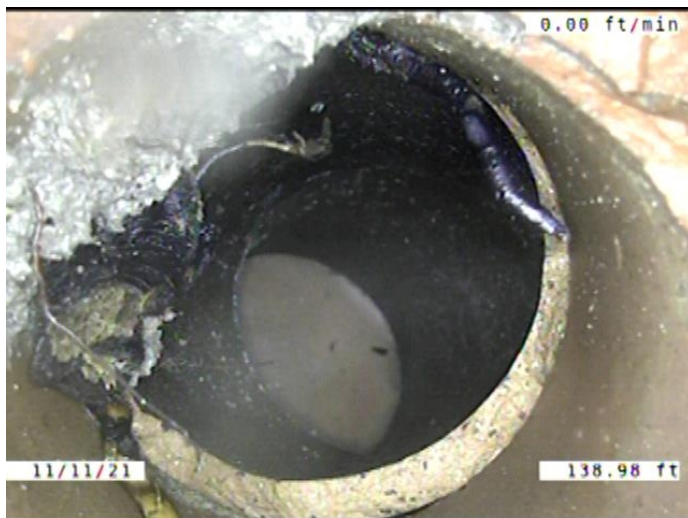
Code: **TFD**  
 Description: **Tap Factory Defective**

Distance (ft): **139.0**  
 Structural Grade: **0**  
 O&M Grade: **3**  
 Clock Start/From: **11**  
 Clock To:  
 1st Value: **4.000**  
 2nd Value:  
 Value Percent:  
 Continuous Index:  
 Within 8" of Joint: **YES**  
 Remarks: **BROKEN. SOIL VISIBLE. ROOTS GROWING OUT OF THE OFFSET AND**

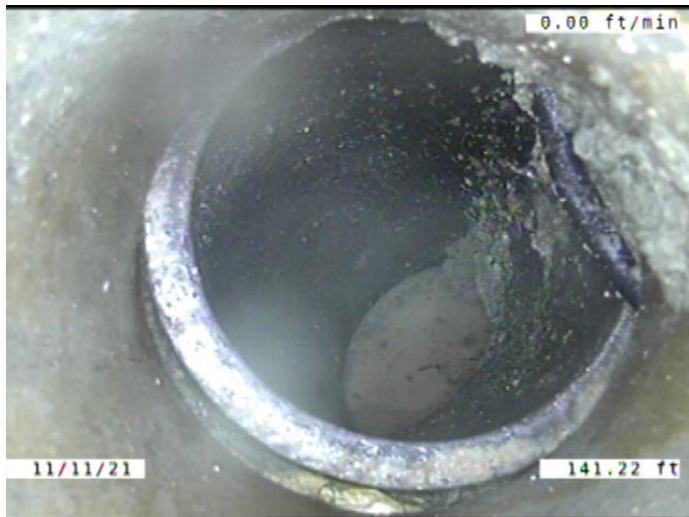
Code:	<b>TFC</b>
Description:	<b>Tap Factory Capped</b>
Distance (ft):	<b>141.2</b>
Structural Grade:	<b>0</b>
O&M Grade:	<b>0</b>
Clock Start/From:	<b>1</b>
Clock To:	
1st Value:	<b>4.000</b>
2nd Value:	
Value Percent:	
Continuous Index:	
Within 8" of Joint:	<b>YES</b>
Remarks:	<b>BROKEN. OFFSET. SOIL VISIBLE. ROOTS GROWING FROM THE JOINT</b>

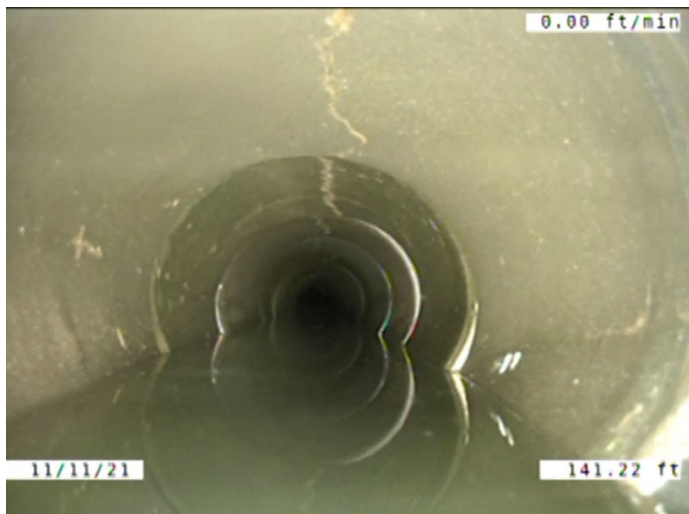
Code:	<b>B</b>
Description:	<b>Broken</b>
Distance (ft):	<b>141.2</b>
Structural Grade:	<b>4</b>
O&M Grade:	<b>0</b>
Clock Start/From:	<b>10</b>
Clock To:	<b>2</b>
1st Value:	
2nd Value:	
Value Percent:	
Continuous Index:	<b>F10</b>
Within 8" of Joint:	<b>YES</b>
Remarks:

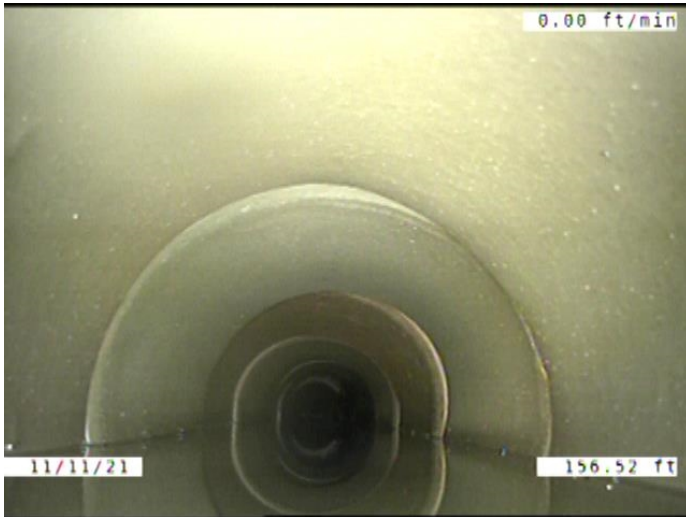
Code: **DAE**  
Description: **Deposits Attached Encrustation**

Distance (ft): **156.5**  
Structural Grade: **0**  
O&M Grade: **2**  
Clock Start/From: **8**  
Clock To: **10**  
1st Value:  
2nd Value:  
Value Percent: **5.000**  
Continuous Index: **F07**  
Within 8" of Joint: **YES**  
Remarks:

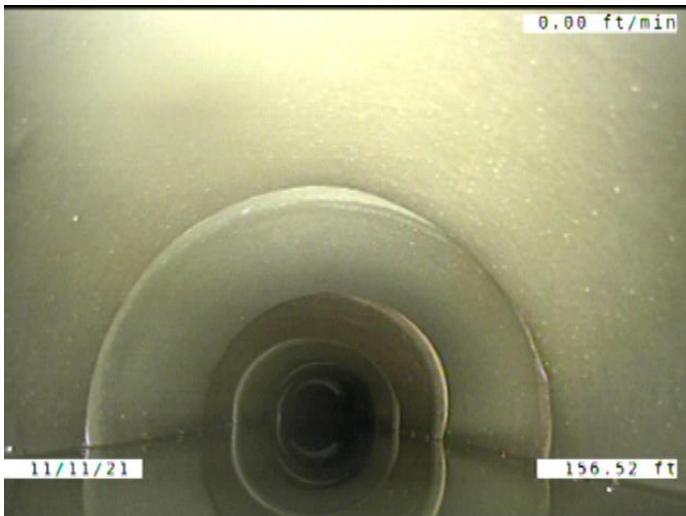
Code: **DAE**  
Description: **Deposits Attached Encrustation**

Distance (ft): **156.5**  
Structural Grade: **0**  
O&M Grade: **2**  
Clock Start/From: **2**  
Clock To: **4**  
1st Value:  
2nd Value:  
Value Percent: **5.000**  
Continuous Index: **F06**  
Within 8" of Joint: **YES**  
Remarks:

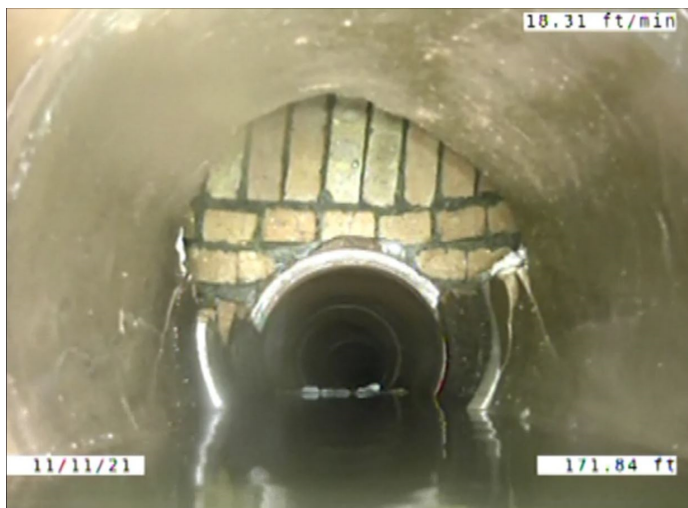
Code: **FM**  
Description: **Fracture Multiple**

Distance (ft): **171.8**  
Structural Grade: **4**  
O&M Grade: **0**  
Clock Start/From: **8**  
Clock To: **4**  
1st Value:  
2nd Value:  
Value Percent:  
Continuous Index: **F09**  
Within 8" of Joint: **YES**  
Remarks:

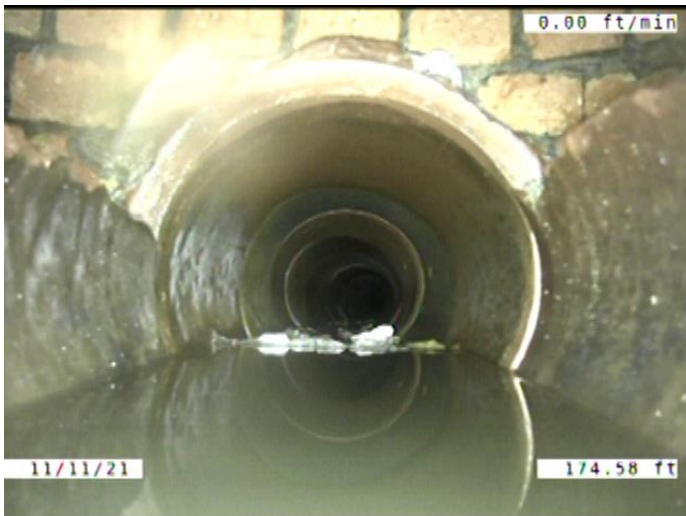
Code: **DSF**  
 Description: **Deposits Settled Fine**

Distance (ft): **174.6**  
 Structural Grade: **0**  
 O&M Grade: **2**  
 Clock Start/From: **5**  
 Clock To: **7**  
 1st Value:  
 2nd Value:  
 Value Percent: **5.000**  
 Continuous Index: **F03**  
 Within 8" of Joint: **YES**  
 Remarks: **ALSO RAGS**
