## Profile/Photo Observation Report

Street:	<b>S Ash St.</b>	Flow Control:	<b>Not Controlled</b>
City:	<b>Hobart, IN</b>	Year Renewed:	
Location:	<b>Other</b>	Tape/Media #:	
Purpose:	<b>Not Known</b>	Dia/Height:	<b>12"</b>
Use:	<b>Sanitary</b>	Material:	<b>VCP</b>
Drain Area:	<b>NA</b>	Lining:	
Category:	<b>NA</b>		
Comment:

Location Details:		Direction of Survey:	<b>Upstream</b>
US MH:	<b>M-605-028</b>	DS MH:	<b>M-605-029</b>
		Total Length Surveyed (ft):	<b>148.4</b>

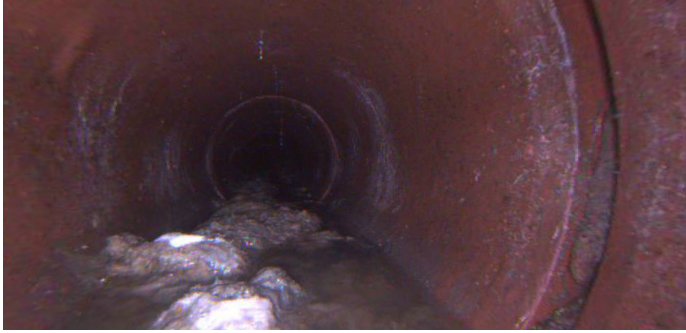
Code: **AMH**  
Description: **Manhole**

Distance (ft): **.0**  
Structural Grade: **0**  
O&M Grade: **0**  
Clock Start/From:  
Clock To:  
1st Value:  
2nd Value:  
Value Percent:  
Continuous Index:  
Within 8" of Joint: **NO**  
Remarks: **M-605-029**

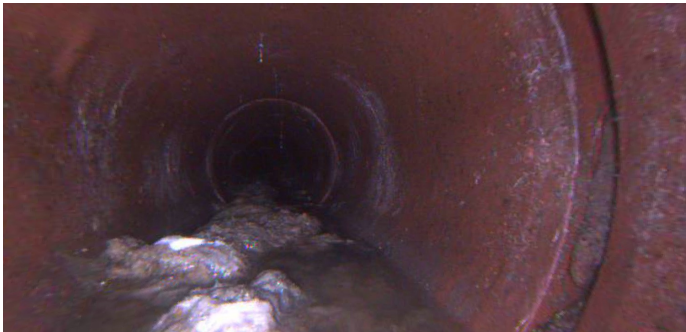
Code: **MWL**  
Description: **Water Level**

Distance (ft): **.0**  
Structural Grade: **0**  
O&M Grade: **0**  
Clock Start/From:  
Clock To:  
1st Value:  
2nd Value:  
Value Percent: **10.000**  
Continuous Index:  
Within 8" of Joint: **NO**  
Remarks:

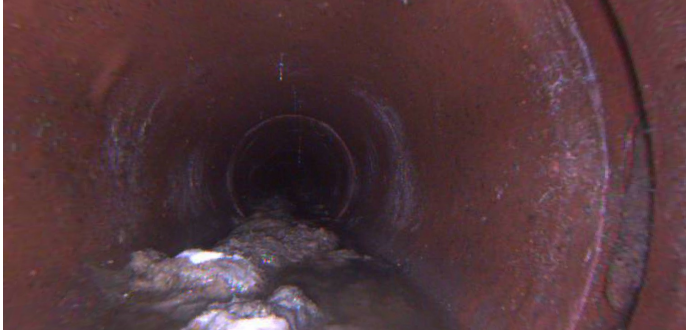
Code: **DSZ**  
Description: **Deposits Settled Other**

Distance (ft): **.0**  
Structural Grade: **0**  
O&M Grade: **2**  
Clock Start/From: **4**  
Clock To: **8**  
1st Value:  
2nd Value:  
Value Percent: **10.000**  
Continuous Index: **S01**  
Within 8" of Joint: **NO**  
Remarks: **misc**

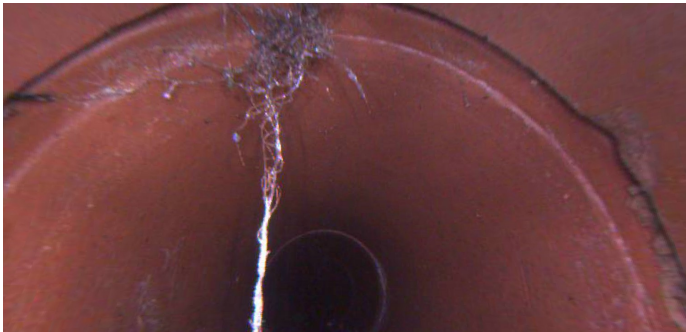
Code: **RFJ**  
Description: **Roots Fine Joint**

Distance (ft): **21.4**  
Structural Grade: **0**  
O&M Grade: **1**  
Clock Start/From: **12**  
Clock To:  
1st Value:  
2nd Value:  
Value Percent:  
Continuous Index:  
Within 8" of Joint: **YES**  
Remarks:

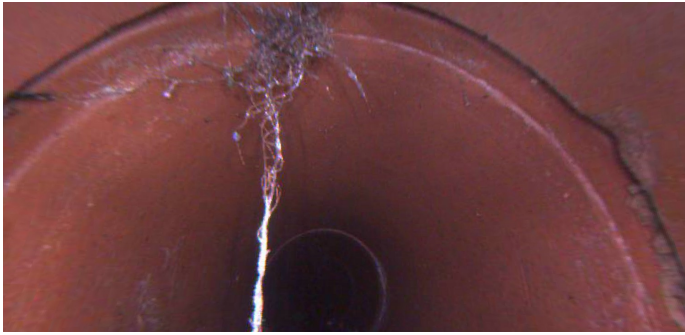
Code: **DSZ**  
Description: **Deposits Settled Other**

Distance (ft): **21.4**  
Structural Grade: **0**  
O&M Grade: **2**  
Clock Start/From: **4**  
Clock To: **8**  
1st Value:  
2nd Value:  
Value Percent: **10.000**  
Continuous Index: **F01**  
Within 8" of Joint: **NO**  
Remarks: **misc**

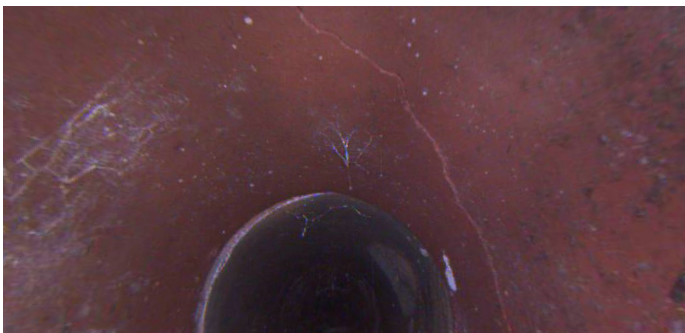
Code: **FS**  
Description: **Fracture Spiral**

Distance (ft): **30.7**  
Structural Grade: **3**  
O&M Grade: **0**  
Clock Start/From: **12**  
Clock To: **4**  
1st Value:  
2nd Value:  
Value Percent:  
Continuous Index:  
Within 8" of Joint:  
Remarks:

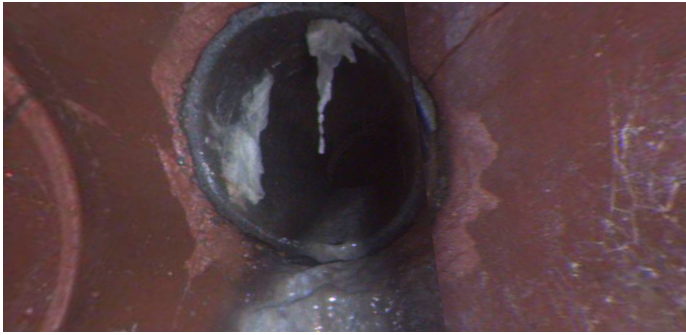
Code: **TB**  
Description: **Tap Break-in**

Distance (ft): **30.7**  
Structural Grade: **0**  
O&M Grade: **0**  
Clock Start/From: **9**  
Clock To:  
1st Value: **4.000**  
2nd Value:  
Value Percent:  
Continuous Index:  
Within 8" of Joint:  
Remarks:

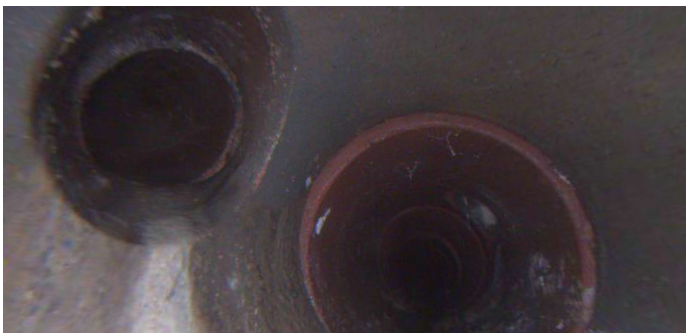
Code: **TF**  
Description: **Tap Factory**

Distance (ft): **33.3**  
Structural Grade: **0**  
O&M Grade: **0**  
Clock Start/From: **2**  
Clock To:  
1st Value: **4.000**  
2nd Value:  
Value Percent:  
Continuous Index:  
Within 8" of Joint:  
Remarks:

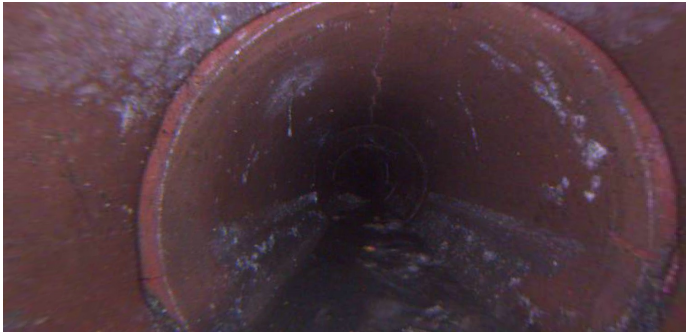
Code: **FL**  
Description: **Fracture Longitudinal**

Distance (ft): **39.8**  
Structural Grade: **3**  
O&M Grade: **0**  
Clock Start/From: **12**  
Clock To:  
1st Value:  
2nd Value:  
Value Percent:  
Continuous Index:  
Within 8" of Joint: **YES**  
Remarks:

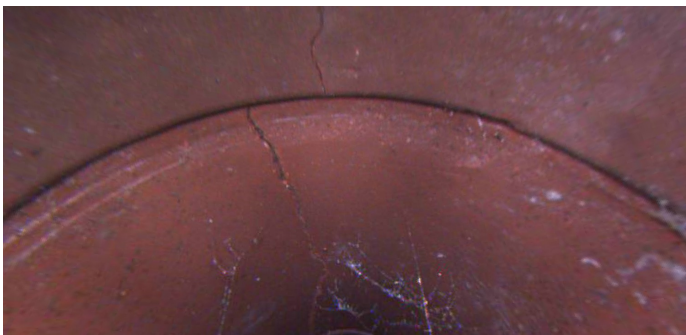
Code: **FL**  
Description: **Fracture Longitudinal**

Distance (ft): **42.0**  
Structural Grade: **3**  
O&M Grade: **0**  
Clock Start/From: **12**  
Clock To:  
1st Value:  
2nd Value:  
Value Percent:  
Continuous Index: **S02**  
Within 8" of Joint: **YES**  
Remarks:

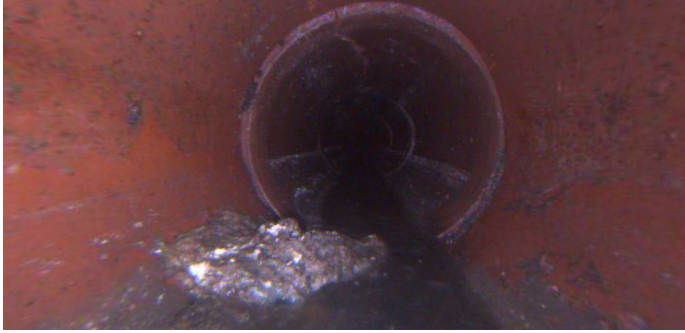
Code: **DSZ**  
Description: **Deposits Settled Other**

Distance (ft): **43.3**  
Structural Grade: **0**  
O&M Grade: **2**  
Clock Start/From: **6**  
Clock To: **7**  
1st Value:  
2nd Value:  
Value Percent: **10.000**  
Continuous Index:  
Within 8" of Joint: **NO**  
Remarks: **misc**

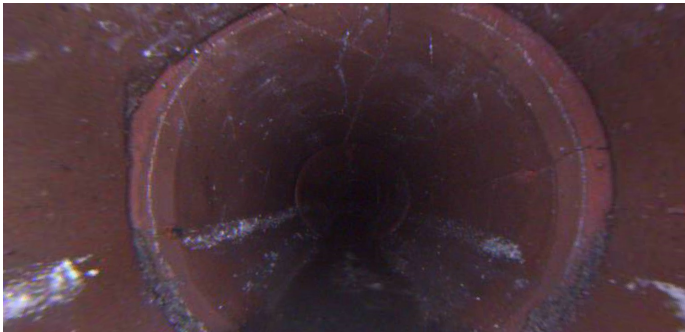
Code: **FM**  
Description: **Fracture Multiple**

Distance (ft): **47.8**  
Structural Grade: **4**  
O&M Grade: **0**  
Clock Start/From: **8**  
Clock To: **4**  
1st Value:  
2nd Value:  
Value Percent:  
Continuous Index: **S03**  
Within 8" of Joint: **YES**  
Remarks:

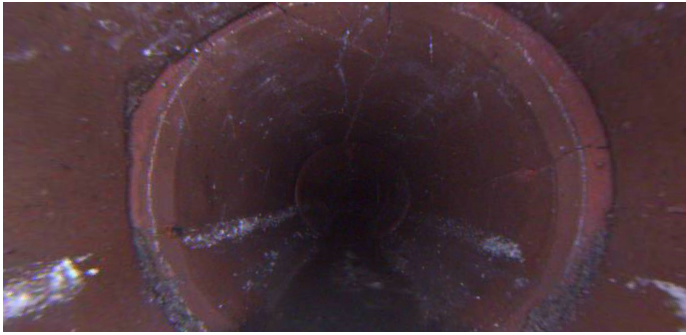
Code: **FL**  
Description: **Fracture Longitudinal**

Distance (ft): **47.8**  
Structural Grade: **3**  
O&M Grade: **0**  
Clock Start/From: **12**  
Clock To:  
1st Value:  
2nd Value:  
Value Percent:  
Continuous Index: **F02**  
Within 8" of Joint: **YES**  
Remarks:

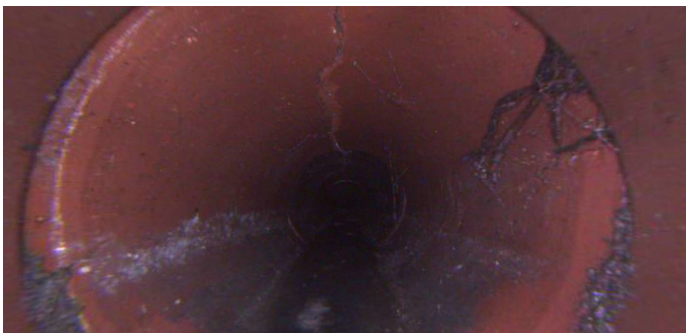
Code: **RFJ**  
Description: **Roots Fine Joint**

Distance (ft): **49.9**  
Structural Grade: **0**  
O&M Grade: **1**  
Clock Start/From: **1**  
Clock To: **2**  
1st Value:  
2nd Value:  
Value Percent:  
Continuous Index:  
Within 8" of Joint: **YES**  
Remarks:

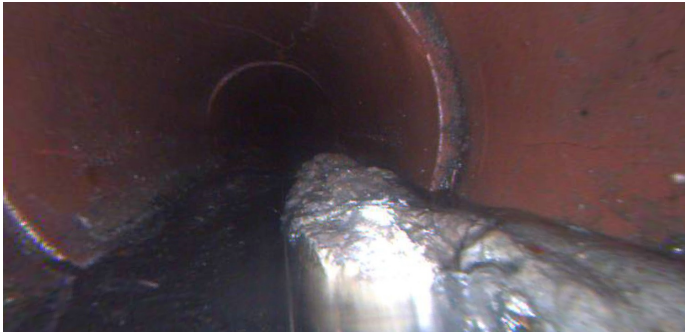
Code: **DSZ**  
Description: **Deposits Settled Other**

Distance (ft): **61.6**  
Structural Grade: **0**  
O&M Grade: **2**  
Clock Start/From: **6**  
Clock To: **8**  
1st Value:  
2nd Value:  
Value Percent: **10.000**  
Continuous Index:  
Within 8" of Joint: **YES**  
Remarks: **misc**

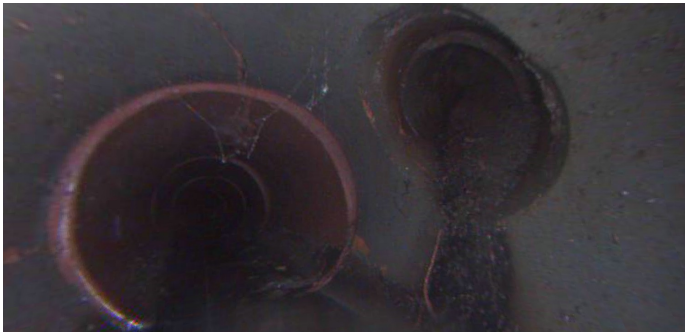
Code: **TFD**  
Description: **Tap Factory Defective**

Distance (ft): **70.4**  
Structural Grade: **0**  
O&M Grade: **2**  
Clock Start/From: **10**  
Clock To:  
1st Value: **4.000**  
2nd Value:  
Value Percent:  
Continuous Index:  
Within 8" of Joint:  
Remarks: **roots**

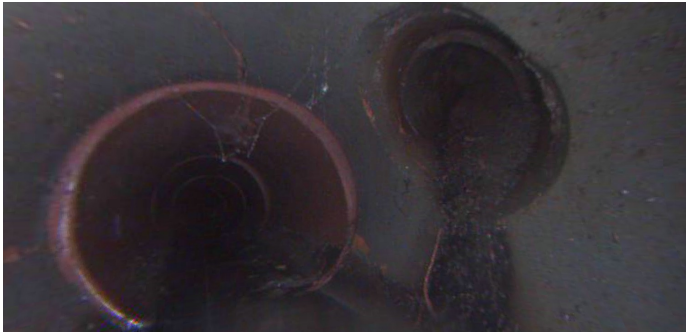
Code: **RFL**  
Description: **Roots Fine Lateral**

Distance (ft): **70.4**  
Structural Grade: **0**  
O&M Grade: **1**  
Clock Start/From: **10**  
Clock To:  
1st Value:  
2nd Value:  
Value Percent:  
Continuous Index:  
Within 8" of Joint: **NO**  
Remarks:

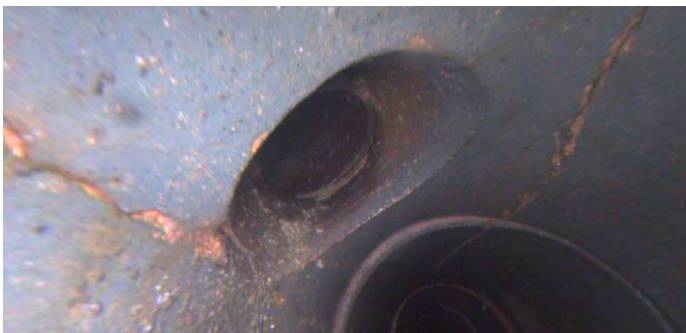
Code: **TF**  
Description: **Tap Factory**

Distance (ft): **72.4**  
Structural Grade: **0**  
O&M Grade: **0**  
Clock Start/From: **1**  
Clock To:  
1st Value: **4.000**  
2nd Value:  
Value Percent:  
Continuous Index:  
Within 8" of Joint:  
Remarks:

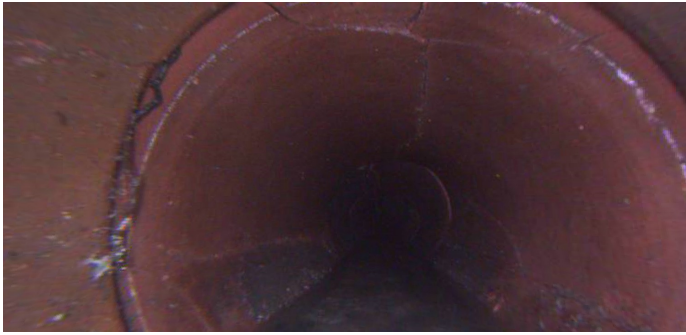
Code: **RFJ**  
Description: **Roots Fine Joint**

Distance (ft): **95.2**  
Structural Grade: **0**  
O&M Grade: **1**  
Clock Start/From: **9**  
Clock To: **10**  
1st Value:  
2nd Value:  
Value Percent:  
Continuous Index:  
Within 8" of Joint: **YES**  
Remarks:

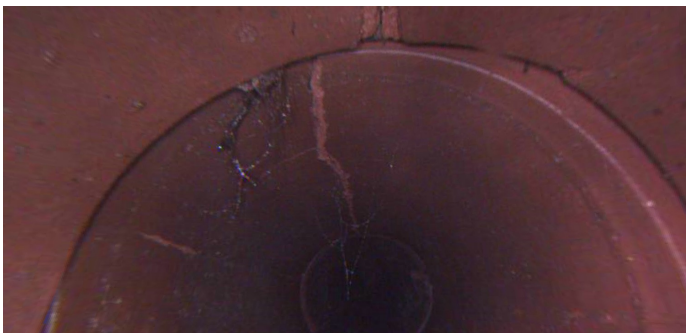
Code: **RFJ**  
Description: **Roots Fine Joint**

Distance (ft): **97.2**  
Structural Grade: **0**  
O&M Grade: **1**  
Clock Start/From: **11**  
Clock To:  
1st Value:  
2nd Value:  
Value Percent:  
Continuous Index:  
Within 8" of Joint: **YES**  
Remarks:

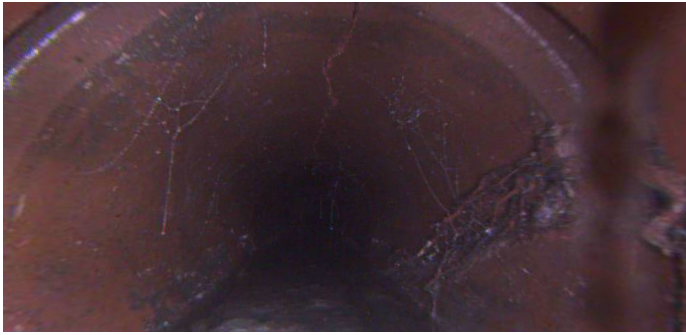
Code: **RMJ**  
Description: **Roots Medium Joint**

Distance (ft): **99.4**  
Structural Grade: **0**  
O&M Grade: **3**  
Clock Start/From: **2**  
Clock To:  
1st Value:  
2nd Value:  
Value Percent: **5.000**  
Continuous Index:  
Within 8" of Joint: **YES**  
Remarks:

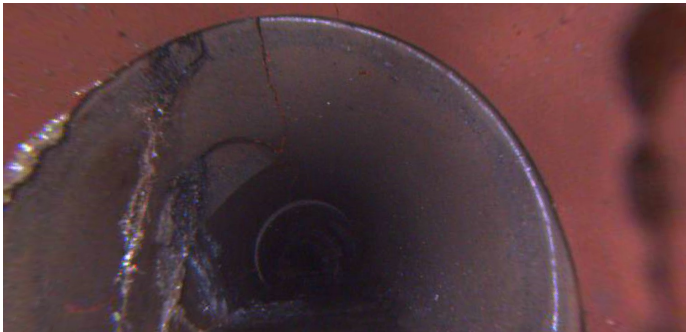
Code: **RFJ**  
Description: **Roots Fine Joint**

Distance (ft): **107.5**  
Structural Grade: **0**  
O&M Grade: **1**  
Clock Start/From: **11**  
Clock To:  
1st Value:  
2nd Value:  
Value Percent:  
Continuous Index:  
Within 8" of Joint: **YES**  
Remarks:

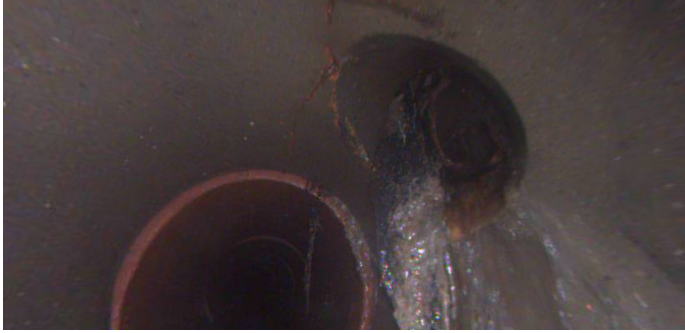
Code: **TFD**  
Description: **Tap Factory Defective**

Distance (ft): **109.5**  
Structural Grade: **0**  
O&M Grade: **2**  
Clock Start/From: **10**  
Clock To:  
1st Value: **4.000**  
2nd Value:  
Value Percent:  
Continuous Index:  
Within 8" of Joint:  
Remarks: **rml**

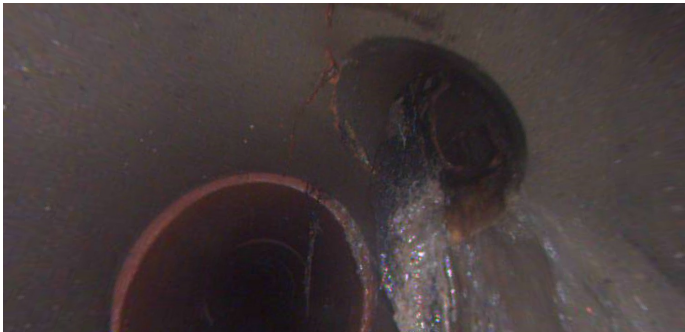
Code: **RML**  
Description: **Roots Medium Lateral**

Distance (ft): **109.5**  
Structural Grade: **0**  
O&M Grade: **3**  
Clock Start/From: **10**  
Clock To:  
1st Value:  
2nd Value:  
Value Percent: **10.000**  
Continuous Index:  
Within 8" of Joint: **NO**  
Remarks:

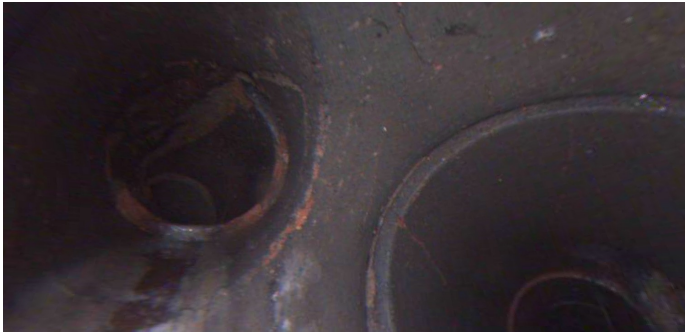
Code: **TF**  
Description: **Tap Factory**

Distance (ft): **111.5**  
Structural Grade: **0**  
O&M Grade: **0**  
Clock Start/From: **2**  
Clock To:  
1st Value: **4.000**  
2nd Value:  
Value Percent:  
Continuous Index:  
Within 8" of Joint:  
Remarks:

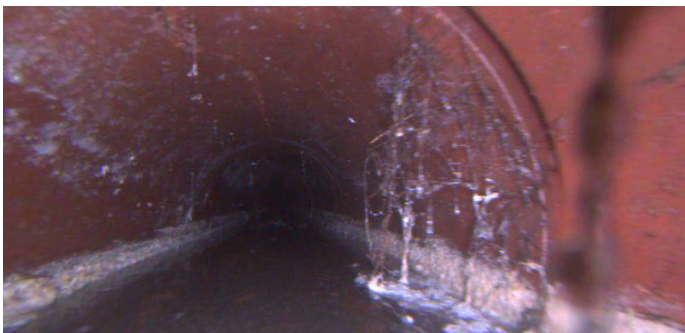
Code: **RFJ**  
Description: **Roots Fine Joint**

Distance (ft): **127.0**  
Structural Grade: **0**  
O&M Grade: **1**  
Clock Start/From: **8**  
Clock To: **4**  
1st Value:  
2nd Value:  
Value Percent:  
Continuous Index: **S04**  
Within 8" of Joint: **YES**  
Remarks:

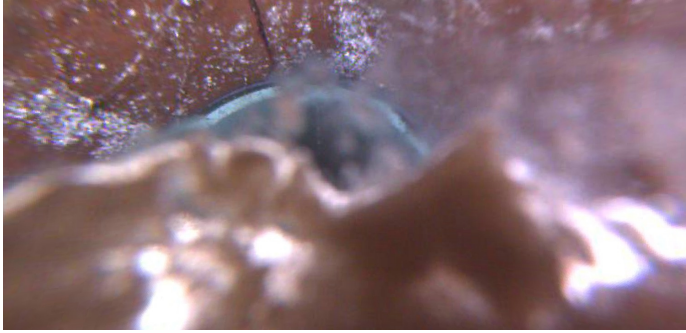
Code: **MWL**  
Description: **Water Level**

Distance (ft): **145.9**  
Structural Grade: **0**  
O&M Grade: **0**  
Clock Start/From:  
Clock To:  
1st Value:  
2nd Value:  
Value Percent: **40.000**  
Continuous Index:  
Within 8" of Joint: **NO**  
Remarks:
