## Profile/Photo Observation Report

Street:	<b>S Ash St.</b>	Flow Control:	<b>Not Controlled</b>
City:	<b>Hobart, IN</b>	Year Renewed:	
Location:	<b>Other</b>	Tape/Media #:	
Purpose:	<b>Not Known</b>	Dia/Height:	<b>12"</b>
Use:	<b>Sanitary</b>	Material:	<b>VCP</b>
Drain Area:	<b>NA</b>	Lining:	
Category:	<b>NA</b>		
Comment:

Location Details:		Direction of Survey:	<b>Downstream</b>
US MH:	<b>M-605-028</b>	DS MH:	<b>M-605-029</b>
		Total Length Surveyed (ft):	<b>13.5</b>

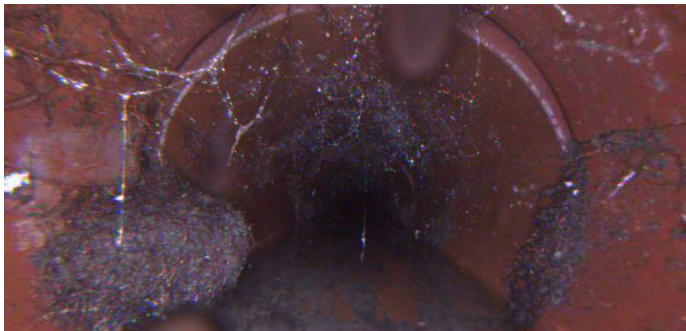
Code: **AMH**  
Description: **Manhole**

Distance (ft): **.0**  
Structural Grade: **0**  
O&M Grade: **0**  
Clock Start/From:  
Clock To:  
1st Value:  
2nd Value:  
Value Percent:  
Continuous Index:  
Within 8" of Joint: **NO**  
Remarks: **M-605-028**

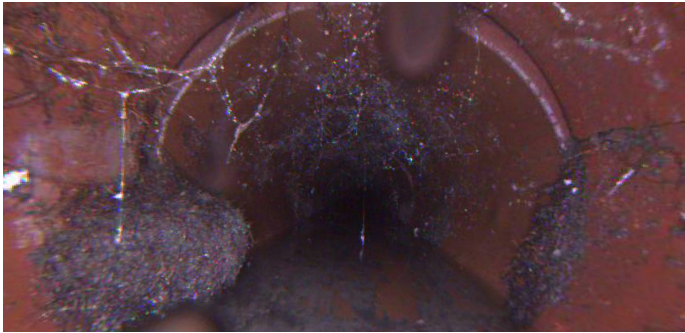
Code:	<b>MWL</b>
Description:	<b>Water Level</b>

Distance (ft):	<b>.0</b>
Structural Grade:	<b>0</b>
O&M Grade:	<b>0</b>
Clock Start/From:	
Clock To:	
1st Value:	
2nd Value:	
Value Percent:	<b>10.000</b>
Continuous Index:	
Within 8" of Joint:	<b>NO</b>
Remarks:

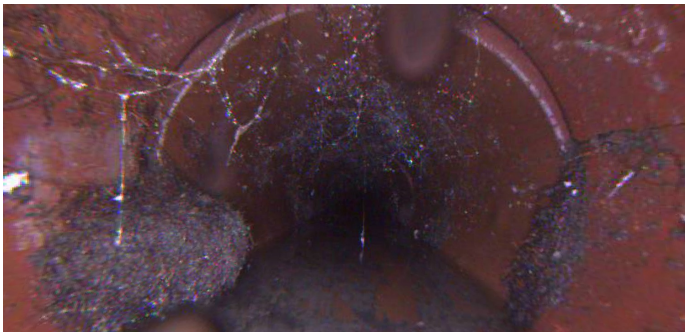
Code:	<b>RMJ</b>
Description:	<b>Roots Medium Joint</b>

Distance (ft):	<b>.0</b>
Structural Grade:	<b>0</b>
O&M Grade:	<b>3</b>
Clock Start/From:	<b>8</b>
Clock To:	<b>4</b>
1st Value:	
2nd Value:	
Value Percent:	<b>10.000</b>
Continuous Index:	<b>S01</b>
Within 8" of Joint:	<b>YES</b>
Remarks:

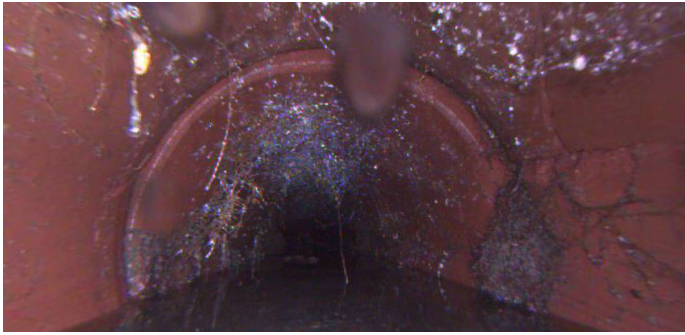
Code: **FL**  
Description: **Fracture Longitudinal**

Distance (ft): **7.1**  
Structural Grade: **3**  
O&M Grade: **0**  
Clock Start/From: **2**  
Clock To:  
1st Value:  
2nd Value:  
Value Percent:  
Continuous Index:  
Within 8" of Joint: **YES**  
Remarks:

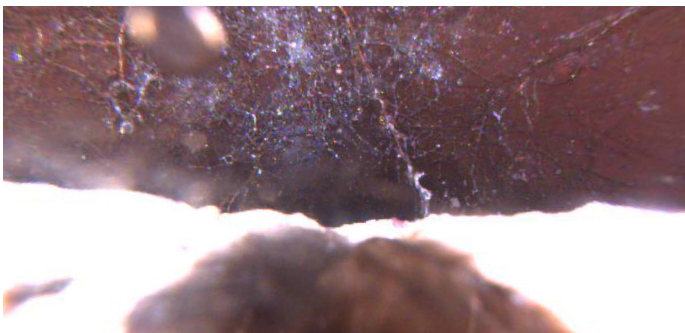
Code: **MSA**  
Description: **Abandoned Survey**

Distance (ft): **13.5**  
Structural Grade: **0**  
O&M Grade: **0**  
Clock Start/From:  
Clock To:  
1st Value:  
2nd Value:  
Value Percent:  
Continuous Index:  
Within 8" of Joint: **NO**  
Remarks: **high water**

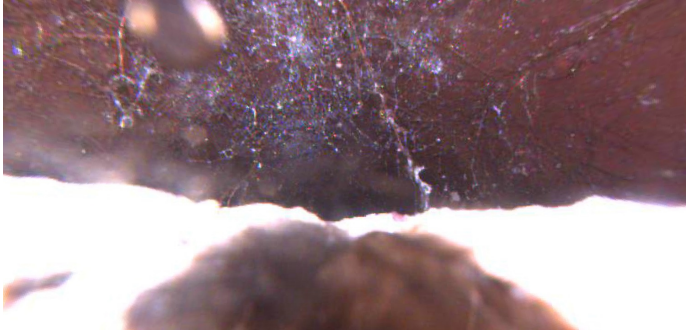
Code:	<b>RMJ</b>
Description:	<b>Roots Medium Joint</b>
Distance (ft):	<b>13.5</b>
Structural Grade:	<b>0</b>
O&M Grade:	<b>3</b>
Clock Start/From:	<b>8</b>
Clock To:	<b>4</b>
1st Value:	
2nd Value:	
Value Percent:	<b>10.000</b>
Continuous Index:	<b>F01</b>
Within 8" of Joint:	<b>YES</b>
Remarks:
