## Profile/Photo Observation Report

Date:	11/11/2021	Weather:		Coding:	PACP 7.0
Pipe Length (ft):	172.2	Owner:	City of Hobart	Pre Clean:	Heavy Cleaning
P.O.#:	YES502259	Surveyor:	Steven Bucklin	PSR:	P-605-029-028
Customer:	City of Hobart, IN (Red	Clean Date:	11/10/2021	Shape:	C

Street:	South Ash Street	Flow Control:	Not Controlled
City:	City of Hobart	Year Renewed:	
Location:	Local rural streets with light traffic, t	Tape/Media #:	
Purpose:	Routine Assessment	Dia/Height:	12"
Use:	Sanitary Sewage Pipe	Material:	VCP
Drain Area:		Lining:	None
Category:	NA		
Comment:			
Location Details:		Direction of Survey:	Downstream
US MH:	M-605-028	DS MH:	M-605-029
		Total Length Surveyed (ft):	172.2

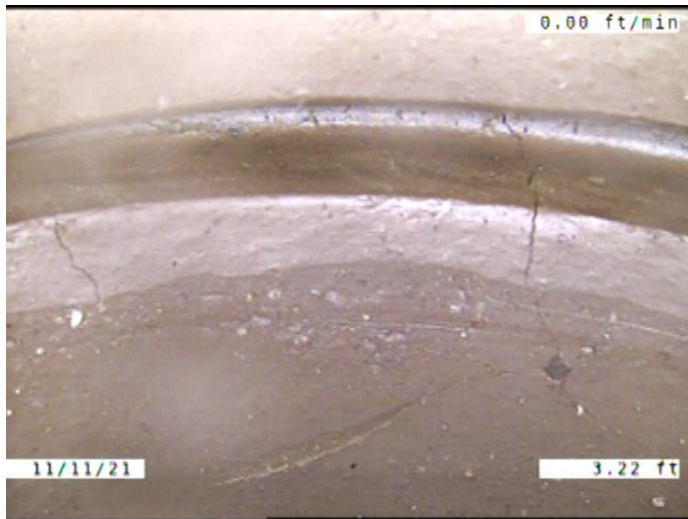
Code: **CM**  
Description: **Crack Multiple**

Distance (ft): **3.2**  
Structural Grade: **3**  
O&M Grade: **0**  
Clock Start/From: **11**  
Clock To: **1**  
1st Value:  
2nd Value:  
Value Percent:  
Continuous Index:  
Within 8" of Joint: **YES**  
Remarks:

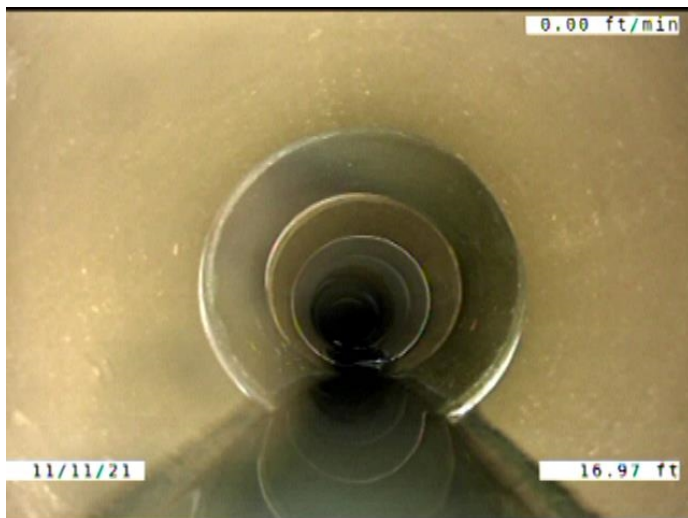
Code: **MWLS**  
Description: **Miscellaneous Water Level Sag**

Distance (ft): **17.0**  
Structural Grade: **2**  
O&M Grade: **0**  
Clock Start/From:  
Clock To:  
1st Value:  
2nd Value:  
Value Percent: **5.000**  
Continuous Index:  
Within 8" of Joint: **NO**  
Remarks:

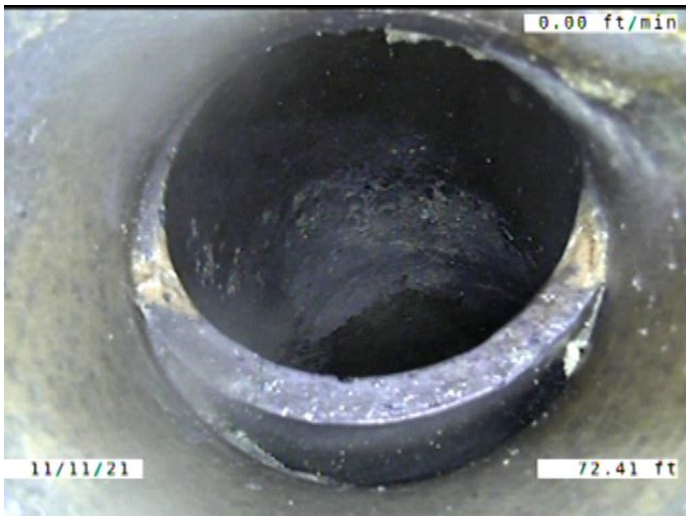
Code: **TF**  
Description: **Tap Factory**

Distance (ft): **72.4**  
Structural Grade: **0**  
O&M Grade: **0**  
Clock Start/From: **2**  
Clock To:  
1st Value: **4.000**  
2nd Value:  
Value Percent:  
Continuous Index:  
Within 8" of Joint: **YES**  
Remarks: **OFFSET.**

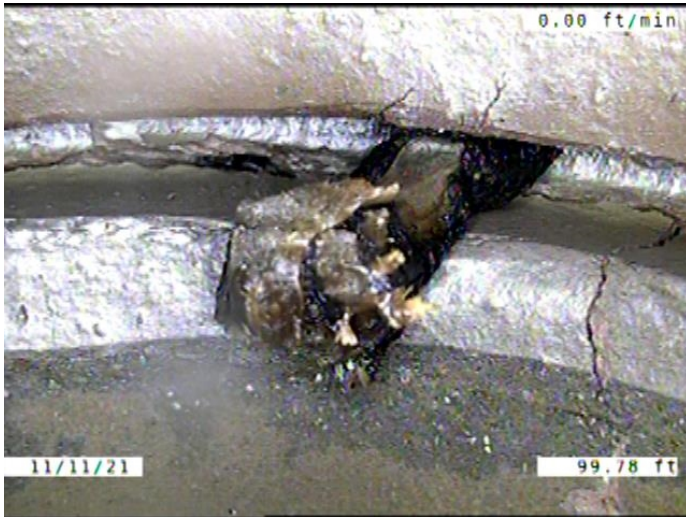
Code: **RTJ**  
 Description: **Roots Tap Joint**

Distance (ft): **99.8**  
 Structural Grade: **0**  
 O&M Grade: **2**  
 Clock Start/From: **2**  
 Clock To:  
 1st Value:  
 2nd Value:  
 Value Percent: **5.000**  
 Continuous Index:  
 Within 8" of Joint: **YES**  
 Remarks:

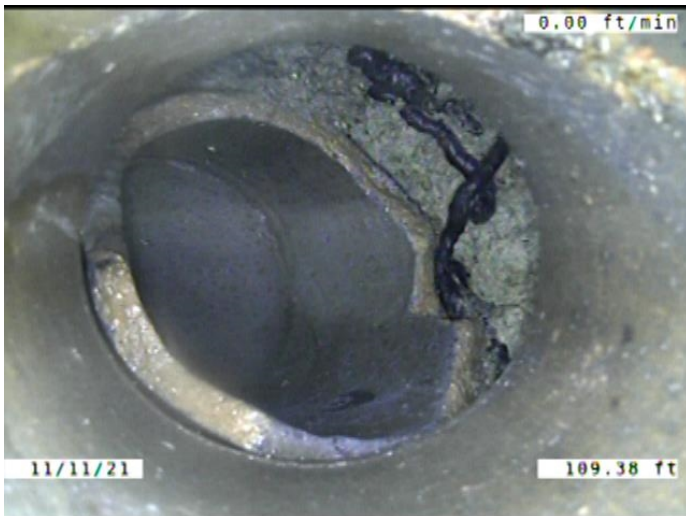
Code: **TFD**  
 Description: **Tap Factory Defective**

Distance (ft): **109.4**  
 Structural Grade: **0**  
 O&M Grade: **3**  
 Clock Start/From: **11**  
 Clock To:  
 1st Value: **4.000**  
 2nd Value:  
 Value Percent:  
 Continuous Index:  
 Within 8" of Joint: **YES**  
 Remarks: **OFFSET. SOIL VISIBLE. ROOTS GROWING AROUND THE OFFSET**

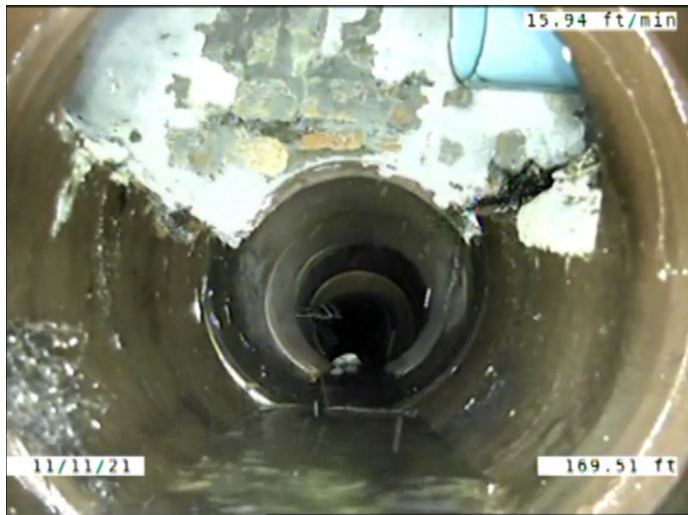
Code: **FM**  
 Description: **Fracture Multiple**

Distance (ft): **169.5**  
 Structural Grade: **4**  
 O&M Grade: **0**  
 Clock Start/From: **8**  
 Clock To: **4**  
 1st Value:  
 2nd Value:  
 Value Percent:  
 Continuous Index: **F08**  
 Within 8" of Joint: **YES**  
 Remarks:

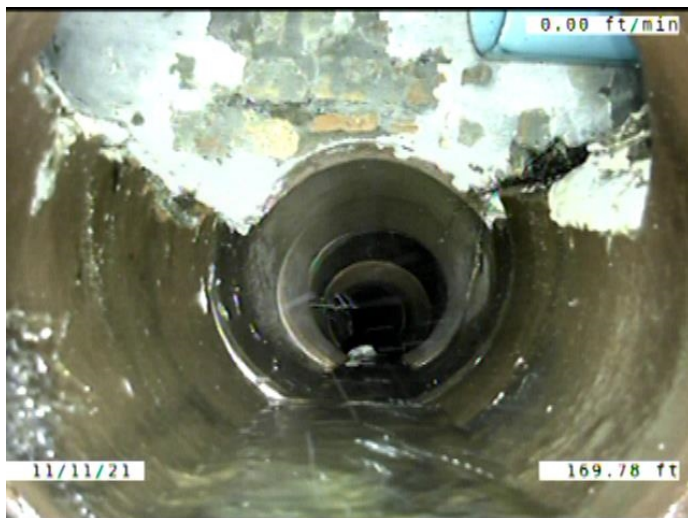
Code: **MWLS**  
 Description: **Miscellaneous Water Level Sag**

Distance (ft): **169.8**  
 Structural Grade: **2**  
 O&M Grade: **0**  
 Clock Start/From:  
 Clock To:  
 1st Value:  
 2nd Value:  
 Value Percent: **10.000**  
 Continuous Index: **F06**  
 Within 8" of Joint: **NO**  
 Remarks:
