## Profile/Photo Observation Report

Date:	11/11/2021	Weather:		Coding:	PACP 7.0
Pipe Length (ft):	172.2	Owner:	City of Hobart	Pre Clean:	Heavy Cleaning
P.O.#:	YES502259	Surveyor:	Steven Bucklin	PSR:	P-605-029-028
Customer:	City of Hobart, IN (Red	Clean Date:	11/10/2021	Shape:	C

Street:	South Ash Street	Flow Control:	Not Controlled
City:	City of Hobart	Year Renewed:	
Location:	Local rural streets with light traffic, t	Tape/Media #:	
Purpose:	Routine Assessment	Dia/Height:	12"
Use:	Sanitary Sewage Pipe	Material:	VCP
Drain Area:		Lining:	None
Category:	NA		
Comment:			
Location Details:		Direction of Survey:	Downstream
US MH:	M-605-028	DS MH:	M-605-029
		Total Length Surveyed (ft):	172.2

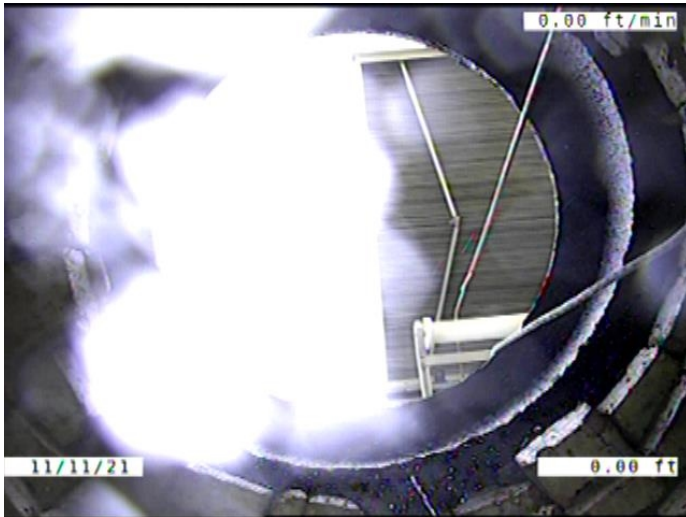
Code: **AMH**  
Description: **Manhole**

Distance (ft): **.0**  
Structural Grade: **0**  
O&M Grade: **0**  
Clock Start/From:  
Clock To:  
1st Value:  
2nd Value:  
Value Percent:  
Continuous Index:  
Within 8" of Joint: **NO**  
Remarks: **M-605-028**

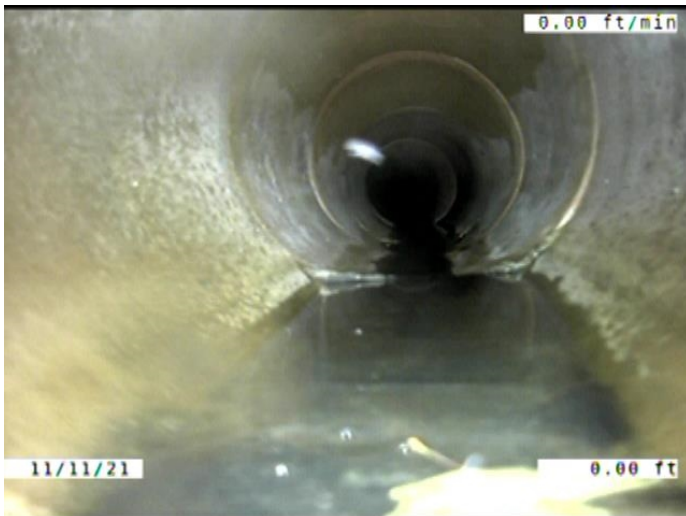
Code: **MWL**  
Description: **Miscellaneous Water Level**

Distance (ft): **.0**  
Structural Grade: **0**  
O&M Grade: **0**  
Clock Start/From:  
Clock To:  
1st Value:  
2nd Value:  
Value Percent: **5.000**  
Continuous Index:  
Within 8" of Joint: **NO**  
Remarks:

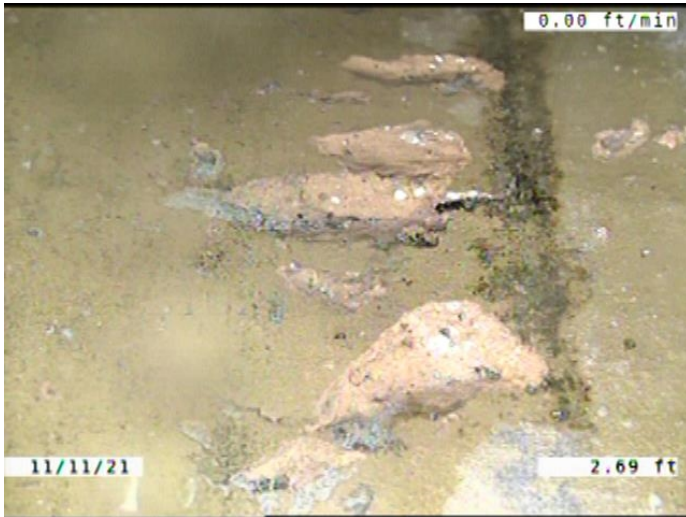
Code: **SSS**  
Description: **Surface Damage Surface Spalling**

Distance (ft): **2.7**  
Structural Grade: **2**  
O&M Grade: **0**  
Clock Start/From: **5**  
Clock To: **6**  
1st Value:  
2nd Value:  
Value Percent:  
Continuous Index:  
Within 8" of Joint: **YES**  
Remarks:

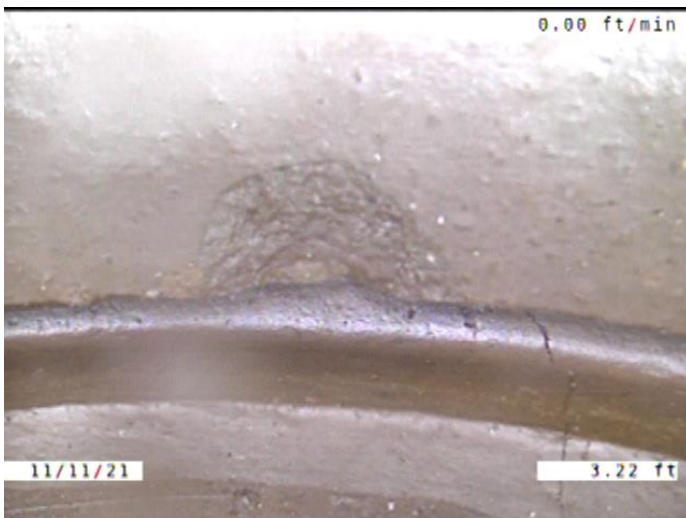
Code: **SZ**  
Description: **Surface Damage Other**

Distance (ft): **3.2**  
Structural Grade: **0**  
O&M Grade: **0**  
Clock Start/From: **1**  
Clock To:  
1st Value:  
2nd Value:  
Value Percent:  
Continuous Index:  
Within 8" of Joint: **YES**  
Remarks: **A PIECE GOT CHIPPED AWAY FROM THE JOINT**

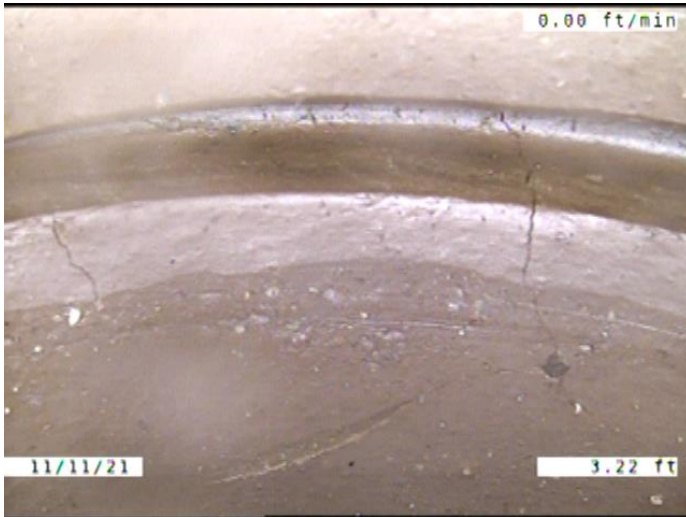
Code: **CM**  
Description: **Crack Multiple**

Distance (ft): **3.2**  
Structural Grade: **3**  
O&M Grade: **0**  
Clock Start/From: **11**  
Clock To: **1**  
1st Value:  
2nd Value:  
Value Percent:  
Continuous Index:  
Within 8" of Joint: **YES**  
Remarks:

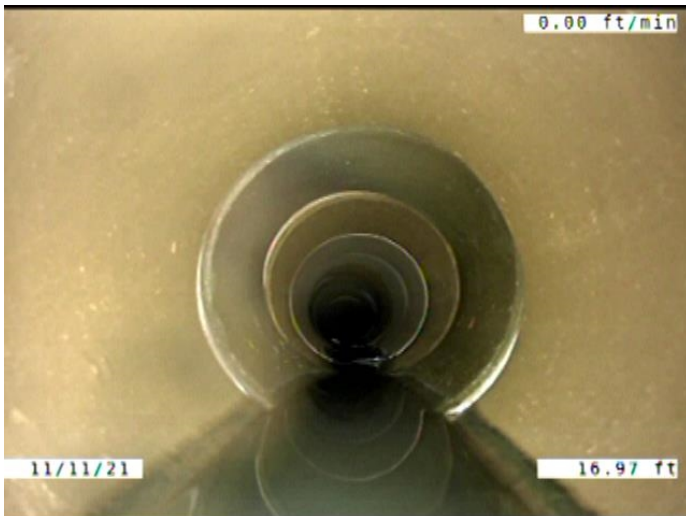
Code: **MWLS**  
Description: **Miscellaneous Water Level Sag**

Distance (ft): **17.0**  
Structural Grade: **2**  
O&M Grade: **0**  
Clock Start/From:  
Clock To:  
1st Value:  
2nd Value:  
Value Percent: **5.000**  
Continuous Index:  
Within 8" of Joint: **NO**  
Remarks:

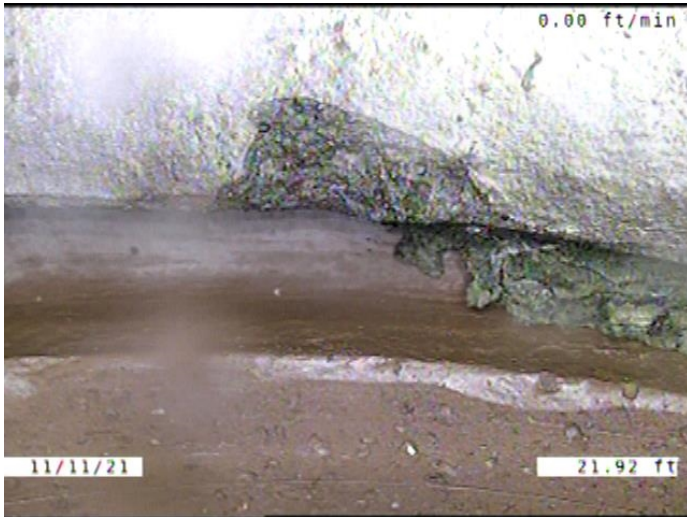
Code: **SZ**  
Description: **Surface Damage Other**

Distance (ft): **21.9**  
Structural Grade: **0**  
O&M Grade: **0**  
Clock Start/From: **2**  
Clock To:  
1st Value:  
2nd Value:  
Value Percent:  
Continuous Index:  
Within 8" of Joint: **YES**  
Remarks: **A PIECE CHIPPED AWAY FROM THE JOINT**

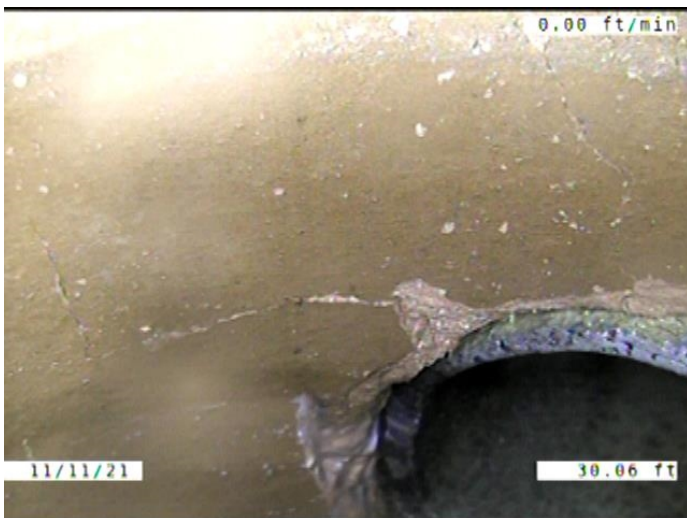
Code: **FM**  
Description: **Fracture Multiple**

Distance (ft): **30.1**  
Structural Grade: **4**  
O&M Grade: **0**  
Clock Start/From: **12**  
Clock To: **12**  
1st Value:  
2nd Value:  
Value Percent:  
Continuous Index: **S01**  
Within 8" of Joint: **YES**  
Remarks: **Wandering**

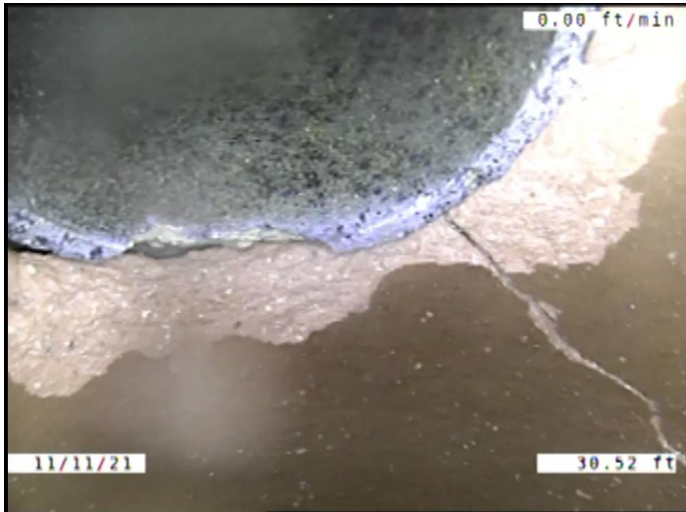
Code: **SSS**  
Description: **Surface Damage Surface Spalling**

Distance (ft): **30.5**  
Structural Grade: **2**  
O&M Grade: **0**  
Clock Start/From: **8**  
Clock To: **10**  
1st Value:  
2nd Value:  
Value Percent:  
Continuous Index:  
Within 8" of Joint: **NO**  
Remarks:

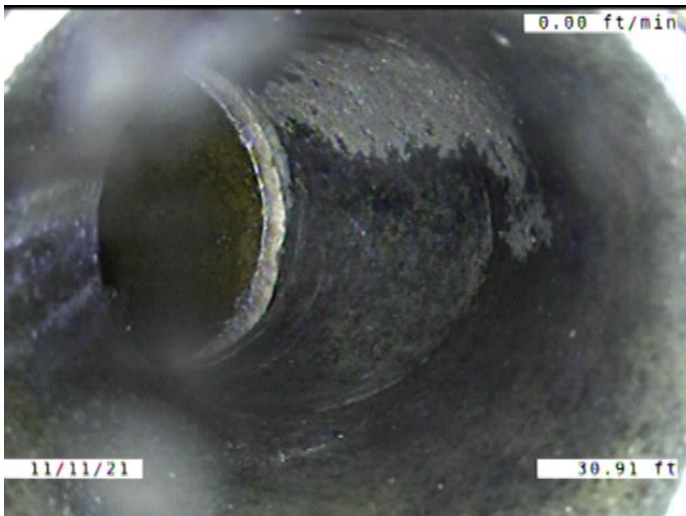
Code: **TB**  
Description: **Tap Break-in/Hammer**

Distance (ft): **30.9**  
Structural Grade: **0**  
O&M Grade: **0**  
Clock Start/From: **10**  
Clock To:  
1st Value: **4.000**  
2nd Value:  
Value Percent:  
Continuous Index:  
Within 8" of Joint: **YES**  
Remarks:

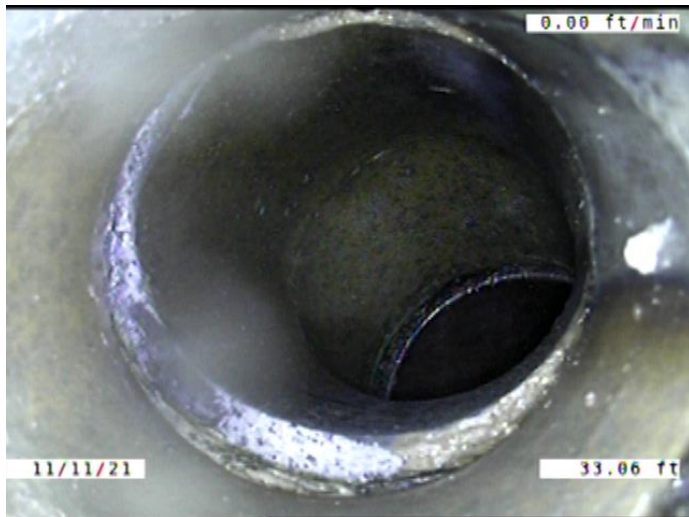
Code: **TF**  
 Description: **Tap Factory**

Distance (ft): **33.1**  
 Structural Grade: **0**  
 O&M Grade: **0**  
 Clock Start/From: **2**  
 Clock To:  
 1st Value: **4.000**  
 2nd Value:  
 Value Percent:  
 Continuous Index:  
 Within 8" of Joint: **YES**  
 Remarks: **BROKEN. OFFSET**

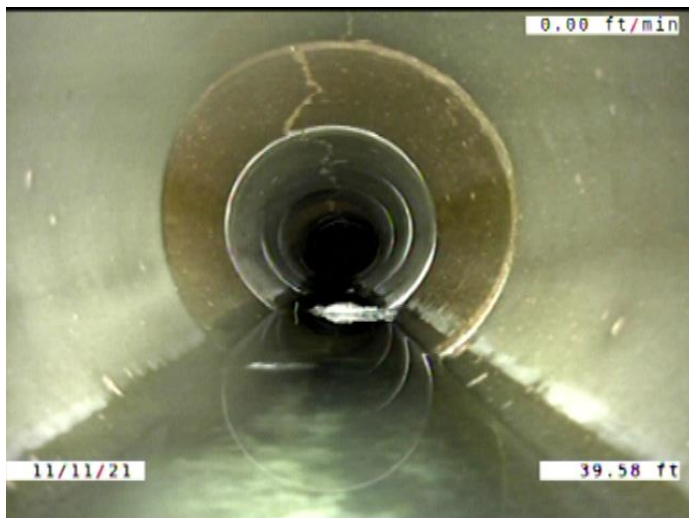
Code: **DSF**  
 Description: **Deposits Settled Fine**

Distance (ft): **39.6**  
 Structural Grade: **0**  
 O&M Grade: **2**  
 Clock Start/From: **5**  
 Clock To: **7**  
 1st Value:  
 2nd Value:  
 Value Percent: **5.000**  
 Continuous Index: **S02**  
 Within 8" of Joint: **YES**  
 Remarks:

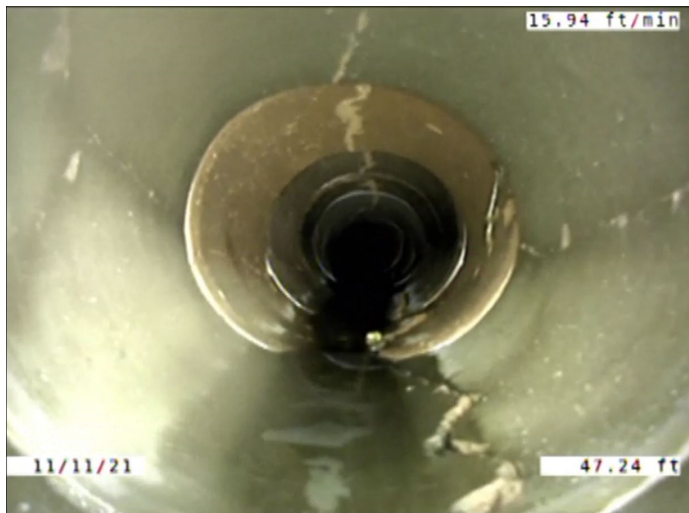
Code: **B**  
 Description: **Broken**

Distance (ft): **47.2**  
 Structural Grade: **4**  
 O&M Grade: **0**  
 Clock Start/From: **5**  
 Clock To:  
 1st Value:  
 2nd Value:  
 Value Percent:  
 Continuous Index:  
 Within 8" of Joint: **YES**  
 Remarks:

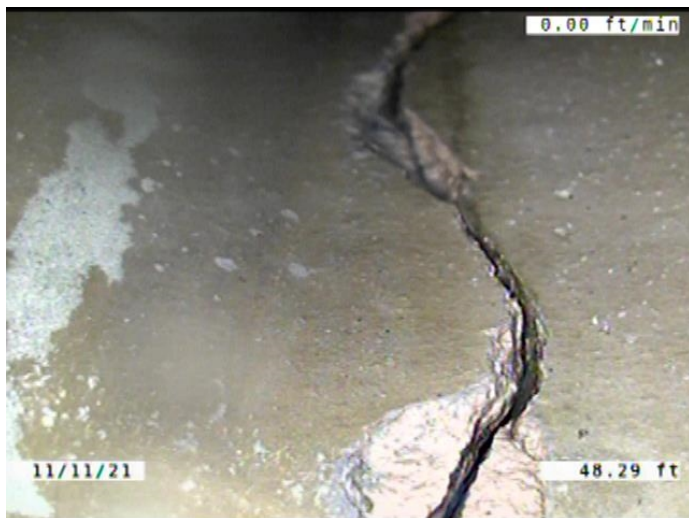
Code: **DR**  
 Description: **Deformed Rigid**

Distance (ft): **48.3**  
 Structural Grade: **4**  
 O&M Grade: **0**  
 Clock Start/From:  
 Clock To:  
 1st Value:  
 2nd Value:  
 Value Percent: **5.000**  
 Continuous Index: **S03**  
 Within 8" of Joint: **NO**  
 Remarks:

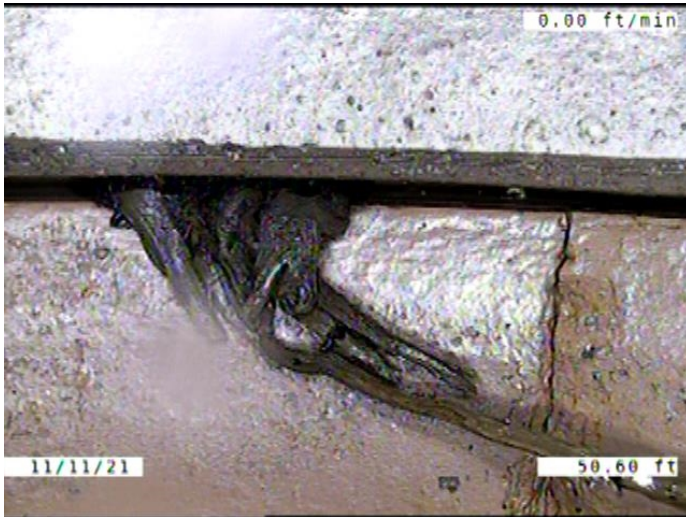
Code: **RFJ**  
Description: **Roots Fine Joint**

Distance (ft): **50.6**  
Structural Grade: **0**  
O&M Grade: **1**  
Clock Start/From: **2**  
Clock To:  
1st Value:  
2nd Value:  
Value Percent:  
Continuous Index:  
Within 8" of Joint: **YES**  
Remarks:

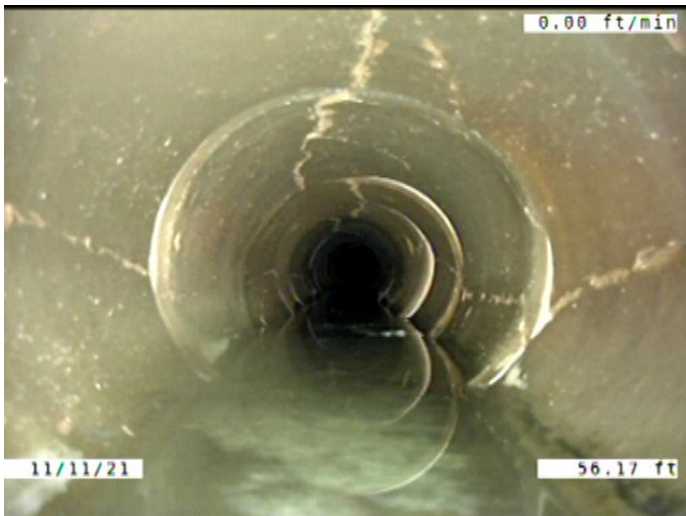
Code: **MWLS**  
Description: **Miscellaneous Water Level Sag**

Distance (ft): **56.2**  
Structural Grade: **2**  
O&M Grade: **0**  
Clock Start/From:  
Clock To:  
1st Value:  
2nd Value:  
Value Percent: **10.000**  
Continuous Index: **S04**  
Within 8" of Joint: **NO**  
Remarks:

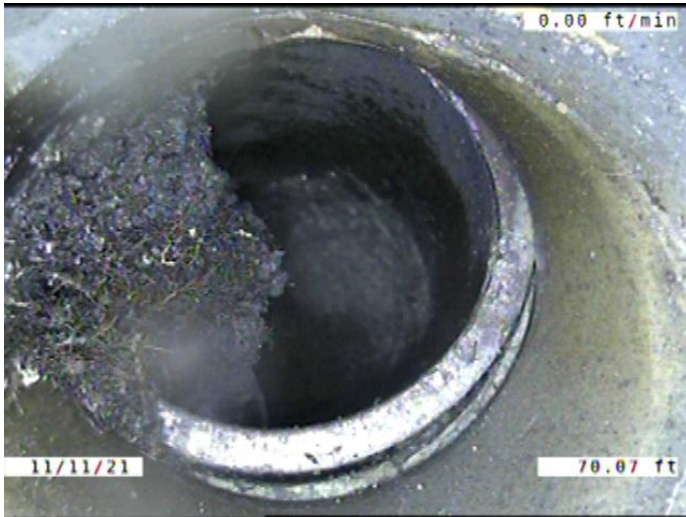
Code:	<b>TFD</b>
Description:	<b>Tap Factory Defective</b>
Distance (ft):	<b>70.1</b>
Structural Grade:	<b>0</b>
O&M Grade:	<b>3</b>
Clock Start/From:	<b>10</b>
Clock To:	
1st Value:	<b>4.000</b>
2nd Value:	
Value Percent:	
Continuous Index:	
Within 8" of Joint:	<b>YES</b>
Remarks:	<b>BROKEN. OFFSET. ROOTS GROWING IN THE TAP</b>

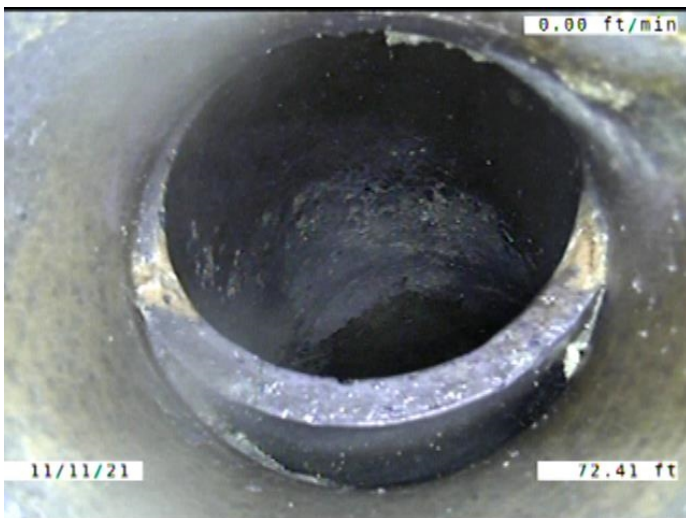
Code:	<b>TF</b>
Description:	<b>Tap Factory</b>
Distance (ft):	<b>72.4</b>
Structural Grade:	<b>0</b>
O&M Grade:	<b>0</b>
Clock Start/From:	<b>2</b>
Clock To:	
1st Value:	<b>4.000</b>
2nd Value:	
Value Percent:	
Continuous Index:	
Within 8" of Joint:	<b>YES</b>
Remarks:	<b>OFFSET.</b>

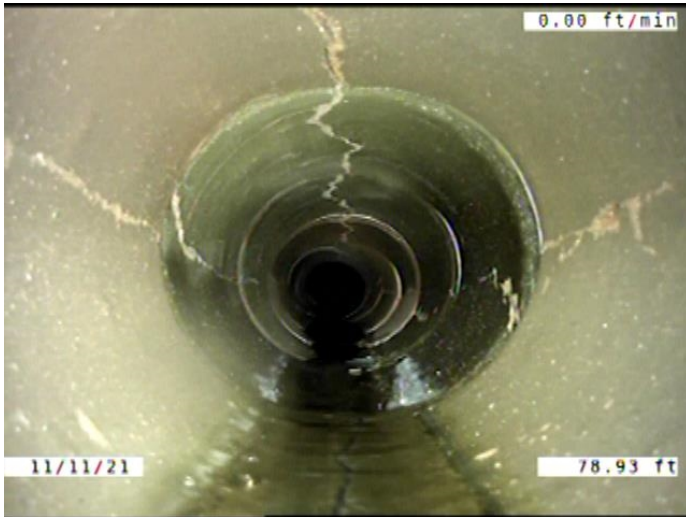
Code: **MWLS**  
Description: **Miscellaneous Water Level Sag**

Distance (ft): **78.9**  
Structural Grade: **2**  
O&M Grade: **0**  
Clock Start/From:  
Clock To:  
1st Value:  
2nd Value:  
Value Percent: **10.000**  
Continuous Index: **F04**  
Within 8" of Joint: **NO**  
Remarks:

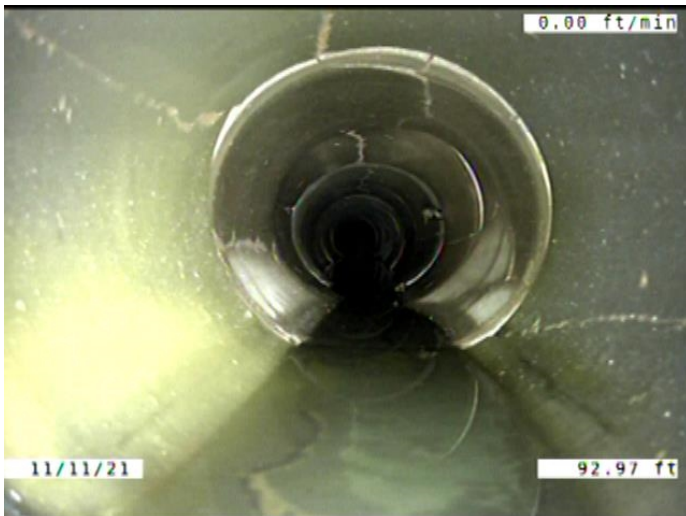
Code: **MWLS**  
Description: **Miscellaneous Water Level Sag**

Distance (ft): **93.0**  
Structural Grade: **2**  
O&M Grade: **0**  
Clock Start/From:  
Clock To:  
1st Value:  
2nd Value:  
Value Percent: **10.000**  
Continuous Index: **S06**  
Within 8" of Joint: **NO**  
Remarks:

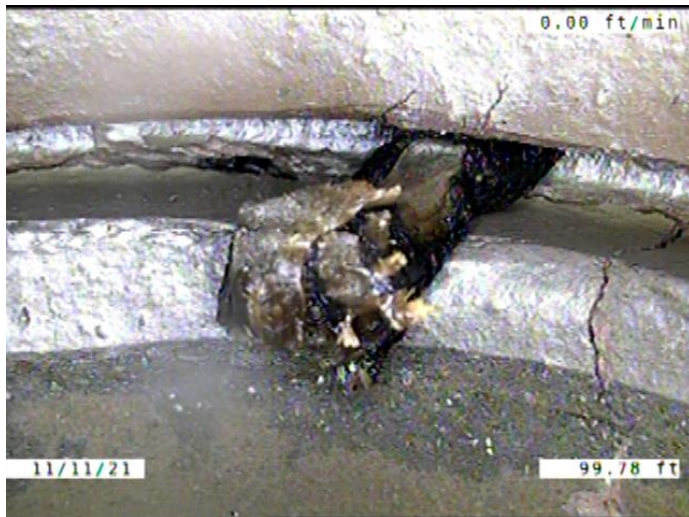
Code: **RTJ**  
 Description: **Roots Tap Joint**

Distance (ft): **99.8**  
 Structural Grade: **0**  
 O&M Grade: **2**  
 Clock Start/From: **2**  
 Clock To:  
 1st Value:  
 2nd Value:  
 Value Percent: **5.000**  
 Continuous Index:  
 Within 8" of Joint: **YES**  
 Remarks:

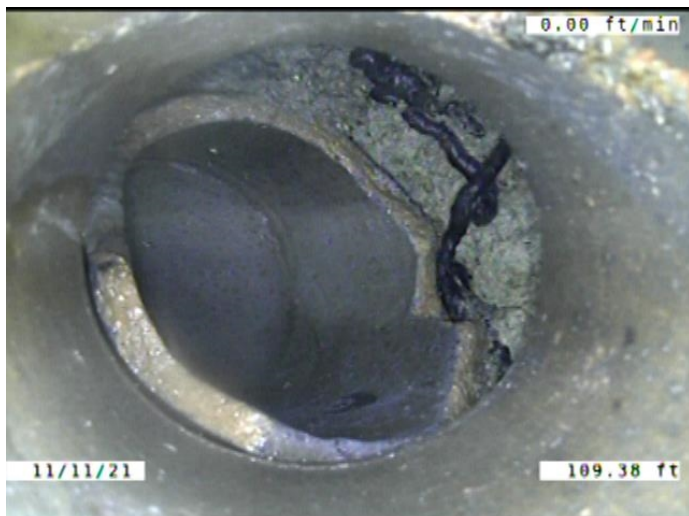
Code: **TFD**  
 Description: **Tap Factory Defective**

Distance (ft): **109.4**  
 Structural Grade: **0**  
 O&M Grade: **3**  
 Clock Start/From: **11**  
 Clock To:  
 1st Value: **4.000**  
 2nd Value:  
 Value Percent:  
 Continuous Index:  
 Within 8" of Joint: **YES**  
 Remarks: **OFFSET. SOIL VISIBLE. ROOTS GROWING AROUND THE OFFSET**

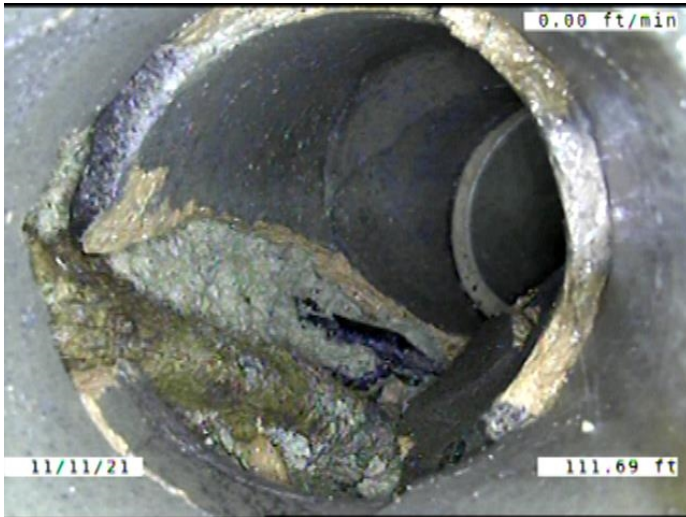
Code:	<b>TFD</b>
Description:	<b>Tap Factory Defective</b>
Distance (ft):	<b>111.7</b>
Structural Grade:	<b>0</b>
O&M Grade:	<b>3</b>
Clock Start/From:	<b>2</b>
Clock To:	
1st Value:	<b>4.000</b>
2nd Value:	
Value Percent:	
Continuous Index:	
Within 8" of Joint:	<b>YES</b>
Remarks:	<b>BROKEN. TAP PIPE WALL MISSING. SOIL VISIBLE. ROOTS GROWING IN T</b>

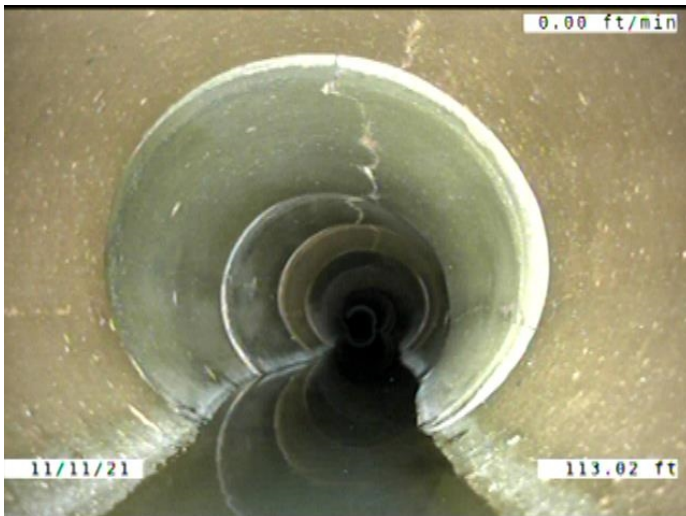
Code:	<b>DR</b>
Description:	<b>Deformed Rigid</b>
Distance (ft):	<b>113.0</b>
Structural Grade:	<b>4</b>
O&M Grade:	<b>0</b>
Clock Start/From:	
Clock To:	
1st Value:	
2nd Value:	
Value Percent:	<b>5.000</b>
Continuous Index:	<b>F03</b>
Within 8" of Joint:	<b>NO</b>
Remarks:

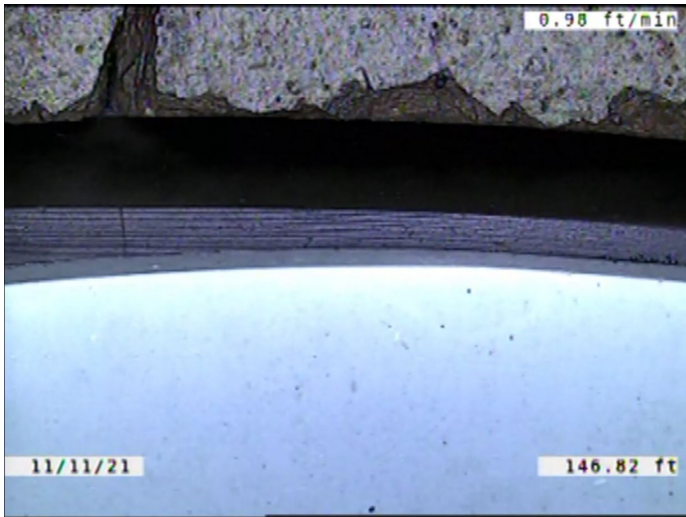
Code: **FM**  
Description: **Fracture Multiple**

Distance (ft): **146.8**  
Structural Grade: **4**  
O&M Grade: **0**  
Clock Start/From: **12**  
Clock To: **12**  
1st Value:  
2nd Value:  
Value Percent:  
Continuous Index: **F01**  
Within 8" of Joint: **YES**  
Remarks: **Wandering**

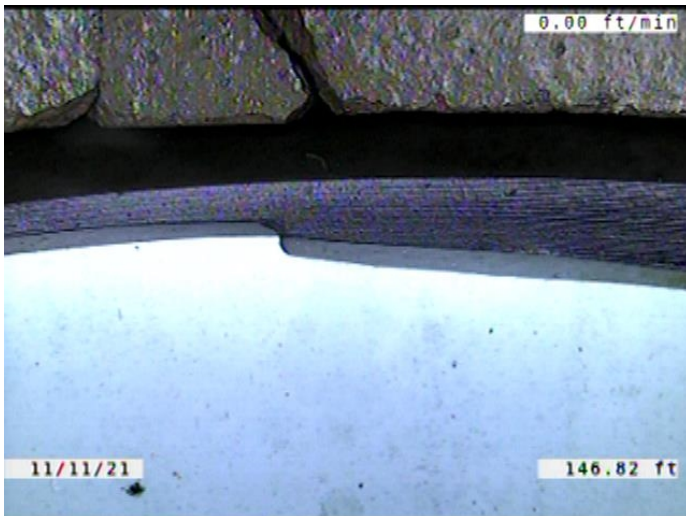
Code: **MMC**  
Description: **Miscellaneous Material Change**

Distance (ft): **146.8**  
Structural Grade: **0**  
O&M Grade: **0**  
Clock Start/From:  
Clock To:  
1st Value:  
2nd Value:  
Value Percent:  
Continuous Index:  
Within 8" of Joint: **NO**  
Remarks: **VCP TO PVC**

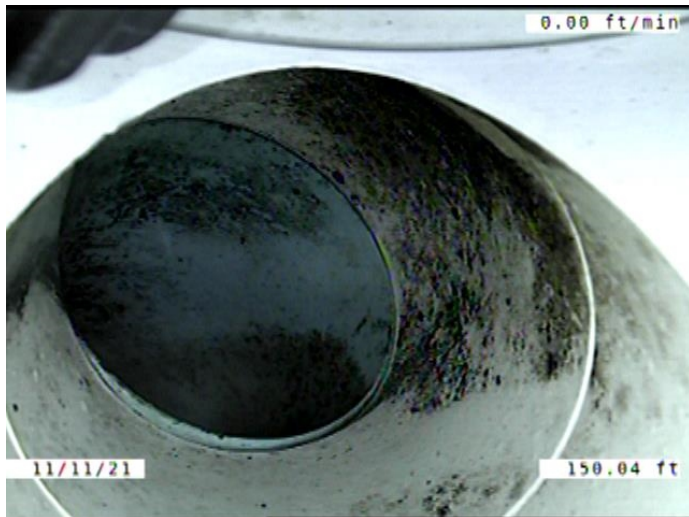
Code: **TF**  
 Description: **Tap Factory**

Distance (ft): **150.0**  
 Structural Grade: **0**  
 O&M Grade: **0**  
 Clock Start/From: **10**  
 Clock To:  
 1st Value: **4.000**  
 2nd Value:  
 Value Percent:  
 Continuous Index:  
 Within 8" of Joint: **YES**  
 Remarks:

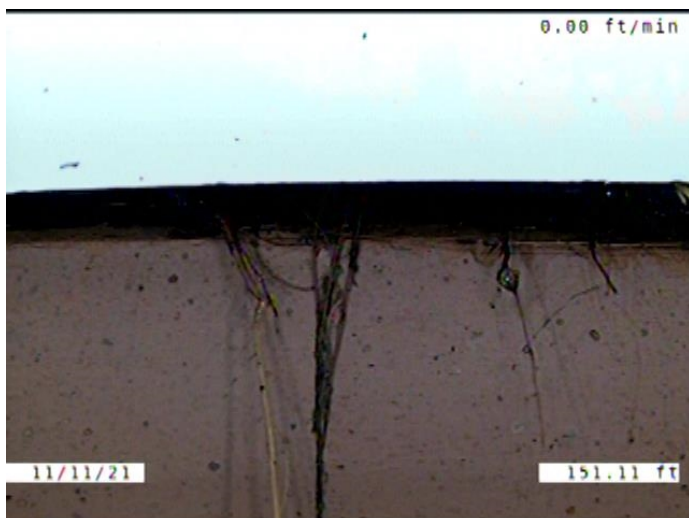
Code: **MMC**  
 Description: **Miscellaneous Material Change**

Distance (ft): **151.1**  
 Structural Grade: **0**  
 O&M Grade: **0**  
 Clock Start/From:  
 Clock To:  
 1st Value:  
 2nd Value:  
 Value Percent:  
 Continuous Index:  
 Within 8" of Joint: **NO**  
 Remarks: **PVC TO VCP**

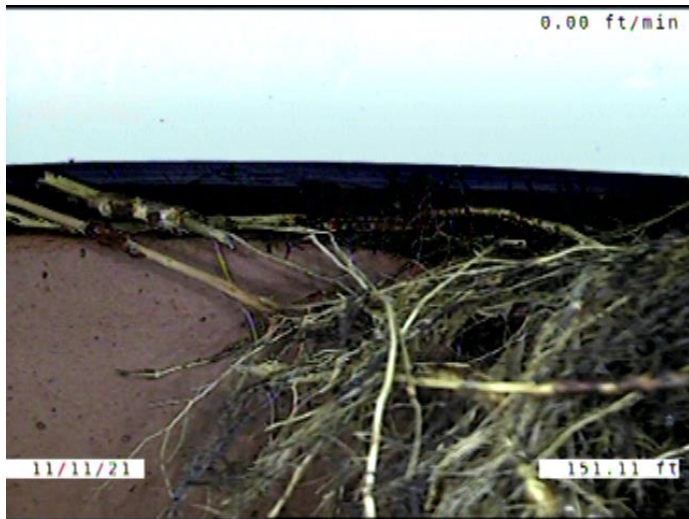
Code: **RMJ**  
Description: **Roots Medium Joint**

Distance (ft): **151.1**  
Structural Grade: **0**  
O&M Grade: **3**  
Clock Start/From: **8**  
Clock To: **4**  
1st Value:  
2nd Value:  
Value Percent: **5.000**  
Continuous Index: **S07**  
Within 8" of Joint: **YES**  
Remarks:

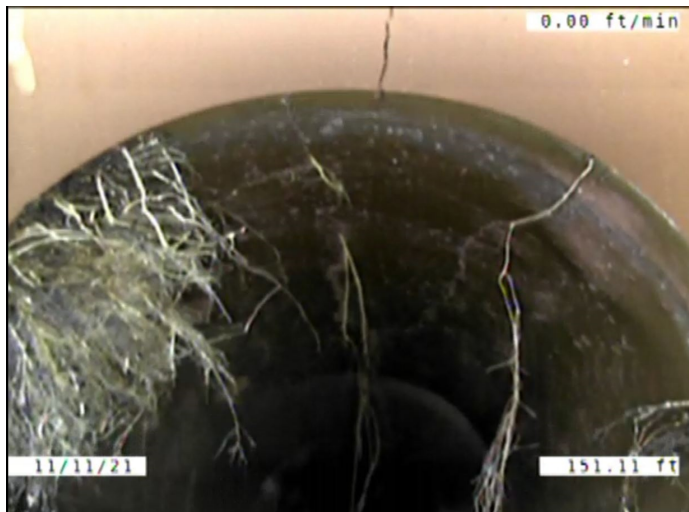
Code: **FM**  
Description: **Fracture Multiple**

Distance (ft): **151.1**  
Structural Grade: **4**  
O&M Grade: **0**  
Clock Start/From: **8**  
Clock To: **4**  
1st Value:  
2nd Value:  
Value Percent:  
Continuous Index: **S08**  
Within 8" of Joint: **YES**  
Remarks:

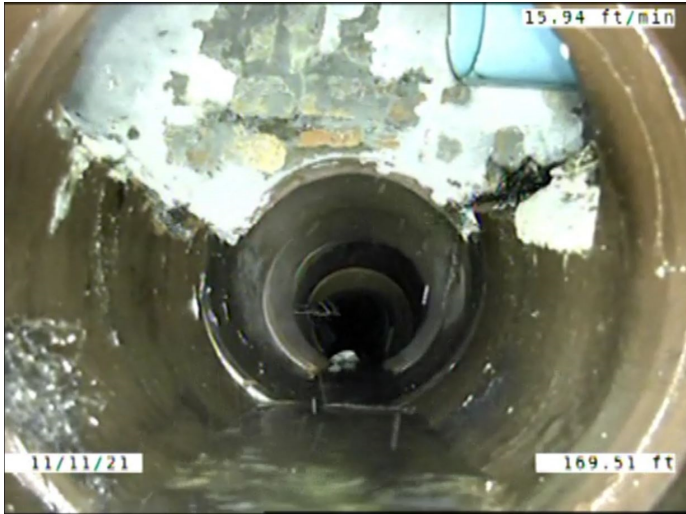
Code: **FM**  
Description: **Fracture Multiple**

Distance (ft): **169.5**  
Structural Grade: **4**  
O&M Grade: **0**  
Clock Start/From: **8**  
Clock To: **4**  
1st Value:  
2nd Value:  
Value Percent:  
Continuous Index: **F08**  
Within 8" of Joint: **YES**  
Remarks:

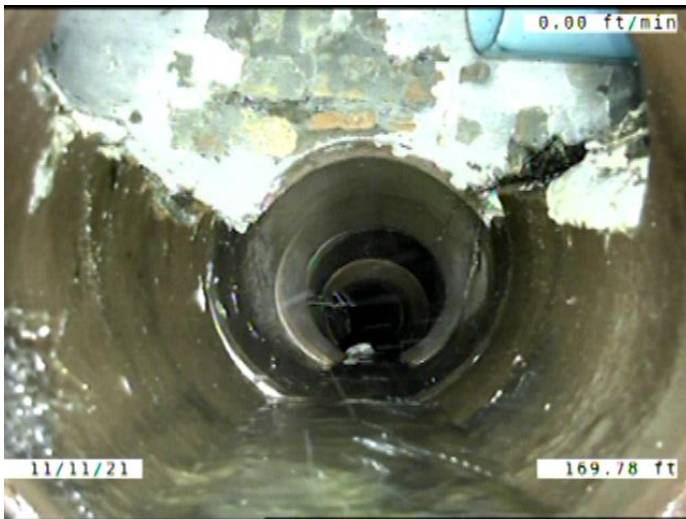
Code: **MWLS**  
Description: **Miscellaneous Water Level Sag**

Distance (ft): **169.8**  
Structural Grade: **2**  
O&M Grade: **0**  
Clock Start/From:  
Clock To:  
1st Value:  
2nd Value:  
Value Percent: **10.000**  
Continuous Index: **F06**  
Within 8" of Joint: **NO**  
Remarks:

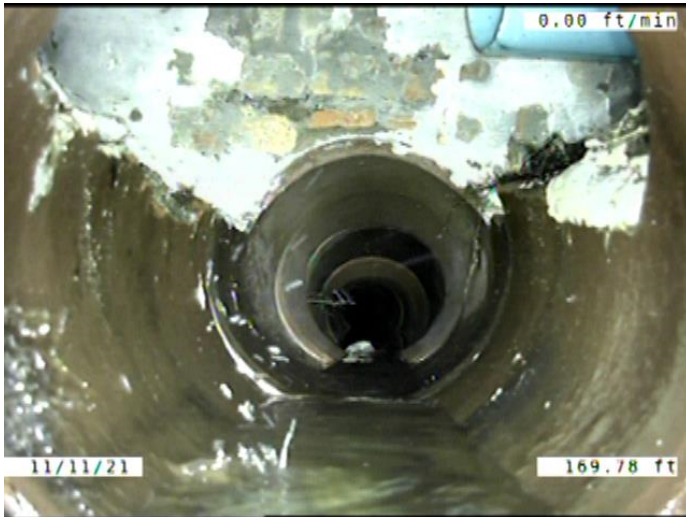
Code: **RMJ**  
 Description: **Roots Medium Joint**

Distance (ft): **169.8**  
 Structural Grade: **0**  
 O&M Grade: **3**  
 Clock Start/From: **8**  
 Clock To: **4**  
 1st Value:  
 2nd Value:  
 Value Percent: **5.000**  
 Continuous Index: **F07**  
 Within 8" of Joint: **YES**  
 Remarks:

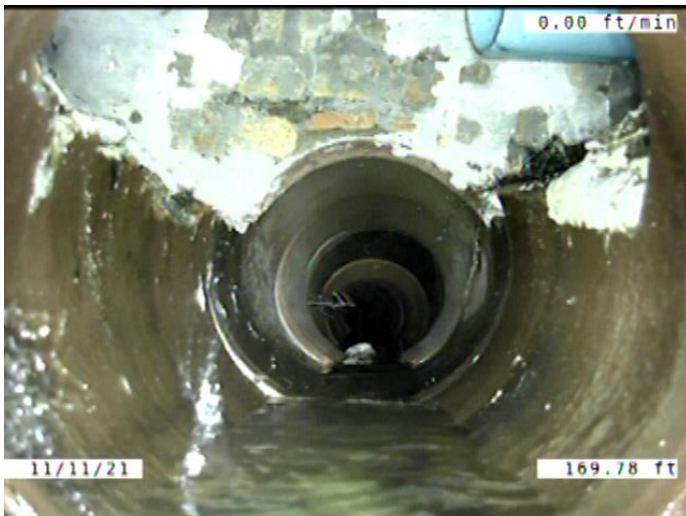
Code: **DSF**  
 Description: **Deposits Settled Fine**

Distance (ft): **169.8**  
 Structural Grade: **0**  
 O&M Grade: **2**  
 Clock Start/From: **5**  
 Clock To: **7**  
 1st Value:  
 2nd Value:  
 Value Percent: **5.000**  
 Continuous Index: **F02**  
 Within 8" of Joint: **YES**  
 Remarks:

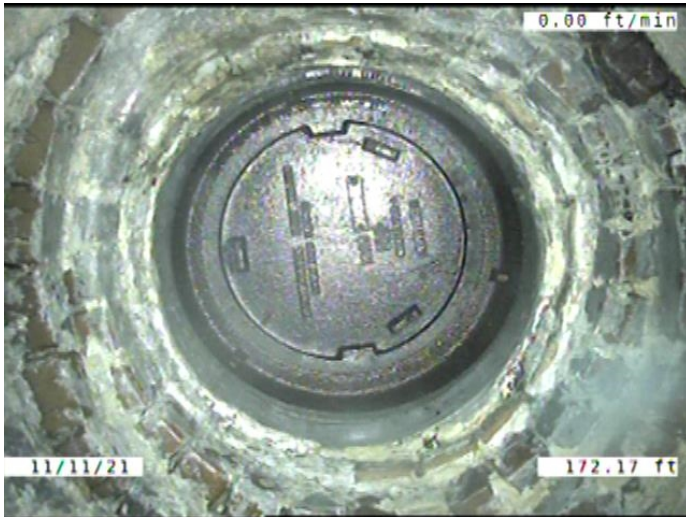
Code:	<b>AMH</b>
Description:	<b>Manhole</b>
Distance (ft):	<b>172.2</b>
Structural Grade:	<b>0</b>
O&M Grade:	<b>0</b>
Clock Start/From:	
Clock To:	
1st Value:	
2nd Value:	
Value Percent:	
Continuous Index:	
Within 8" of Joint:	<b>NO</b>
Remarks:	<b>M-605-029</b>
