## **Profile/Photo Observation Report**

Profile/Photo Observation Report								
Date: Pipe Length (ft P.O.#: Customer:	04/16/2018 ): 59-1 City of Hobart	Weather: Owner: Surveyor: Clean Date:	City of Ho M. Pielac		Pre Clean:	PACP 6.0 No Pre-Cleaning M-605-031-M-605-032		
Street:	Connecticut Street		Flow Contr	ol:	Not Controlled			
City:	Hobart, IN		Year Renev	wed:				
Location:	Light Highway		Tape/Med	ia #:	DEP 59			
Purpose:	<b>Routine Assessment</b>		Dia/Height	::	18"			
Use:	Sanitary		Material:		VCP			
Drain Area:			Lining:					
Category:	NA							
Comment:								
Location Detail	ls:		Direction o	of Survey:	Downstream			
US MH:	M-605-031	DS MH:	M-605-032		Total Length Surveyed (ft):	234.5		
O&M Index:	0.00	O&M Quick:		0000	O&M Rating:	0.00		
Structural Index:	2.62	– Structural Qı	uick:	4137	Structural Rating:	34.00		
Overall Index:	2.62	— Overall Quicl	k:	4137	Overall Rating:	34.00

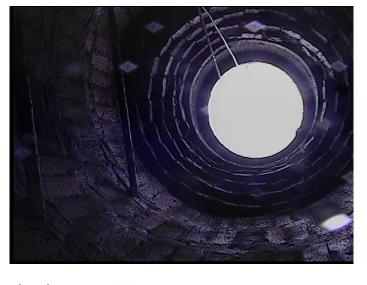
Code:	АМН
Description:	Manhole
Distance (ft):	.0
Structural Grade:	0
O&M Grade:	0
Clock Start/From:	
Clock To:	
1st Value:	
2nd Value:	
Value Percent:	
Continuous Index:	
Within 8" of Joint:	NO
Remarks:	M-605-031

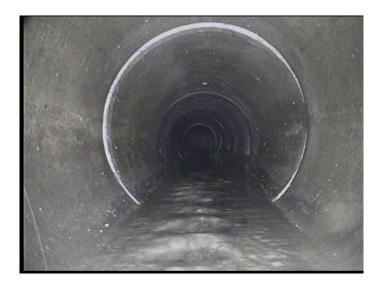
Code: MWL

Description: **Water Level**

Distance (ft): .0 Structural Grade: 0 O&M Grade: 0

Value Percent: 10.000

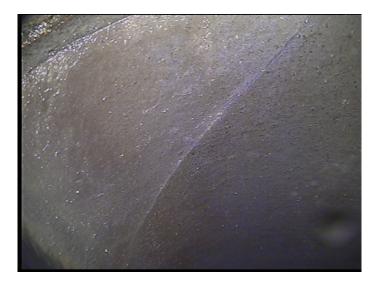
Code: CC

**Crack Circumferential** Description:

Distance (ft): 24.6 Structural Grade: 1 O&M Grade: 0 Clock Start/From: 7 Clock To: 10 1st Value:

Within 8" of Joint: YES

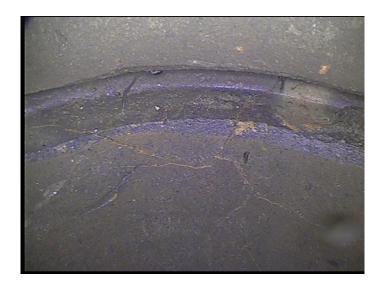
Code: CM

Description: Crack Multiple

Distance (ft): 51.3
Structural Grade: 3
O&M Grade: 0
Clock Start/From: 11
Clock To: 1

Within 8" of Joint: YES

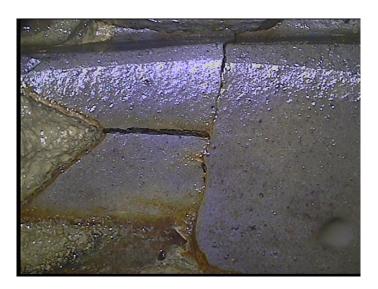
Code: FM

Description: Fracture Multiple

Distance (ft): 64.1
Structural Grade: 4

Clock Start/From: 9

Clock To: 10

Within 8" of Joint: YES

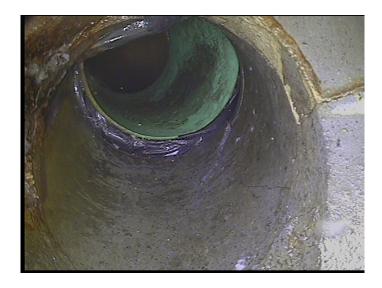
Code: TF

Description: **Tap Factory**

Distance (ft): 65.3 Structural Grade: 0 O&M Grade: 0 Clock Start/From: 10

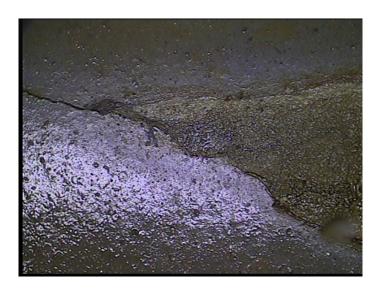
Code: CM

Description: **Crack Multiple**

Distance (ft): 65.3 Structural Grade: 3 O&M Grade: 0 Clock Start/From: 10 3 Clock To: 1st Value: 2nd Value:

YES

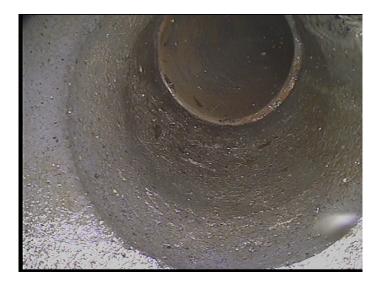
Code: **TF**

Description: Tap Factory

Distance (ft): 68.6
Structural Grade: 0

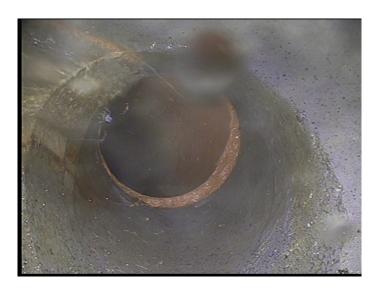
Code: **TF**

Description: Tap Factory

Distance (ft): 105.3
Structural Grade: 0
O&M Grade: 0
Clock Start/From: 10

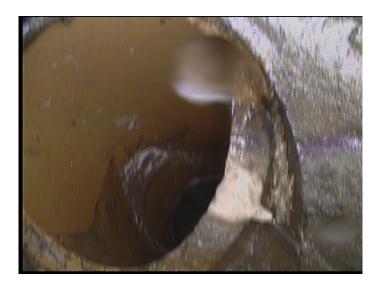
Code: TBA

Description: Tap Break-in Active

Distance (ft): 107.5
Structural Grade: 0
O&M Grade: 0
Clock Start/From: 2

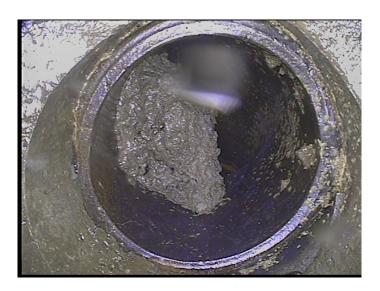
Code: **TF**

Description: Tap Factory

Distance (ft): 143.8
Structural Grade: 0
O&M Grade: 0
Clock Start/From: 10

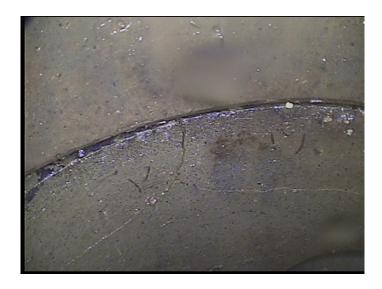
Code: CM

Description: Crack Multiple

Distance (ft): 145.5
Structural Grade: 3
O&M Grade: 0
Clock Start/From: 10
Clock To: 2

YES

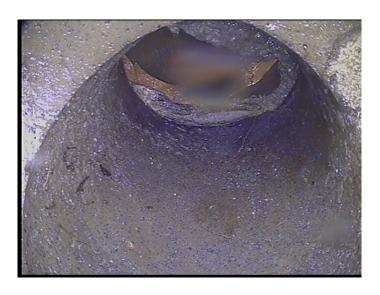
Code: **TF**

Description: Tap Factory

Distance (ft): 146.9
Structural Grade: 0
O&M Grade: 0
Clock Start/From: 2

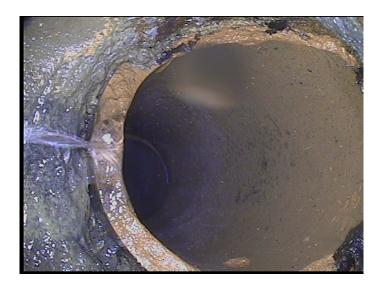
Code: TBA

Description: **Tap Break-in Active**

Distance (ft): 183.3 Structural Grade: 0 O&M Grade: 0 Clock Start/From: 10

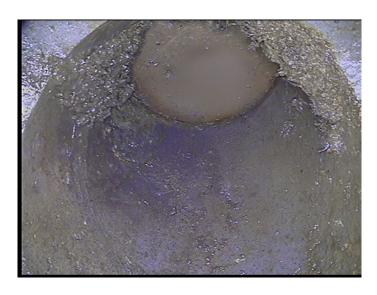
TFC Code:

Description: **Tap Factory Capped**

Distance (ft): 186.1 Structural Grade: 0 O&M Grade: 0 Clock Start/From: 10

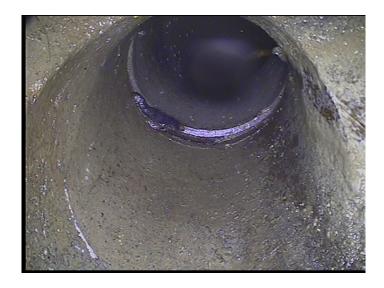
Code: **TF**

Description: Tap Factory

Distance (ft): 201.5
Structural Grade: 0
O&M Grade: 0
Clock Start/From: 2

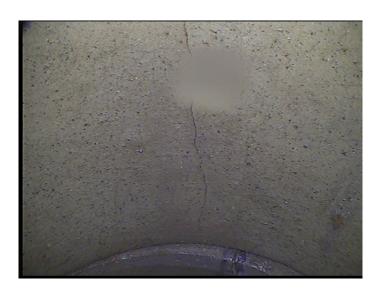
Code: CL

Description: Crack Longitudinal

Distance (ft): 202.1
Structural Grade: 2
O&M Grade: 0
Clock Start/From: 12

YES

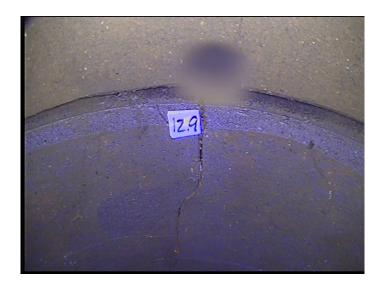
Code: FL

Description: Fracture Longitudinal

Distance (ft): 208.7
Structural Grade: 3
O&M Grade: 0
Clock Start/From: 12

Continuous Index: **S01**Within 8" of Joint: **YES**

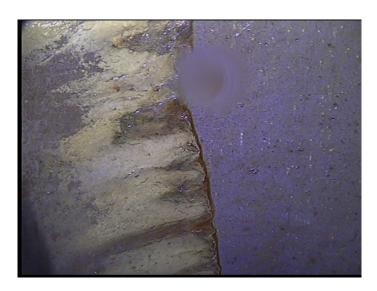
Code: CL

Description: Crack Longitudinal

Distance (ft): 215.4
Structural Grade: 2
O&M Grade: 0
Clock Start/From: 9

Continuous Index: **S02** Within 8" of Joint: **YES**

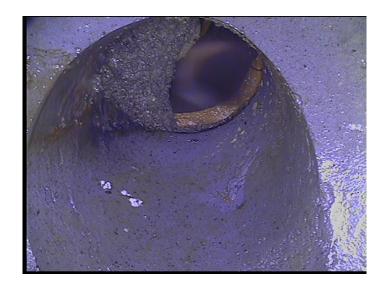
Code: TF

Description: **Tap Factory**

Distance (ft): 219.3 Structural Grade: 0 0 O&M Grade: Clock Start/From: 10

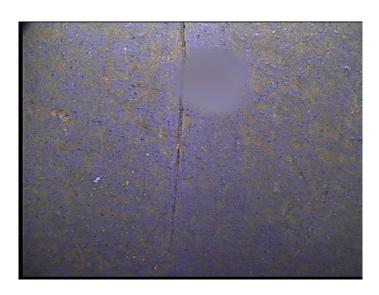
Code: FL

Description: **Fracture Longitudinal**

Distance (ft): 228.9 Structural Grade: 3 O&M Grade: 0 Clock Start/From: 12

Continuous Index: F01 Within 8" of Joint: NO

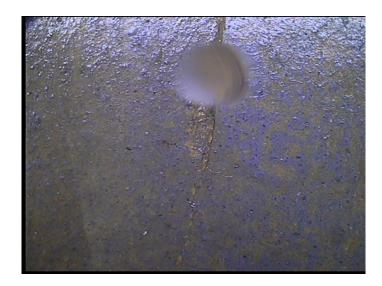
Code: CL

Description: Crack Longitudinal

Distance (ft): 228.9
Structural Grade: 2
O&M Grade: 0
Clock Start/From: 9

Continuous Index: F02
Within 8" of Joint: NO

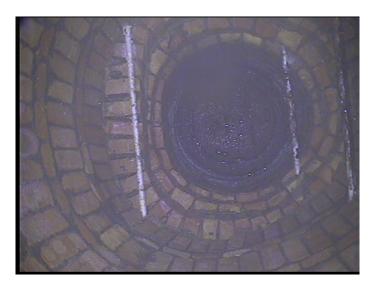
Code: AMH
Description: Manhole

Distance (ft): 234.5
Structural Grade: 0

Remarks: M-605-032
