Profile/Photo Observation Report

Date:	04/16/2018	Weather:		Coding:	PACP 6.0
Pipe Length (ft):		Owner:	City of Hobart	Pre Clean:	No Pre-Cleaning
P.O.#:	59-1	Surveyor:	M. Pielacha	PSR:	M-605-031-M-605-032
Customer:	City of Hobart	Clean Date:		Shape:	C

Street:	Connecticut Street	Flow Control:	Not Controlled
City:	Hobart, IN	Year Renewed:	
Location:	Light Highway	Tape/Media #:	DEP 59
Purpose:	Routine Assessment	Dia/Height:	18"
Use:	Sanitary	Material:	VCP
Drain Area:		Lining:	
Category:	NA		
Comment:			
Location Details:		Direction of Survey:	Downstream
US MH:	M-605-031	DS MH:	M-605-032
		Total Length Surveyed (ft):	234.5

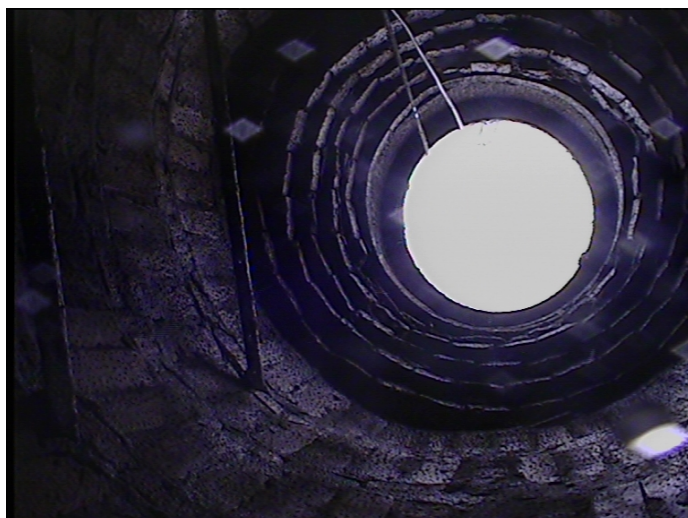
Code: **AMH**
 Description: **Manhole**

Distance (ft): **.0**
 Structural Grade: **0**
 O&M Grade: **0**
 Clock Start/From:
 Clock To:
 1st Value:
 2nd Value:
 Value Percent:
 Continuous Index:
 Within 8" of Joint: **NO**
 Remarks: **M-605-031**

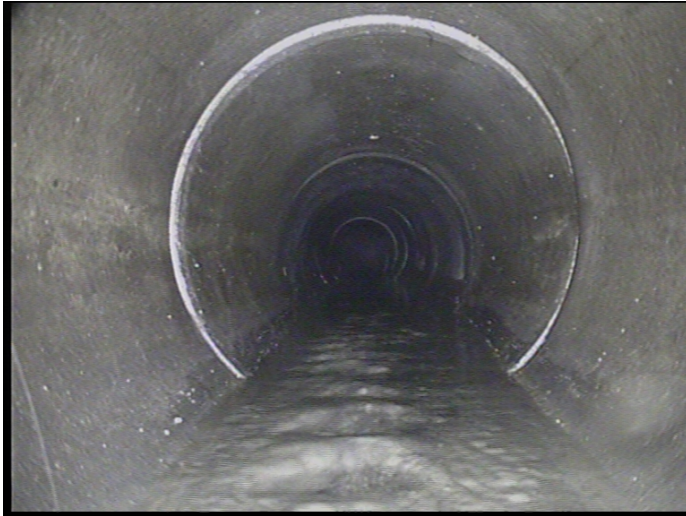
Code: **MWL**
Description: **Water Level**

Distance (ft): **.0**
Structural Grade: **0**
O&M Grade: **0**
Clock Start/From:
Clock To:
1st Value:
2nd Value:
Value Percent: **10.000**
Continuous Index:
Within 8" of Joint: **NO**
Remarks:

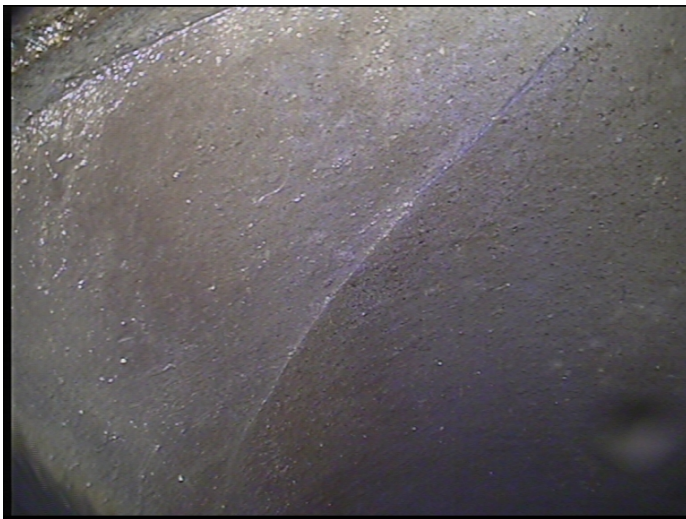
Code: **CC**
Description: **Crack Circumferential**

Distance (ft): **24.6**
Structural Grade: **1**
O&M Grade: **0**
Clock Start/From: **7**
Clock To: **10**
1st Value:
2nd Value:
Value Percent:
Continuous Index:
Within 8" of Joint: **YES**
Remarks:

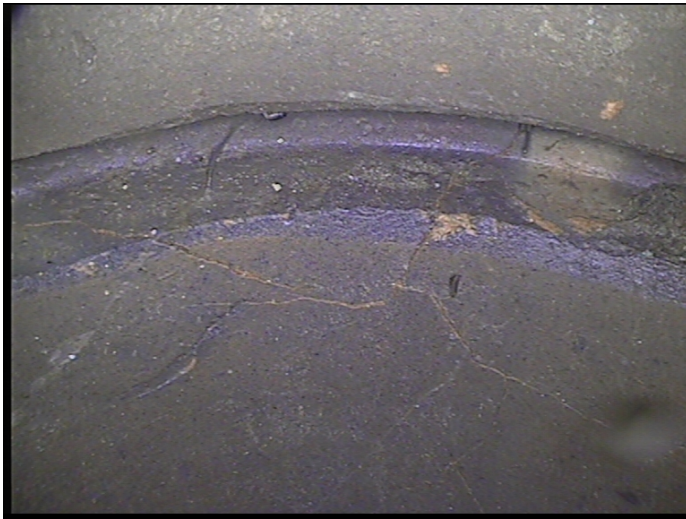
Code: **CM**
Description: **Crack Multiple**

Distance (ft): **51.3**
Structural Grade: **3**
O&M Grade: **0**
Clock Start/From: **11**
Clock To: **1**
1st Value:
2nd Value:
Value Percent:
Continuous Index:
Within 8" of Joint: **YES**
Remarks:

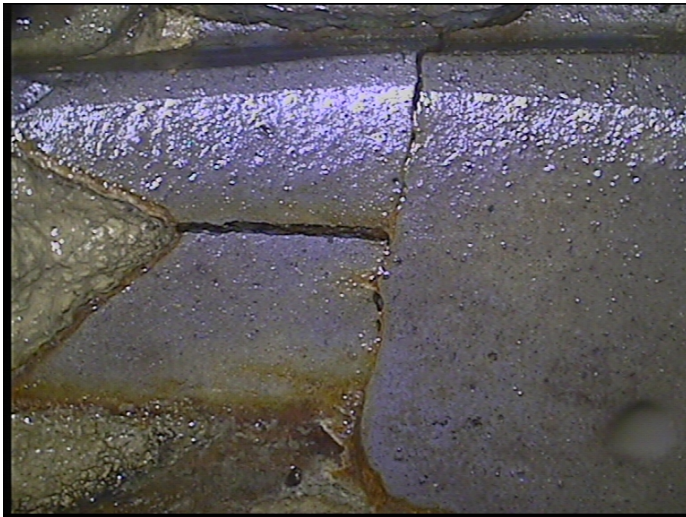
Code: **FM**
Description: **Fracture Multiple**

Distance (ft): **64.1**
Structural Grade: **4**
O&M Grade: **0**
Clock Start/From: **9**
Clock To: **10**
1st Value:
2nd Value:
Value Percent:
Continuous Index:
Within 8" of Joint: **YES**
Remarks:

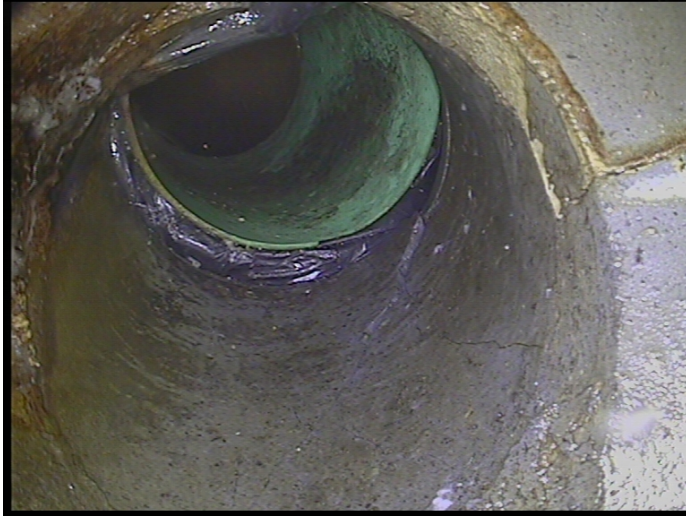
Code:	TF
Description:	Tap Factory
Distance (ft):	65.3
Structural Grade:	0
O&M Grade:	0
Clock Start/From:	10
Clock To:	
1st Value:	4.000
2nd Value:	
Value Percent:	
Continuous Index:	
Within 8" of Joint:	NO
Remarks:

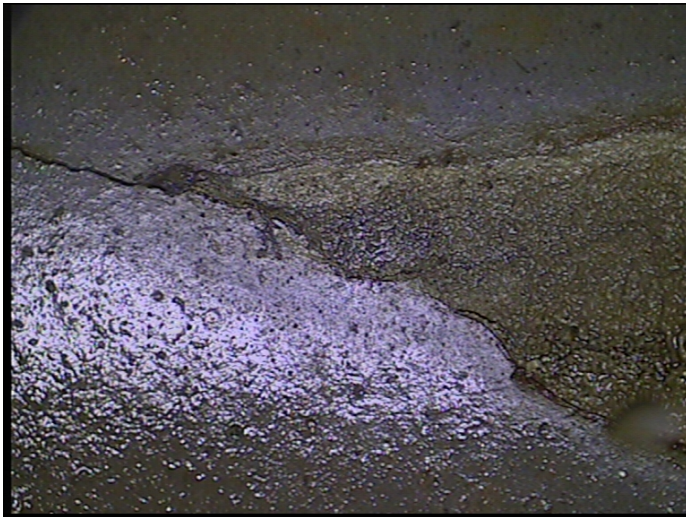
Code:	CM
Description:	Crack Multiple
Distance (ft):	65.3
Structural Grade:	3
O&M Grade:	0
Clock Start/From:	10
Clock To:	3
1st Value:	
2nd Value:	
Value Percent:	
Continuous Index:	
Within 8" of Joint:	YES
Remarks:

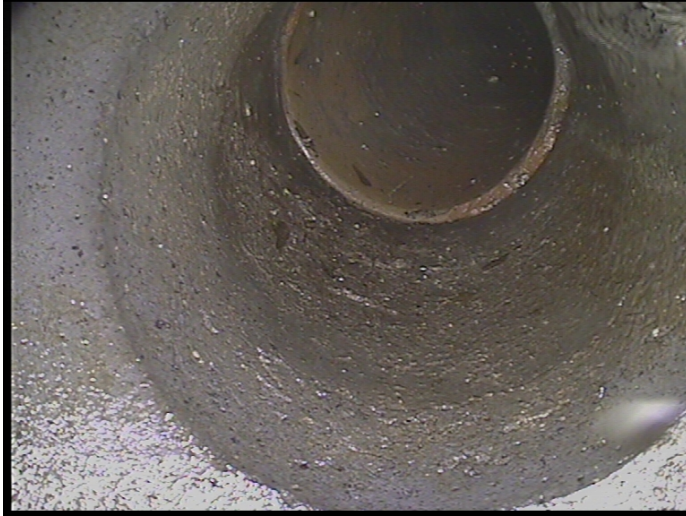
Code: **TF**
Description: **Tap Factory**

Distance (ft): **68.6**
Structural Grade: **0**
O&M Grade: **0**
Clock Start/From: **2**
Clock To:
1st Value: **4.000**
2nd Value:
Value Percent:
Continuous Index:
Within 8" of Joint: **NO**
Remarks:

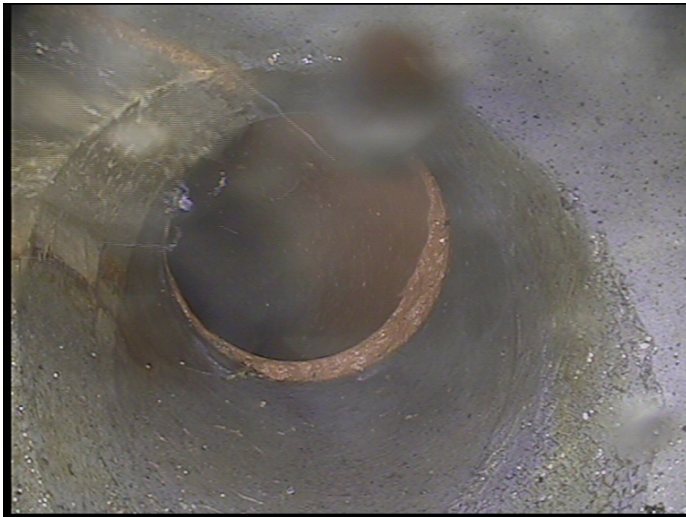
Code: **TF**
Description: **Tap Factory**

Distance (ft): **105.3**
Structural Grade: **0**
O&M Grade: **0**
Clock Start/From: **10**
Clock To:
1st Value: **4.000**
2nd Value:
Value Percent:
Continuous Index:
Within 8" of Joint: **NO**
Remarks:

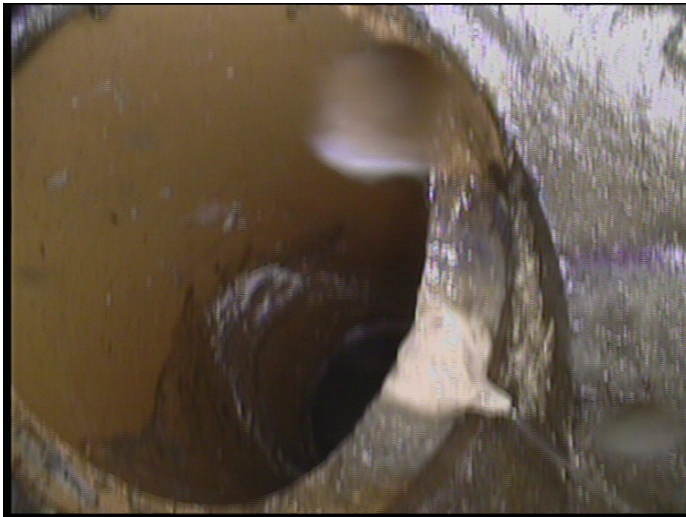
Code: **TBA**
Description: **Tap Break-in Active**

Distance (ft): **107.5**
Structural Grade: **0**
O&M Grade: **0**
Clock Start/From: **2**
Clock To:
1st Value: **4.000**
2nd Value:
Value Percent:
Continuous Index:
Within 8" of Joint: **NO**
Remarks:

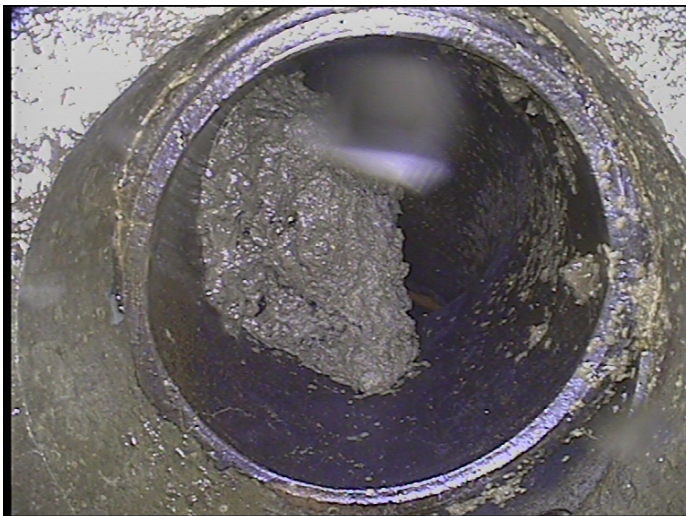
Code: **TF**
Description: **Tap Factory**

Distance (ft): **143.8**
Structural Grade: **0**
O&M Grade: **0**
Clock Start/From: **10**
Clock To:
1st Value: **4.000**
2nd Value:
Value Percent:
Continuous Index:
Within 8" of Joint: **NO**
Remarks:

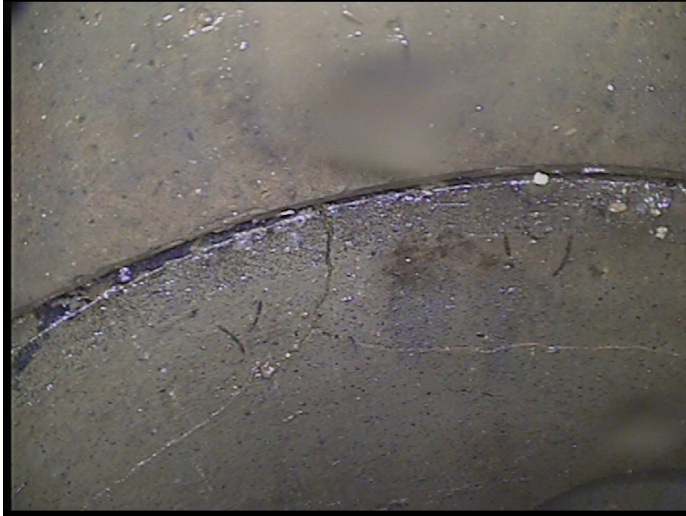
Code:	CM
Description:	Crack Multiple
Distance (ft):	145.5
Structural Grade:	3
O&M Grade:	0
Clock Start/From:	10
Clock To:	2
1st Value:	
2nd Value:	
Value Percent:	
Continuous Index:	
Within 8" of Joint:	YES
Remarks:

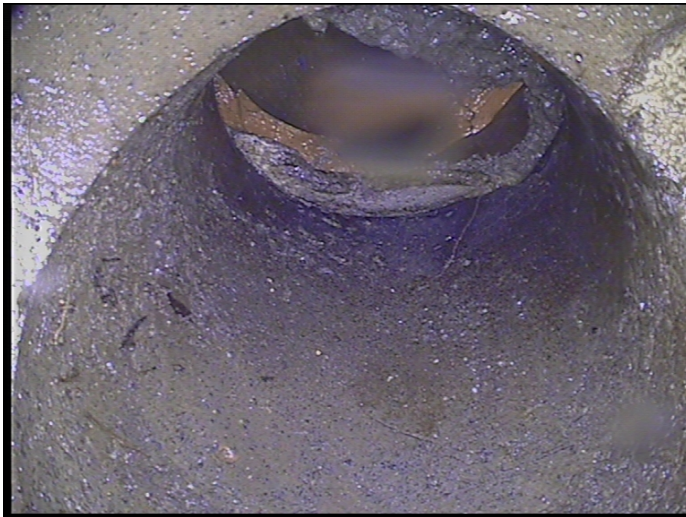
Code:	TF
Description:	Tap Factory
Distance (ft):	146.9
Structural Grade:	0
O&M Grade:	0
Clock Start/From:	2
Clock To:	
1st Value:	4.000
2nd Value:	
Value Percent:	
Continuous Index:	
Within 8" of Joint:	NO
Remarks:

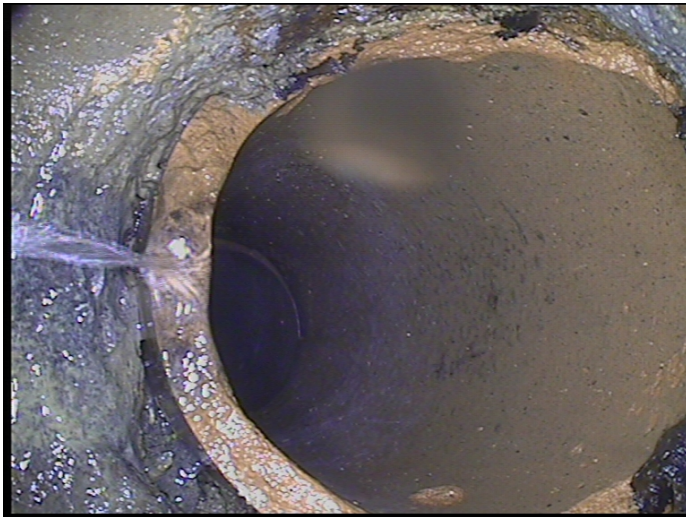
Code: **TBA**
Description: **Tap Break-in Active**

Distance (ft): **183.3**
Structural Grade: **0**
O&M Grade: **0**
Clock Start/From: **10**
Clock To:
1st Value: **5.000**
2nd Value:
Value Percent:
Continuous Index:
Within 8" of Joint: **NO**
Remarks:

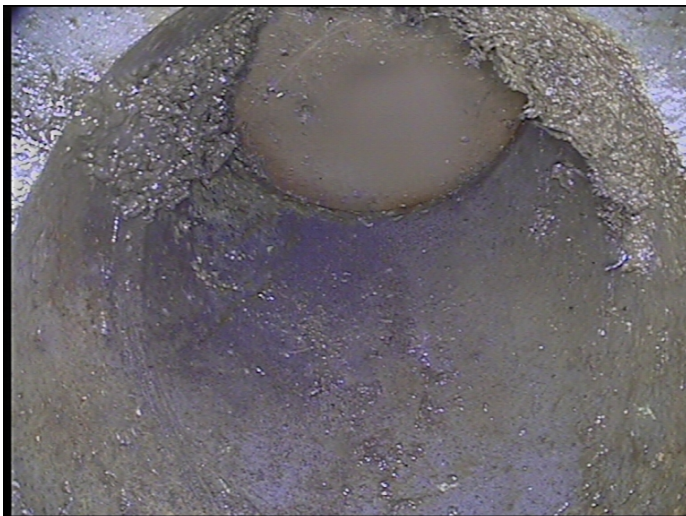
Code: **TFC**
Description: **Tap Factory Capped**

Distance (ft): **186.1**
Structural Grade: **0**
O&M Grade: **0**
Clock Start/From: **10**
Clock To:
1st Value: **4.000**
2nd Value:
Value Percent:
Continuous Index:
Within 8" of Joint: **NO**
Remarks:

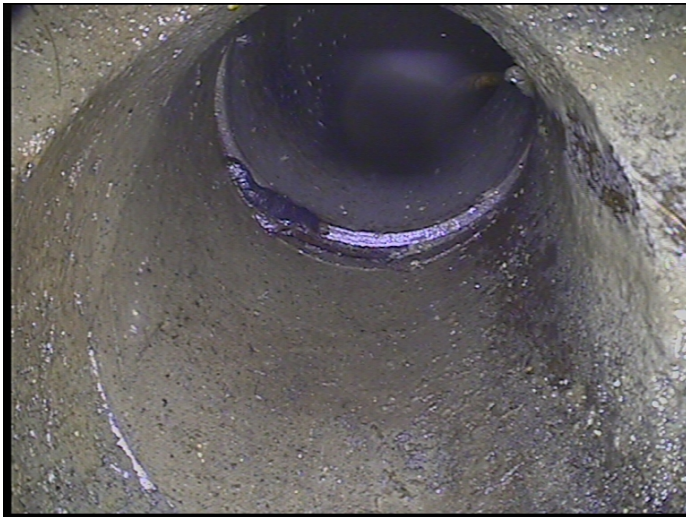
Code: **TF**
Description: **Tap Factory**

Distance (ft): **201.5**
Structural Grade: **0**
O&M Grade: **0**
Clock Start/From: **2**
Clock To:
1st Value: **4.000**
2nd Value:
Value Percent:
Continuous Index:
Within 8" of Joint: **NO**
Remarks:

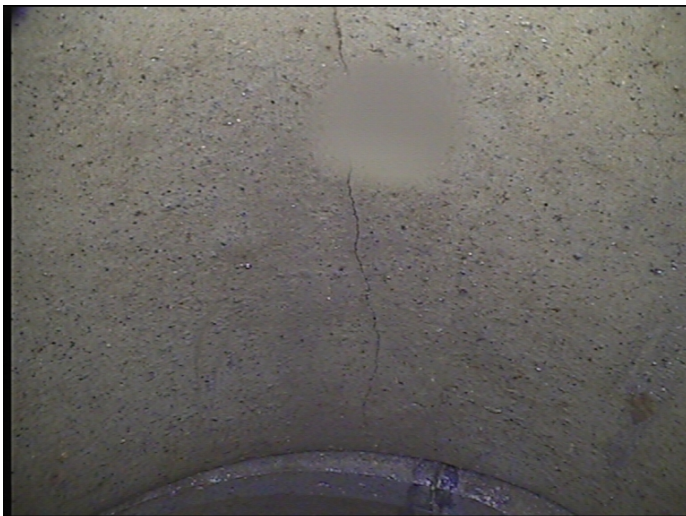
Code: **CL**
Description: **Crack Longitudinal**

Distance (ft): **202.1**
Structural Grade: **2**
O&M Grade: **0**
Clock Start/From: **12**
Clock To:
1st Value:
2nd Value:
Value Percent:
Continuous Index:
Within 8" of Joint: **YES**
Remarks:

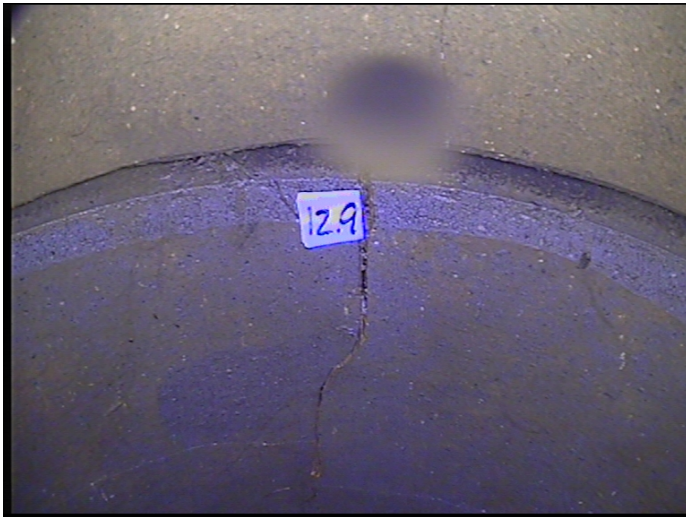
Code: **FL**
 Description: **Fracture Longitudinal**

Distance (ft): **208.7**
 Structural Grade: **3**
 O&M Grade: **0**
 Clock Start/From: **12**
 Clock To:
 1st Value: **4.000**
 2nd Value:
 Value Percent:
 Continuous Index: **S01**
 Within 8" of Joint: **YES**
 Remarks:

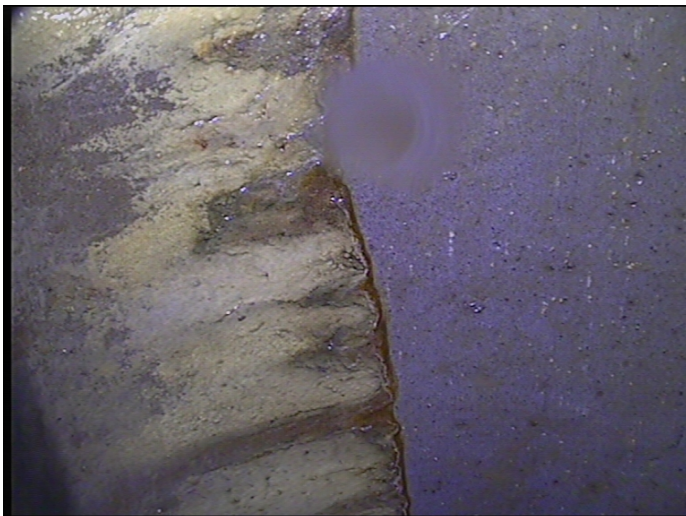
Code: **CL**
 Description: **Crack Longitudinal**

Distance (ft): **215.4**
 Structural Grade: **2**
 O&M Grade: **0**
 Clock Start/From: **9**
 Clock To:
 1st Value:
 2nd Value:
 Value Percent:
 Continuous Index: **S02**
 Within 8" of Joint: **YES**
 Remarks:

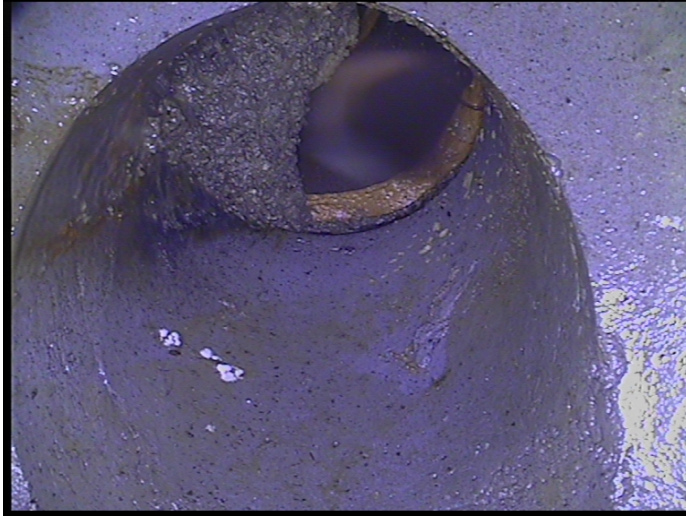
Code: **TF**
Description: **Tap Factory**

Distance (ft): **219.3**
Structural Grade: **0**
O&M Grade: **0**
Clock Start/From: **10**
Clock To:
1st Value: **4.000**
2nd Value:
Value Percent:
Continuous Index:
Within 8" of Joint: **NO**
Remarks:

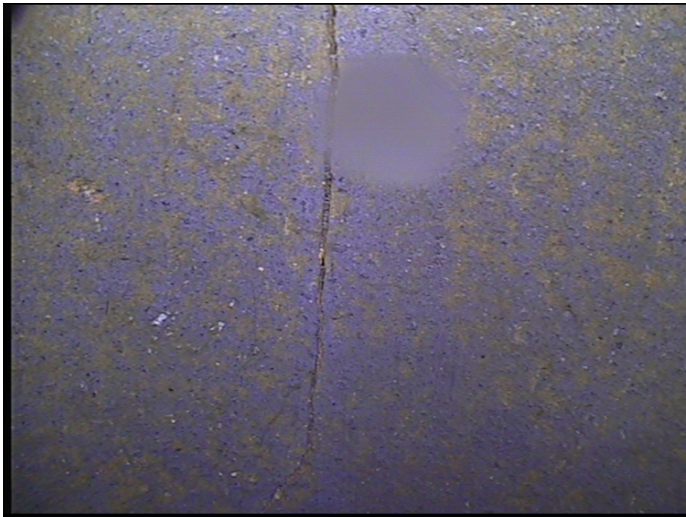
Code: **FL**
Description: **Fracture Longitudinal**

Distance (ft): **228.9**
Structural Grade: **3**
O&M Grade: **0**
Clock Start/From: **12**
Clock To:
1st Value: **4.000**
2nd Value:
Value Percent:
Continuous Index: **F01**
Within 8" of Joint: **NO**
Remarks:

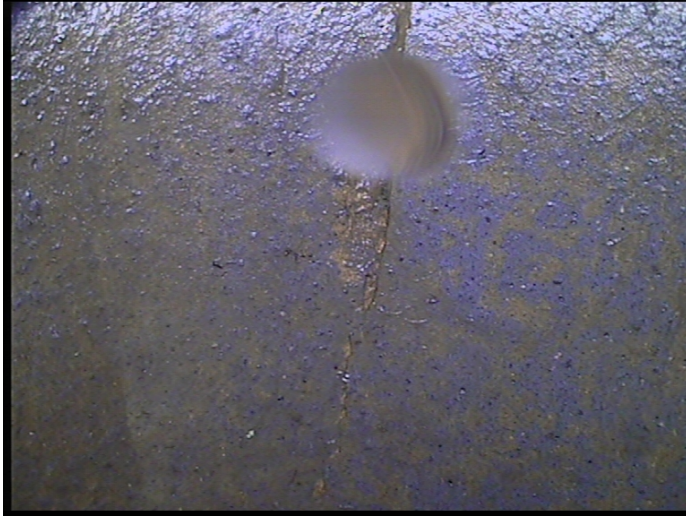
Code: **CL**
Description: **Crack Longitudinal**

Distance (ft): **228.9**
Structural Grade: **2**
O&M Grade: **0**
Clock Start/From: **9**
Clock To:
1st Value:
2nd Value:
Value Percent:
Continuous Index: **F02**
Within 8" of Joint: **NO**
Remarks:

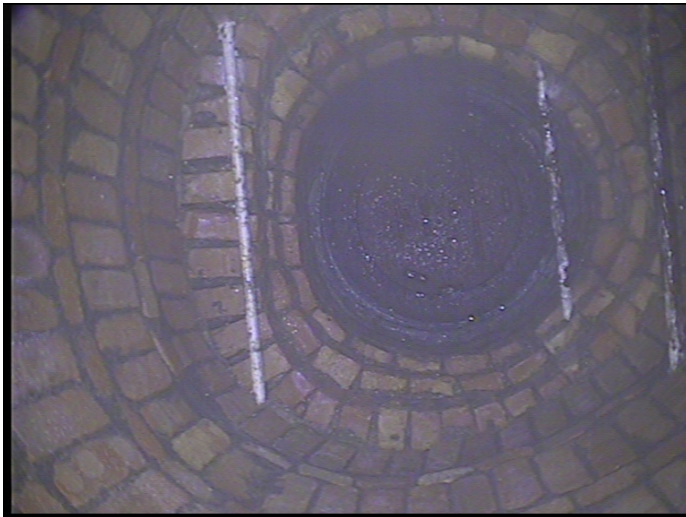
Code: **AMH**
Description: **Manhole**

Distance (ft): **234.5**
Structural Grade: **0**
O&M Grade: **0**
Clock Start/From:
Clock To:
1st Value:
2nd Value:
Value Percent:
Continuous Index:
Within 8" of Joint: **NO**
Remarks: **M-605-032**
