## Profile/Photo Observation Report

Date:	<b>04/16/2018</b>	Weather:		Coding:	<b>PACP 6.0</b>
Pipe Length (ft):		Owner:	<b>City of Hobart</b>	Pre Clean:	<b>No Pre-Cleaning</b>
P.O.#:	<b>60-1</b>	Surveyor:	<b>M. Pielacha</b>	PSR:	<b>M-605-032-M-605-033</b>
Customer:	<b>City of Hobart</b>	Clean Date:		Shape:	<b>C</b>

Street:	<b>Connecticut Street</b>	Flow Control:	<b>Not Controlled</b>
City:	<b>Hobart, IN</b>	Year Renewed:	
Location:	<b>Light Highway</b>	Tape/Media #:	<b>DEP 60</b>
Purpose:	<b>Routine Assessment</b>	Dia/Height:	<b>18"</b>
Use:	<b>Sanitary</b>	Material:	<b>VCP</b>
Drain Area:		Lining:	
Category:	<b>NA</b>		
Comment:			
Location Details:		Direction of Survey:	<b>Upstream</b>
US MH:	<b>M-605-032</b>	DS MH:	<b>M-605-033</b>
		Total Length Surveyed (ft):	<b>238.1</b>

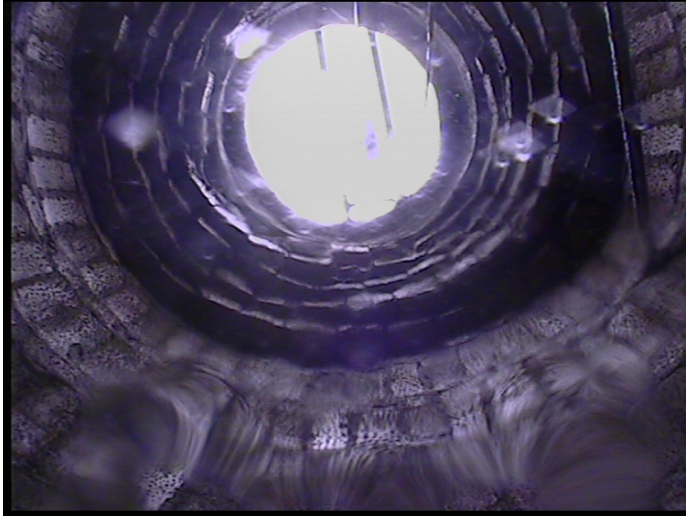
Code: **AMH**  
Description: **Manhole**

Distance (ft): **.0**  
Structural Grade: **0**  
O&M Grade: **0**  
Clock Start/From:  
Clock To:  
1st Value:  
2nd Value:  
Value Percent:  
Continuous Index:  
Within 8" of Joint: **NO**  
Remarks: **M-605-033**

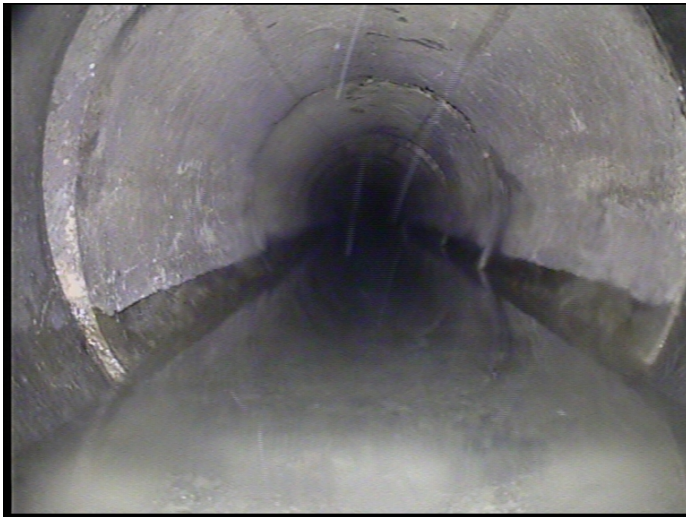
Code: **MWL**  
Description: **Water Level**

Distance (ft): **.0**  
Structural Grade: **0**  
O&M Grade: **0**  
Clock Start/From:  
Clock To:  
1st Value:  
2nd Value:  
Value Percent: **10.000**  
Continuous Index:  
Within 8" of Joint: **NO**  
Remarks:

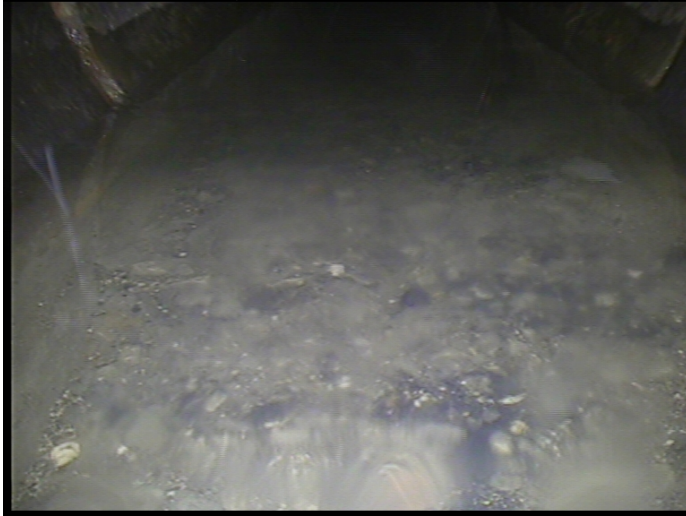
Code: **DSF**  
Description: **Deposits Settled Fine**

Distance (ft): **.0**  
Structural Grade: **0**  
O&M Grade: **2**  
Clock Start/From: **5**  
Clock To: **7**  
1st Value:  
2nd Value:  
Value Percent: **10.000**  
Continuous Index: **S01**  
Within 8" of Joint: **YES**  
Remarks:

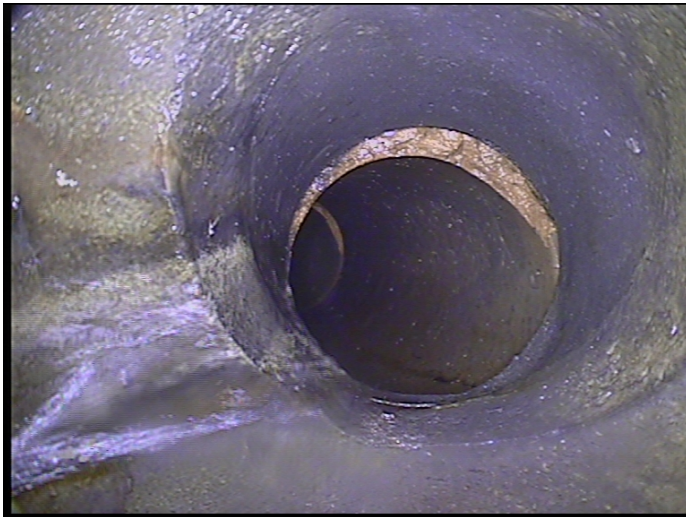
Code: **TFA**  
Description: **Tap Factory Active**

Distance (ft): **30.2**  
Structural Grade: **0**  
O&M Grade: **0**  
Clock Start/From: **10**  
Clock To:  
1st Value: **4.000**  
2nd Value:  
Value Percent:  
Continuous Index:  
Within 8" of Joint: **NO**  
Remarks:

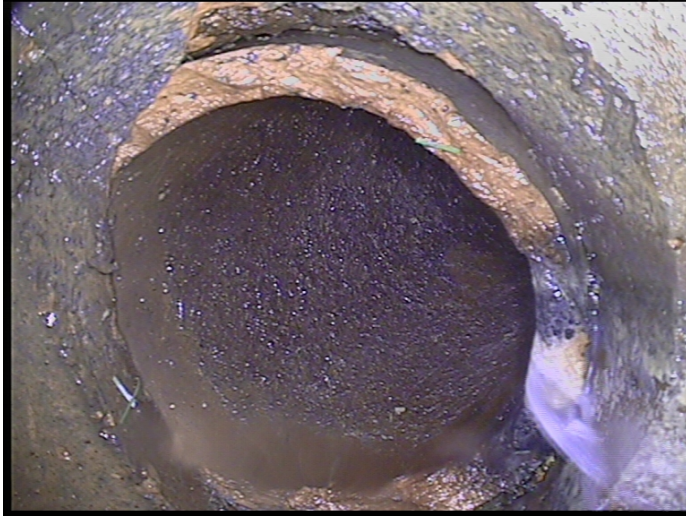
Code: **TBA**  
Description: **Tap Break-in Active**

Distance (ft): **33.5**  
Structural Grade: **0**  
O&M Grade: **0**  
Clock Start/From: **2**  
Clock To:  
1st Value: **4.000**  
2nd Value:  
Value Percent:  
Continuous Index:  
Within 8" of Joint: **NO**  
Remarks:

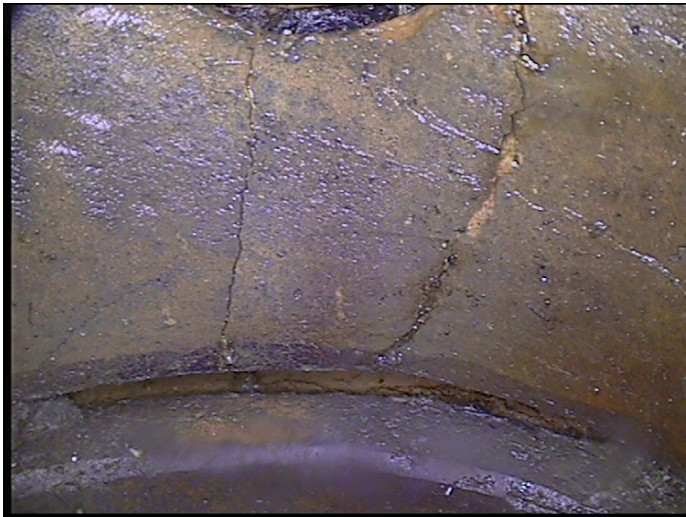
Code: **FL**  
Description: **Fracture Longitudinal**

Distance (ft): **33.9**  
Structural Grade: **3**  
O&M Grade: **0**  
Clock Start/From: **2**  
Clock To:  
1st Value:  
2nd Value:  
Value Percent:  
Continuous Index:  
Within 8" of Joint: **YES**  
Remarks:

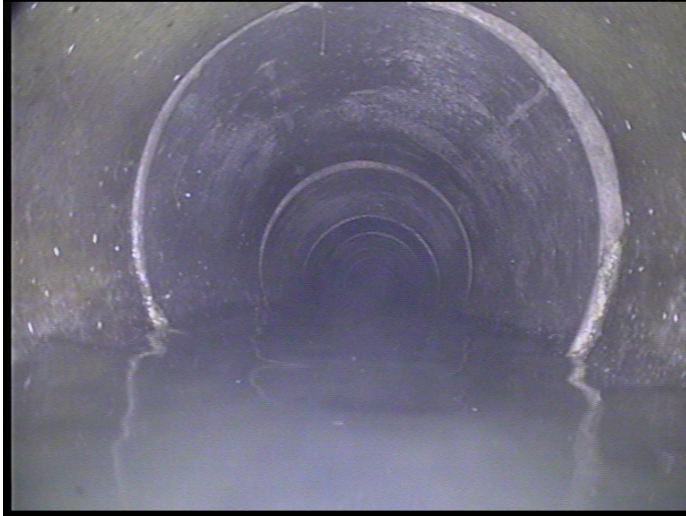
Code: **DSF**  
Description: **Deposits Settled Fine**

Distance (ft): **47.2**  
Structural Grade: **0**  
O&M Grade: **2**  
Clock Start/From: **5**  
Clock To: **7**  
1st Value:  
2nd Value:  
Value Percent: **10.000**  
Continuous Index: **F01**  
Within 8" of Joint: **NO**  
Remarks:

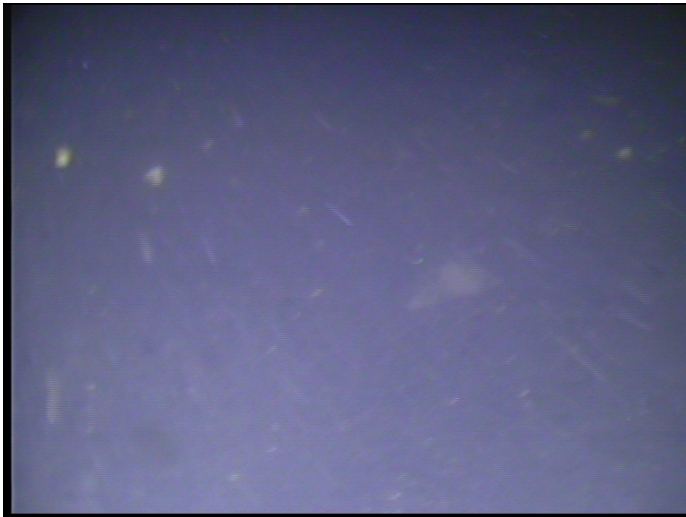
Code: **DSF**  
Description: **Deposits Settled Fine**

Distance (ft): **66.6**  
Structural Grade: **0**  
O&M Grade: **3**  
Clock Start/From: **5**  
Clock To: **7**  
1st Value:  
2nd Value:  
Value Percent: **15.000**  
Continuous Index: **S02**  
Within 8" of Joint: **YES**  
Remarks:

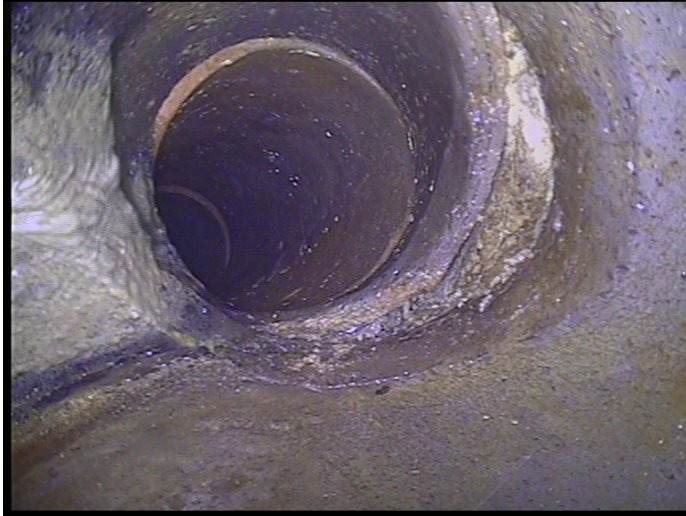
Code: **TFA**  
Description: **Tap Factory Active**

Distance (ft): **68.9**  
Structural Grade: **0**  
O&M Grade: **0**  
Clock Start/From: **10**  
Clock To:  
1st Value: **4.000**  
2nd Value:  
Value Percent:  
Continuous Index:  
Within 8" of Joint: **NO**  
Remarks:

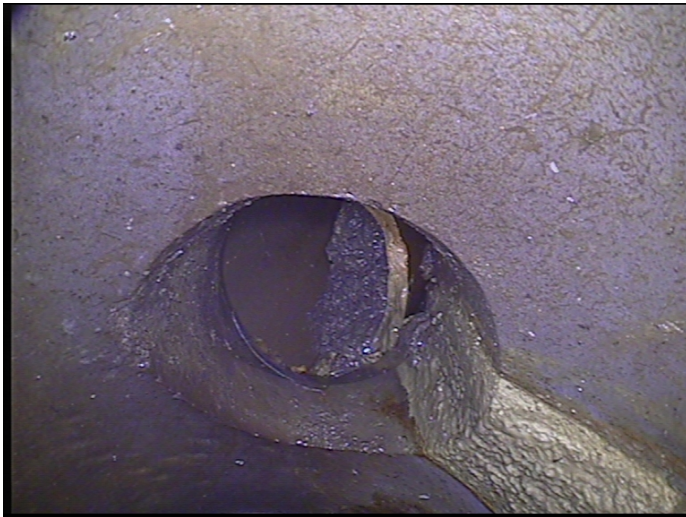
Code: **TF**  
Description: **Tap Factory**

Distance (ft): **71.2**  
Structural Grade: **0**  
O&M Grade: **0**  
Clock Start/From: **3**  
Clock To:  
1st Value: **4.000**  
2nd Value:  
Value Percent:  
Continuous Index:  
Within 8" of Joint: **NO**  
Remarks:

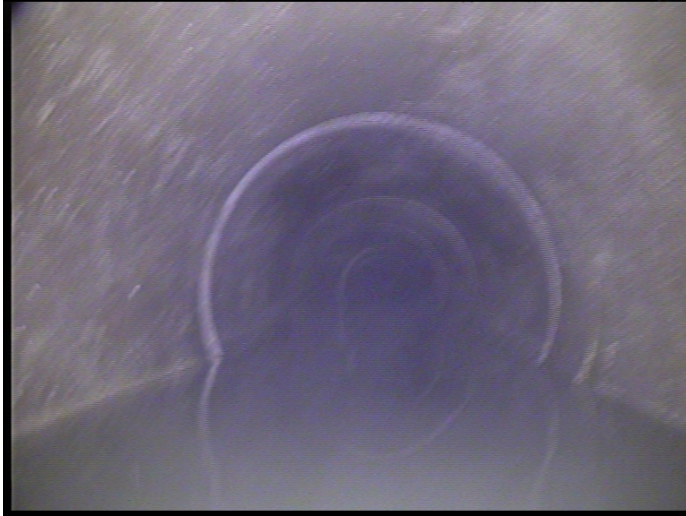
Code: **DSF**  
Description: **Deposits Settled Fine**

Distance (ft): **73.0**  
Structural Grade: **0**  
O&M Grade: **3**  
Clock Start/From: **5**  
Clock To: **7**  
1st Value:  
2nd Value:  
Value Percent: **15.000**  
Continuous Index: **F02**  
Within 8" of Joint: **NO**  
Remarks:

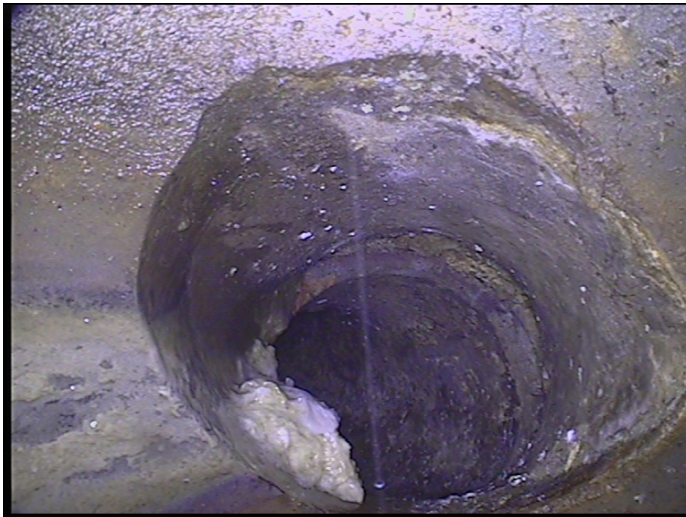
Code: **TF**  
Description: **Tap Factory**

Distance (ft): **108.0**  
Structural Grade: **0**  
O&M Grade: **0**  
Clock Start/From: **10**  
Clock To:  
1st Value: **4.000**  
2nd Value:  
Value Percent:  
Continuous Index:  
Within 8" of Joint: **NO**  
Remarks:

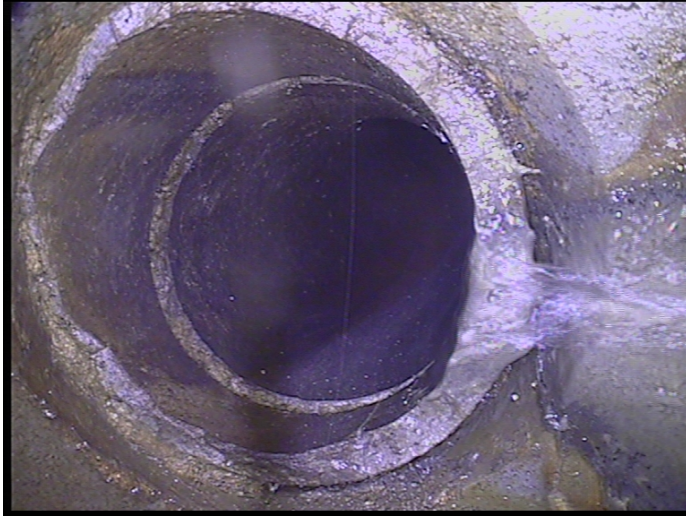
Code: **TBA**  
Description: **Tap Break-in Active**

Distance (ft): **111.2**  
Structural Grade: **0**  
O&M Grade: **0**  
Clock Start/From: **2**  
Clock To:  
1st Value: **4.000**  
2nd Value:  
Value Percent:  
Continuous Index:  
Within 8" of Joint: **NO**  
Remarks:

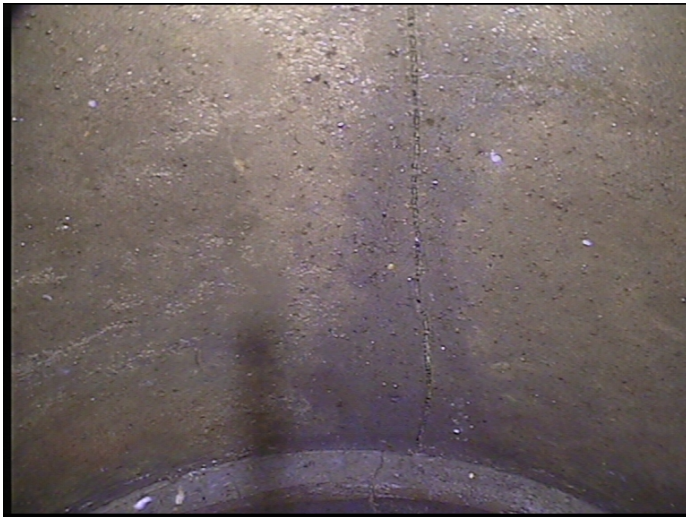
Code: **FL**  
Description: **Fracture Longitudinal**

Distance (ft): **111.2**  
Structural Grade: **3**  
O&M Grade: **0**  
Clock Start/From: **12**  
Clock To:  
1st Value:  
2nd Value:  
Value Percent:  
Continuous Index:  
Within 8" of Joint: **YES**  
Remarks:

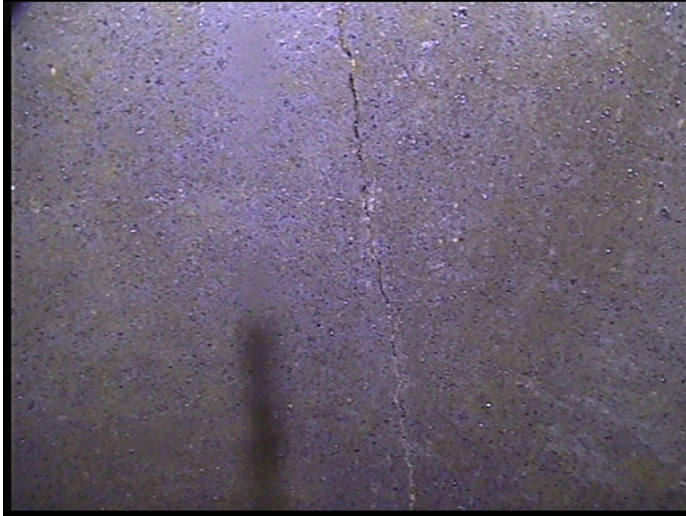
Code: **CL**  
Description: **Crack Longitudinal**

Distance (ft): **133.3**  
Structural Grade: **2**  
O&M Grade: **0**  
Clock Start/From: **12**  
Clock To:  
1st Value:  
2nd Value:  
Value Percent:  
Continuous Index:  
Within 8" of Joint: **YES**  
Remarks:

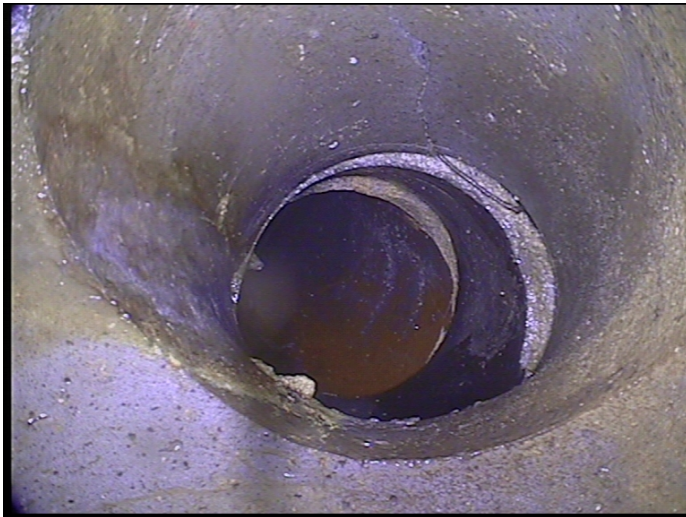
Code: **TF**  
Description: **Tap Factory**

Distance (ft): **150.2**  
Structural Grade: **0**  
O&M Grade: **0**  
Clock Start/From: **10**  
Clock To:  
1st Value: **4.000**  
2nd Value:  
Value Percent:  
Continuous Index:  
Within 8" of Joint: **NO**  
Remarks:

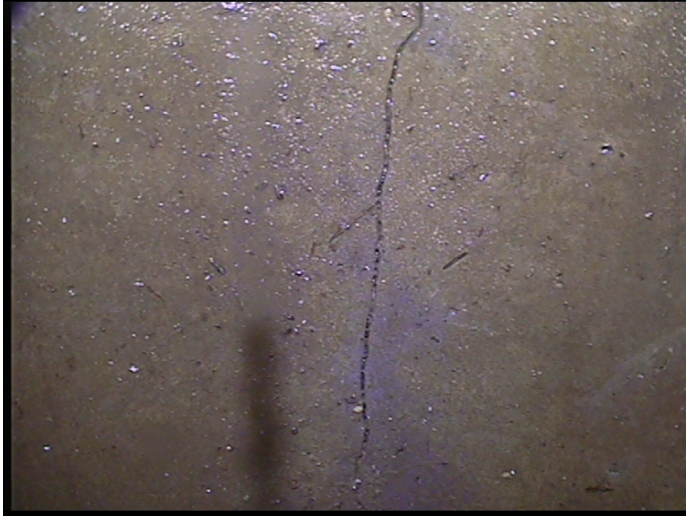
Code: **FL**  
Description: **Fracture Longitudinal**

Distance (ft): **152.6**  
Structural Grade: **3**  
O&M Grade: **0**  
Clock Start/From: **12**  
Clock To:  
1st Value:  
2nd Value:  
Value Percent:  
Continuous Index: **S03**  
Within 8" of Joint: **YES**  
Remarks:

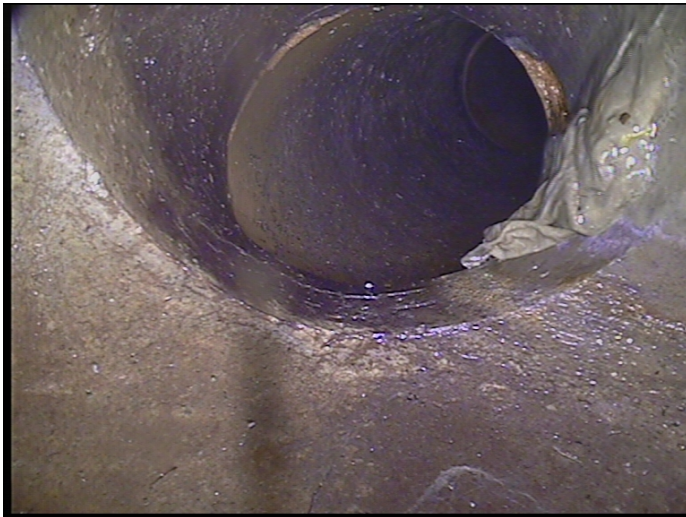
Code: **TFA**  
Description: **Tap Factory Active**

Distance (ft): **153.2**  
Structural Grade: **0**  
O&M Grade: **0**  
Clock Start/From: **2**  
Clock To:  
1st Value: **4.000**  
2nd Value:  
Value Percent:  
Continuous Index:  
Within 8" of Joint: **NO**  
Remarks:

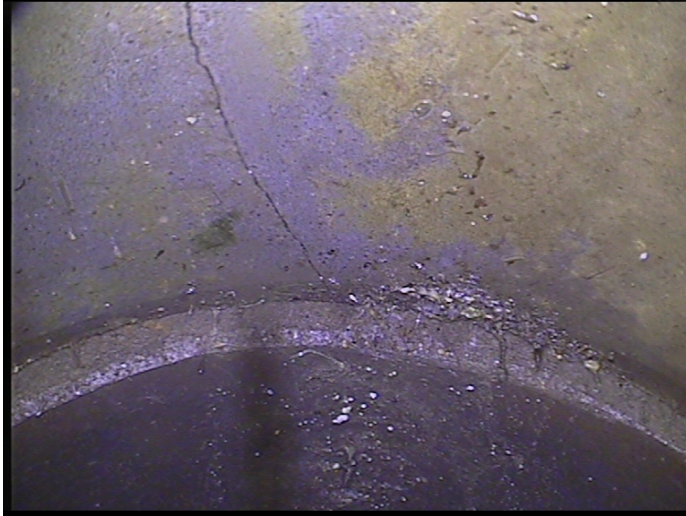
Code: **FL**  
Description: **Fracture Longitudinal**

Distance (ft): **177.6**  
Structural Grade: **3**  
O&M Grade: **0**  
Clock Start/From: **12**  
Clock To:  
1st Value:  
2nd Value:  
Value Percent:  
Continuous Index: **F03**  
Within 8" of Joint: **NO**  
Remarks:

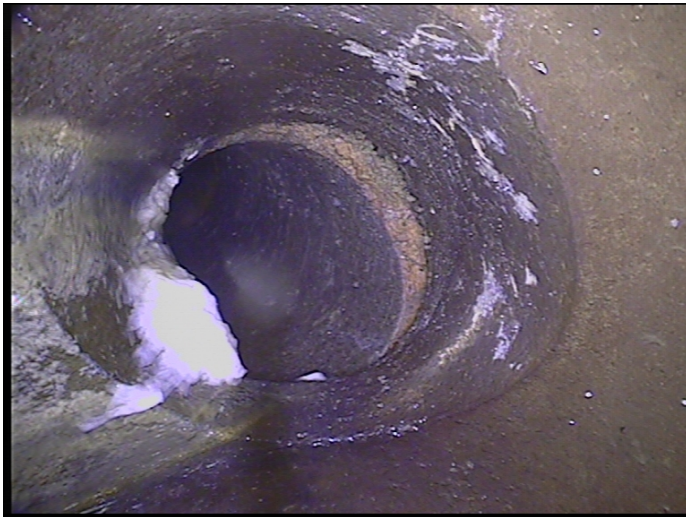
Code: **TF**  
Description: **Tap Factory**

Distance (ft): **183.1**  
Structural Grade: **0**  
O&M Grade: **0**  
Clock Start/From: **10**  
Clock To:  
1st Value: **4.000**  
2nd Value:  
Value Percent:  
Continuous Index:  
Within 8" of Joint: **NO**  
Remarks:

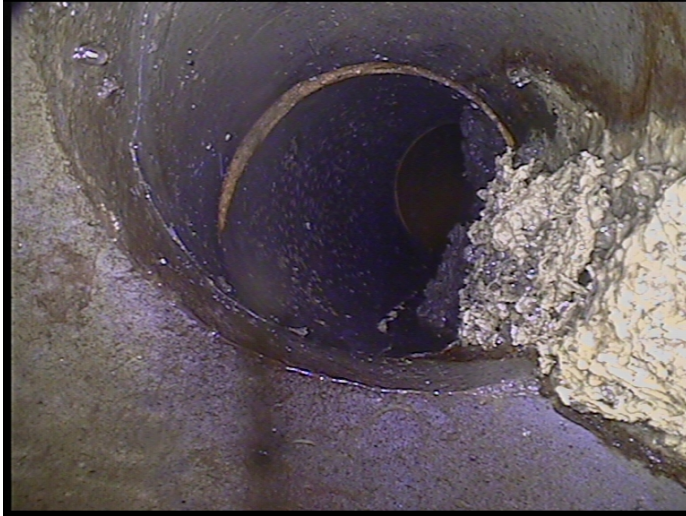
Code: **TF**  
Description: **Tap Factory**

Distance (ft): **186.5**  
Structural Grade: **0**  
O&M Grade: **0**  
Clock Start/From: **3**  
Clock To:  
1st Value: **4.000**  
2nd Value:  
Value Percent:  
Continuous Index:  
Within 8" of Joint: **NO**  
Remarks:

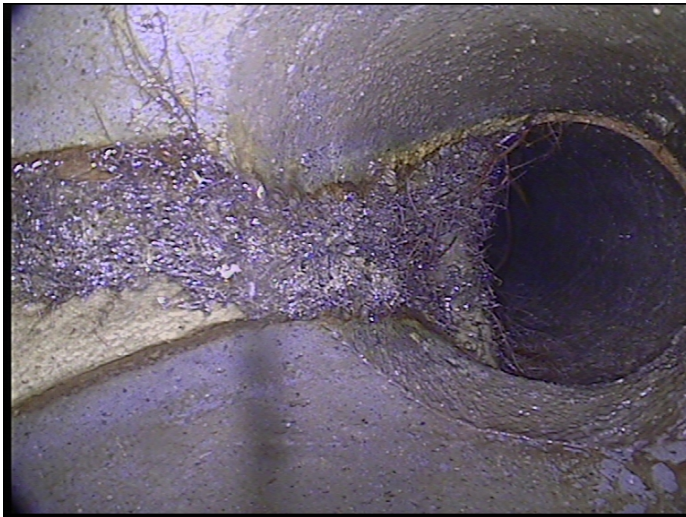
Code: **TFD**  
Description: **Tap Factory Defective**

Distance (ft): **222.8**  
Structural Grade: **0**  
O&M Grade: **2**  
Clock Start/From: **9**  
Clock To:  
1st Value: **4.000**  
2nd Value:  
Value Percent:  
Continuous Index:  
Within 8" of Joint: **NO**  
Remarks: **Defective**

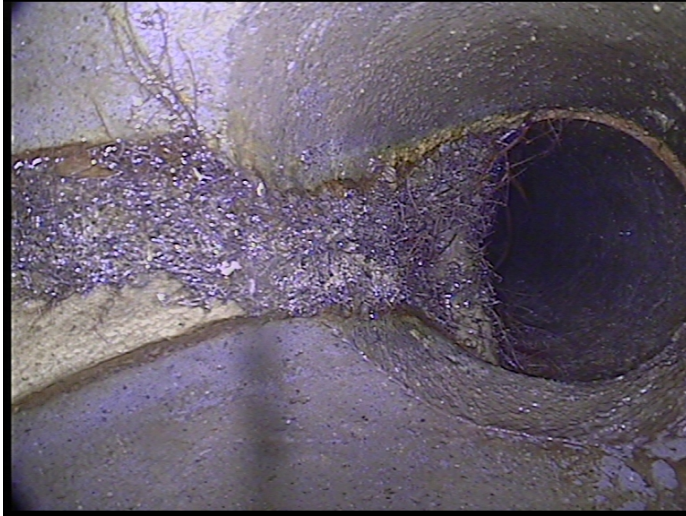
Code: **RFL**  
Description: **Roots Fine Lateral**

Distance (ft): **222.8**  
Structural Grade: **0**  
O&M Grade: **1**  
Clock Start/From: **10**  
Clock To:  
1st Value:  
2nd Value:  
Value Percent:  
Continuous Index:  
Within 8" of Joint: **NO**  
Remarks:

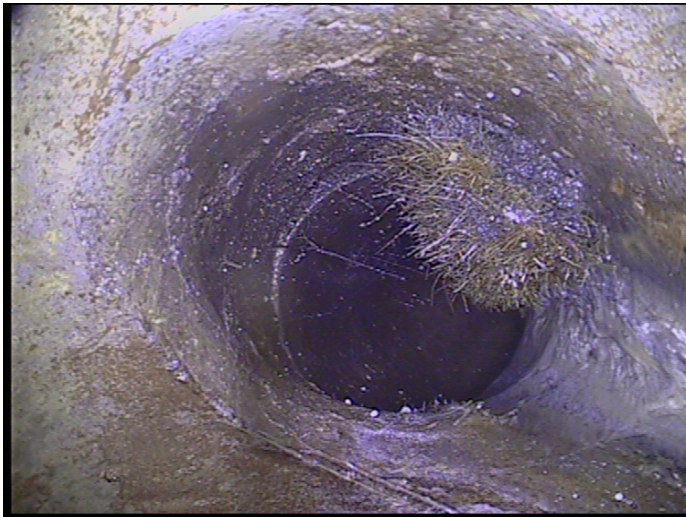
Code: **TFA**  
Description: **Tap Factory Active**

Distance (ft): **225.7**  
Structural Grade: **0**  
O&M Grade: **0**  
Clock Start/From: **2**  
Clock To:  
1st Value: **4.000**  
2nd Value:  
Value Percent:  
Continuous Index:  
Within 8" of Joint: **NO**  
Remarks:

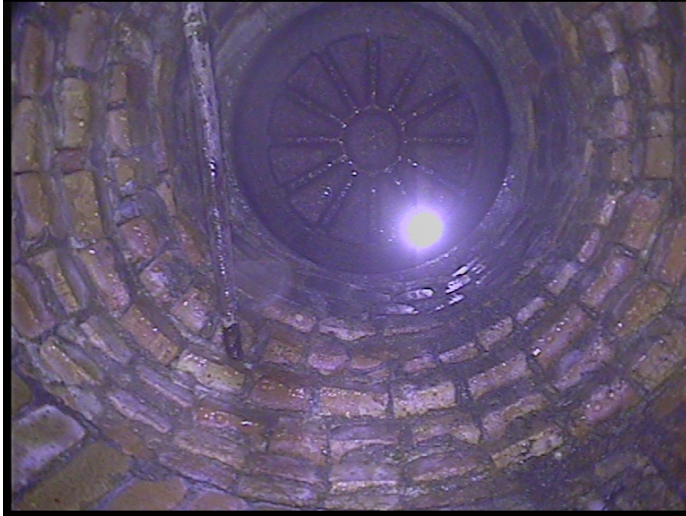
Code:	<b>AMH</b>
Description:	<b>Manhole</b>
Distance (ft):	<b>238.1</b>
Structural Grade:	<b>0</b>
O&M Grade:	<b>0</b>
Clock Start/From:	
Clock To:	
1st Value:	
2nd Value:	
Value Percent:	
Continuous Index:	
Within 8" of Joint:	<b>NO</b>
Remarks:	<b>M-605-032</b>
