## Profile/Photo Observation Report

Date:	<b>04/16/2018</b>	Weather:		Coding:	<b>PACP 6.0</b>
Pipe Length (ft):		Owner:	<b>City of Hobart</b>	Pre Clean:	<b>No Pre-Cleaning</b>
P.O.#:	<b>60-2</b>	Surveyor:	<b>M. Pielacha</b>	PSR:	<b>M-605-033-M-605-034</b>
Customer:	<b>City of Hobart</b>	Clean Date:		Shape:	<b>C</b>

Street:	<b>Connecticut Street</b>	Flow Control:	<b>Not Controlled</b>
City:	<b>Hobart, IN</b>	Year Renewed:	
Location:	<b>Light Highway</b>	Tape/Media #:	<b>DEP 60</b>
Purpose:	<b>Routine Assessment</b>	Dia/Height:	<b>18"</b>
Use:	<b>Sanitary</b>	Material:	<b>VCP</b>
Drain Area:		Lining:	
Category:	<b>NA</b>		
Comment:			
Location Details:		Direction of Survey:	<b>Upstream</b>
US MH:	<b>M-605-033</b>	DS MH:	<b>M-605-034</b>
		Total Length Surveyed (ft):	<b>238.1</b>

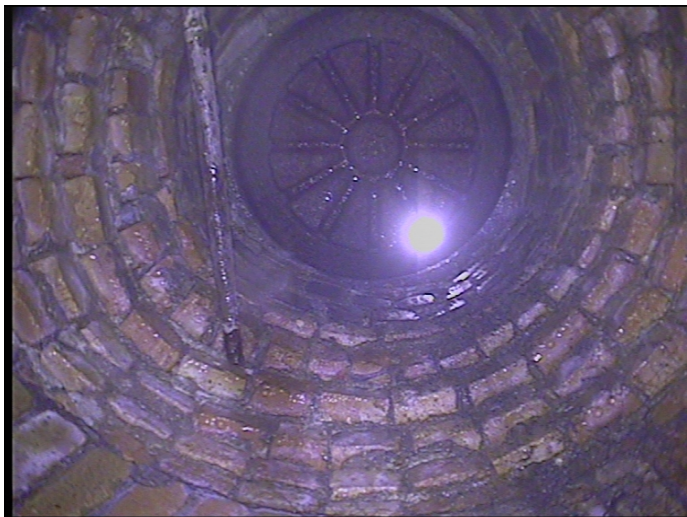
Code: **AMH**  
 Description: **Manhole**

Distance (ft): **.0**  
 Structural Grade: **0**  
 O&M Grade: **0**  
 Clock Start/From:  
 Clock To:  
 1st Value:  
 2nd Value:  
 Value Percent:  
 Continuous Index:  
 Within 8" of Joint: **NO**  
 Remarks: **M-605-034**

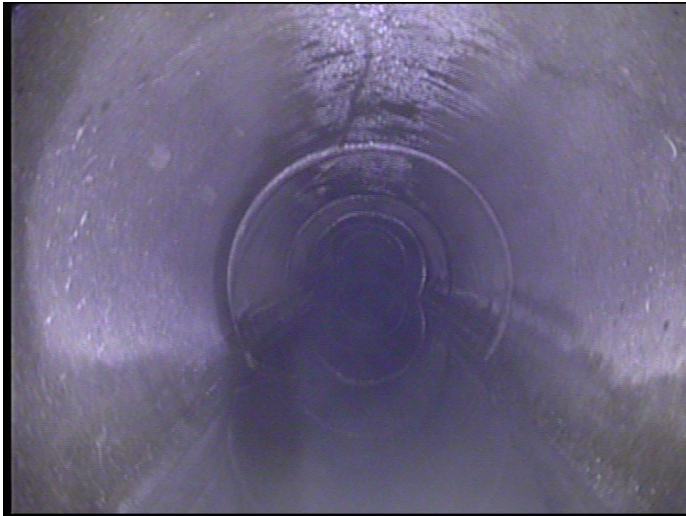
Code: **MWL**  
Description: **Water Level**

Distance (ft): **.0**  
Structural Grade: **0**  
O&M Grade: **0**  
Clock Start/From:  
Clock To:  
1st Value:  
2nd Value:  
Value Percent: **10.000**  
Continuous Index:  
Within 8" of Joint: **NO**  
Remarks:

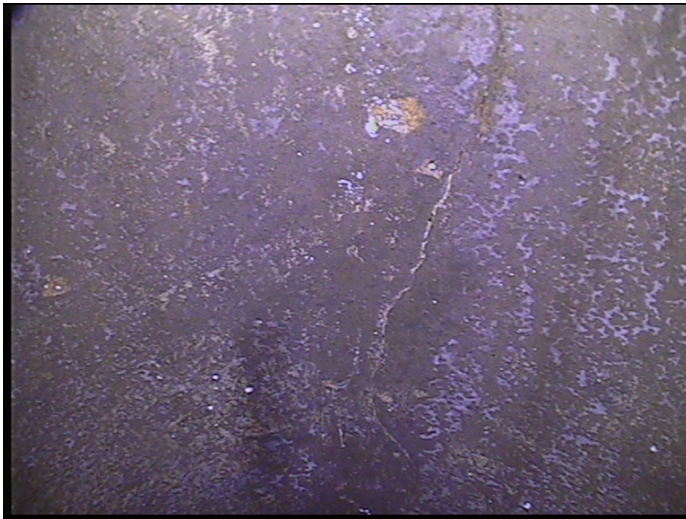
Code: **CL**  
Description: **Crack Longitudinal**

Distance (ft): **7.5**  
Structural Grade: **2**  
O&M Grade: **0**  
Clock Start/From: **12**  
Clock To:  
1st Value:  
2nd Value:  
Value Percent:  
Continuous Index: **S01**  
Within 8" of Joint: **YES**  
Remarks:

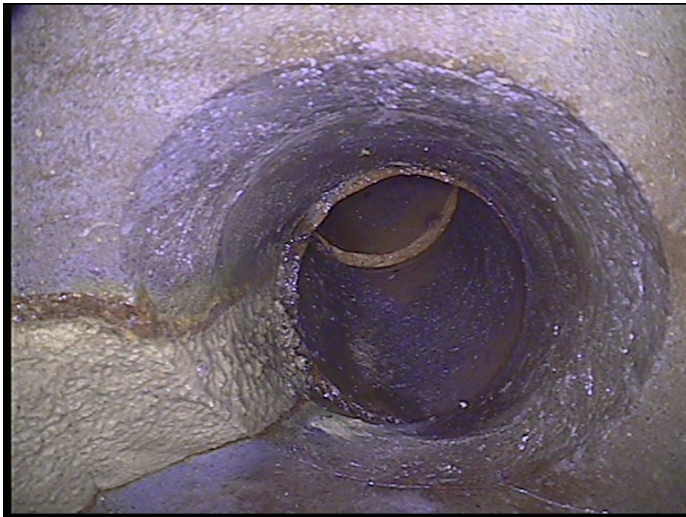
Code: **TF**  
Description: **Tap Factory**

Distance (ft): **23.6**  
Structural Grade: **0**  
O&M Grade: **0**  
Clock Start/From: **10**  
Clock To:  
1st Value: **4.000**  
2nd Value:  
Value Percent:  
Continuous Index:  
Within 8" of Joint: **NO**  
Remarks:

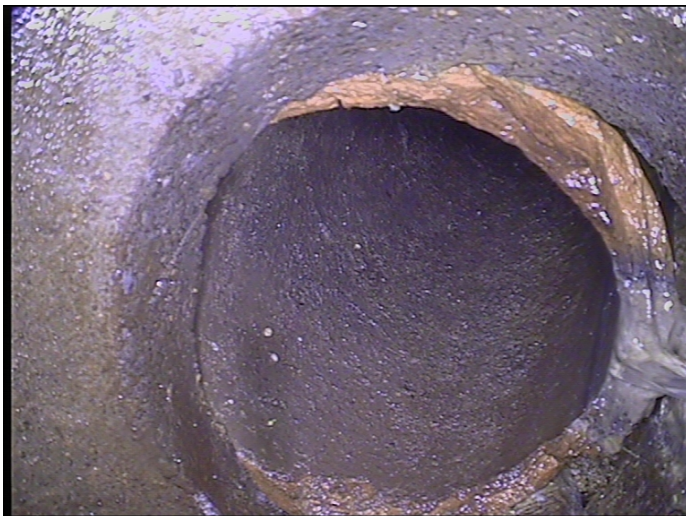
Code: **TBA**  
Description: **Tap Break-in Active**

Distance (ft): **27.1**  
Structural Grade: **0**  
O&M Grade: **0**  
Clock Start/From: **2**  
Clock To:  
1st Value: **4.000**  
2nd Value:  
Value Percent:  
Continuous Index:  
Within 8" of Joint: **NO**  
Remarks:

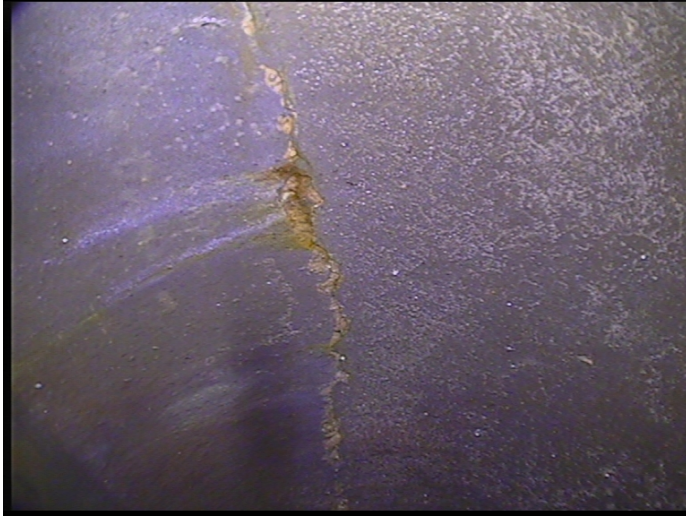
Code:	<b>CL</b>
Description:	<b>Crack Longitudinal</b>
Distance (ft):	<b>31.6</b>
Structural Grade:	<b>2</b>
O&M Grade:	<b>0</b>
Clock Start/From:	<b>9</b>
Clock To:	
1st Value:	
2nd Value:	
Value Percent:	
Continuous Index:	
Within 8" of Joint:	<b>YES</b>
Remarks:

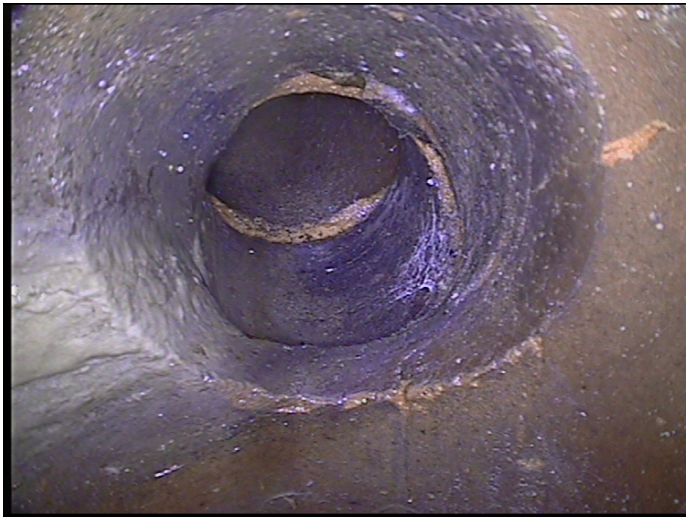
Code:	<b>TF</b>
Description:	<b>Tap Factory</b>
Distance (ft):	<b>63.3</b>
Structural Grade:	<b>0</b>
O&M Grade:	<b>0</b>
Clock Start/From:	<b>10</b>
Clock To:	
1st Value:	<b>4.000</b>
2nd Value:	
Value Percent:	
Continuous Index:	
Within 8" of Joint:	<b>NO</b>
Remarks:

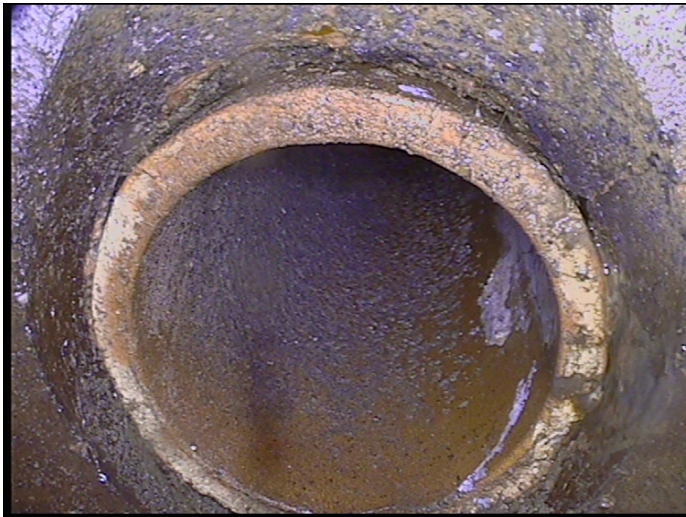
Code: **TB**  
Description: **Tap Break-in**

Distance (ft): **66.7**  
Structural Grade: **0**  
O&M Grade: **0**  
Clock Start/From: **3**  
Clock To:  
1st Value: **4.000**  
2nd Value:  
Value Percent:  
Continuous Index:  
Within 8" of Joint: **NO**  
Remarks:

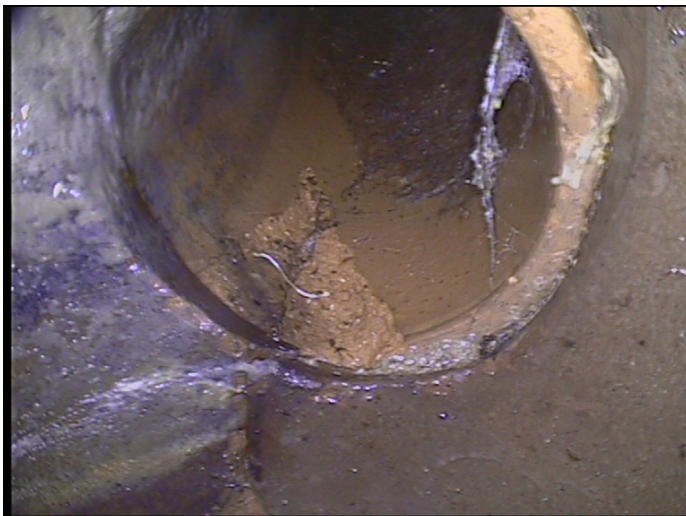
Code: **TB**  
Description: **Tap Break-in**

Distance (ft): **103.8**  
Structural Grade: **0**  
O&M Grade: **0**  
Clock Start/From: **9**  
Clock To:  
1st Value: **4.000**  
2nd Value:  
Value Percent:  
Continuous Index:  
Within 8" of Joint: **NO**  
Remarks:

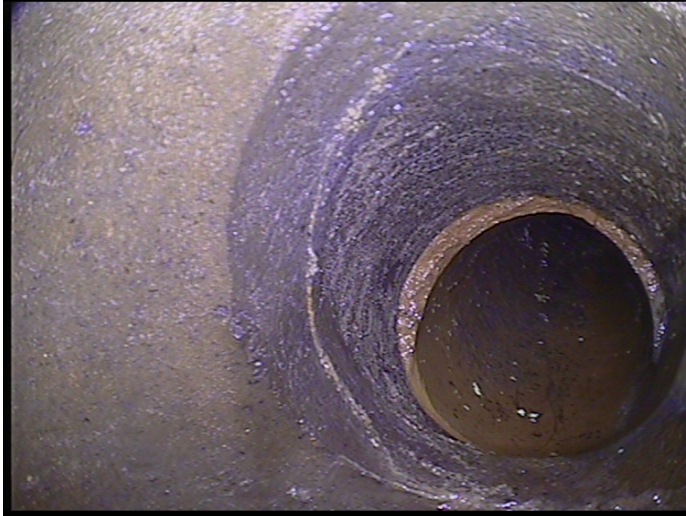
Code: **TF**  
Description: **Tap Factory**

Distance (ft): **106.0**  
Structural Grade: **0**  
O&M Grade: **0**  
Clock Start/From: **2**  
Clock To:  
1st Value: **4.000**  
2nd Value:  
Value Percent:  
Continuous Index:  
Within 8" of Joint: **NO**  
Remarks:

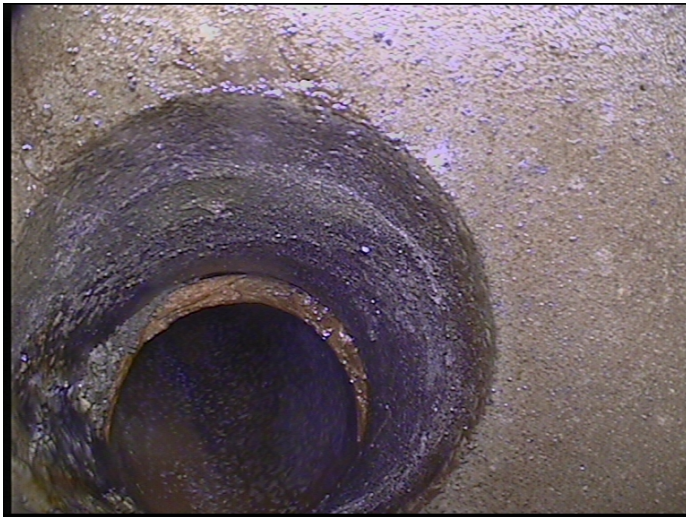
Code: **TF**  
Description: **Tap Factory**

Distance (ft): **142.5**  
Structural Grade: **0**  
O&M Grade: **0**  
Clock Start/From: **10**  
Clock To:  
1st Value: **4.000**  
2nd Value:  
Value Percent:  
Continuous Index:  
Within 8" of Joint: **NO**  
Remarks:

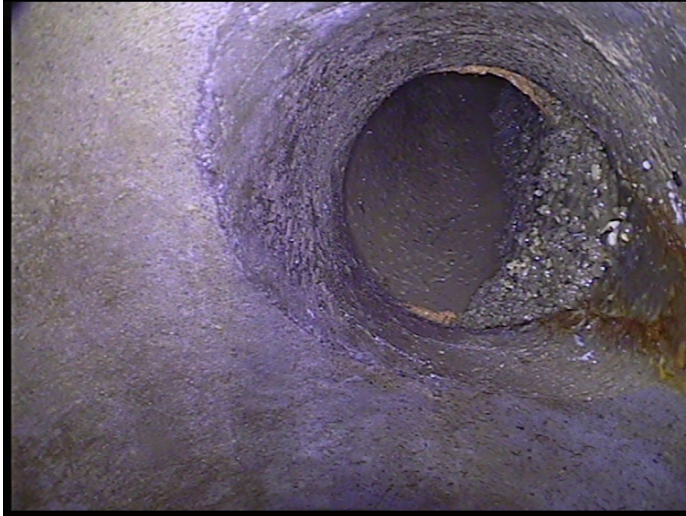
Code: **TF**  
Description: **Tap Factory**

Distance (ft): **145.4**  
Structural Grade: **0**  
O&M Grade: **0**  
Clock Start/From: **3**  
Clock To:  
1st Value: **4.000**  
2nd Value:  
Value Percent:  
Continuous Index:  
Within 8" of Joint: **NO**  
Remarks:

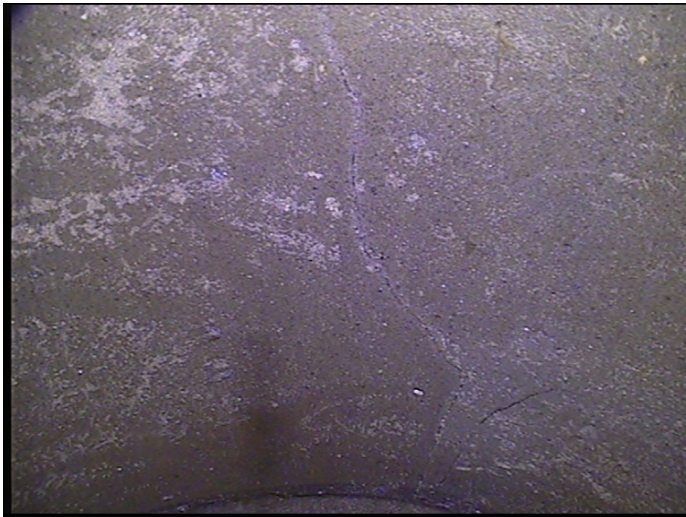
Code: **CL**  
Description: **Crack Longitudinal**

Distance (ft): **176.0**  
Structural Grade: **2**  
O&M Grade: **0**  
Clock Start/From: **12**  
Clock To:  
1st Value:  
2nd Value:  
Value Percent:  
Continuous Index: **F01**  
Within 8" of Joint: **NO**  
Remarks:

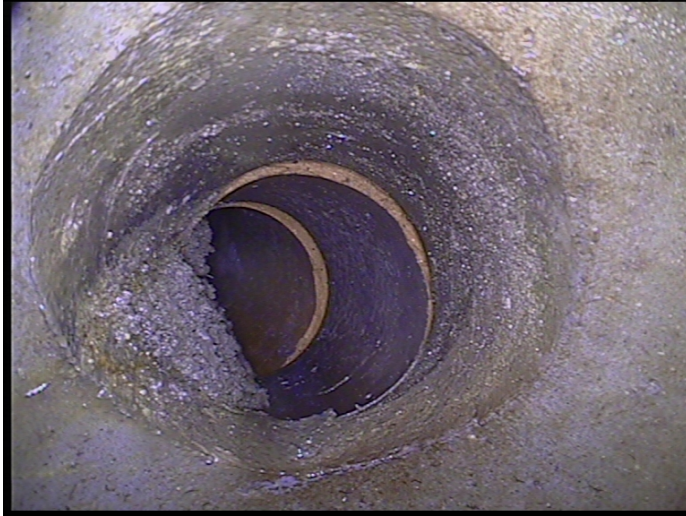
Code: **TF**  
Description: **Tap Factory**

Distance (ft): **181.7**  
Structural Grade: **0**  
O&M Grade: **0**  
Clock Start/From: **9**  
Clock To:  
1st Value: **4.000**  
2nd Value:  
Value Percent:  
Continuous Index:  
Within 8" of Joint: **NO**  
Remarks:

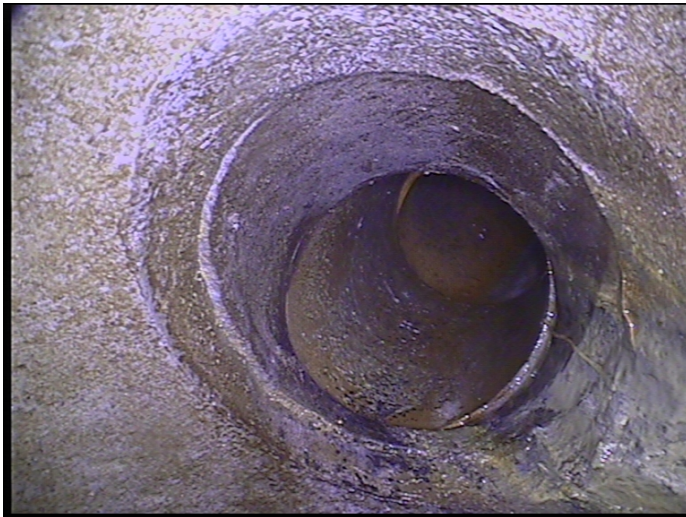
Code: **TF**  
Description: **Tap Factory**

Distance (ft): **184.5**  
Structural Grade: **0**  
O&M Grade: **0**  
Clock Start/From: **3**  
Clock To:  
1st Value: **4.000**  
2nd Value:  
Value Percent:  
Continuous Index:  
Within 8" of Joint: **NO**  
Remarks:

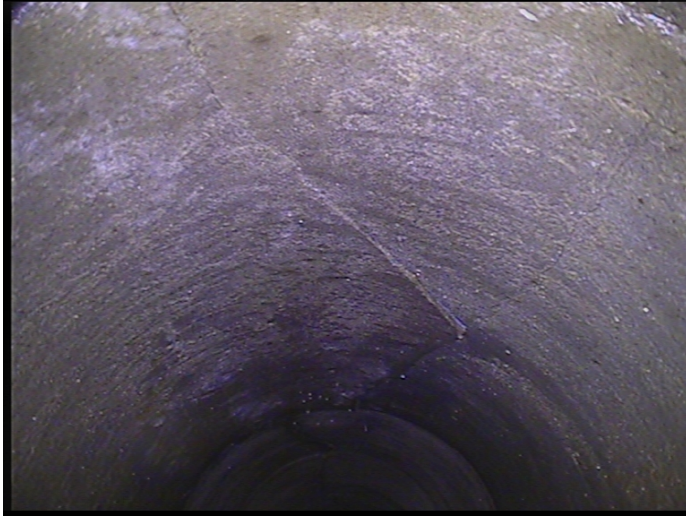
Code: **FL**  
Description: **Fracture Longitudinal**

Distance (ft): **197.2**  
Structural Grade: **3**  
O&M Grade: **0**  
Clock Start/From: **12**  
Clock To:  
1st Value:  
2nd Value:  
Value Percent:  
Continuous Index: **S02**  
Within 8" of Joint: **YES**  
Remarks:

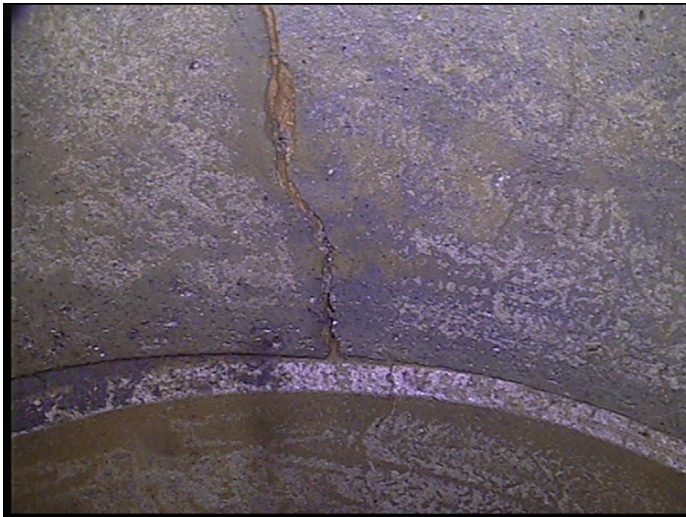
Code: **FL**  
Description: **Fracture Longitudinal**

Distance (ft): **206.3**  
Structural Grade: **3**  
O&M Grade: **0**  
Clock Start/From: **12**  
Clock To:  
1st Value:  
2nd Value:  
Value Percent:  
Continuous Index: **F02**  
Within 8" of Joint: **NO**  
Remarks:

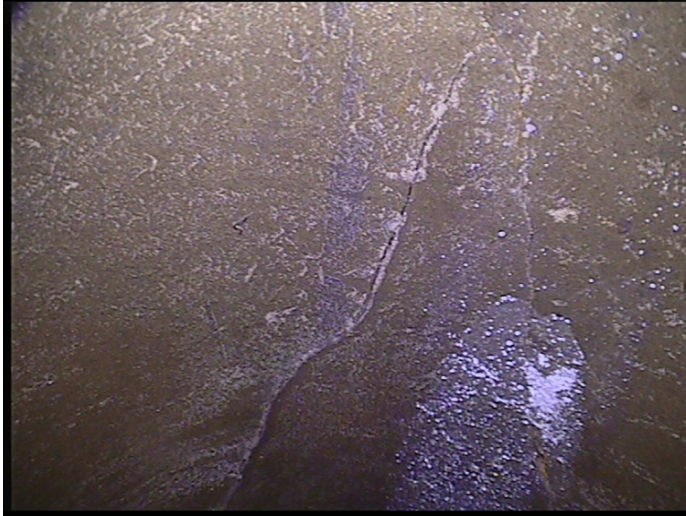
Code:	<b>FL</b>
Description:	<b>Fracture Longitudinal</b>
Distance (ft):	<b>221.6</b>
Structural Grade:	<b>3</b>
O&M Grade:	<b>0</b>
Clock Start/From:	<b>11</b>
Clock To:	
1st Value:	
2nd Value:	
Value Percent:	
Continuous Index:	
Within 8" of Joint:	<b>YES</b>
Remarks:

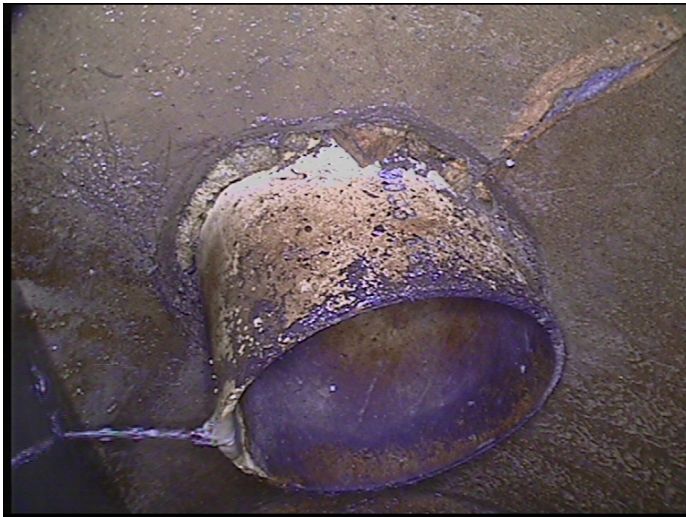
Code:	<b>TBI</b>
Description:	<b>Tap Break-in Intruding</b>
Distance (ft):	<b>223.2</b>
Structural Grade:	<b>0</b>
O&M Grade:	<b>2</b>
Clock Start/From:	<b>9</b>
Clock To:	
1st Value:	<b>4.000</b>
2nd Value:	<b>2.000</b>
Value Percent:	
Continuous Index:	
Within 8" of Joint:	<b>NO</b>
Remarks:

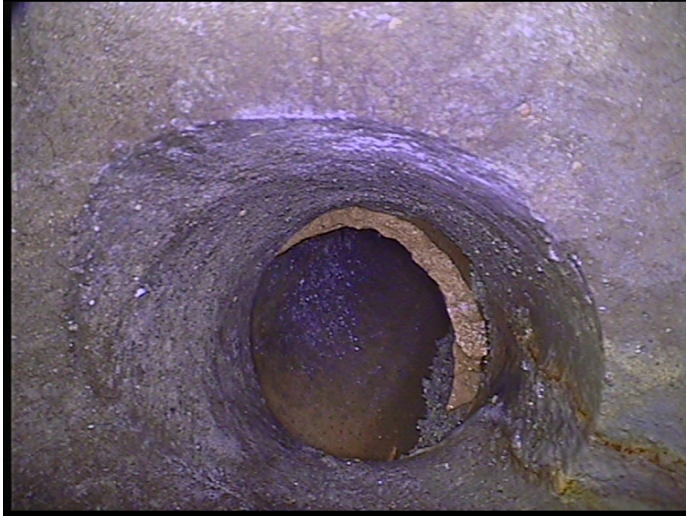
Code: **TF**  
Description: **Tap Factory**

Distance (ft): **226.3**  
Structural Grade: **0**  
O&M Grade: **0**  
Clock Start/From: **3**  
Clock To:  
1st Value: **4.000**  
2nd Value:  
Value Percent:  
Continuous Index:  
Within 8" of Joint: **NO**  
Remarks:

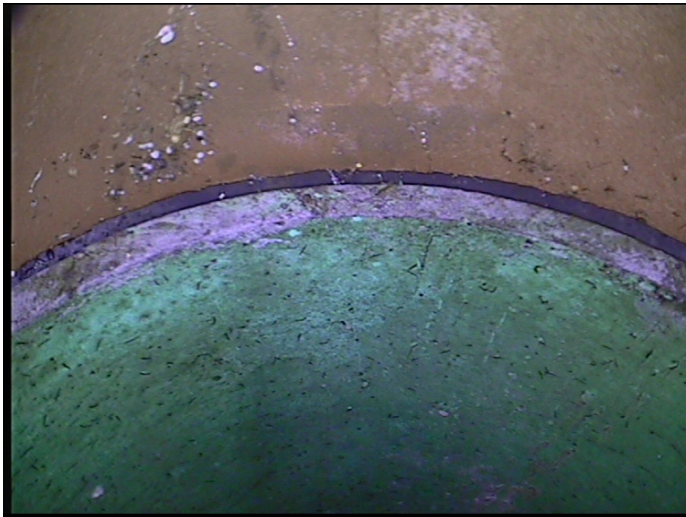
Code: **MMC**  
Description: **Material Change**

Distance (ft): **233.2**  
Structural Grade: **0**  
O&M Grade: **0**  
Clock Start/From:  
Clock To:  
1st Value:  
2nd Value:  
Value Percent:  
Continuous Index:  
Within 8" of Joint: **NO**  
Remarks: **pvc**

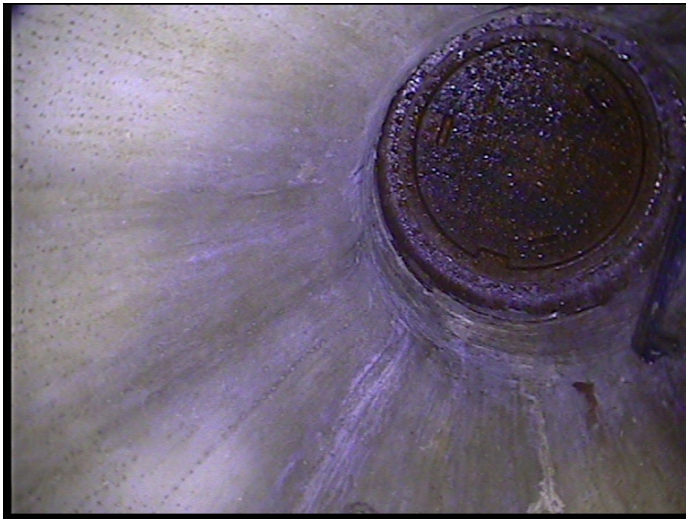
Code:	<b>AMH</b>
Description:	<b>Manhole</b>
Distance (ft):	<b>238.1</b>
Structural Grade:	<b>0</b>
O&M Grade:	<b>0</b>
Clock Start/From:	
Clock To:	
1st Value:	
2nd Value:	
Value Percent:	
Continuous Index:	
Within 8" of Joint:	<b>NO</b>
Remarks:	<b>M-605-033</b>
