Profile/Photo Observation Report

Date:	04/16/2018	Weather:		Coding:	PACP 6.0
Pipe Length (ft):		Owner:	City of Hobart	Pre Clean:	No Pre-Cleaning
P.O.#:	60-2	Surveyor:	M. Pielacha	PSR:	M-605-033-M-605-034
Customer:	City of Hobart	Clean Date:		Shape:	C

Street:	Connecticut Street	Flow Control:	Not Controlled
City:	Hobart, IN	Year Renewed:	
Location:	Light Highway	Tape/Media #:	DEP 60
Purpose:	Routine Assessment	Dia/Height:	18"
Use:	Sanitary	Material:	VCP
Drain Area:		Lining:	
Category:	NA		
Comment:			
Location Details:		Direction of Survey:	Upstream
US MH:	M-605-033	DS MH:	M-605-034
		Total Length Surveyed (ft):	238.1

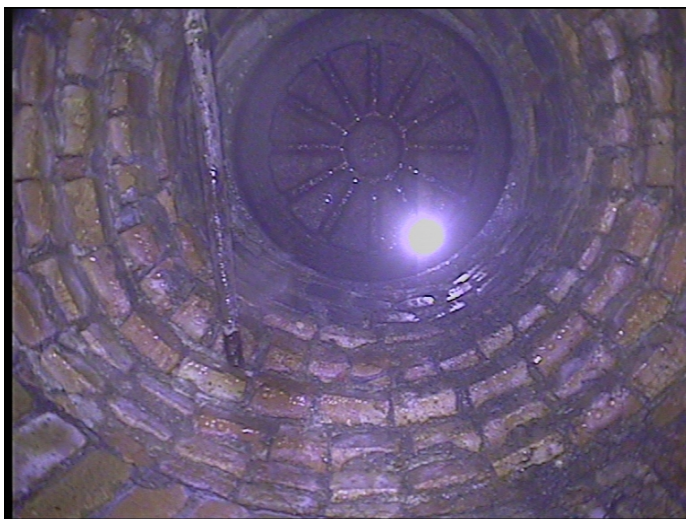
Code: **AMH**
 Description: **Manhole**

Distance (ft): **.0**
 Structural Grade: **0**
 O&M Grade: **0**
 Clock Start/From:
 Clock To:
 1st Value:
 2nd Value:
 Value Percent:
 Continuous Index:
 Within 8" of Joint: **NO**
 Remarks: **M-605-034**

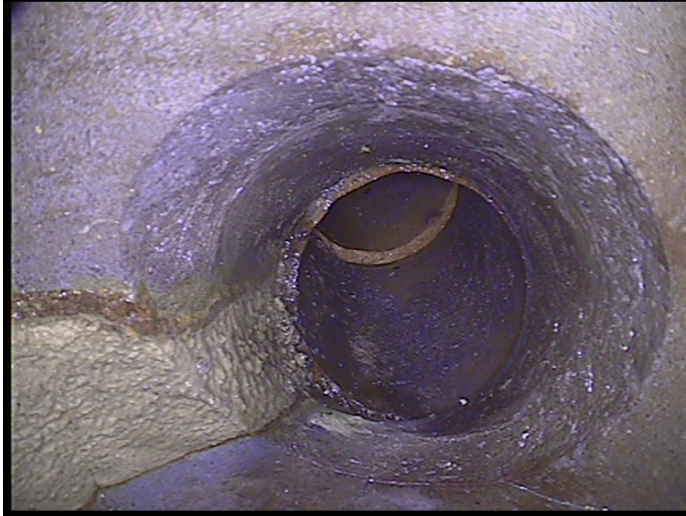
Code: **TF**
Description: **Tap Factory**

Distance (ft): **23.6**
Structural Grade: **0**
O&M Grade: **0**
Clock Start/From: **10**
Clock To:
1st Value: **4.000**
2nd Value:
Value Percent:
Continuous Index:
Within 8" of Joint: **NO**
Remarks:

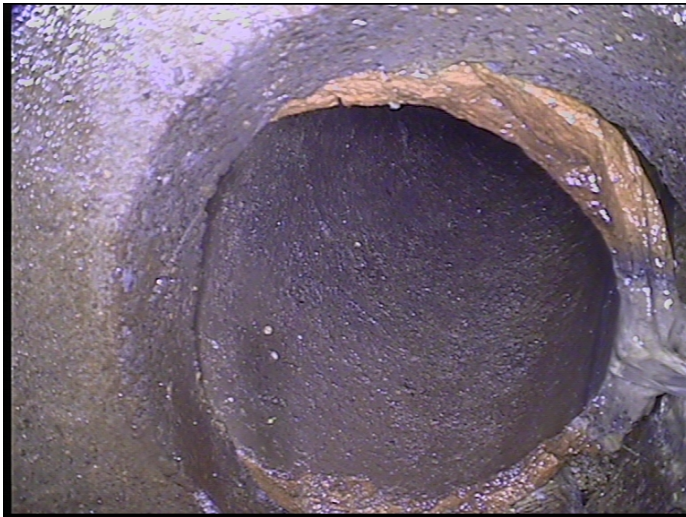
Code: **TBA**
Description: **Tap Break-in Active**

Distance (ft): **27.1**
Structural Grade: **0**
O&M Grade: **0**
Clock Start/From: **2**
Clock To:
1st Value: **4.000**
2nd Value:
Value Percent:
Continuous Index:
Within 8" of Joint: **NO**
Remarks:
