Profile/Photo Observation Report

Street:	S PENNSYLVANIA ST & W 2ND ST	Flow Control:	Not Controlled
City:	Hobart, IN	Year Renewed:	
Location:	Light Highway	Tape/Media #:	
Purpose:	Not Known	Dia/Height:	12"
Use:	Sanitary	Material:	VCP
Drain Area:	NA	Lining:	
Category:	NA		
Comment:

Location Details:		Direction of Survey:	Downstream
US MH:	M-605-037	DS MH:	M-605-038
		Total Length Surveyed (ft):	288.0

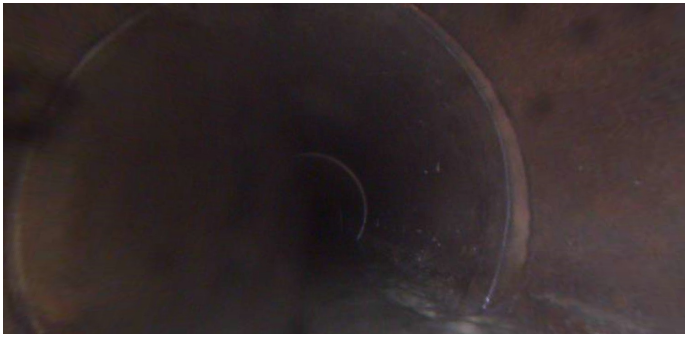
Code: **AMH**
Description: **Manhole**

Distance (ft): **.0**
Structural Grade: **0**
O&M Grade: **0**
Clock Start/From:
Clock To:
1st Value:
2nd Value:
Value Percent:
Continuous Index:
Within 8" of Joint: **NO**
Remarks: **M-605-037**

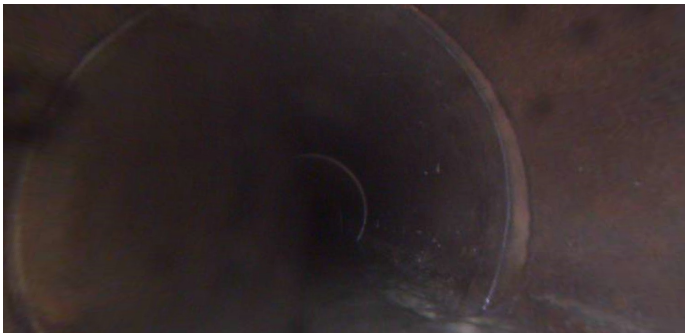
Code: **MWL**
Description: **Water Level**

Distance (ft): **.0**
Structural Grade: **0**
O&M Grade: **0**
Clock Start/From:
Clock To:
1st Value:
2nd Value:
Value Percent: **5.000**
Continuous Index:
Within 8" of Joint: **NO**
Remarks:

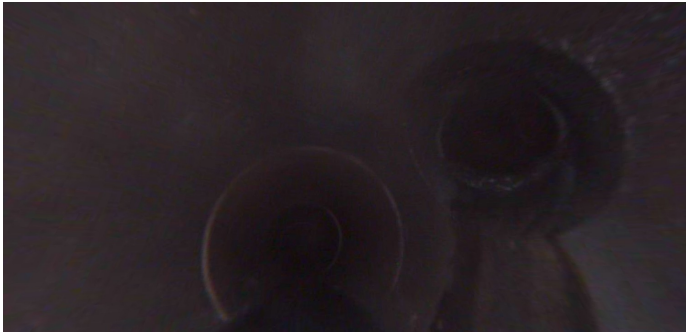
Code: **TFA**
Description: **Tap Factory Active**

Distance (ft): **51.0**
Structural Grade: **0**
O&M Grade: **0**
Clock Start/From: **9**
Clock To:
1st Value: **4.000**
2nd Value:
Value Percent:
Continuous Index:
Within 8" of Joint:
Remarks:

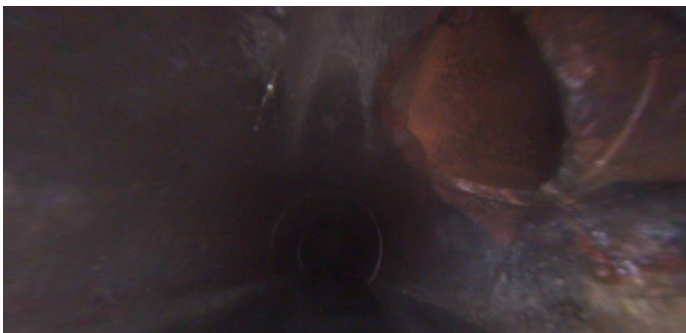
Code: **TBI**
Description: **Tap Break-in Intruding**

Distance (ft): **68.0**
Structural Grade: **0**
O&M Grade: **2**
Clock Start/From: **10**
Clock To:
1st Value: **4.000**
2nd Value: **2.000**
Value Percent:
Continuous Index:
Within 8" of Joint:
Remarks:

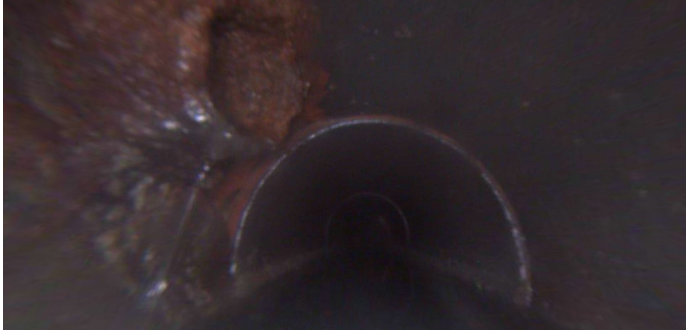
Code: **TBI**
Description: **Tap Break-in Intruding**

Distance (ft): **72.7**
Structural Grade: **0**
O&M Grade: **2**
Clock Start/From: **2**
Clock To:
1st Value: **4.000**
2nd Value: **1.000**
Value Percent:
Continuous Index:
Within 8" of Joint:
Remarks:

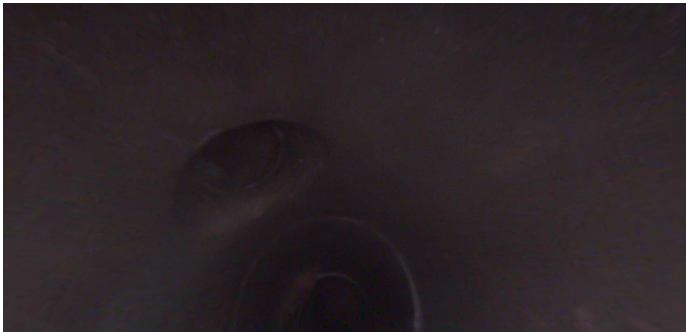
Code: **TF**
Description: **Tap Factory**

Distance (ft): **75.3**
Structural Grade: **0**
O&M Grade: **0**
Clock Start/From: **1**
Clock To:
1st Value: **4.000**
2nd Value:
Value Percent:
Continuous Index:
Within 8" of Joint:
Remarks:

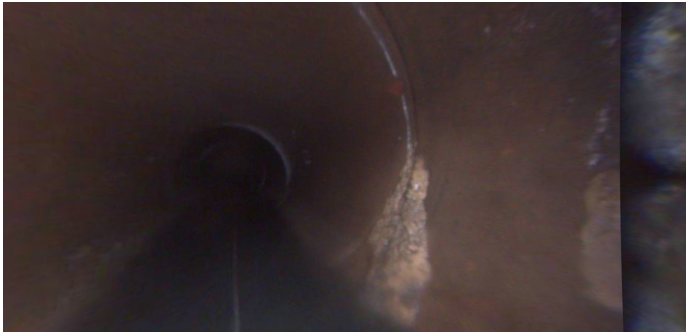
Code: **DAE**
Description: **Deposits Attached Encrustation**

Distance (ft): **78.4**
Structural Grade: **0**
O&M Grade: **2**
Clock Start/From: **8**
Clock To: **9**
1st Value:
2nd Value:
Value Percent: **5.000**
Continuous Index:
Within 8" of Joint: **YES**
Remarks:

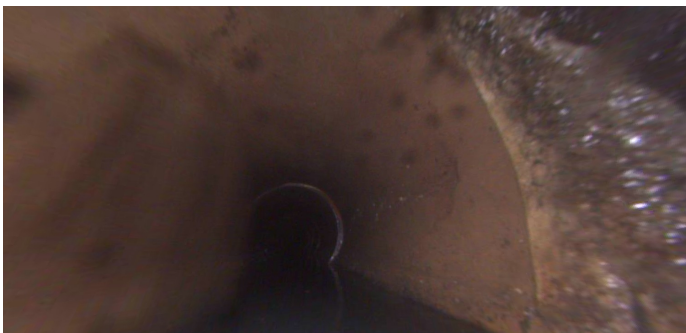
Code: **DAE**
Description: **Deposits Attached Encrustation**

Distance (ft): **85.8**
Structural Grade: **0**
O&M Grade: **2**
Clock Start/From: **1**
Clock To: **4**
1st Value:
2nd Value:
Value Percent: **5.000**
Continuous Index:
Within 8" of Joint: **YES**
Remarks:

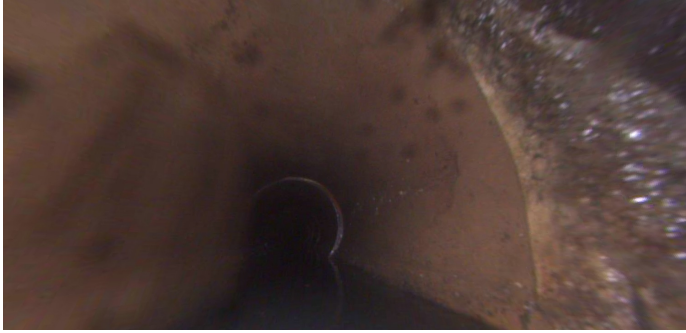
Code: **IW**
Description: **Infil Weeper**

Distance (ft): **85.8**
Structural Grade: **0**
O&M Grade: **2**
Clock Start/From: **1**
Clock To: **4**
1st Value:
2nd Value:
Value Percent:
Continuous Index:
Within 8" of Joint: **YES**
Remarks:

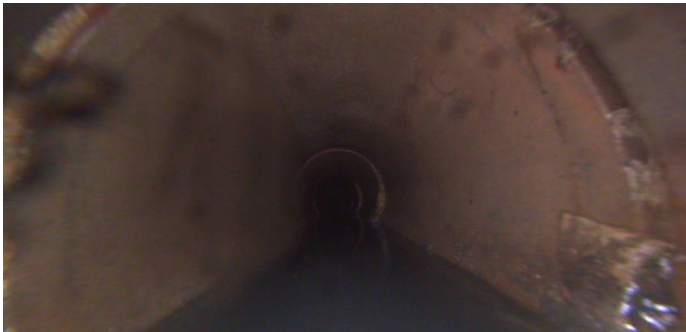
Code: **FM**
Description: **Fracture Multiple**

Distance (ft): **89.7**
Structural Grade: **4**
O&M Grade: **0**
Clock Start/From: **1**
Clock To: **4**
1st Value:
2nd Value:
Value Percent:
Continuous Index:
Within 8" of Joint: **YES**
Remarks:

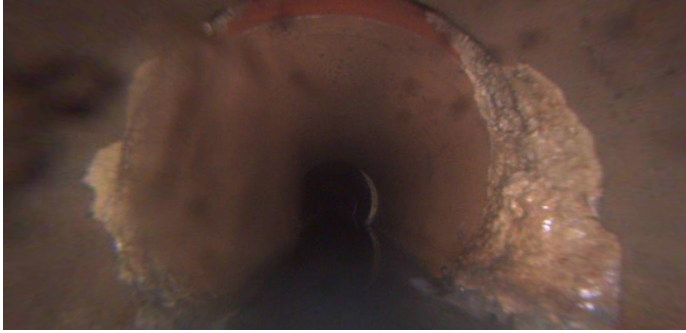
Code: **DAE**
Description: **Deposits Attached Encrustation**

Distance (ft): **91.5**
Structural Grade: **0**
O&M Grade: **2**
Clock Start/From: **8**
Clock To: **4**
1st Value:
2nd Value:
Value Percent: **5.000**
Continuous Index: **S01**
Within 8" of Joint: **YES**
Remarks:

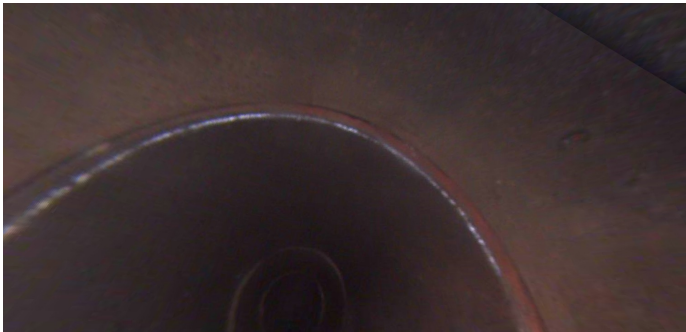
Code: **FM**
Description: **Fracture Multiple**

Distance (ft): **96.5**
Structural Grade: **4**
O&M Grade: **0**
Clock Start/From: **12**
Clock To: **3**
1st Value:
2nd Value:
Value Percent:
Continuous Index:
Within 8" of Joint: **YES**
Remarks:

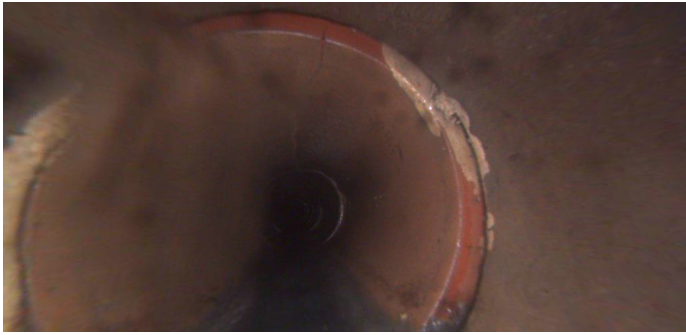
Code: **FM**
Description: **Fracture Multiple**

Distance (ft): **101.6**
Structural Grade: **4**
O&M Grade: **0**
Clock Start/From: **8**
Clock To: **4**
1st Value:
2nd Value:
Value Percent:
Continuous Index: **S02**
Within 8" of Joint: **YES**
Remarks:

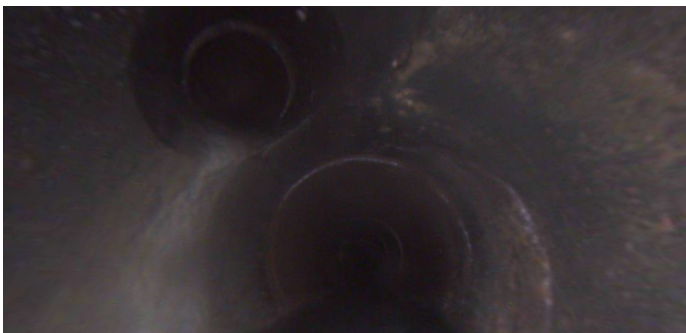
Code: **TFA**
Description: **Tap Factory Active**

Distance (ft): **115.3**
Structural Grade: **0**
O&M Grade: **0**
Clock Start/From: **1**
Clock To:
1st Value: **4.000**
2nd Value:
Value Percent:
Continuous Index:
Within 8" of Joint:
Remarks:

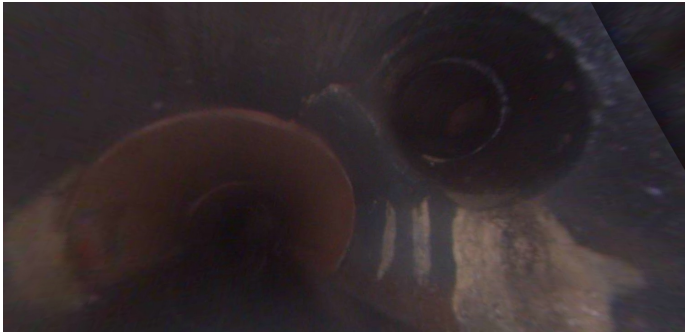
Code: **TFD**
Description: **Tap Factory Defective**

Distance (ft): **153.3**
Structural Grade: **0**
O&M Grade: **2**
Clock Start/From: **10**
Clock To:
1st Value: **4.000**
2nd Value:
Value Percent:
Continuous Index:
Within 8" of Joint:
Remarks: **fm**

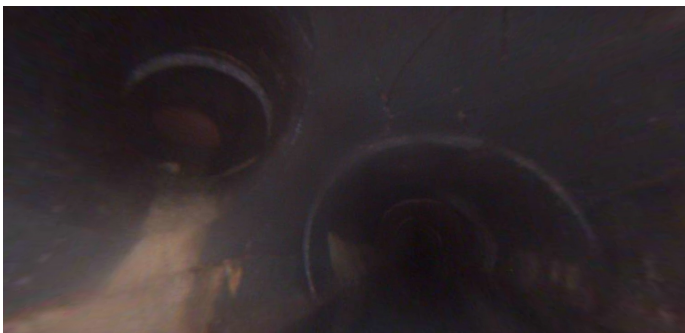
Code: **TF**
Description: **Tap Factory**

Distance (ft): **155.2**
Structural Grade: **0**
O&M Grade: **0**
Clock Start/From: **2**
Clock To:
1st Value: **4.000**
2nd Value:
Value Percent:
Continuous Index:
Within 8" of Joint:
Remarks:

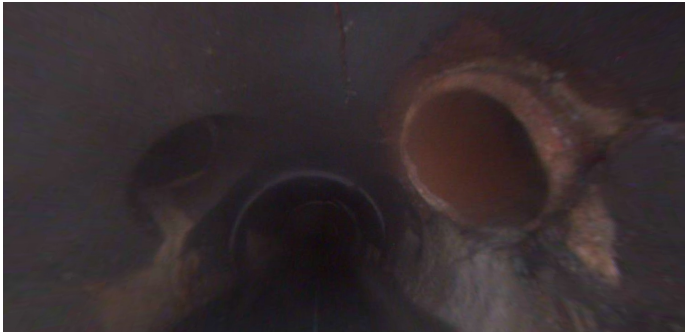
Code: **TBI**
Description: **Tap Break-in Intruding**

Distance (ft): **155.8**
Structural Grade: **0**
O&M Grade: **2**
Clock Start/From: **10**
Clock To:
1st Value: **4.000**
2nd Value: **1.000**
Value Percent:
Continuous Index:
Within 8" of Joint:
Remarks:

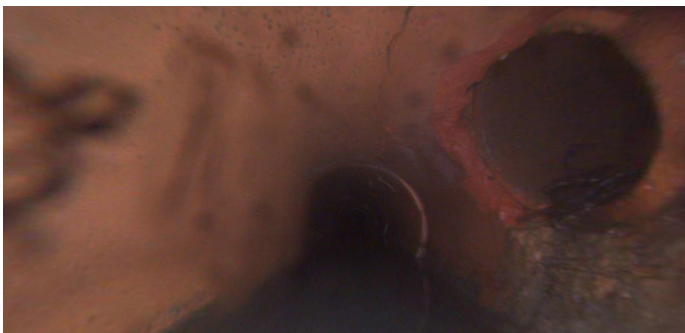
Code: **TBI**
Description: **Tap Break-in Intruding**

Distance (ft): **156.7**
Structural Grade: **0**
O&M Grade: **2**
Clock Start/From: **3**
Clock To:
1st Value: **4.000**
2nd Value: **1.000**
Value Percent:
Continuous Index:
Within 8" of Joint:
Remarks:

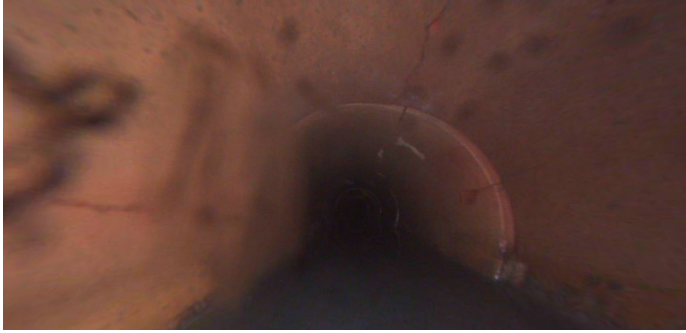
Code: **DAE**
Description: **Deposits Attached Encrustation**

Distance (ft): **157.4**
Structural Grade: **0**
O&M Grade: **2**
Clock Start/From: **8**
Clock To: **4**
1st Value:
2nd Value:
Value Percent: **5.000**
Continuous Index: **F01**
Within 8" of Joint: **YES**
Remarks:

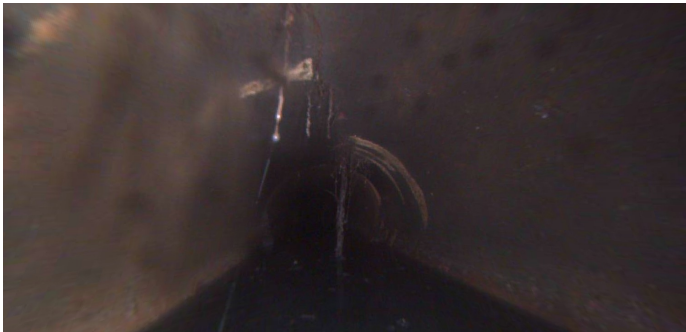
Code: **RFB**
Description: **Roots Fine Barrel**

Distance (ft): **182.8**
Structural Grade: **0**
O&M Grade: **2**
Clock Start/From: **12**
Clock To:
1st Value:
2nd Value:
Value Percent:
Continuous Index:
Within 8" of Joint: **NO**
Remarks:

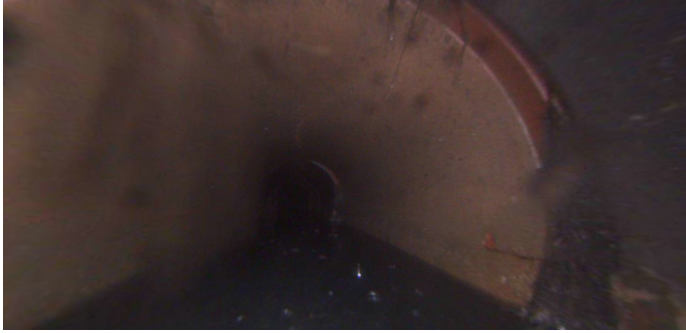
Code: **RMJ**
Description: **Roots Medium Joint**

Distance (ft): **184.3**
Structural Grade: **0**
O&M Grade: **3**
Clock Start/From: **8**
Clock To: **4**
1st Value:
2nd Value:
Value Percent: **5.000**
Continuous Index: **S03**
Within 8" of Joint: **YES**
Remarks:

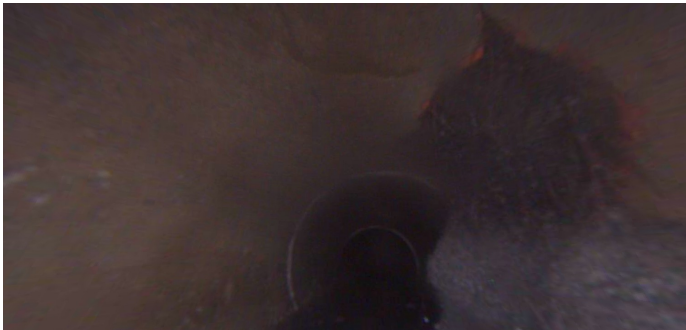
Code: **TBD**
Description: **Tap Break-in Defective**

Distance (ft): **195.7**
Structural Grade: **0**
O&M Grade: **3**
Clock Start/From: **10**
Clock To:
1st Value: **4.000**
2nd Value:
Value Percent:
Continuous Index:
Within 8" of Joint: **NO**
Remarks: **roots**

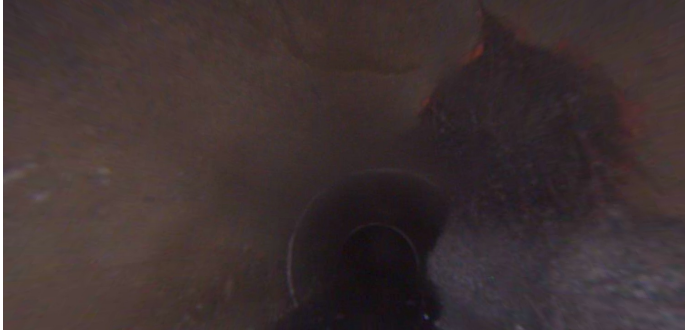
Code: **TBD**
Description: **Tap Break-in Defective**

Distance (ft): **195.7**
Structural Grade: **0**
O&M Grade: **3**
Clock Start/From: **10**
Clock To:
1st Value: **4.000**
2nd Value:
Value Percent:
Continuous Index:
Within 8" of Joint:
Remarks: **roots**

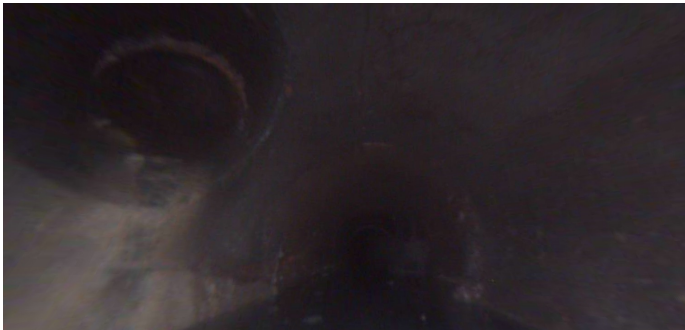
Code: **TF**
Description: **Tap Factory**

Distance (ft): **197.5**
Structural Grade: **0**
O&M Grade: **0**
Clock Start/From: **2**
Clock To:
1st Value: **4.000**
2nd Value:
Value Percent:
Continuous Index:
Within 8" of Joint:
Remarks:

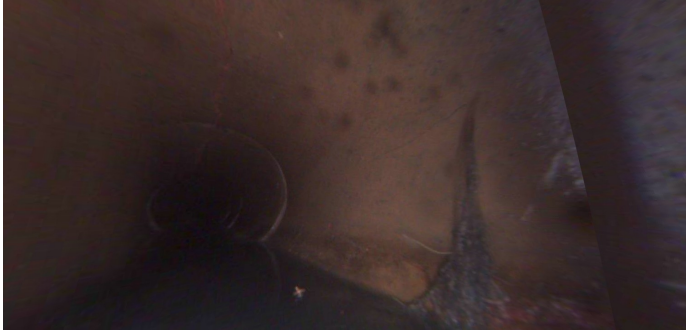
Code: **RFB**
Description: **Roots Fine Barrel**

Distance (ft): **206.8**
Structural Grade: **0**
O&M Grade: **2**
Clock Start/From: **2**
Clock To:
1st Value:
2nd Value:
Value Percent:
Continuous Index:
Within 8" of Joint: **NO**
Remarks:

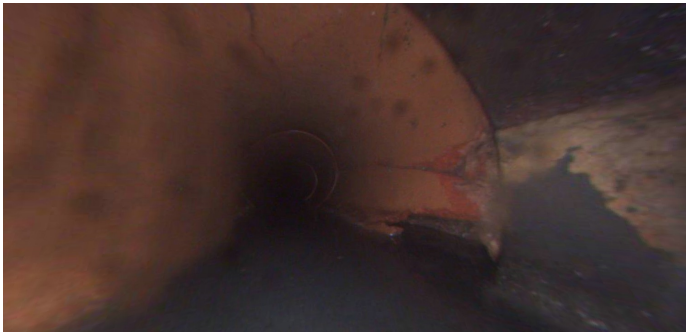
Code: **HVV**
Description: **Hole Void Visible**

Distance (ft): **218.2**
Structural Grade: **5**
O&M Grade: **0**
Clock Start/From: **4**
Clock To:
1st Value:
2nd Value:
Value Percent:
Continuous Index:
Within 8" of Joint:
Remarks:

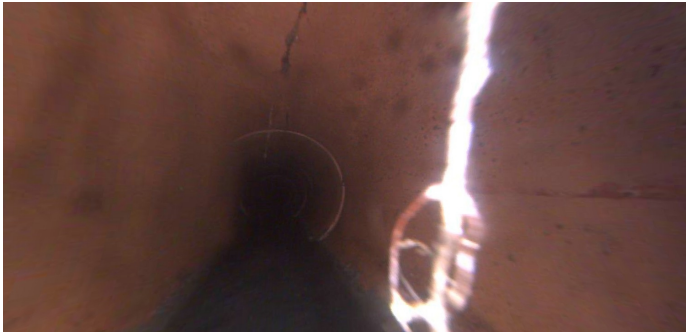
Code: **RFB**
Description: **Roots Fine Barrel**

Distance (ft): **229.2**
Structural Grade: **0**
O&M Grade: **2**
Clock Start/From: **12**
Clock To:
1st Value:
2nd Value:
Value Percent:
Continuous Index:
Within 8" of Joint: **NO**
Remarks:

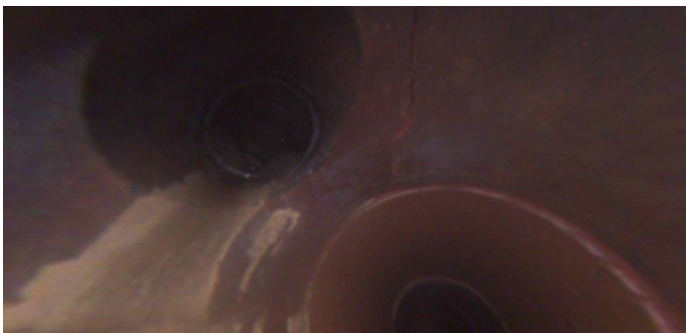
Code: **TF**
Description: **Tap Factory**

Distance (ft): **235.9**
Structural Grade: **0**
O&M Grade: **0**
Clock Start/From: **1**
Clock To:
1st Value: **4.000**
2nd Value:
Value Percent:
Continuous Index:
Within 8" of Joint:
Remarks:

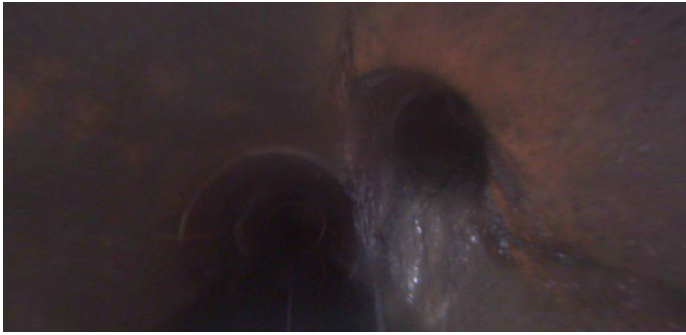
Code: **TFD**
Description: **Tap Factory Defective**

Distance (ft): **238.5**
Structural Grade: **0**
O&M Grade: **2**
Clock Start/From: **10**
Clock To:
1st Value: **4.000**
2nd Value:
Value Percent:
Continuous Index:
Within 8" of Joint:
Remarks: **FM, RML**

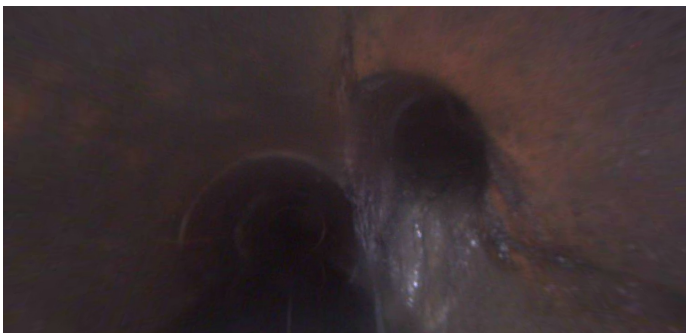
Code: **RML**
Description: **Roots Medium Lateral**

Distance (ft): **238.5**
Structural Grade: **0**
O&M Grade: **3**
Clock Start/From: **10**
Clock To:
1st Value:
2nd Value:
Value Percent: **5.000**
Continuous Index:
Within 8" of Joint: **NO**
Remarks:

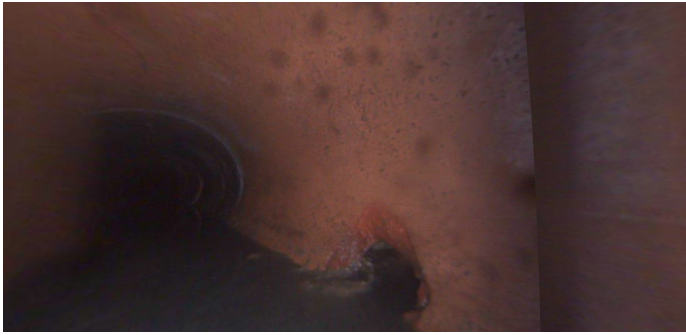
Code: HSV
Description: Hole Soil Visible

Distance (ft): 273.7
Structural Grade: 5
O&M Grade: 0
Clock Start/From: 4
Clock To:
1st Value:
2nd Value:
Value Percent:
Continuous Index:
Within 8" of Joint:
Remarks:

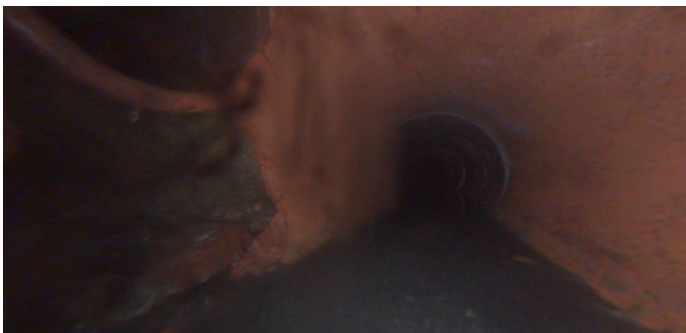
Code: HSV
Description: Hole Soil Visible

Distance (ft): 273.7
Structural Grade: 5
O&M Grade: 0
Clock Start/From: 8
Clock To: 9
1st Value:
2nd Value:
Value Percent:
Continuous Index:
Within 8" of Joint:
Remarks:

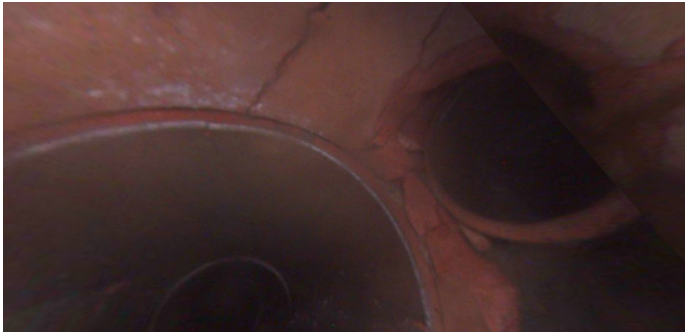
Code: **TBI**
Description: **Tap Break-in Intruding**

Distance (ft): **274.1**
Structural Grade: **0**
O&M Grade: **2**
Clock Start/From: **10**
Clock To:
1st Value: **4.000**
2nd Value: **1.000**
Value Percent:
Continuous Index:
Within 8" of Joint:
Remarks:

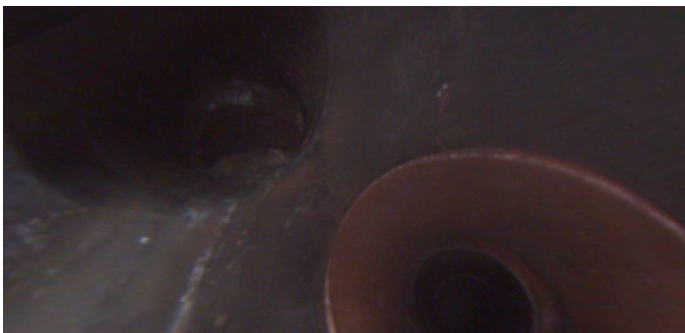
Code: **TF**
Description: **Tap Factory**

Distance (ft): **276.5**
Structural Grade: **0**
O&M Grade: **0**
Clock Start/From: **2**
Clock To:
1st Value: **4.000**
2nd Value:
Value Percent:
Continuous Index:
Within 8" of Joint:
Remarks:

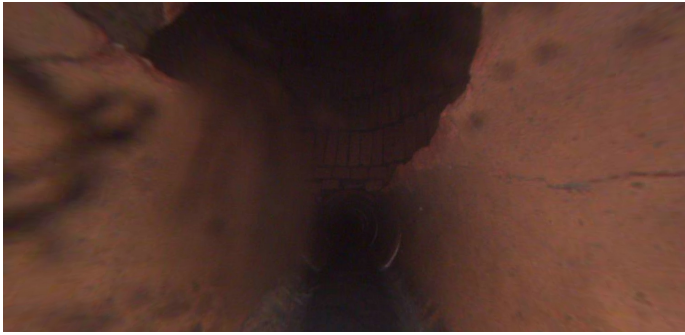
Code: **RMJ**
Description: **Roots Medium Joint**

Distance (ft): **285.9**
Structural Grade: **0**
O&M Grade: **3**
Clock Start/From: **8**
Clock To: **4**
1st Value:
2nd Value:
Value Percent: **5.000**
Continuous Index: **F03**
Within 8" of Joint: **YES**
Remarks:

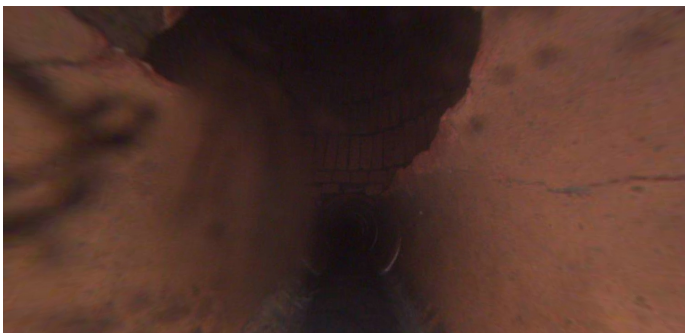
Code: **FM**
Description: **Fracture Multiple**

Distance (ft): **285.9**
Structural Grade: **4**
O&M Grade: **0**
Clock Start/From: **8**
Clock To: **4**
1st Value:
2nd Value:
Value Percent:
Continuous Index: **F02**
Within 8" of Joint: **YES**
Remarks:

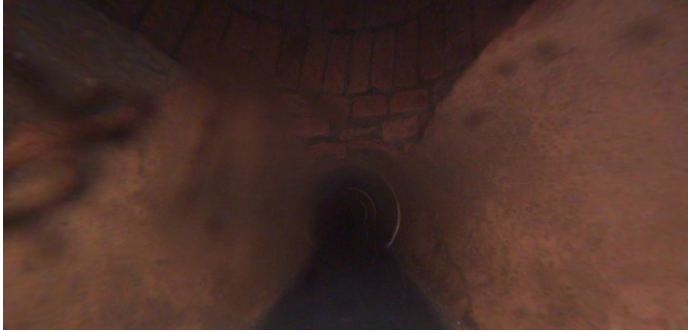
Code: **AMH**
Description: **Manhole**

Distance (ft): **288.0**
Structural Grade: **0**
O&M Grade: **0**
Clock Start/From:
Clock To:
1st Value:
2nd Value:
Value Percent:
Continuous Index:
Within 8" of Joint: **NO**
Remarks: **M-605-038**
