Profile/Photo Observation Report

Date:	04/25/2018	Weather:		Coding:	PACP 6.0
Pipe Length (ft):	.0	Owner:	NA	Pre Clean:	Not Known
P.O.#:		Surveyor:	Jen Costello	PSR:	P-605-038-037
Customer:		Clean Date:	01/01/1900	Shape:	C

Street:	Summerlin	Flow Control:	Not Controlled
City:	Hobart, IN	Year Renewed:	
Location:	Light Highway	Tape/Media #:	
Purpose:	Not Known	Dia/Height:	12"
Use:	Sanitary	Material:	VCP
Drain Area:	NA	Lining:	
Category:	NA		
Comment:

Location Details:		Direction of Survey:	Downstream
US MH:	M-605-037	DS MH:	M-605-038
		Total Length Surveyed (ft):	288.0

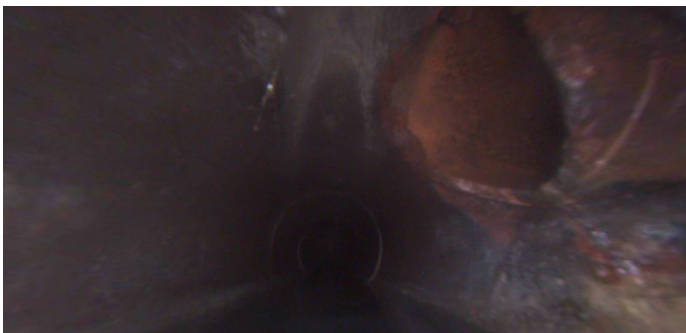
Code: **TBI**
Description: **Tap Break-in Intruding**

Distance (ft): **68.0**
Structural Grade: **0**
O&M Grade: **2**
Clock Start/From: **10**
Clock To:
1st Value: **4.000**
2nd Value: **2.000**
Value Percent:
Continuous Index:
Within 8" of Joint:
Remarks:

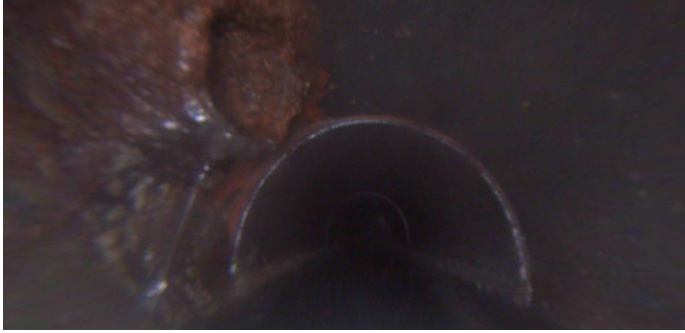
Code: **TBI**
Description: **Tap Break-in Intruding**

Distance (ft): **72.7**
Structural Grade: **0**
O&M Grade: **2**
Clock Start/From: **2**
Clock To:
1st Value: **4.000**
2nd Value: **1.000**
Value Percent:
Continuous Index:
Within 8" of Joint:
Remarks:

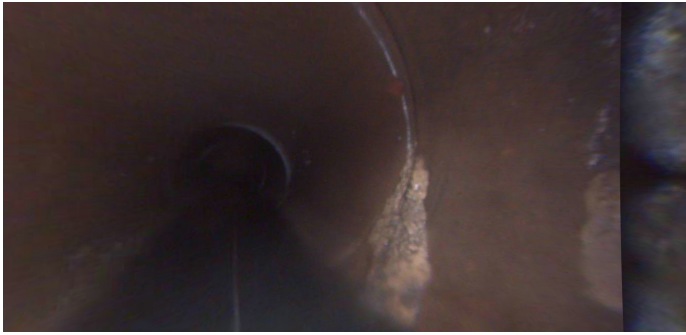
Code: **DAE**
Description: **Deposits Attached Encrustation**

Distance (ft): **78.4**
Structural Grade: **0**
O&M Grade: **2**
Clock Start/From: **8**
Clock To: **9**
1st Value:
2nd Value:
Value Percent: **5.000**
Continuous Index:
Within 8" of Joint: **YES**
Remarks:

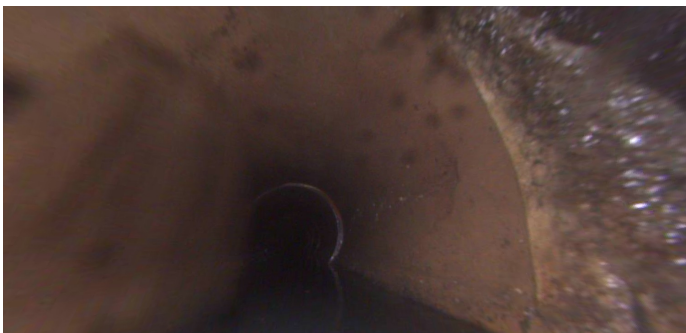
Code: **DAE**
Description: **Deposits Attached Encrustation**

Distance (ft): **85.8**
Structural Grade: **0**
O&M Grade: **2**
Clock Start/From: **1**
Clock To: **4**
1st Value:
2nd Value:
Value Percent: **5.000**
Continuous Index:
Within 8" of Joint: **YES**
Remarks:

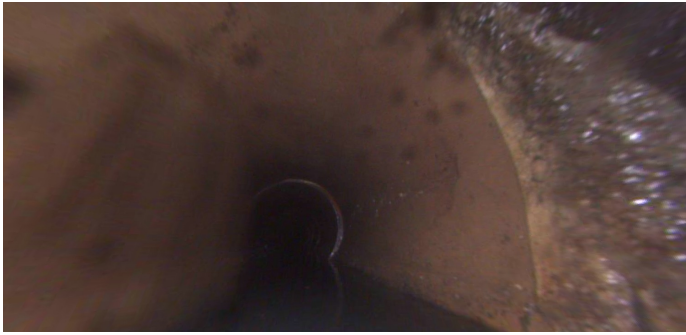
Code: **IW**
Description: **Infil Weeper**

Distance (ft): **85.8**
Structural Grade: **0**
O&M Grade: **2**
Clock Start/From: **1**
Clock To: **4**
1st Value:
2nd Value:
Value Percent:
Continuous Index:
Within 8" of Joint: **YES**
Remarks:

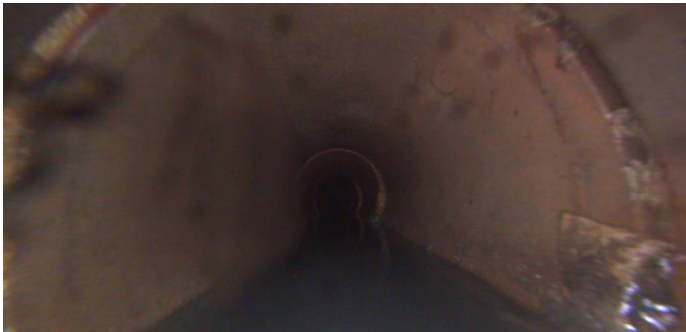
Code: **FM**
Description: **Fracture Multiple**

Distance (ft): **89.7**
Structural Grade: **4**
O&M Grade: **0**
Clock Start/From: **1**
Clock To: **4**
1st Value:
2nd Value:
Value Percent:
Continuous Index:
Within 8" of Joint: **YES**
Remarks:

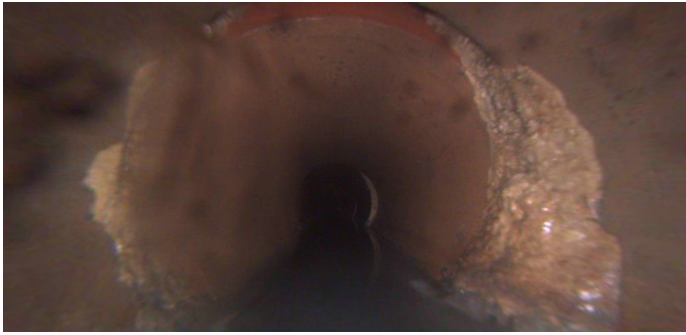
Code: **DAE**
Description: **Deposits Attached Encrustation**

Distance (ft): **91.5**
Structural Grade: **0**
O&M Grade: **2**
Clock Start/From: **8**
Clock To: **4**
1st Value:
2nd Value:
Value Percent: **5.000**
Continuous Index: **S01**
Within 8" of Joint: **YES**
Remarks:

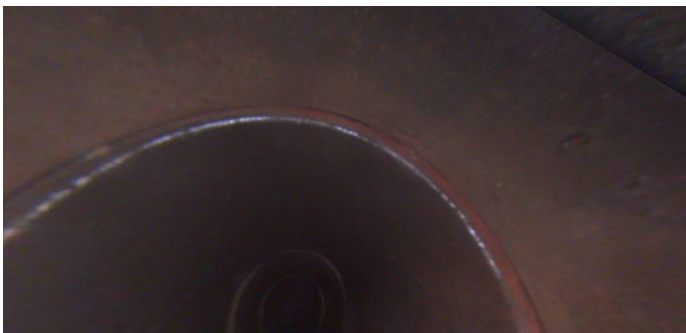
Code: **FM**
Description: **Fracture Multiple**

Distance (ft): **96.5**
Structural Grade: **4**
O&M Grade: **0**
Clock Start/From: **12**
Clock To: **3**
1st Value:
2nd Value:
Value Percent:
Continuous Index:
Within 8" of Joint: **YES**
Remarks:

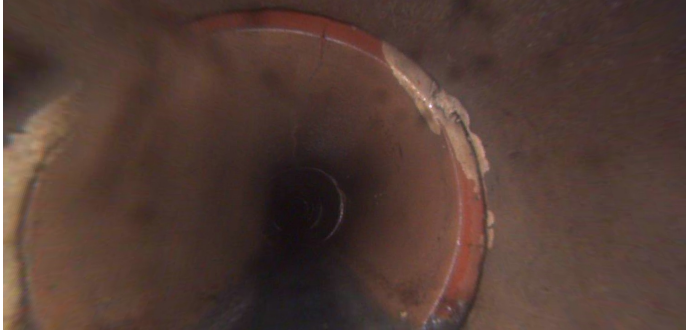
Code: **FM**
Description: **Fracture Multiple**

Distance (ft): **101.6**
Structural Grade: **4**
O&M Grade: **0**
Clock Start/From: **8**
Clock To: **4**
1st Value:
2nd Value:
Value Percent:
Continuous Index: **S02**
Within 8" of Joint: **YES**
Remarks:

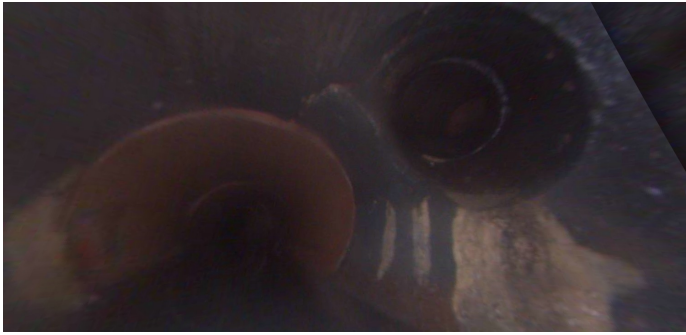
Code: **TFD**
Description: **Tap Factory Defective**

Distance (ft): **153.3**
Structural Grade: **0**
O&M Grade: **2**
Clock Start/From: **10**
Clock To:
1st Value: **4.000**
2nd Value:
Value Percent:
Continuous Index:
Within 8" of Joint:
Remarks: **fm**

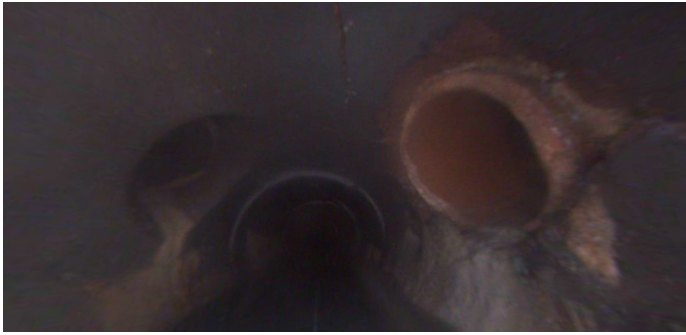
Code: **TBI**
Description: **Tap Break-in Intruding**

Distance (ft): **155.8**
Structural Grade: **0**
O&M Grade: **2**
Clock Start/From: **10**
Clock To:
1st Value: **4.000**
2nd Value: **1.000**
Value Percent:
Continuous Index:
Within 8" of Joint:
Remarks:

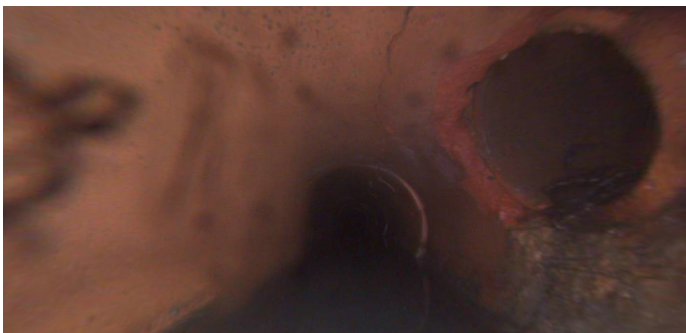
Code: **TBI**
Description: **Tap Break-in Intruding**

Distance (ft): **156.7**
Structural Grade: **0**
O&M Grade: **2**
Clock Start/From: **3**
Clock To:
1st Value: **4.000**
2nd Value: **1.000**
Value Percent:
Continuous Index:
Within 8" of Joint:
Remarks:

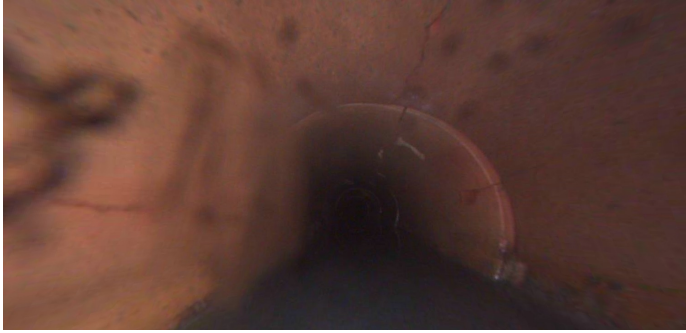
Code: **DAE**
Description: **Deposits Attached Encrustation**

Distance (ft): **157.4**
Structural Grade: **0**
O&M Grade: **2**
Clock Start/From: **8**
Clock To: **4**
1st Value:
2nd Value:
Value Percent: **5.000**
Continuous Index: **F01**
Within 8" of Joint: **YES**
Remarks:

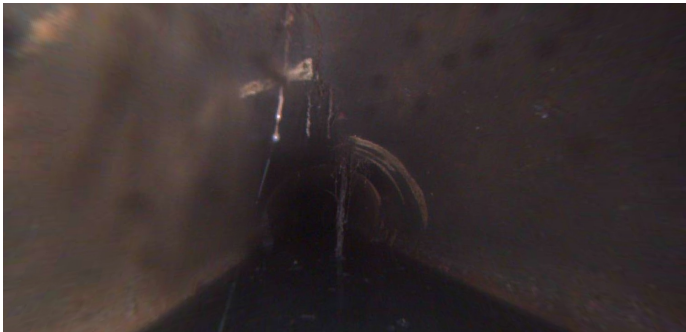
Code: **RFB**
Description: **Roots Fine Barrel**

Distance (ft): **182.8**
Structural Grade: **0**
O&M Grade: **2**
Clock Start/From: **12**
Clock To:
1st Value:
2nd Value:
Value Percent:
Continuous Index:
Within 8" of Joint: **NO**
Remarks:

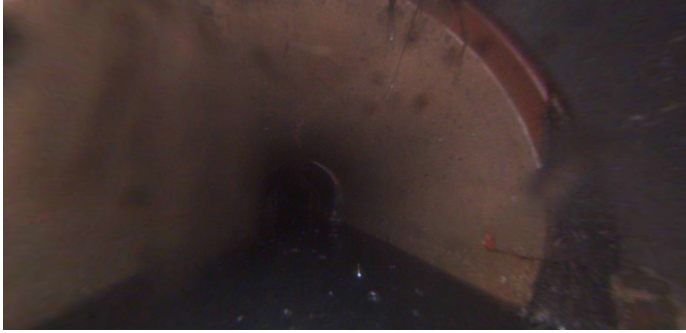
Code: **RMJ**
Description: **Roots Medium Joint**

Distance (ft): **184.3**
Structural Grade: **0**
O&M Grade: **3**
Clock Start/From: **8**
Clock To: **4**
1st Value:
2nd Value:
Value Percent: **5.000**
Continuous Index: **S03**
Within 8" of Joint: **YES**
Remarks:

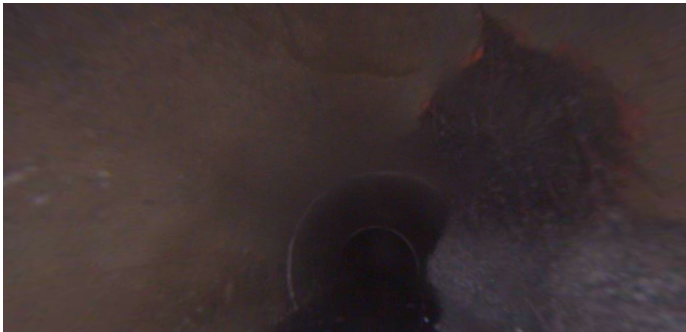
Code: **TBD**
Description: **Tap Break-in Defective**

Distance (ft): **195.7**
Structural Grade: **0**
O&M Grade: **3**
Clock Start/From: **10**
Clock To:
1st Value: **4.000**
2nd Value:
Value Percent:
Continuous Index:
Within 8" of Joint: **NO**
Remarks: **roots**

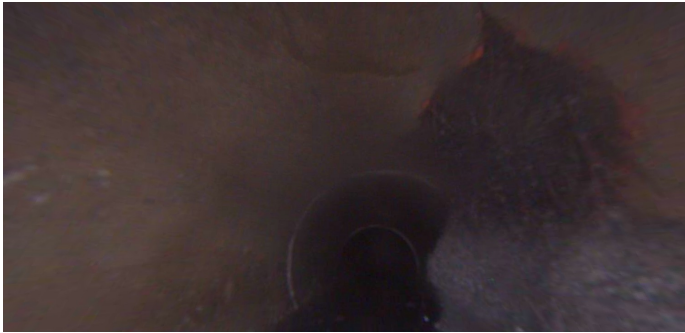
Code: **TBD**
Description: **Tap Break-in Defective**

Distance (ft): **195.7**
Structural Grade: **0**
O&M Grade: **3**
Clock Start/From: **10**
Clock To:
1st Value: **4.000**
2nd Value:
Value Percent:
Continuous Index:
Within 8" of Joint:
Remarks: **roots**

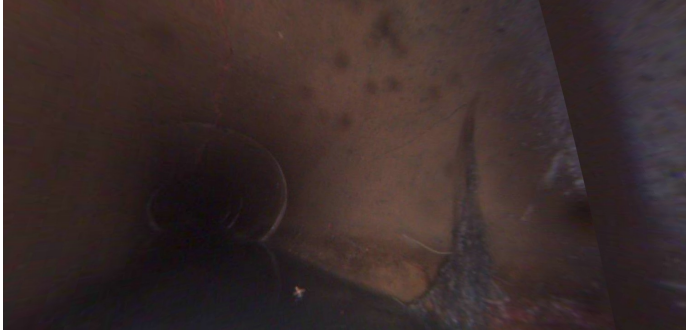
Code: **RFB**
Description: **Roots Fine Barrel**

Distance (ft): **206.8**
Structural Grade: **0**
O&M Grade: **2**
Clock Start/From: **2**
Clock To:
1st Value:
2nd Value:
Value Percent:
Continuous Index:
Within 8" of Joint: **NO**
Remarks:

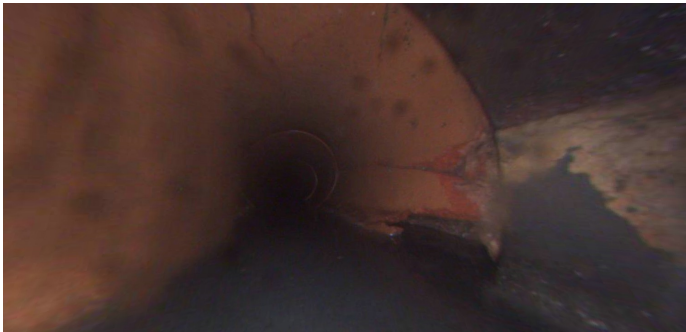
Code: **HVV**
Description: **Hole Void Visible**

Distance (ft): **218.2**
Structural Grade: **5**
O&M Grade: **0**
Clock Start/From: **4**
Clock To:
1st Value:
2nd Value:
Value Percent:
Continuous Index:
Within 8" of Joint:
Remarks:

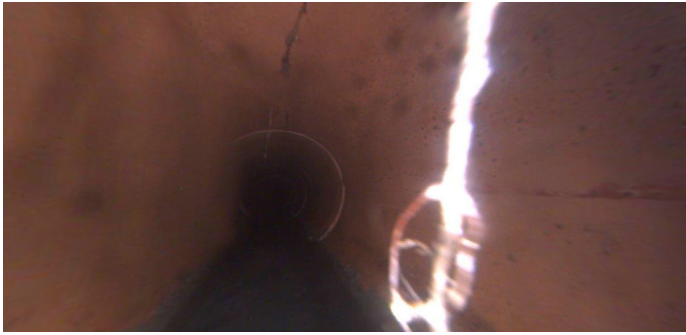
Code: **RFB**
Description: **Roots Fine Barrel**

Distance (ft): **229.2**
Structural Grade: **0**
O&M Grade: **2**
Clock Start/From: **12**
Clock To:
1st Value:
2nd Value:
Value Percent:
Continuous Index:
Within 8" of Joint: **NO**
Remarks:

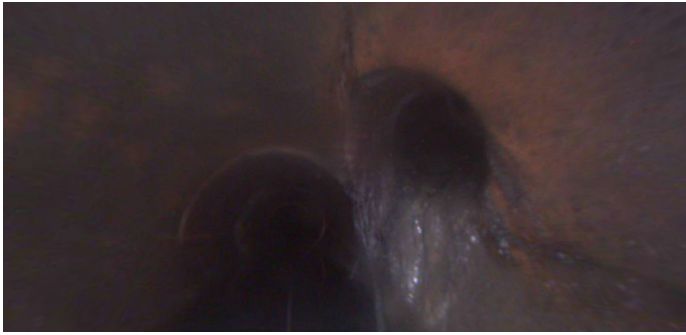
Code: **TFD**
Description: **Tap Factory Defective**

Distance (ft): **238.5**
Structural Grade: **0**
O&M Grade: **2**
Clock Start/From: **10**
Clock To:
1st Value: **4.000**
2nd Value:
Value Percent:
Continuous Index:
Within 8" of Joint:
Remarks: **FM, RML**

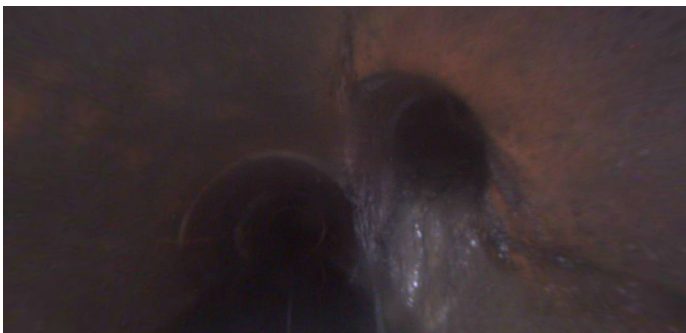
Code: **RML**
Description: **Roots Medium Lateral**

Distance (ft): **238.5**
Structural Grade: **0**
O&M Grade: **3**
Clock Start/From: **10**
Clock To:
1st Value:
2nd Value:
Value Percent: **5.000**
Continuous Index:
Within 8" of Joint: **NO**
Remarks:

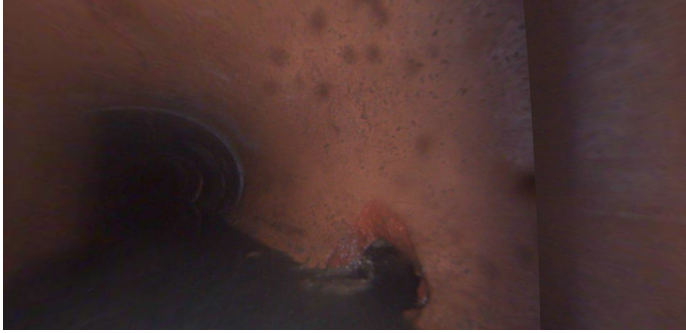
Code: HSV
Description: Hole Soil Visible

Distance (ft): 273.7
Structural Grade: 5
O&M Grade: 0
Clock Start/From: 4
Clock To:
1st Value:
2nd Value:
Value Percent:
Continuous Index:
Within 8" of Joint:
Remarks:

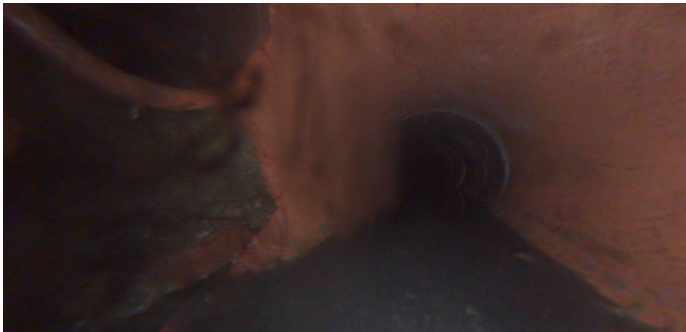
Code: HSV
Description: Hole Soil Visible

Distance (ft): 273.7
Structural Grade: 5
O&M Grade: 0
Clock Start/From: 8
Clock To: 9
1st Value:
2nd Value:
Value Percent:
Continuous Index:
Within 8" of Joint:
Remarks:

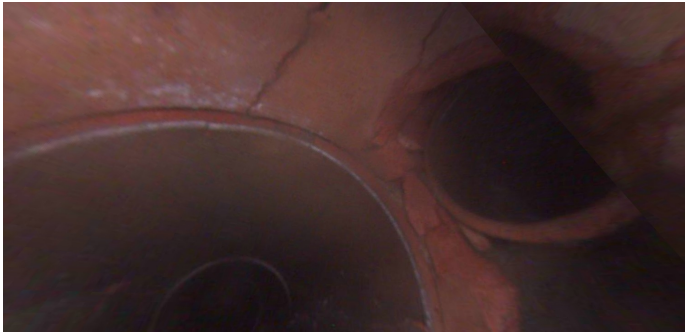
Code: **TBI**
Description: **Tap Break-in Intruding**

Distance (ft): **274.1**
Structural Grade: **0**
O&M Grade: **2**
Clock Start/From: **10**
Clock To:
1st Value: **4.000**
2nd Value: **1.000**
Value Percent:
Continuous Index:
Within 8" of Joint:
Remarks:

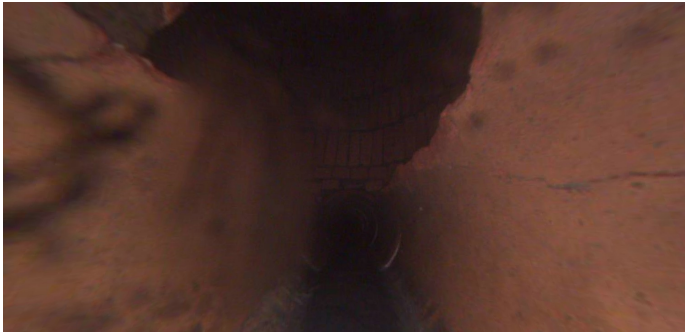
Code: **RMJ**
Description: **Roots Medium Joint**

Distance (ft): **285.9**
Structural Grade: **0**
O&M Grade: **3**
Clock Start/From: **8**
Clock To: **4**
1st Value:
2nd Value:
Value Percent: **5.000**
Continuous Index: **F03**
Within 8" of Joint: **YES**
Remarks:

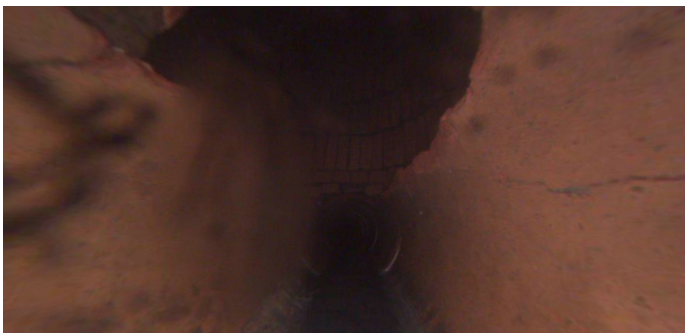
Code: **FM**
Description: **Fracture Multiple**

Distance (ft): **285.9**
Structural Grade: **4**
O&M Grade: **0**
Clock Start/From: **8**
Clock To: **4**
1st Value:
2nd Value:
Value Percent:
Continuous Index: **F02**
Within 8" of Joint: **YES**
Remarks:
