Profile/Photo Observation Report

Date:	04/24/2018	Weather:		Coding:	PACP 6.0
Pipe Length (ft):	210.4	Owner:	NA	Pre Clean:	Not Known
P.O.#:		Surveyor:	Jen Costello	PSR:	P-605-039-038
Customer:		Clean Date:	01/01/1900	Shape:	C

Street:	S PENNSYLVANIA ST	Flow Control:	Not Controlled
City:	Hobart, IN	Year Renewed:	
Location:	Other	Tape/Media #:	
Purpose:	Not Known	Dia/Height:	12"
Use:	Sanitary	Material:	VCP
Drain Area:	NA	Lining:	
Category:	NA		
Comment:

Location Details:		Direction of Survey:	Upstream
US MH:	M-605-038	DS MH:	M-605-039
		Total Length Surveyed (ft):	108.1

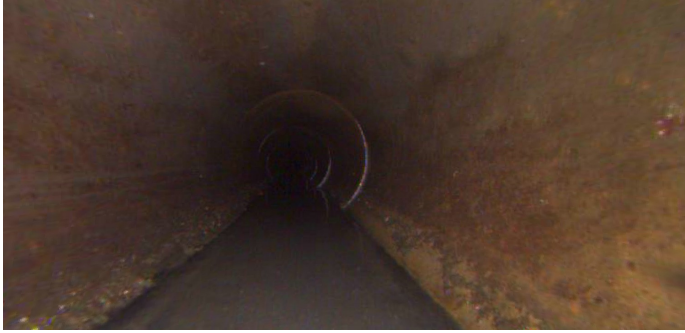
Code: **AMH**
Description: **Manhole**

Distance (ft): **.0**
Structural Grade: **0**
O&M Grade: **0**
Clock Start/From:
Clock To:
1st Value:
2nd Value:
Value Percent:
Continuous Index:
Within 8" of Joint: **NO**
Remarks: **M-605-039**

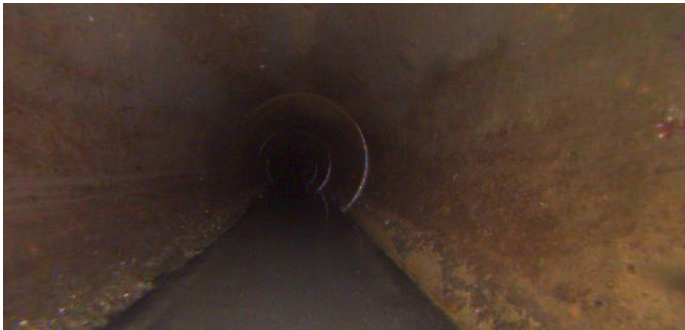
Code: **MWL**
Description: **Water Level**

Distance (ft): **.0**
Structural Grade: **0**
O&M Grade: **0**
Clock Start/From:
Clock To:
1st Value:
2nd Value:
Value Percent: **10.000**
Continuous Index:
Within 8" of Joint: **NO**
Remarks:

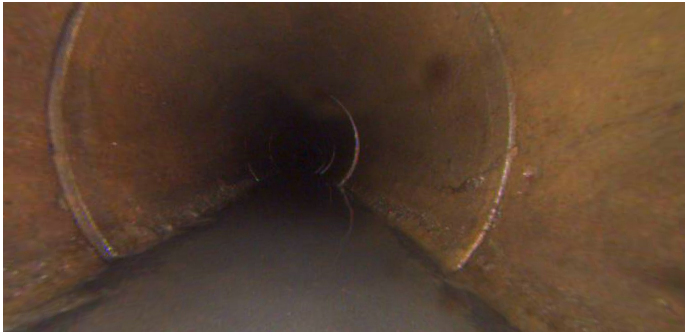
Code: **RFJ**
Description: **Roots Fine Joint**

Distance (ft): **8.1**
Structural Grade: **0**
O&M Grade: **1**
Clock Start/From: **3**
Clock To:
1st Value:
2nd Value:
Value Percent:
Continuous Index:
Within 8" of Joint: **YES**
Remarks:

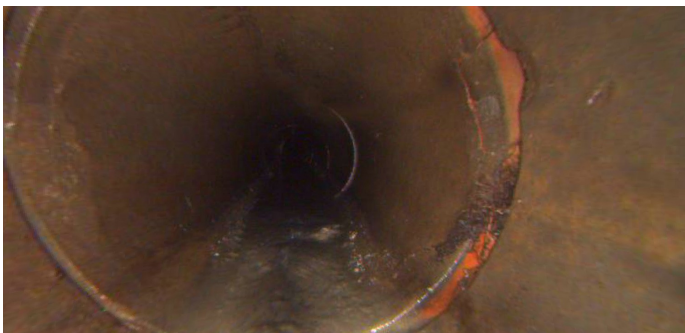
Code: **FC**
Description: **Fracture Circumferential**

Distance (ft): **14.0**
Structural Grade: **2**
O&M Grade: **0**
Clock Start/From: **2**
Clock To: **4**
1st Value:
2nd Value:
Value Percent:
Continuous Index:
Within 8" of Joint: **YES**
Remarks:

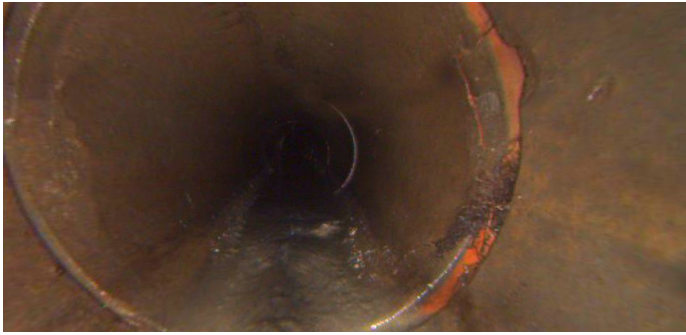
Code: **RFJ**
Description: **Roots Fine Joint**

Distance (ft): **14.0**
Structural Grade: **0**
O&M Grade: **1**
Clock Start/From: **3**
Clock To: **4**
1st Value:
2nd Value:
Value Percent:
Continuous Index:
Within 8" of Joint: **YES**
Remarks:

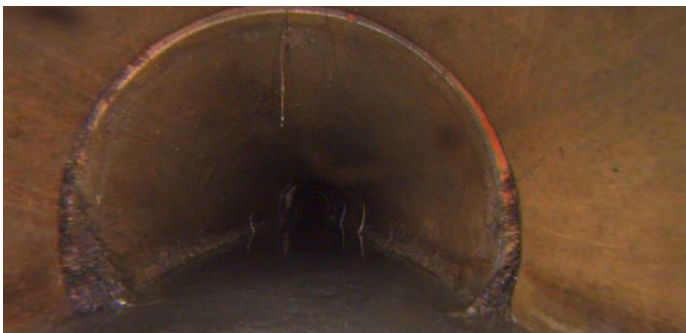
Code: **RFJ**
Description: **Roots Fine Joint**

Distance (ft): **17.9**
Structural Grade: **0**
O&M Grade: **1**
Clock Start/From: **8**
Clock To: **4**
1st Value:
2nd Value:
Value Percent:
Continuous Index:
Within 8" of Joint: **YES**
Remarks:

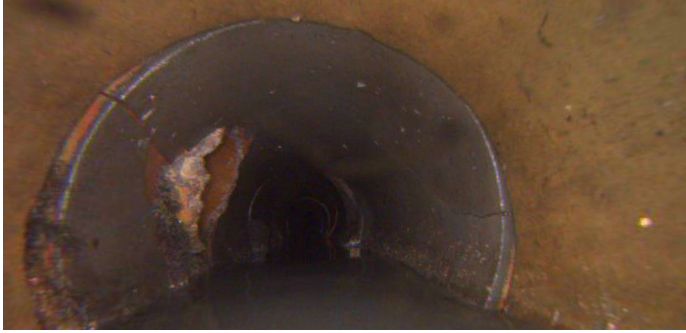
Code: **FM**
Description: **Fracture Multiple**

Distance (ft): **21.9**
Structural Grade: **4**
O&M Grade: **0**
Clock Start/From: **8**
Clock To: **4**
1st Value:
2nd Value:
Value Percent:
Continuous Index:
Within 8" of Joint: **YES**
Remarks:

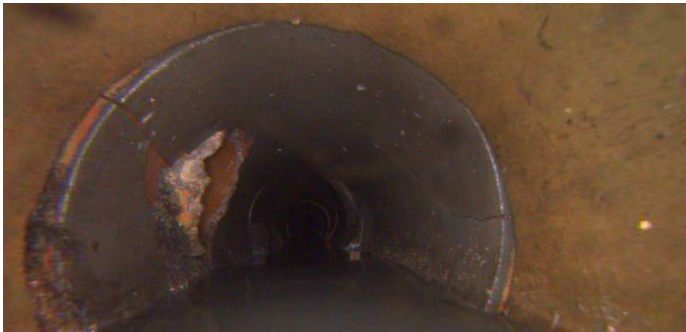
Code: **RFJ**
Description: **Roots Fine Joint**

Distance (ft): **21.9**
Structural Grade: **0**
O&M Grade: **1**
Clock Start/From: **8**
Clock To: **9**
1st Value:
2nd Value:
Value Percent:
Continuous Index:
Within 8" of Joint: **YES**
Remarks:

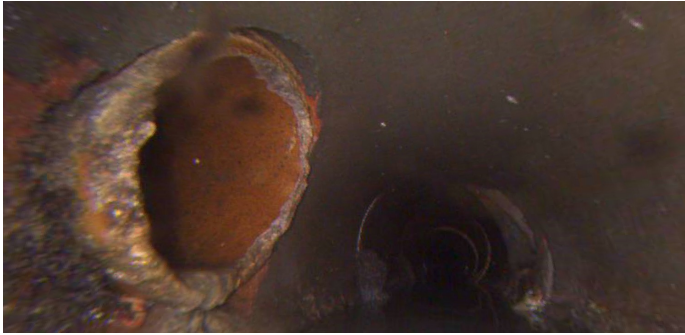
Code: **TBI**
Description: **Tap Break-in Intruding**

Distance (ft): **22.7**
Structural Grade: **0**
O&M Grade: **2**
Clock Start/From: **9**
Clock To:
1st Value: **4.000**
2nd Value: **1.000**
Value Percent:
Continuous Index:
Within 8" of Joint:
Remarks:

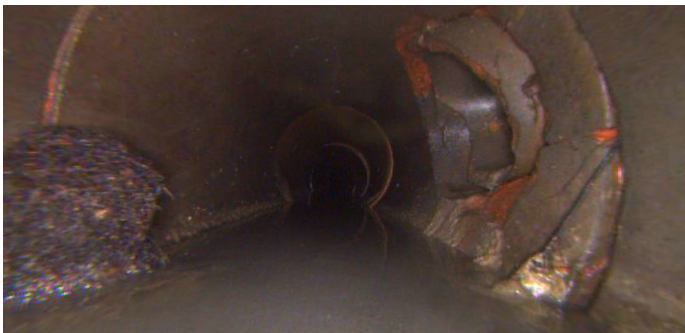
Code: **RMJ**
Description: **Roots Medium Joint**

Distance (ft): **24.0**
Structural Grade: **0**
O&M Grade: **3**
Clock Start/From: **8**
Clock To: **4**
1st Value:
2nd Value:
Value Percent: **10.000**
Continuous Index:
Within 8" of Joint: **YES**
Remarks:

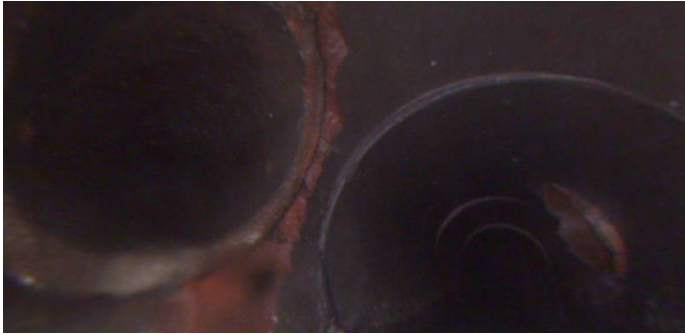
Code: **TBI**
Description: **Tap Break-in Intruding**

Distance (ft): **25.5**
Structural Grade: **0**
O&M Grade: **2**
Clock Start/From: **2**
Clock To:
1st Value: **4.000**
2nd Value: **1.000**
Value Percent:
Continuous Index:
Within 8" of Joint:
Remarks:

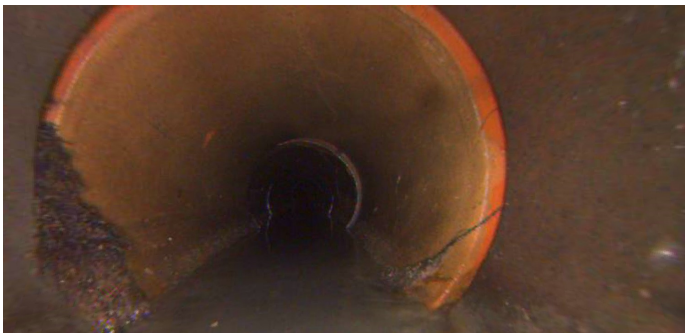
Code: **RMJ**
Description: **Roots Medium Joint**

Distance (ft): **25.8**
Structural Grade: **0**
O&M Grade: **3**
Clock Start/From: **8**
Clock To: **4**
1st Value:
2nd Value:
Value Percent: **5.000**
Continuous Index:
Within 8" of Joint: **YES**
Remarks:

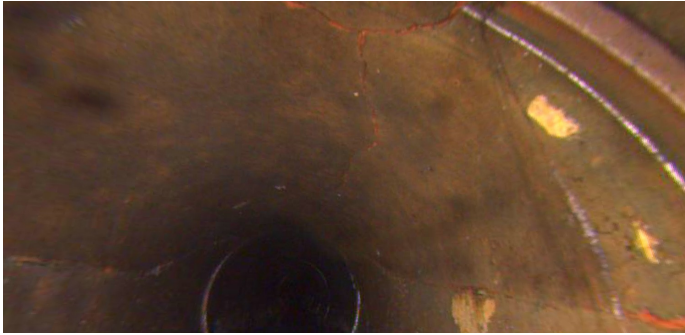
Code: **RFJ**
Description: **Roots Fine Joint**

Distance (ft): **28.3**
Structural Grade: **0**
O&M Grade: **1**
Clock Start/From: **1**
Clock To:
1st Value:
2nd Value:
Value Percent:
Continuous Index:
Within 8" of Joint: **YES**
Remarks:

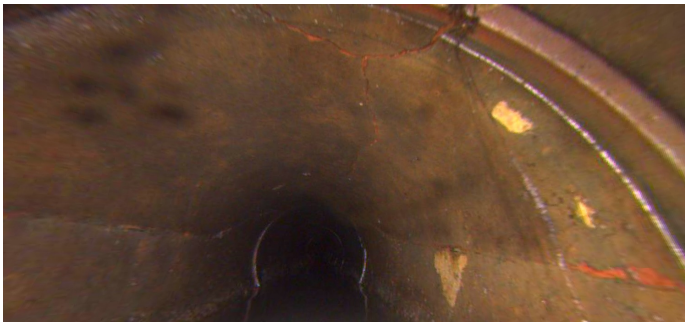
Code: **FM**
Description: **Fracture Multiple**

Distance (ft): **28.3**
Structural Grade: **4**
O&M Grade: **0**
Clock Start/From: **8**
Clock To: **4**
1st Value:
2nd Value:
Value Percent:
Continuous Index:
Within 8" of Joint: **YES**
Remarks:

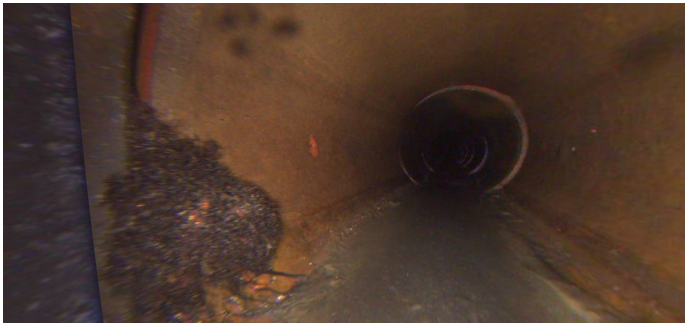
Code: **RMJ**
Description: **Roots Medium Joint**

Distance (ft): **40.3**
Structural Grade: **0**
O&M Grade: **3**
Clock Start/From: **8**
Clock To: **9**
1st Value:
2nd Value:
Value Percent: **5.000**
Continuous Index:
Within 8" of Joint: **YES**
Remarks:

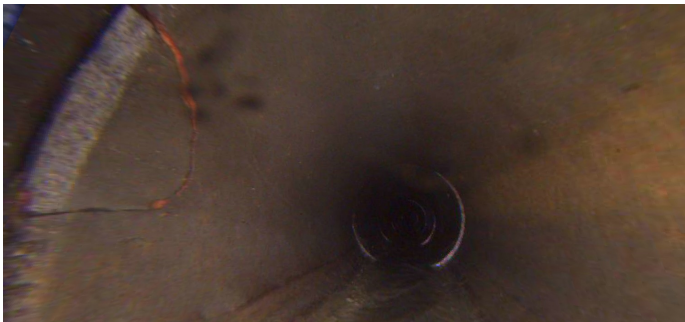
Code: **FS**
Description: **Fracture Spiral**

Distance (ft): **46.3**
Structural Grade: **3**
O&M Grade: **0**
Clock Start/From: **9**
Clock To: **10**
1st Value:
2nd Value:
Value Percent:
Continuous Index:
Within 8" of Joint: **YES**
Remarks:

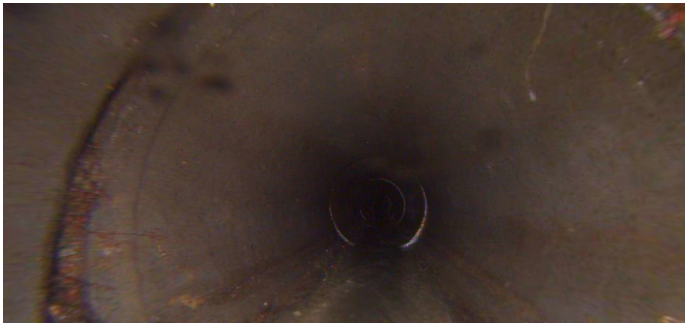
Code: **RFJ**
Description: **Roots Fine Joint**

Distance (ft): **48.1**
Structural Grade: **0**
O&M Grade: **1**
Clock Start/From: **8**
Clock To: **4**
1st Value:
2nd Value:
Value Percent:
Continuous Index:
Within 8" of Joint: **YES**
Remarks:

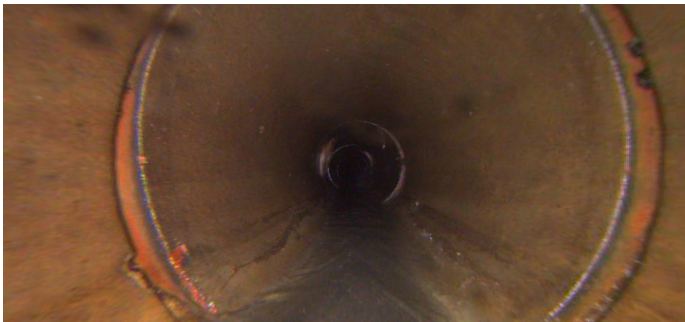
Code: **FL**
Description: **Fracture Longitudinal**

Distance (ft): **60.0**
Structural Grade: **3**
O&M Grade: **0**
Clock Start/From: **8**
Clock To:
1st Value:
2nd Value:
Value Percent:
Continuous Index:
Within 8" of Joint: **YES**
Remarks:

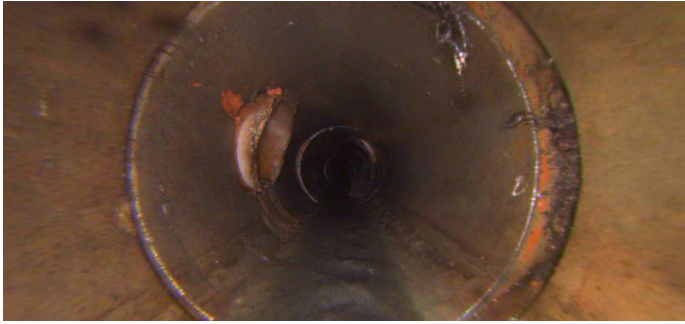
Code: **RFJ**
Description: **Roots Fine Joint**

Distance (ft): **61.9**
Structural Grade: **0**
O&M Grade: **1**
Clock Start/From: **8**
Clock To: **4**
1st Value:
2nd Value:
Value Percent:
Continuous Index: **S01**
Within 8" of Joint: **YES**
Remarks:

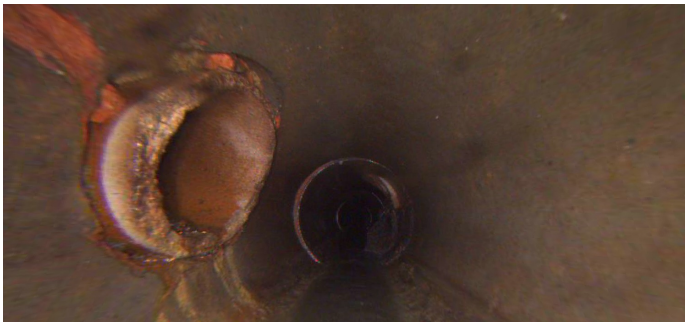
Code: **TBI**
Description: **Tap Break-in Intruding**

Distance (ft): **62.6**
Structural Grade: **0**
O&M Grade: **2**
Clock Start/From: **9**
Clock To:
1st Value: **4.000**
2nd Value: **1.000**
Value Percent:
Continuous Index:
Within 8" of Joint:
Remarks:

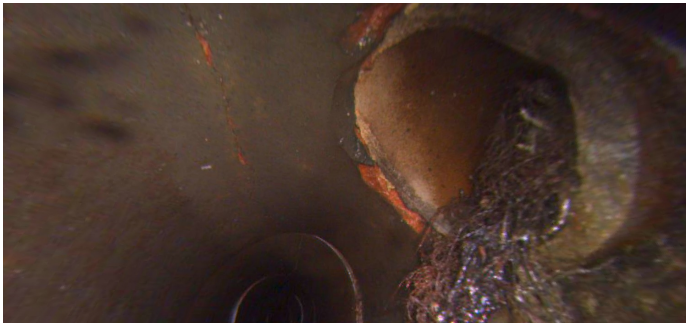
Code: **TBI**
Description: **Tap Break-in Intruding**

Distance (ft): **64.8**
Structural Grade: **0**
O&M Grade: **2**
Clock Start/From: **1**
Clock To:
1st Value: **4.000**
2nd Value: **1.000**
Value Percent:
Continuous Index:
Within 8" of Joint:
Remarks: **ROOTS**

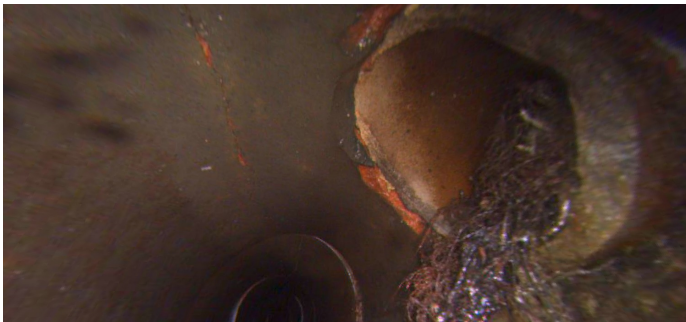
Code: **RML**
Description: **Roots Medium Lateral**

Distance (ft): **64.8**
Structural Grade: **0**
O&M Grade: **3**
Clock Start/From: **2**
Clock To:
1st Value:
2nd Value:
Value Percent: **10.000**
Continuous Index:
Within 8" of Joint: **NO**
Remarks:

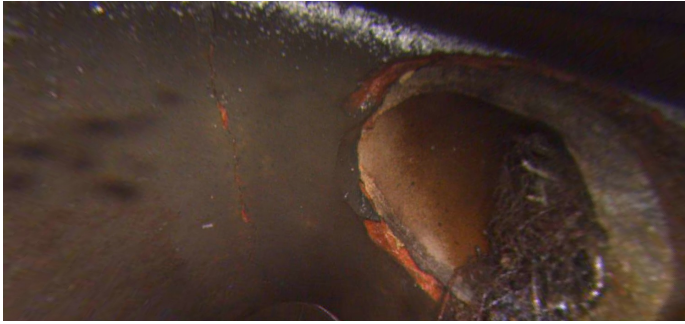
Code: **FL**
Description: **Fracture Longitudinal**

Distance (ft): **64.8**
Structural Grade: **3**
O&M Grade: **0**
Clock Start/From: **12**
Clock To:
1st Value:
2nd Value:
Value Percent:
Continuous Index:
Within 8" of Joint: **YES**
Remarks:

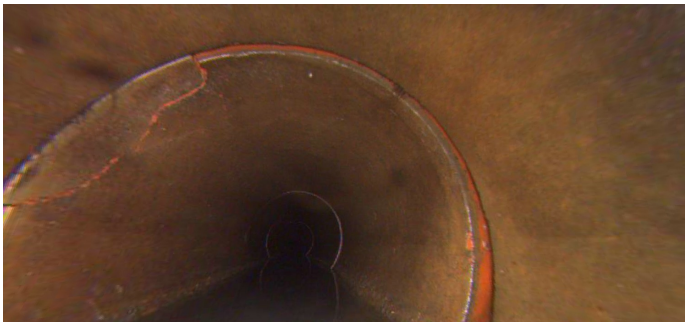
Code: **FC**
Description: **Fracture Circumferential**

Distance (ft): **81.8**
Structural Grade: **2**
O&M Grade: **0**
Clock Start/From: **10**
Clock To: **12**
1st Value:
2nd Value:
Value Percent:
Continuous Index:
Within 8" of Joint: **YES**
Remarks:

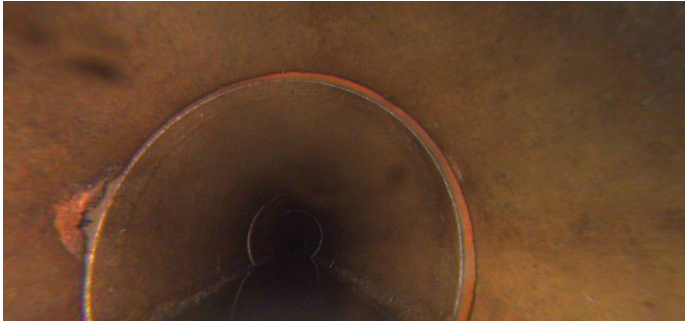
Code: **SSS**
Description: **Surface Spalling**

Distance (ft): **83.7**
Structural Grade: **2**
O&M Grade: **0**
Clock Start/From: **9**
Clock To:
1st Value:
2nd Value:
Value Percent:
Continuous Index:
Within 8" of Joint: **YES**
Remarks:

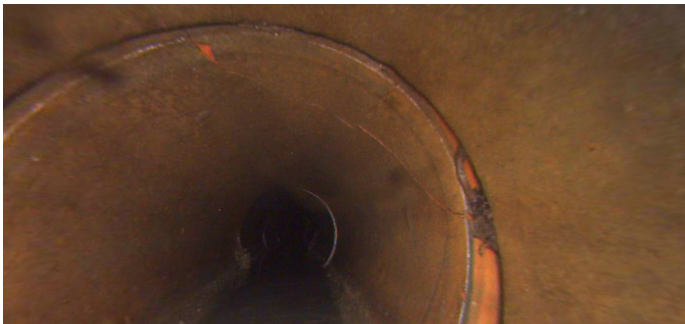
Code: **FM**
Description: **Fracture Multiple**

Distance (ft): **91.9**
Structural Grade: **4**
O&M Grade: **0**
Clock Start/From: **12**
Clock To: **3**
1st Value:
2nd Value:
Value Percent:
Continuous Index:
Within 8" of Joint: **YES**
Remarks:

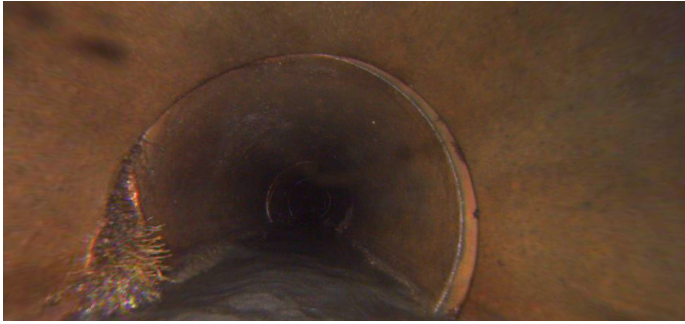
Code: **RMJ**
Description: **Roots Medium Joint**

Distance (ft): **93.7**
Structural Grade: **0**
O&M Grade: **3**
Clock Start/From: **8**
Clock To: **9**
1st Value:
2nd Value:
Value Percent: **5.000**
Continuous Index:
Within 8" of Joint: **YES**
Remarks:

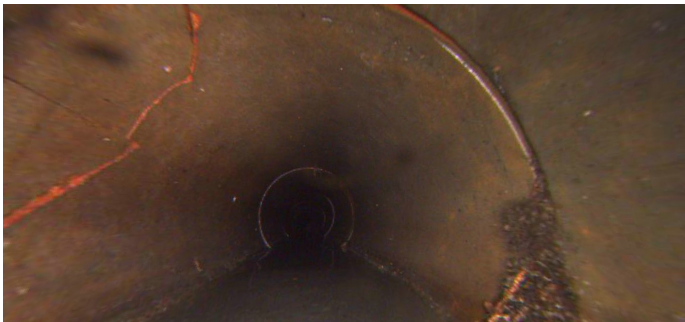
Code: **FM**
Description: **Fracture Multiple**

Distance (ft): **96.0**
Structural Grade: **4**
O&M Grade: **0**
Clock Start/From: **8**
Clock To: **4**
1st Value:
2nd Value:
Value Percent:
Continuous Index: **S02**
Within 8" of Joint: **YES**
Remarks:

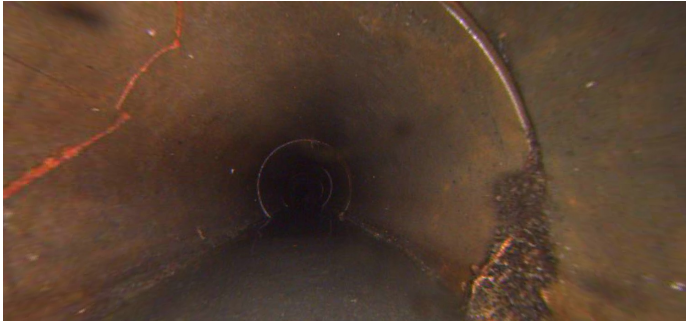
Code: **RMJ**
Description: **Roots Medium Joint**

Distance (ft): **96.0**
Structural Grade: **0**
O&M Grade: **3**
Clock Start/From: **3**
Clock To: **4**
1st Value:
2nd Value:
Value Percent: **5.000**
Continuous Index:
Within 8" of Joint: **YES**
Remarks:

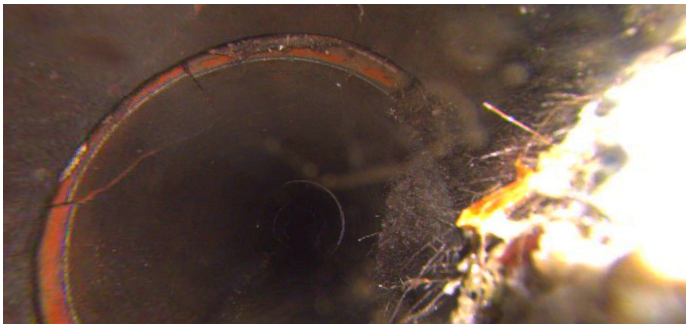
Code: **RMJ**
Description: **Roots Medium Joint**

Distance (ft): **108.1**
Structural Grade: **0**
O&M Grade: **3**
Clock Start/From: **1**
Clock To: **4**
1st Value:
2nd Value:
Value Percent: **10.000**
Continuous Index:
Within 8" of Joint: **YES**
Remarks:

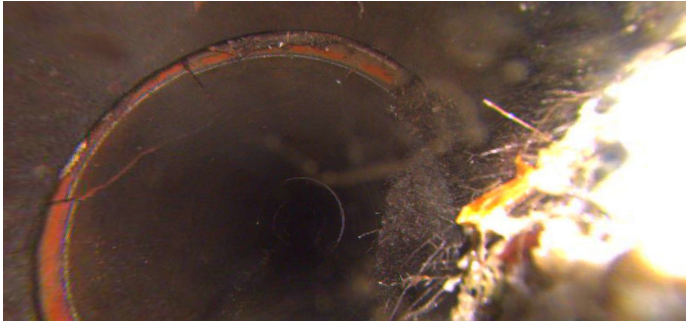
Code: **FM**
Description: **Fracture Multiple**

Distance (ft): **108.1**
Structural Grade: **4**
O&M Grade: **0**
Clock Start/From: **8**
Clock To: **4**
1st Value:
2nd Value:
Value Percent:
Continuous Index: **F02**
Within 8" of Joint: **YES**
Remarks:

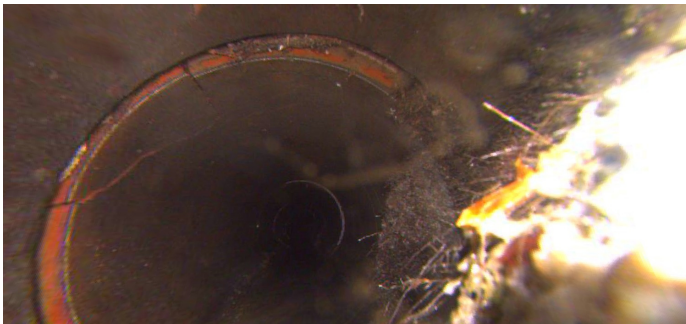
Code: **RFJ**
Description: **Roots Fine Joint**

Distance (ft): **108.1**
Structural Grade: **0**
O&M Grade: **1**
Clock Start/From: **8**
Clock To: **4**
1st Value:
2nd Value:
Value Percent:
Continuous Index: **F01**
Within 8" of Joint: **YES**
Remarks:

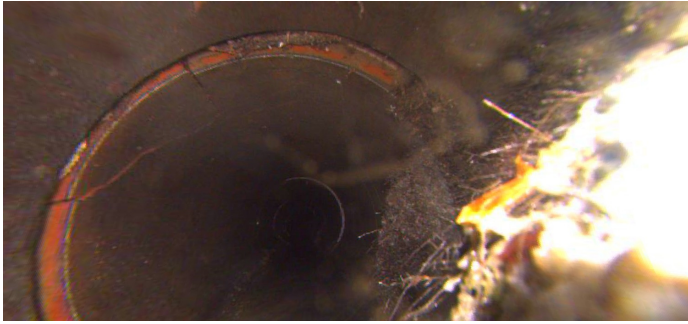
Code:	MSA
Description:	Abandoned Survey
Distance (ft):	108.1
Structural Grade:	0
O&M Grade:	0
Clock Start/From:	
Clock To:	
1st Value:	
2nd Value:	
Value Percent:	
Continuous Index:	
Within 8" of Joint:	NO
Remarks:	ROOTS
