Profile/Photo Observation Report

Date:	04/24/2018	Weather:		Coding:	PACP 6.0
Pipe Length (ft):	210.4	Owner:	NA	Pre Clean:	Not Known
P.O.#:		Surveyor:	Jen Costello	PSR:	P-605-039-038
Customer:		Clean Date:	01/01/1900	Shape:	C

Street:	S Pennsylvania St.	Flow Control:	Not Controlled
City:	Hobart, IN	Year Renewed:	
Location:	Other	Tape/Media #:	
Purpose:	Not Known	Dia/Height:	12"
Use:	Sanitary	Material:	VCP
Drain Area:	NA	Lining:	
Category:	NA		
Comment:

Location Details:		Direction of Survey:	Upstream
US MH:	M-605-038	DS MH:	M-605-039
		Total Length Surveyed (ft):	108.1

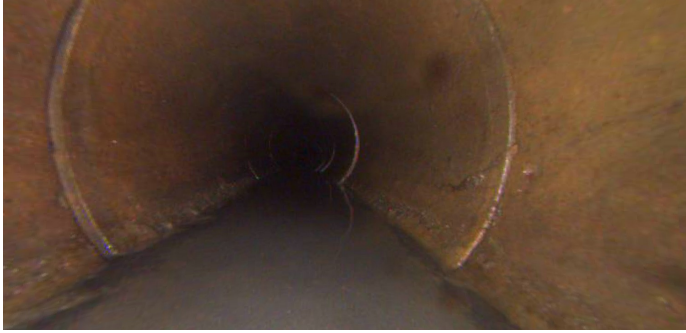
Code: **RFJ**
Description: **Roots Fine Joint**

Distance (ft): **8.1**
Structural Grade: **0**
O&M Grade: **1**
Clock Start/From: **3**
Clock To:
1st Value:
2nd Value:
Value Percent:
Continuous Index:
Within 8" of Joint: **YES**
Remarks:

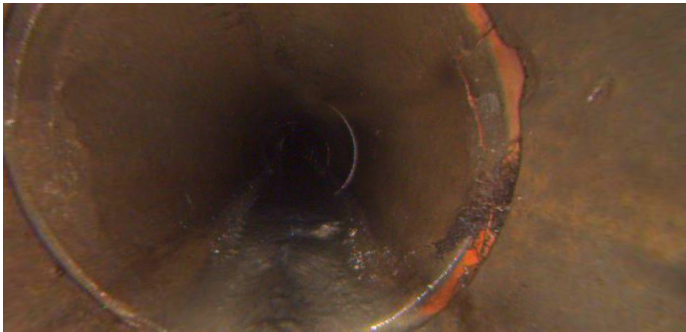
Code: **FC**
Description: **Fracture Circumferential**

Distance (ft): **14.0**
Structural Grade: **2**
O&M Grade: **0**
Clock Start/From: **2**
Clock To: **4**
1st Value:
2nd Value:
Value Percent:
Continuous Index:
Within 8" of Joint: **YES**
Remarks:

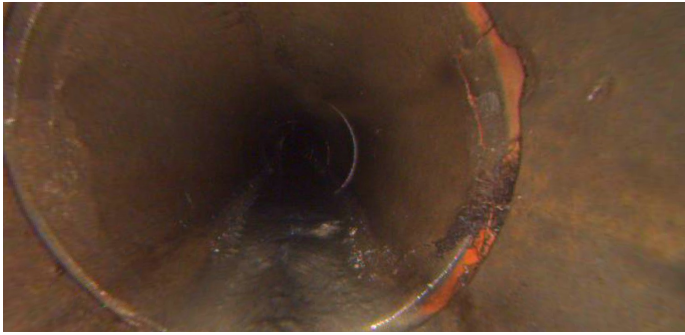
Code: **RFJ**
Description: **Roots Fine Joint**

Distance (ft): **14.0**
Structural Grade: **0**
O&M Grade: **1**
Clock Start/From: **3**
Clock To: **4**
1st Value:
2nd Value:
Value Percent:
Continuous Index:
Within 8" of Joint: **YES**
Remarks:

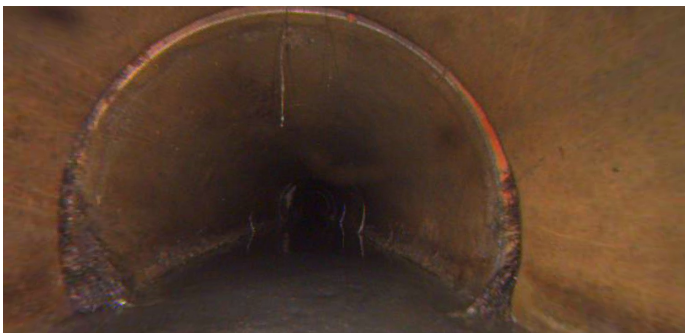
Code: **RFJ**
Description: **Roots Fine Joint**

Distance (ft): **17.9**
Structural Grade: **0**
O&M Grade: **1**
Clock Start/From: **8**
Clock To: **4**
1st Value:
2nd Value:
Value Percent:
Continuous Index:
Within 8" of Joint: **YES**
Remarks:

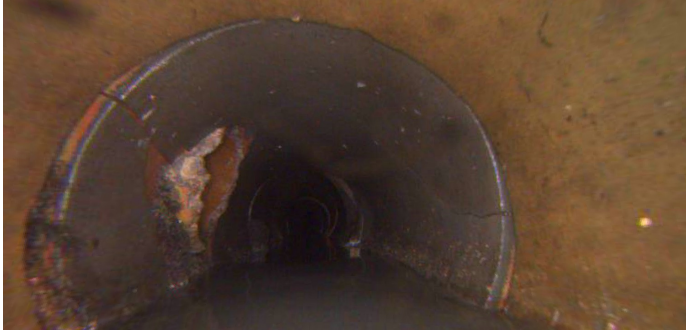
Code: **FM**
Description: **Fracture Multiple**

Distance (ft): **21.9**
Structural Grade: **4**
O&M Grade: **0**
Clock Start/From: **8**
Clock To: **4**
1st Value:
2nd Value:
Value Percent:
Continuous Index:
Within 8" of Joint: **YES**
Remarks:

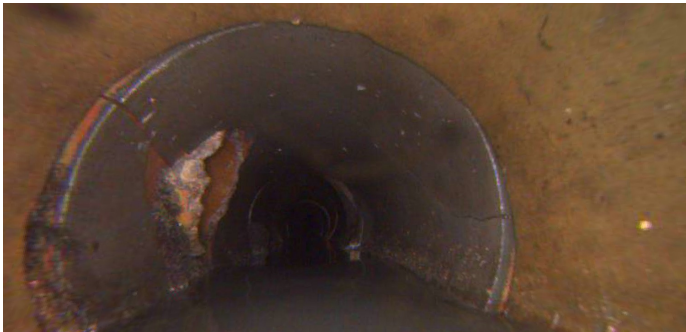
Code: **RFJ**
Description: **Roots Fine Joint**

Distance (ft): **21.9**
Structural Grade: **0**
O&M Grade: **1**
Clock Start/From: **8**
Clock To: **9**
1st Value:
2nd Value:
Value Percent:
Continuous Index:
Within 8" of Joint: **YES**
Remarks:

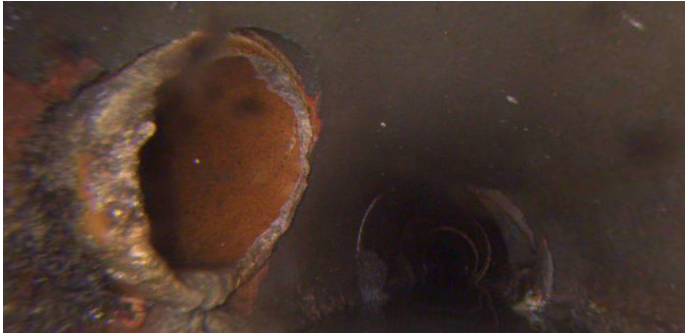
Code: **TBI**
Description: **Tap Break-in Intruding**

Distance (ft): **22.7**
Structural Grade: **0**
O&M Grade: **2**
Clock Start/From: **9**
Clock To:
1st Value: **4.000**
2nd Value: **1.000**
Value Percent:
Continuous Index:
Within 8" of Joint:
Remarks:

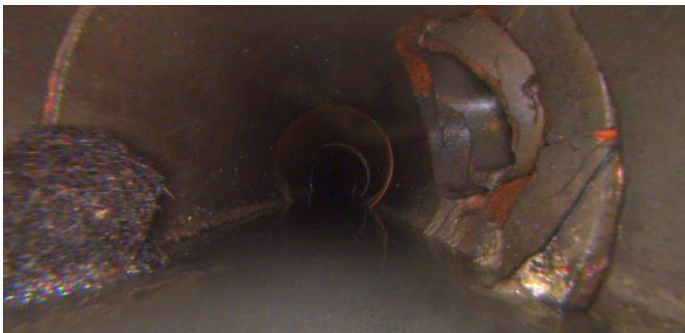
Code: **RMJ**
Description: **Roots Medium Joint**

Distance (ft): **24.0**
Structural Grade: **0**
O&M Grade: **3**
Clock Start/From: **8**
Clock To: **4**
1st Value:
2nd Value:
Value Percent: **10.000**
Continuous Index:
Within 8" of Joint: **YES**
Remarks:

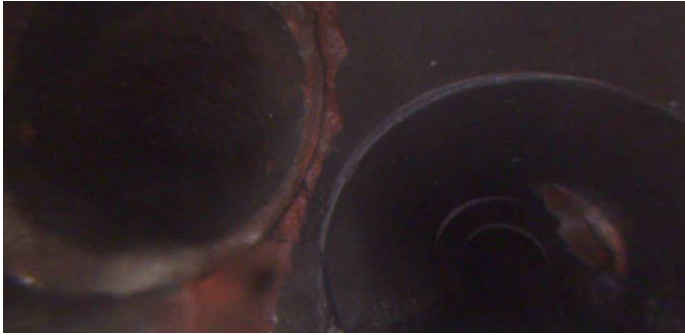
Code: **TBI**
Description: **Tap Break-in Intruding**

Distance (ft): **25.5**
Structural Grade: **0**
O&M Grade: **2**
Clock Start/From: **2**
Clock To:
1st Value: **4.000**
2nd Value: **1.000**
Value Percent:
Continuous Index:
Within 8" of Joint:
Remarks:

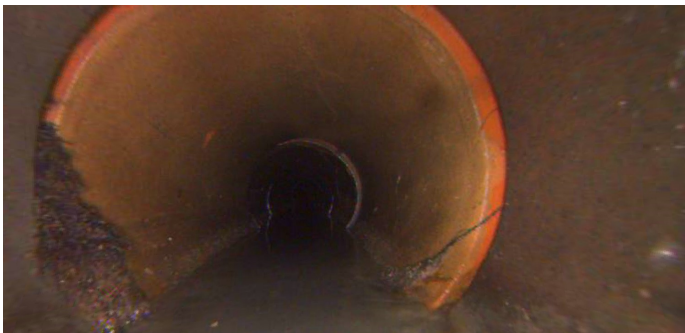
Code: **RMJ**
Description: **Roots Medium Joint**

Distance (ft): **25.8**
Structural Grade: **0**
O&M Grade: **3**
Clock Start/From: **8**
Clock To: **4**
1st Value:
2nd Value:
Value Percent: **5.000**
Continuous Index:
Within 8" of Joint: **YES**
Remarks:

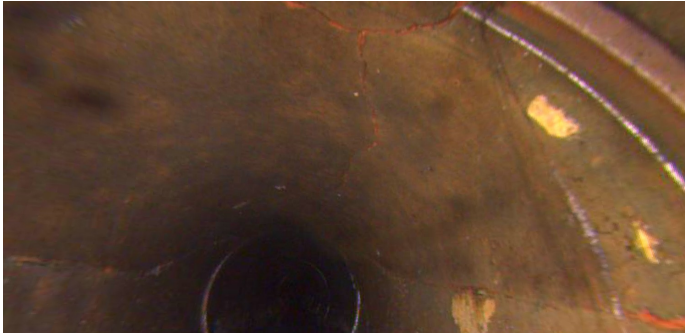
Code: **RFJ**
Description: **Roots Fine Joint**

Distance (ft): **28.3**
Structural Grade: **0**
O&M Grade: **1**
Clock Start/From: **1**
Clock To:
1st Value:
2nd Value:
Value Percent:
Continuous Index:
Within 8" of Joint: **YES**
Remarks:

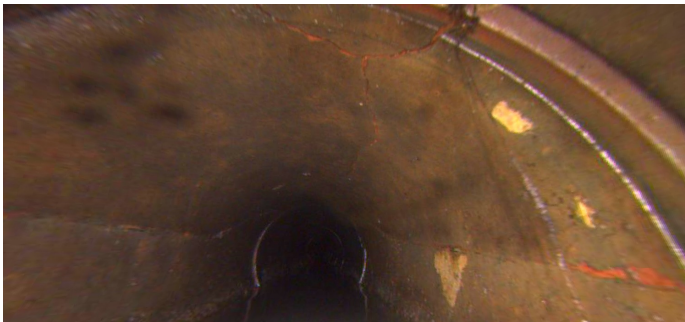
Code: **FM**
Description: **Fracture Multiple**

Distance (ft): **28.3**
Structural Grade: **4**
O&M Grade: **0**
Clock Start/From: **8**
Clock To: **4**
1st Value:
2nd Value:
Value Percent:
Continuous Index:
Within 8" of Joint: **YES**
Remarks:

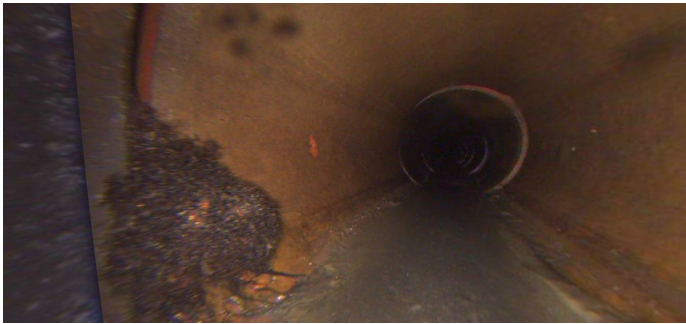
Code: **RMJ**
Description: **Roots Medium Joint**

Distance (ft): **40.3**
Structural Grade: **0**
O&M Grade: **3**
Clock Start/From: **8**
Clock To: **9**
1st Value:
2nd Value:
Value Percent: **5.000**
Continuous Index:
Within 8" of Joint: **YES**
Remarks:

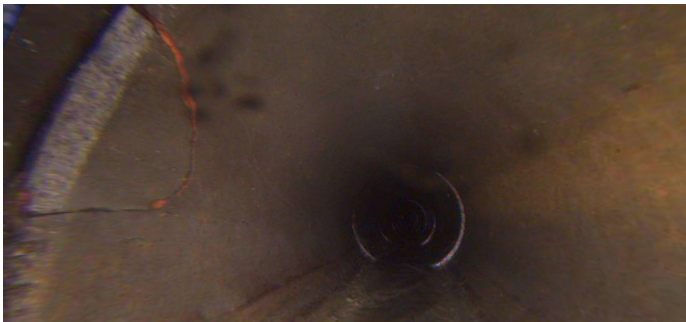
Code: **FS**
Description: **Fracture Spiral**

Distance (ft): **46.3**
Structural Grade: **3**
O&M Grade: **0**
Clock Start/From: **9**
Clock To: **10**
1st Value:
2nd Value:
Value Percent:
Continuous Index:
Within 8" of Joint: **YES**
Remarks:

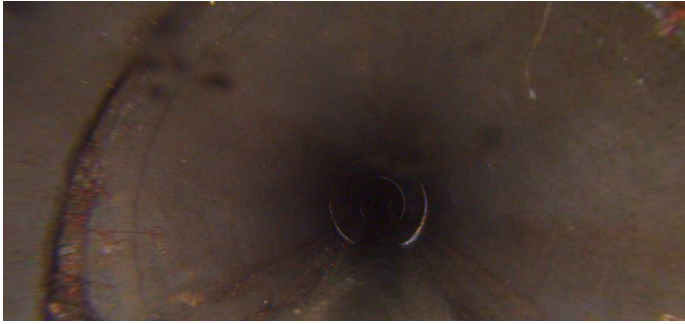
Code: **RFJ**
Description: **Roots Fine Joint**

Distance (ft): **48.1**
Structural Grade: **0**
O&M Grade: **1**
Clock Start/From: **8**
Clock To: **4**
1st Value:
2nd Value:
Value Percent:
Continuous Index:
Within 8" of Joint: **YES**
Remarks:

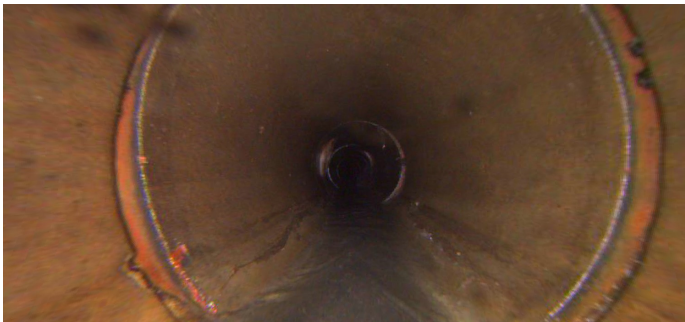
Code: **FL**
Description: **Fracture Longitudinal**

Distance (ft): **60.0**
Structural Grade: **3**
O&M Grade: **0**
Clock Start/From: **8**
Clock To:
1st Value:
2nd Value:
Value Percent:
Continuous Index:
Within 8" of Joint: **YES**
Remarks:

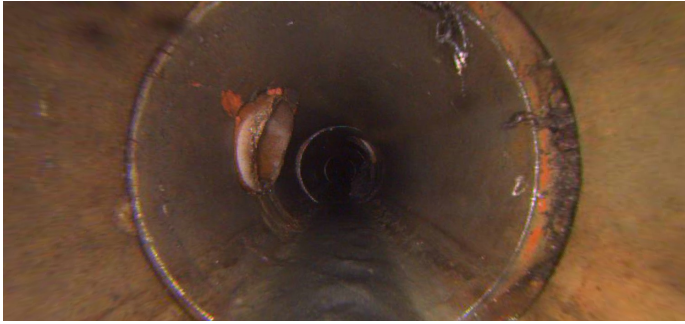
Code: **RFJ**
Description: **Roots Fine Joint**

Distance (ft): **61.9**
Structural Grade: **0**
O&M Grade: **1**
Clock Start/From: **8**
Clock To: **4**
1st Value:
2nd Value:
Value Percent:
Continuous Index: **S01**
Within 8" of Joint: **YES**
Remarks:

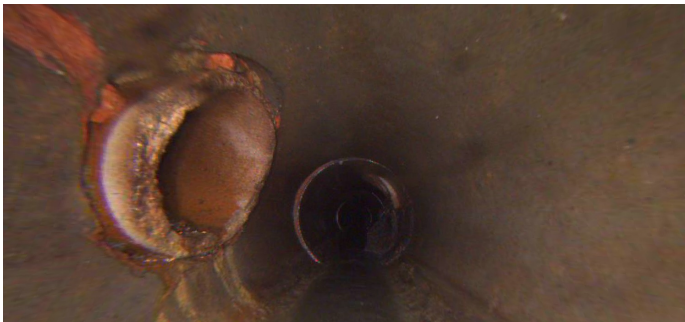
Code: **TBI**
Description: **Tap Break-in Intruding**

Distance (ft): **62.6**
Structural Grade: **0**
O&M Grade: **2**
Clock Start/From: **9**
Clock To:
1st Value: **4.000**
2nd Value: **1.000**
Value Percent:
Continuous Index:
Within 8" of Joint:
Remarks:

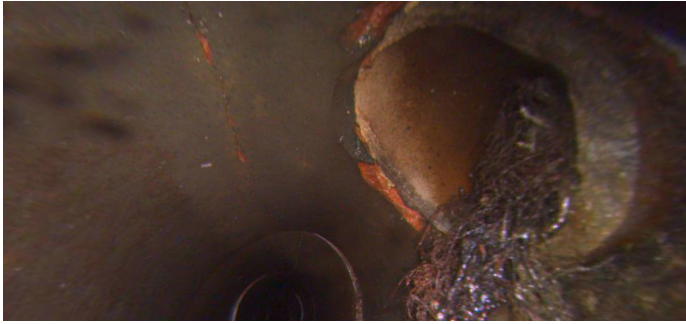
Code: **TBI**
Description: **Tap Break-in Intruding**

Distance (ft): **64.8**
Structural Grade: **0**
O&M Grade: **2**
Clock Start/From: **1**
Clock To:
1st Value: **4.000**
2nd Value: **1.000**
Value Percent:
Continuous Index:
Within 8" of Joint:
Remarks: **ROOTS**

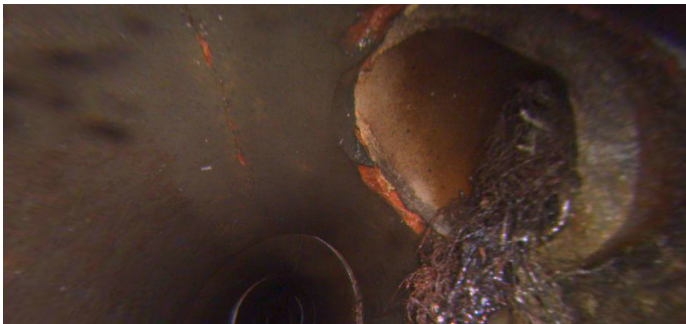
Code: **RML**
Description: **Roots Medium Lateral**

Distance (ft): **64.8**
Structural Grade: **0**
O&M Grade: **3**
Clock Start/From: **2**
Clock To:
1st Value:
2nd Value:
Value Percent: **10.000**
Continuous Index:
Within 8" of Joint: **NO**
Remarks:

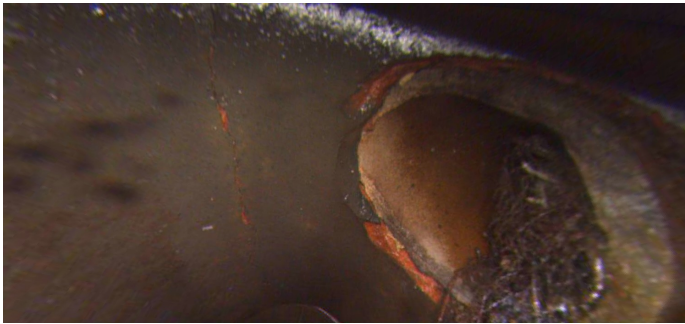
Code: **FL**
Description: **Fracture Longitudinal**

Distance (ft): **64.8**
Structural Grade: **3**
O&M Grade: **0**
Clock Start/From: **12**
Clock To:
1st Value:
2nd Value:
Value Percent:
Continuous Index:
Within 8" of Joint: **YES**
Remarks:

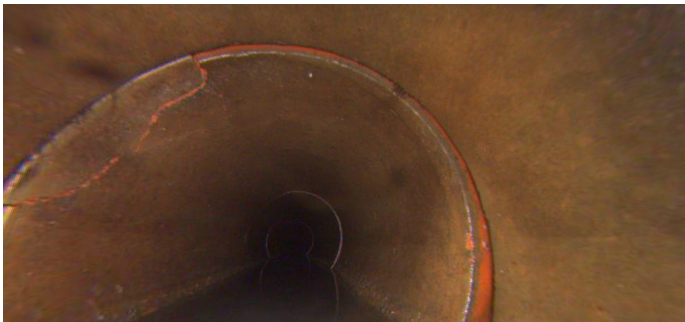
Code: **FC**
Description: **Fracture Circumferential**

Distance (ft): **81.8**
Structural Grade: **2**
O&M Grade: **0**
Clock Start/From: **10**
Clock To: **12**
1st Value:
2nd Value:
Value Percent:
Continuous Index:
Within 8" of Joint: **YES**
Remarks:

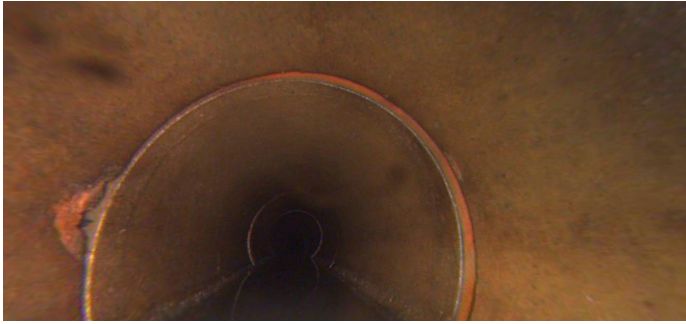
Code: **SSS**
Description: **Surface Spalling**

Distance (ft): **83.7**
Structural Grade: **2**
O&M Grade: **0**
Clock Start/From: **9**
Clock To:
1st Value:
2nd Value:
Value Percent:
Continuous Index:
Within 8" of Joint: **YES**
Remarks:

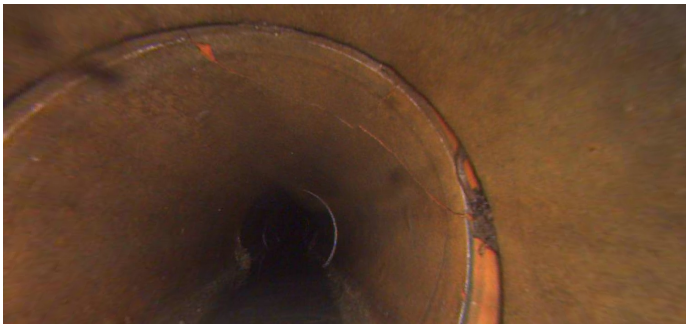
Code: **FM**
Description: **Fracture Multiple**

Distance (ft): **91.9**
Structural Grade: **4**
O&M Grade: **0**
Clock Start/From: **12**
Clock To: **3**
1st Value:
2nd Value:
Value Percent:
Continuous Index:
Within 8" of Joint: **YES**
Remarks:

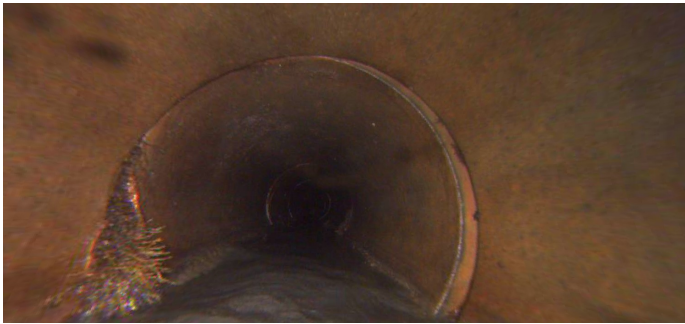
Code: **RMJ**
Description: **Roots Medium Joint**

Distance (ft): **93.7**
Structural Grade: **0**
O&M Grade: **3**
Clock Start/From: **8**
Clock To: **9**
1st Value:
2nd Value:
Value Percent: **5.000**
Continuous Index:
Within 8" of Joint: **YES**
Remarks:

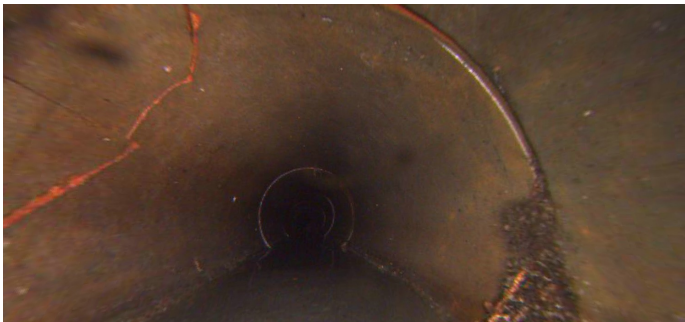
Code: **FM**
Description: **Fracture Multiple**

Distance (ft): **96.0**
Structural Grade: **4**
O&M Grade: **0**
Clock Start/From: **8**
Clock To: **4**
1st Value:
2nd Value:
Value Percent:
Continuous Index: **S02**
Within 8" of Joint: **YES**
Remarks:

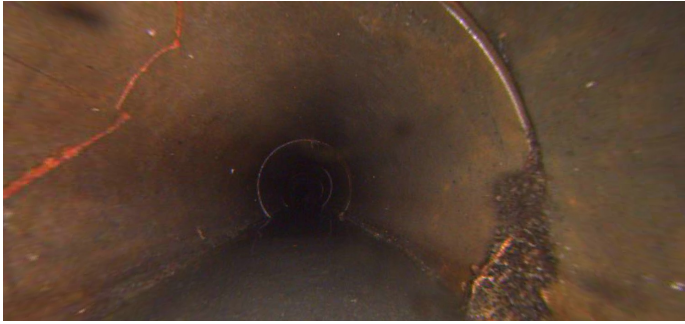
Code: **RMJ**
Description: **Roots Medium Joint**

Distance (ft): **96.0**
Structural Grade: **0**
O&M Grade: **3**
Clock Start/From: **3**
Clock To: **4**
1st Value:
2nd Value:
Value Percent: **5.000**
Continuous Index:
Within 8" of Joint: **YES**
Remarks:

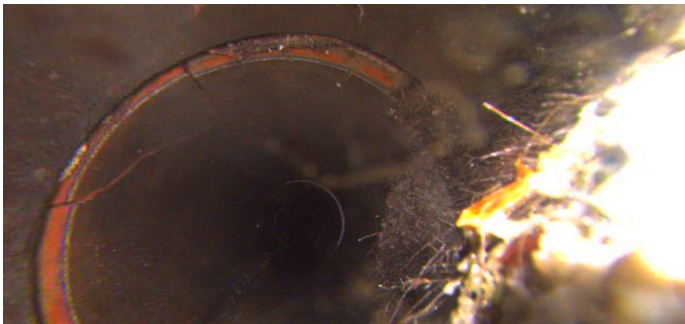
Code: **RMJ**
Description: **Roots Medium Joint**

Distance (ft): **108.1**
Structural Grade: **0**
O&M Grade: **3**
Clock Start/From: **1**
Clock To: **4**
1st Value:
2nd Value:
Value Percent: **10.000**
Continuous Index:
Within 8" of Joint: **YES**
Remarks:

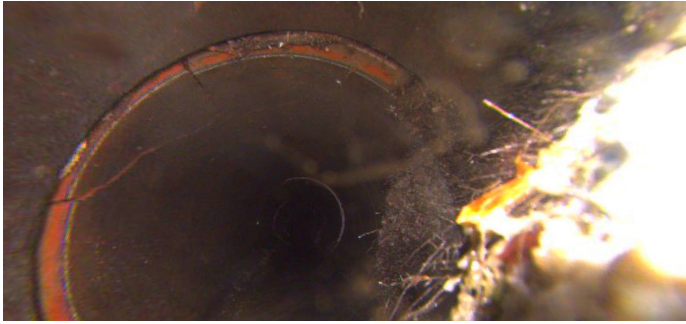
Code: **FM**
Description: **Fracture Multiple**

Distance (ft): **108.1**
Structural Grade: **4**
O&M Grade: **0**
Clock Start/From: **8**
Clock To: **4**
1st Value:
2nd Value:
Value Percent:
Continuous Index: **F02**
Within 8" of Joint: **YES**
Remarks:

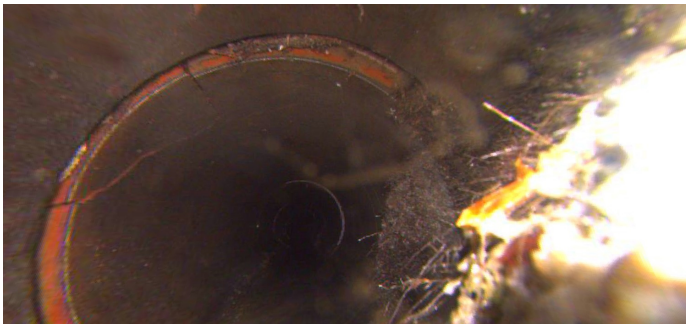
Code: **RFJ**
Description: **Roots Fine Joint**

Distance (ft): **108.1**
Structural Grade: **0**
O&M Grade: **1**
Clock Start/From: **8**
Clock To: **4**
1st Value:
2nd Value:
Value Percent:
Continuous Index: **F01**
Within 8" of Joint: **YES**
Remarks:

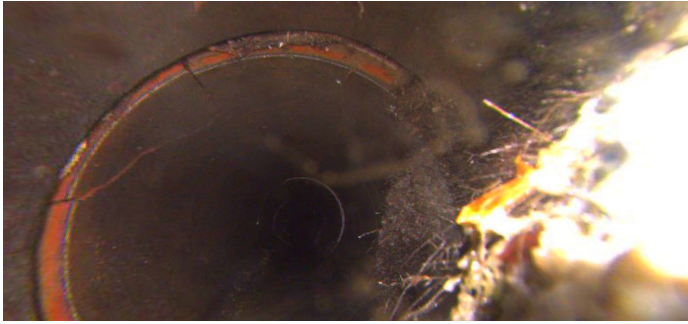
Code: **MSA**
Description: **Abandoned Survey**

Distance (ft): **108.1**
Structural Grade: **0**
O&M Grade: **0**
Clock Start/From:
Clock To:
1st Value:
2nd Value:
Value Percent:
Continuous Index:
Within 8" of Joint: **NO**
Remarks: **ROOTS**
