## Profile/Photo Observation Report

| Street: | <b>S PENNSYLVANIA ST</b> | Flow Control: | <b>Not Controlled</b> |
| City: | <b>Hobart, IN</b> | Year Renewed: | |

| US MH: | <b>M-605-038</b> | DS MH: | <b>M-605-039</b> |

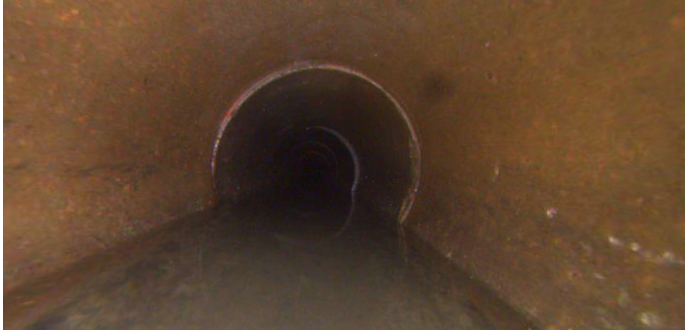
Code: **AMH**  
Description: **Manhole**

Distance (ft): **.0**  
Structural Grade: **0**  
O&M Grade: **0**  
Clock Start/From:  
Clock To:  
1st Value:  
2nd Value:  
Value Percent:  
Continuous Index:  
Within 8" of Joint: **NO**  
Remarks: **M-605-038**

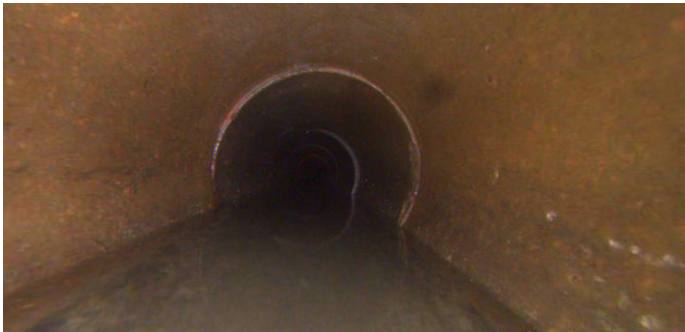
Code: **MWL**  
Description: **Water Level**

Distance (ft): **.0**  
Structural Grade: **0**  
O&M Grade: **0**  
Clock Start/From:  
Clock To:  
1st Value:  
2nd Value:  
Value Percent: **20.000**  
Continuous Index:  
Within 8" of Joint: **NO**  
Remarks:

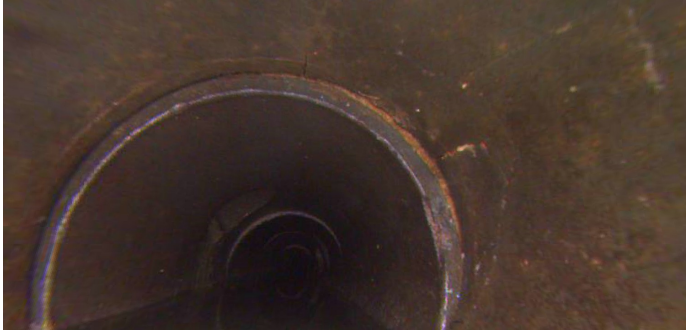
Code: **FM**  
Description: **Fracture Multiple**

Distance (ft): **21.6**  
Structural Grade: **4**  
O&M Grade: **0**  
Clock Start/From: **12**  
Clock To: **4**  
1st Value:  
2nd Value:  
Value Percent:  
Continuous Index:  
Within 8" of Joint: **YES**  
Remarks:

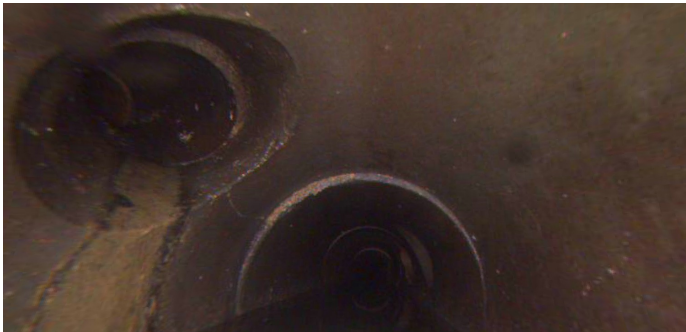
Code: **TF**  
Description: **Tap Factory**

Distance (ft): **23.1**  
Structural Grade: **0**  
O&M Grade: **0**  
Clock Start/From: **10**  
Clock To:  
1st Value: **4.000**  
2nd Value:  
Value Percent:  
Continuous Index:  
Within 8" of Joint:  
Remarks:

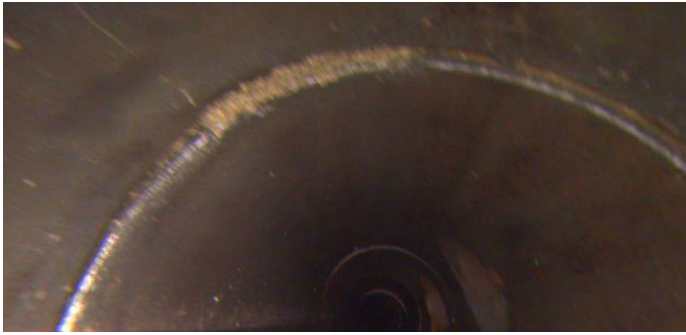
Code: **CL**  
Description: **Crack Longitudinal**

Distance (ft): **23.8**  
Structural Grade: **2**  
O&M Grade: **0**  
Clock Start/From: **10**  
Clock To:  
1st Value:  
2nd Value:  
Value Percent:  
Continuous Index:  
Within 8" of Joint: **YES**  
Remarks:

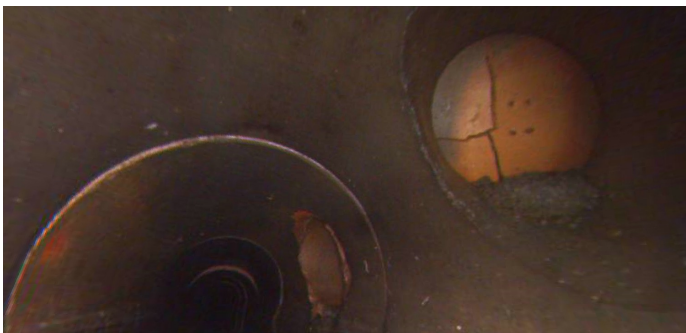
Code: **TFC**  
Description: **Tap Factory Capped**

Distance (ft): **25.3**  
Structural Grade: **0**  
O&M Grade: **0**  
Clock Start/From: **2**  
Clock To:  
1st Value: **4.000**  
2nd Value:  
Value Percent:  
Continuous Index:  
Within 8" of Joint:  
Remarks:

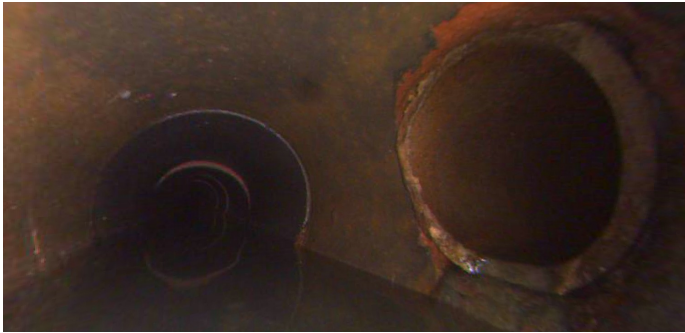
Code: **TBI**  
Description: **Tap Break-in Intruding**

Distance (ft): **26.7**  
Structural Grade: **0**  
O&M Grade: **2**  
Clock Start/From: **3**  
Clock To:  
1st Value: **4.000**  
2nd Value: **1.000**  
Value Percent:  
Continuous Index:  
Within 8" of Joint:  
Remarks:

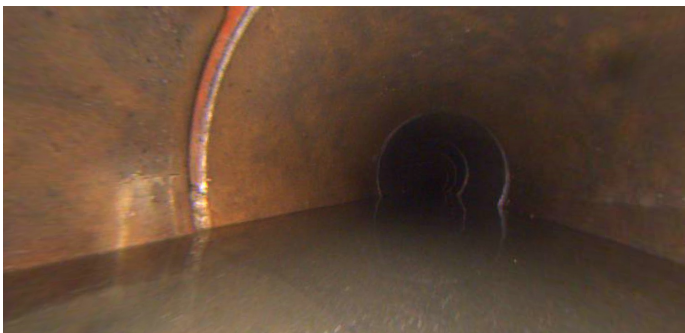
Code: **FL**  
Description: **Fracture Longitudinal**

Distance (ft): **37.7**  
Structural Grade: **3**  
O&M Grade: **0**  
Clock Start/From: **9**  
Clock To:  
1st Value:  
2nd Value:  
Value Percent:  
Continuous Index:  
Within 8" of Joint: **YES**  
Remarks:

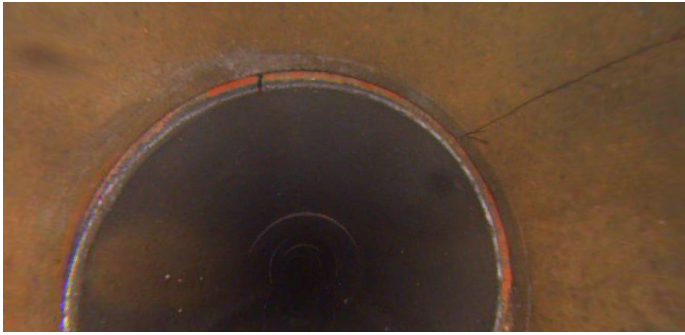
Code: **RFJ**  
Description: **Roots Fine Joint**

Distance (ft): **49.4**  
Structural Grade: **0**  
O&M Grade: **1**  
Clock Start/From: **12**  
Clock To: **2**  
1st Value:  
2nd Value:  
Value Percent:  
Continuous Index:  
Within 8" of Joint: **YES**  
Remarks:

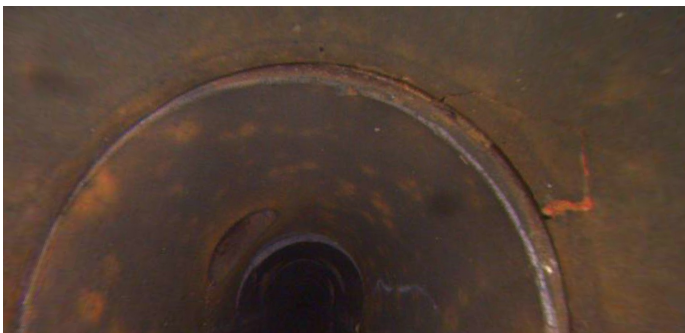
Code: **FC**  
Description: **Fracture Circumferential**

Distance (ft): **57.4**  
Structural Grade: **2**  
O&M Grade: **0**  
Clock Start/From: **1**  
Clock To: **2**  
1st Value:  
2nd Value:  
Value Percent:  
Continuous Index:  
Within 8" of Joint: **YES**  
Remarks:

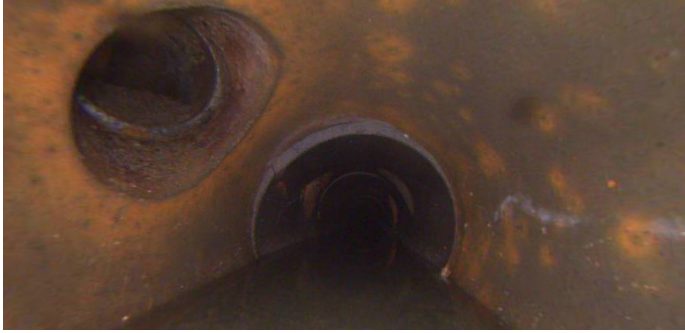
Code: **TF**  
Description: **Tap Factory**

Distance (ft): **58.7**  
Structural Grade: **0**  
O&M Grade: **0**  
Clock Start/From: **10**  
Clock To:  
1st Value: **4.000**  
2nd Value:  
Value Percent:  
Continuous Index:  
Within 8" of Joint:  
Remarks:

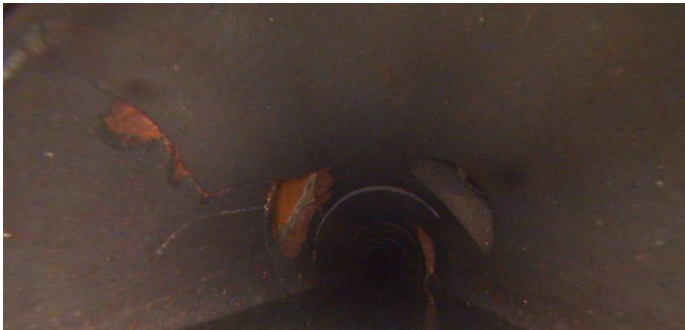
Code: **FL**  
Description: **Fracture Longitudinal**

Distance (ft): **59.8**  
Structural Grade: **3**  
O&M Grade: **0**  
Clock Start/From: **10**  
Clock To:  
1st Value:  
2nd Value:  
Value Percent:  
Continuous Index:  
Within 8" of Joint: **YES**  
Remarks:

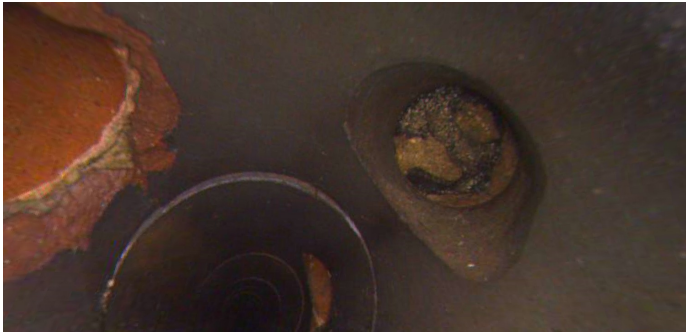
Code: **TFC**  
Description: **Tap Factory Capped**

Distance (ft): **60.7**  
Structural Grade: **0**  
O&M Grade: **0**  
Clock Start/From: **2**  
Clock To:  
1st Value: **4.000**  
2nd Value:  
Value Percent:  
Continuous Index:  
Within 8" of Joint:  
Remarks:

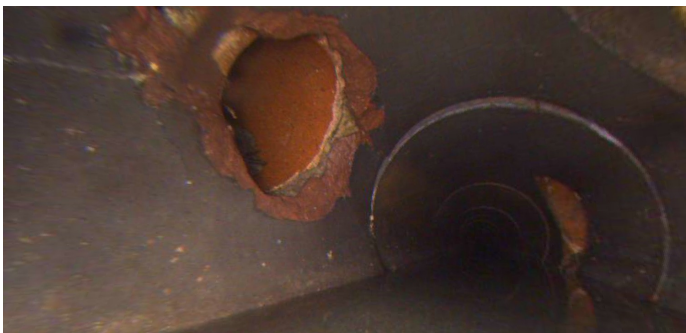
Code: **TB**  
Description: **Tap Break-in**

Distance (ft): **60.7**  
Structural Grade: **0**  
O&M Grade: **0**  
Clock Start/From: **10**  
Clock To:  
1st Value: **4.000**  
2nd Value:  
Value Percent:  
Continuous Index:  
Within 8" of Joint:  
Remarks:

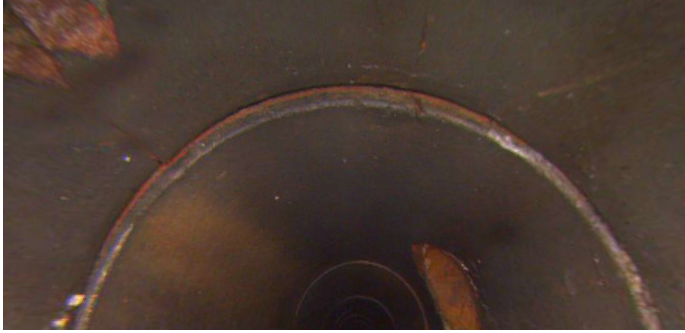
Code: **FM**  
Description: **Fracture Multiple**

Distance (ft): **61.5**  
Structural Grade: **4**  
O&M Grade: **0**  
Clock Start/From: **10**  
Clock To: **2**  
1st Value:  
2nd Value:  
Value Percent:  
Continuous Index:  
Within 8" of Joint: **YES**  
Remarks:

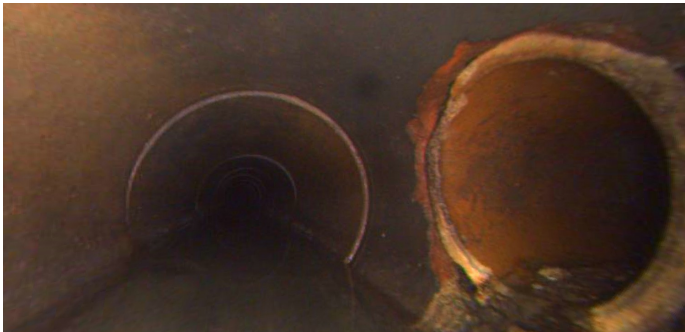
Code: **TB**  
Description: **Tap Break-in**

Distance (ft): **62.6**  
Structural Grade: **0**  
O&M Grade: **0**  
Clock Start/From: **3**  
Clock To:  
1st Value: **4.000**  
2nd Value:  
Value Percent:  
Continuous Index:  
Within 8" of Joint:  
Remarks:

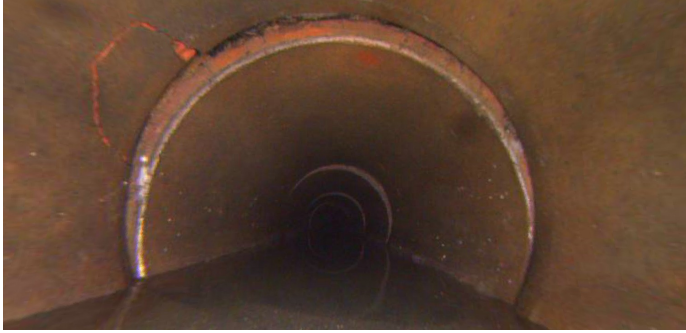
Code: **FS**  
Description: **Fracture Spiral**

Distance (ft): **69.3**  
Structural Grade: **3**  
O&M Grade: **0**  
Clock Start/From: **9**  
Clock To: **11**  
1st Value:  
2nd Value:  
Value Percent:  
Continuous Index:  
Within 8" of Joint: **YES**  
Remarks:

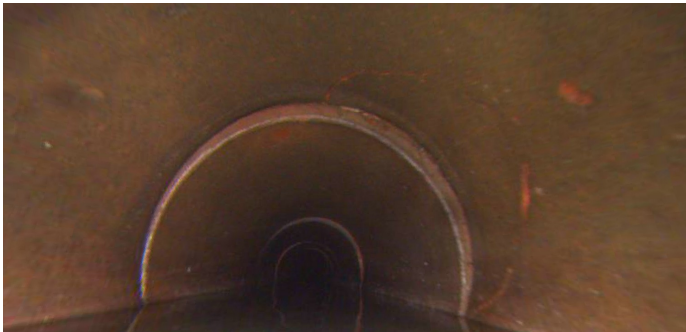
Code: **FM**  
Description: **Fracture Multiple**

Distance (ft): **71.0**  
Structural Grade: **4**  
O&M Grade: **0**  
Clock Start/From: **12**  
Clock To: **4**  
1st Value:  
2nd Value:  
Value Percent:  
Continuous Index:  
Within 8" of Joint: **YES**  
Remarks:

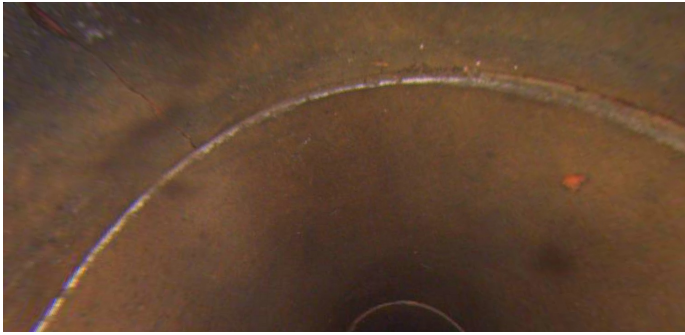
Code: **FL**  
Description: **Fracture Longitudinal**

Distance (ft): **83.5**  
Structural Grade: **3**  
O&M Grade: **0**  
Clock Start/From: **10**  
Clock To:  
1st Value:  
2nd Value:  
Value Percent:  
Continuous Index:  
Within 8" of Joint: **YES**  
Remarks:

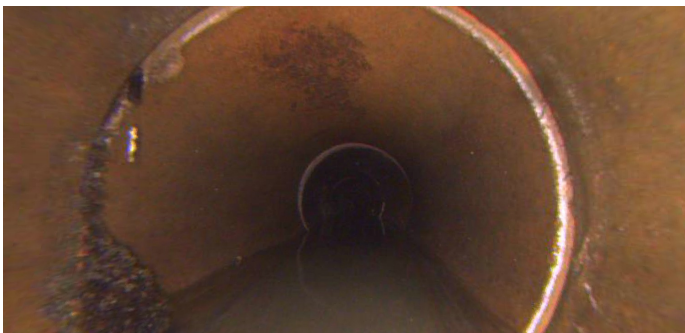
Code: **RMJ**  
Description: **Roots Medium Joint**

Distance (ft): **85.3**  
Structural Grade: **0**  
O&M Grade: **3**  
Clock Start/From: **8**  
Clock To: **10**  
1st Value:  
2nd Value:  
Value Percent: **5.000**  
Continuous Index:  
Within 8" of Joint: **YES**  
Remarks:

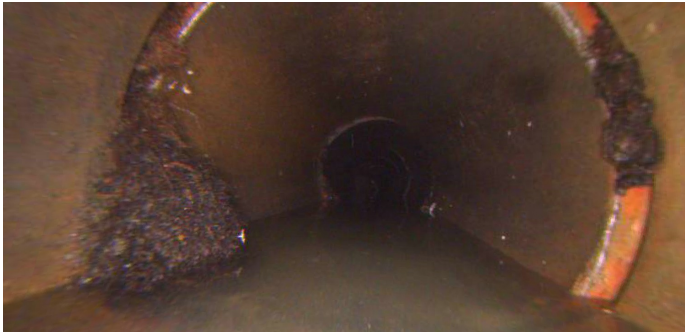
Code: **RMJ**  
Description: **Roots Medium Joint**

Distance (ft): **89.3**  
Structural Grade: **0**  
O&M Grade: **3**  
Clock Start/From: **8**  
Clock To: **4**  
1st Value:  
2nd Value:  
Value Percent: **10.000**  
Continuous Index:  
Within 8" of Joint: **YES**  
Remarks:

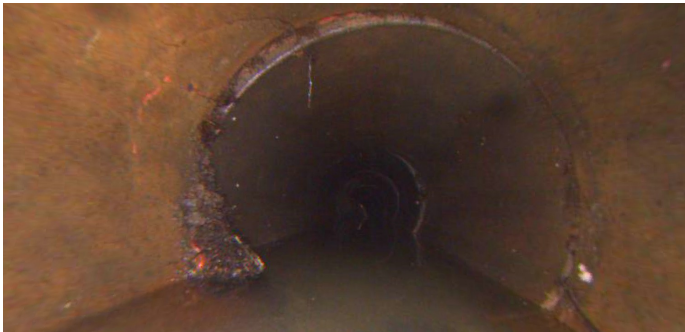
Code: **FM**  
Description: **Fracture Multiple**

Distance (ft): **91.1**  
Structural Grade: **4**  
O&M Grade: **0**  
Clock Start/From: **8**  
Clock To: **4**  
1st Value:  
2nd Value:  
Value Percent:  
Continuous Index:  
Within 8" of Joint: **YES**  
Remarks:

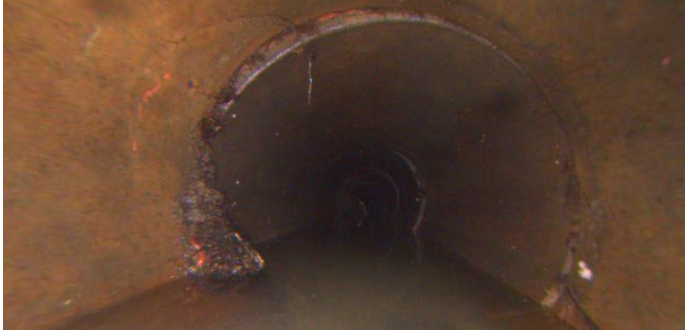
Code: **RMJ**  
Description: **Roots Medium Joint**

Distance (ft): **91.1**  
Structural Grade: **0**  
O&M Grade: **3**  
Clock Start/From: **8**  
Clock To: **4**  
1st Value:  
2nd Value:  
Value Percent: **10.000**  
Continuous Index:  
Within 8" of Joint: **YES**  
Remarks:

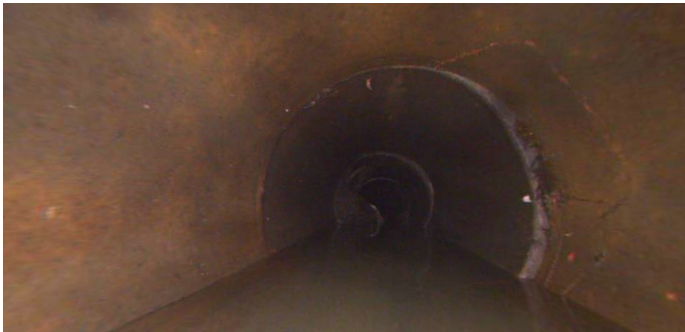
Code: **FM**  
Description: **Fracture Multiple**

Distance (ft): **92.8**  
Structural Grade: **4**  
O&M Grade: **0**  
Clock Start/From: **12**  
Clock To: **4**  
1st Value:  
2nd Value:  
Value Percent:  
Continuous Index:  
Within 8" of Joint: **YES**  
Remarks:

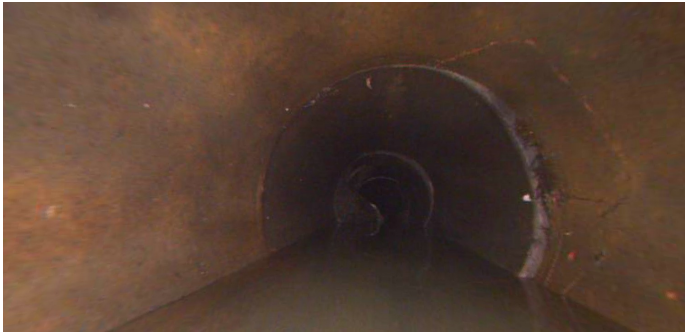
Code: **RFJ**  
Description: **Roots Fine Joint**

Distance (ft): **92.8**  
Structural Grade: **0**  
O&M Grade: **1**  
Clock Start/From: **8**  
Clock To: **4**  
1st Value:  
2nd Value:  
Value Percent:  
Continuous Index:  
Within 8" of Joint: **YES**  
Remarks:

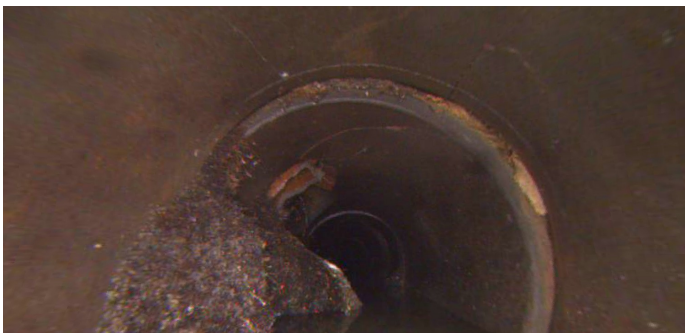
Code: **RMJ**  
Description: **Roots Medium Joint**

Distance (ft): **95.2**  
Structural Grade: **0**  
O&M Grade: **3**  
Clock Start/From: **8**  
Clock To: **9**  
1st Value:  
2nd Value:  
Value Percent: **30.000**  
Continuous Index:  
Within 8" of Joint: **YES**  
Remarks:

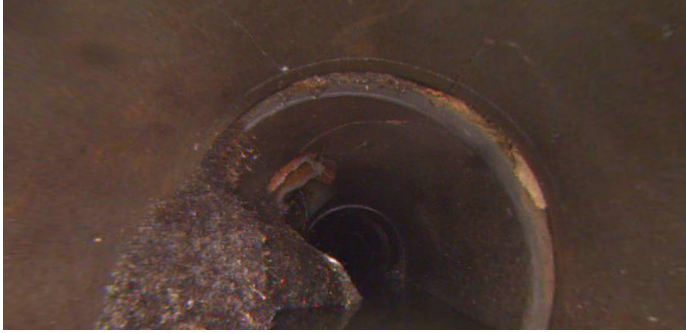
Code: **FM**  
Description: **Fracture Multiple**

Distance (ft): **95.2**  
Structural Grade: **4**  
O&M Grade: **0**  
Clock Start/From: **8**  
Clock To: **4**  
1st Value:  
2nd Value:  
Value Percent:  
Continuous Index:  
Within 8" of Joint: **YES**  
Remarks:

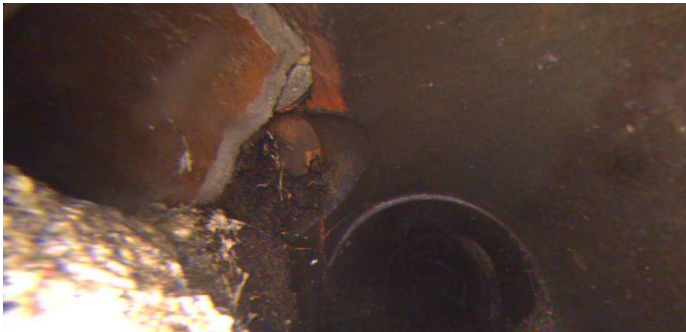
Code: **TBI**  
Description: **Tap Break-in Intruding**

Distance (ft): **96.5**  
Structural Grade: **0**  
O&M Grade: **2**  
Clock Start/From: **10**  
Clock To:  
1st Value: **4.000**  
2nd Value: **1.000**  
Value Percent:  
Continuous Index:  
Within 8" of Joint:  
Remarks:

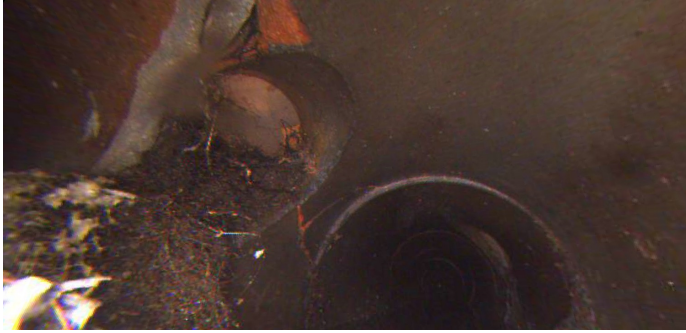
Code: **TF**  
Description: **Tap Factory**

Distance (ft): **97.1**  
Structural Grade: **0**  
O&M Grade: **0**  
Clock Start/From: **10**  
Clock To:  
1st Value: **4.000**  
2nd Value:  
Value Percent:  
Continuous Index:  
Within 8" of Joint:  
Remarks:

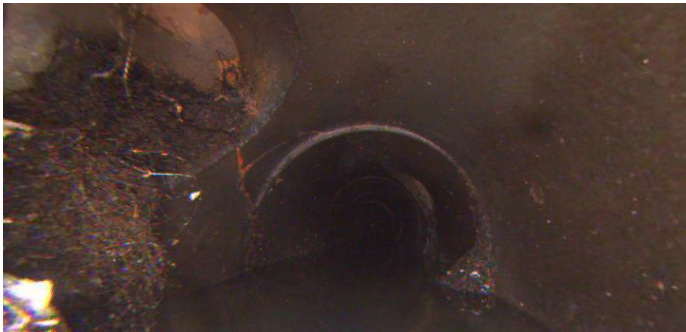
Code: **MSA**  
Description: **Abandoned Survey**

Distance (ft): **97.1**  
Structural Grade: **0**  
O&M Grade: **0**  
Clock Start/From:  
Clock To:  
1st Value:  
2nd Value:  
Value Percent:  
Continuous Index:  
Within 8" of Joint: **NO**  
Remarks: **RMJ**
