Profile/Photo Observation Report

Street:	S Pennsylvania St.	Flow Control:	Not Controlled
City:	Hobart, IN	Year Renewed:	
Location:	Other	Tape/Media #:	
Purpose:	Not Known	Dia/Height:	12"
Use:	Sanitary	Material:	VCP
Drain Area:	NA	Lining:	
Category:	NA		
Comment:

Location Details:		Direction of Survey:	Downstream
US MH:	M-605-038	DS MH:	M-605-039
		Total Length Surveyed (ft):	97.1

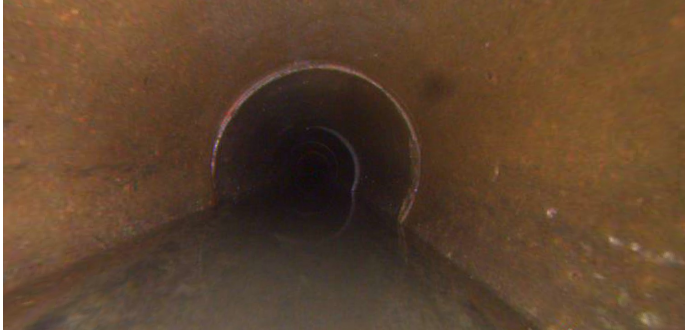
Code: **AMH**
Description: **Manhole**

Distance (ft): **.0**
Structural Grade: **0**
O&M Grade: **0**
Clock Start/From:
Clock To:
1st Value:
2nd Value:
Value Percent:
Continuous Index:
Within 8" of Joint: **NO**
Remarks: **M-605-038**

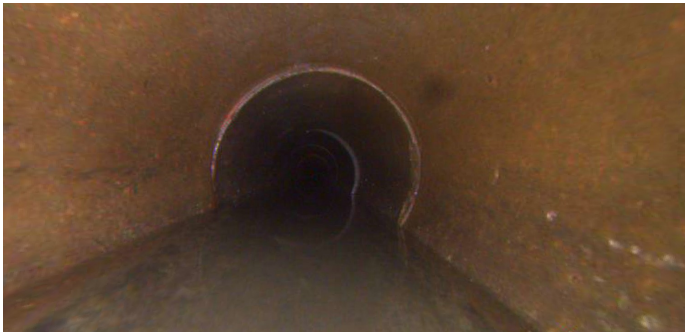
Code: **MWL**
Description: **Water Level**

Distance (ft): **.0**
Structural Grade: **0**
O&M Grade: **0**
Clock Start/From:
Clock To:
1st Value:
2nd Value:
Value Percent: **20.000**
Continuous Index:
Within 8" of Joint: **NO**
Remarks:

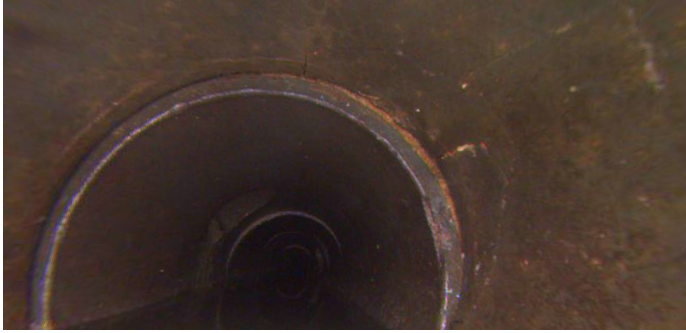
Code: **FM**
Description: **Fracture Multiple**

Distance (ft): **21.6**
Structural Grade: **4**
O&M Grade: **0**
Clock Start/From: **12**
Clock To: **4**
1st Value:
2nd Value:
Value Percent:
Continuous Index:
Within 8" of Joint: **YES**
Remarks:

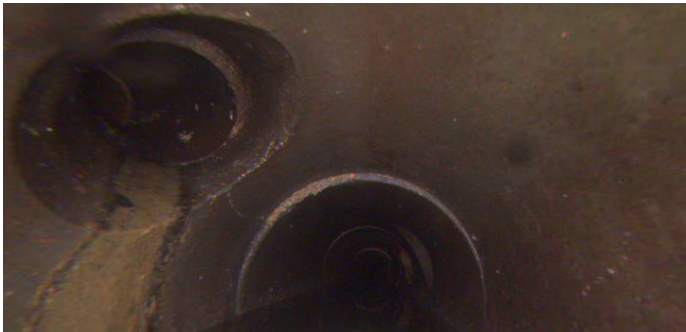
Code: **TF**
Description: **Tap Factory**

Distance (ft): **23.1**
Structural Grade: **0**
O&M Grade: **0**
Clock Start/From: **10**
Clock To:
1st Value: **4.000**
2nd Value:
Value Percent:
Continuous Index:
Within 8" of Joint:
Remarks:

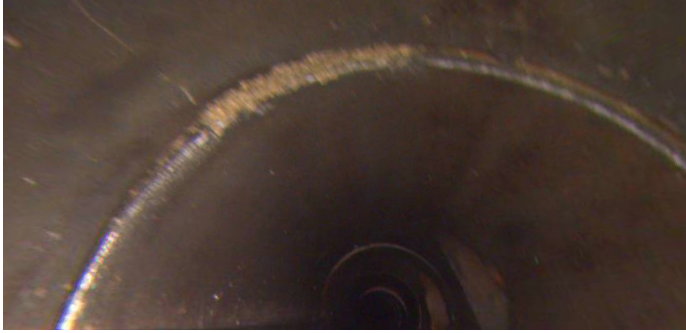
Code: **CL**
Description: **Crack Longitudinal**

Distance (ft): **23.8**
Structural Grade: **2**
O&M Grade: **0**
Clock Start/From: **10**
Clock To:
1st Value:
2nd Value:
Value Percent:
Continuous Index:
Within 8" of Joint: **YES**
Remarks:

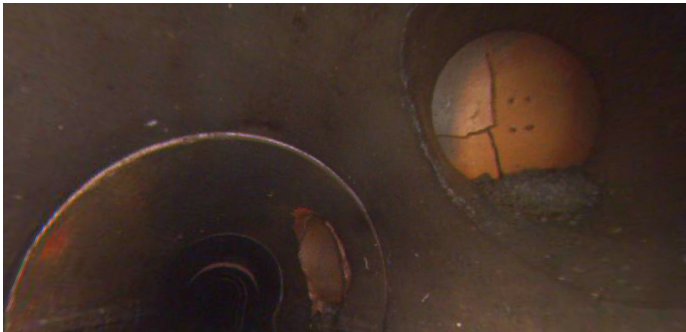
Code: **TFC**
Description: **Tap Factory Capped**

Distance (ft): **25.3**
Structural Grade: **0**
O&M Grade: **0**
Clock Start/From: **2**
Clock To:
1st Value: **4.000**
2nd Value:
Value Percent:
Continuous Index:
Within 8" of Joint:
Remarks:

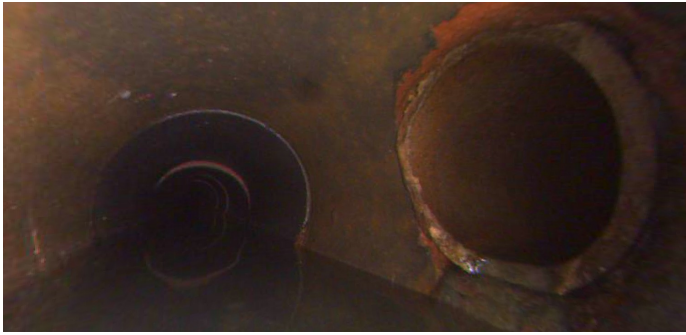
Code: **TBI**
Description: **Tap Break-in Intruding**

Distance (ft): **26.7**
Structural Grade: **0**
O&M Grade: **2**
Clock Start/From: **3**
Clock To:
1st Value: **4.000**
2nd Value: **1.000**
Value Percent:
Continuous Index:
Within 8" of Joint:
Remarks:

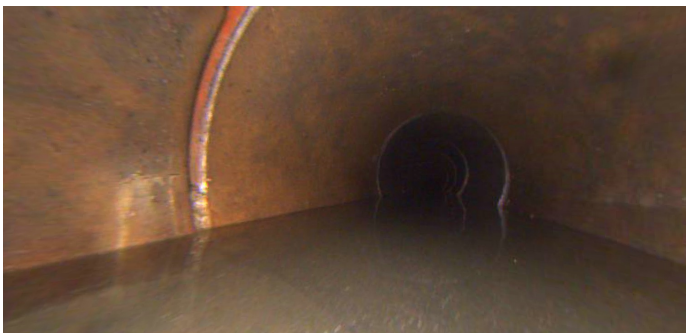
Code: **FL**
Description: **Fracture Longitudinal**

Distance (ft): **37.7**
Structural Grade: **3**
O&M Grade: **0**
Clock Start/From: **9**
Clock To:
1st Value:
2nd Value:
Value Percent:
Continuous Index:
Within 8" of Joint: **YES**
Remarks:

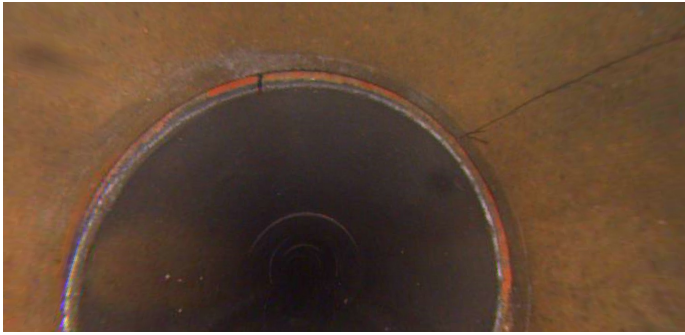
Code: **RFJ**
Description: **Roots Fine Joint**

Distance (ft): **49.4**
Structural Grade: **0**
O&M Grade: **1**
Clock Start/From: **12**
Clock To: **2**
1st Value:
2nd Value:
Value Percent:
Continuous Index:
Within 8" of Joint: **YES**
Remarks:

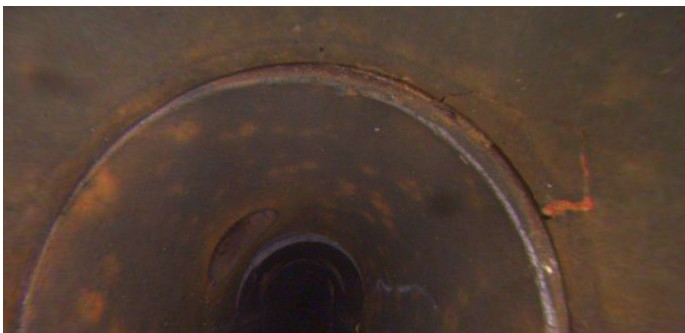
Code: **FC**
Description: **Fracture Circumferential**

Distance (ft): **57.4**
Structural Grade: **2**
O&M Grade: **0**
Clock Start/From: **1**
Clock To: **2**
1st Value:
2nd Value:
Value Percent:
Continuous Index:
Within 8" of Joint: **YES**
Remarks:

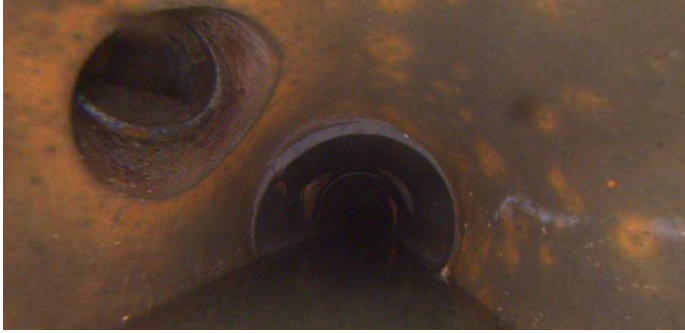
Code: **TF**
Description: **Tap Factory**

Distance (ft): **58.7**
Structural Grade: **0**
O&M Grade: **0**
Clock Start/From: **10**
Clock To:
1st Value: **4.000**
2nd Value:
Value Percent:
Continuous Index:
Within 8" of Joint:
Remarks:

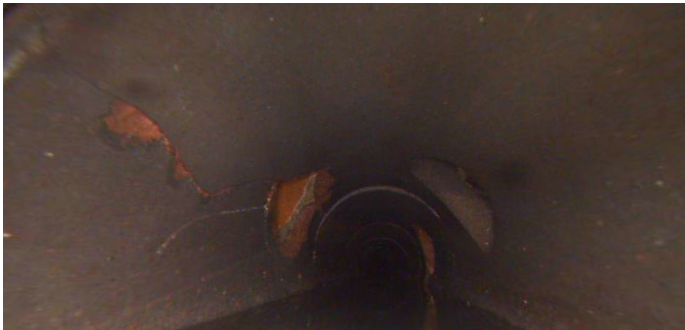
Code: **FL**
Description: **Fracture Longitudinal**

Distance (ft): **59.8**
Structural Grade: **3**
O&M Grade: **0**
Clock Start/From: **10**
Clock To:
1st Value:
2nd Value:
Value Percent:
Continuous Index:
Within 8" of Joint: **YES**
Remarks:

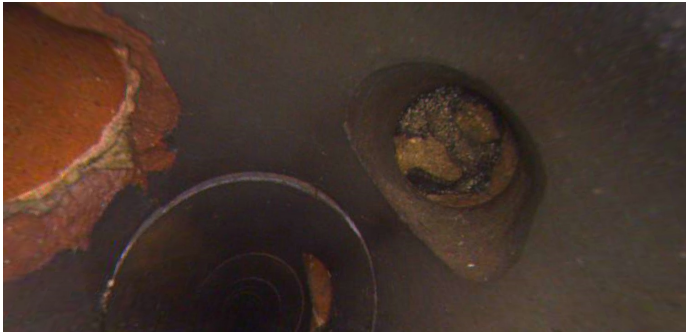
Code: **TFC**
Description: **Tap Factory Capped**

Distance (ft): **60.7**
Structural Grade: **0**
O&M Grade: **0**
Clock Start/From: **2**
Clock To:
1st Value: **4.000**
2nd Value:
Value Percent:
Continuous Index:
Within 8" of Joint:
Remarks:

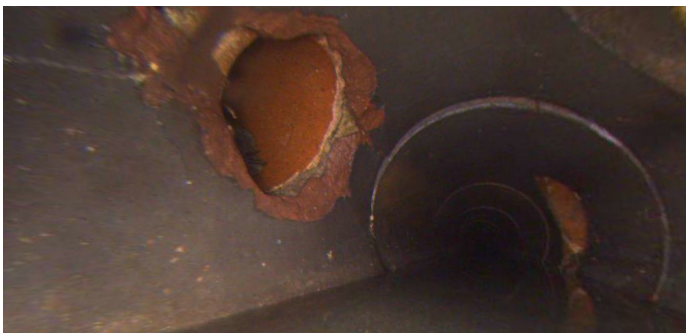
Code: **TB**
Description: **Tap Break-in**

Distance (ft): **60.7**
Structural Grade: **0**
O&M Grade: **0**
Clock Start/From: **10**
Clock To:
1st Value: **4.000**
2nd Value:
Value Percent:
Continuous Index:
Within 8" of Joint:
Remarks:

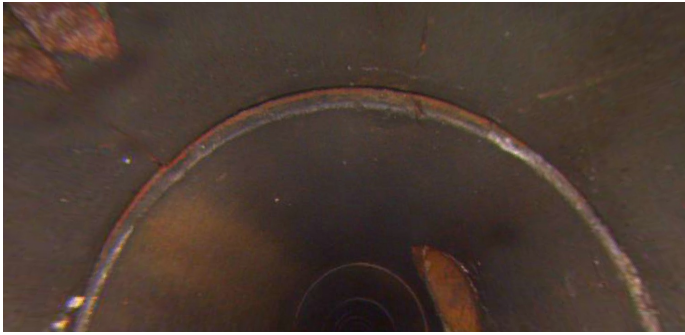
Code: **FM**
Description: **Fracture Multiple**

Distance (ft): **61.5**
Structural Grade: **4**
O&M Grade: **0**
Clock Start/From: **10**
Clock To: **2**
1st Value:
2nd Value:
Value Percent:
Continuous Index:
Within 8" of Joint: **YES**
Remarks:

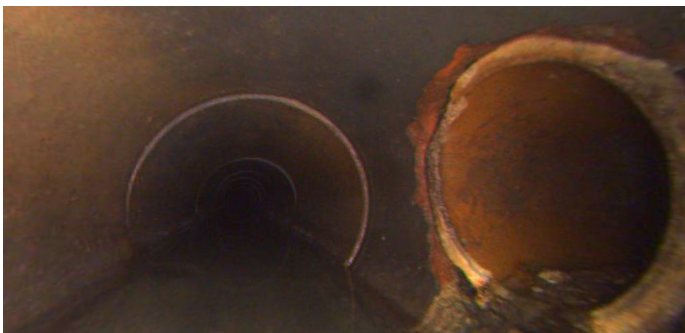
Code: **TB**
Description: **Tap Break-in**

Distance (ft): **62.6**
Structural Grade: **0**
O&M Grade: **0**
Clock Start/From: **3**
Clock To:
1st Value: **4.000**
2nd Value:
Value Percent:
Continuous Index:
Within 8" of Joint:
Remarks:

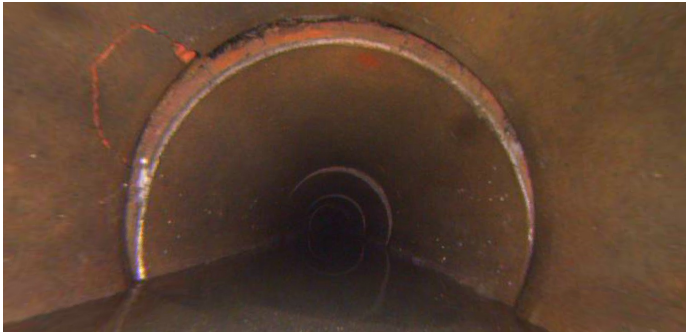
Code: **FS**
Description: **Fracture Spiral**

Distance (ft): **69.3**
Structural Grade: **3**
O&M Grade: **0**
Clock Start/From: **9**
Clock To: **11**
1st Value:
2nd Value:
Value Percent:
Continuous Index:
Within 8" of Joint: **YES**
Remarks:

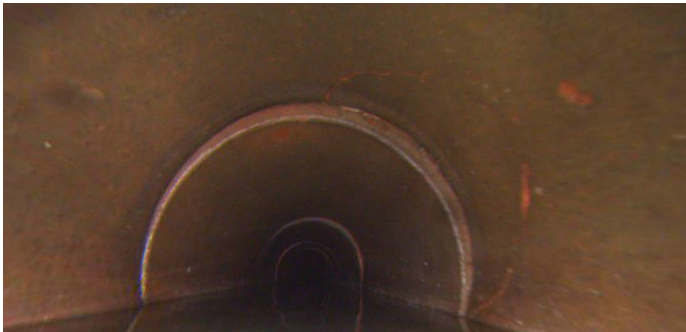
Code: **FM**
Description: **Fracture Multiple**

Distance (ft): **71.0**
Structural Grade: **4**
O&M Grade: **0**
Clock Start/From: **12**
Clock To: **4**
1st Value:
2nd Value:
Value Percent:
Continuous Index:
Within 8" of Joint: **YES**
Remarks:

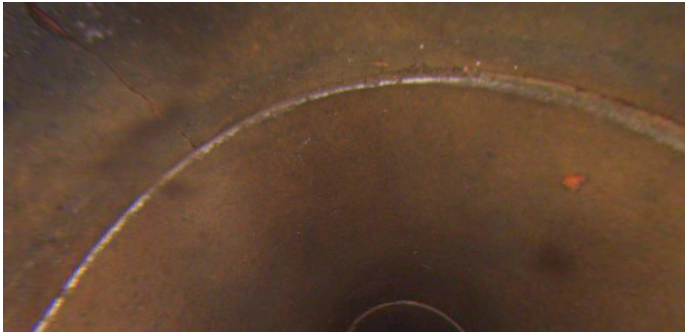
Code: **FL**
Description: **Fracture Longitudinal**

Distance (ft): **83.5**
Structural Grade: **3**
O&M Grade: **0**
Clock Start/From: **10**
Clock To:
1st Value:
2nd Value:
Value Percent:
Continuous Index:
Within 8" of Joint: **YES**
Remarks:

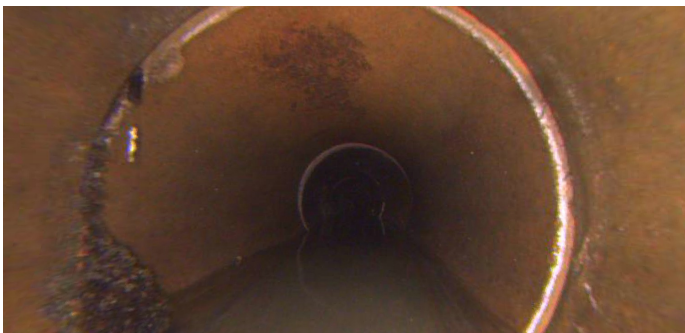
Code: **RMJ**
Description: **Roots Medium Joint**

Distance (ft): **85.3**
Structural Grade: **0**
O&M Grade: **3**
Clock Start/From: **8**
Clock To: **10**
1st Value:
2nd Value:
Value Percent: **5.000**
Continuous Index:
Within 8" of Joint: **YES**
Remarks:

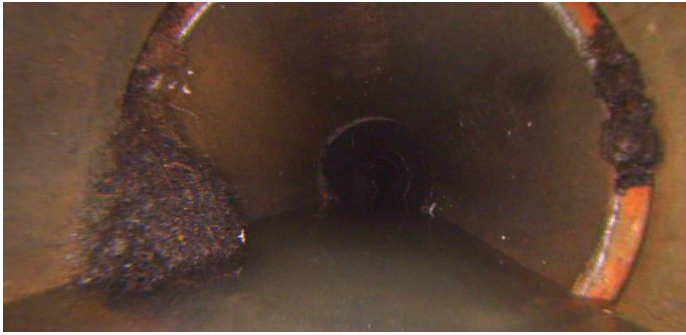
Code: **RMJ**
Description: **Roots Medium Joint**

Distance (ft): **89.3**
Structural Grade: **0**
O&M Grade: **3**
Clock Start/From: **8**
Clock To: **4**
1st Value:
2nd Value:
Value Percent: **10.000**
Continuous Index:
Within 8" of Joint: **YES**
Remarks:

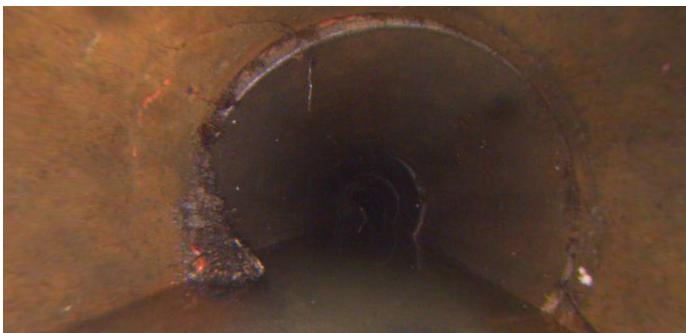
Code: **FM**
Description: **Fracture Multiple**

Distance (ft): **91.1**
Structural Grade: **4**
O&M Grade: **0**
Clock Start/From: **8**
Clock To: **4**
1st Value:
2nd Value:
Value Percent:
Continuous Index:
Within 8" of Joint: **YES**
Remarks:

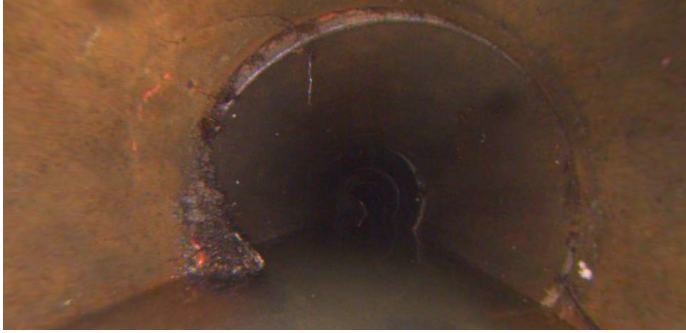
Code: **RMJ**
Description: **Roots Medium Joint**

Distance (ft): **91.1**
Structural Grade: **0**
O&M Grade: **3**
Clock Start/From: **8**
Clock To: **4**
1st Value:
2nd Value:
Value Percent: **10.000**
Continuous Index:
Within 8" of Joint: **YES**
Remarks:

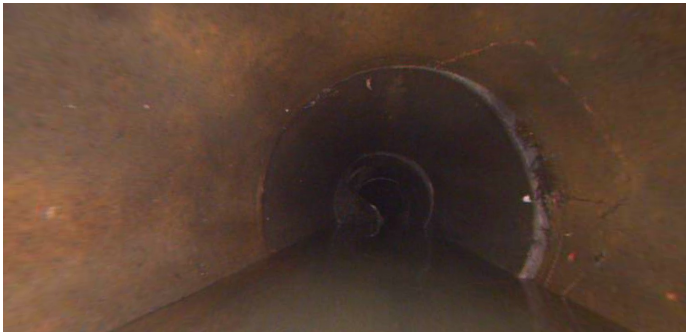
Code: **FM**
Description: **Fracture Multiple**

Distance (ft): **92.8**
Structural Grade: **4**
O&M Grade: **0**
Clock Start/From: **12**
Clock To: **4**
1st Value:
2nd Value:
Value Percent:
Continuous Index:
Within 8" of Joint: **YES**
Remarks:

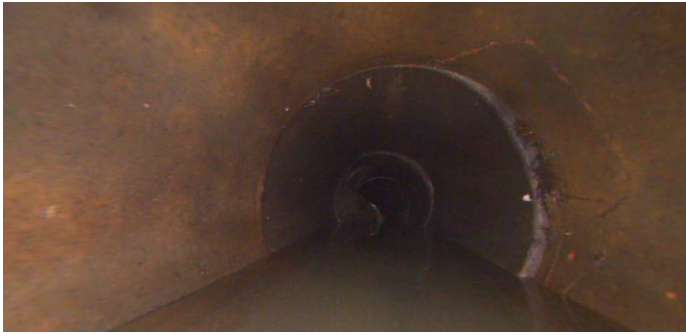
Code: **RFJ**
Description: **Roots Fine Joint**

Distance (ft): **92.8**
Structural Grade: **0**
O&M Grade: **1**
Clock Start/From: **8**
Clock To: **4**
1st Value:
2nd Value:
Value Percent:
Continuous Index:
Within 8" of Joint: **YES**
Remarks:

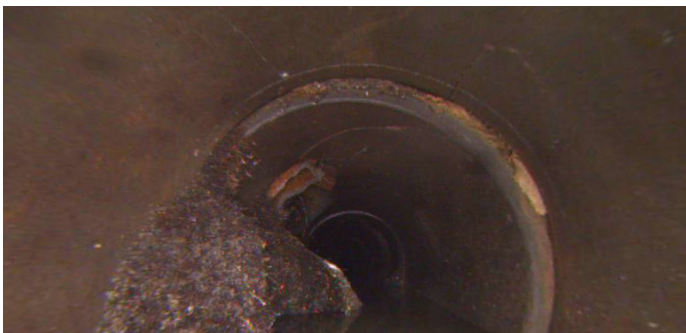
Code: **RMJ**
Description: **Roots Medium Joint**

Distance (ft): **95.2**
Structural Grade: **0**
O&M Grade: **3**
Clock Start/From: **8**
Clock To: **9**
1st Value:
2nd Value:
Value Percent: **30.000**
Continuous Index:
Within 8" of Joint: **YES**
Remarks:

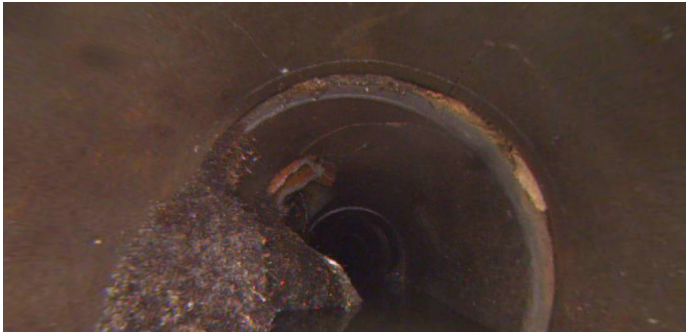
Code: **FM**
Description: **Fracture Multiple**

Distance (ft): **95.2**
Structural Grade: **4**
O&M Grade: **0**
Clock Start/From: **8**
Clock To: **4**
1st Value:
2nd Value:
Value Percent:
Continuous Index:
Within 8" of Joint: **YES**
Remarks:

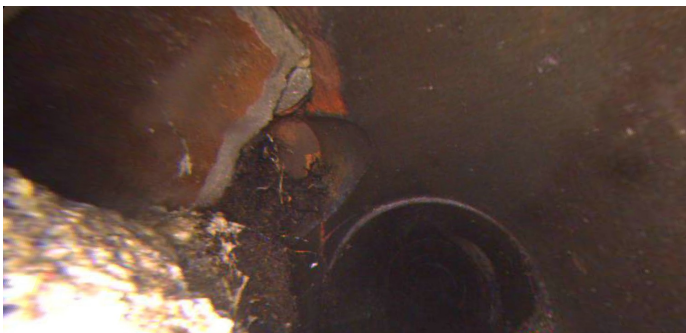
Code: **TBI**
Description: **Tap Break-in Intruding**

Distance (ft): **96.5**
Structural Grade: **0**
O&M Grade: **2**
Clock Start/From: **10**
Clock To:
1st Value: **4.000**
2nd Value: **1.000**
Value Percent:
Continuous Index:
Within 8" of Joint:
Remarks:

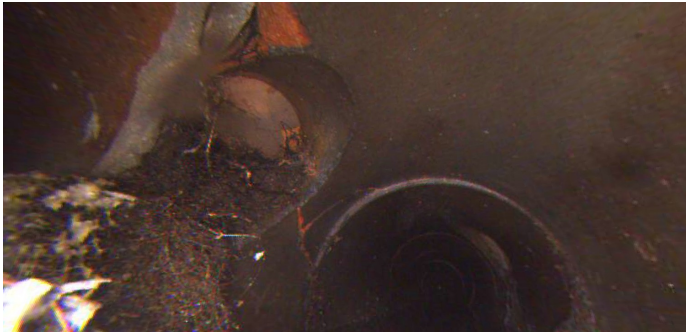
Code: **TF**
Description: **Tap Factory**

Distance (ft): **97.1**
Structural Grade: **0**
O&M Grade: **0**
Clock Start/From: **10**
Clock To:
1st Value: **4.000**
2nd Value:
Value Percent:
Continuous Index:
Within 8" of Joint:
Remarks:

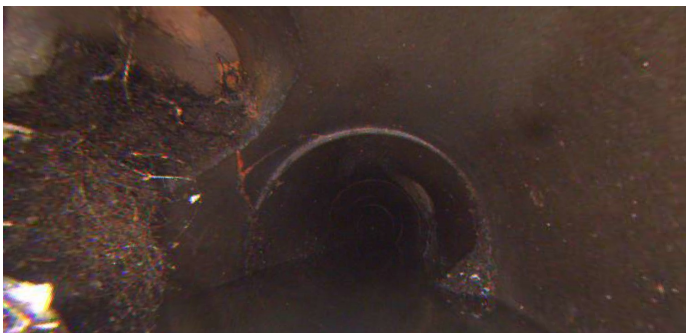
Code: **MSA**
Description: **Abandoned Survey**

Distance (ft): **97.1**
Structural Grade: **0**
O&M Grade: **0**
Clock Start/From:
Clock To:
1st Value:
2nd Value:
Value Percent:
Continuous Index:
Within 8" of Joint: **NO**
Remarks: **RMJ**
