Profile/Photo Observation Report

Date:	04/24/2018	Weather:		Coding:	PACP 6.0
Pipe Length (ft):	214.3	Owner:	NA	Pre Clean:	Not Known
P.O.#:		Surveyor:	Jen Costello	PSR:	P-605-040-039
Customer:		Clean Date:	01/01/1900	Shape:	C

Street:	S PENNSYLVANIA ST	Flow Control:	Not Controlled
City:	Hobart, IN	Year Renewed:	
Location:	Other	Tape/Media #:	
Purpose:	Not Known	Dia/Height:	12"
Use:	Sanitary	Material:	VCP
Drain Area:	NA	Lining:	
Category:	NA		
Comment:

Location Details:		Direction of Survey:	Downstream
US MH:	M-605-039	DS MH:	M-605-040
		Total Length Surveyed (ft):	58.7

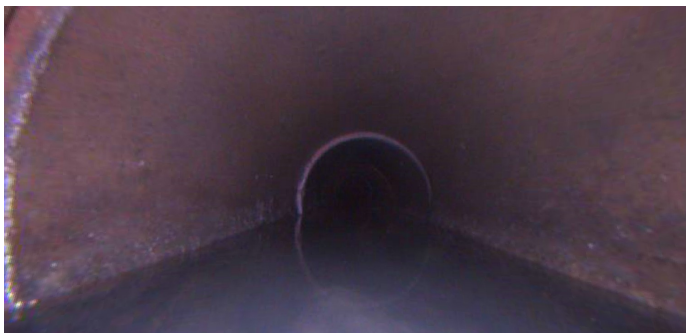
Code: **AMH**
Description: **Manhole**

Distance (ft): **.0**
Structural Grade: **0**
O&M Grade: **0**
Clock Start/From:
Clock To:
1st Value:
2nd Value:
Value Percent:
Continuous Index:
Within 8" of Joint: **NO**
Remarks: **M-605-039**

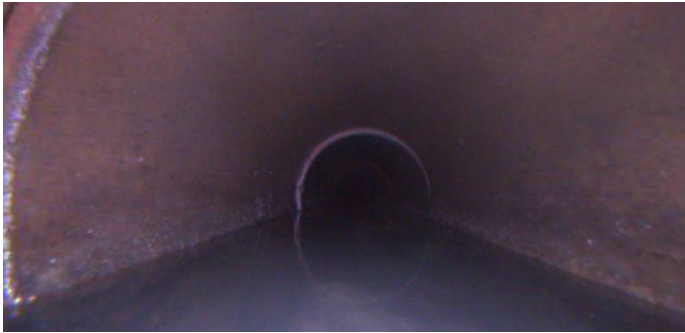
Code:	MWL
Description:	Water Level

Distance (ft):	.0
Structural Grade:	0
O&M Grade:	0
Clock Start/From:	
Clock To:	
1st Value:	
2nd Value:	
Value Percent:	30.000
Continuous Index:	
Within 8" of Joint:	NO
Remarks:

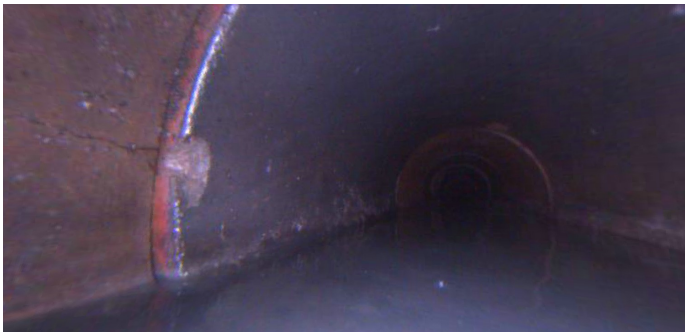
Code:	FL
Description:	Fracture Longitudinal

Distance (ft):	2.7
Structural Grade:	3
O&M Grade:	0
Clock Start/From:	9
Clock To:	
1st Value:	
2nd Value:	
Value Percent:	
Continuous Index:	
Within 8" of Joint:	YES
Remarks:

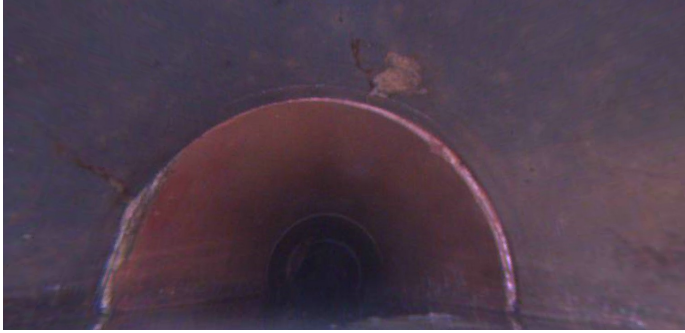
Code: **FM**
Description: **Fracture Multiple**

Distance (ft): **3.9**
Structural Grade: **4**
O&M Grade: **0**
Clock Start/From: **9**
Clock To: **12**
1st Value:
2nd Value:
Value Percent:
Continuous Index:
Within 8" of Joint: **YES**
Remarks:

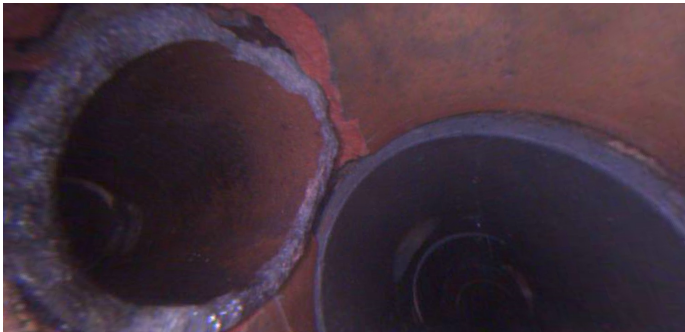
Code: **TBI**
Description: **Tap Break-in Intruding**

Distance (ft): **7.5**
Structural Grade: **0**
O&M Grade: **2**
Clock Start/From: **10**
Clock To:
1st Value: **4.000**
2nd Value: **1.000**
Value Percent:
Continuous Index:
Within 8" of Joint:
Remarks:

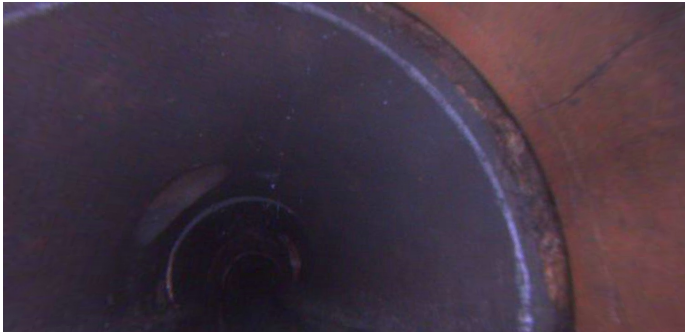
Code: **FL**
Description: **Fracture Longitudinal**

Distance (ft): **8.0**
Structural Grade: **3**
O&M Grade: **0**
Clock Start/From: **2**
Clock To:
1st Value:
2nd Value:
Value Percent:
Continuous Index:
Within 8" of Joint: **YES**
Remarks:

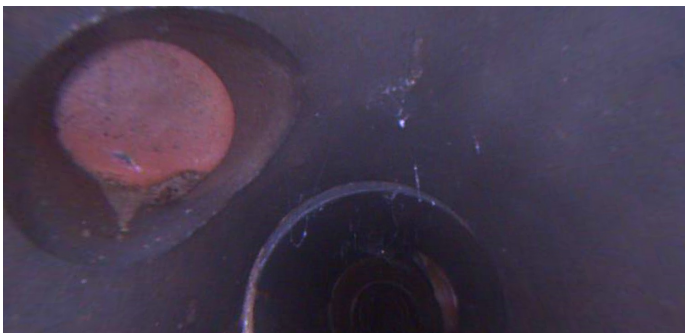
Code: **TF**
Description: **Tap Factory**

Distance (ft): **9.1**
Structural Grade: **0**
O&M Grade: **0**
Clock Start/From: **10**
Clock To:
1st Value: **4.000**
2nd Value:
Value Percent:
Continuous Index:
Within 8" of Joint:
Remarks:

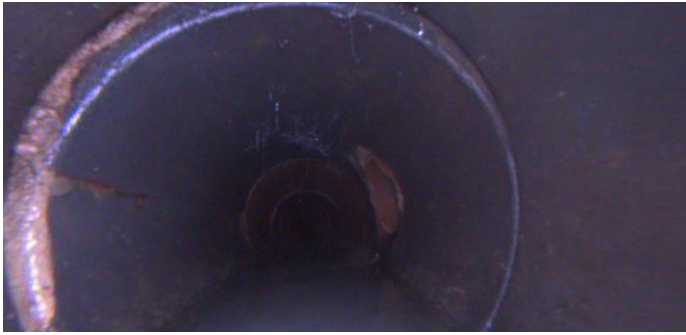
Code: **FL**
Description: **Fracture Longitudinal**

Distance (ft): **9.8**
Structural Grade: **3**
O&M Grade: **0**
Clock Start/From: **9**
Clock To:
1st Value:
2nd Value:
Value Percent:
Continuous Index:
Within 8" of Joint: **YES**
Remarks:

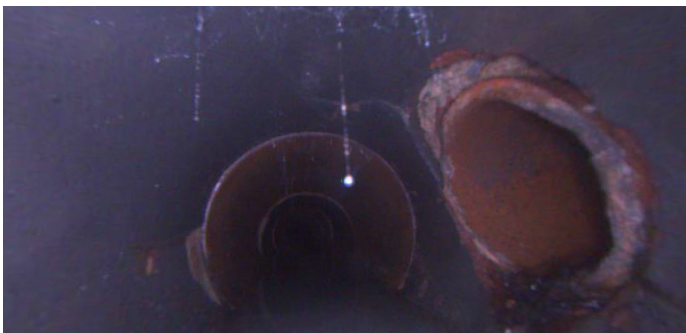
Code: **TBI**
Description: **Tap Break-in Intruding**

Distance (ft): **10.8**
Structural Grade: **0**
O&M Grade: **2**
Clock Start/From: **3**
Clock To:
1st Value: **4.000**
2nd Value: **1.000**
Value Percent:
Continuous Index:
Within 8" of Joint:
Remarks:

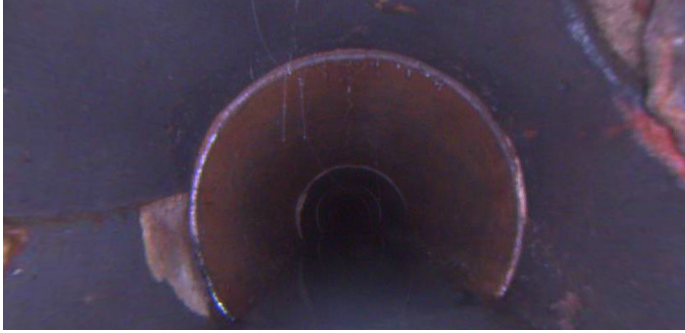
Code: **FM**
Description: **Fracture Multiple**

Distance (ft): **11.3**
Structural Grade: **4**
O&M Grade: **0**
Clock Start/From: **8**
Clock To: **4**
1st Value:
2nd Value:
Value Percent:
Continuous Index: **S01**
Within 8" of Joint: **YES**
Remarks:

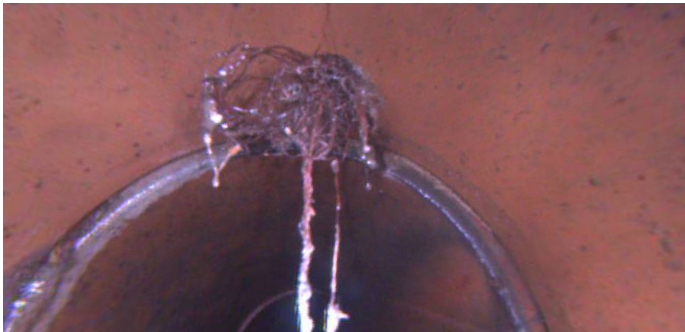
Code: **RMB**
Description: **Roots Medium Barrel**

Distance (ft): **21.3**
Structural Grade: **0**
O&M Grade: **4**
Clock Start/From: **12**
Clock To:
1st Value:
2nd Value:
Value Percent: **5.000**
Continuous Index:
Within 8" of Joint: **NO**
Remarks:

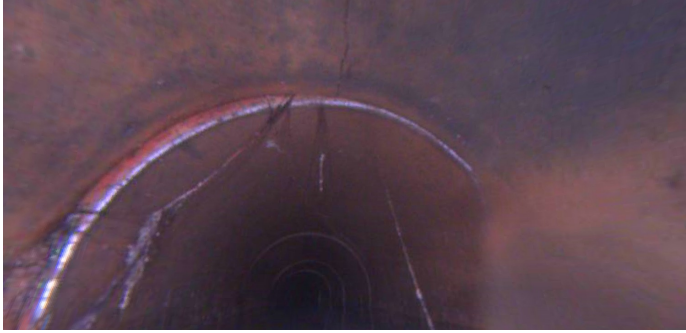
Code: **RFJ**
Description: **Roots Fine Joint**

Distance (ft): **23.3**
Structural Grade: **0**
O&M Grade: **1**
Clock Start/From: **8**
Clock To: **4**
1st Value:
2nd Value:
Value Percent:
Continuous Index:
Within 8" of Joint: **YES**
Remarks:

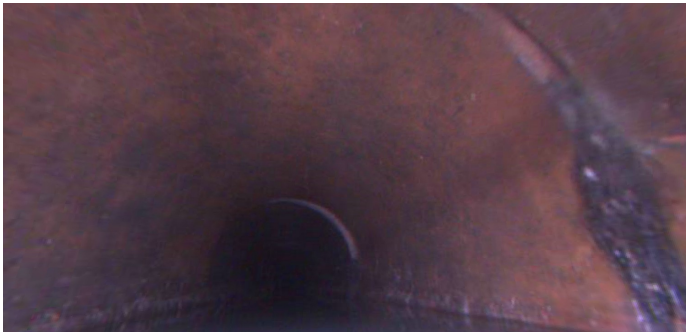
Code: **RFJ**
Description: **Roots Fine Joint**

Distance (ft): **37.3**
Structural Grade: **0**
O&M Grade: **1**
Clock Start/From: **3**
Clock To:
1st Value:
2nd Value:
Value Percent:
Continuous Index:
Within 8" of Joint: **YES**
Remarks:

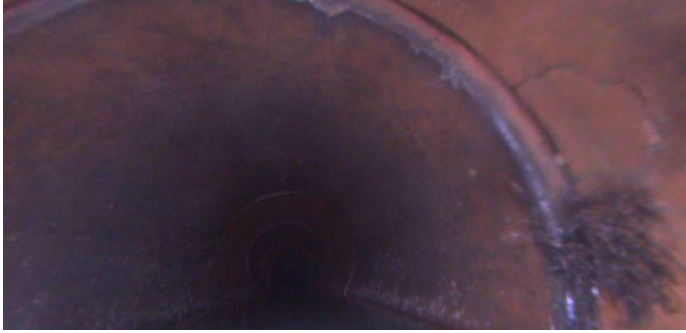
Code: **RFJ**
Description: **Roots Fine Joint**

Distance (ft): **38.5**
Structural Grade: **0**
O&M Grade: **1**
Clock Start/From: **3**
Clock To:
1st Value:
2nd Value:
Value Percent:
Continuous Index:
Within 8" of Joint: **YES**
Remarks:

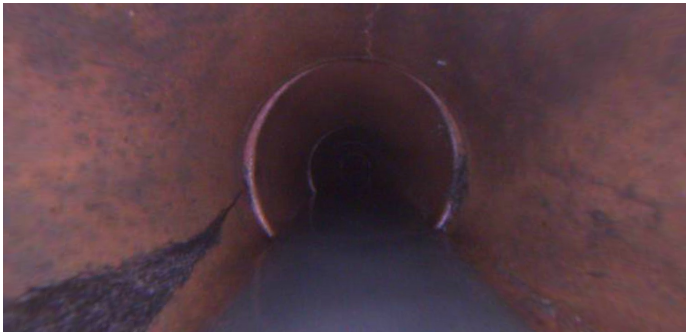
Code: **RFJ**
Description: **Roots Fine Joint**

Distance (ft): **43.5**
Structural Grade: **0**
O&M Grade: **1**
Clock Start/From: **8**
Clock To: **4**
1st Value:
2nd Value:
Value Percent:
Continuous Index:
Within 8" of Joint: **YES**
Remarks:

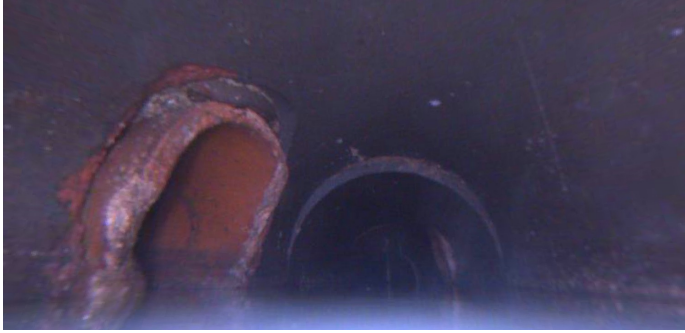
Code: **TBI**
Description: **Tap Break-in Intruding**

Distance (ft): **53.1**
Structural Grade: **0**
O&M Grade: **2**
Clock Start/From: **9**
Clock To:
1st Value: **4.000**
2nd Value: **1.000**
Value Percent:
Continuous Index:
Within 8" of Joint:
Remarks: **ACTIVE**

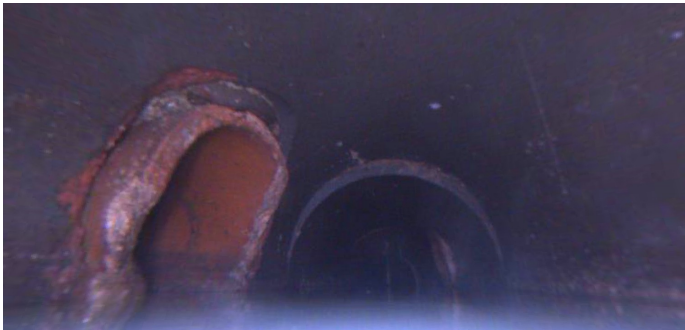
Code: **MWL**
Description: **Water Level**

Distance (ft): **53.1**
Structural Grade: **0**
O&M Grade: **0**
Clock Start/From:
Clock To:
1st Value:
2nd Value:
Value Percent: **40.000**
Continuous Index:
Within 8" of Joint: **NO**
Remarks:

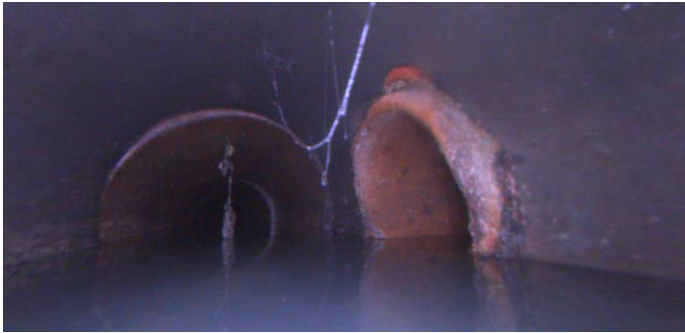
Code: **TBI**
Description: **Tap Break-in Intruding**

Distance (ft): **55.0**
Structural Grade: **0**
O&M Grade: **2**
Clock Start/From: **3**
Clock To:
1st Value: **4.000**
2nd Value: **1.000**
Value Percent:
Continuous Index:
Within 8" of Joint:
Remarks:

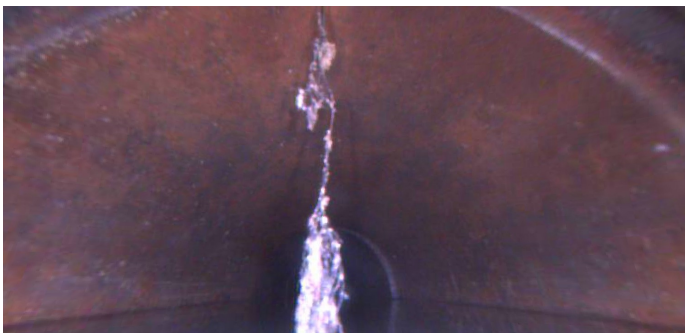
Code: **RFJ**
Description: **Roots Fine Joint**

Distance (ft): **56.2**
Structural Grade: **0**
O&M Grade: **1**
Clock Start/From: **8**
Clock To: **4**
1st Value:
2nd Value:
Value Percent:
Continuous Index:
Within 8" of Joint: **YES**
Remarks:
