Profile/Photo Observation Report

Date:	04/24/2018	Weather:		Coding:	PACP 6.0
Pipe Length (ft):	214.3	Owner:	NA	Pre Clean:	Not Known
P.O.#:		Surveyor:	Jen Costello	PSR:	P-605-040-039
Customer:		Clean Date:	01/01/1900	Shape:	C

Street:	S Pennsylvania St.	Flow Control:	Not Controlled
City:	Hobart, IN	Year Renewed:	
Location:	Other	Tape/Media #:	
Purpose:	Not Known	Dia/Height:	12"
Use:	Sanitary	Material:	VCP
Drain Area:	NA	Lining:	
Category:	NA		
Comment:

Location Details:		Direction of Survey:	Downstream
US MH:	M-605-039	DS MH:	M-605-040
		Total Length Surveyed (ft):	58.7

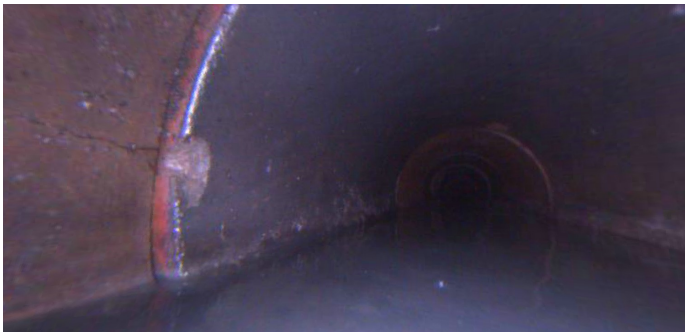
Code:	FL
Description:	Fracture Longitudinal

Distance (ft):	2.7
Structural Grade:	3
O&M Grade:	0
Clock Start/From:	9
Clock To:	
1st Value:	
2nd Value:	
Value Percent:	
Continuous Index:	
Within 8" of Joint:	YES
Remarks:

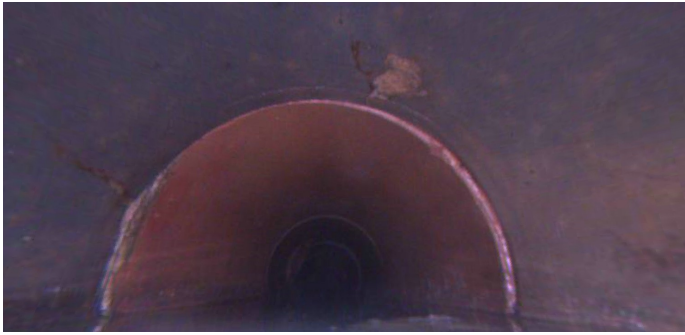
Code: **FM**
Description: **Fracture Multiple**

Distance (ft): **3.9**
Structural Grade: **4**
O&M Grade: **0**
Clock Start/From: **9**
Clock To: **12**
1st Value:
2nd Value:
Value Percent:
Continuous Index:
Within 8" of Joint: **YES**
Remarks:

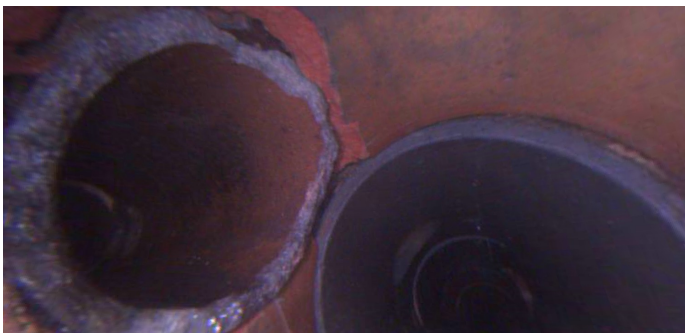
Code: **TBI**
Description: **Tap Break-in Intruding**

Distance (ft): **7.5**
Structural Grade: **0**
O&M Grade: **2**
Clock Start/From: **10**
Clock To:
1st Value: **4.000**
2nd Value: **1.000**
Value Percent:
Continuous Index:
Within 8" of Joint:
Remarks:

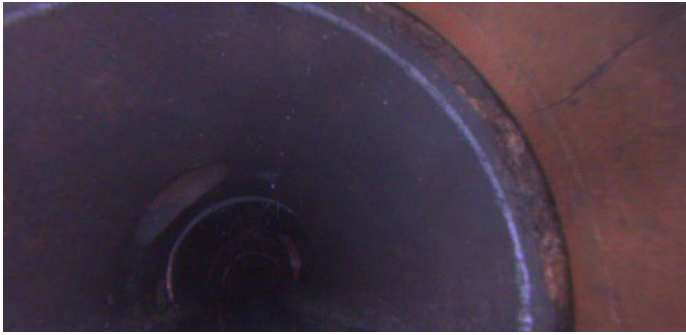
Code: **FL**
Description: **Fracture Longitudinal**

Distance (ft): **8.0**
Structural Grade: **3**
O&M Grade: **0**
Clock Start/From: **2**
Clock To:
1st Value:
2nd Value:
Value Percent:
Continuous Index:
Within 8" of Joint: **YES**
Remarks:

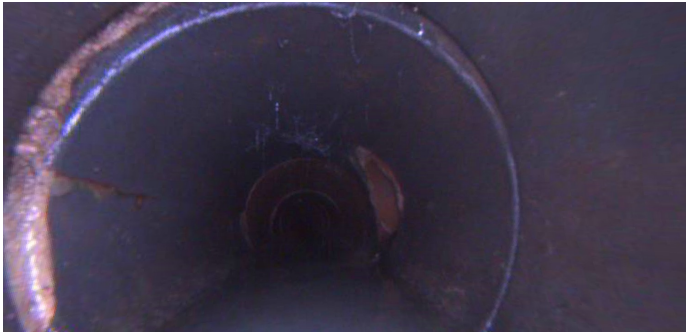
Code: **FL**
Description: **Fracture Longitudinal**

Distance (ft): **9.8**
Structural Grade: **3**
O&M Grade: **0**
Clock Start/From: **9**
Clock To:
1st Value:
2nd Value:
Value Percent:
Continuous Index:
Within 8" of Joint: **YES**
Remarks:

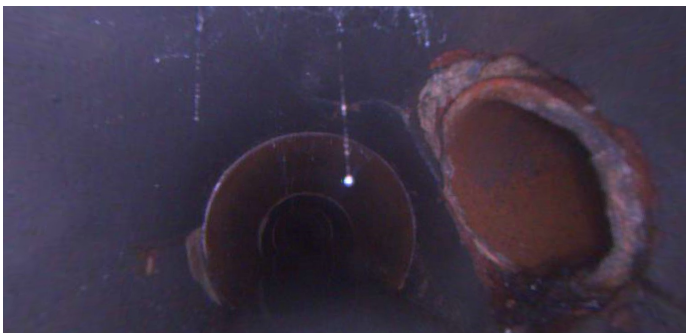
Code: **TBI**
Description: **Tap Break-in Intruding**

Distance (ft): **10.8**
Structural Grade: **0**
O&M Grade: **2**
Clock Start/From: **3**
Clock To:
1st Value: **4.000**
2nd Value: **1.000**
Value Percent:
Continuous Index:
Within 8" of Joint:
Remarks:

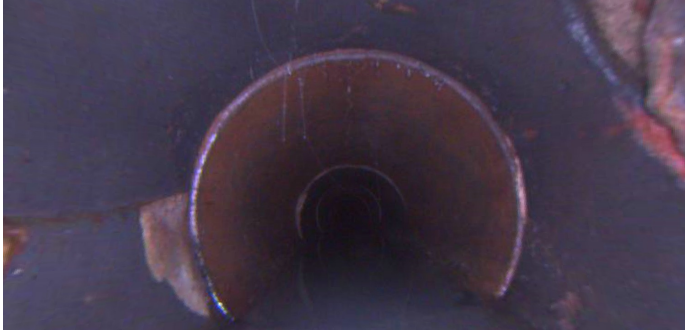
Code: **FM**
Description: **Fracture Multiple**

Distance (ft): **11.3**
Structural Grade: **4**
O&M Grade: **0**
Clock Start/From: **8**
Clock To: **4**
1st Value:
2nd Value:
Value Percent:
Continuous Index: **S01**
Within 8" of Joint: **YES**
Remarks:

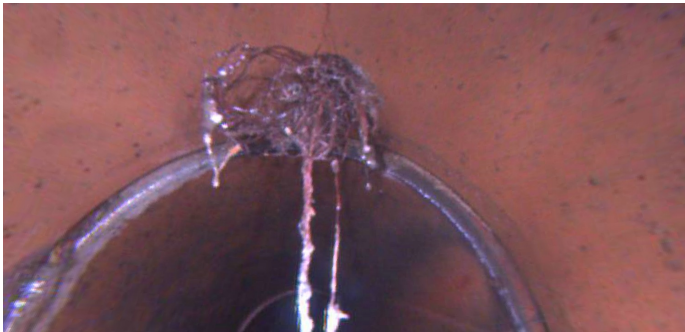
Code: **RMB**
Description: **Roots Medium Barrel**

Distance (ft): **21.3**
Structural Grade: **0**
O&M Grade: **4**
Clock Start/From: **12**
Clock To:
1st Value:
2nd Value:
Value Percent: **5.000**
Continuous Index:
Within 8" of Joint: **NO**
Remarks:

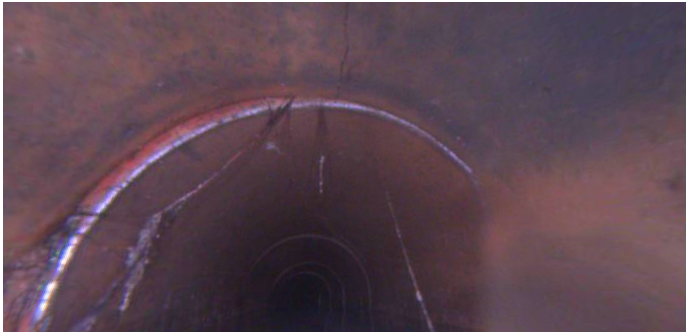
Code: **RFJ**
Description: **Roots Fine Joint**

Distance (ft): **23.3**
Structural Grade: **0**
O&M Grade: **1**
Clock Start/From: **8**
Clock To: **4**
1st Value:
2nd Value:
Value Percent:
Continuous Index:
Within 8" of Joint: **YES**
Remarks:

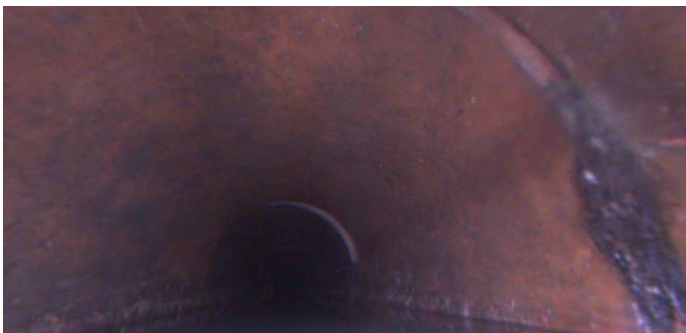
Code: **RFJ**
Description: **Roots Fine Joint**

Distance (ft): **37.3**
Structural Grade: **0**
O&M Grade: **1**
Clock Start/From: **3**
Clock To:
1st Value:
2nd Value:
Value Percent:
Continuous Index:
Within 8" of Joint: **YES**
Remarks:

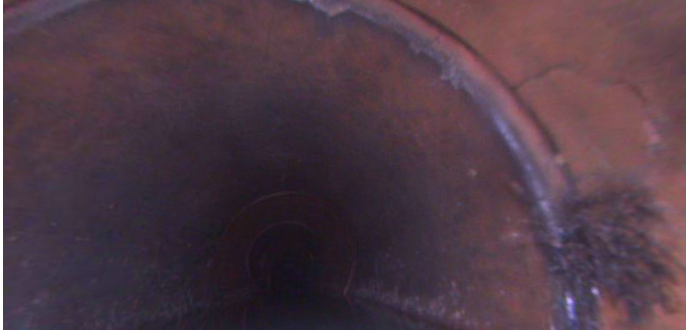
Code: **RFJ**
Description: **Roots Fine Joint**

Distance (ft): **38.5**
Structural Grade: **0**
O&M Grade: **1**
Clock Start/From: **3**
Clock To:
1st Value:
2nd Value:
Value Percent:
Continuous Index:
Within 8" of Joint: **YES**
Remarks:

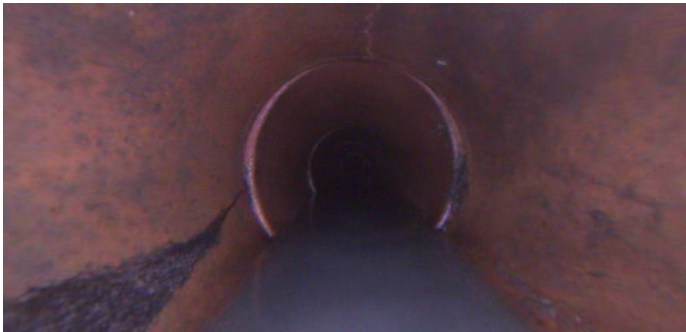
Code: **RFJ**
Description: **Roots Fine Joint**

Distance (ft): **43.5**
Structural Grade: **0**
O&M Grade: **1**
Clock Start/From: **8**
Clock To: **4**
1st Value:
2nd Value:
Value Percent:
Continuous Index:
Within 8" of Joint: **YES**
Remarks:

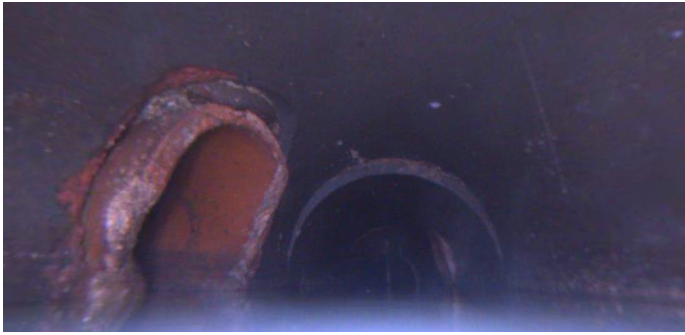
Code: **TBI**
Description: **Tap Break-in Intruding**

Distance (ft): **53.1**
Structural Grade: **0**
O&M Grade: **2**
Clock Start/From: **9**
Clock To:
1st Value: **4.000**
2nd Value: **1.000**
Value Percent:
Continuous Index:
Within 8" of Joint:
Remarks: **ACTIVE**

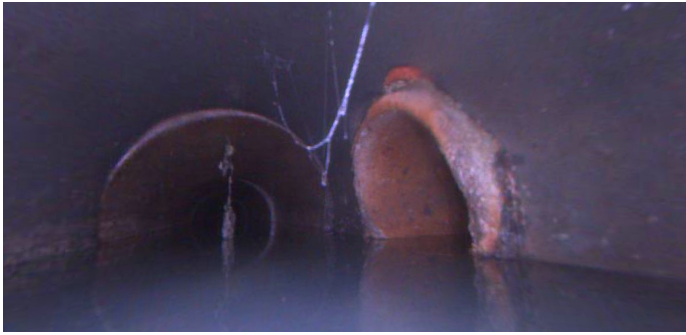
Code: **TBI**
Description: **Tap Break-in Intruding**

Distance (ft): **55.0**
Structural Grade: **0**
O&M Grade: **2**
Clock Start/From: **3**
Clock To:
1st Value: **4.000**
2nd Value: **1.000**
Value Percent:
Continuous Index:
Within 8" of Joint:
Remarks:

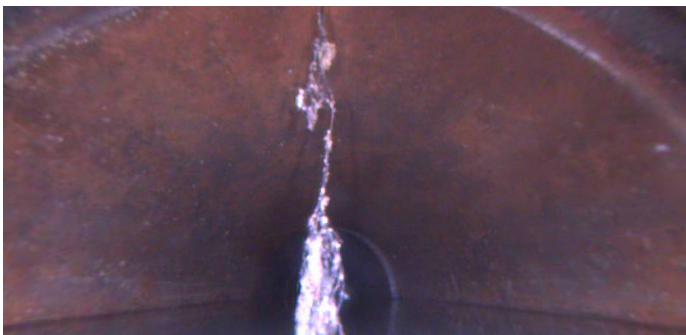
Code: **RFJ**
Description: **Roots Fine Joint**

Distance (ft): **56.2**
Structural Grade: **0**
O&M Grade: **1**
Clock Start/From: **8**
Clock To: **4**
1st Value:
2nd Value:
Value Percent:
Continuous Index:
Within 8" of Joint: **YES**
Remarks:
