RedZone
ROBOTICS

Street:	South Pennsylvania Street		Flow Control:	Not Controlled	
City:	City of Hobart		Year Renewed:		
Location:	Local rural streets with light traffic, t		Tape/Media #:		
Purpose:	Routine Assessment		Dia/Height:	12"	
Use:	Sanitary Sewage Pipe		Material:	VCP	
Drain Area:			Lining:	None	
Category:	NA				
Comment:					
Location Details:			Direction of Survey:	Downstream	
US MH:	M-605-039	DS MH:	M-605-040	Total Length Surveyed (ft):	212.4

O&M Index:	2.19	O&M Quick:	372A	O&M Rating:	46.00
Structural Index:	3.21	Structural Quick:	4H2E	Structural Rating:	260.00
Overall Index:	3.00	Overall Quick:	4H37	Overall Rating:	306.00

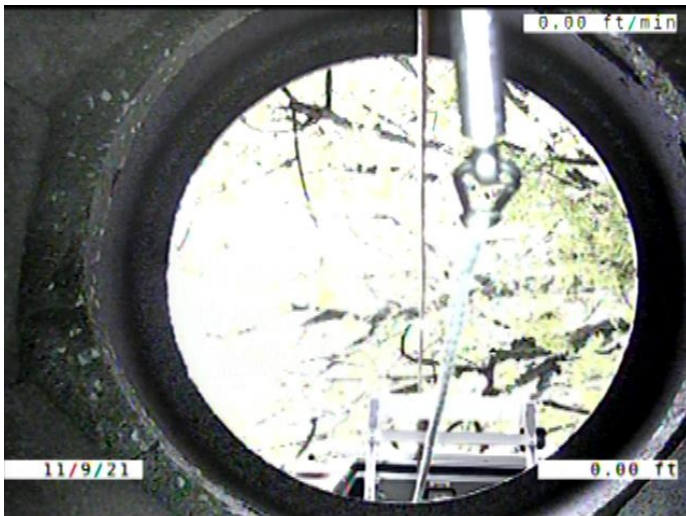
Code: **AMH**
Description: **Manhole**

Distance (ft): **.0**
Structural Grade: **0**
O&M Grade: **0**
Clock Start/From:
Clock To:
1st Value:
2nd Value:
Value Percent:
Continuous Index:
Within 8" of Joint: **NO**
Remarks: **M-605-039**

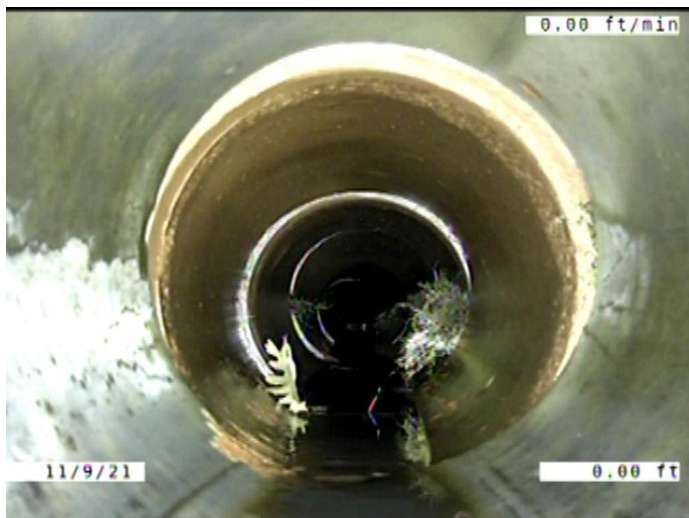
Code: **MWL**
 Description: **Miscellaneous Water Level**

Distance (ft): **.0**
 Structural Grade: **0**
 O&M Grade: **0**
 Clock Start/From:
 Clock To:
 1st Value:
 2nd Value:
 Value Percent: **5.000**
 Continuous Index:
 Within 8" of Joint: **NO**
 Remarks:

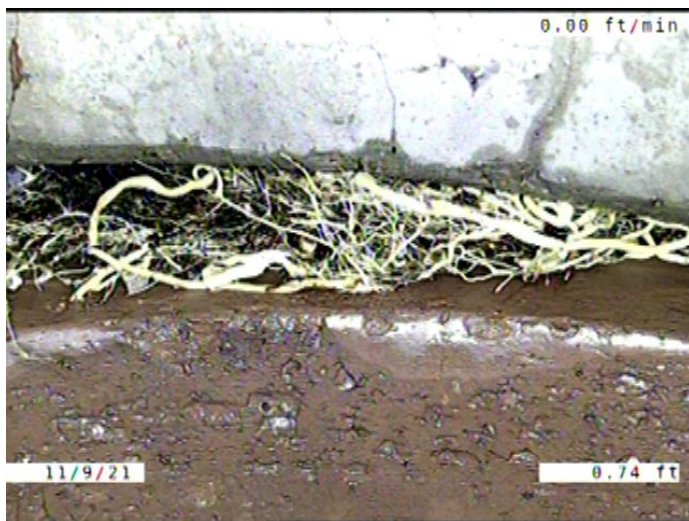
Code: **RFJ**
 Description: **Roots Fine Joint**

Distance (ft): **.7**
 Structural Grade: **0**
 O&M Grade: **1**
 Clock Start/From: **3**
 Clock To: **4**
 1st Value:
 2nd Value:
 Value Percent:
 Continuous Index:
 Within 8" of Joint: **YES**
 Remarks:

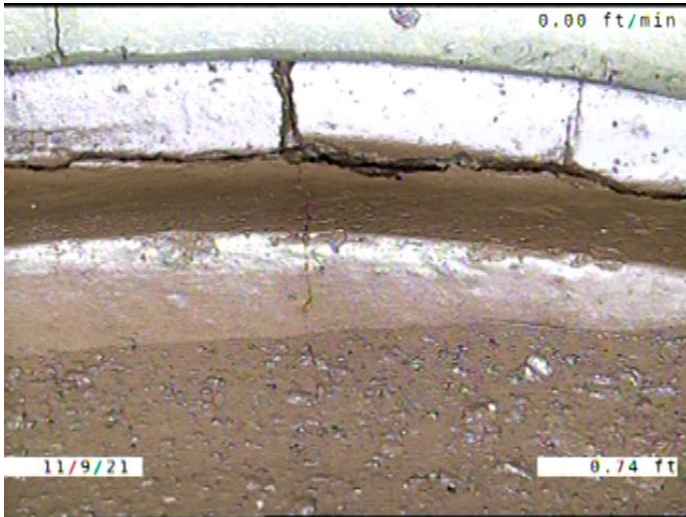
Code: **FM**
 Description: **Fracture Multiple**

Distance (ft): **.7**
 Structural Grade: **4**
 O&M Grade: **0**
 Clock Start/From: **12**
 Clock To: **12**
 1st Value:
 2nd Value:
 Value Percent:
 Continuous Index: **S03**
 Within 8" of Joint: **YES**
 Remarks:

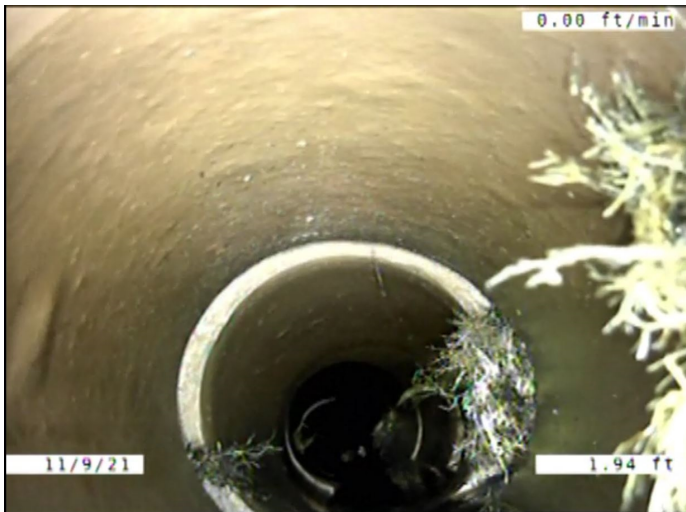
Code: **SZ**
 Description: **Surface Damage Other**

Distance (ft): **1.9**
 Structural Grade: **0**
 O&M Grade: **0**
 Clock Start/From: **10**
 Clock To:
 1st Value:
 2nd Value:
 Value Percent:
 Continuous Index:
 Within 8" of Joint: **NO**
 Remarks: **Indentation, Factory Defect**

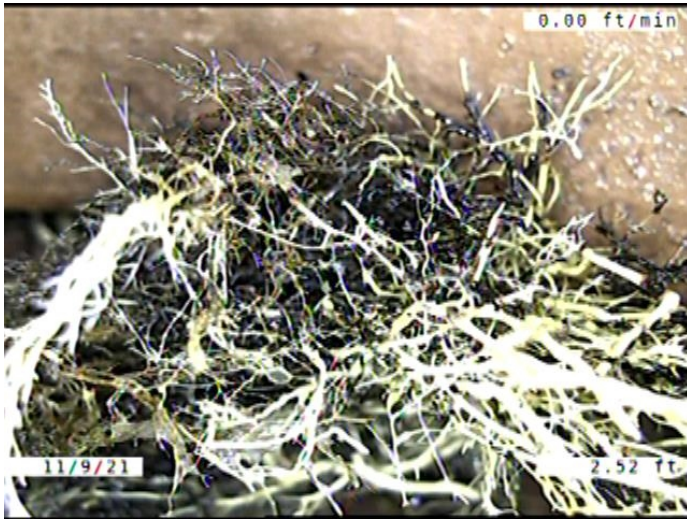
Code: **RMJ**
 Description: **Roots Medium Joint**

Distance (ft): **2.5**
 Structural Grade: **0**
 O&M Grade: **3**
 Clock Start/From: **8**
 Clock To: **4**
 1st Value:
 2nd Value:
 Value Percent: **10.000**
 Continuous Index: **S01**
 Within 8" of Joint: **YES**
 Remarks:

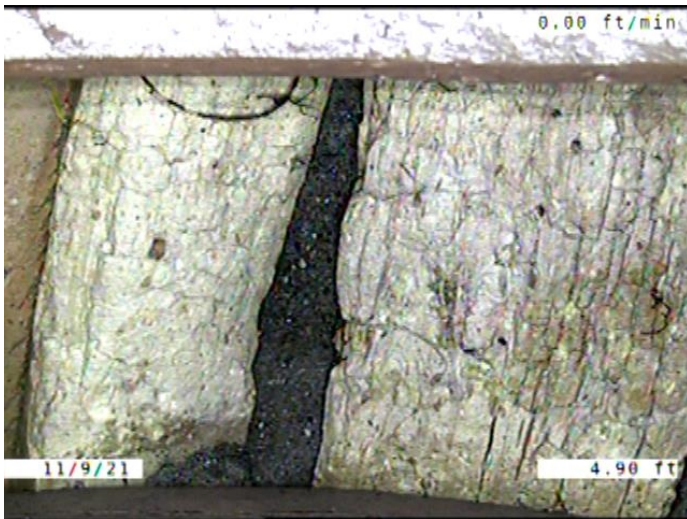
Code: **JSL**
 Description: **Joint Separated Large**

Distance (ft): **4.9**
 Structural Grade: **4**
 O&M Grade: **0**
 Clock Start/From:
 Clock To:
 1st Value:
 2nd Value:
 Value Percent:
 Continuous Index:
 Within 8" of Joint: **NO**
 Remarks: **HAS BEEN BRICKED BACK TOGETHER.**

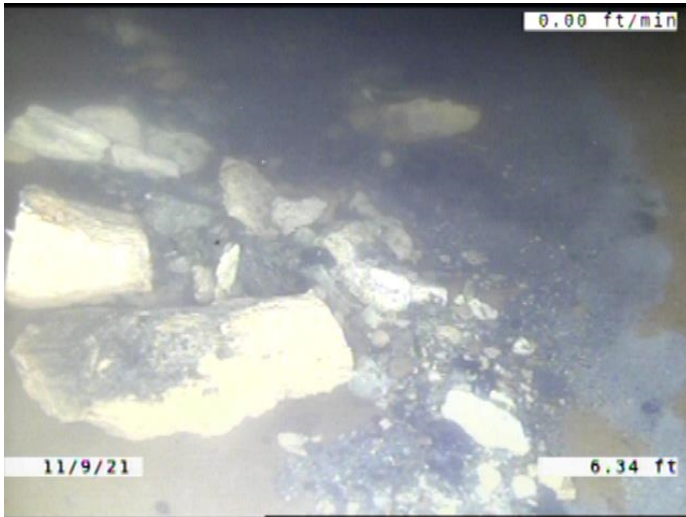
Code: **DSF**
Description: **Deposits Settled Fine**

Distance (ft): **6.3**
Structural Grade: **0**
O&M Grade: **2**
Clock Start/From: **5**
Clock To: **7**
1st Value:
2nd Value:
Value Percent: **5.000**
Continuous Index:
Within 8" of Joint: **YES**
Remarks:

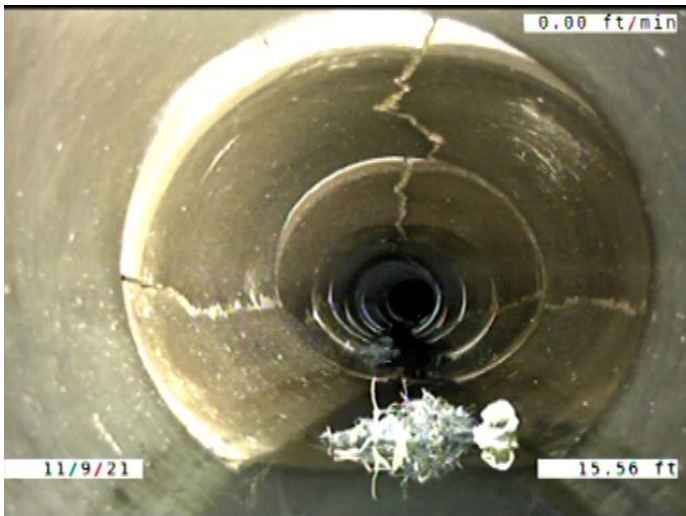
Code: **DR**
Description: **Deformed Rigid**

Distance (ft): **15.6**
Structural Grade: **4**
O&M Grade: **0**
Clock Start/From:
Clock To:
1st Value:
2nd Value:
Value Percent: **5.000**
Continuous Index: **S02**
Within 8" of Joint: **NO**
Remarks:

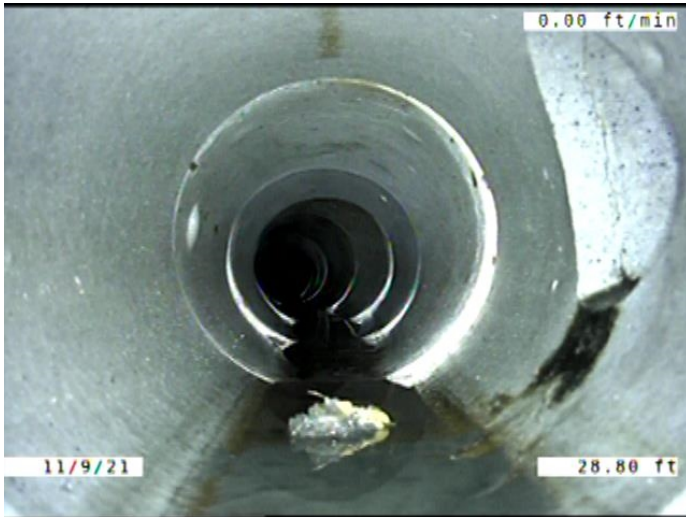
Code: **RMJ**
Description: **Roots Medium Joint**

Distance (ft): **28.8**
Structural Grade: **0**
O&M Grade: **3**
Clock Start/From: **8**
Clock To: **4**
1st Value:
2nd Value:
Value Percent: **10.000**
Continuous Index: **F01**
Within 8" of Joint: **YES**
Remarks:

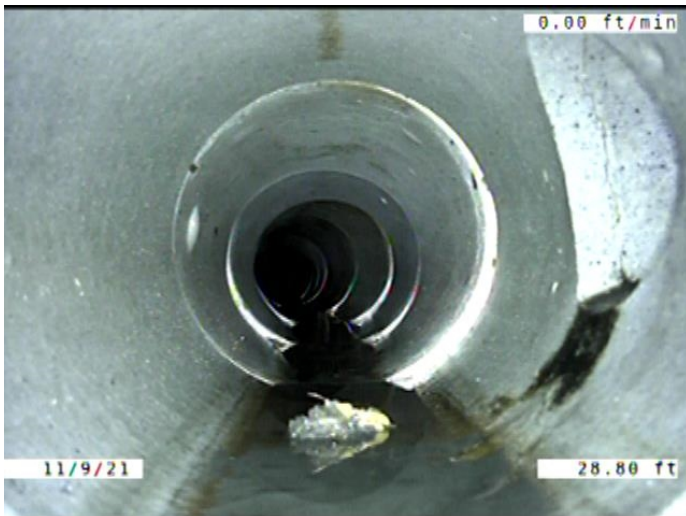
Code: **DR**
Description: **Deformed Rigid**

Distance (ft): **28.8**
Structural Grade: **4**
O&M Grade: **0**
Clock Start/From:
Clock To:
1st Value:
2nd Value:
Value Percent: **5.000**
Continuous Index: **F02**
Within 8" of Joint: **NO**
Remarks:

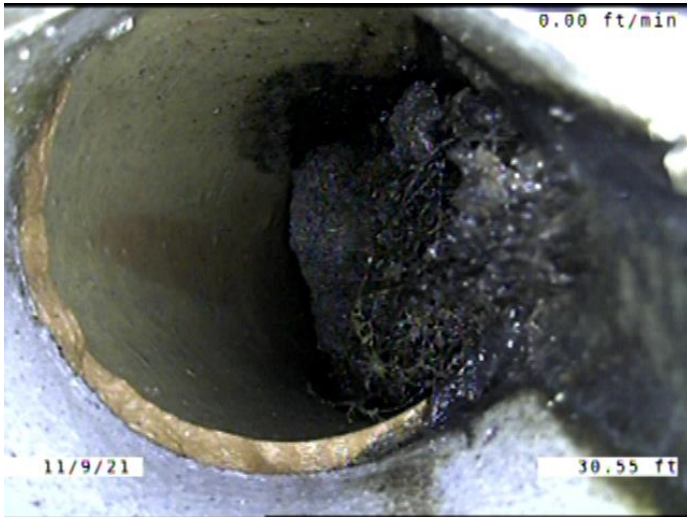
Code:	TFD
Description:	Tap Factory Defective
Distance (ft):	30.6
Structural Grade:	0
O&M Grade:	3
Clock Start/From:	2
Clock To:	
1st Value:	4.000
2nd Value:	
Value Percent:	
Continuous Index:	
Within 8" of Joint:	YES
Remarks:	CRACKED. LOOKS TO BE 95% PLUGGED

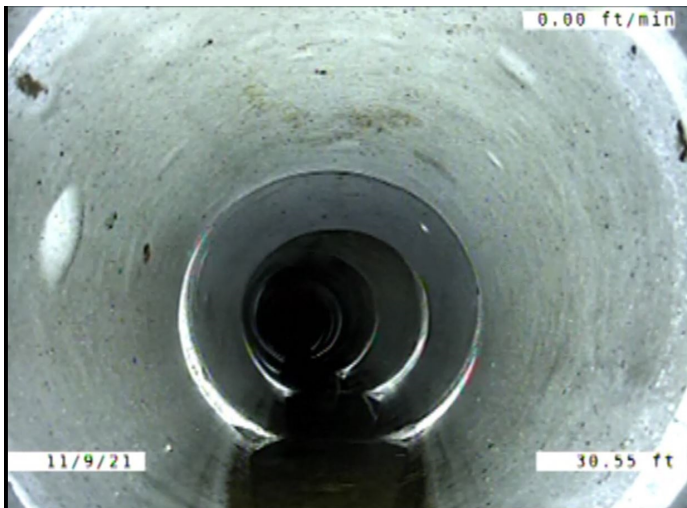
Code:	SZ
Description:	Surface Damage Other
Distance (ft):	30.6
Structural Grade:	0
O&M Grade:	0
Clock Start/From:	10
Clock To:	2
1st Value:	
2nd Value:	
Value Percent:	
Continuous Index:	
Within 8" of Joint:	NO
Remarks:	Indentations. Factory defect.

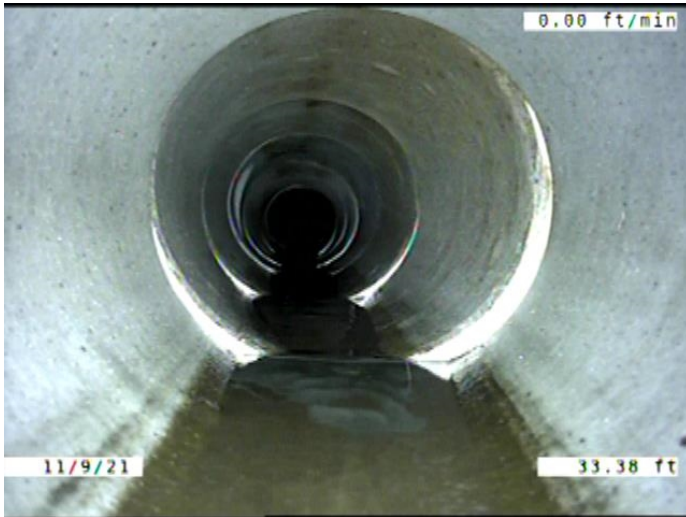
Code: **FM**
Description: **Fracture Multiple**

Distance (ft): **33.4**
Structural Grade: **4**
O&M Grade: **0**
Clock Start/From: **12**
Clock To: **12**
1st Value:
2nd Value:
Value Percent:
Continuous Index: **F03**
Within 8" of Joint: **YES**
Remarks:

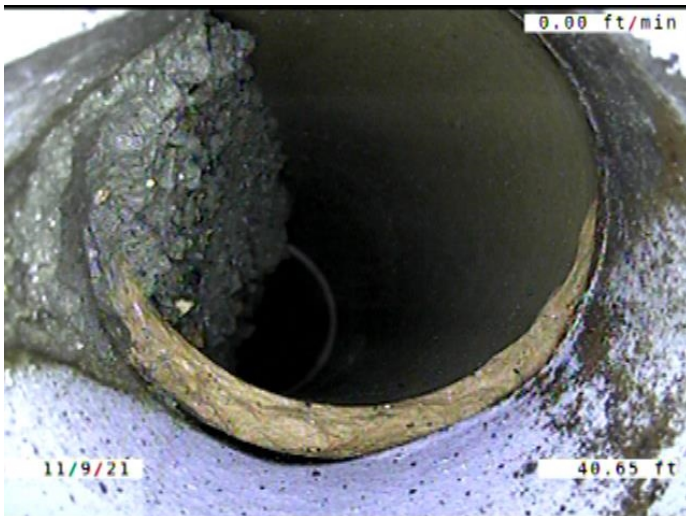
Code: **TFD**
Description: **Tap Factory Defective**

Distance (ft): **40.6**
Structural Grade: **0**
O&M Grade: **3**
Clock Start/From: **9**
Clock To:
1st Value: **4.000**
2nd Value:
Value Percent:
Continuous Index:
Within 8" of Joint: **YES**
Remarks: **OFFSET.**

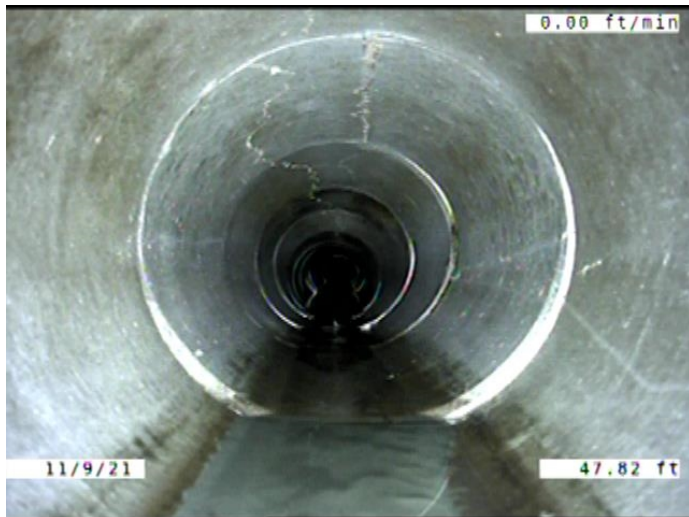
Code: **FM**
 Description: **Fracture Multiple**

Distance (ft): **47.8**
 Structural Grade: **4**
 O&M Grade: **0**
 Clock Start/From: **12**
 Clock To: **12**
 1st Value:
 2nd Value:
 Value Percent:
 Continuous Index: **S04**
 Within 8" of Joint: **YES**
 Remarks: **Wandering**

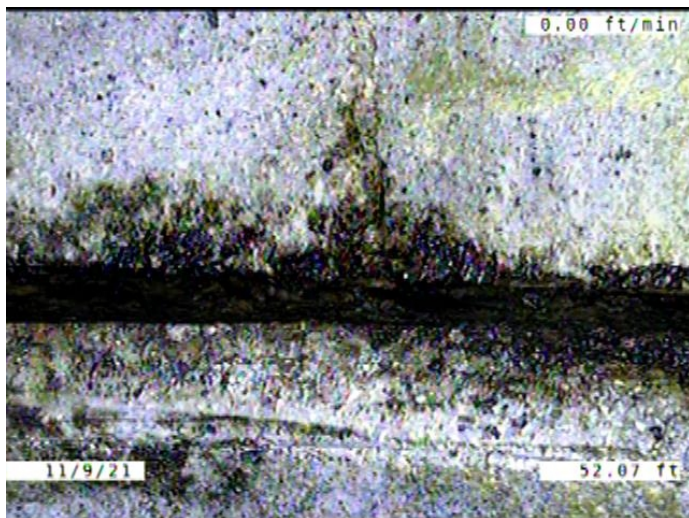
Code: **ISJ**
 Description: **Infiltration Stain Joint**

Distance (ft): **52.1**
 Structural Grade: **0**
 O&M Grade: **1**
 Clock Start/From: **2**
 Clock To: **5**
 1st Value:
 2nd Value:
 Value Percent:
 Continuous Index:
 Within 8" of Joint: **YES**
 Remarks:

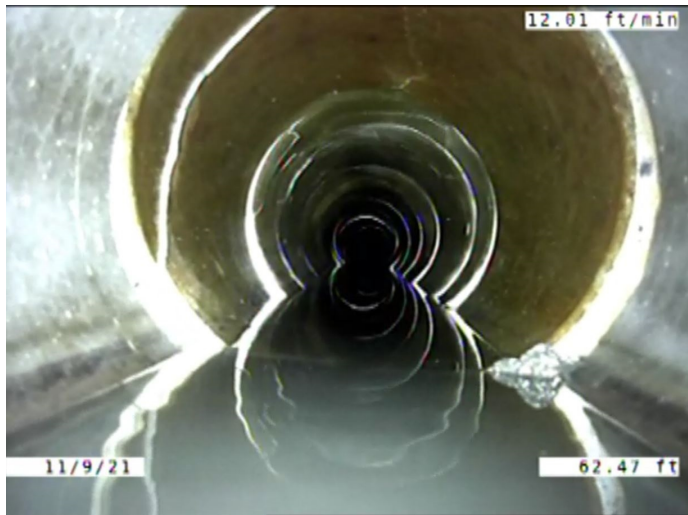
Code: **B**
 Description: **Broken**

Distance (ft): **62.5**
 Structural Grade: **4**
 O&M Grade: **0**
 Clock Start/From: **8**
 Clock To: **12**
 1st Value:
 2nd Value:
 Value Percent:
 Continuous Index:
 Within 8" of Joint: **YES**
 Remarks:

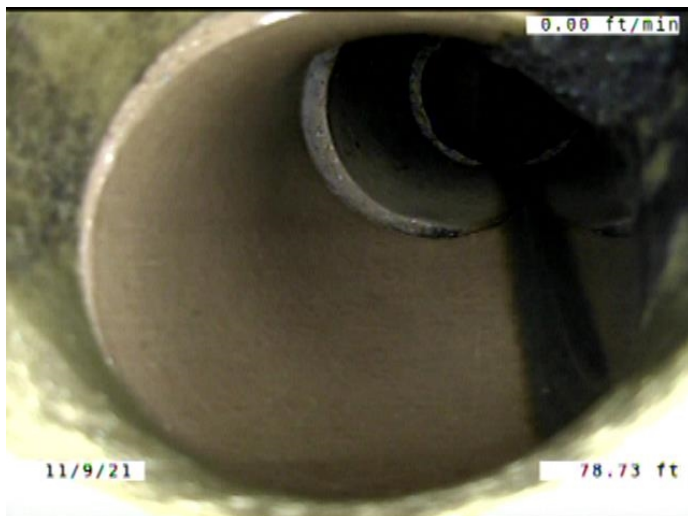
Code: **TF**
 Description: **Tap Factory**

Distance (ft): **78.7**
 Structural Grade: **0**
 O&M Grade: **0**
 Clock Start/From: **2**
 Clock To:
 1st Value: **4.000**
 2nd Value:
 Value Percent:
 Continuous Index:
 Within 8" of Joint: **YES**
 Remarks: **ROOTS GROWING IN THE TAP**

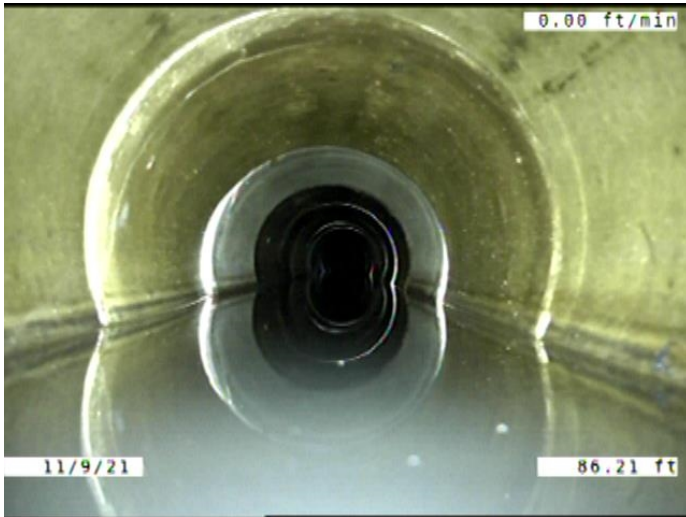
Code: **MWLS**
 Description: **Miscellaneous Water Level Sag**

Distance (ft): **86.2**
 Structural Grade: **2**
 O&M Grade: **0**
 Clock Start/From:
 Clock To:
 1st Value:
 2nd Value:
 Value Percent: **15.000**
 Continuous Index: **S05**
 Within 8" of Joint: **NO**
 Remarks:

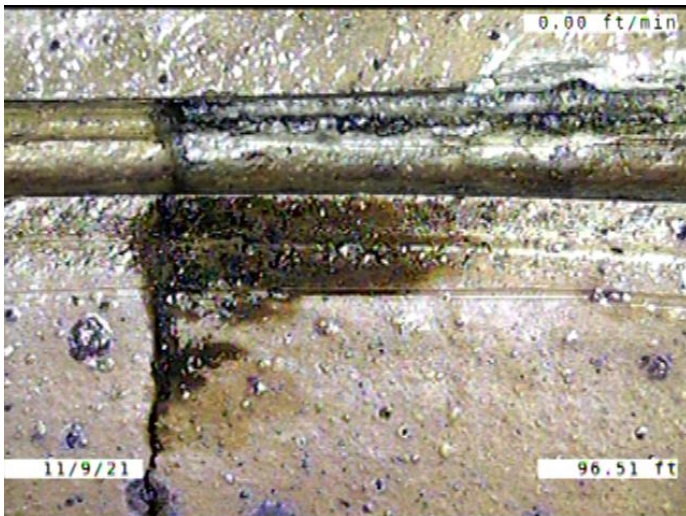
Code: **ISB**
 Description: **Infiltration Stain Barrel**

Distance (ft): **96.5**
 Structural Grade: **0**
 O&M Grade: **1**
 Clock Start/From: **2**
 Clock To:
 1st Value:
 2nd Value:
 Value Percent:
 Continuous Index:
 Within 8" of Joint: **YES**
 Remarks:

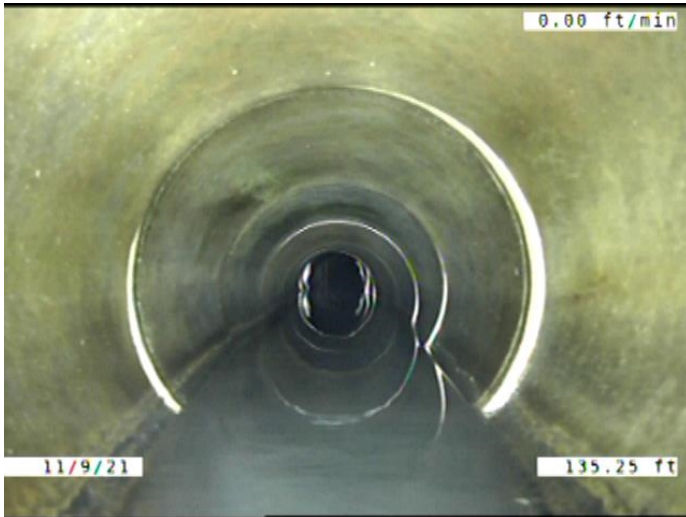
Code: **MWLS**
 Description: **Miscellaneous Water Level Sag**

Distance (ft): **135.2**
 Structural Grade: **2**
 O&M Grade: **0**
 Clock Start/From:
 Clock To:
 1st Value:
 2nd Value:
 Value Percent: **20.000**
 Continuous Index: **S06**
 Within 8" of Joint: **NO**
 Remarks:

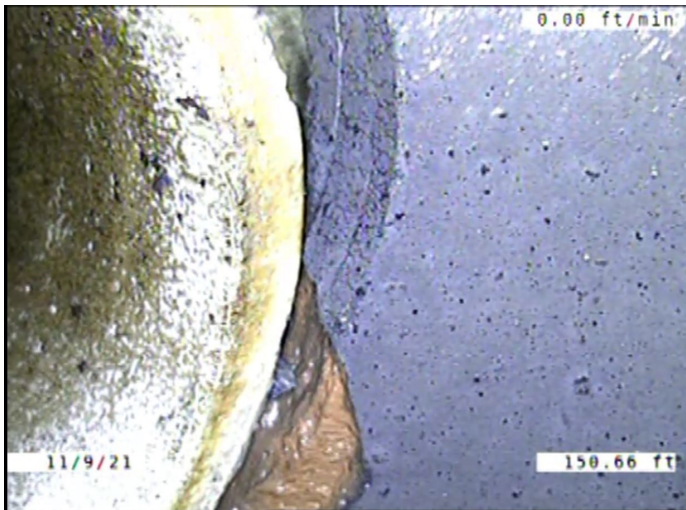
Code: **SSS**
 Description: **Surface Damage Surface Spalling**

Distance (ft): **150.7**
 Structural Grade: **2**
 O&M Grade: **0**
 Clock Start/From: **9**
 Clock To: **10**
 1st Value:
 2nd Value:
 Value Percent:
 Continuous Index:
 Within 8" of Joint: **NO**
 Remarks:

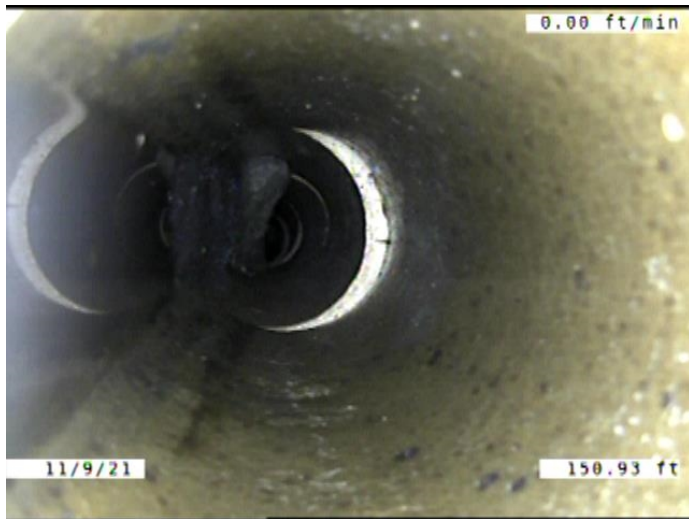
Code: **TBI**
 Description: **Tap Break-in Intruding**

Distance (ft): **150.9**
 Structural Grade: **0**
 O&M Grade: **2**
 Clock Start/From: **9**
 Clock To:
 1st Value: **4.000**
 2nd Value: **2.000**
 Value Percent:
 Continuous Index:
 Within 8" of Joint: **YES**
 Remarks:

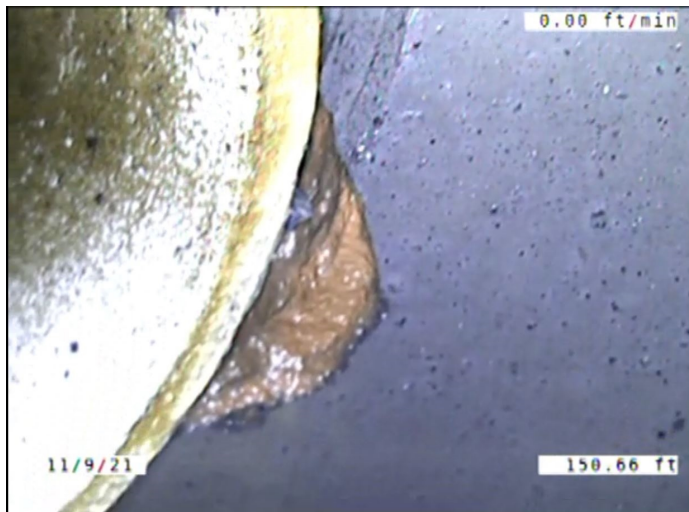
Code: **SSS**
 Description: **Surface Damage Surface Spalling**

Distance (ft): **152.5**
 Structural Grade: **2**
 O&M Grade: **0**
 Clock Start/From: **1**
 Clock To: **3**
 1st Value:
 2nd Value:
 Value Percent:
 Continuous Index:
 Within 8" of Joint: **NO**
 Remarks:

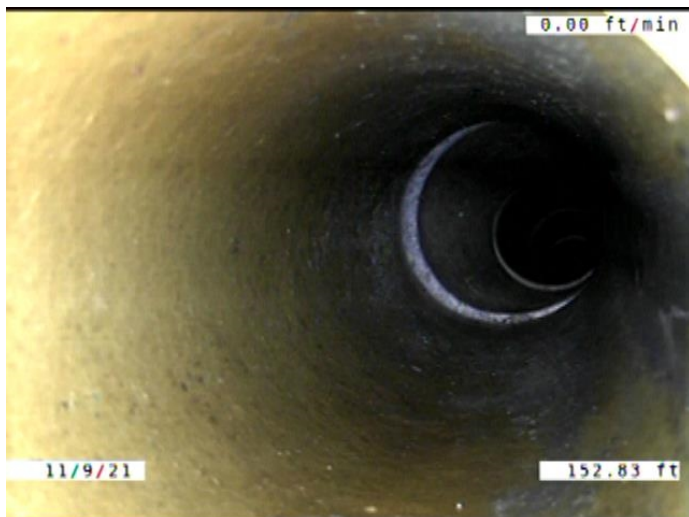
Code: **TBI**
Description: **Tap Break-in Intruding**

Distance (ft): **152.8**
Structural Grade: **0**
O&M Grade: **2**
Clock Start/From: **2**
Clock To:
1st Value: **4.000**
2nd Value: **2.000**
Value Percent:
Continuous Index:
Within 8" of Joint: **YES**
Remarks:

Code: **MWLS**
Description: **Miscellaneous Water Level Sag**

Distance (ft): **152.8**
Structural Grade: **2**
O&M Grade: **0**
Clock Start/From:
Clock To:
1st Value:
2nd Value:
Value Percent: **15.000**
Continuous Index: **F05**
Within 8" of Joint: **NO**
Remarks:

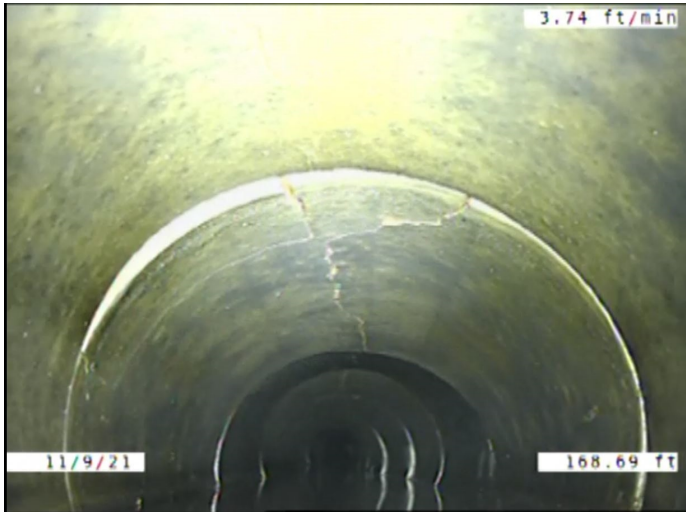
Code: **B**
 Description: **Broken**

Distance (ft): **168.7**
 Structural Grade: **4**
 O&M Grade: **0**
 Clock Start/From: **10**
 Clock To: **1**
 1st Value:
 2nd Value:
 Value Percent:
 Continuous Index:
 Within 8" of Joint: **YES**
 Remarks:

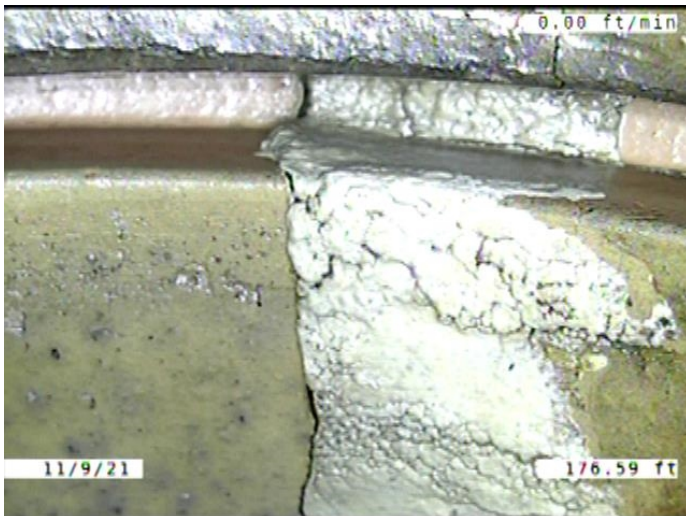
Code: **DAE**
 Description: **Deposits Attached Encrustation**

Distance (ft): **176.6**
 Structural Grade: **0**
 O&M Grade: **2**
 Clock Start/From: **2**
 Clock To: **3**
 1st Value:
 2nd Value:
 Value Percent: **5.000**
 Continuous Index:
 Within 8" of Joint: **YES**
 Remarks:

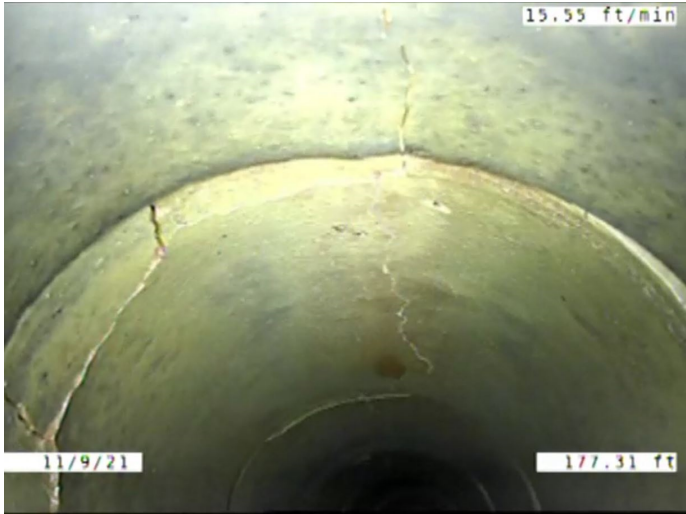
Code: **B**
Description: **Broken**

Distance (ft): **177.3**
Structural Grade: **4**
O&M Grade: **0**
Clock Start/From: **8**
Clock To: **11**
1st Value:
2nd Value:
Value Percent:
Continuous Index:
Within 8" of Joint: **YES**
Remarks:

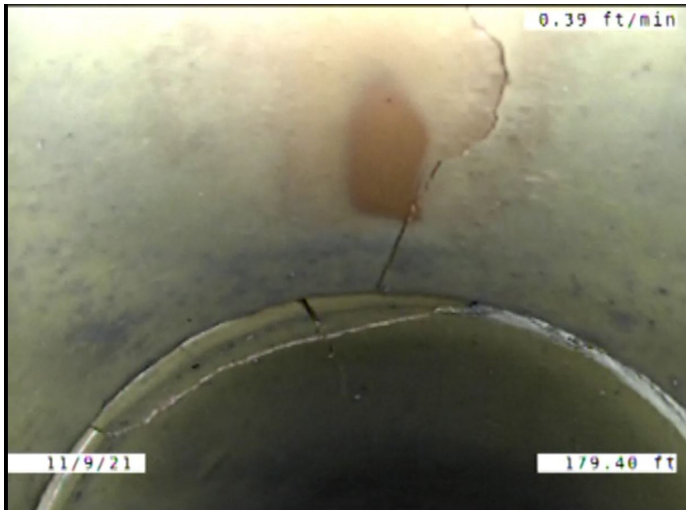
Code: **B**
Description: **Broken**

Distance (ft): **179.4**
Structural Grade: **4**
O&M Grade: **0**
Clock Start/From: **10**
Clock To: **12**
1st Value:
2nd Value:
Value Percent:
Continuous Index:
Within 8" of Joint: **YES**
Remarks:

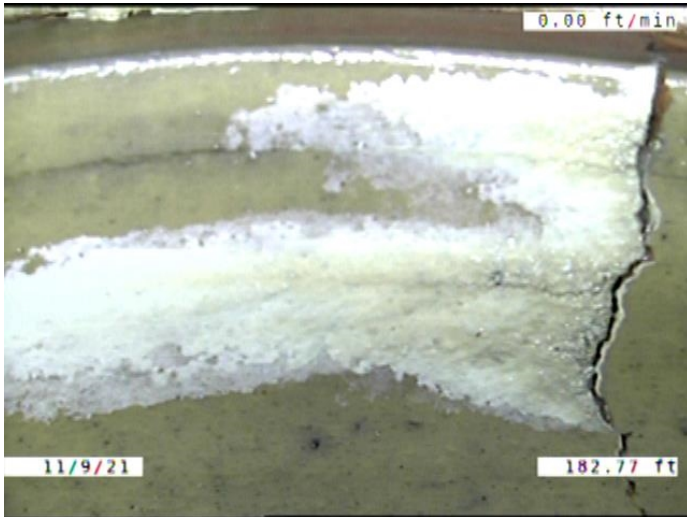
Code: **DAE**
 Description: **Deposits Attached Encrustation**

Distance (ft): **182.8**
 Structural Grade: **0**
 O&M Grade: **2**
 Clock Start/From: **10**
 Clock To: **11**
 1st Value:
 2nd Value:
 Value Percent: **5.000**
 Continuous Index:
 Within 8" of Joint: **YES**
 Remarks:

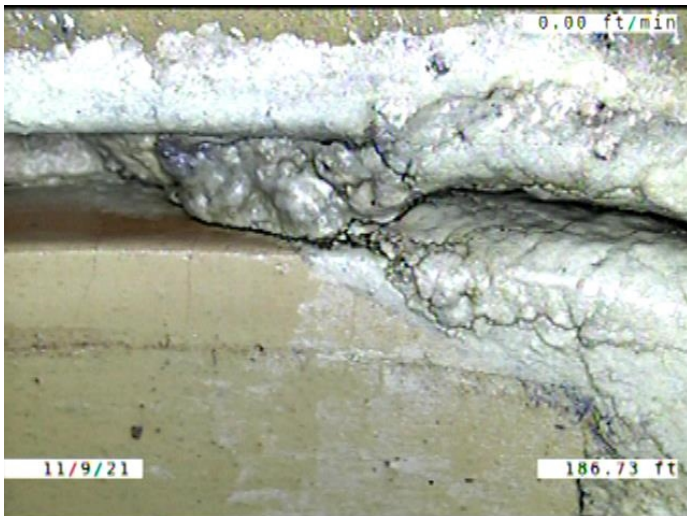
Code: **DAE**
 Description: **Deposits Attached Encrustation**

Distance (ft): **186.7**
 Structural Grade: **0**
 O&M Grade: **2**
 Clock Start/From: **9**
 Clock To: **3**
 1st Value:
 2nd Value:
 Value Percent: **5.000**
 Continuous Index:
 Within 8" of Joint: **YES**
 Remarks:

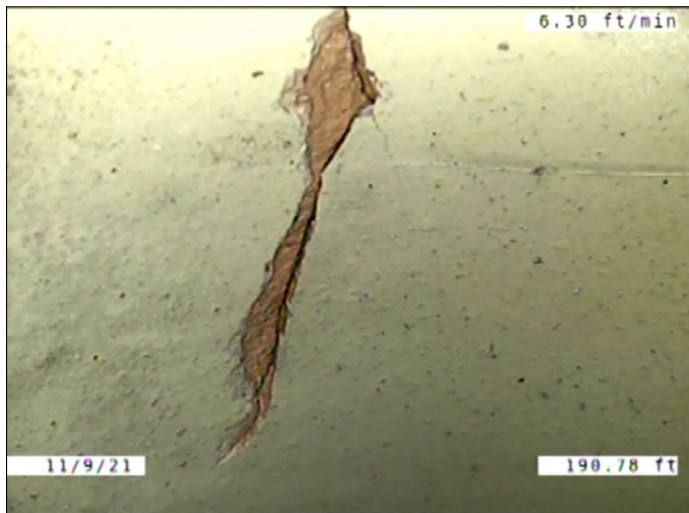
Code: **SSS**
Description: **Surface Damage Surface Spalling**

Distance (ft): **190.8**
Structural Grade: **2**
O&M Grade: **0**
Clock Start/From: **10**
Clock To:
1st Value:
2nd Value:
Value Percent:
Continuous Index:
Within 8" of Joint: **YES**
Remarks:

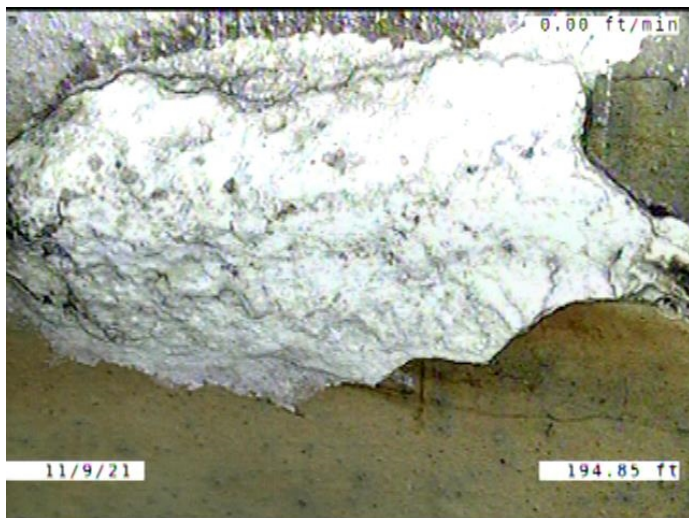
Code: **DAE**
Description: **Deposits Attached Encrustation**

Distance (ft): **194.9**
Structural Grade: **0**
O&M Grade: **2**
Clock Start/From: **9**
Clock To: **3**
1st Value:
2nd Value:
Value Percent: **5.000**
Continuous Index:
Within 8" of Joint: **YES**
Remarks:

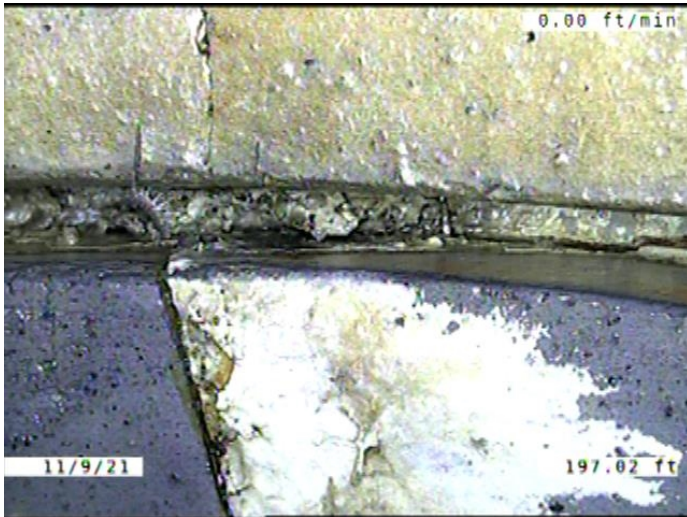
Code: **DAE**
 Description: **Deposits Attached Encrustation**

Distance (ft): **197.0**
 Structural Grade: **0**
 O&M Grade: **2**
 Clock Start/From: **3**
 Clock To: **4**
 1st Value:
 2nd Value:
 Value Percent: **5.000**
 Continuous Index:
 Within 8" of Joint: **YES**
 Remarks:

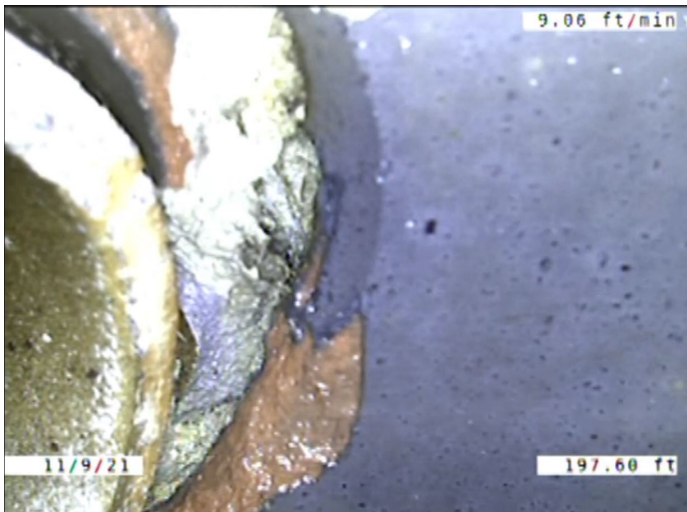
Code: **SSS**
 Description: **Surface Damage Surface Spalling**

Distance (ft): **197.6**
 Structural Grade: **2**
 O&M Grade: **0**
 Clock Start/From: **8**
 Clock To: **10**
 1st Value:
 2nd Value:
 Value Percent:
 Continuous Index:
 Within 8" of Joint: **NO**
 Remarks:

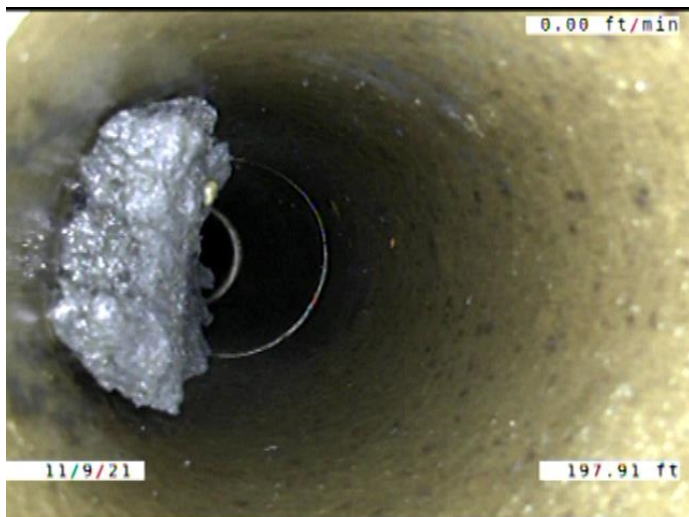
Code: **TBI**
Description: **Tap Break-in Intruding**

Distance (ft): **197.9**
Structural Grade: **0**
O&M Grade: **2**
Clock Start/From: **9**
Clock To:
1st Value: **4.000**
2nd Value: **1.000**
Value Percent:
Continuous Index:
Within 8" of Joint: **YES**
Remarks:

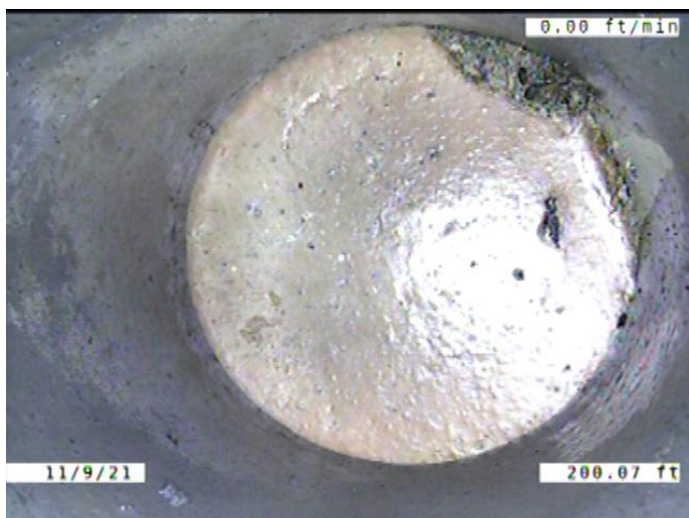
Code: **TFC**
Description: **Tap Factory Capped**

Distance (ft): **200.1**
Structural Grade: **0**
O&M Grade: **0**
Clock Start/From: **1**
Clock To:
1st Value: **4.000**
2nd Value:
Value Percent:
Continuous Index:
Within 8" of Joint: **YES**
Remarks:

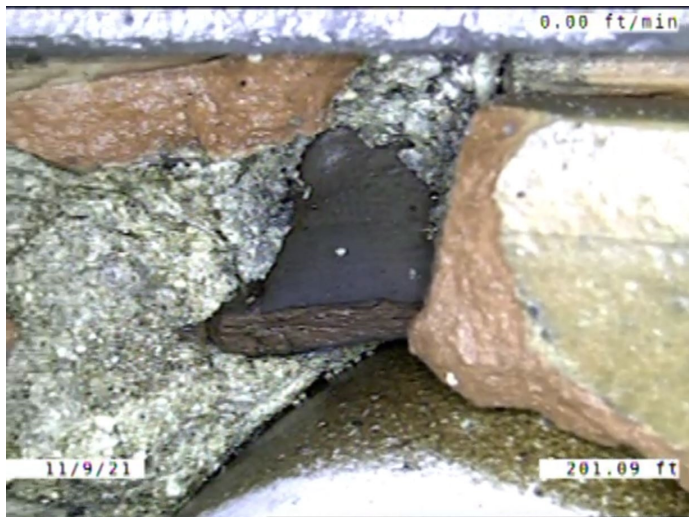
Code: **B**
 Description: **Broken**

Distance (ft): **201.1**
 Structural Grade: **4**
 O&M Grade: **0**
 Clock Start/From: **2**
 Clock To: **3**
 1st Value:
 2nd Value:
 Value Percent:
 Continuous Index:
 Within 8" of Joint: **NO**
 Remarks:

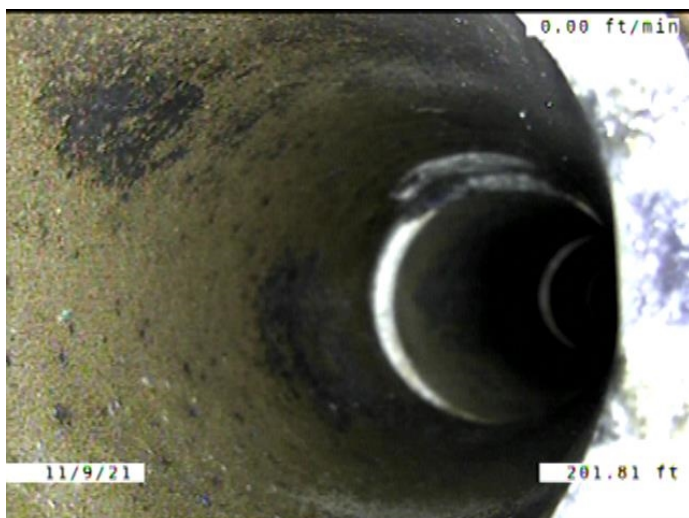
Code: **TBI**
 Description: **Tap Break-in Intruding**

Distance (ft): **201.8**
 Structural Grade: **0**
 O&M Grade: **2**
 Clock Start/From: **2**
 Clock To:
 1st Value: **4.000**
 2nd Value: **1.000**
 Value Percent:
 Continuous Index:
 Within 8" of Joint: **YES**
 Remarks:

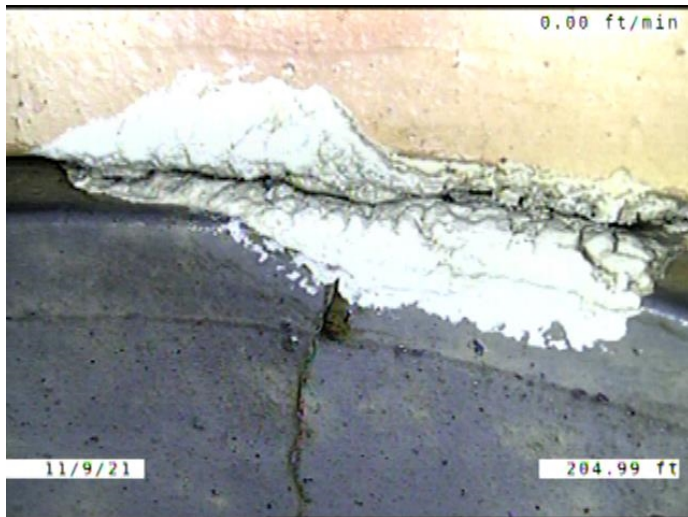
Code: **DAE**
 Description: **Deposits Attached Encrustation**

Distance (ft): **205.0**
 Structural Grade: **0**
 O&M Grade: **2**
 Clock Start/From: **2**
 Clock To: **3**
 1st Value:
 2nd Value:
 Value Percent: **5.000**
 Continuous Index:
 Within 8" of Joint: **YES**
 Remarks:

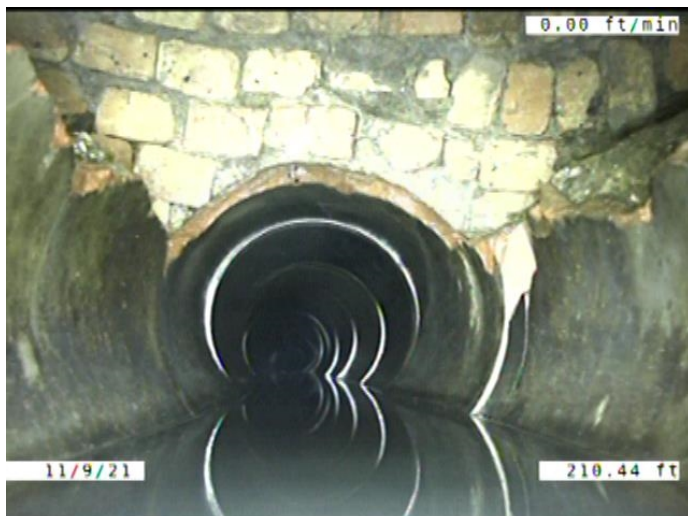
Code: **FM**
 Description: **Fracture Multiple**

Distance (ft): **210.4**
 Structural Grade: **4**
 O&M Grade: **0**
 Clock Start/From: **12**
 Clock To: **12**
 1st Value:
 2nd Value:
 Value Percent:
 Continuous Index: **F04**
 Within 8" of Joint: **YES**
 Remarks: **Wandering**

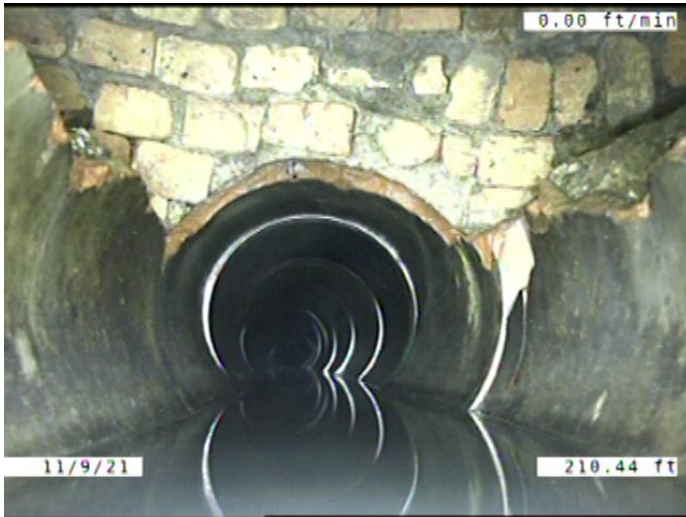
Code: **MWLS**
 Description: **Miscellaneous Water Level Sag**

Distance (ft): **210.4**
 Structural Grade: **2**
 O&M Grade: **0**
 Clock Start/From:
 Clock To:
 1st Value:
 2nd Value:
 Value Percent: **20.000**
 Continuous Index: **F06**
 Within 8" of Joint: **NO**
 Remarks:

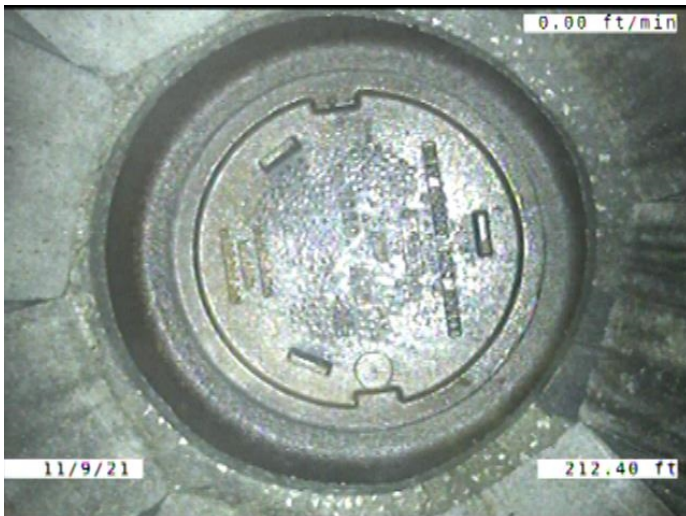
Code: **AMH**
 Description: **Manhole**

Distance (ft): **212.4**
 Structural Grade: **0**
 O&M Grade: **0**
 Clock Start/From:
 Clock To:
 1st Value:
 2nd Value:
 Value Percent:
 Continuous Index:
 Within 8" of Joint: **NO**
 Remarks: **M-605-040**
