Profile/Photo Observation Report

Date: 11/09/2021 **PACP 7.0** Weather: Coding: Pipe Length (ft): 212.4 Owner: Pre Clean: **Heavy Cleaning City of Hobart** P.O.#: Surveyor: P-605-040-039 YES502259 Steven Bucklin PSR:

Street: South Pennsylvania Street Flow Control: Not Controlled

US MH: M-605-039 DS MH: M-605-040 Total Length Surveyed (ft): 212.4

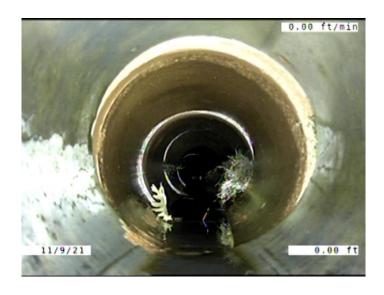
Code: MWL

Description: Miscellaneous Water Level

Distance (ft): .0
Structural Grade: 0
O&M Grade: 0

Value Percent: 5.000

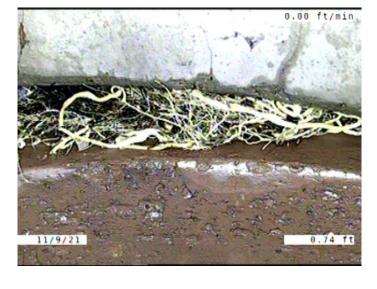
Code: RFJ

Description: Roots Fine Joint

Distance (ft): .7
Structural Grade: 0
O&M Grade: 1
Clock Start/From: 3
Clock To: 4
1st Value:

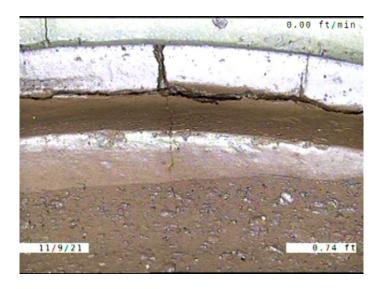
Code: FM
Description: Fracture Multiple

Distance (ft): .7
Structural Grade: 4

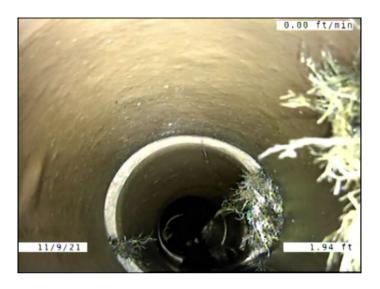
Code: SZ

Description: Surface Damage Other

Remarks: Indentation, Factory Defect

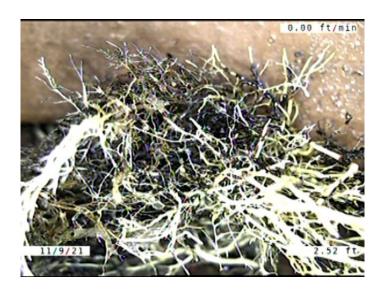
Code: RMJ

Description: Roots Medium Joint

Distance (ft): 2.5
Structural Grade: 0
O&M Grade: 3
Clock Start/From: 8
Clock To: 4

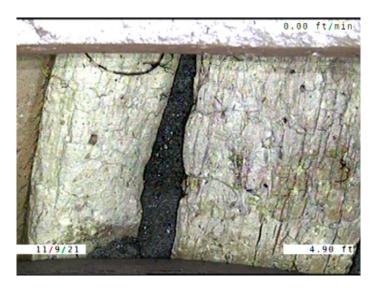
Code: JSL

Description: Joint Separated Large

Distance (ft): 4.9
Structural Grade: 4

Remarks: HAS BEEN BRICKED BACK

TOGETHER.

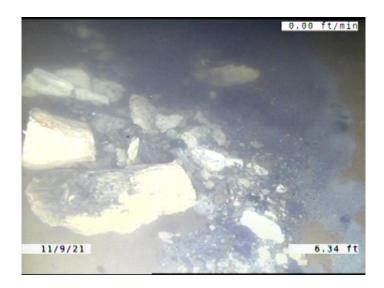
Code: **DSF**

Description: **Deposits Settled Fine**

Distance (ft): 6.3 Structural Grade: 0 2 O&M Grade: Clock Start/From: 5 Clock To: 7

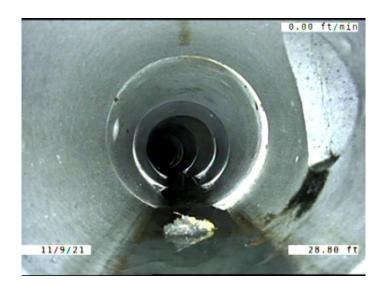
Code: RMJ

Description: Roots Medium Joint

Distance (ft): 28.8
Structural Grade: 0
O&M Grade: 3
Clock Start/From: 8
Clock To: 4

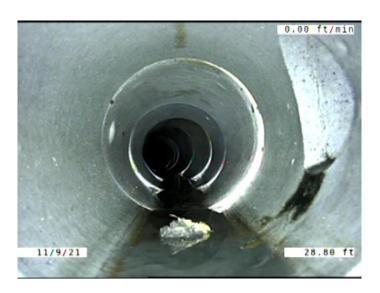
Code: DR

Description: Deformed Rigid

Distance (ft): 28.8
Structural Grade: 4
O&M Grade: 0

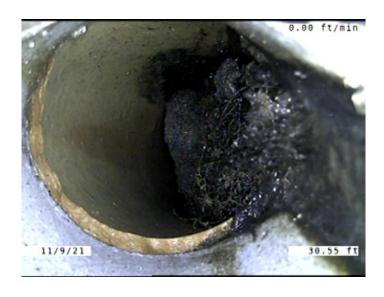
Code: **TFD**

Description: Tap Factory Defective

Distance (ft): 30.6
Structural Grade: 0

Remarks: CRACKED. LOOKS TO BE 95%

PLUGGED

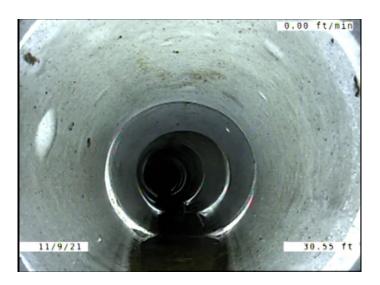
Code: SZ

Description: Surface Damage Other

Remarks: Indentations. Factory defect.

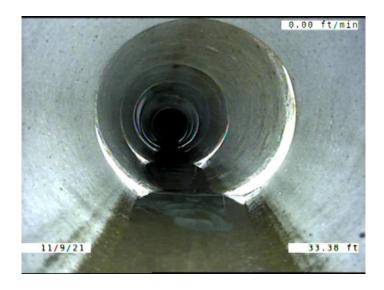
Code: FM

Description: Fracture Multiple

Distance (ft): 33.4
Structural Grade: 4

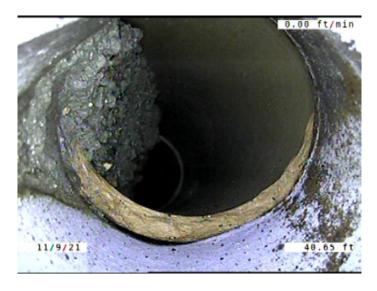
Code: **TFD**

Description: Tap Factory Defective

Distance (ft): 40.6
Structural Grade: 0
O&M Grade: 3
Clock Start/From: 9

Remarks: **OFFSET.**

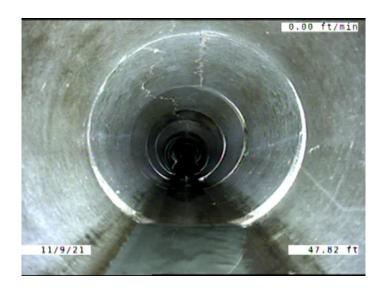
Code: FM

Description: Fracture Multiple

Distance (ft): 47.8
Structural Grade: 4

Remarks: Wandering

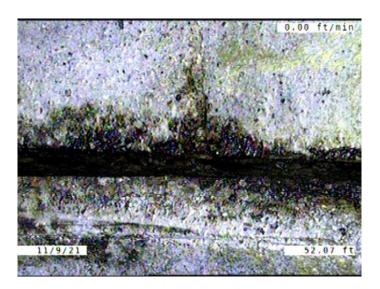
Code: ISJ

Description: Infiltration Stain Joint

Distance (ft): 52.1
Structural Grade: 0
O&M Grade: 1
Clock Start/From: 2
Clock To: 5
1st Value:
2nd Value:
Value Percent:
Continuous Index:

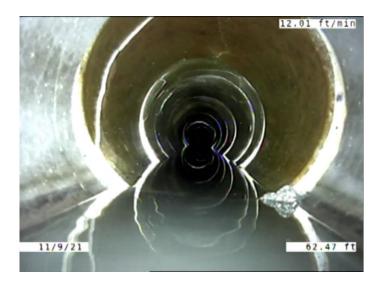
Code: B
Description: Broken

Distance (ft): 62.5
Structural Grade: 4
O&M Grade: 0
Clock Start/From: 8
Clock To: 12

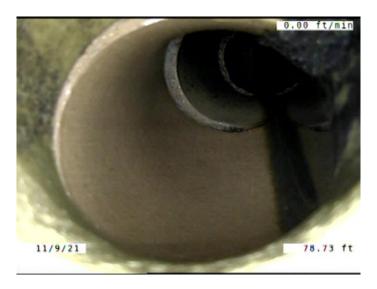
Code: TF

Description: Tap Factory

Remarks: ROOTS GROWING IN THE TAP

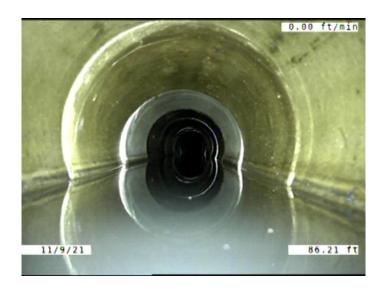
Code: MWLS

Description: Miscellaneous Water Level Sag

Distance (ft): 86.2
Structural Grade: 2
O&M Grade: 0

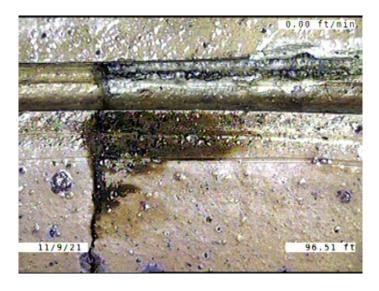
Code: ISB

Description: Infiltration Stain Barrel

Distance (ft): 96.5
Structural Grade: 0
O&M Grade: 1
Clock Start/From: 2
Clock To:
1st Value:
2nd Value:

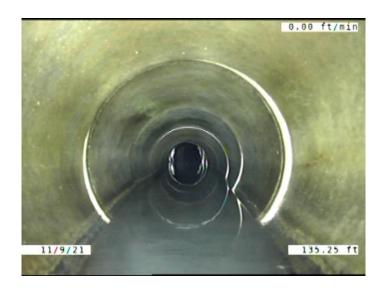
Code: MWLS

Description: Miscellaneous Water Level Sag

Distance (ft): 135.2
Structural Grade: 2
O&M Grade: 0

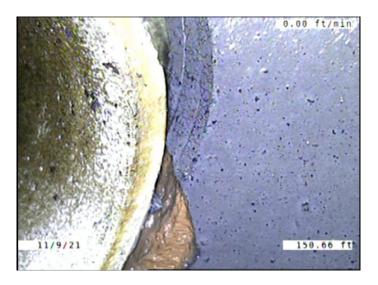
Code: SSS

Description: Surface Damage Surface Spalling

Distance (ft): 150.7
Structural Grade: 2
O&M Grade: 0
Clock Start/From: 9
Clock To: 10
1st Value:
2nd Value:

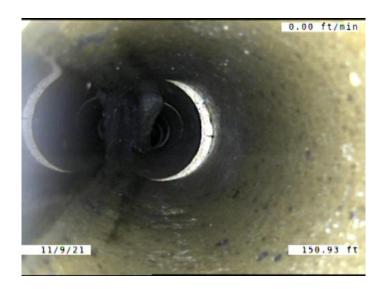
Code: TBI

Description: Tap Break-in Intruding

Distance (ft): 150.9
Structural Grade: 0
O&M Grade: 2
Clock Start/From: 9

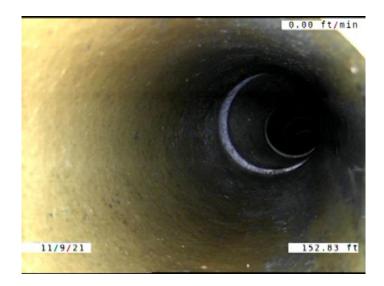
Code: TBI

Description: Tap Break-in Intruding

Distance (ft): 152.8
Structural Grade: 0
O&M Grade: 2
Clock Start/From: 2

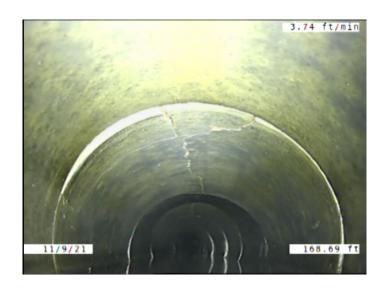
Code: B
Description: Broken

Distance (ft): 168.7 Structural Grade: 4 O&M Grade: 0 Clock Start/From: 10 Clock To: 1 1st Value: 2nd Value: Value Percent: Continuous Index: Within 8" of Joint: YES

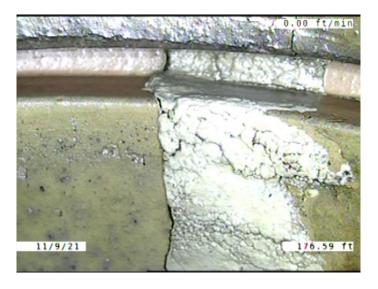
Code: DAE

Description: Deposits Attached Encrustation

Distance (ft): 176.6
Structural Grade: 0
O&M Grade: 2
Clock Start/From: 2
Clock To: 3
1st Value:
2nd Value:

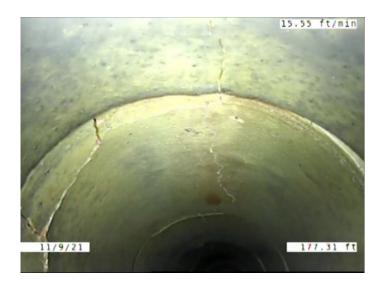
Code: B
Description: Broken

Distance (ft): 177.3

Structural Grade: 4

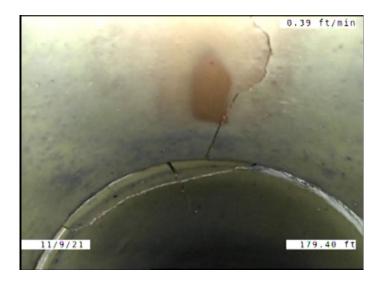
Code: B
Description: Broken

Distance (ft): 179.4 Structural Grade: 4 O&M Grade: 0 Clock Start/From: 10 Clock To: 12 1st Value: 2nd Value: Value Percent: Continuous Index: Within 8" of Joint: YES

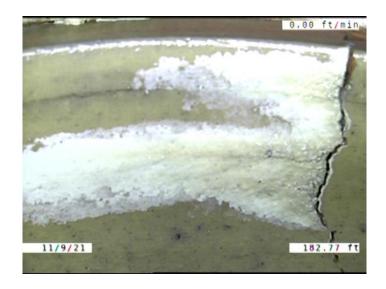
Code: DAE

Description: Deposits Attached Encrustation

Distance (ft): 182.8
Structural Grade: 0
O&M Grade: 2
Clock Start/From: 10
Clock To: 11

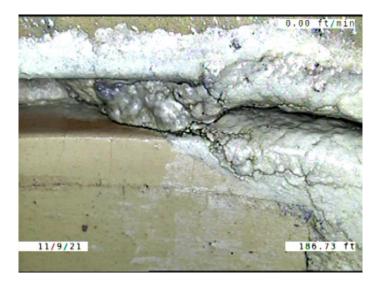
Code: DAE

Description: Deposits Attached Encrustation

Distance (ft): 186.7
Structural Grade: 0
O&M Grade: 2
Clock Start/From: 9
Clock To: 3
1st Value:

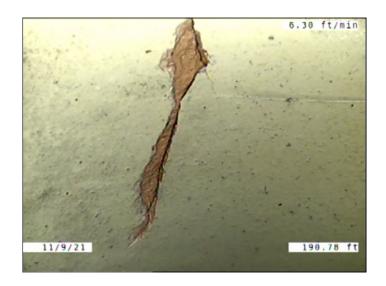
Code: SSS

Description: Surface Damage Surface Spalling

Distance (ft): 190.8
Structural Grade: 2
O&M Grade: 0
Clock Start/From: 10

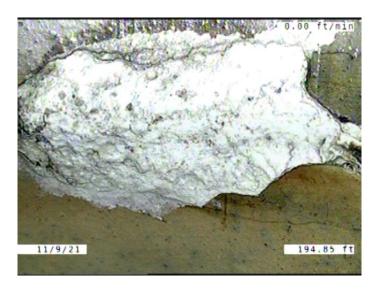
Code: DAE

Description: Deposits Attached Encrustation

Distance (ft): 194.9
Structural Grade: 0
O&M Grade: 2
Clock Start/From: 9
Clock To: 3
1st Value:

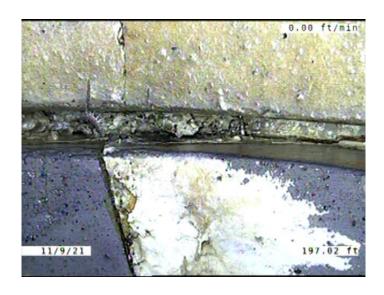
Code: DAE

Description: Deposits Attached Encrustation

Distance (ft): 197.0
Structural Grade: 0
O&M Grade: 2
Clock Start/From: 3
Clock To: 4

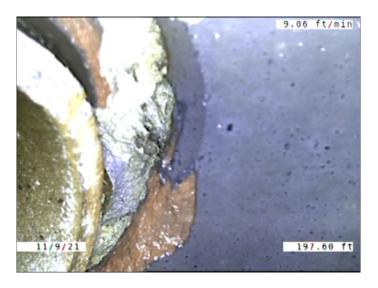
Code: SSS

Description: Surface Damage Surface Spalling

Distance (ft): 197.6
Structural Grade: 2
O&M Grade: 0
Clock Start/From: 8
Clock To: 10
1st Value:
2nd Value:

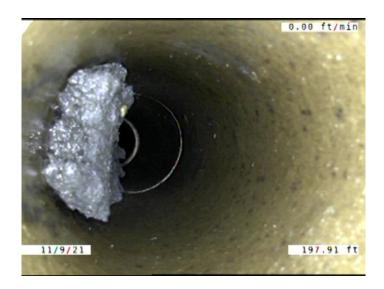
Code: **TBI**

Description: Tap Break-in Intruding

Distance (ft): 197.9
Structural Grade: 0
O&M Grade: 2
Clock Start/From: 9

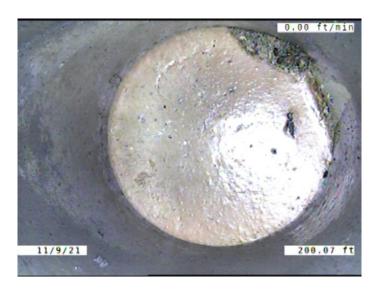
Code: TFC

Description: Tap Factory Capped

Distance (ft): 200.1
Structural Grade: 0
O&M Grade: 0
Clock Start/From: 1

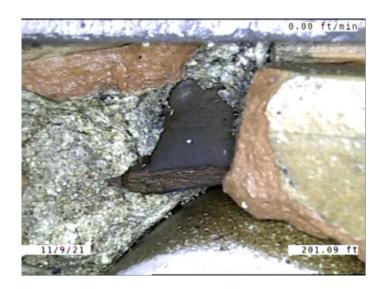
Code: B
Description: Broken

Distance (ft): 201.1 Structural Grade: 4 0 O&M Grade: Clock Start/From: 2 Clock To: 3 1st Value: 2nd Value: Value Percent: Continuous Index: Within 8" of Joint: NO

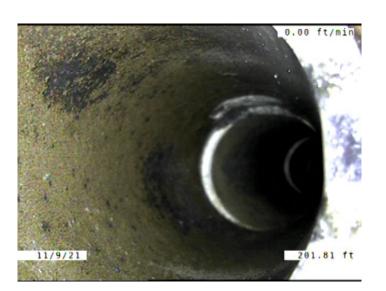
Code: TBI

Description: Tap Break-in Intruding

Distance (ft): 201.8
Structural Grade: 0
O&M Grade: 2
Clock Start/From: 2
Clock To:

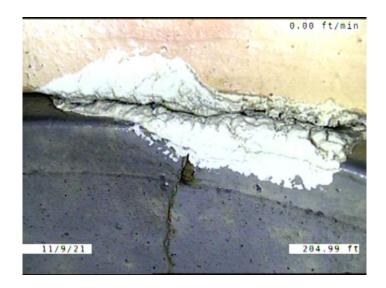
Code: DAE

Description: Deposits Attached Encrustation

Distance (ft): 205.0
Structural Grade: 0
O&M Grade: 2
Clock Start/From: 2
Clock To: 3

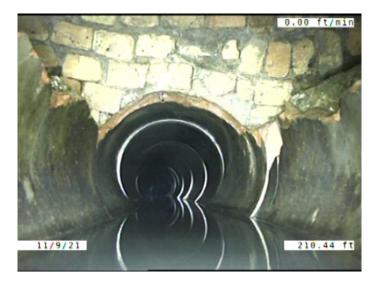
Code: FM

Description: Fracture Multiple

Distance (ft): 210.4
Structural Grade: 4
O&M Grade: 0
Clock Start/From: 12
Clock To: 12

Remarks: Wandering

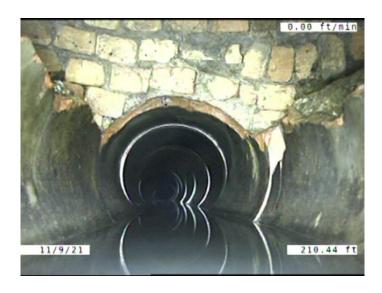
Code: MWLS

Description: Miscellaneous Water Level Sag

Distance (ft): 210.4
Structural Grade: 2
O&M Grade: 0
