Profile/Photo Observation Report

Street:	S WASHINGTON ST & W 2ND ST	Flow Control:	Not Controlled
City:	Hobart, IN	Year Renewed:	
Location:	Light Highway	Tape/Media #:	
Purpose:	Not Known	Dia/Height:	12"
Use:	Sanitary	Material:	VCP
Drain Area:	NA	Lining:	
Category:	NA		
Comment:

Location Details:		Direction of Survey:	Downstream
US MH:	M-605-044	DS MH:	M-605-045
		Total Length Surveyed (ft):	199.5

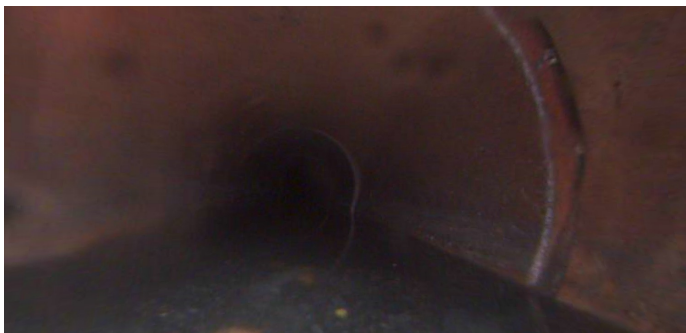
Code: **AMH**
Description: **Manhole**

Distance (ft): **.0**
Structural Grade: **0**
O&M Grade: **0**
Clock Start/From:
Clock To:
1st Value:
2nd Value:
Value Percent:
Continuous Index:
Within 8" of Joint: **NO**
Remarks: **M-605-044**

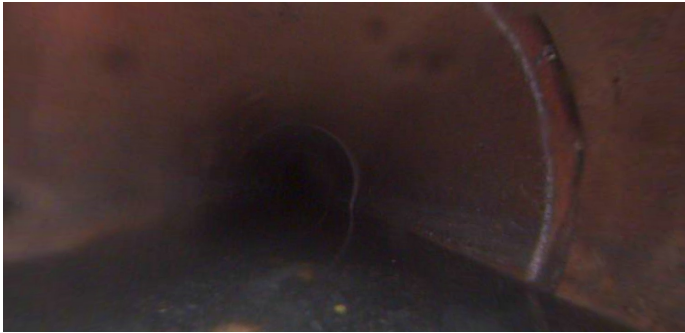
Code:	MWL
Description:	Water Level

Distance (ft):	.0
Structural Grade:	0
O&M Grade:	0
Clock Start/From:	
Clock To:	
1st Value:	
2nd Value:	
Value Percent:	30.000
Continuous Index:	
Within 8" of Joint:	NO
Remarks:

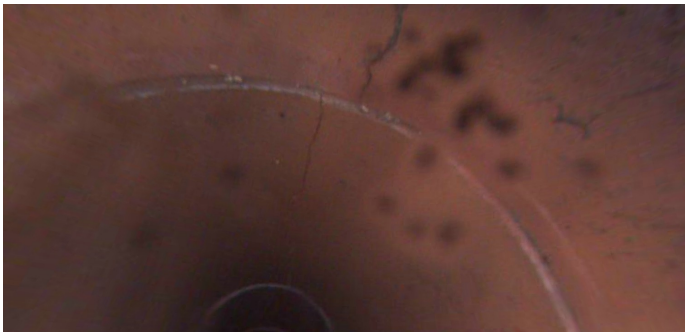
Code:	FL
Description:	Fracture Longitudinal

Distance (ft):	17.2
Structural Grade:	3
O&M Grade:	0
Clock Start/From:	1
Clock To:	
1st Value:	
2nd Value:	
Value Percent:	
Continuous Index:	S01
Within 8" of Joint:	YES
Remarks:

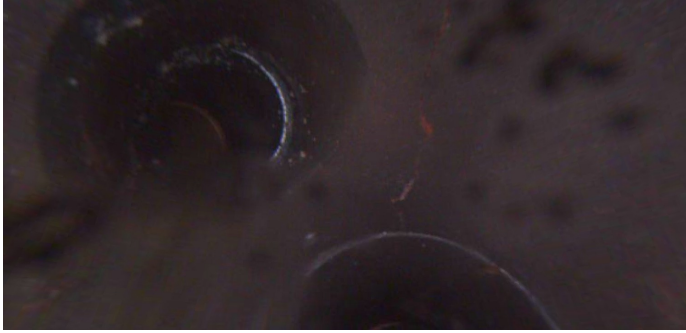
Code: **TF**
Description: **Tap Factory**

Distance (ft): **39.0**
Structural Grade: **0**
O&M Grade: **0**
Clock Start/From: **11**
Clock To:
1st Value: **4.000**
2nd Value:
Value Percent:
Continuous Index:
Within 8" of Joint:
Remarks:

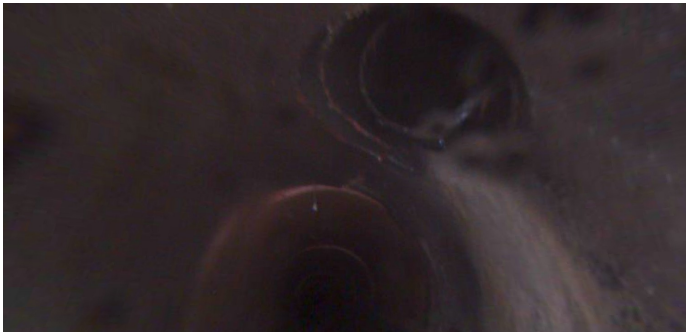
Code: **TFA**
Description: **Tap Factory Active**

Distance (ft): **40.7**
Structural Grade: **0**
O&M Grade: **0**
Clock Start/From: **1**
Clock To:
1st Value: **4.000**
2nd Value:
Value Percent:
Continuous Index:
Within 8" of Joint:
Remarks:

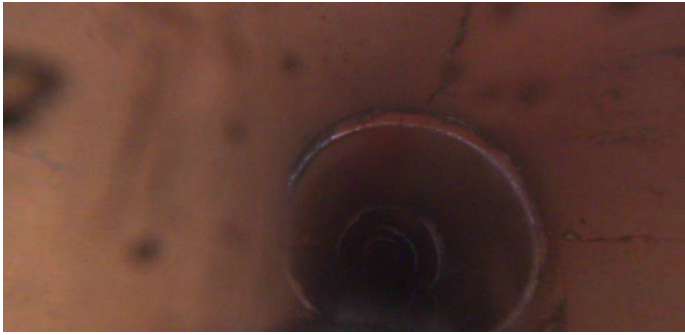
Code: **FM**
Description: **Fracture Multiple**

Distance (ft): **73.6**
Structural Grade: **4**
O&M Grade: **0**
Clock Start/From: **8**
Clock To: **4**
1st Value:
2nd Value:
Value Percent:
Continuous Index:
Within 8" of Joint: **YES**
Remarks:

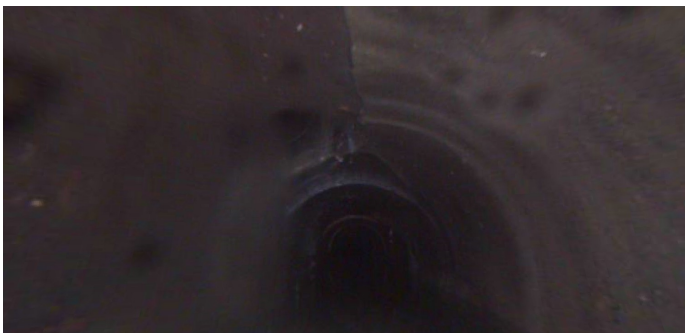
Code: **ID**
Description: **Infil Dripper**

Distance (ft): **79.1**
Structural Grade: **0**
O&M Grade: **3**
Clock Start/From: **12**
Clock To:
1st Value:
2nd Value:
Value Percent:
Continuous Index:
Within 8" of Joint:
Remarks:

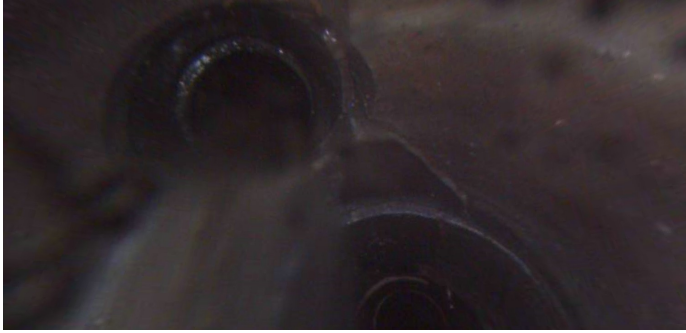
Code: **TFA**
Description: **Tap Factory Active**

Distance (ft): **79.7**
Structural Grade: **0**
O&M Grade: **0**
Clock Start/From: **11**
Clock To:
1st Value: **4.000**
2nd Value:
Value Percent:
Continuous Index:
Within 8" of Joint:
Remarks:

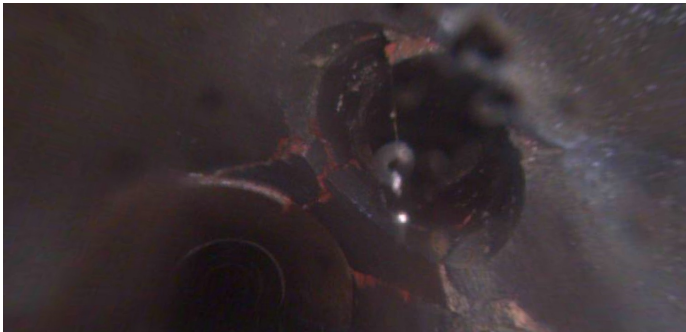
Code: **TFD**
Description: **Tap Factory Defective**

Distance (ft): **81.6**
Structural Grade: **0**
O&M Grade: **2**
Clock Start/From: **2**
Clock To:
1st Value: **4.000**
2nd Value:
Value Percent:
Continuous Index:
Within 8" of Joint:
Remarks: **broken**

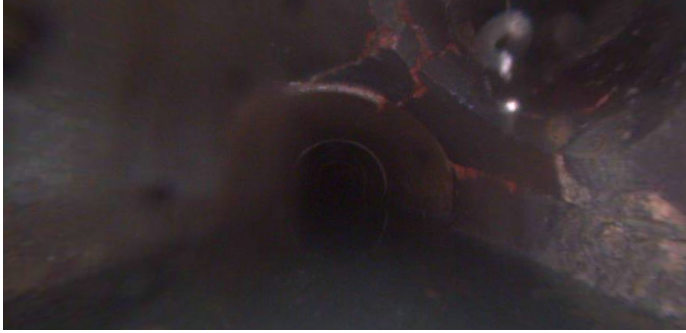
Code: **FM**
Description: **Fracture Multiple**

Distance (ft): **81.6**
Structural Grade: **4**
O&M Grade: **0**
Clock Start/From: **8**
Clock To: **4**
1st Value:
2nd Value:
Value Percent:
Continuous Index: **S02**
Within 8" of Joint: **YES**
Remarks:

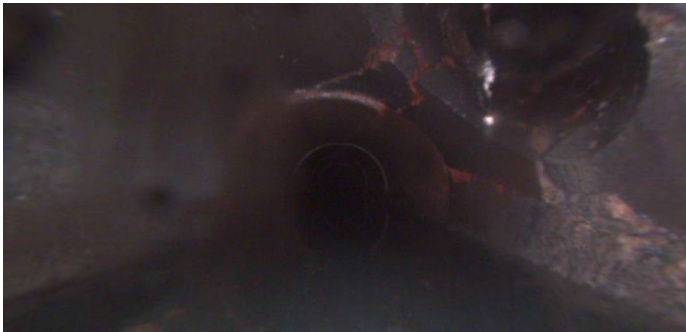
Code: **FL**
Description: **Fracture Longitudinal**

Distance (ft): **81.6**
Structural Grade: **3**
O&M Grade: **0**
Clock Start/From: **1**
Clock To:
1st Value:
2nd Value:
Value Percent:
Continuous Index: **F01**
Within 8" of Joint: **YES**
Remarks:

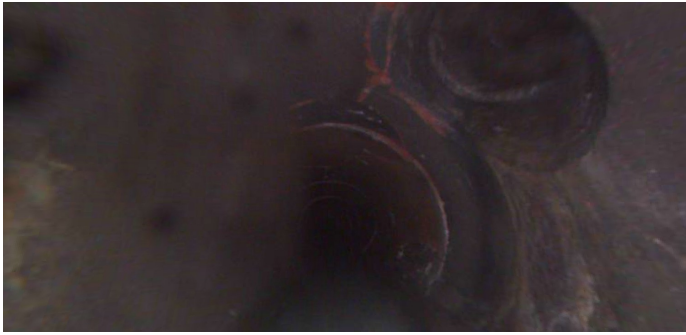
Code: **TF**
Description: **Tap Factory**

Distance (ft): **120.1**
Structural Grade: **0**
O&M Grade: **0**
Clock Start/From: **2**
Clock To:
1st Value: **4.000**
2nd Value:
Value Percent:
Continuous Index:
Within 8" of Joint:
Remarks:

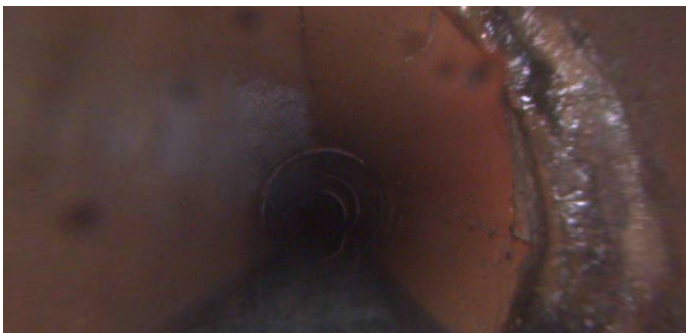
Code: **DAE**
Description: **Deposits Attached Encrustation**

Distance (ft): **129.1**
Structural Grade: **0**
O&M Grade: **2**
Clock Start/From: **8**
Clock To: **4**
1st Value:
2nd Value:
Value Percent: **5.000**
Continuous Index: **S03**
Within 8" of Joint: **YES**
Remarks:

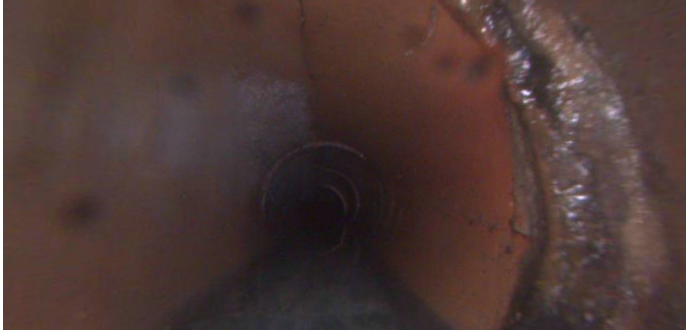
Code: **IW**
Description: **Infil Weeper**

Distance (ft): **129.1**
Structural Grade: **0**
O&M Grade: **2**
Clock Start/From: **8**
Clock To: **4**
1st Value:
2nd Value:
Value Percent:
Continuous Index: **S04**
Within 8" of Joint: **YES**
Remarks:

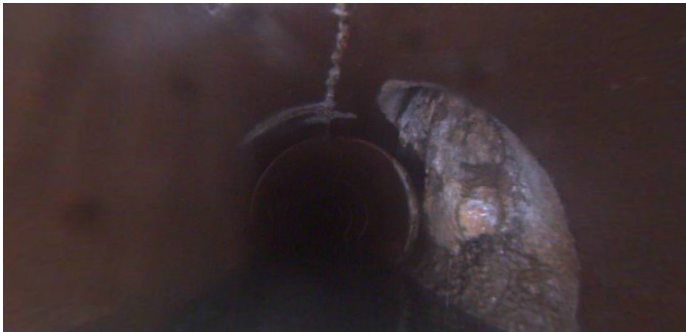
Code: **TFD**
Description: **Tap Factory Defective**

Distance (ft): **160.1**
Structural Grade: **0**
O&M Grade: **2**
Clock Start/From: **2**
Clock To:
1st Value: **4.000**
2nd Value:
Value Percent:
Continuous Index:
Within 8" of Joint:
Remarks: **dae**

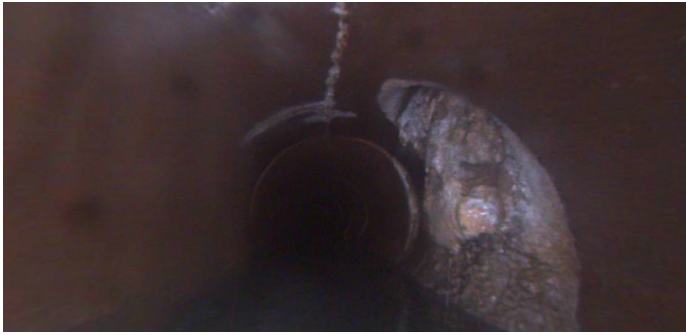
Code: **DAE**
Description: **Deposits Attached Encrustation**

Distance (ft): **160.1**
Structural Grade: **0**
O&M Grade: **2**
Clock Start/From: **1**
Clock To: **3**
1st Value:
2nd Value:
Value Percent: **10.000**
Continuous Index:
Within 8" of Joint: **NO**
Remarks:

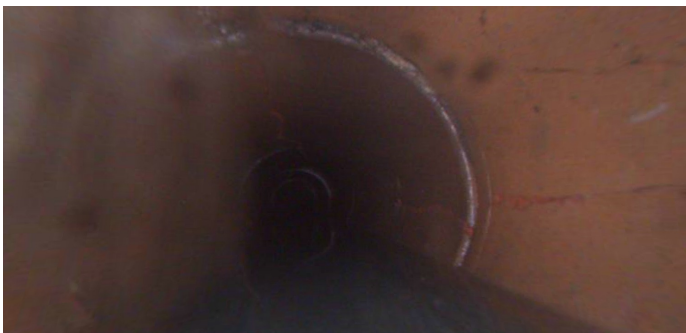
Code: **IW**
Description: **Infil Weeper**

Distance (ft): **171.3**
Structural Grade: **0**
O&M Grade: **2**
Clock Start/From: **8**
Clock To: **4**
1st Value:
2nd Value:
Value Percent:
Continuous Index: **F04**
Within 8" of Joint: **YES**
Remarks:

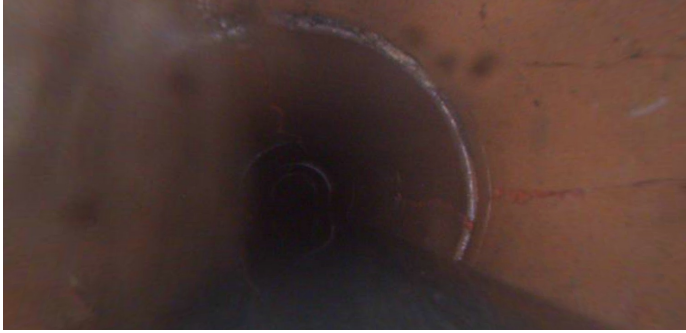
Code: **DAE**
Description: **Deposits Attached Encrustation**

Distance (ft): **171.3**
Structural Grade: **0**
O&M Grade: **2**
Clock Start/From: **8**
Clock To: **4**
1st Value:
2nd Value:
Value Percent: **5.000**
Continuous Index: **F03**
Within 8" of Joint: **YES**
Remarks:

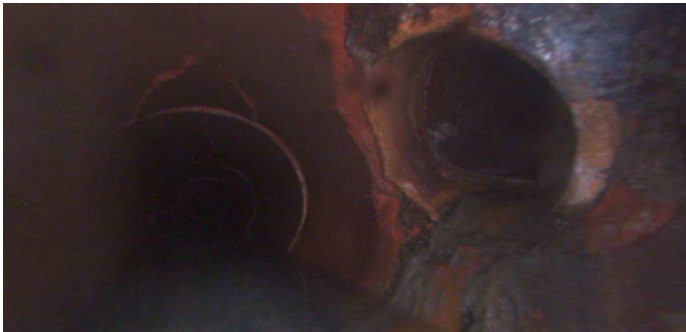
Code: **TBI**
Description: **Tap Break-in Intruding**

Distance (ft): **178.5**
Structural Grade: **0**
O&M Grade: **2**
Clock Start/From: **3**
Clock To:
1st Value: **4.000**
2nd Value: **1.000**
Value Percent:
Continuous Index:
Within 8" of Joint:
Remarks:

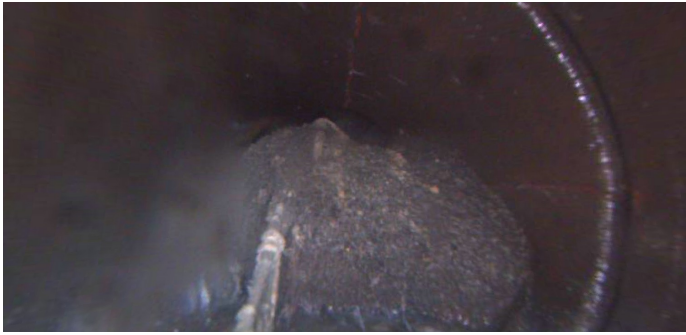
Code: **RBB**
Description: **Roots Ball Barrel**

Distance (ft): **198.0**
Structural Grade: **0**
O&M Grade: **5**
Clock Start/From: **2**
Clock To: **10**
1st Value:
2nd Value:
Value Percent: **90.000**
Continuous Index:
Within 8" of Joint: **NO**
Remarks:
