Profile/Photo Observation Report

Street:	Summerlin	Flow Control:	Not Controlled
City:	Hobart, IN	Year Renewed:	
Location:	Light Highway	Tape/Media #:	
Purpose:	Not Known	Dia/Height:	12"
Use:	Sanitary	Material:	VCP
Drain Area:	NA	Lining:	
Category:	NA		
Comment:

Location Details:		Direction of Survey:	Downstream
US MH:	M-605-044	DS MH:	M-605-045
		Total Length Surveyed (ft):	199.5

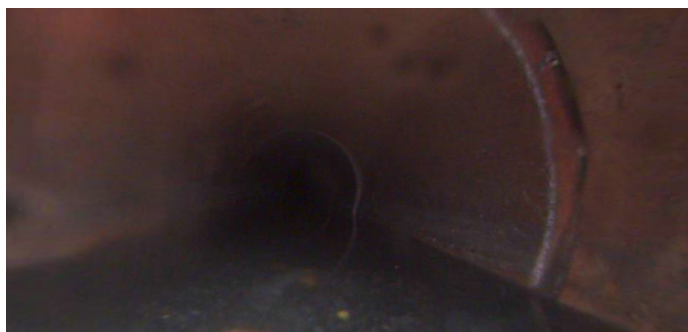
Code: **AMH**
 Description: **Manhole**
 Distance (ft): **.0**
 Structural Grade: **0**
 O&M Grade: **0**
 Clock Start/From:
 Clock To:
 1st Value:
 2nd Value:
 Value Percent:
 Continuous Index:
 Within 8" of Joint: **NO**
 Remarks: **M-605-044**

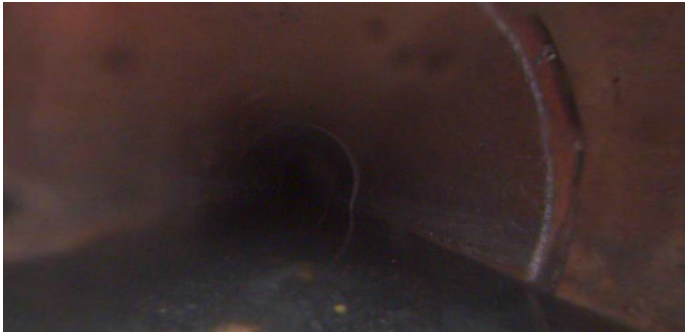
Code:	MWL
Description:	Water Level

Distance (ft):	.0
Structural Grade:	0
O&M Grade:	0
Clock Start/From:	
Clock To:	
1st Value:	
2nd Value:	
Value Percent:	30.000
Continuous Index:	
Within 8" of Joint:	NO
Remarks:

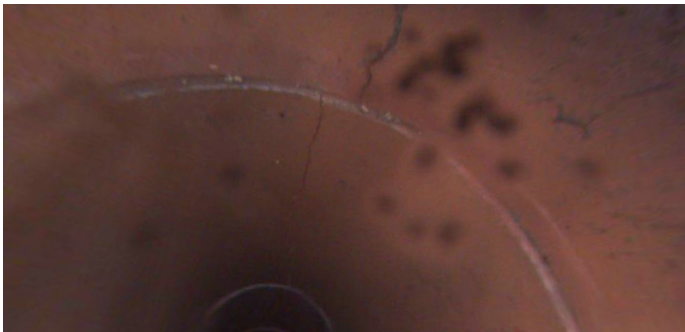
Code:	FL
Description:	Fracture Longitudinal

Distance (ft):	17.2
Structural Grade:	3
O&M Grade:	0
Clock Start/From:	1
Clock To:	
1st Value:	
2nd Value:	
Value Percent:	
Continuous Index:	S01
Within 8" of Joint:	YES
Remarks:

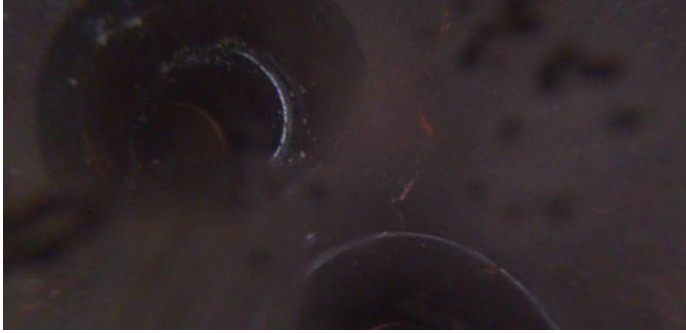
Code: **TF**
Description: **Tap Factory**

Distance (ft): **39.0**
Structural Grade: **0**
O&M Grade: **0**
Clock Start/From: **11**
Clock To:
1st Value: **4.000**
2nd Value:
Value Percent:
Continuous Index:
Within 8" of Joint:
Remarks:

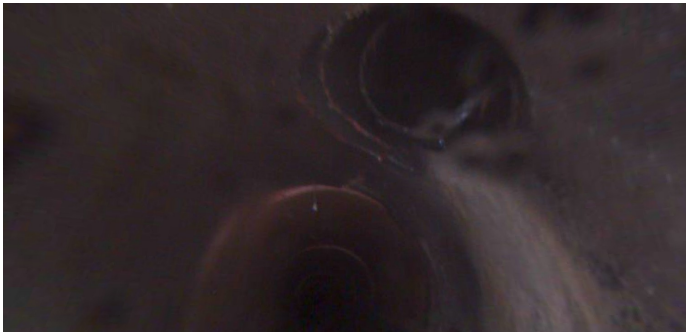
Code: **TFA**
Description: **Tap Factory Active**

Distance (ft): **40.7**
Structural Grade: **0**
O&M Grade: **0**
Clock Start/From: **1**
Clock To:
1st Value: **4.000**
2nd Value:
Value Percent:
Continuous Index:
Within 8" of Joint:
Remarks:

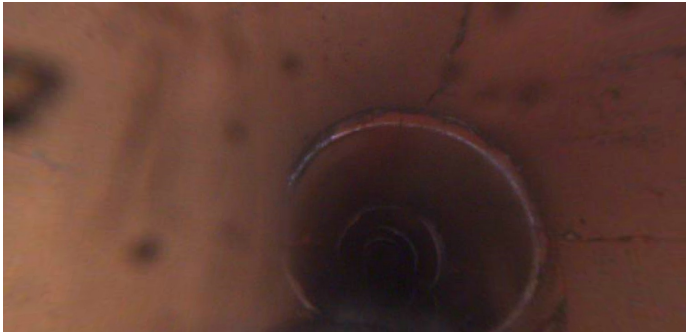
Code: **FM**
Description: **Fracture Multiple**

Distance (ft): **73.6**
Structural Grade: **4**
O&M Grade: **0**
Clock Start/From: **8**
Clock To: **4**
1st Value:
2nd Value:
Value Percent:
Continuous Index:
Within 8" of Joint: **YES**
Remarks:

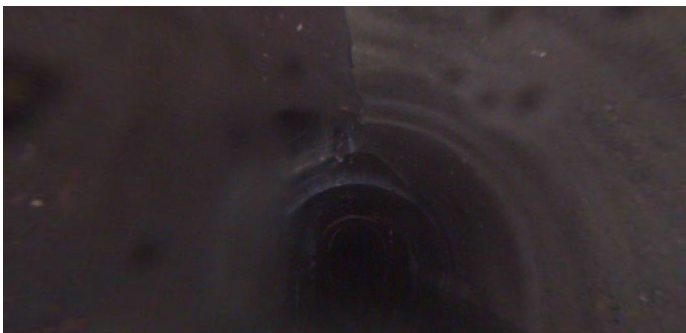
Code: **ID**
Description: **Infil Dripper**

Distance (ft): **79.1**
Structural Grade: **0**
O&M Grade: **3**
Clock Start/From: **12**
Clock To:
1st Value:
2nd Value:
Value Percent:
Continuous Index:
Within 8" of Joint:
Remarks:

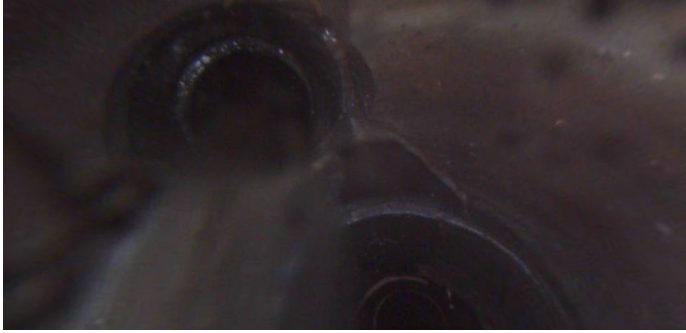
Code: **TFA**
Description: **Tap Factory Active**

Distance (ft): **79.7**
Structural Grade: **0**
O&M Grade: **0**
Clock Start/From: **11**
Clock To:
1st Value: **4.000**
2nd Value:
Value Percent:
Continuous Index:
Within 8" of Joint:
Remarks:

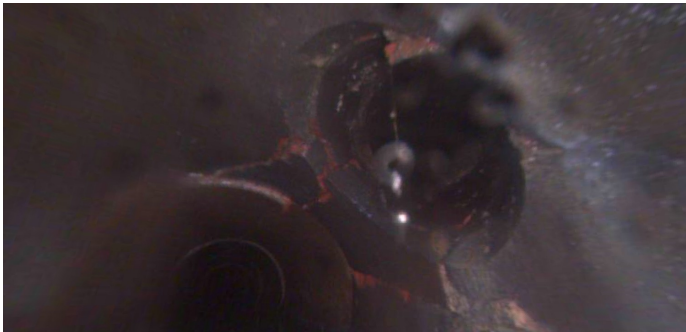
Code: **TFD**
Description: **Tap Factory Defective**

Distance (ft): **81.6**
Structural Grade: **0**
O&M Grade: **2**
Clock Start/From: **2**
Clock To:
1st Value: **4.000**
2nd Value:
Value Percent:
Continuous Index:
Within 8" of Joint:
Remarks: **broken**

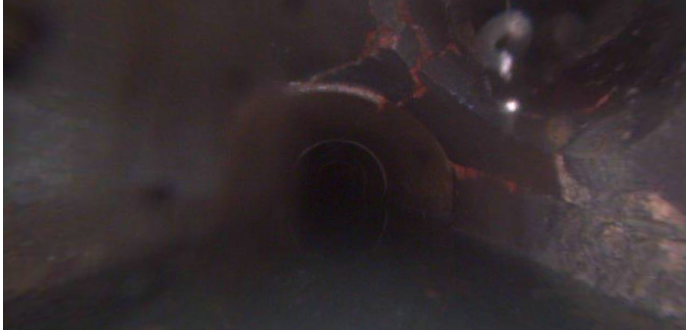
Code: **FM**
Description: **Fracture Multiple**

Distance (ft): **81.6**
Structural Grade: **4**
O&M Grade: **0**
Clock Start/From: **8**
Clock To: **4**
1st Value:
2nd Value:
Value Percent:
Continuous Index: **S02**
Within 8" of Joint: **YES**
Remarks:

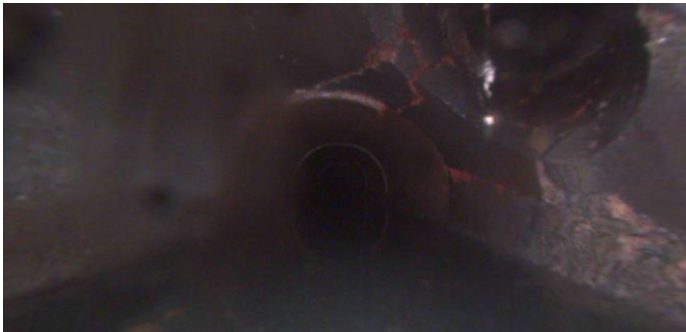
Code: **FL**
Description: **Fracture Longitudinal**

Distance (ft): **81.6**
Structural Grade: **3**
O&M Grade: **0**
Clock Start/From: **1**
Clock To:
1st Value:
2nd Value:
Value Percent:
Continuous Index: **F01**
Within 8" of Joint: **YES**
Remarks:

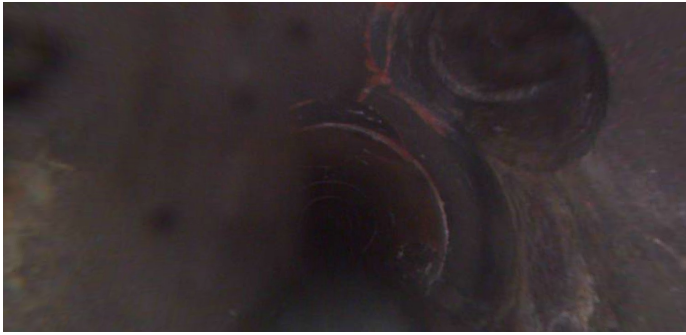
Code: **TF**
Description: **Tap Factory**

Distance (ft): **120.1**
Structural Grade: **0**
O&M Grade: **0**
Clock Start/From: **2**
Clock To:
1st Value: **4.000**
2nd Value:
Value Percent:
Continuous Index:
Within 8" of Joint:
Remarks:

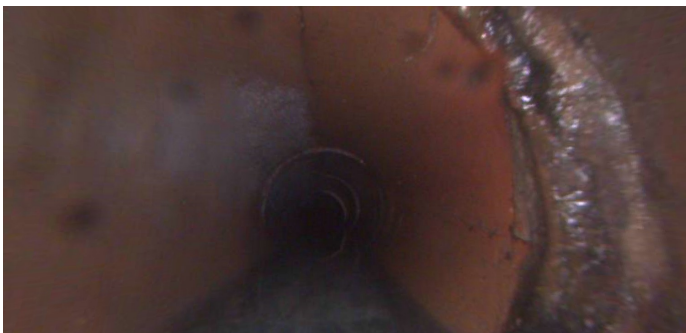
Code: **DAE**
Description: **Deposits Attached Encrustation**

Distance (ft): **129.1**
Structural Grade: **0**
O&M Grade: **2**
Clock Start/From: **8**
Clock To: **4**
1st Value:
2nd Value:
Value Percent: **5.000**
Continuous Index: **S03**
Within 8" of Joint: **YES**
Remarks:

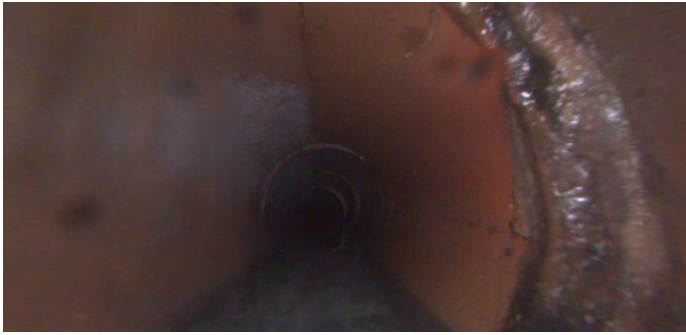
Code: **IW**
Description: **Infil Weeper**

Distance (ft): **129.1**
Structural Grade: **0**
O&M Grade: **2**
Clock Start/From: **8**
Clock To: **4**
1st Value:
2nd Value:
Value Percent:
Continuous Index: **S04**
Within 8" of Joint: **YES**
Remarks:

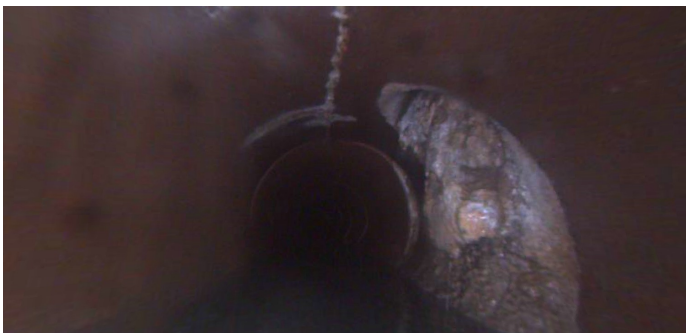
Code: **TFD**
Description: **Tap Factory Defective**

Distance (ft): **160.1**
Structural Grade: **0**
O&M Grade: **2**
Clock Start/From: **2**
Clock To:
1st Value: **4.000**
2nd Value:
Value Percent:
Continuous Index:
Within 8" of Joint:
Remarks: **dae**

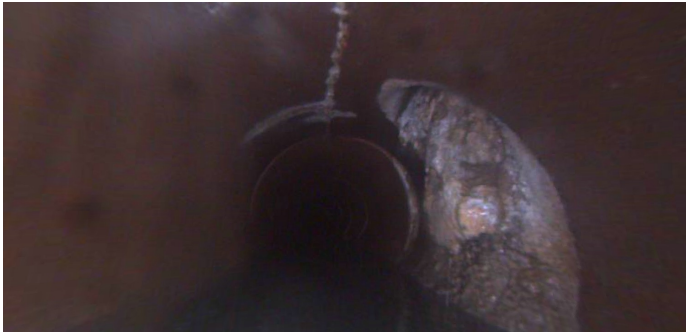
Code: **DAE**
Description: **Deposits Attached Encrustation**

Distance (ft): **160.1**
Structural Grade: **0**
O&M Grade: **2**
Clock Start/From: **1**
Clock To: **3**
1st Value:
2nd Value:
Value Percent: **10.000**
Continuous Index:
Within 8" of Joint: **NO**
Remarks:

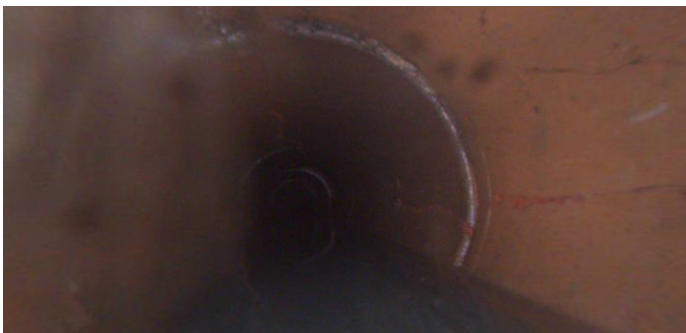
Code: **IW**
Description: **Infil Weeper**

Distance (ft): **171.3**
Structural Grade: **0**
O&M Grade: **2**
Clock Start/From: **8**
Clock To: **4**
1st Value:
2nd Value:
Value Percent:
Continuous Index: **F04**
Within 8" of Joint: **YES**
Remarks:

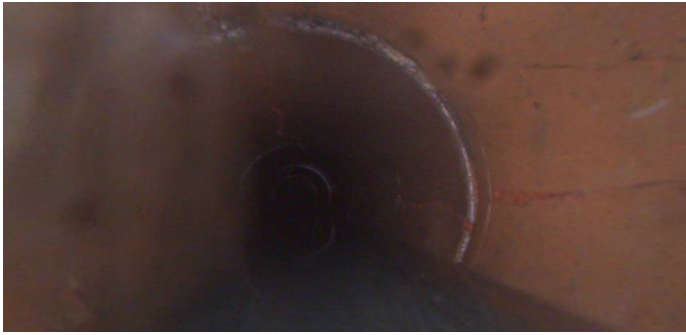
Code: **DAE**
Description: **Deposits Attached Encrustation**

Distance (ft): **171.3**
Structural Grade: **0**
O&M Grade: **2**
Clock Start/From: **8**
Clock To: **4**
1st Value:
2nd Value:
Value Percent: **5.000**
Continuous Index: **F03**
Within 8" of Joint: **YES**
Remarks:

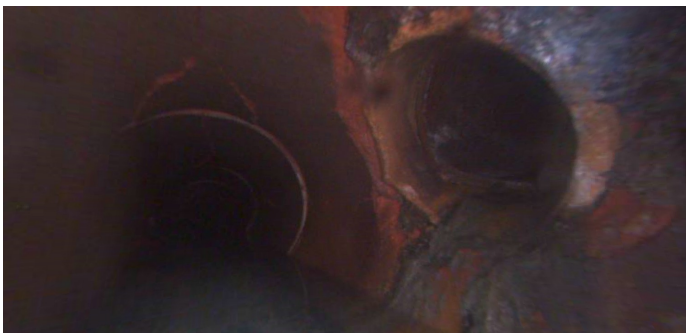
Code: **TBI**
Description: **Tap Break-in Intruding**

Distance (ft): **178.5**
Structural Grade: **0**
O&M Grade: **2**
Clock Start/From: **3**
Clock To:
1st Value: **4.000**
2nd Value: **1.000**
Value Percent:
Continuous Index:
Within 8" of Joint:
Remarks:

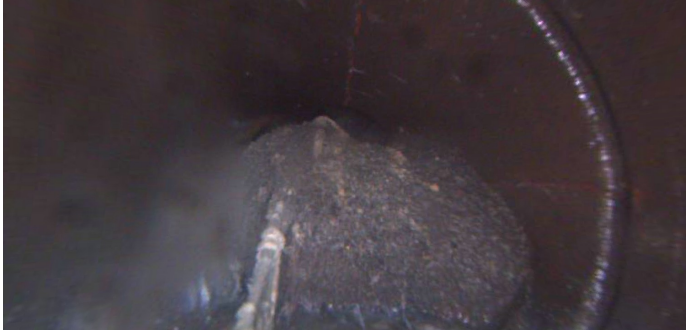
Code: **RBB**
Description: **Roots Ball Barrel**

Distance (ft): **198.0**
Structural Grade: **0**
O&M Grade: **5**
Clock Start/From: **2**
Clock To: **10**
1st Value:
2nd Value:
Value Percent: **90.000**
Continuous Index:
Within 8" of Joint: **NO**
Remarks:
