Profile/Photo Observation Report

Date:	04/25/2018	Weather:		Coding:	PACP 6.0
Pipe Length (ft):	212.2	Owner:	NA	Pre Clean:	Not Known
P.O.#:		Surveyor:	Jen Costello	PSR:	P-605-046-045
Customer:		Clean Date:	01/01/1900	Shape:	C

Street:	S WASHINGTON ST	Flow Control:	Not Controlled
City:	Hobart, IN	Year Renewed:	
Location:	Light Highway	Tape/Media #:	
Purpose:	Not Known	Dia/Height:	12"
Use:	Sanitary	Material:	VCP
Drain Area:	NA	Lining:	
Category:	NA		
Comment:

Location Details:		Direction of Survey:	Downstream
US MH:	M-605-045	DS MH:	M-605-046
		Total Length Surveyed (ft):	27.9

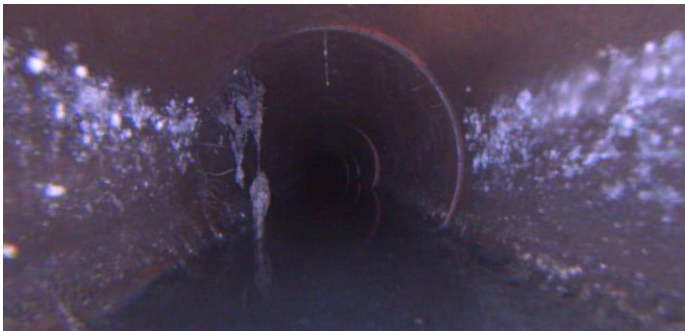
Code: **AMH**
Description: **Manhole**

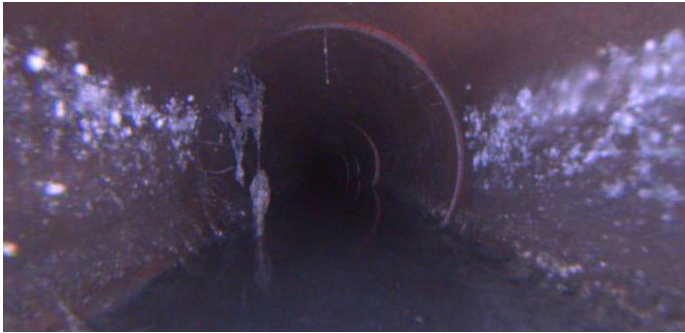
Code:	MWL
Description:	Water Level

Distance (ft):	.0
Structural Grade:	0
O&M Grade:	0
Clock Start/From:	
Clock To:	
1st Value:	
2nd Value:	
Value Percent:	20.000
Continuous Index:	
Within 8" of Joint:	NO
Remarks:

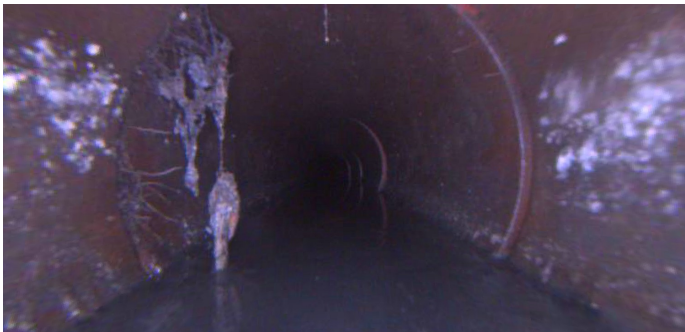
Code:	RFJ
Description:	Roots Fine Joint

Distance (ft):	.4
Structural Grade:	0
O&M Grade:	1
Clock Start/From:	8
Clock To:	4
1st Value:	
2nd Value:	
Value Percent:	
Continuous Index:	
Within 8" of Joint:	YES
Remarks:

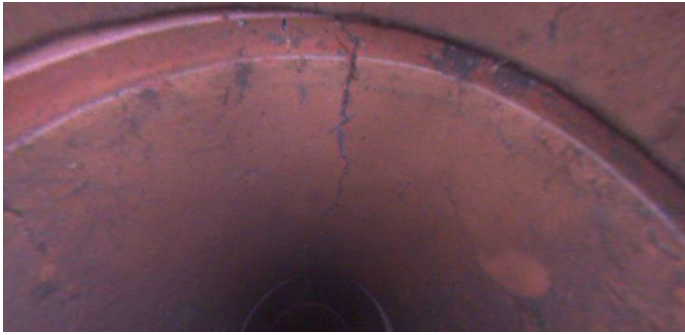
Code: **FL**
Description: **Fracture Longitudinal**

Distance (ft): **13.4**
Structural Grade: **3**
O&M Grade: **0**
Clock Start/From: **12**
Clock To:
1st Value:
2nd Value:
Value Percent:
Continuous Index:
Within 8" of Joint: **YES**
Remarks:

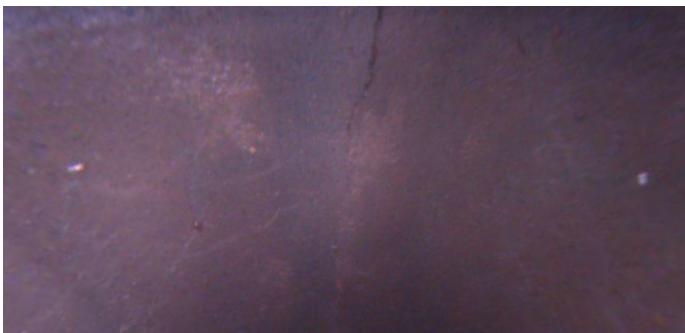
Code: **FL**
Description: **Fracture Longitudinal**

Distance (ft): **15.7**
Structural Grade: **3**
O&M Grade: **0**
Clock Start/From: **12**
Clock To:
1st Value:
2nd Value:
Value Percent:
Continuous Index:
Within 8" of Joint: **YES**
Remarks:

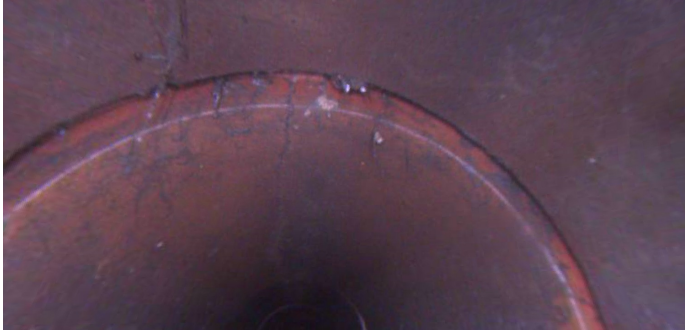
Code: **RFJ**
Description: **Roots Fine Joint**

Distance (ft): **17.1**
Structural Grade: **0**
O&M Grade: **1**
Clock Start/From: **8**
Clock To: **4**
1st Value:
2nd Value:
Value Percent:
Continuous Index:
Within 8" of Joint: **YES**
Remarks:

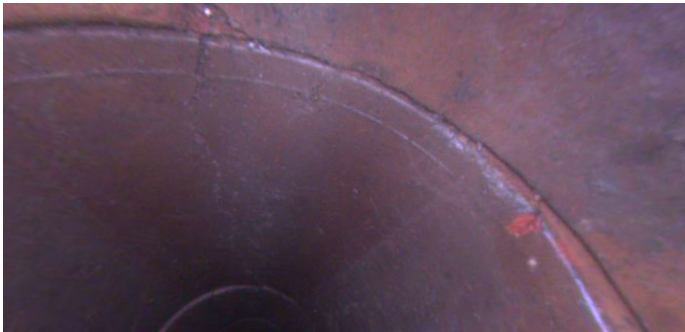
Code: **FL**
Description: **Fracture Longitudinal**

Distance (ft): **19.2**
Structural Grade: **3**
O&M Grade: **0**
Clock Start/From: **12**
Clock To:
1st Value:
2nd Value:
Value Percent:
Continuous Index:
Within 8" of Joint: **YES**
Remarks:

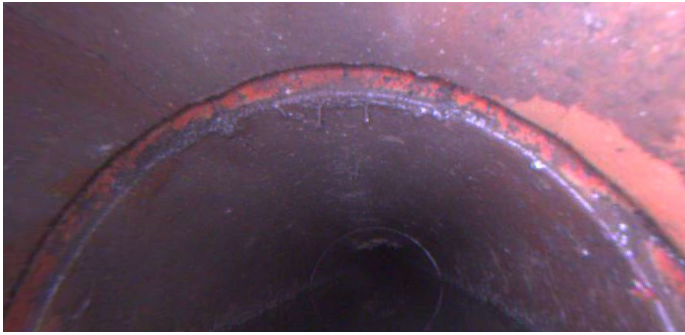
Code: **FL**
Description: **Fracture Longitudinal**

Distance (ft): **23.0**
Structural Grade: **3**
O&M Grade: **0**
Clock Start/From: **11**
Clock To:
1st Value:
2nd Value:
Value Percent:
Continuous Index:
Within 8" of Joint: **YES**
Remarks:

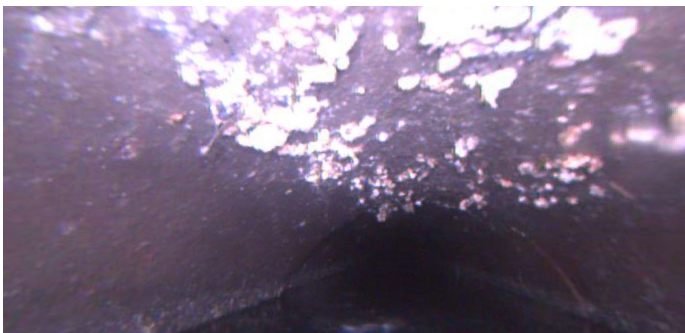
Code: **DAGS**
Description: **Deposits Attached Grease**

Distance (ft): **26.0**
Structural Grade: **0**
O&M Grade: **2**
Clock Start/From: **10**
Clock To: **2**
1st Value:
2nd Value:
Value Percent: **5.000**
Continuous Index:
Within 8" of Joint: **NO**
Remarks:

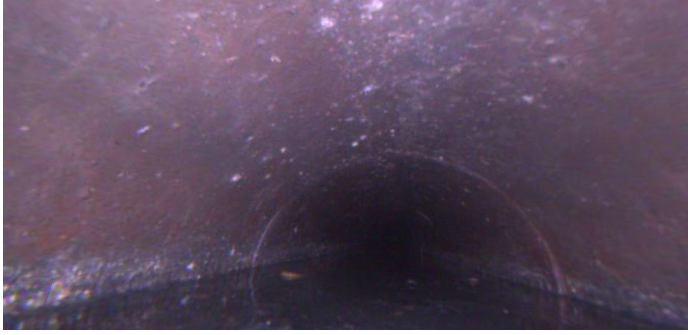
Code:	MSA
Description:	Abandoned Survey
Distance (ft):	27.9
Structural Grade:	0
O&M Grade:	0
Clock Start/From:	
Clock To:	
1st Value:	
2nd Value:	
Value Percent:	
Continuous Index:	
Within 8" of Joint:	NO
Remarks:	debris under water
