Profile/Photo Observation Report

| Date: | 04/25/2018 | Weather: | | Coding: | PACP 6.0 |

| Street: | Summerlin | Flow Control: | Not Controlled |

| US MH: | M-605-045 | DS MH: | M-605-046 |

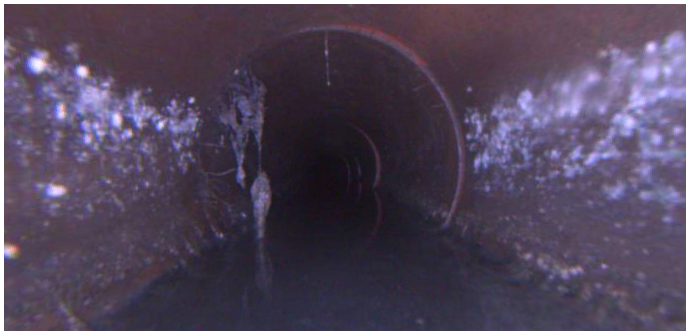
Code: **AMH**
Description: **Manhole**

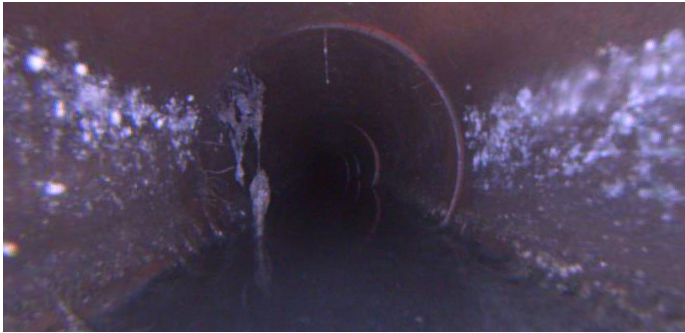
| Code: | MWL |
| Description: | Water Level |

| Distance (ft): | .0 |
| Value Percent: | 20.000 |

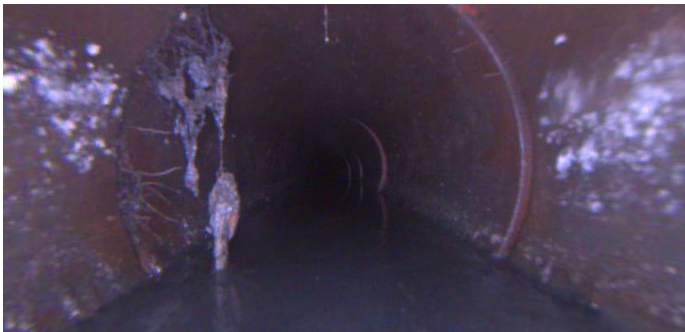
| Position | Code | Observation | Video (sec) | Grade |
|---|---|---|---|---|
| .4 | RFJ | Roots Fine Joint | 33 | M 1 |

| Code: | RFJ |
| Description: | Roots Fine Joint |

| Distance (ft): | .4 |
| O&M Grade: | 1 |
| Clock Start/From: | 8 |
| Clock To: | 4 |

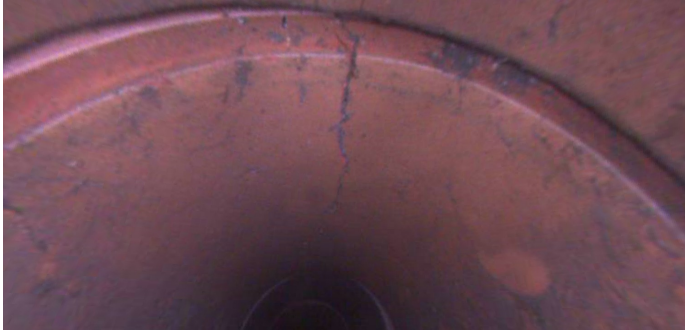
| Position | Code | Observation | Video (sec) | Grade |
|---|---|---|---|---|
| 13.4 | FL | Fracture Longitudinal | 71 | S 3 |

Code: **FL**
Description: **Fracture Longitudinal**

Distance (ft): **13.4**
Structural Grade: **3**
O&M Grade: **0**
Clock Start/From: **12**
Clock To:
1st Value:
2nd Value:
Value Percent:
Continuous Index:
Within 8" of Joint: **YES**
Remarks:

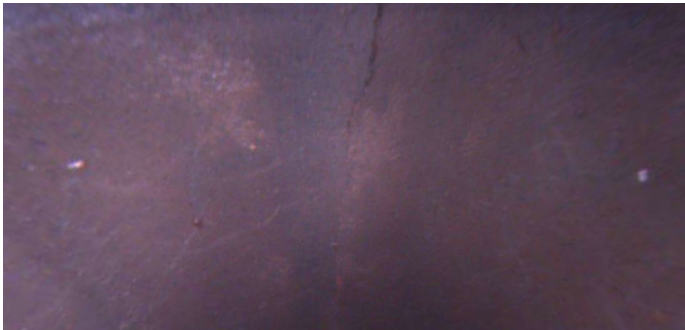
| Position | Code | Observation | Video (sec) | Grade |
|---|---|---|---|---|
| 15.7 | FL | Fracture Longitudinal | 88 | S 3 |

Code: **FL**
Description: **Fracture Longitudinal**

Distance (ft): **15.7**
Structural Grade: **3**
O&M Grade: **0**
Clock Start/From: **12**
Clock To:
1st Value:
2nd Value:
Value Percent:
Continuous Index:
Within 8" of Joint: **YES**
Remarks:

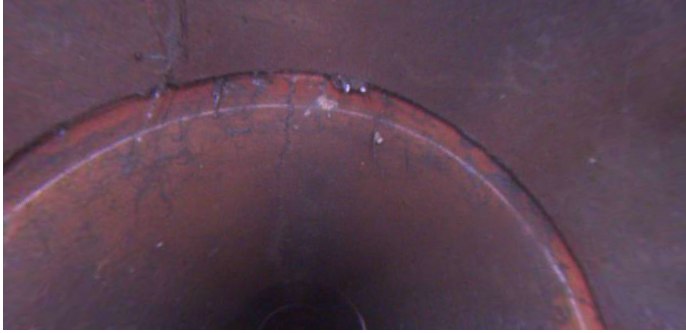
| Position | Code | Observation | Video (sec) | Grade |
|---|---|---|---|---|
| 17.1 | RFJ | Roots Fine Joint | 103 | M 1 |

Code: **RFJ**
Description: **Roots Fine Joint**

Distance (ft): **17.1**
Structural Grade: **0**
O&M Grade: **1**
Clock Start/From: **8**
Clock To: **4**
1st Value:
2nd Value:
Value Percent:
Continuous Index:
Within 8" of Joint: **YES**
Remarks:

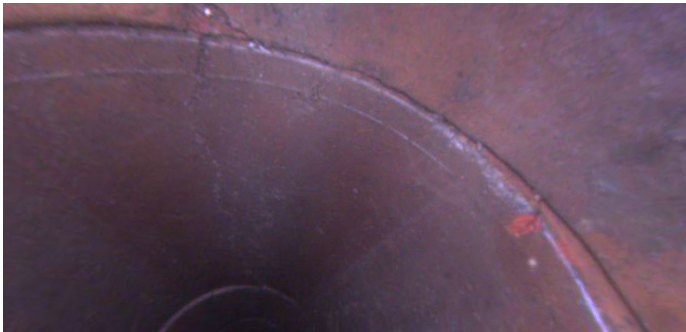
| Position | Code | Observation | Video (sec) | Grade |
|---|---|---|---|---|
| 19.2 | FL | Fracture Longitudinal | 119 | S 3 |

Code: **FL**
Description: **Fracture Longitudinal**

Distance (ft): **19.2**
Structural Grade: **3**
O&M Grade: **0**
Clock Start/From: **12**
Clock To:
1st Value:
2nd Value:
Value Percent:
Continuous Index:
Within 8" of Joint: **YES**
Remarks:

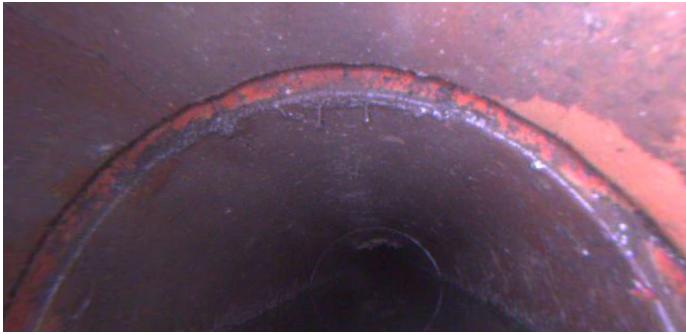
| Position | Code | Observation | Video (sec) | Grade |
|---|---|---|---|---|
| 23.0 | FL | Fracture Longitudinal | 138 | S 3 |

Code: **FL**
Description: **Fracture Longitudinal**

Distance (ft): **23.0**
Structural Grade: **3**
O&M Grade: **0**
Clock Start/From: **11**
Clock To:
1st Value:
2nd Value:
Value Percent:
Continuous Index:
Within 8" of Joint: **YES**
Remarks:

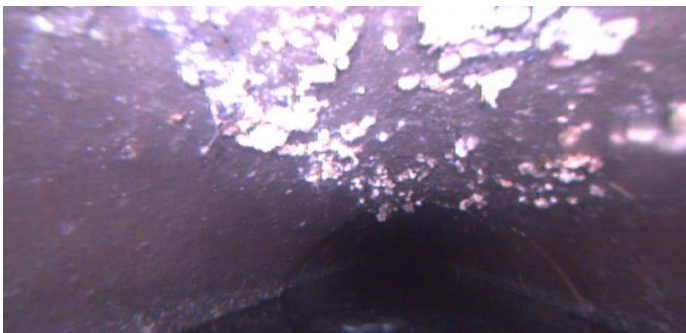
| Position | Code | Observation | Video (sec) | Grade |
|---|---|---|---|---|
| 26.0 | DAGS | Deposits Attached Grease | 156 | M 2 |

Code: **DAGS**
Description: **Deposits Attached Grease**

Distance (ft): **26.0**
Structural Grade: **0**
O&M Grade: **2**
Clock Start/From: **10**
Clock To: **2**
1st Value:
2nd Value:
Value Percent: **5.000**
Continuous Index:
Within 8" of Joint: **NO**
Remarks:

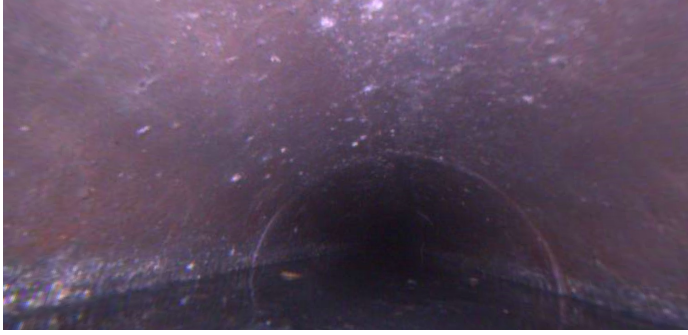
| Code: | MSA |
| Description: | Abandoned Survey |
| Distance (ft): | 27.9 |
| Remarks: | debris under water |
