Profile/Photo Observation Report

Date:	04/29/2018	Weather:		Coding:	PACP 6.0
Pipe Length (ft):		Owner:	City of Hobart	Pre Clean:	No Pre-Cleaning
P.O.#:	136	Surveyor:	M. Pielacha	PSR:	P-605-048-018
Customer:	City of Hobart	Clean Date:		Shape:	C

Street:	Wisconsin Street	Flow Control:	Not Controlled
City:	Hobart, IN	Year Renewed:	
Location:	Light Highway	Tape/Media #:	DEP 136
Purpose:	Routine Assessment	Dia/Height:	20"
Use:	Sanitary	Material:	VCP
Drain Area:		Lining:	
Category:	NA		
Comment:	5-21-2018		
Location Details:		Direction of Survey:	Downstream
US MH:	M-605-048	DS MH:	M-505-018
		Total Length Surveyed (ft):	225.3

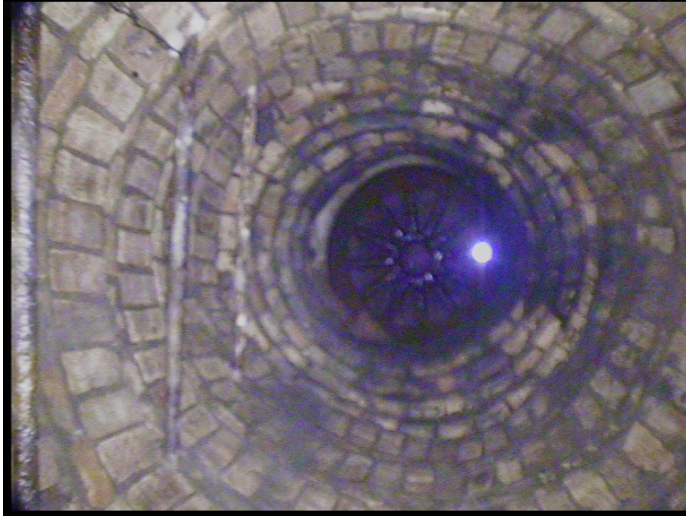
Code: **AMH**
Description: **Manhole**

Distance (ft): **.0**
Structural Grade: **0**
O&M Grade: **0**
Clock Start/From:
Clock To:
1st Value:
2nd Value:
Value Percent:
Continuous Index:
Within 8" of Joint: **NO**
Remarks: **M-605-048**

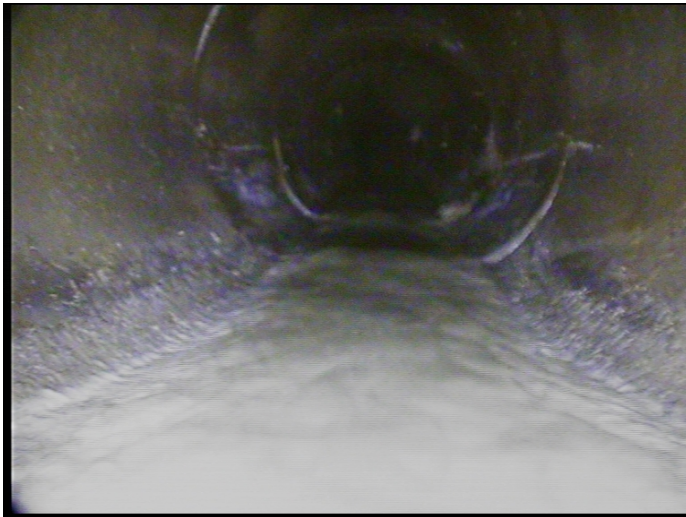
Code: **MWL**
Description: **Water Level**

Distance (ft): **.0**
Structural Grade: **0**
O&M Grade: **0**
Clock Start/From:
Clock To:
1st Value:
2nd Value:
Value Percent: **5.000**
Continuous Index:
Within 8" of Joint: **NO**
Remarks:

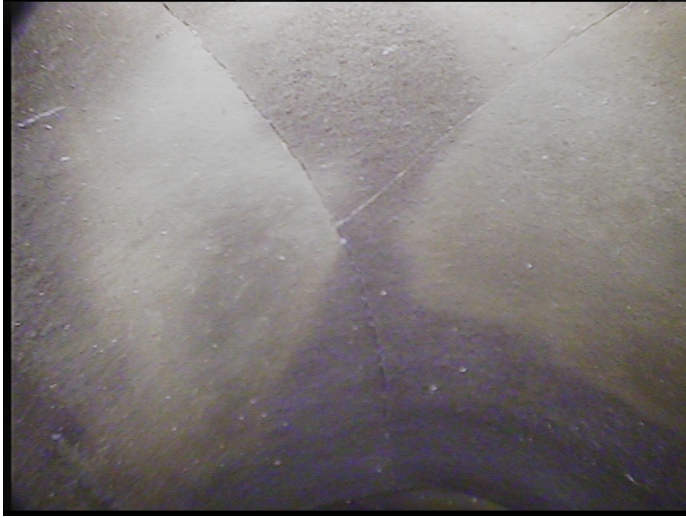
Code: **CM**
Description: **Crack Multiple**

Distance (ft): **3.3**
Structural Grade: **3**
O&M Grade: **0**
Clock Start/From: **11**
Clock To: **1**
1st Value:
2nd Value:
Value Percent:
Continuous Index:
Within 8" of Joint: **YES**
Remarks:

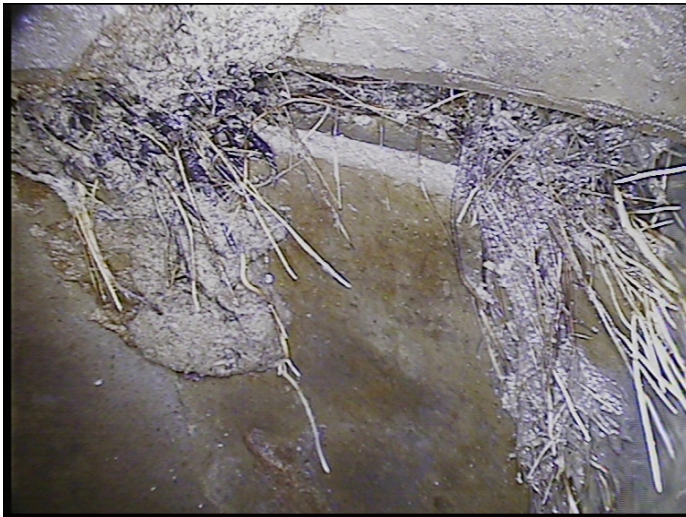
Code: **RFJ**
Description: **Roots Fine Joint**

Distance (ft): **5.5**
Structural Grade: **0**
O&M Grade: **1**
Clock Start/From: **3**
Clock To: **5**
1st Value:
2nd Value:
Value Percent:
Continuous Index:
Within 8" of Joint: **YES**
Remarks:

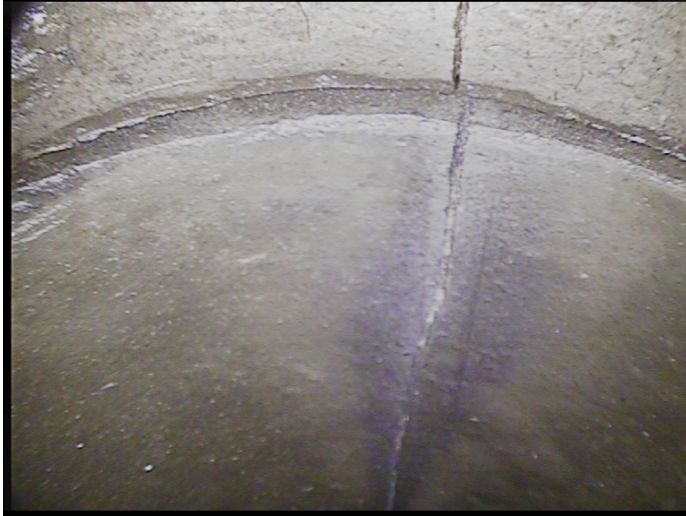
Code:	FL
Description:	Fracture Longitudinal
Distance (ft):	7.6
Structural Grade:	3
O&M Grade:	0
Clock Start/From:	12
Clock To:	
1st Value:	
2nd Value:	
Value Percent:	
Continuous Index:	S01
Within 8" of Joint:	YES
Remarks:

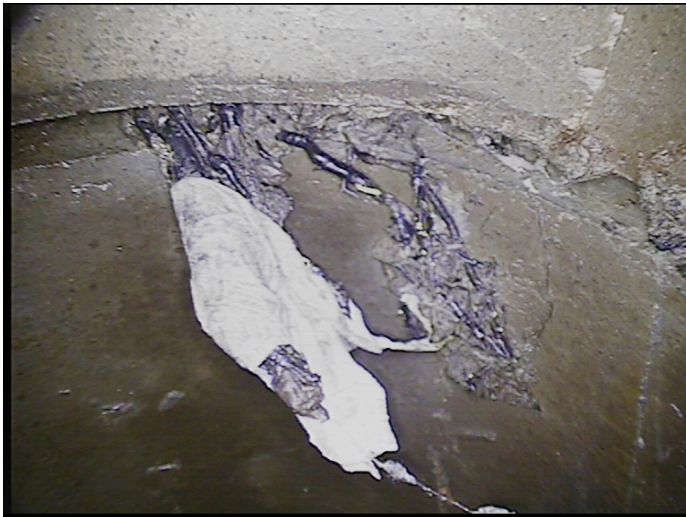
Code:	RFJ
Description:	Roots Fine Joint
Distance (ft):	15.4
Structural Grade:	0
O&M Grade:	1
Clock Start/From:	1
Clock To:	2
1st Value:	
2nd Value:	
Value Percent:	
Continuous Index:	
Within 8" of Joint:	YES
Remarks:

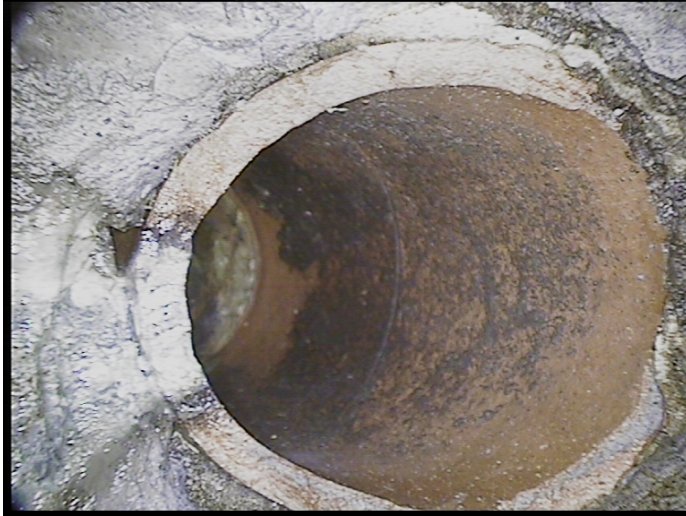
Code:	TBA
Description:	Tap Break-in Active
Distance (ft):	22.6
Structural Grade:	0
O&M Grade:	0
Clock Start/From:	10
Clock To:	
1st Value:	4.000
2nd Value:	
Value Percent:	
Continuous Index:	
Within 8" of Joint:	NO
Remarks:

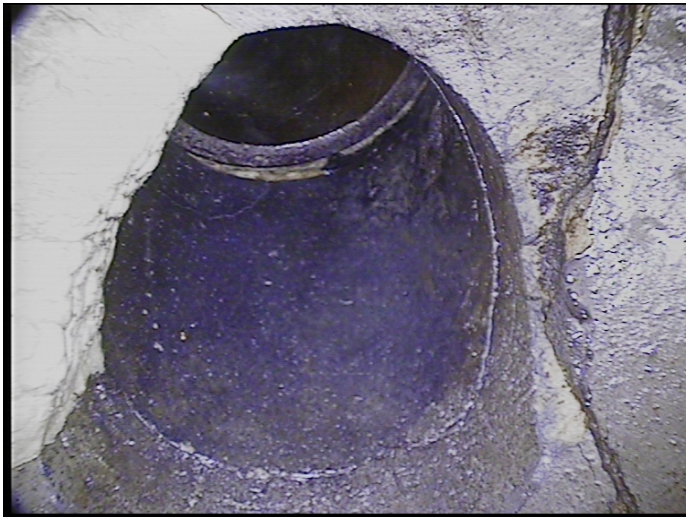
Code:	TF
Description:	Tap Factory
Distance (ft):	40.0
Structural Grade:	0
O&M Grade:	0
Clock Start/From:	10
Clock To:	
1st Value:	4.000
2nd Value:	
Value Percent:	
Continuous Index:	
Within 8" of Joint:	NO
Remarks:

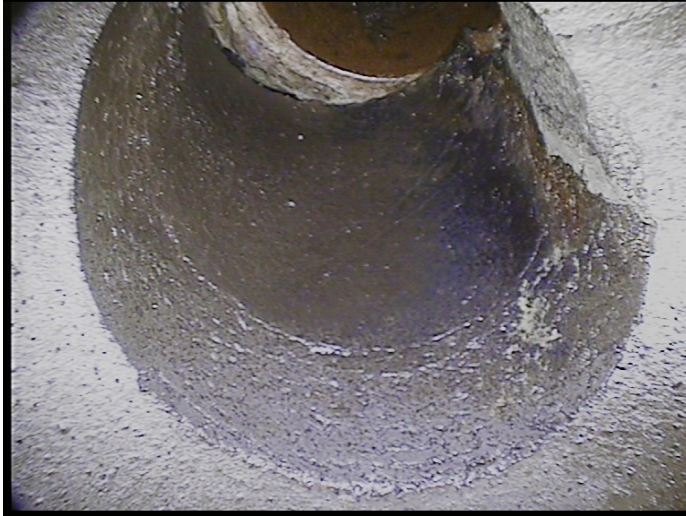
Code: **TF**
Description: **Tap Factory**

Distance (ft): **42.7**
Structural Grade: **0**
O&M Grade: **0**
Clock Start/From: **2**
Clock To:
1st Value: **4.000**
2nd Value:
Value Percent:
Continuous Index:
Within 8" of Joint: **NO**
Remarks:

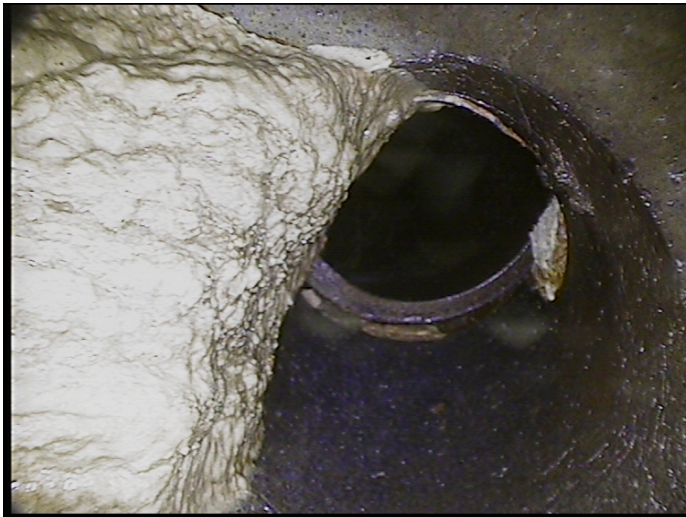
Code: **TF**
Description: **Tap Factory**

Distance (ft): **86.9**
Structural Grade: **0**
O&M Grade: **0**
Clock Start/From: **10**
Clock To:
1st Value: **4.000**
2nd Value:
Value Percent:
Continuous Index:
Within 8" of Joint: **NO**
Remarks:

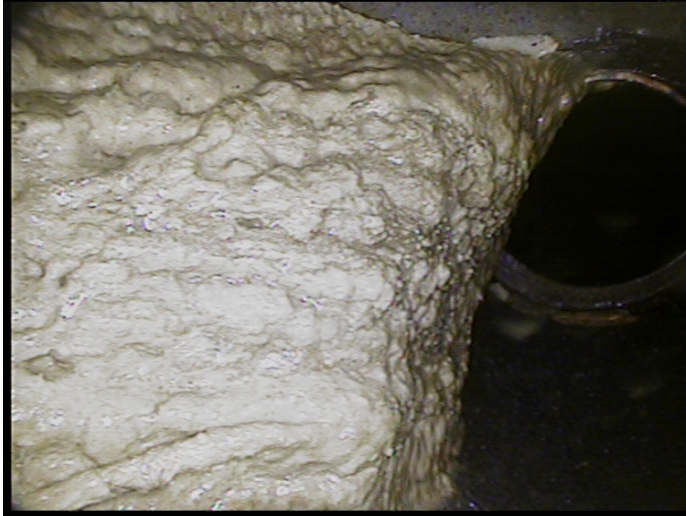
Code:	DAE
Description:	Deposits Attached Encrustation
Distance (ft):	86.9
Structural Grade:	0
O&M Grade:	2
Clock Start/From:	7
Clock To:	11
1st Value:	
2nd Value:	
Value Percent:	5.000
Continuous Index:	
Within 8" of Joint:	YES
Remarks:

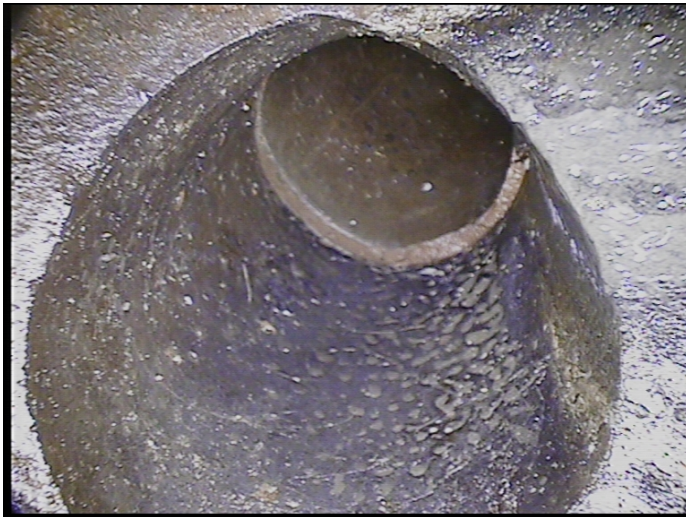
Code:	TF
Description:	Tap Factory
Distance (ft):	89.2
Structural Grade:	0
O&M Grade:	0
Clock Start/From:	2
Clock To:	
1st Value:	4.000
2nd Value:	
Value Percent:	
Continuous Index:	
Within 8" of Joint:	NO
Remarks:

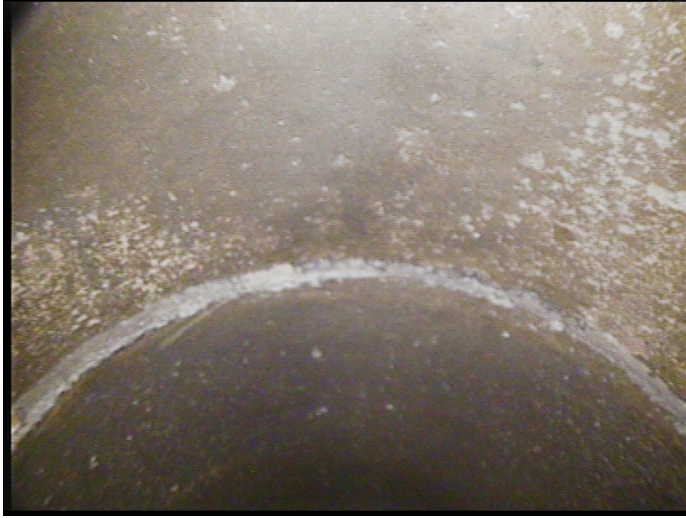
Code: **FL**
Description: **Fracture Longitudinal**

Distance (ft): **89.2**
Structural Grade: **3**
O&M Grade: **0**
Clock Start/From: **12**
Clock To:
1st Value:
2nd Value:
Value Percent:
Continuous Index: **F01**
Within 8" of Joint: **NO**
Remarks:

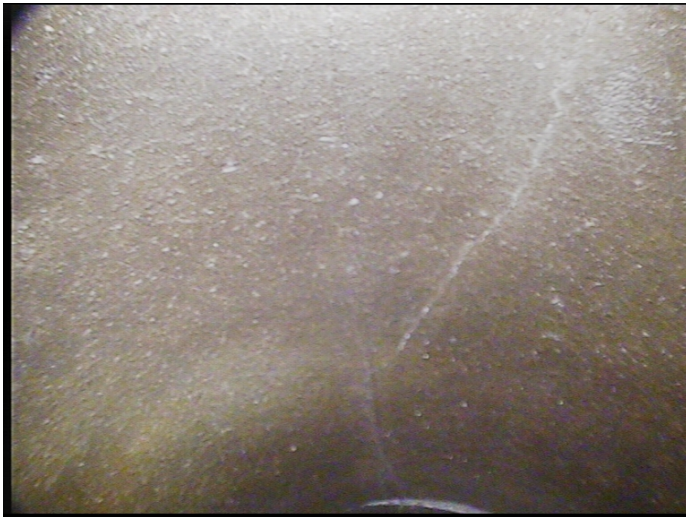
Code: **CL**
Description: **Crack Longitudinal**

Distance (ft): **105.6**
Structural Grade: **2**
O&M Grade: **0**
Clock Start/From: **12**
Clock To:
1st Value:
2nd Value:
Value Percent:
Continuous Index: **S02**
Within 8" of Joint: **YES**
Remarks:

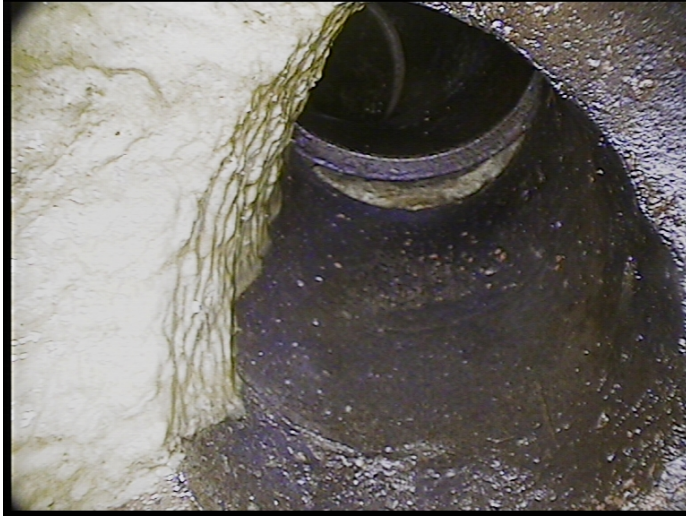
Code: **TF**
Description: **Tap Factory**

Distance (ft): **130.1**
Structural Grade: **0**
O&M Grade: **0**
Clock Start/From: **10**
Clock To:
1st Value: **4.000**
2nd Value:
Value Percent:
Continuous Index:
Within 8" of Joint: **NO**
Remarks:

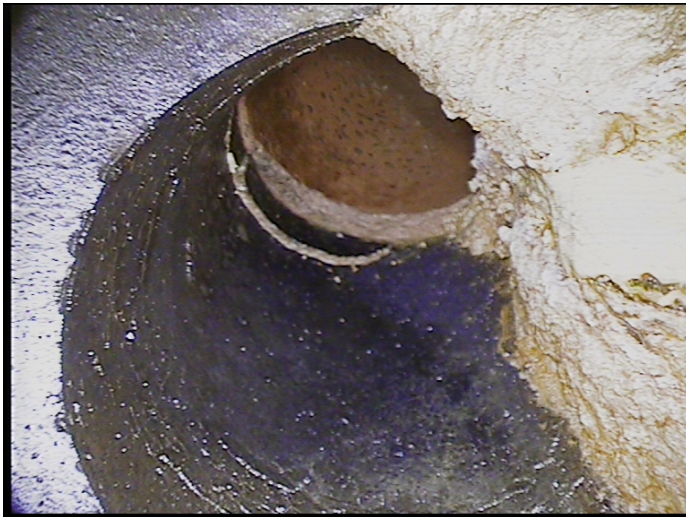
Code: **TF**
Description: **Tap Factory**

Distance (ft): **132.6**
Structural Grade: **0**
O&M Grade: **0**
Clock Start/From: **2**
Clock To:
1st Value: **4.000**
2nd Value:
Value Percent:
Continuous Index:
Within 8" of Joint: **NO**
Remarks:

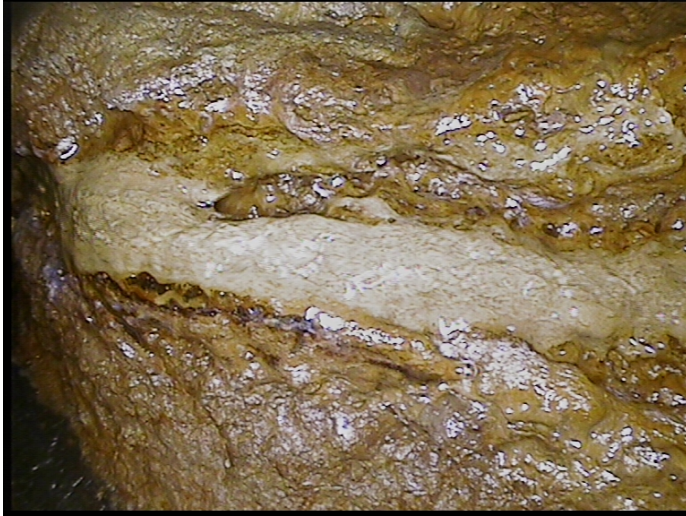
Code:	DAE
Description:	Deposits Attached Encrustation
Distance (ft):	132.6
Structural Grade:	0
O&M Grade:	2
Clock Start/From:	2
Clock To:	5
1st Value:	
2nd Value:	
Value Percent:	5.000
Continuous Index:	
Within 8" of Joint:	YES
Remarks:

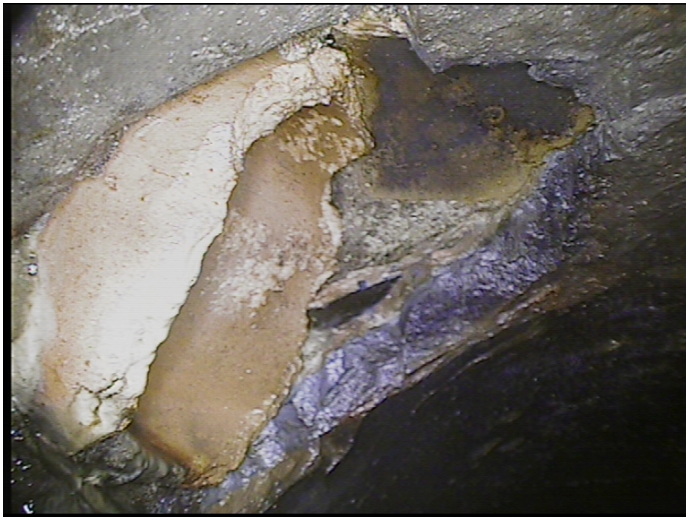
Code:	TB
Description:	Tap Break-in
Distance (ft):	166.2
Structural Grade:	0
O&M Grade:	0
Clock Start/From:	10
Clock To:	
1st Value:	4.000
2nd Value:	
Value Percent:	
Continuous Index:	
Within 8" of Joint:	NO
Remarks:

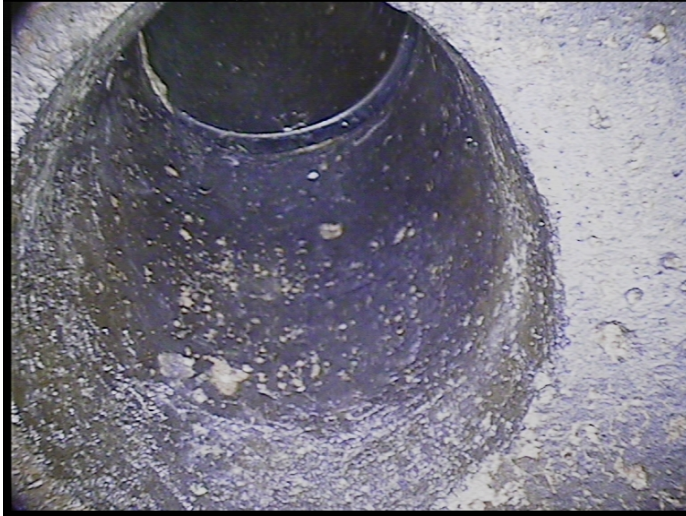
Code: **TF**
Description: **Tap Factory**

Distance (ft): **171.5**
Structural Grade: **0**
O&M Grade: **0**
Clock Start/From: **10**
Clock To:
1st Value: **4.000**
2nd Value:
Value Percent:
Continuous Index:
Within 8" of Joint: **NO**
Remarks:

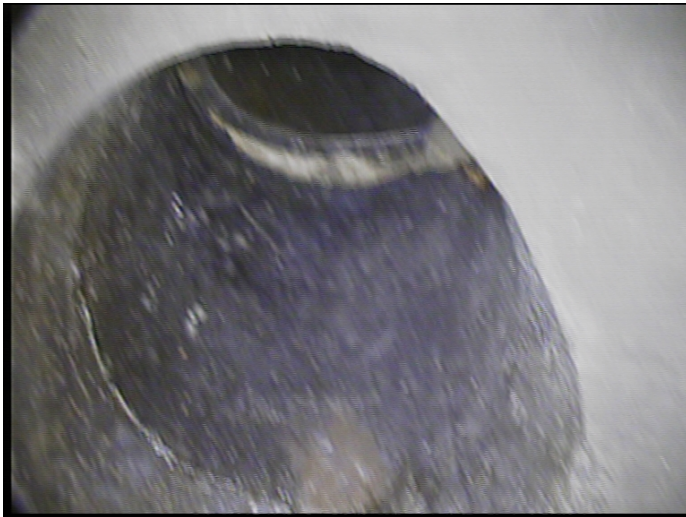
Code: **TF**
Description: **Tap Factory**

Distance (ft): **174.0**
Structural Grade: **0**
O&M Grade: **0**
Clock Start/From: **2**
Clock To:
1st Value: **4.000**
2nd Value:
Value Percent:
Continuous Index:
Within 8" of Joint: **NO**
Remarks:

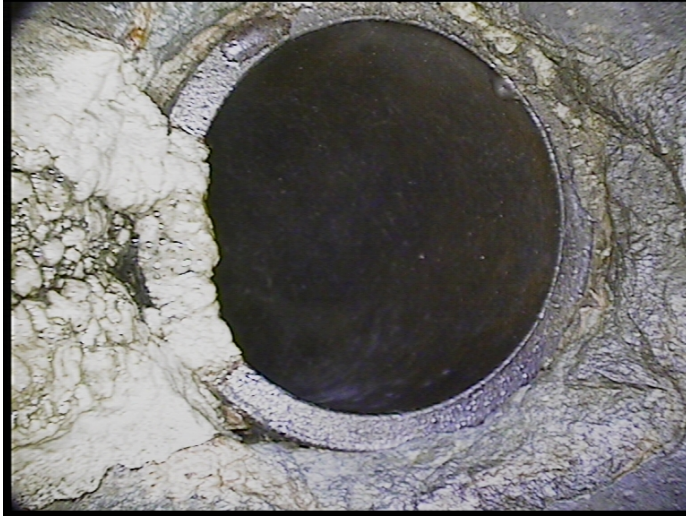
Code: **TB**
Description: **Tap Break-in**

Distance (ft): **176.7**
Structural Grade: **0**
O&M Grade: **0**
Clock Start/From: **10**
Clock To:
1st Value: **4.000**
2nd Value:
Value Percent:
Continuous Index:
Within 8" of Joint: **NO**
Remarks:

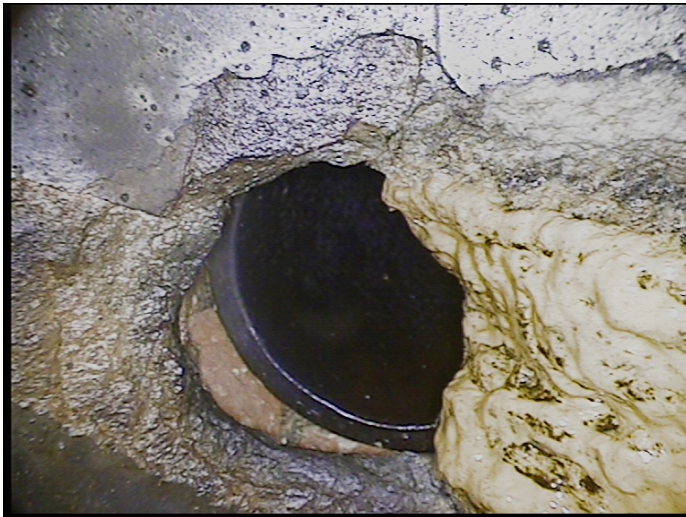
Code: **TFD**
Description: **Tap Factory Defective**

Distance (ft): **178.5**
Structural Grade: **0**
O&M Grade: **2**
Clock Start/From: **2**
Clock To:
1st Value: **4.000**
2nd Value:
Value Percent:
Continuous Index:
Within 8" of Joint: **NO**
Remarks: **Defective**

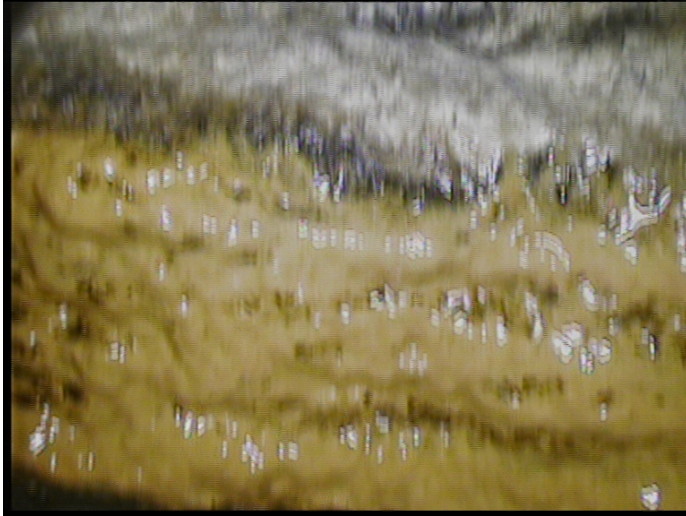
Code:	DAE
Description:	Deposits Attached Encrustation
Distance (ft):	178.5
Structural Grade:	0
O&M Grade:	2
Clock Start/From:	1
Clock To:	4
1st Value:	
2nd Value:	
Value Percent:	5.000
Continuous Index:	
Within 8" of Joint:	YES
Remarks:

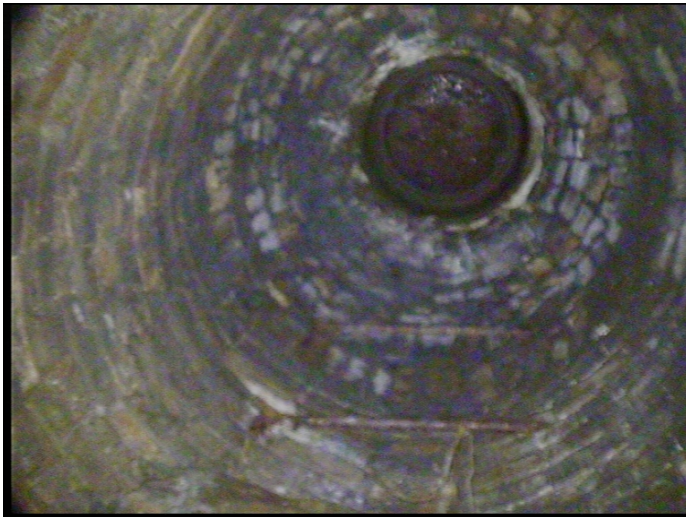
Code:	CL
Description:	Crack Longitudinal
Distance (ft):	225.0
Structural Grade:	2
O&M Grade:	0
Clock Start/From:	12
Clock To:	
1st Value:	
2nd Value:	
Value Percent:	
Continuous Index:	F02
Within 8" of Joint:	NO
Remarks:

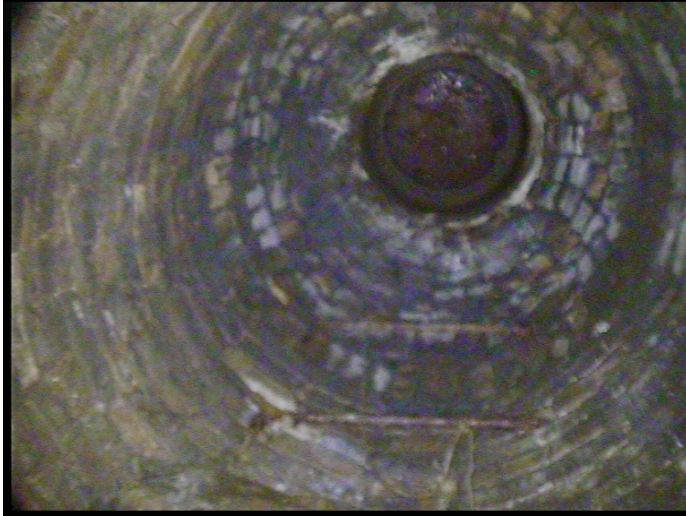
Code:	AMH
Description:	Manhole
Distance (ft):	225.0
Structural Grade:	0
O&M Grade:	0
Clock Start/From:	
Clock To:	
1st Value:	
2nd Value:	
Value Percent:	
Continuous Index:	
Within 8" of Joint:	NO
Remarks:	M-505-018
