Profile/Photo Observation Report

Date:	04/27/2018	Weather:		Coding:	PACP 6.0
Pipe Length (ft):		Owner:	City of Hobart	Pre Clean:	No Pre-Cleaning
P.O.#:	120	Surveyor:	M. Pielacha	PSR:	P-605-076-048
Customer:	City of Hobart	Clean Date:		Shape:	C

Street:	Off Wisconsin Street	Flow Control:	Not Controlled
City:	Hobart, IN	Year Renewed:	
Location:	Parking Lot	Tape/Media #:	DEP 120
Purpose:	Routine Assessment	Dia/Height:	6"
Use:	Sanitary	Material:	PVC
Drain Area:		Lining:	
Category:	NA		
Comment:	YES501824 Submittal 2		
Location Details:		Direction of Survey:	Downstream
US MH:	M-605-076	DS MH:	M-605-048
		Total Length Surveyed (ft):	3.2

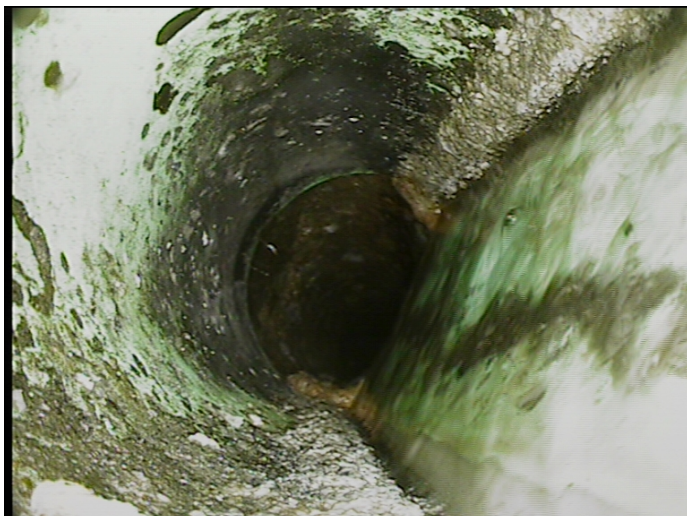
Code: **AMH**
 Description: **Manhole**

Distance (ft): **.0**
 Structural Grade: **0**
 O&M Grade: **0**
 Clock Start/From:
 Clock To:
 1st Value:
 2nd Value:
 Value Percent:
 Continuous Index:
 Within 8" of Joint: **NO**
 Remarks: **M-605-076**

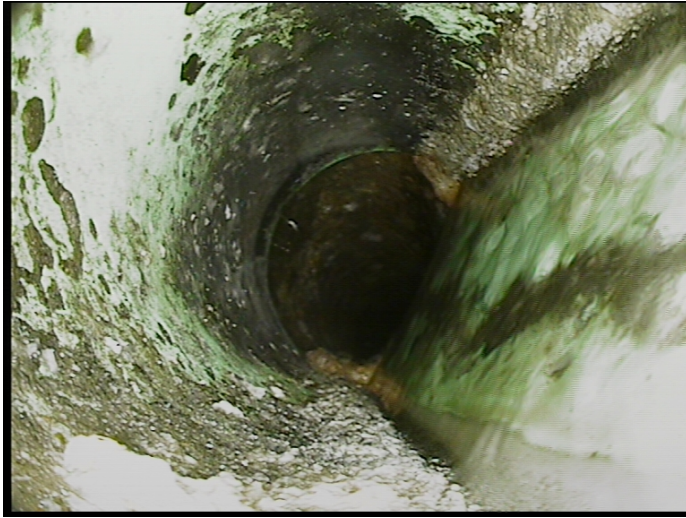
Code: **MWL**
Description: **Water Level**

Distance (ft): **.0**
Structural Grade: **0**
O&M Grade: **0**
Clock Start/From:
Clock To:
1st Value:
2nd Value:
Value Percent: **10.000**
Continuous Index:
Within 8" of Joint: **NO**
Remarks:

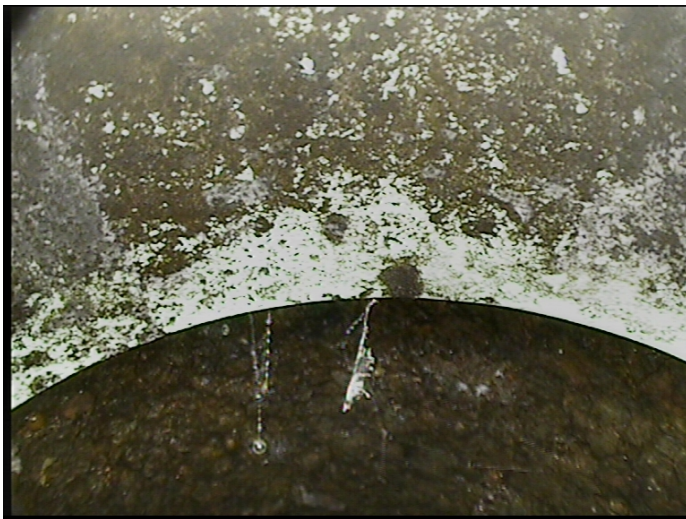
Code: **MMC**
Description: **Material Change**

Distance (ft): **2.0**
Structural Grade: **0**
O&M Grade: **0**
Clock Start/From:
Clock To:
1st Value:
2nd Value:
Value Percent:
Continuous Index:
Within 8" of Joint: **NO**
Remarks: **steel pipe**

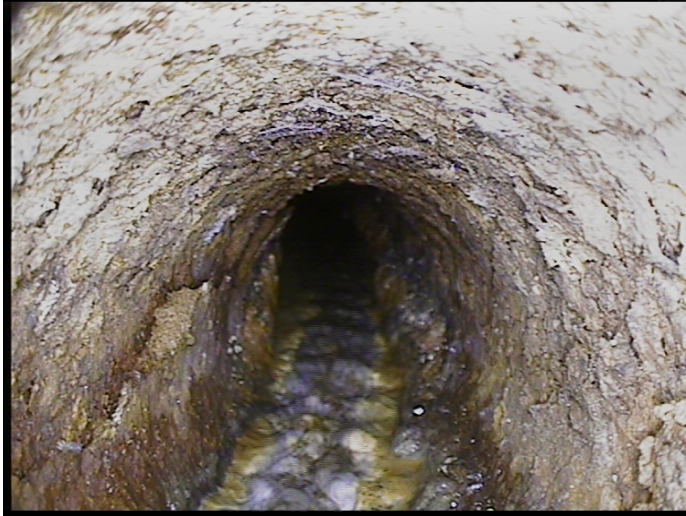
Code: **SRI**
Description: **Surface Roughness Increased**

Distance (ft): **3.2**
Structural Grade: **1**
O&M Grade: **0**
Clock Start/From: **7**
Clock To: **5**
1st Value:
2nd Value:
Value Percent:
Continuous Index:
Within 8" of Joint: **YES**
Remarks:

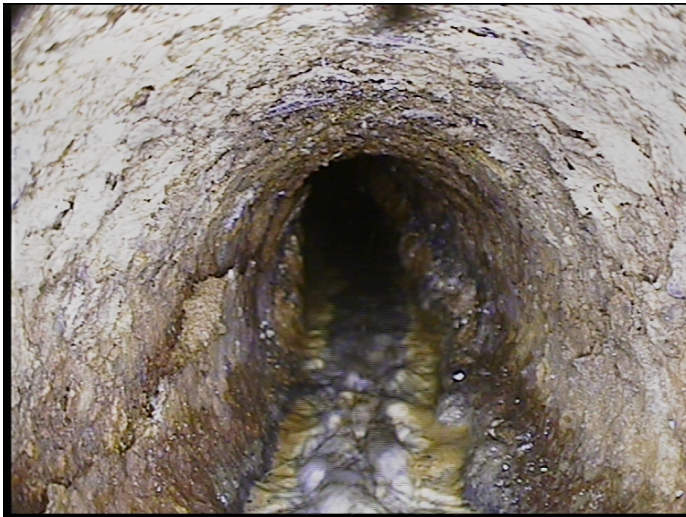
Code: **MSA**
Description: **Abandoned Survey**

Distance (ft): **3.2**
Structural Grade: **0**
O&M Grade: **0**
Clock Start/From:
Clock To:
1st Value:
2nd Value:
Value Percent:
Continuous Index:
Within 8" of Joint: **NO**
Remarks: **pipe is too corroded**
