## Profile/Photo Observation Report

Date:	<b>04/29/2018</b>	Weather:		Coding:	<b>PACP 6.0</b>
Pipe Length (ft):		Owner:	<b>City of Hobart</b>	Pre Clean:	<b>No Pre-Cleaning</b>
P.O.#:	<b>136</b>	Surveyor:	<b>M. Pielacha</b>	PSR:	<b>P-605-049-048</b>
Customer:	<b>City of Hobart</b>	Clean Date:		Shape:	<b>C</b>

Street:	<b>Wisconsin Street</b>	Flow Control:	<b>Not Controlled</b>
City:	<b>Hobart, IN</b>	Year Renewed:	
Location:	<b>Light Highway</b>	Tape/Media #:	<b>DEP 136</b>
Purpose:	<b>Routine Assessment</b>	Dia/Height:	<b>20"</b>
Use:	<b>Sanitary</b>	Material:	<b>VCP</b>
Drain Area:		Lining:	
Category:	<b>NA</b>		
Comment:	<b>5-21-2018</b>		
Location Details:		Direction of Survey:	<b>Downstream</b>
US MH:	<b>M-605-049</b>	DS MH:	<b>M-605-048</b>
		Total Length Surveyed (ft):	<b>219.7</b>

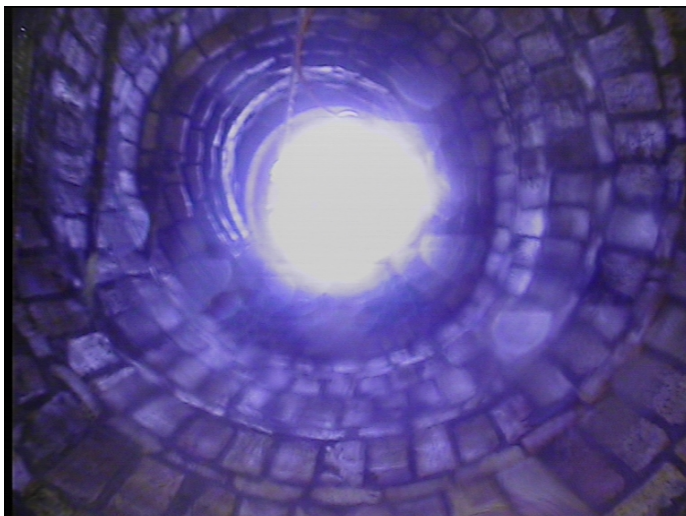
Code: **AMH**  
 Description: **Manhole**

Distance (ft): **.0**  
 Structural Grade: **0**  
 O&M Grade: **0**  
 Clock Start/From:  
 Clock To:  
 1st Value:  
 2nd Value:  
 Value Percent:  
 Continuous Index:  
 Within 8" of Joint: **NO**  
 Remarks: **M-605-049**

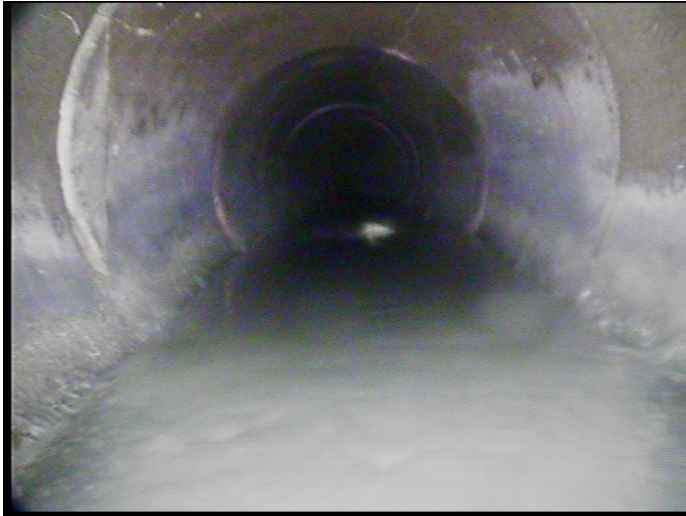
Code: **MWL**  
Description: **Water Level**

Distance (ft): **.0**  
Structural Grade: **0**  
O&M Grade: **0**  
Clock Start/From:  
Clock To:  
1st Value:  
2nd Value:  
Value Percent: **15.000**  
Continuous Index:  
Within 8" of Joint: **NO**  
Remarks:

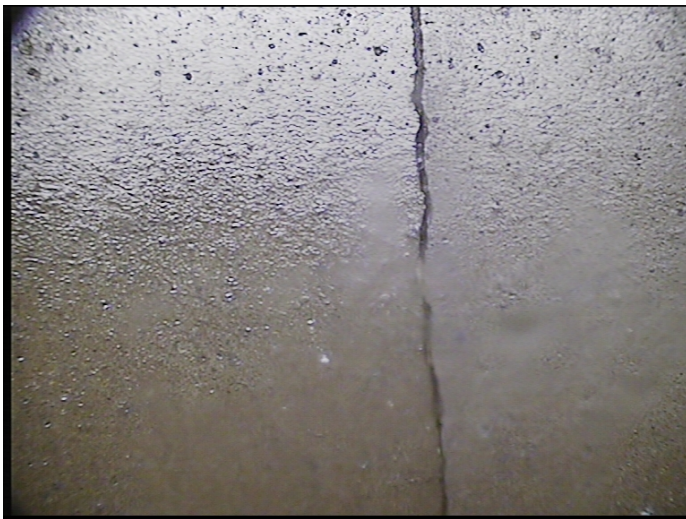
Code: **FL**  
Description: **Fracture Longitudinal**

Distance (ft): **5.4**  
Structural Grade: **3**  
O&M Grade: **0**  
Clock Start/From: **12**  
Clock To:  
1st Value:  
2nd Value:  
Value Percent:  
Continuous Index: **S01**  
Within 8" of Joint: **YES**  
Remarks:

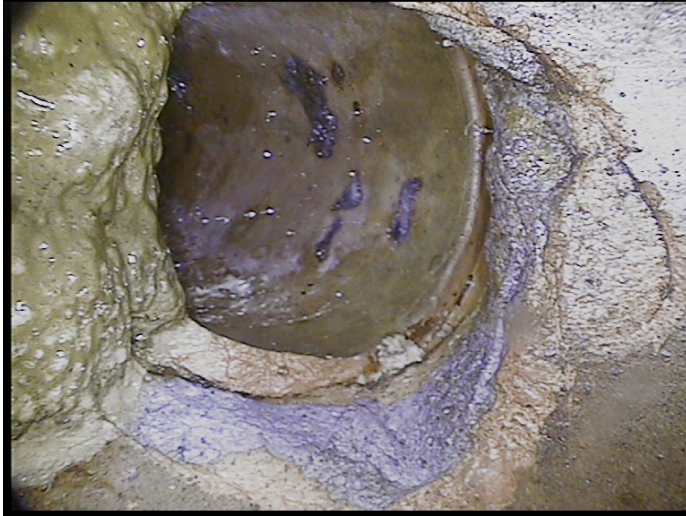
Code: **TF**  
Description: **Tap Factory**

Distance (ft): **21.9**  
Structural Grade: **0**  
O&M Grade: **0**  
Clock Start/From: **10**  
Clock To:  
1st Value: **4.000**  
2nd Value:  
Value Percent:  
Continuous Index:  
Within 8" of Joint: **NO**  
Remarks:

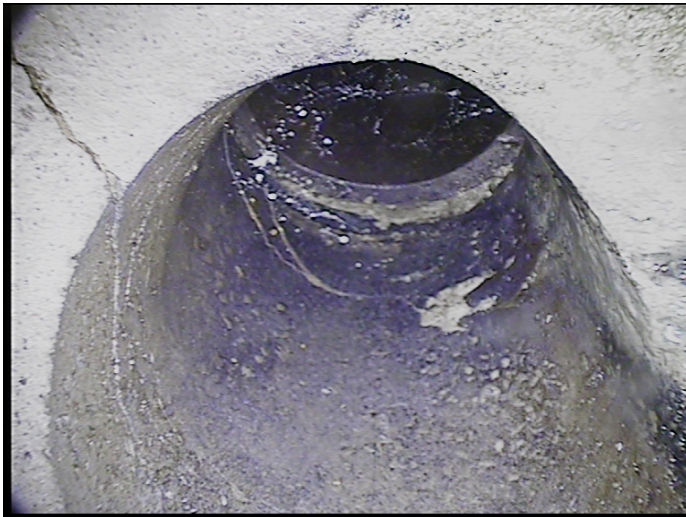
Code: **TF**  
Description: **Tap Factory**

Distance (ft): **23.8**  
Structural Grade: **0**  
O&M Grade: **0**  
Clock Start/From: **2**  
Clock To:  
1st Value: **4.000**  
2nd Value:  
Value Percent:  
Continuous Index:  
Within 8" of Joint: **NO**  
Remarks:

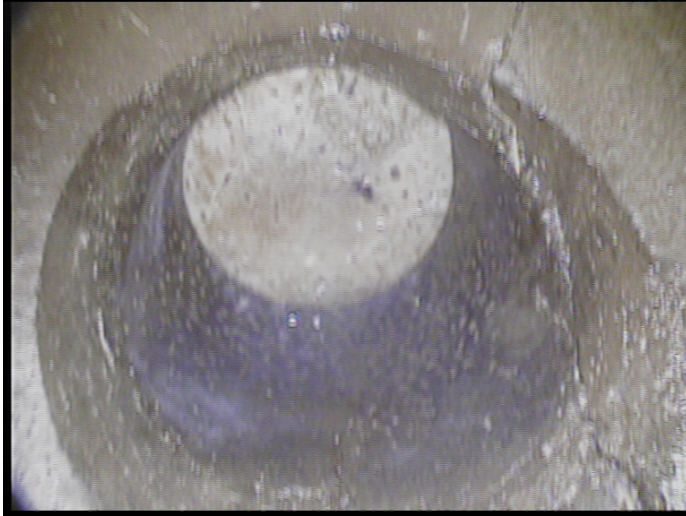
Code:	<b>TFC</b>
Description:	<b>Tap Factory Capped</b>
Distance (ft):	<b>26.6</b>
Structural Grade:	<b>0</b>
O&M Grade:	<b>0</b>
Clock Start/From:	<b>10</b>
Clock To:	
1st Value:	<b>4.000</b>
2nd Value:	
Value Percent:	
Continuous Index:	
Within 8" of Joint:	<b>NO</b>
Remarks:

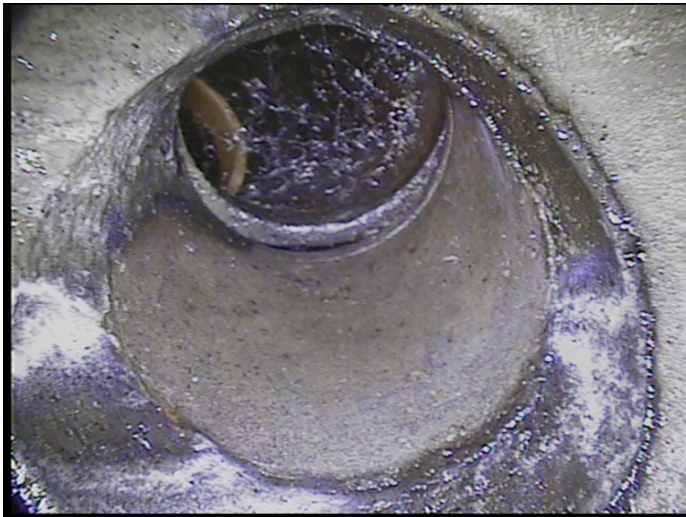
Code:	<b>TF</b>
Description:	<b>Tap Factory</b>
Distance (ft):	<b>62.3</b>
Structural Grade:	<b>0</b>
O&M Grade:	<b>0</b>
Clock Start/From:	<b>10</b>
Clock To:	
1st Value:	<b>4.000</b>
2nd Value:	
Value Percent:	
Continuous Index:	
Within 8" of Joint:	<b>NO</b>
Remarks:

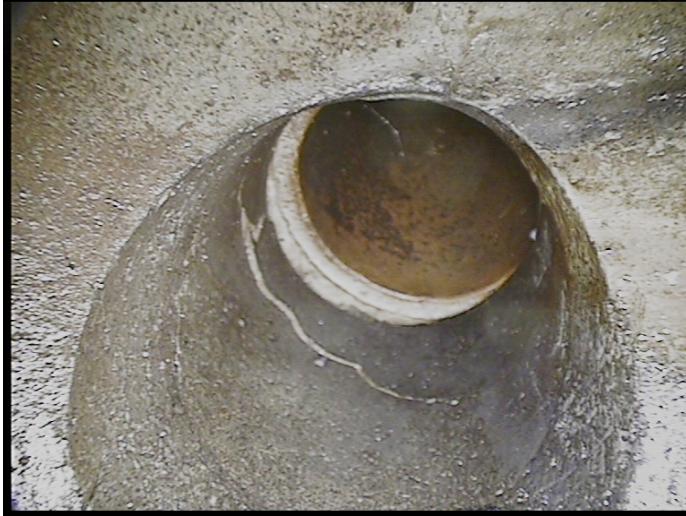
Code: **TF**  
Description: **Tap Factory**

Distance (ft): **64.8**  
Structural Grade: **0**  
O&M Grade: **0**  
Clock Start/From: **2**  
Clock To:  
1st Value: **4.000**  
2nd Value:  
Value Percent:  
Continuous Index:  
Within 8" of Joint: **NO**  
Remarks:

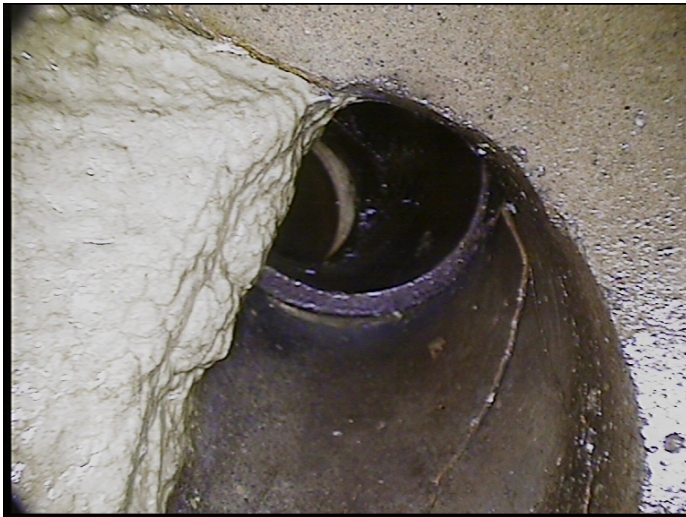
Code: **TF**  
Description: **Tap Factory**

Distance (ft): **100.0**  
Structural Grade: **0**  
O&M Grade: **0**  
Clock Start/From: **10**  
Clock To:  
1st Value: **4.000**  
2nd Value:  
Value Percent:  
Continuous Index:  
Within 8" of Joint: **NO**  
Remarks:

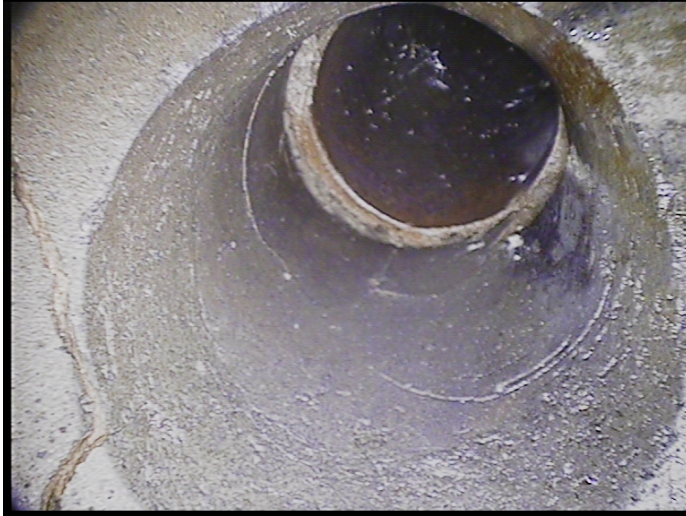
Code: **TF**  
Description: **Tap Factory**

Distance (ft): **102.8**  
Structural Grade: **0**  
O&M Grade: **0**  
Clock Start/From: **2**  
Clock To:  
1st Value: **4.000**  
2nd Value:  
Value Percent:  
Continuous Index:  
Within 8" of Joint: **NO**  
Remarks:

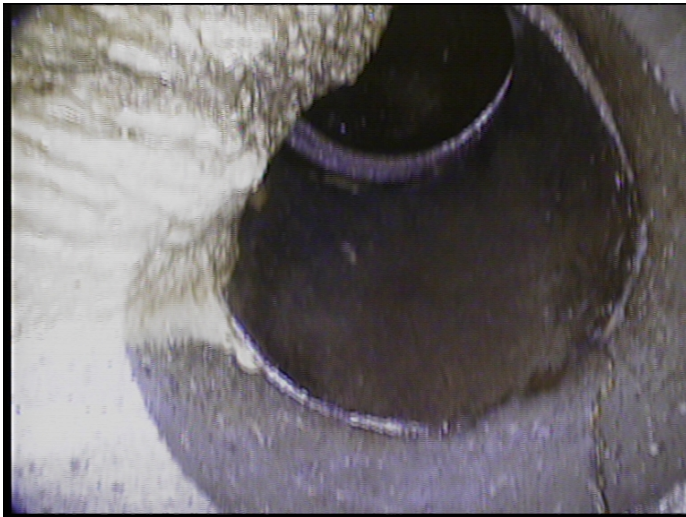
Code: **TF**  
Description: **Tap Factory**

Distance (ft): **151.0**  
Structural Grade: **0**  
O&M Grade: **0**  
Clock Start/From: **10**  
Clock To:  
1st Value: **4.000**  
2nd Value:  
Value Percent:  
Continuous Index:  
Within 8" of Joint: **NO**  
Remarks:

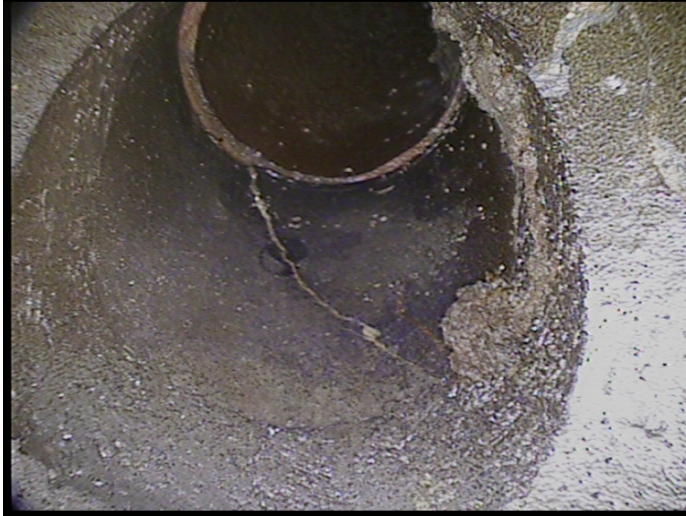
Code: **TF**  
Description: **Tap Factory**

Distance (ft): **153.5**  
Structural Grade: **0**  
O&M Grade: **0**  
Clock Start/From: **2**  
Clock To:  
1st Value: **4.000**  
2nd Value:  
Value Percent:  
Continuous Index:  
Within 8" of Joint: **NO**  
Remarks:

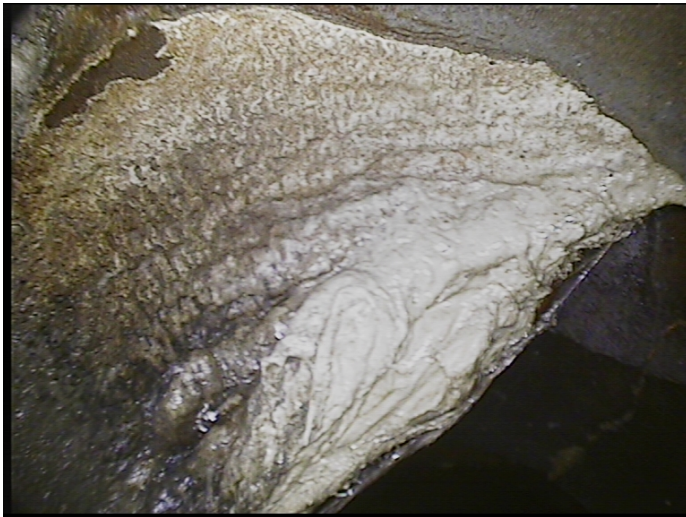
Code: **DAE**  
Description: **Deposits Attached Encrustation**

Distance (ft): **179.6**  
Structural Grade: **0**  
O&M Grade: **3**  
Clock Start/From: **7**  
Clock To: **11**  
1st Value:  
2nd Value:  
Value Percent: **15.000**  
Continuous Index:  
Within 8" of Joint: **NO**  
Remarks:

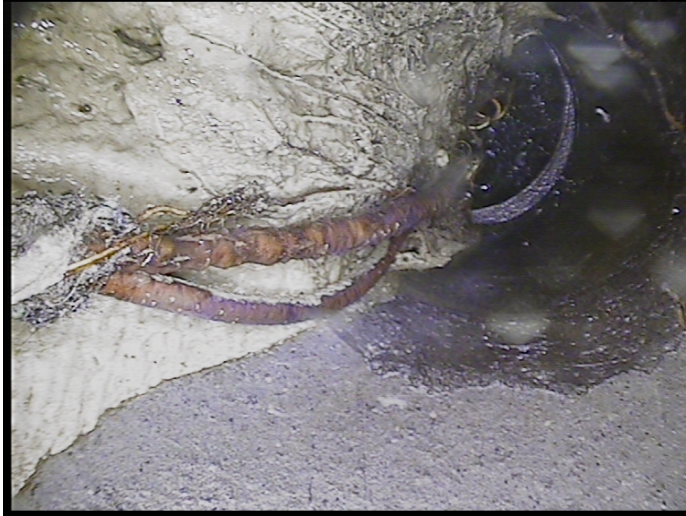
Code: **TFD**  
Description: **Tap Factory Defective**

Distance (ft): **181.9**  
Structural Grade: **0**  
O&M Grade: **2**  
Clock Start/From: **10**  
Clock To:  
1st Value: **4.000**  
2nd Value:  
Value Percent:  
Continuous Index:  
Within 8" of Joint: **NO**  
Remarks: **Defective**

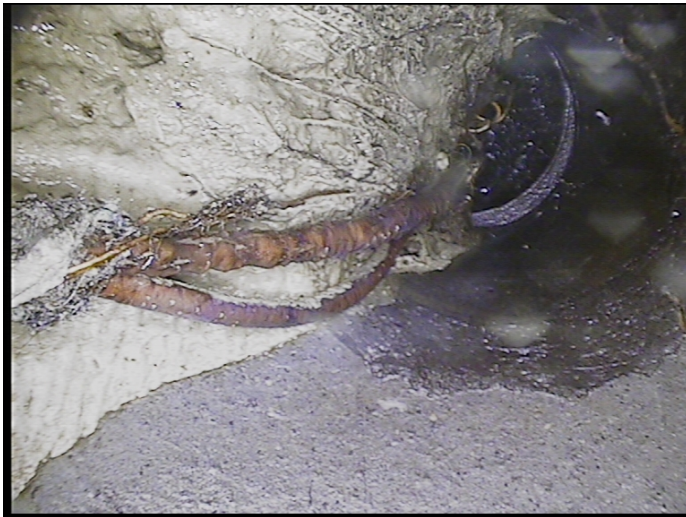
Code: **RML**  
Description: **Roots Medium Lateral**

Distance (ft): **181.9**  
Structural Grade: **0**  
O&M Grade: **3**  
Clock Start/From: **10**  
Clock To:  
1st Value:  
2nd Value:  
Value Percent: **10.000**  
Continuous Index:  
Within 8" of Joint: **NO**  
Remarks:

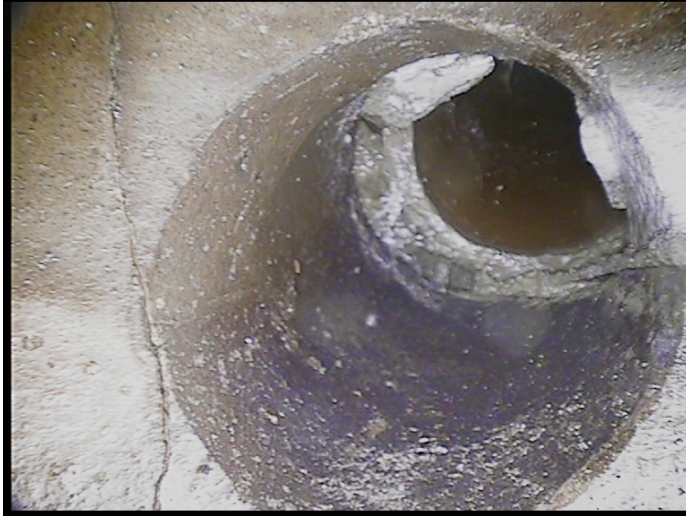
Code: **TF**  
Description: **Tap Factory**

Distance (ft): **183.9**  
Structural Grade: **0**  
O&M Grade: **0**  
Clock Start/From: **2**  
Clock To:  
1st Value: **4.000**  
2nd Value:  
Value Percent:  
Continuous Index:  
Within 8" of Joint: **NO**  
Remarks:

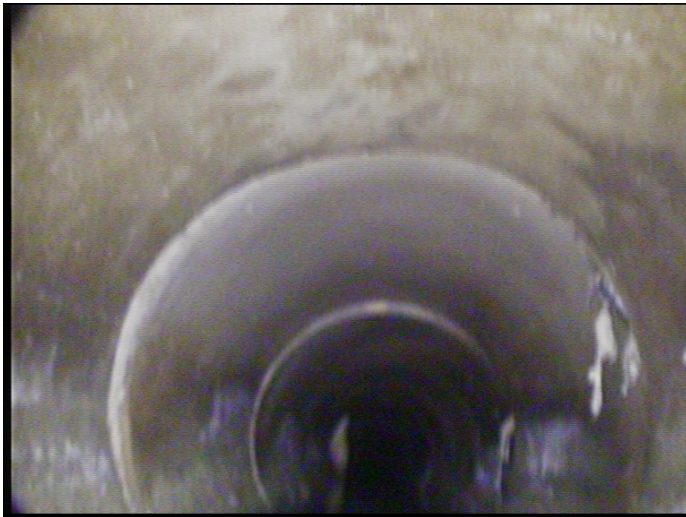
Code: **FL**  
Description: **Fracture Longitudinal**

Distance (ft): **200.4**  
Structural Grade: **3**  
O&M Grade: **0**  
Clock Start/From: **12**  
Clock To:  
1st Value:  
2nd Value:  
Value Percent:  
Continuous Index: **F01**  
Within 8" of Joint: **NO**  
Remarks:

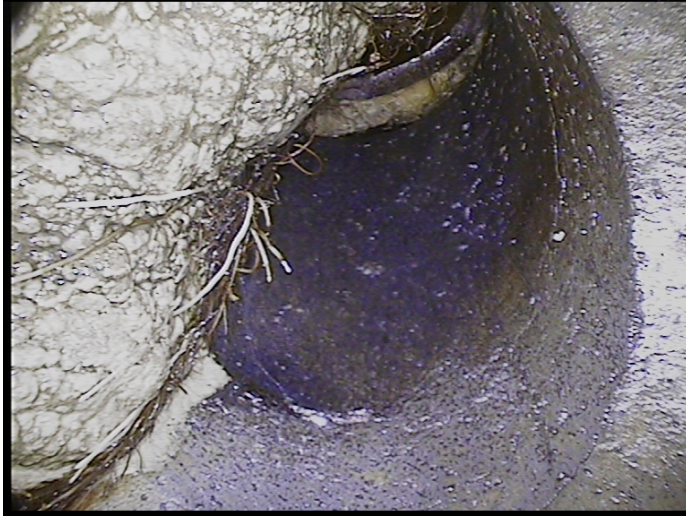
Code: **TFD**  
Description: **Tap Factory Defective**

Distance (ft): **214.0**  
Structural Grade: **0**  
O&M Grade: **2**  
Clock Start/From: **10**  
Clock To:  
1st Value: **4.000**  
2nd Value:  
Value Percent:  
Continuous Index:  
Within 8" of Joint: **NO**  
Remarks: **Defective**

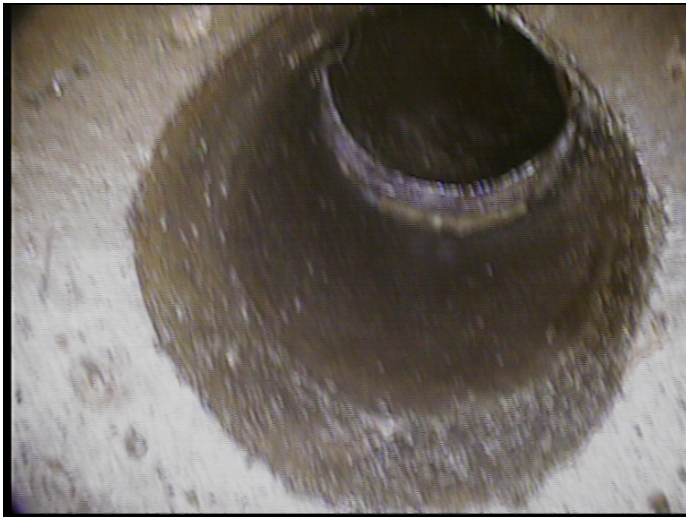
Code: **TF**  
Description: **Tap Factory**

Distance (ft): **216.8**  
Structural Grade: **0**  
O&M Grade: **0**  
Clock Start/From: **2**  
Clock To:  
1st Value: **4.000**  
2nd Value:  
Value Percent:  
Continuous Index:  
Within 8" of Joint: **NO**  
Remarks:

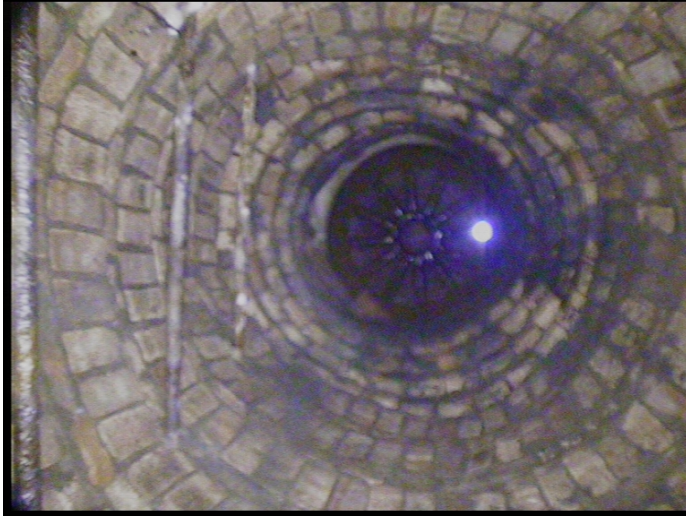
Code:	<b>AMH</b>
Description:	<b>Manhole</b>
Distance (ft):	<b>219.7</b>
Structural Grade:	<b>0</b>
O&M Grade:	<b>0</b>
Clock Start/From:	
Clock To:	
1st Value:	
2nd Value:	
Value Percent:	
Continuous Index:	
Within 8" of Joint:	<b>NO</b>
Remarks:	<b>M-605-048</b>
