Profile/Photo Observation Report

Date:	04/28/2018	Weather:		Coding:	PACP 6.0
Pipe Length (ft):		Owner:	City of Hobart	Pre Clean:	No Pre-Cleaning
P.O.#:	128	Surveyor:	M. Pielacha	PSR:	P-605-050-049
Customer:	City of Hobart	Clean Date:		Shape:	C

Street:	Wisconsin Street	Flow Control:	Not Controlled
City:	Hobart, IN	Year Renewed:	
Location:	Light Highway	Tape/Media #:	DEP 128
Purpose:	Routine Assessment	Dia/Height:	20"
Use:	Sanitary	Material:	VCP
Drain Area:		Lining:	
Category:	NA		
Comment:	YES501824 Submittal 2		
Location Details:		Direction of Survey:	Downstream
US MH:	M-605-050	DS MH:	M-605-049
		Total Length Surveyed (ft):	35.5

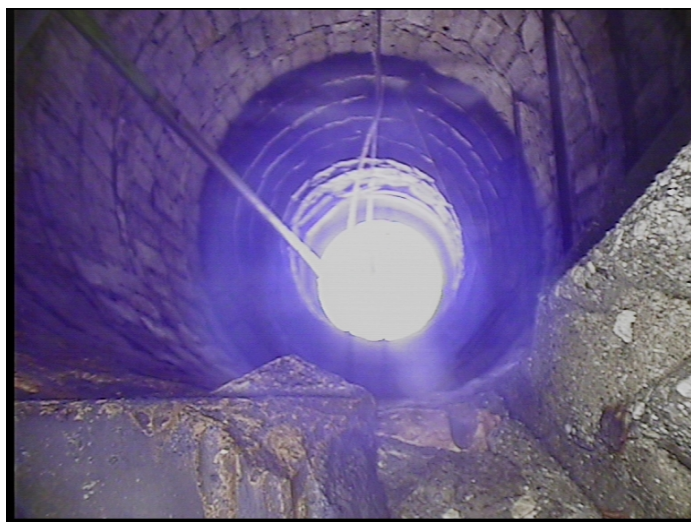
Code: **AMH**
Description: **Manhole**

Distance (ft): **.0**
Structural Grade: **0**
O&M Grade: **0**
Clock Start/From:
Clock To:
1st Value:
2nd Value:
Value Percent:
Continuous Index:
Within 8" of Joint: **NO**
Remarks: **M-605-050**

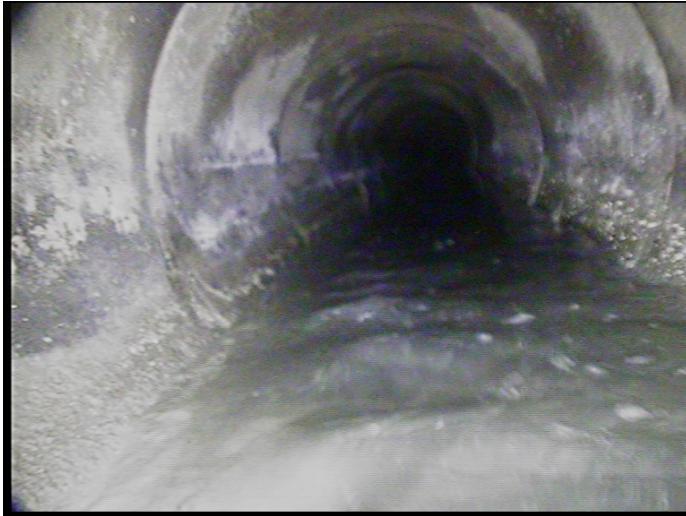
Code: **MWL**
Description: **Water Level**

Distance (ft): **.0**
Structural Grade: **0**
O&M Grade: **0**
Clock Start/From:
Clock To:
1st Value:
2nd Value:
Value Percent: **15.000**
Continuous Index:
Within 8" of Joint: **NO**
Remarks:

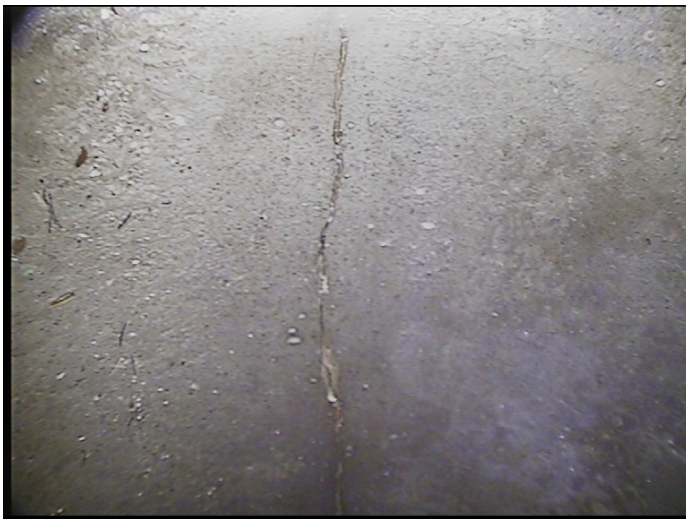
Code: **CL**
Description: **Crack Longitudinal**

Distance (ft): **35.0**
Structural Grade: **2**
O&M Grade: **0**
Clock Start/From: **12**
Clock To:
1st Value:
2nd Value:
Value Percent:
Continuous Index:
Within 8" of Joint: **YES**
Remarks:

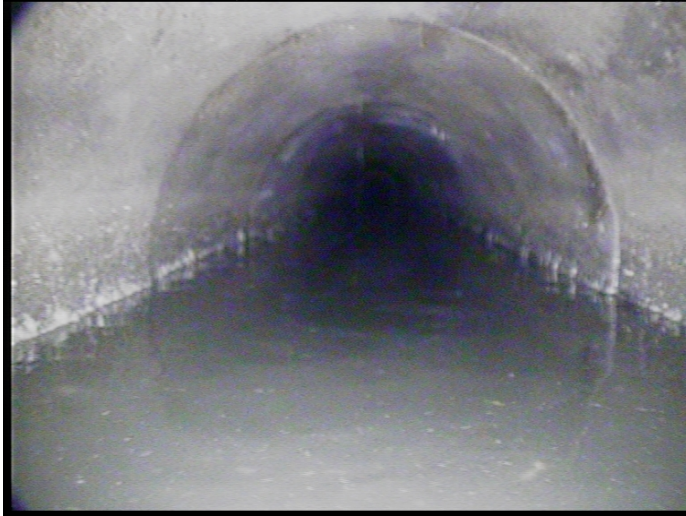
Code:	MSA
Description:	Abandoned Survey
Distance (ft):	35.5
Structural Grade:	0
O&M Grade:	0
Clock Start/From:	
Clock To:	
1st Value:	
2nd Value:	
Value Percent:	
Continuous Index:	
Within 8" of Joint:	NO
Remarks:	underwater debris
