Profile/Photo Observation Report

Date:	04/28/2018	Weather:		Coding:	PACP 6.0
Pipe Length (ft):		Owner:	City of Hobart	Pre Clean:	No Pre-Cleaning
P.O.#:	126	Surveyor:	M. Pielacha	PSR:	P-605-051-050
Customer:	City of Hobart	Clean Date:		Shape:	C

Street:	Wisconsin Street	Flow Control:	Not Controlled
City:	Hobart, IN	Year Renewed:	
Location:	Light Highway	Tape/Media #:	DEP 126
Purpose:	Routine Assessment	Dia/Height:	18"
Use:	Sanitary	Material:	VCP
Drain Area:		Lining:	
Category:	NA		
Comment:	YES501824 Submittal 2		
Location Details:		Direction of Survey:	Downstream
US MH:	M-605-051	DS MH:	M-605-050
		Total Length Surveyed (ft):	127.4

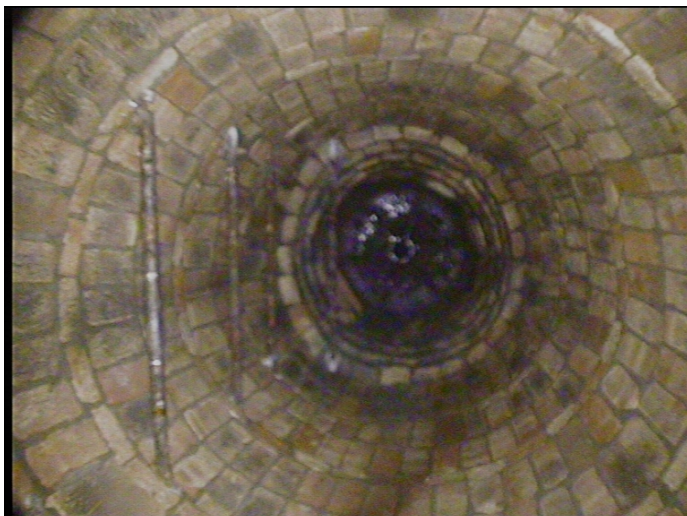
Code: **AMH**
 Description: **Manhole**

Distance (ft): **.0**
 Structural Grade: **0**
 O&M Grade: **0**
 Clock Start/From:
 Clock To:
 1st Value:
 2nd Value:
 Value Percent:
 Continuous Index:
 Within 8" of Joint: **NO**
 Remarks: **M-605-051**

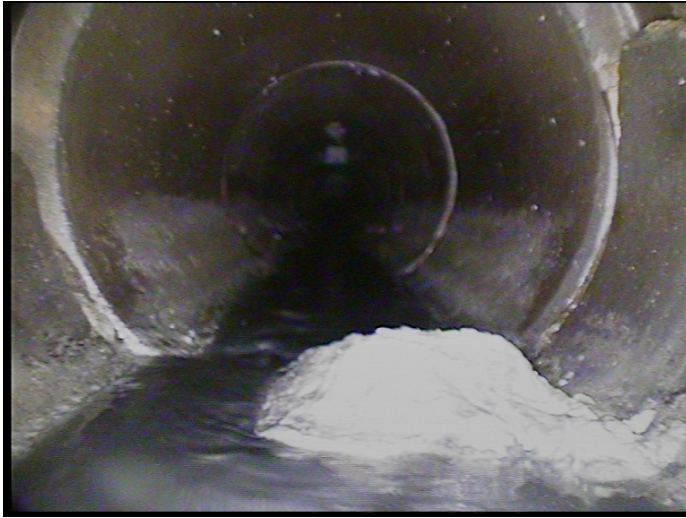
Code: **MWL**
Description: **Water Level**

Distance (ft): **.0**
Structural Grade: **0**
O&M Grade: **0**
Clock Start/From:
Clock To:
1st Value:
2nd Value:
Value Percent: **10.000**
Continuous Index:
Within 8" of Joint: **NO**
Remarks:

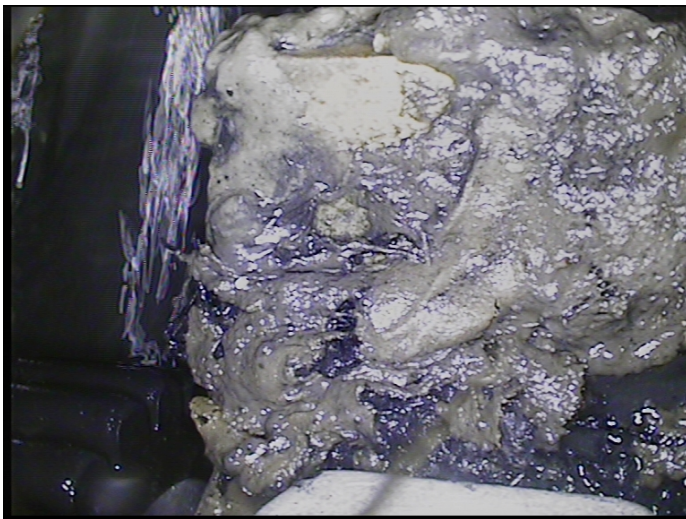
Code: **OBB**
Description: **Obstacle Brick**

Distance (ft): **5.9**
Structural Grade: **0**
O&M Grade: **3**
Clock Start/From: **6**
Clock To:
1st Value:
2nd Value:
Value Percent: **15.000**
Continuous Index:
Within 8" of Joint: **NO**
Remarks:

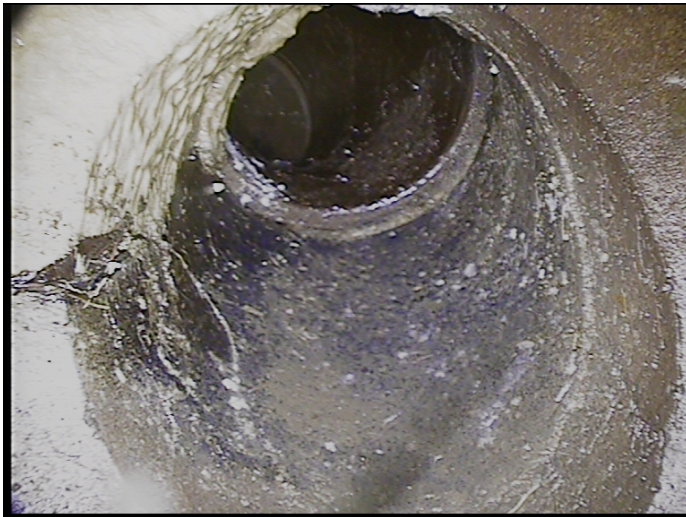
Code: **TF**
Description: **Tap Factory**

Distance (ft): **18.4**
Structural Grade: **0**
O&M Grade: **0**
Clock Start/From: **10**
Clock To:
1st Value: **4.000**
2nd Value:
Value Percent:
Continuous Index:
Within 8" of Joint: **NO**
Remarks:

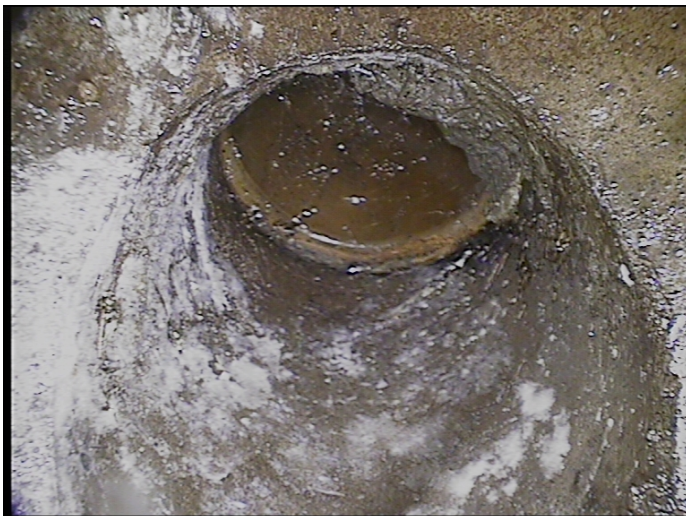
Code: **TF**
Description: **Tap Factory**

Distance (ft): **21.3**
Structural Grade: **0**
O&M Grade: **0**
Clock Start/From: **2**
Clock To:
1st Value: **4.000**
2nd Value:
Value Percent:
Continuous Index:
Within 8" of Joint: **NO**
Remarks:

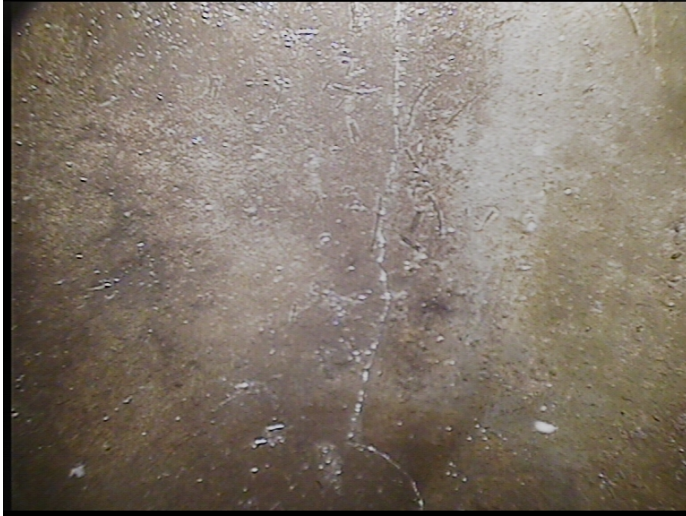
Code: **CL**
Description: **Crack Longitudinal**

Distance (ft): **36.4**
Structural Grade: **2**
O&M Grade: **0**
Clock Start/From: **12**
Clock To:
1st Value:
2nd Value:
Value Percent:
Continuous Index: **S01**
Within 8" of Joint: **YES**
Remarks:

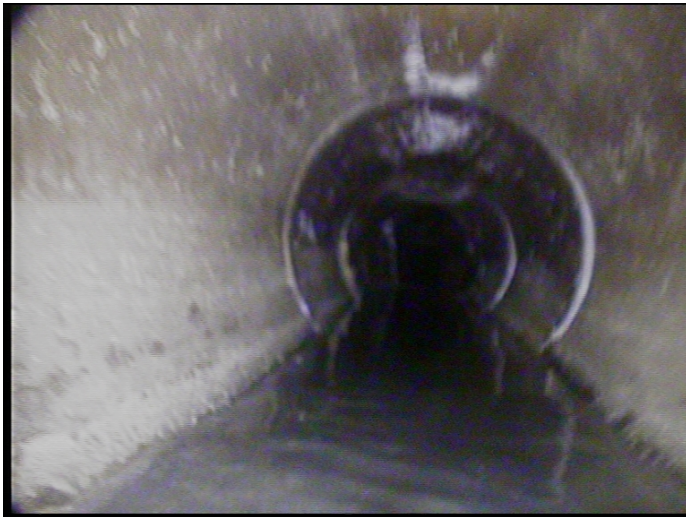
Code: **CL**
Description: **Crack Longitudinal**

Distance (ft): **46.2**
Structural Grade: **2**
O&M Grade: **0**
Clock Start/From: **12**
Clock To:
1st Value:
2nd Value:
Value Percent:
Continuous Index: **F01**
Within 8" of Joint: **NO**
Remarks:

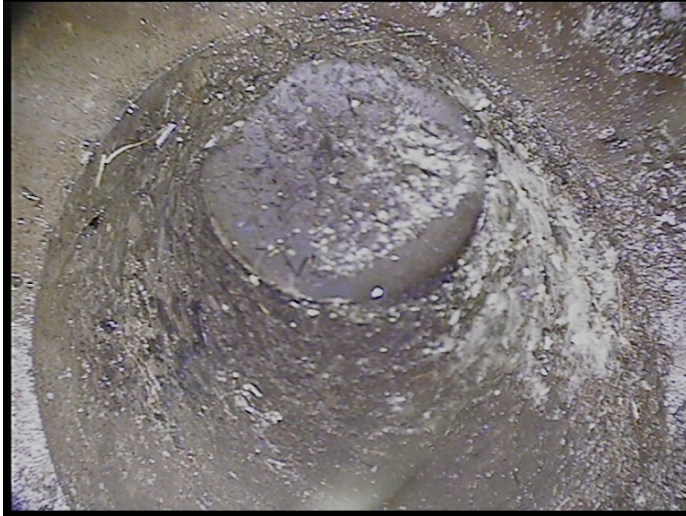
Code: **TFC**
Description: **Tap Factory Capped**

Distance (ft): **54.6**
Structural Grade: **0**
O&M Grade: **0**
Clock Start/From: **10**
Clock To:
1st Value: **4.000**
2nd Value:
Value Percent:
Continuous Index:
Within 8" of Joint: **NO**
Remarks:

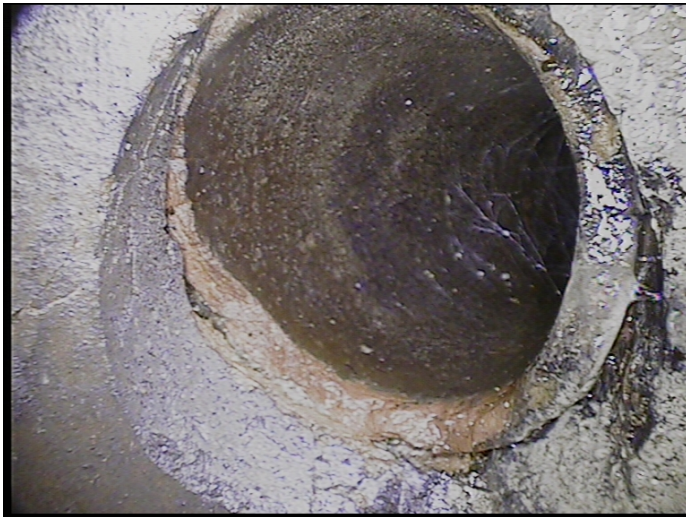
Code: **TBA**
Description: **Tap Break-in Active**

Distance (ft): **57.1**
Structural Grade: **0**
O&M Grade: **0**
Clock Start/From: **2**
Clock To:
1st Value: **4.000**
2nd Value:
Value Percent:
Continuous Index:
Within 8" of Joint: **NO**
Remarks:

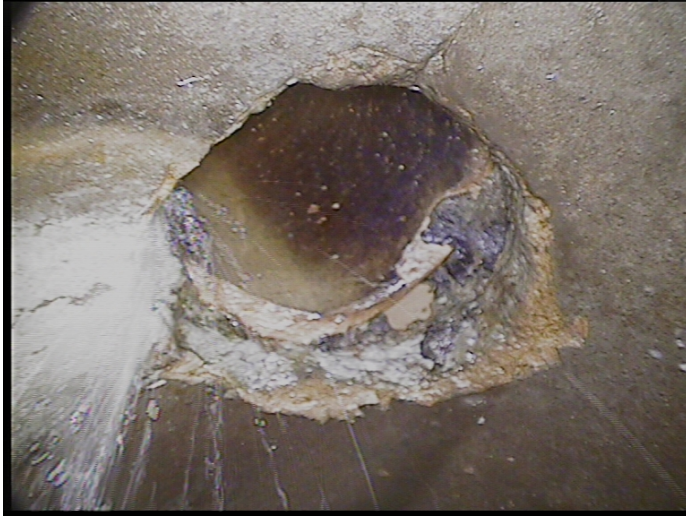
Code: **TBA**
Description: **Tap Break-in Active**

Distance (ft): **57.6**
Structural Grade: **0**
O&M Grade: **0**
Clock Start/From: **10**
Clock To:
1st Value: **4.000**
2nd Value:
Value Percent:
Continuous Index:
Within 8" of Joint: **NO**
Remarks:

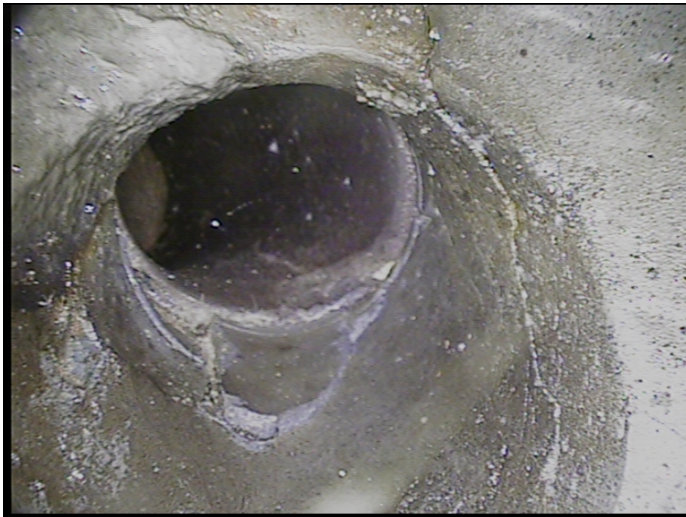
Code: **TF**
Description: **Tap Factory**

Distance (ft): **88.0**
Structural Grade: **0**
O&M Grade: **0**
Clock Start/From: **10**
Clock To:
1st Value: **4.000**
2nd Value:
Value Percent:
Continuous Index:
Within 8" of Joint: **NO**
Remarks:

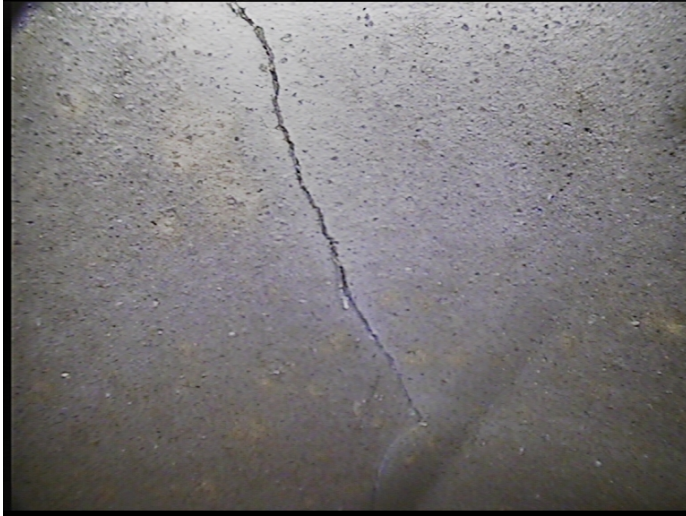
Code:	FL
Description:	Fracture Longitudinal
Distance (ft):	88.0
Structural Grade:	3
O&M Grade:	0
Clock Start/From:	12
Clock To:	
1st Value:	
2nd Value:	
Value Percent:	
Continuous Index:	
Within 8" of Joint:	YES
Remarks:

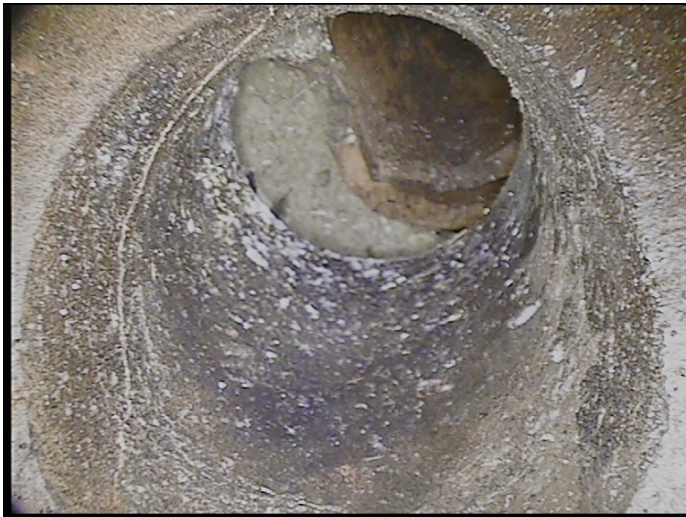
Code:	TF
Description:	Tap Factory
Distance (ft):	91.1
Structural Grade:	0
O&M Grade:	0
Clock Start/From:	2
Clock To:	
1st Value:	4.000
2nd Value:	
Value Percent:	
Continuous Index:	
Within 8" of Joint:	NO
Remarks:

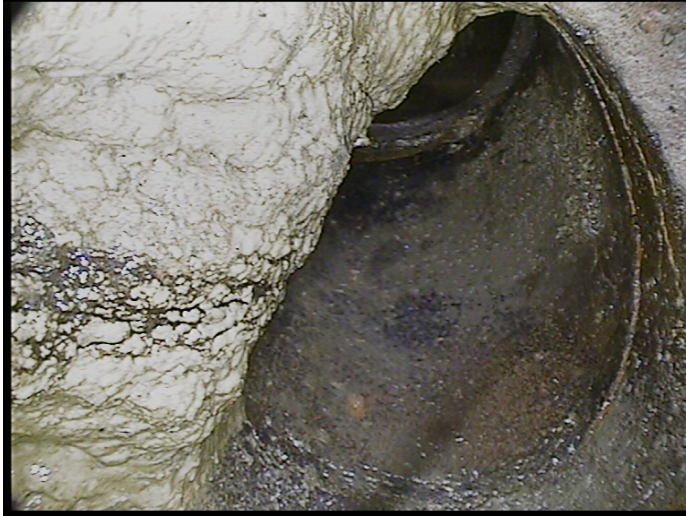
Code: **TFD**
Description: **Tap Factory Defective**

Distance (ft): **127.1**
Structural Grade: **0**
O&M Grade: **2**
Clock Start/From: **10**
Clock To:
1st Value: **4.000**
2nd Value:
Value Percent:
Continuous Index:
Within 8" of Joint: **NO**
Remarks: **Defective**

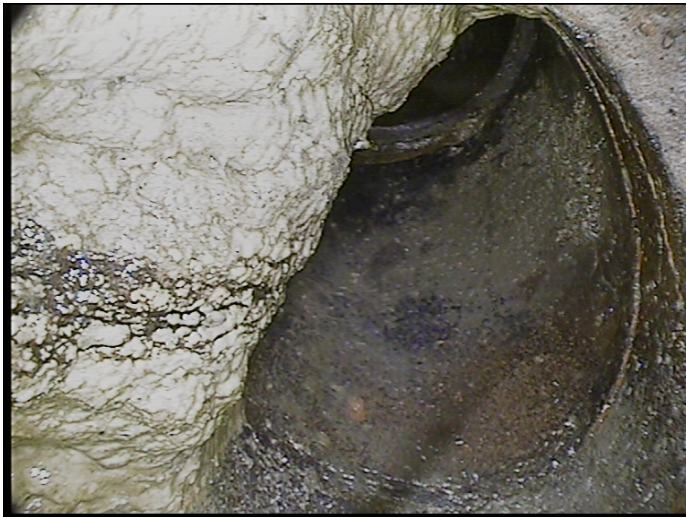
Code: **DAE**
Description: **Deposits Attached Encrustation**

Distance (ft): **127.1**
Structural Grade: **0**
O&M Grade: **3**
Clock Start/From: **7**
Clock To: **11**
1st Value:
2nd Value:
Value Percent: **15.000**
Continuous Index:
Within 8" of Joint: **YES**
Remarks:

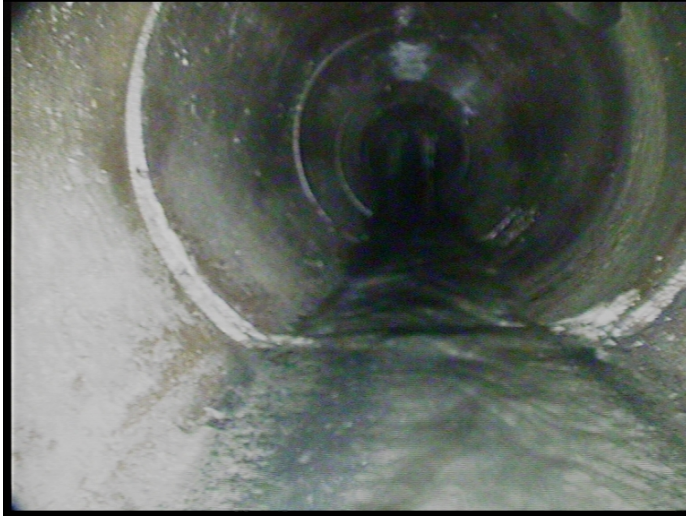
Code:	MSA
Description:	Abandoned Survey
Distance (ft):	127.4
Structural Grade:	0
O&M Grade:	0
Clock Start/From:	
Clock To:	
1st Value:	
2nd Value:	
Value Percent:	
Continuous Index:	
Within 8" of Joint:	NO
Remarks:	encrustation
