## Profile/Photo Observation Report

Date:	<b>04/28/2018</b>	Weather:		Coding:	<b>PACP 6.0</b>
Pipe Length (ft):		Owner:	<b>City of Hobart</b>	Pre Clean:	<b>No Pre-Cleaning</b>
P.O.#:	<b>127</b>	Surveyor:	<b>M. Pielacha</b>	PSR:	<b>P-605-051-050</b>
Customer:	<b>City of Hobart</b>	Clean Date:		Shape:	<b>C</b>

Street:	<b>Wisconsin Street</b>	Flow Control:	<b>Not Controlled</b>
City:	<b>Hobart, IN</b>	Year Renewed:	
Location:	<b>Light Highway</b>	Tape/Media #:	<b>DEP 127</b>
Purpose:	<b>Routine Assessment</b>	Dia/Height:	<b>18"</b>
Use:	<b>Sanitary</b>	Material:	<b>VCP</b>
Drain Area:		Lining:	
Category:	<b>NA</b>		
Comment:	<b>YES501824 Submittal 2</b>		
Location Details:		Direction of Survey:	<b>Upstream</b>
US MH:	<b>M-605-051</b>	DS MH:	<b>M-605-050</b>
		Total Length Surveyed (ft):	<b>91.3</b>

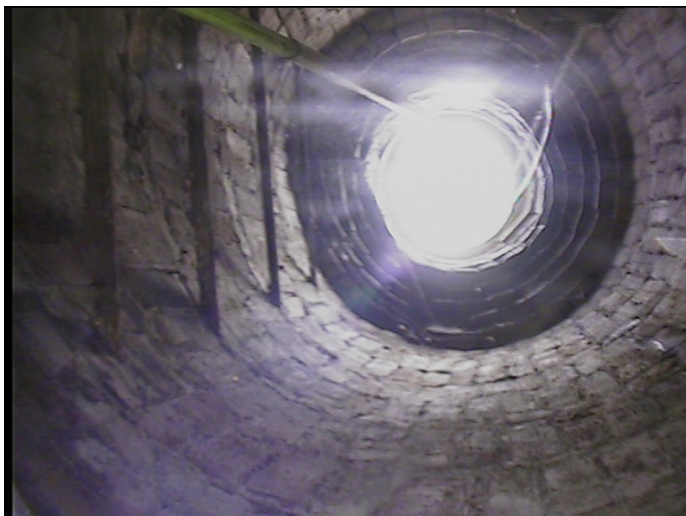
Code: **AMH**  
 Description: **Manhole**

Distance (ft): **.0**  
 Structural Grade: **0**  
 O&M Grade: **0**  
 Clock Start/From:  
 Clock To:  
 1st Value:  
 2nd Value:  
 Value Percent:  
 Continuous Index:  
 Within 8" of Joint: **NO**  
 Remarks: **M-605-050**

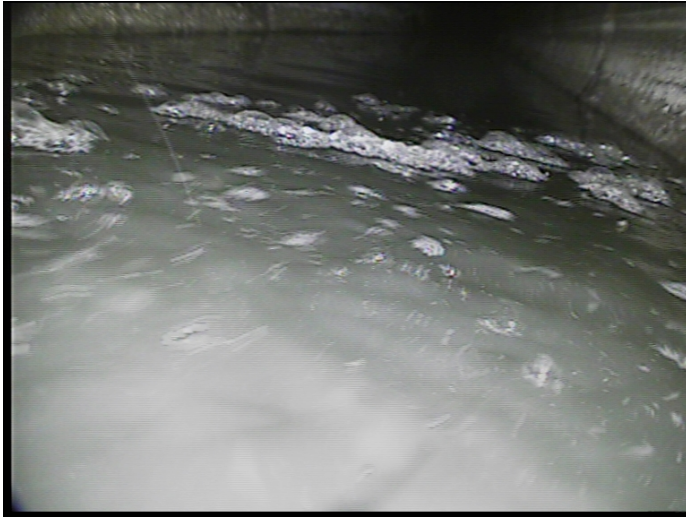
Code: **MWL**  
Description: **Water Level**

Distance (ft): **.0**  
Structural Grade: **0**  
O&M Grade: **0**  
Clock Start/From:  
Clock To:  
1st Value:  
2nd Value:  
Value Percent: **20.000**  
Continuous Index:  
Within 8" of Joint: **NO**  
Remarks:

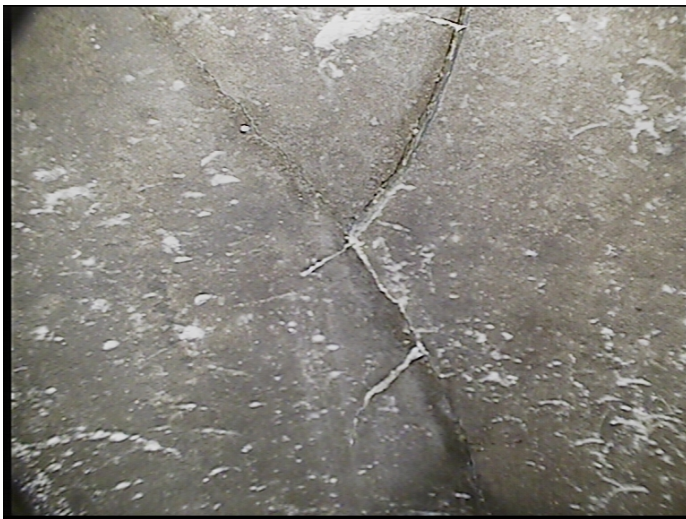
Code: **FM**  
Description: **Fracture Multiple**

Distance (ft): **14.1**  
Structural Grade: **4**  
O&M Grade: **0**  
Clock Start/From: **9**  
Clock To: **12**  
1st Value:  
2nd Value:  
Value Percent:  
Continuous Index:  
Within 8" of Joint: **YES**  
Remarks:

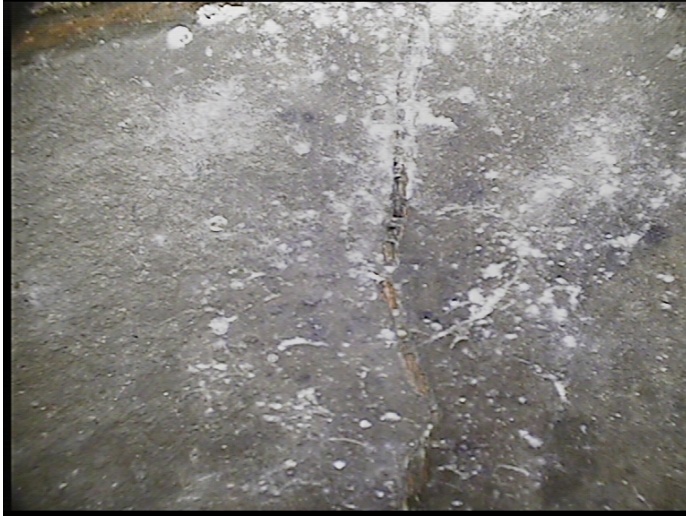
Code:	<b>FL</b>
Description:	<b>Fracture Longitudinal</b>
Distance (ft):	<b>18.3</b>
Structural Grade:	<b>3</b>
O&M Grade:	<b>0</b>
Clock Start/From:	<b>12</b>
Clock To:	
1st Value:	
2nd Value:	
Value Percent:	
Continuous Index:	<b>S01</b>
Within 8" of Joint:	<b>YES</b>
Remarks:

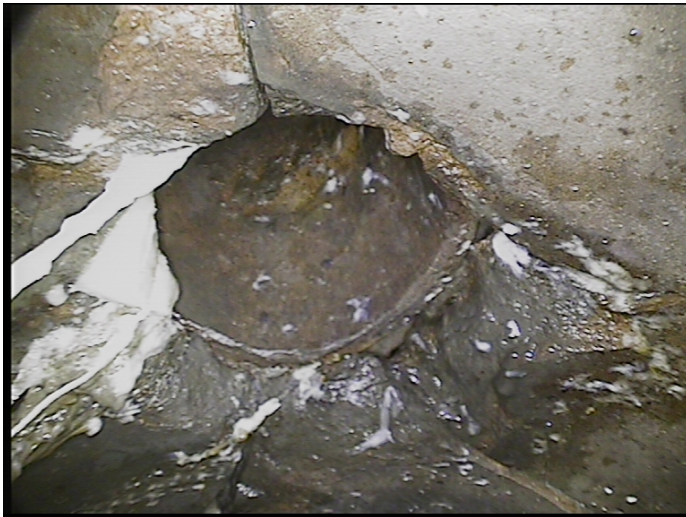
Code:	<b>TB</b>
Description:	<b>Tap Break-in</b>
Distance (ft):	<b>41.0</b>
Structural Grade:	<b>0</b>
O&M Grade:	<b>0</b>
Clock Start/From:	<b>10</b>
Clock To:	
1st Value:	<b>4.000</b>
2nd Value:	
Value Percent:	
Continuous Index:	
Within 8" of Joint:	<b>NO</b>
Remarks:

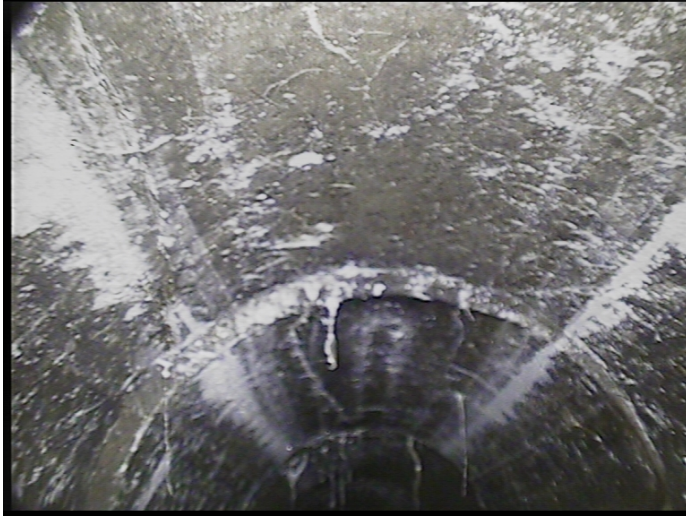
Code:	<b>FL</b>
Description:	<b>Fracture Longitudinal</b>
Distance (ft):	<b>49.5</b>
Structural Grade:	<b>3</b>
O&M Grade:	<b>0</b>
Clock Start/From:	<b>12</b>
Clock To:	
1st Value:	
2nd Value:	
Value Percent:	
Continuous Index:	<b>F01</b>
Within 8" of Joint:	<b>NO</b>
Remarks:

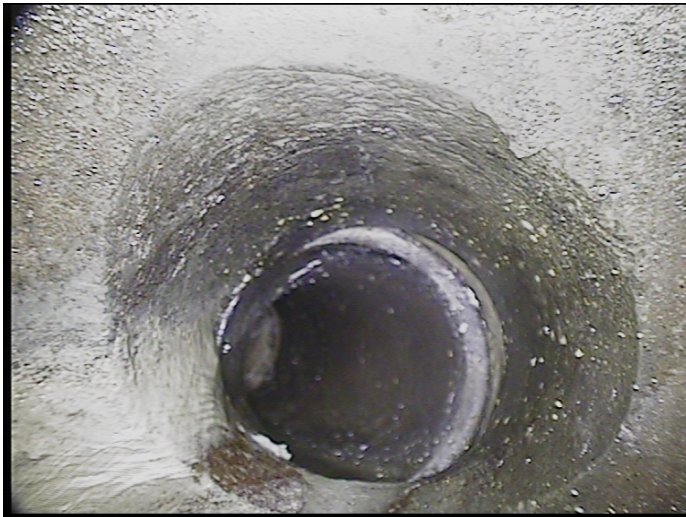
Code:	<b>TF</b>
Description:	<b>Tap Factory</b>
Distance (ft):	<b>88.8</b>
Structural Grade:	<b>0</b>
O&M Grade:	<b>0</b>
Clock Start/From:	<b>10</b>
Clock To:	
1st Value:	<b>4.000</b>
2nd Value:	
Value Percent:	
Continuous Index:	
Within 8" of Joint:	<b>NO</b>
Remarks:

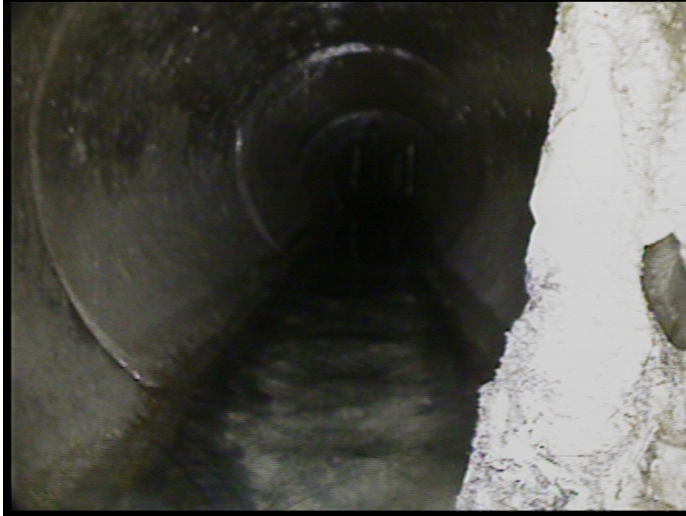
Code:	<b>MSA</b>
Description:	<b>Abandoned Survey</b>
Distance (ft):	<b>91.3</b>
Structural Grade:	<b>0</b>
O&M Grade:	<b>0</b>
Clock Start/From:	
Clock To:	
1st Value:	
2nd Value:	
Value Percent:	
Continuous Index:	
Within 8" of Joint:	<b>NO</b>
Remarks:	<b>reverse complete</b>
