Profile/Photo Observation Report

Date:	04/28/2018	Weather:		Coding:	PACP 6.0
Pipe Length (ft):		Owner:	City of Hobart	Pre Clean:	No Pre-Cleaning
P.O.#:	126	Surveyor:	M. Pielacha	PSR:	P-605-052-051
Customer:	City of Hobart	Clean Date:		Shape:	C

Street:	Wisconsin Street	Flow Control:	Not Controlled
City:	Hobart, IN	Year Renewed:	
Location:	Light Highway	Tape/Media #:	DEP 126
Purpose:	Routine Assessment	Dia/Height:	18"
Use:	Sanitary	Material:	VCP
Drain Area:		Lining:	
Category:	NA		
Comment:	YES501824 Submittal 2		
Location Details:		Direction of Survey:	Downstream
US MH:	M-605-052	DS MH:	M-605-051
		Total Length Surveyed (ft):	213.6

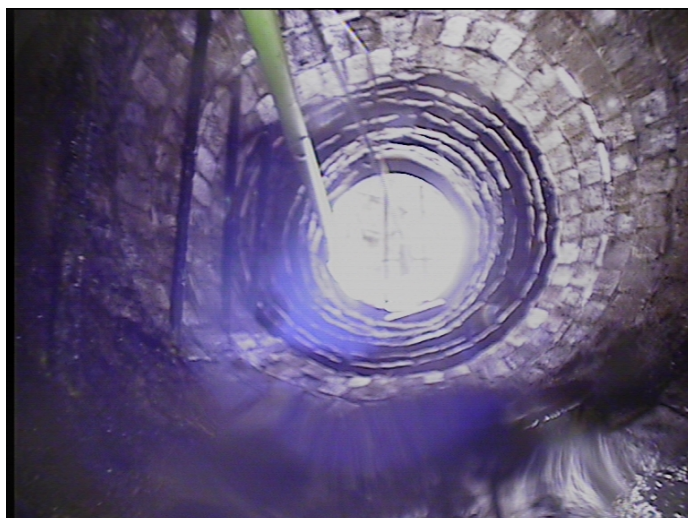
Code: **AMH**
Description: **Manhole**

Distance (ft): **.0**
Structural Grade: **0**
O&M Grade: **0**
Clock Start/From:
Clock To:
1st Value:
2nd Value:
Value Percent:
Continuous Index:
Within 8" of Joint: **NO**
Remarks: **M-605-052**

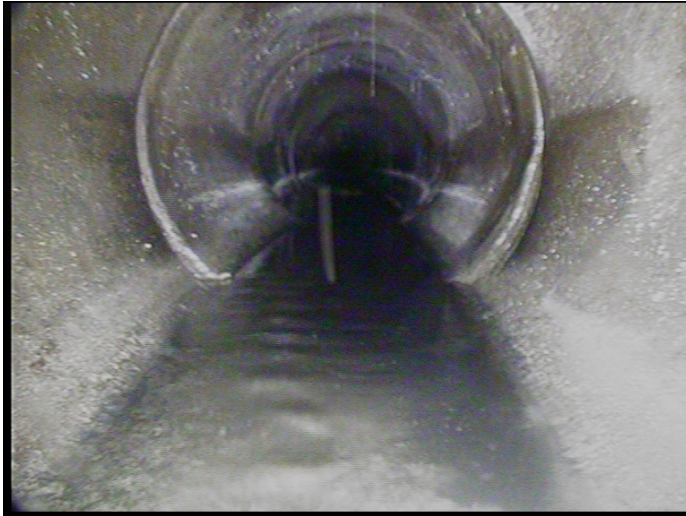
Code: **MWL**
Description: **Water Level**

Distance (ft): **.0**
Structural Grade: **0**
O&M Grade: **0**
Clock Start/From:
Clock To:
1st Value:
2nd Value:
Value Percent: **10.000**
Continuous Index:
Within 8" of Joint: **NO**
Remarks:

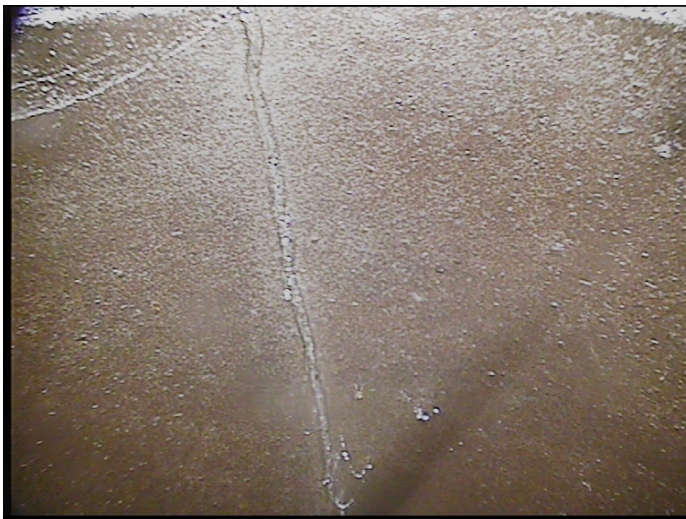
Code: **CL**
Description: **Crack Longitudinal**

Distance (ft): **33.3**
Structural Grade: **2**
O&M Grade: **0**
Clock Start/From: **12**
Clock To:
1st Value:
2nd Value:
Value Percent:
Continuous Index: **S01**
Within 8" of Joint: **YES**
Remarks:

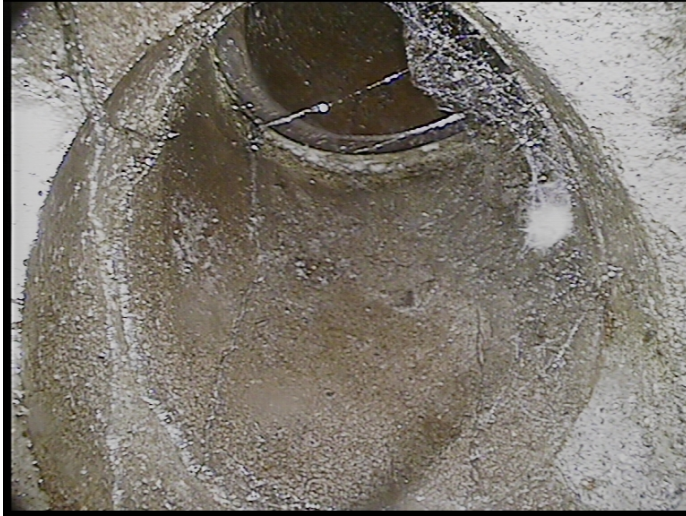
Code: **TF**
Description: **Tap Factory**

Distance (ft): **37.5**
Structural Grade: **0**
O&M Grade: **0**
Clock Start/From: **2**
Clock To:
1st Value: **4.000**
2nd Value:
Value Percent:
Continuous Index:
Within 8" of Joint: **NO**
Remarks:

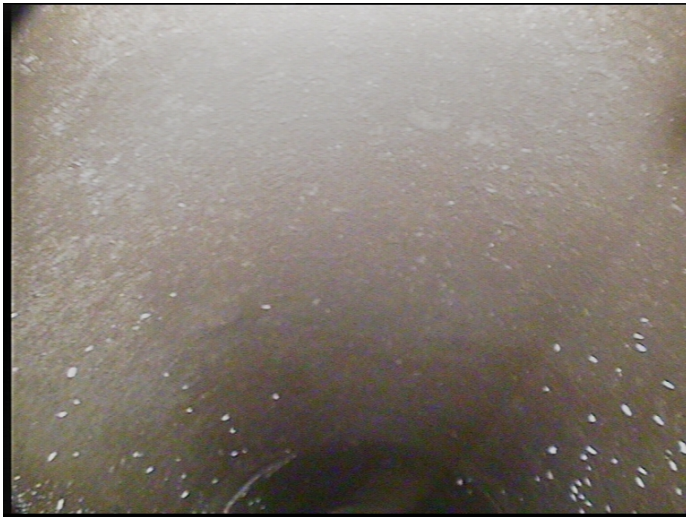
Code: **CL**
Description: **Crack Longitudinal**

Distance (ft): **66.4**
Structural Grade: **2**
O&M Grade: **0**
Clock Start/From: **12**
Clock To:
1st Value:
2nd Value:
Value Percent:
Continuous Index: **F01**
Within 8" of Joint: **NO**
Remarks:

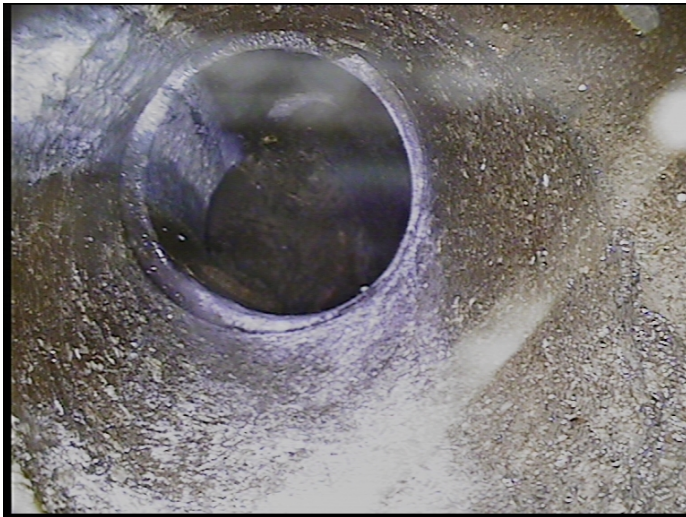
Code: **TF**
Description: **Tap Factory**

Distance (ft): **74.4**
Structural Grade: **0**
O&M Grade: **0**
Clock Start/From: **10**
Clock To:
1st Value: **4.000**
2nd Value:
Value Percent:
Continuous Index:
Within 8" of Joint: **NO**
Remarks:

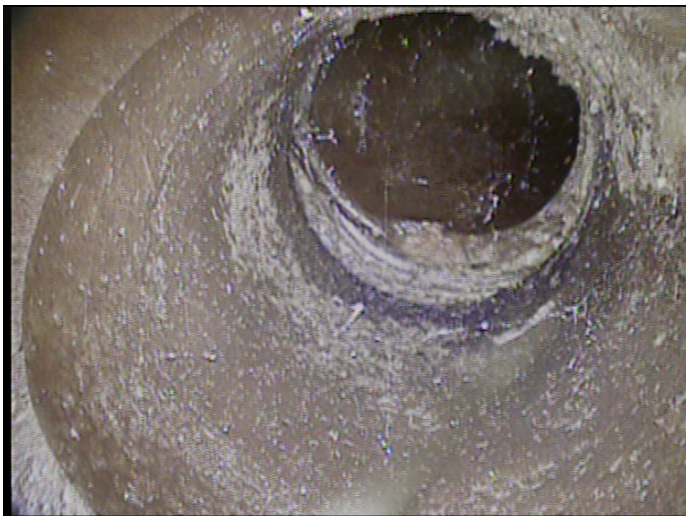
Code: **TF**
Description: **Tap Factory**

Distance (ft): **77.3**
Structural Grade: **0**
O&M Grade: **0**
Clock Start/From: **2**
Clock To:
1st Value: **4.000**
2nd Value:
Value Percent:
Continuous Index:
Within 8" of Joint: **NO**
Remarks:

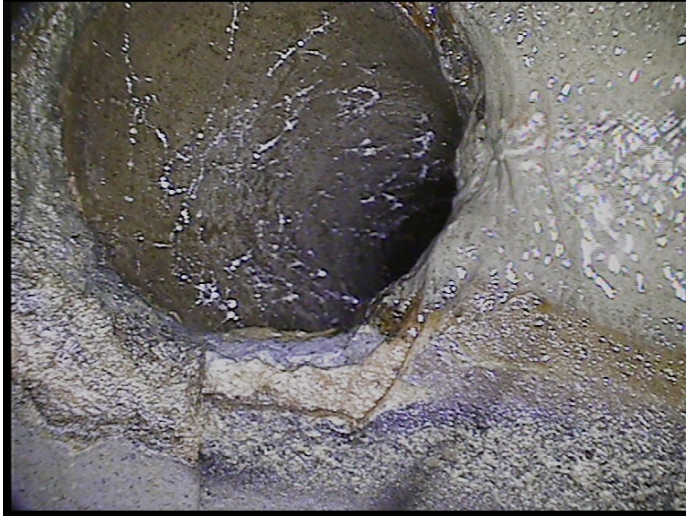
Code: **TBA**
Description: **Tap Break-in Active**

Distance (ft): **114.2**
Structural Grade: **0**
O&M Grade: **0**
Clock Start/From: **2**
Clock To:
1st Value: **4.000**
2nd Value:
Value Percent:
Continuous Index:
Within 8" of Joint: **NO**
Remarks:

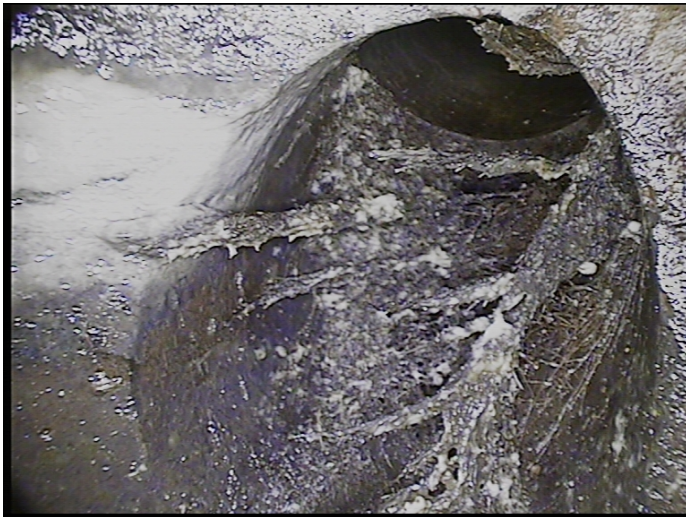
Code: **TFD**
Description: **Tap Factory Defective**

Distance (ft): **116.2**
Structural Grade: **0**
O&M Grade: **2**
Clock Start/From: **11**
Clock To:
1st Value: **4.000**
2nd Value:
Value Percent:
Continuous Index:
Within 8" of Joint: **NO**
Remarks: **roots**

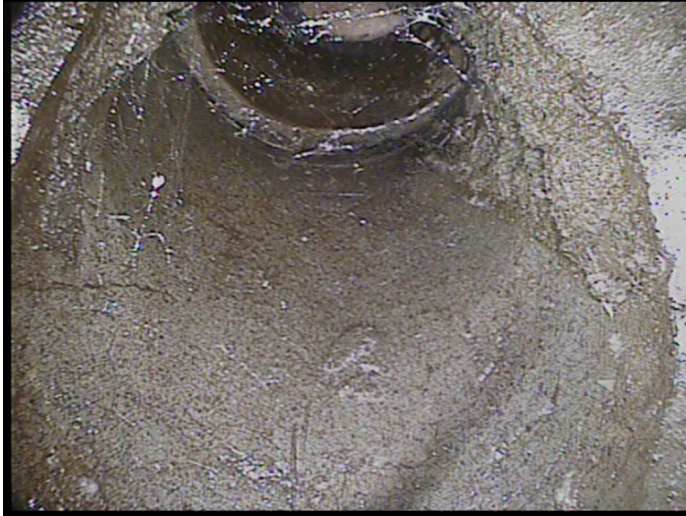
Code: **TFC**
Description: **Tap Factory Capped**

Distance (ft): **119.2**
Structural Grade: **0**
O&M Grade: **0**
Clock Start/From: **2**
Clock To:
1st Value: **4.000**
2nd Value:
Value Percent:
Continuous Index:
Within 8" of Joint: **NO**
Remarks:

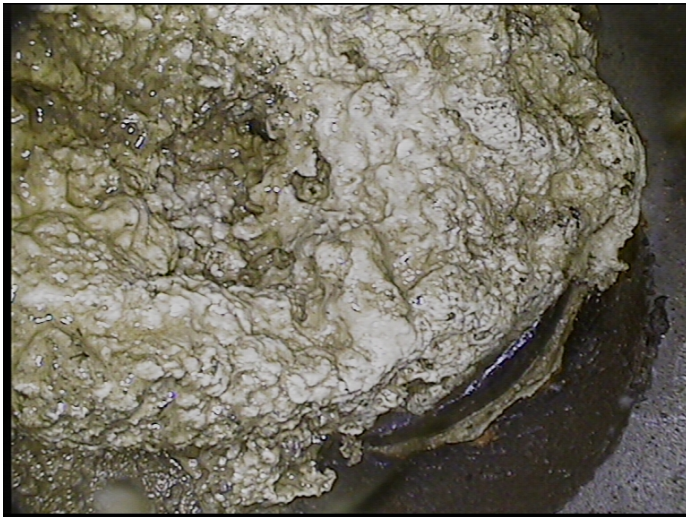
Code: **TFD**
Description: **Tap Factory Defective**

Distance (ft): **153.4**
Structural Grade: **0**
O&M Grade: **2**
Clock Start/From: **10**
Clock To:
1st Value: **4.000**
2nd Value:
Value Percent:
Continuous Index:
Within 8" of Joint: **NO**
Remarks: **Defective**

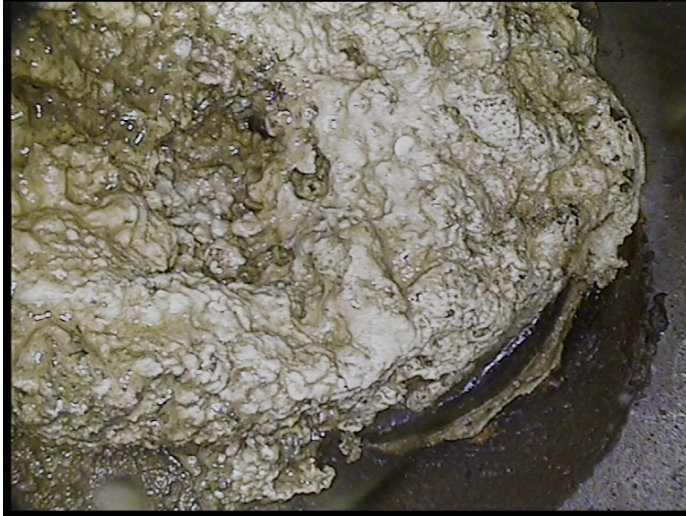
Code:	DAE
Description:	Deposits Attached Encrustation
Distance (ft):	153.4
Structural Grade:	0
O&M Grade:	2
Clock Start/From:	9
Clock To:	11
1st Value:	
2nd Value:	
Value Percent:	5.000
Continuous Index:	
Within 8" of Joint:	YES
Remarks:

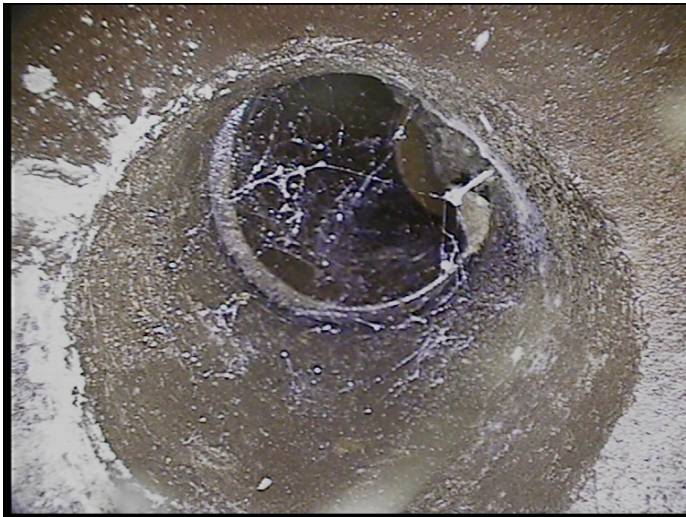
Code:	TF
Description:	Tap Factory
Distance (ft):	156.4
Structural Grade:	0
O&M Grade:	0
Clock Start/From:	2
Clock To:	
1st Value:	4.000
2nd Value:	
Value Percent:	
Continuous Index:	
Within 8" of Joint:	NO
Remarks:

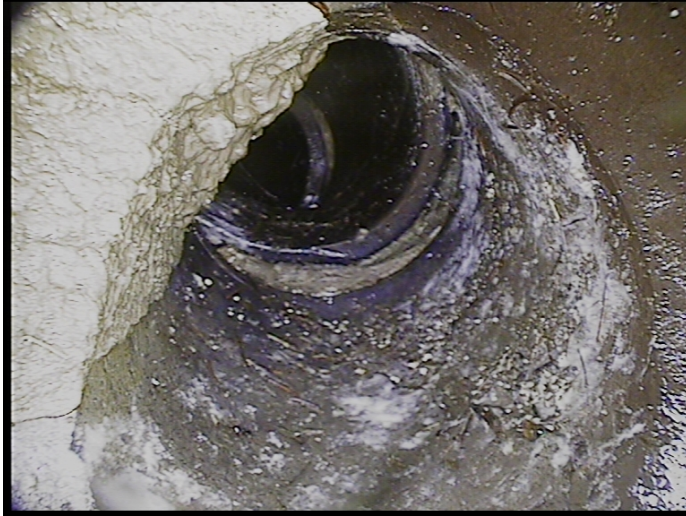
Code: **TF**
Description: **Tap Factory**

Distance (ft): **192.7**
Structural Grade: **0**
O&M Grade: **0**
Clock Start/From: **10**
Clock To:
1st Value: **4.000**
2nd Value:
Value Percent:
Continuous Index:
Within 8" of Joint: **NO**
Remarks:

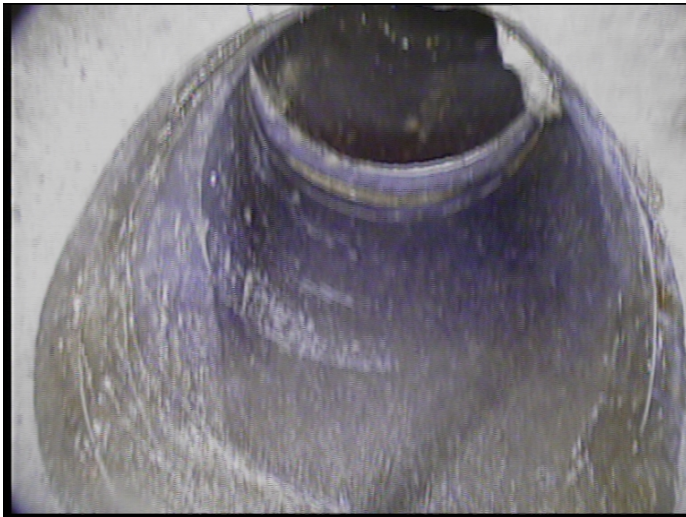
Code: **TF**
Description: **Tap Factory**

Distance (ft): **195.7**
Structural Grade: **0**
O&M Grade: **0**
Clock Start/From: **2**
Clock To:
1st Value: **4.000**
2nd Value:
Value Percent:
Continuous Index:
Within 8" of Joint: **NO**
Remarks:

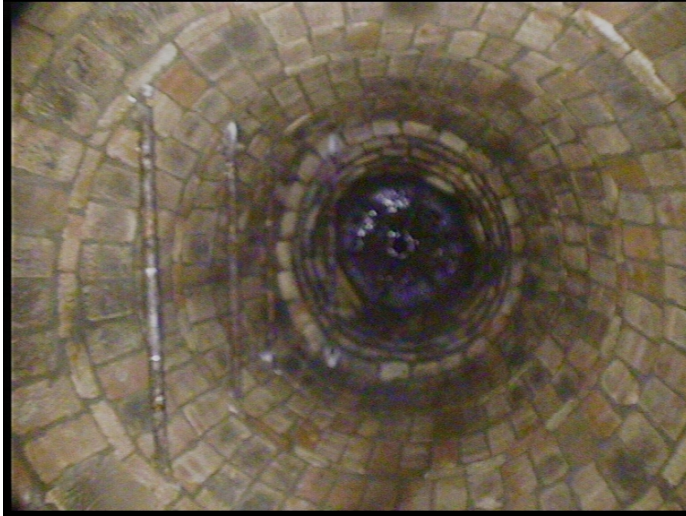
Code:	AMH
Description:	Manhole
Distance (ft):	213.6
Structural Grade:	0
O&M Grade:	0
Clock Start/From:	
Clock To:	
1st Value:	
2nd Value:	
Value Percent:	
Continuous Index:	
Within 8" of Joint:	NO
Remarks:	M-605-051
