## **Profile/Photo Observation Report**

ioto Observation	•				ROBOTICS	
Date:	04/28/2018	Weather:			Coding:	PACP 6.0	
Pipe Length (ft):		Owner:	City of Hobart		Pre Clean:	No Pre-Cleaning	
P.O.#:	125	Surveyor:	M. Pielacha		PSR:	P-504-001-052	
Customer:	City of Hobart	Clean Date:			Shape:	С	
Street:	Wisconsin Street		Flow Control:		Not Controlled		
City:	Hobart, IN		Year Renewed	•			
Location:	<b>Light Highway</b>		Tape/Media #	:	<b>DEP 125</b>		
Purpose:	Routine Assessme	nt	Dia/Height:		18"		
Use:	Sanitary		Material:		VCP		
Drain Area:			Lining:				
Category:	NA						
Comment:	YES501824 Submit	al 2					
Location Detai	ls:		Direction of Su	ırvey:	Upstream		
US MH:	M-504-001	DS MH:	M-605-052	Total	Length Surveyed (ft	: 134.1	
0&M Index:	2.75	O&M Quick:	3	321	O&M Rating:	11.00	
tructural Index	2.33	Structural Q	2	326	Structural Rating:	21.00	
Overall Index:	2.46	Overall Quic	k: 3	627	Overall Rating:	32.00

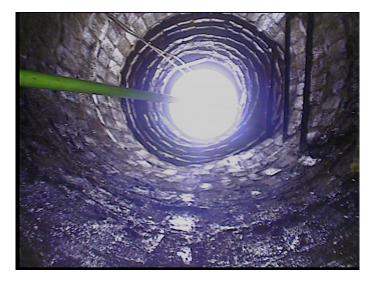
Code:

Description:	Manhole		
Distance (ft):	.0		
Structural Grade:	0		
O&M Grade:	0		
Clock Start/From:			
Clock To:			
1st Value:			
2nd Value:			
Value Percent:			
Continuous Index:			
Within 8" of Joint:	NO		
Remarks:	M-605-052

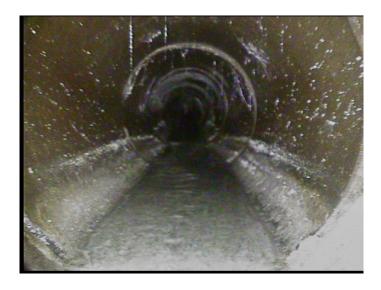
Code: MWL

Description: Water Level

Distance (ft): .0
Structural Grade: 0
O&M Grade: 0

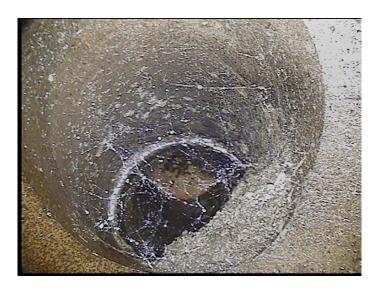
Code: **TFC**

Description: Tap Factory Capped

Distance (ft): 6.1
Structural Grade: 0
O&M Grade: 0
Clock Start/From: 2

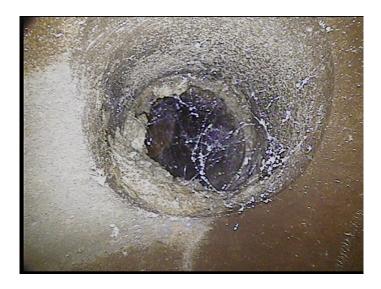
Code: **TF**

Description: Tap Factory

Distance (ft): 11.7
Structural Grade: 0

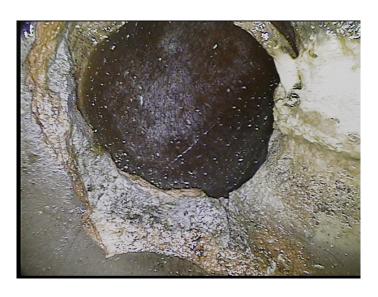
Code: TB

Description: Tap Break-in

Distance (ft): 15.2
Structural Grade: 0
O&M Grade: 0
Clock Start/From: 2

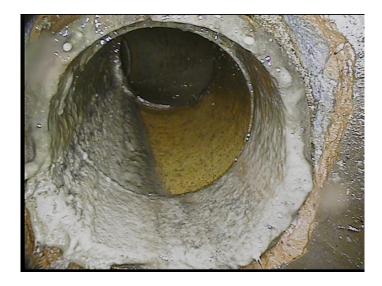
Code: TBD

Description: **Tap Break-in Defective**

Distance (ft): 16.2 Structural Grade: 0 3 O&M Grade: Clock Start/From: 1

Remarks: **Defective**

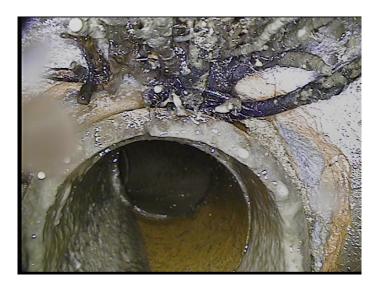
Code: **RML**

Description: **Roots Medium Lateral**

Distance (ft): 16.2 Structural Grade: 0 O&M Grade: 3 Clock Start/From: 1

Value Percent: 10.000

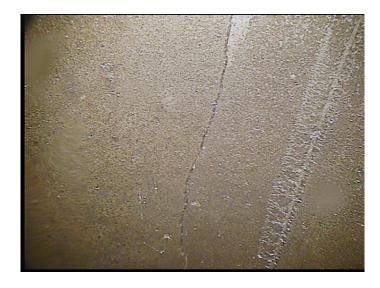
Code: FL

Description: Fracture Longitudinal

Distance (ft): 32.0
Structural Grade: 3
O&M Grade: 0
Clock Start/From: 1

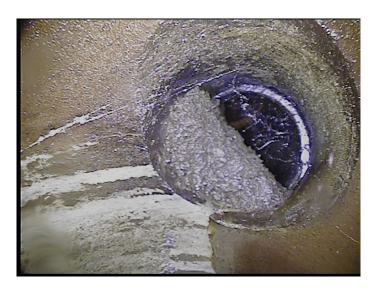
Code: **TF**

Description: Tap Factory

Distance (ft): 48.8
Structural Grade: 0

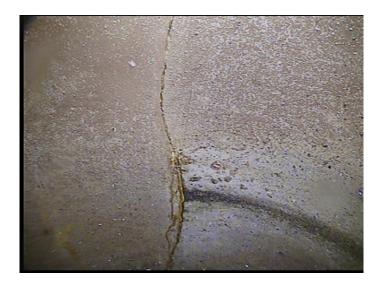
Code: FL

Description: Fracture Longitudinal

Distance (ft): 50.7
Structural Grade: 3
O&M Grade: 0
Clock Start/From: 1

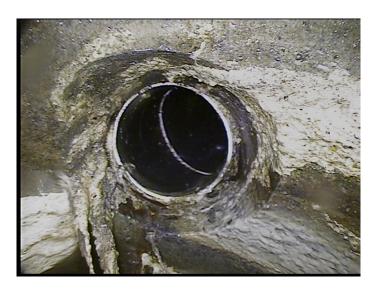
Code: **TF**

Description: Tap Factory

Distance (ft): 51.7
Structural Grade: 0

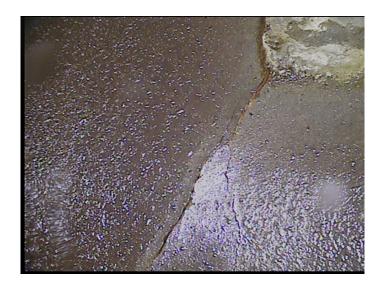
Code: CM

Description: Crack Multiple

Distance (ft): 54.3
Structural Grade: 3
O&M Grade: 0
Clock Start/From: 1
Clock To: 3

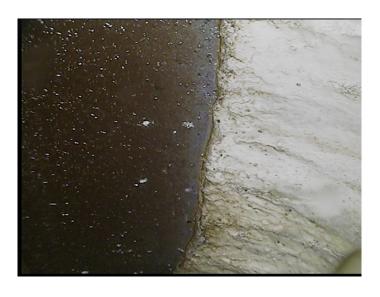
Code: CL

Description: Crack Longitudinal

Distance (ft): 67.5
Structural Grade: 2
O&M Grade: 0
Clock Start/From: 2

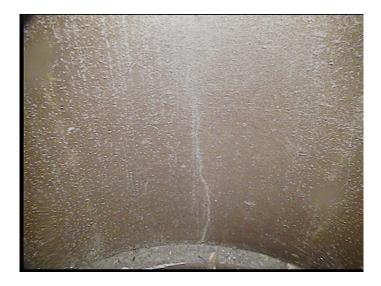
Code: CL

Description: Crack Longitudinal

Distance (ft): 76.2
Structural Grade: 2
O&M Grade: 0
Clock Start/From: 12

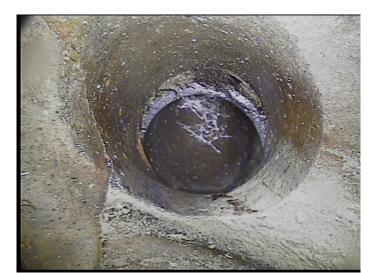
Code: **TF**

Description: Tap Factory

Distance (ft): 82.2
Structural Grade: 0
O&M Grade: 0
Clock Start/From: 2

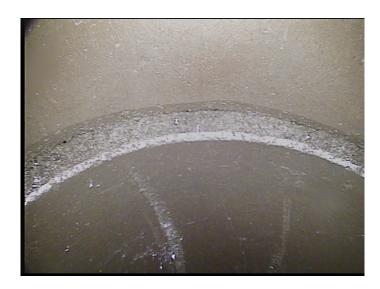
Code: CL

Description: Crack Longitudinal

Distance (ft): 95.1
Structural Grade: 2
O&M Grade: 0
Clock Start/From: 12

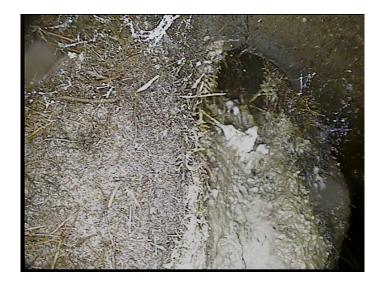
Code: **TFD**

Description: **Tap Factory Defective**

Distance (ft): 133.2 Structural Grade: 0 2 O&M Grade: Clock Start/From: 11

Remarks: **Defective**

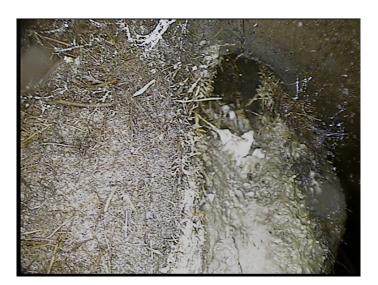
Code: **RML**

Description: **Roots Medium Lateral**

Distance (ft): 133.2 Structural Grade: 0 O&M Grade: 3 Clock Start/From: 11

Value Percent: 30.000

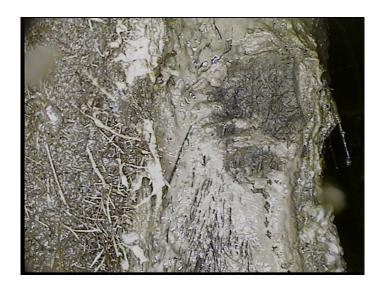
Code: MSA

Description: Abandoned Survey

Distance (ft): 134.1
Structural Grade: 0

Remarks: roots
