Profile/Photo Observation Report						
Date: Pipe Length (f	<b>04/16/2018</b>	Weather: Owner:	City of Hobar	Coding: t Pre Clean:	PACP 6.0 No Pre-Cleaning	
P.O.#:	6 <b>4-3</b>	Surveyor:	M. Pielacha	PSR:	M-605-056-M-605-055	
Customer:	City of Hobart	Clean Date:		Shape:	С	
Street:	Beverly Lane		Flow Control:	Not Controlle	d	
City:	Hobart, IN		Year Renewed:			
Location:	Light Highway		Tape/Media #:	DEP 64		
Purpose:	Routine Assessmen	nt	Dia/Height:	15"		
Use:	Sanitary		Material:	СР		
Drain Area:			Lining:			
Category:	NA					
Comment:						
Location Deta	ils:		Direction of Su	rvey: Downstream		
US MH:	M-605-056	DS MH:	M-605-055	Total Length Surveyed (f	t): <b>20.7</b>	
D&M Index:	4.00	O&M Quick:	41	00 O&M Rating:	4.00	
Structural Inde>	<: <b>0.00</b>	 Structural Q	uick: 00	00 Structural Rating	0.00	
Overall Index:	4.00	Overall Quic	k: 41	00 Overall Rating:	4.00

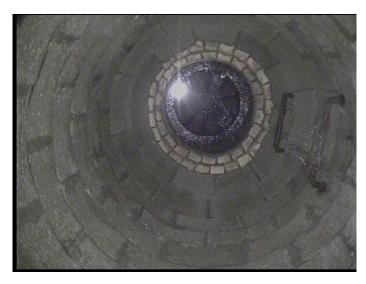
Code: Description:	AMH Manhole
Distance (ft):	.0
Structural Grade:	0
O&M Grade:	0
Clock Start/From:	
Clock To:	
1st Value:	
2nd Value:	
Value Percent:	
Continuous Index:	
Within 8" of Joint:	NO
Remarks:	M-605-056

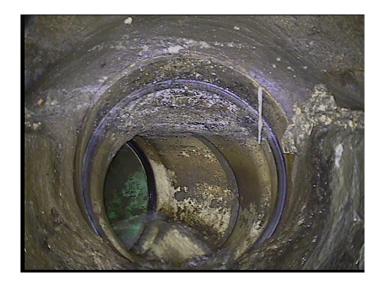
Code:	MWL
Description:	Water Level
	•
Distance (ft):	.0
Structural Grade:	0
O&M Grade:	0
Clock Start/From:	
Clock To:	
1st Value:	
2nd Value:	
Value Percent:	10.000
Continuous Index:	
Within 8" of Joint:	NO
Remarks:

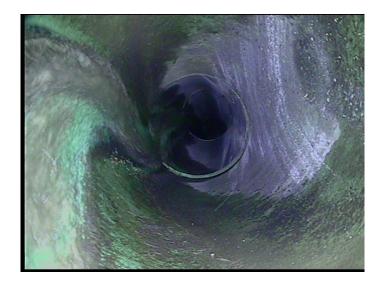
Code: Description:	LL Alignment Left
Distance (ft):	3.6
Structural Grade:	0
O&M Grade:	4
Clock Start/From:	
Clock To:	
1st Value:	
2nd Value:	
Value Percent:	25.000
Continuous Index:	
Within 8" of Joint:	NO
Remarks:

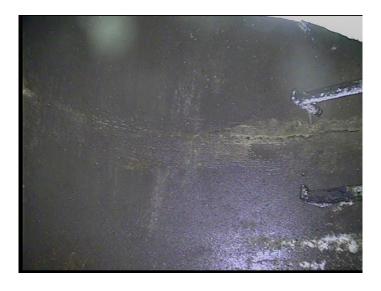
Code:	AMH
Description:	Manhole
Distance (ft):	20.7
Distance (ft):	20.7
Structural Grade:	0
O&M Grade:	0
Clock Start/From:	
Clock To:	
1st Value:	
2nd Value:	
Value Percent:	
Continuous Index:	
Within 8" of Joint:	NO
Remarks:	M-605-055
