## Profile/Photo Observation Report

Date:	<b>04/16/2018</b>	Weather:		Coding:	<b>PACP 6.0</b>
Pipe Length (ft):		Owner:	<b>City of Hobart</b>	Pre Clean:	<b>No Pre-Cleaning</b>
P.O.#:	<b>64-2</b>	Surveyor:	<b>M. Pielacha</b>	PSR:	<b>M-605-057-M-605-056</b>
Customer:	<b>City of Hobart</b>	Clean Date:		Shape:	<b>C</b>

Street:	<b>Beverly Lane</b>	Flow Control:	<b>Not Controlled</b>
City:	<b>Hobart, IN</b>	Year Renewed:	
Location:	<b>Light Highway</b>	Tape/Media #:	<b>DEP 64</b>
Purpose:	<b>Routine Assessment</b>	Dia/Height:	<b>15"</b>
Use:	<b>Sanitary</b>	Material:	<b>CP</b>
Drain Area:		Lining:	
Category:	<b>NA</b>		
Comment:			
Location Details:		Direction of Survey:	<b>Downstream</b>
US MH:	<b>M-605-057</b>	DS MH:	<b>M-605-056</b>
		Total Length Surveyed (ft):	<b>298.7</b>

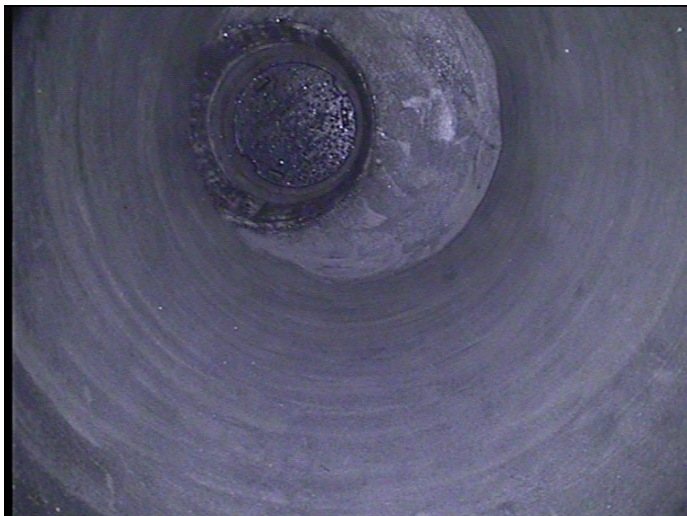
Code: **AMH**  
 Description: **Manhole**

Distance (ft): **.0**  
 Structural Grade: **0**  
 O&M Grade: **0**  
 Clock Start/From:  
 Clock To:  
 1st Value:  
 2nd Value:  
 Value Percent:  
 Continuous Index:  
 Within 8" of Joint: **NO**  
 Remarks: **M-605-057**

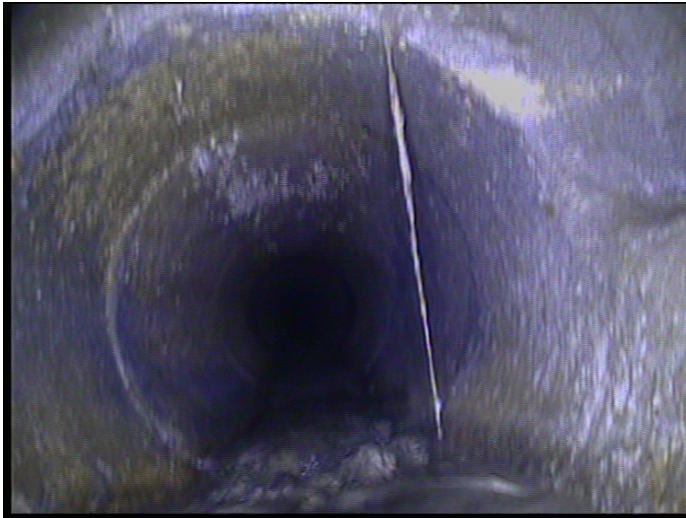
Code:	<b>MWL</b>
Description:	<b>Water Level</b>
Distance (ft):	<b>.0</b>
Structural Grade:	<b>0</b>
O&M Grade:	<b>0</b>
Clock Start/From:	
Clock To:	
1st Value:	
2nd Value:	
Value Percent:	<b>10.000</b>
Continuous Index:	
Within 8" of Joint:	<b>NO</b>
Remarks:

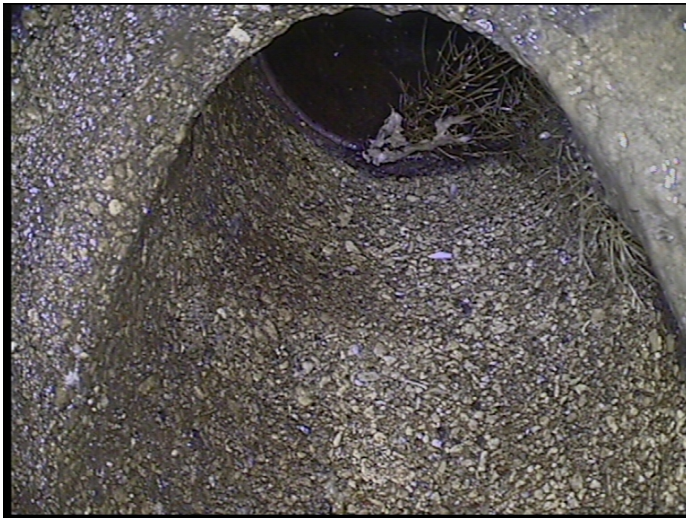
Code:	<b>TF</b>
Description:	<b>Tap Factory</b>
Distance (ft):	<b>9.7</b>
Structural Grade:	<b>0</b>
O&M Grade:	<b>0</b>
Clock Start/From:	<b>2</b>
Clock To:	
1st Value:	<b>4.000</b>
2nd Value:	
Value Percent:	
Continuous Index:	
Within 8" of Joint:	<b>NO</b>
Remarks:

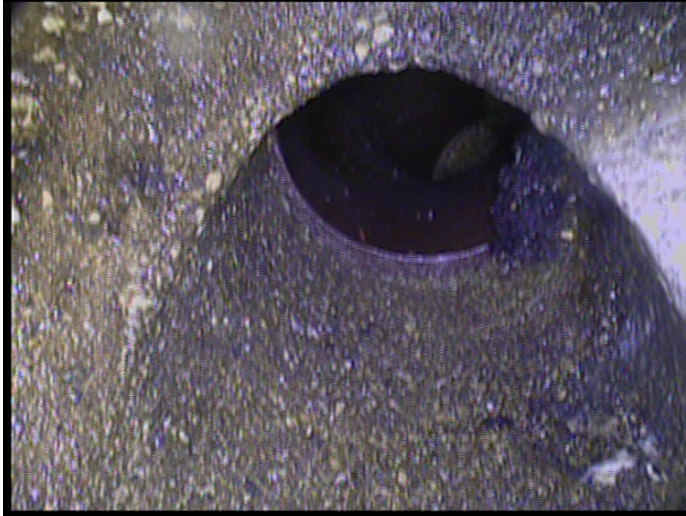
Code: **TF**  
Description: **Tap Factory**

Distance (ft): **52.7**  
Structural Grade: **0**  
O&M Grade: **0**  
Clock Start/From: **2**  
Clock To:  
1st Value: **4.000**  
2nd Value:  
Value Percent:  
Continuous Index:  
Within 8" of Joint: **NO**  
Remarks:

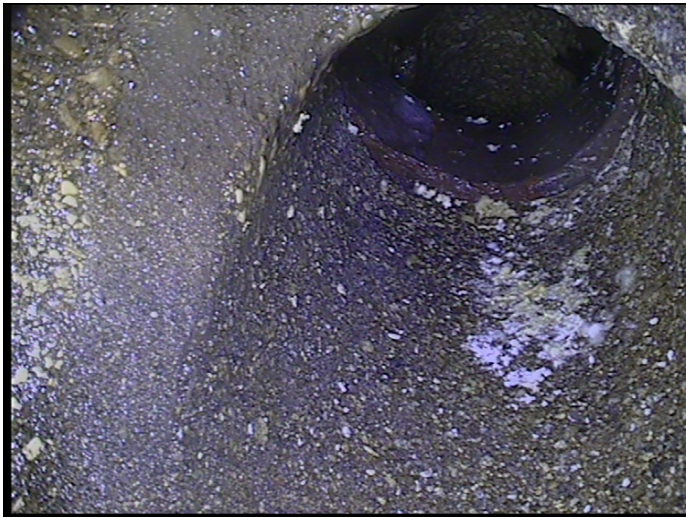
Code: **TF**  
Description: **Tap Factory**

Distance (ft): **55.8**  
Structural Grade: **0**  
O&M Grade: **0**  
Clock Start/From: **10**  
Clock To:  
1st Value: **4.000**  
2nd Value:  
Value Percent:  
Continuous Index:  
Within 8" of Joint: **NO**  
Remarks:

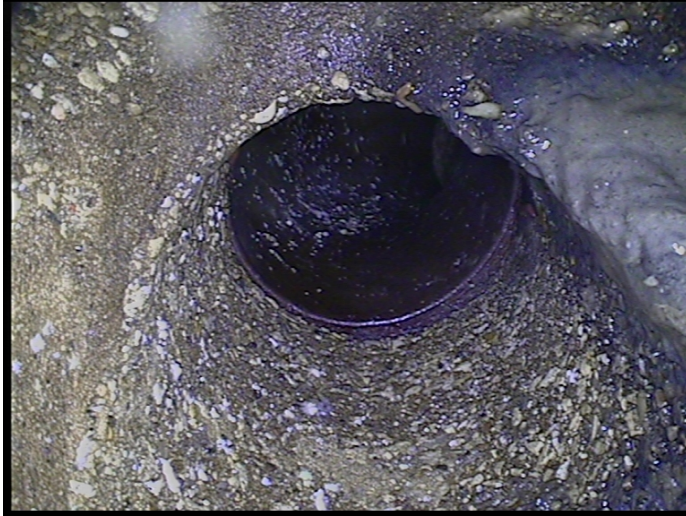
Code: **TF**  
Description: **Tap Factory**

Distance (ft): **95.4**  
Structural Grade: **0**  
O&M Grade: **0**  
Clock Start/From: **2**  
Clock To:  
1st Value: **4.000**  
2nd Value:  
Value Percent:  
Continuous Index:  
Within 8" of Joint: **NO**  
Remarks:

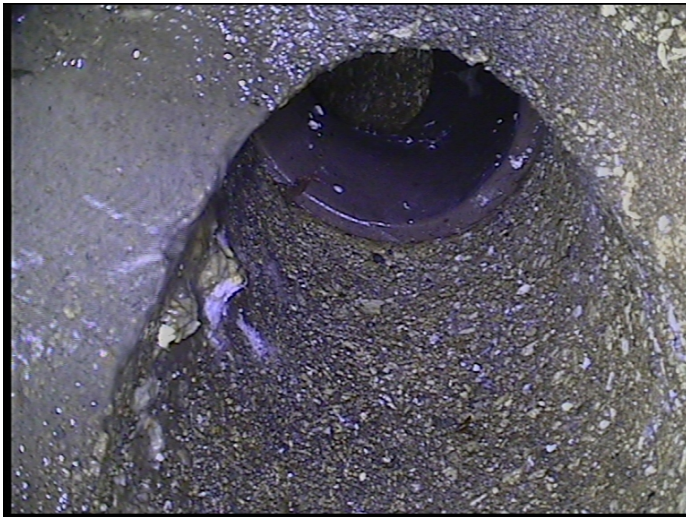
Code: **TFA**  
Description: **Tap Factory Active**

Distance (ft): **122.7**  
Structural Grade: **0**  
O&M Grade: **0**  
Clock Start/From: **10**  
Clock To:  
1st Value: **4.000**  
2nd Value:  
Value Percent:  
Continuous Index:  
Within 8" of Joint: **NO**  
Remarks:

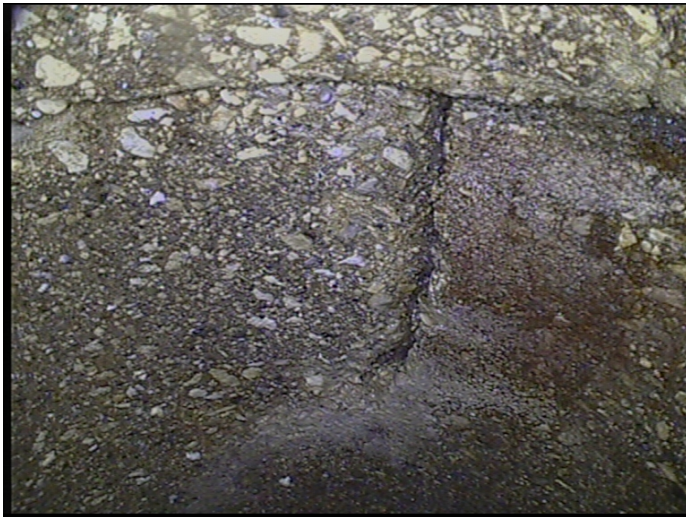
Code: **FL**  
Description: **Fracture Longitudinal**

Distance (ft): **127.1**  
Structural Grade: **3**  
O&M Grade: **0**  
Clock Start/From: **3**  
Clock To:  
1st Value:  
2nd Value:  
Value Percent:  
Continuous Index:  
Within 8" of Joint: **YES**  
Remarks:

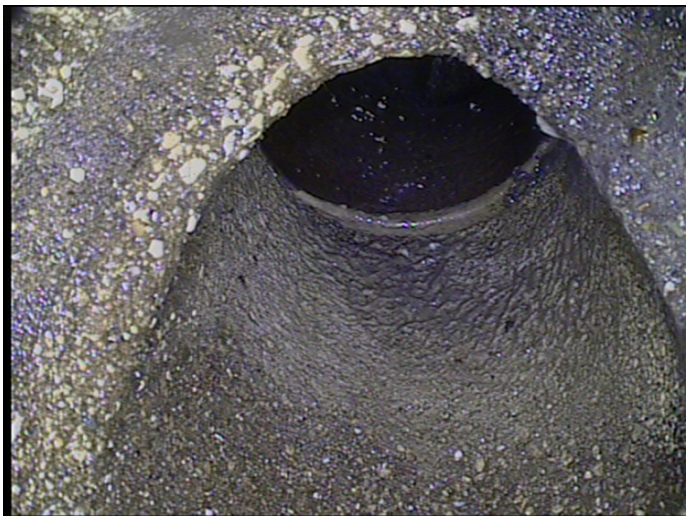
Code: **TF**  
Description: **Tap Factory**

Distance (ft): **153.1**  
Structural Grade: **0**  
O&M Grade: **0**  
Clock Start/From: **2**  
Clock To:  
1st Value: **4.000**  
2nd Value:  
Value Percent:  
Continuous Index:  
Within 8" of Joint: **NO**  
Remarks:

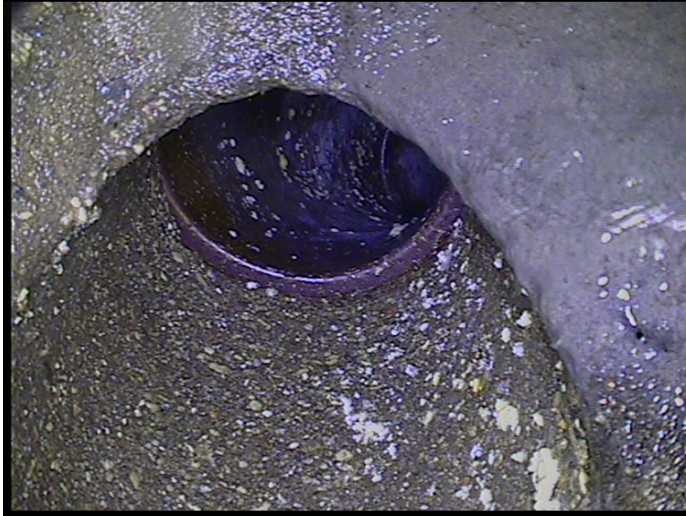
Code: **TFA**  
Description: **Tap Factory Active**

Distance (ft): **201.7**  
Structural Grade: **0**  
O&M Grade: **0**  
Clock Start/From: **2**  
Clock To:  
1st Value: **4.000**  
2nd Value:  
Value Percent:  
Continuous Index:  
Within 8" of Joint: **NO**  
Remarks:

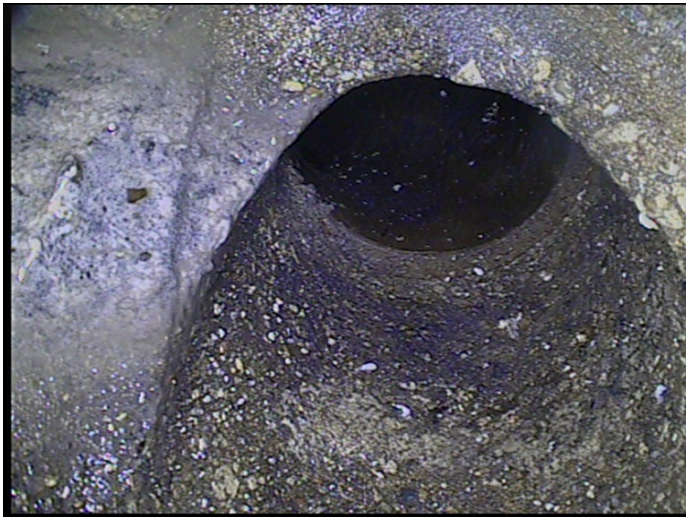
Code: **TFA**  
Description: **Tap Factory Active**

Distance (ft): **229.1**  
Structural Grade: **0**  
O&M Grade: **0**  
Clock Start/From: **10**  
Clock To:  
1st Value: **4.000**  
2nd Value:  
Value Percent:  
Continuous Index:  
Within 8" of Joint: **NO**  
Remarks:

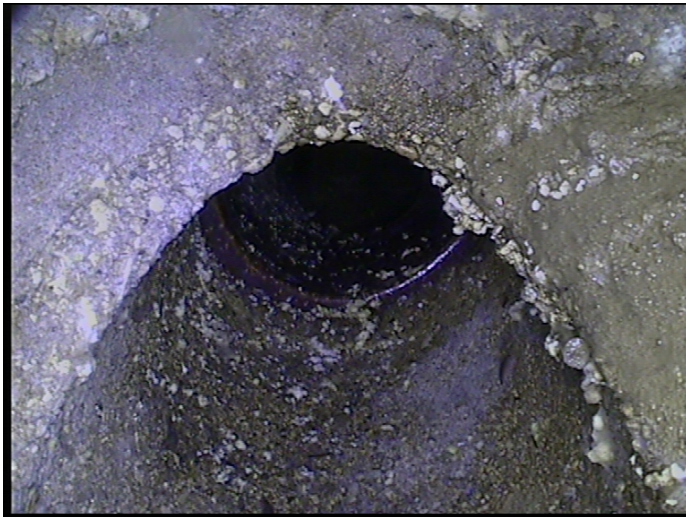
Code: **TF**  
Description: **Tap Factory**

Distance (ft): **268.6**  
Structural Grade: **0**  
O&M Grade: **0**  
Clock Start/From: **2**  
Clock To:  
1st Value: **4.000**  
2nd Value:  
Value Percent:  
Continuous Index:  
Within 8" of Joint: **NO**  
Remarks:

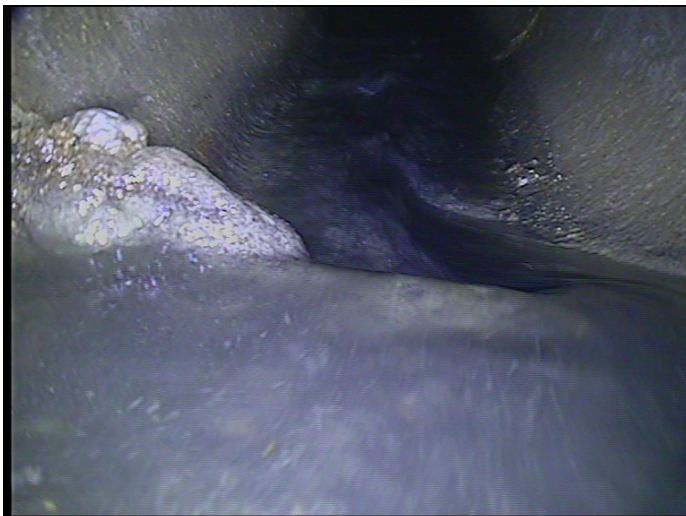
Code: **OBZ**  
Description: **Obstacle Other**

Distance (ft): **276.0**  
Structural Grade: **0**  
O&M Grade: **3**  
Clock Start/From: **5**  
Clock To: **8**  
1st Value:  
2nd Value:  
Value Percent: **15.000**  
Continuous Index:  
Within 8" of Joint: **NO**  
Remarks: **Debris**

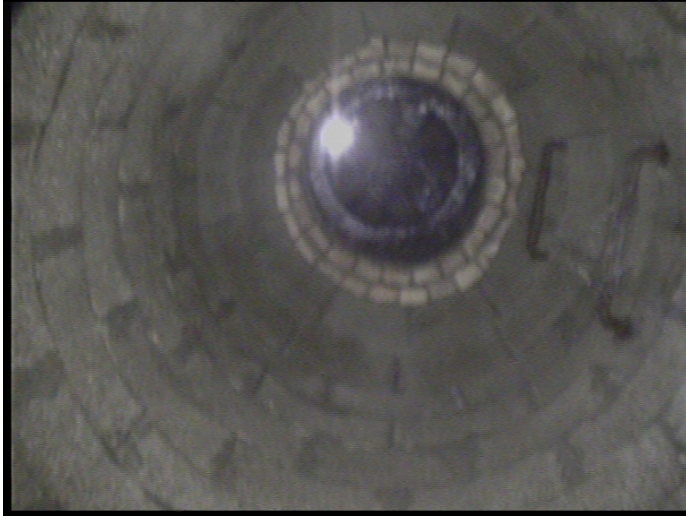
Code:	<b>AMH</b>
Description:	<b>Manhole</b>
Distance (ft):	<b>298.7</b>
Structural Grade:	<b>0</b>
O&M Grade:	<b>0</b>
Clock Start/From:	
Clock To:	
1st Value:	
2nd Value:	
Value Percent:	
Continuous Index:	
Within 8" of Joint:	<b>NO</b>
Remarks:	<b>M-605-056</b>
