Profile/Photo Observation Report

Date:	11/15/2021	Weather:		Coding:	PACP 7.0
Pipe Length (ft):	80.0	Owner:	City of Hobart	Pre Clean:	Heavy Cleaning
P.O.#:	YES502259	Surveyor:	S. Bucklin	PSR:	P-605-061-059
Customer:	City of Hobart	Clean Date:	11/14/2021	Shape:	C

Street:	South Lake Park Avenue	Flow Control:	Not Controlled
City:	Hobart, IN	Year Renewed:	
Location:	Local rural streets with light traffic, t	Tape/Media #:	
Purpose:	Routine Assessment	Dia/Height:	12"
Use:	Sanitary Sewage Pipe	Material:	VCP
Drain Area:		Lining:	None
Category:	NA		
Comment:			
Location Details:		Direction of Survey:	Downstream
US MH:	M-605-059	DS MH:	M-605-061
		Total Length Surveyed (ft):	68.4

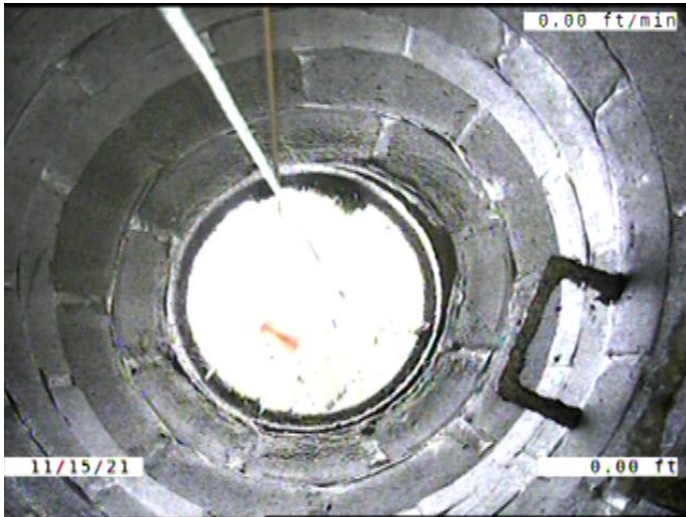
Code: **AMH**
 Description: **Manhole**

Distance (ft): **.0**
 Structural Grade: **0**
 O&M Grade: **0**
 Clock Start/From:
 Clock To:
 1st Value:
 2nd Value:
 Value Percent:
 Continuous Index:
 Within 8" of Joint: **NO**
 Remarks: **M-605-059**

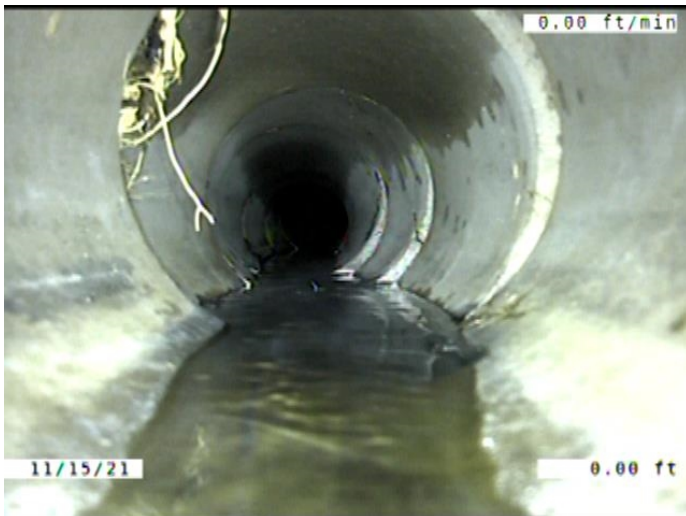
Code: **MWL**
 Description: **Miscellaneous Water Level**

Distance (ft): **.0**
 Structural Grade: **0**
 O&M Grade: **0**
 Clock Start/From:
 Clock To:
 1st Value:
 2nd Value:
 Value Percent: **5.000**
 Continuous Index:
 Within 8" of Joint: **NO**
 Remarks:

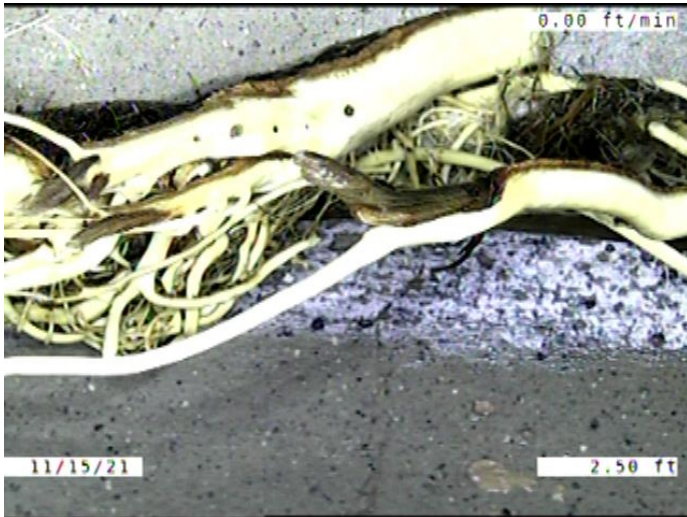
Code: **RMJ**
 Description: **Roots Medium Joint**

Distance (ft): **2.5**
 Structural Grade: **0**
 O&M Grade: **3**
 Clock Start/From: **8**
 Clock To: **3**
 1st Value:
 2nd Value:
 Value Percent: **5.000**
 Continuous Index:
 Within 8" of Joint: **YES**
 Remarks:

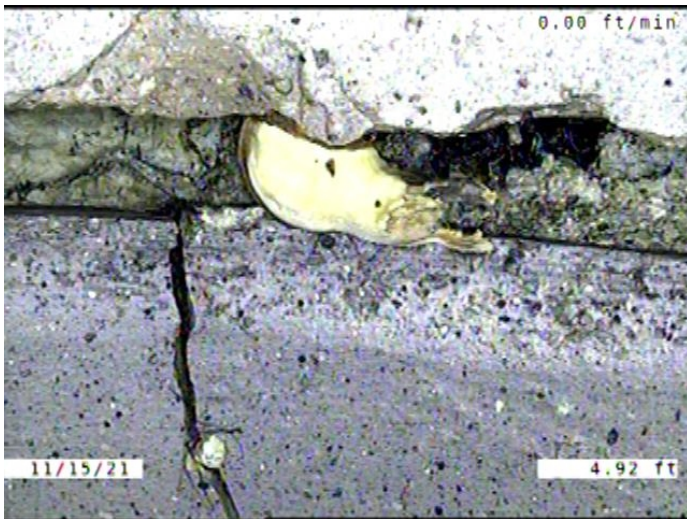
Code: **RFJ**
 Description: **Roots Fine Joint**

Distance (ft): **4.9**
 Structural Grade: **0**
 O&M Grade: **1**
 Clock Start/From: **9**
 Clock To: **1**
 1st Value:
 2nd Value:
 Value Percent:
 Continuous Index:
 Within 8" of Joint: **YES**
 Remarks:

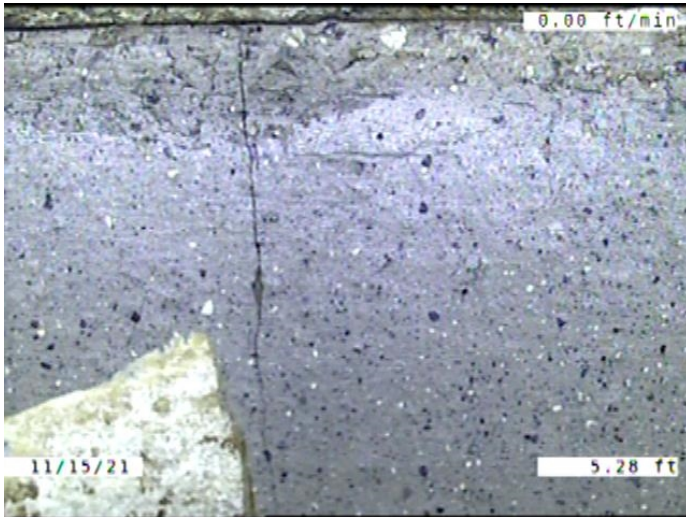
Code: **CL**
Description: **Crack Longitudinal**

Distance (ft): **5.3**
Structural Grade: **2**
O&M Grade: **0**
Clock Start/From: **12**
Clock To:
1st Value:
2nd Value:
Value Percent:
Continuous Index:
Within 8" of Joint: **YES**
Remarks:

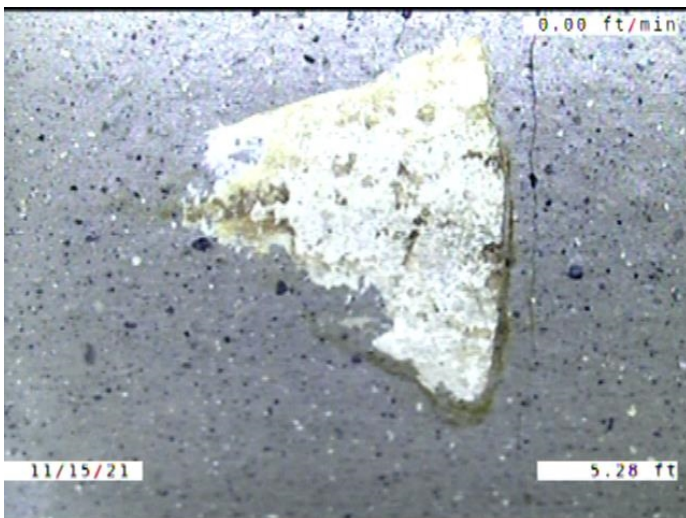
Code: **DAE**
Description: **Deposits Attached Encrustation**

Distance (ft): **5.3**
Structural Grade: **0**
O&M Grade: **2**
Clock Start/From: **11**
Clock To: **12**
1st Value:
2nd Value:
Value Percent: **5.000**
Continuous Index:
Within 8" of Joint: **YES**
Remarks:

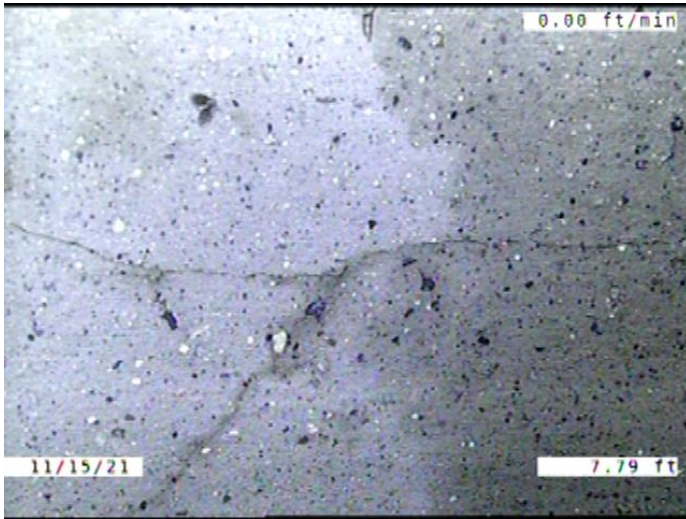
Code: **CM**
Description: **Crack Multiple**

Distance (ft): **7.8**
Structural Grade: **3**
O&M Grade: **0**
Clock Start/From: **8**
Clock To: **12**
1st Value:
2nd Value:
Value Percent:
Continuous Index:
Within 8" of Joint: **YES**
Remarks:

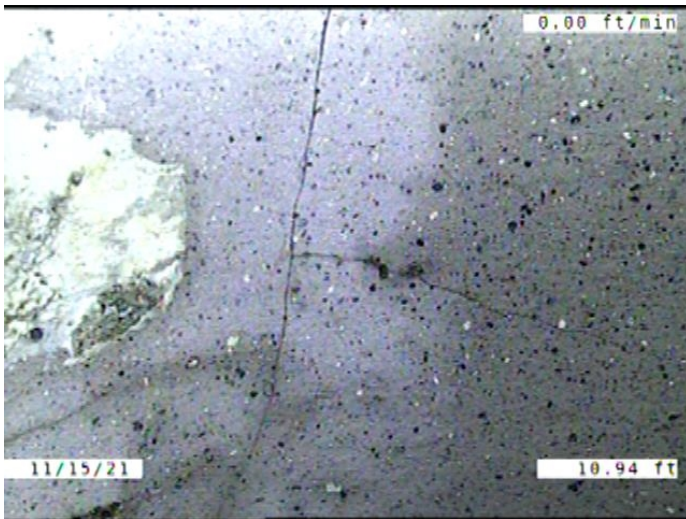
Code: **CM**
Description: **Crack Multiple**

Distance (ft): **10.9**
Structural Grade: **3**
O&M Grade: **0**
Clock Start/From: **8**
Clock To: **11**
1st Value:
2nd Value:
Value Percent:
Continuous Index:
Within 8" of Joint: **YES**
Remarks:

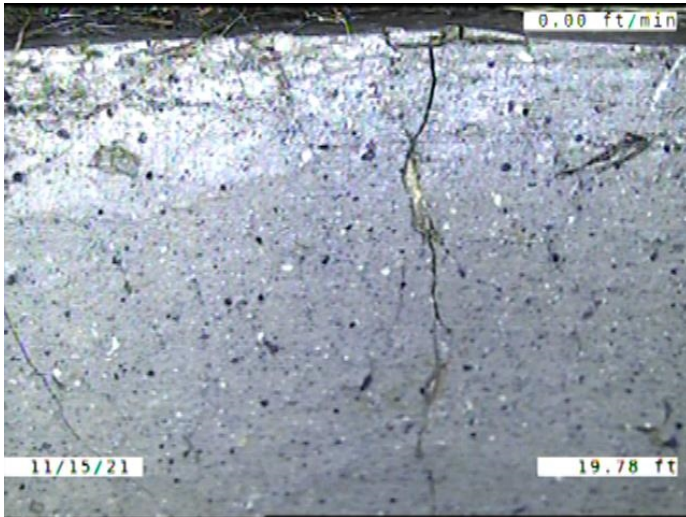
Code: **CM**
 Description: **Crack Multiple**

Distance (ft): **19.8**
 Structural Grade: **3**
 O&M Grade: **0**
 Clock Start/From: **9**
 Clock To: **3**
 1st Value:
 2nd Value:
 Value Percent:
 Continuous Index:
 Within 8" of Joint: **YES**
 Remarks:

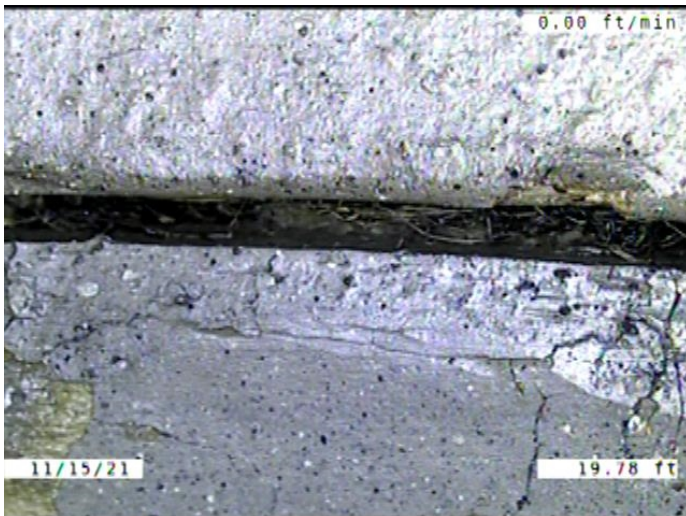
Code: **RFJ**
 Description: **Roots Fine Joint**

Distance (ft): **19.8**
 Structural Grade: **0**
 O&M Grade: **1**
 Clock Start/From: **9**
 Clock To: **4**
 1st Value:
 2nd Value:
 Value Percent:
 Continuous Index:
 Within 8" of Joint: **YES**
 Remarks:

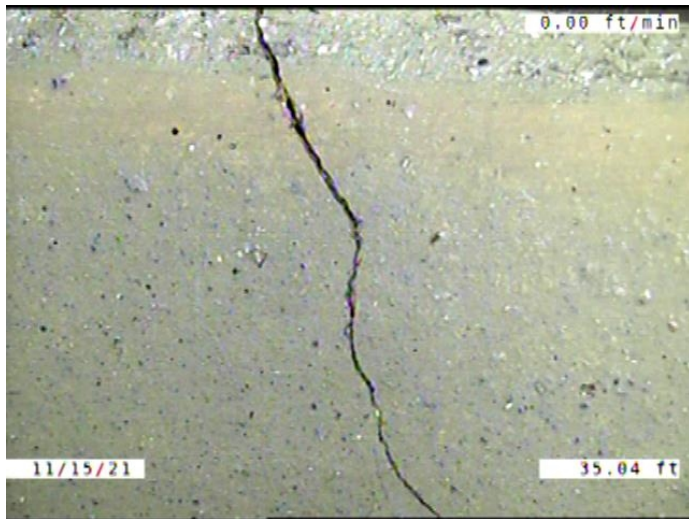
Code: **FM**
 Description: **Fracture Multiple**

Distance (ft): **35.0**
 Structural Grade: **4**
 O&M Grade: **0**
 Clock Start/From: **12**
 Clock To: **12**
 1st Value:
 2nd Value:
 Value Percent:
 Continuous Index:
 Within 8" of Joint: **YES**
 Remarks:

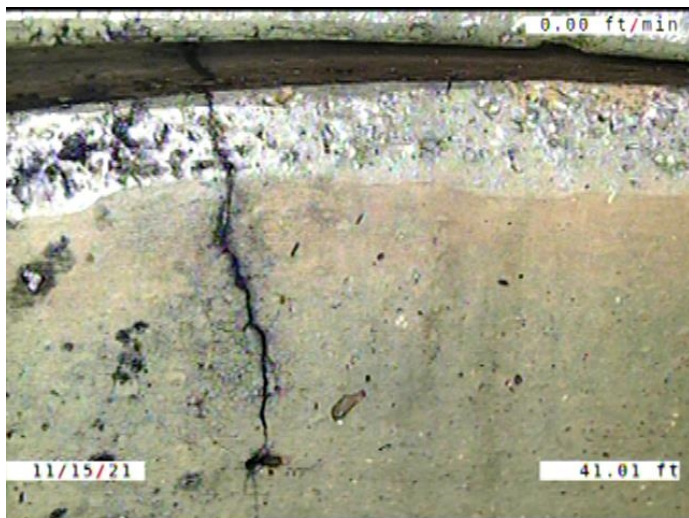
Code: **CL**
 Description: **Crack Longitudinal**

Distance (ft): **41.0**
 Structural Grade: **2**
 O&M Grade: **0**
 Clock Start/From: **9**
 Clock To:
 1st Value:
 2nd Value:
 Value Percent:
 Continuous Index:
 Within 8" of Joint: **YES**
 Remarks:

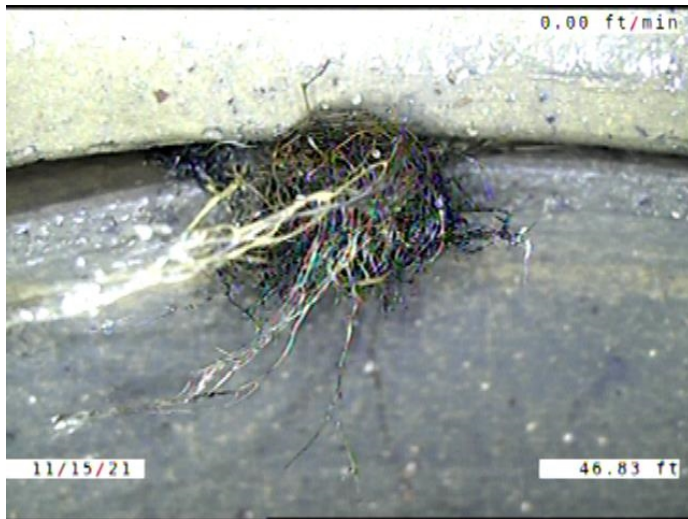
Code: **RFJ**
Description: **Roots Fine Joint**

Distance (ft): **46.8**
Structural Grade: **0**
O&M Grade: **1**
Clock Start/From: **10**
Clock To:
1st Value:
2nd Value:
Value Percent:
Continuous Index:
Within 8" of Joint: **YES**
Remarks:

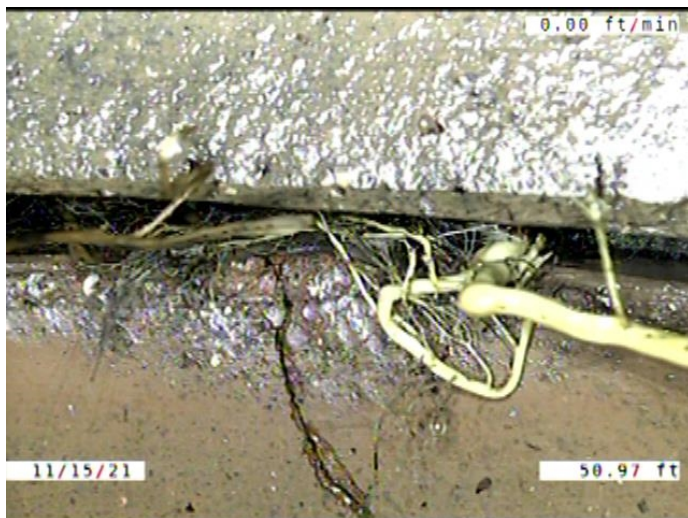
Code: **RFJ**
Description: **Roots Fine Joint**

Distance (ft): **51.0**
Structural Grade: **0**
O&M Grade: **1**
Clock Start/From: **12**
Clock To: **2**
1st Value:
2nd Value:
Value Percent:
Continuous Index:
Within 8" of Joint: **YES**
Remarks:

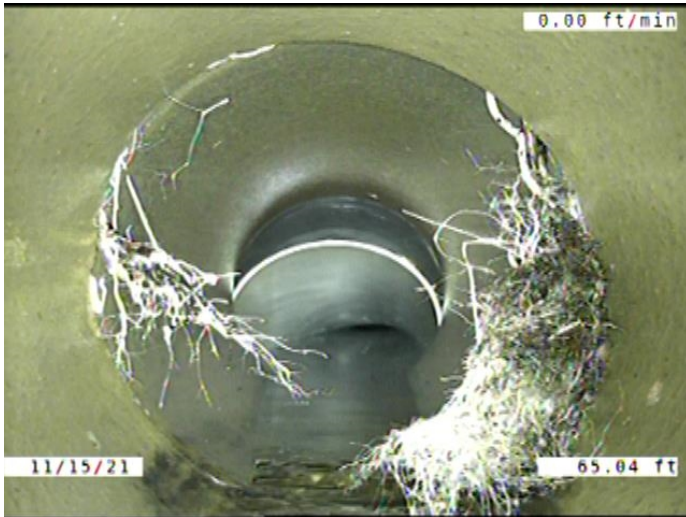
Code: **RMJ**
 Description: **Roots Medium Joint**

Distance (ft): **65.0**
 Structural Grade: **0**
 O&M Grade: **3**
 Clock Start/From: **8**
 Clock To: **5**
 1st Value:
 2nd Value:
 Value Percent: **15.000**
 Continuous Index:
 Within 8" of Joint: **YES**
 Remarks:

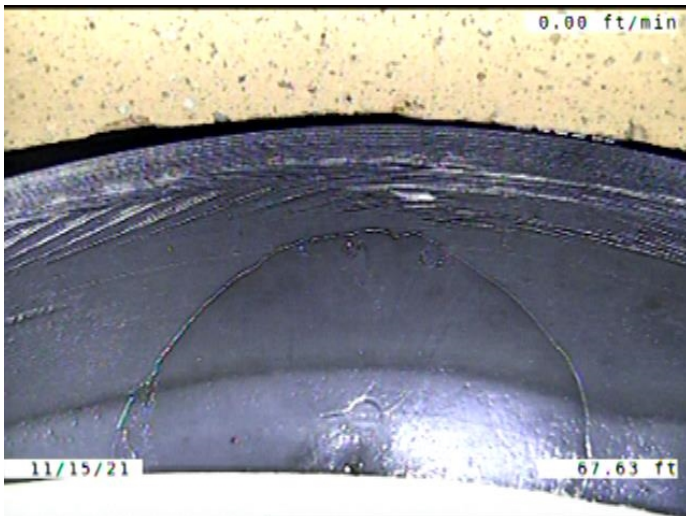
Code: **JOLD**
 Description: **Joint Offset Large Defective**

Distance (ft): **67.6**
 Structural Grade: **4**
 O&M Grade: **0**
 Clock Start/From:
 Clock To:
 1st Value:
 2nd Value:
 Value Percent:
 Continuous Index:
 Within 8" of Joint: **NO**
 Remarks:

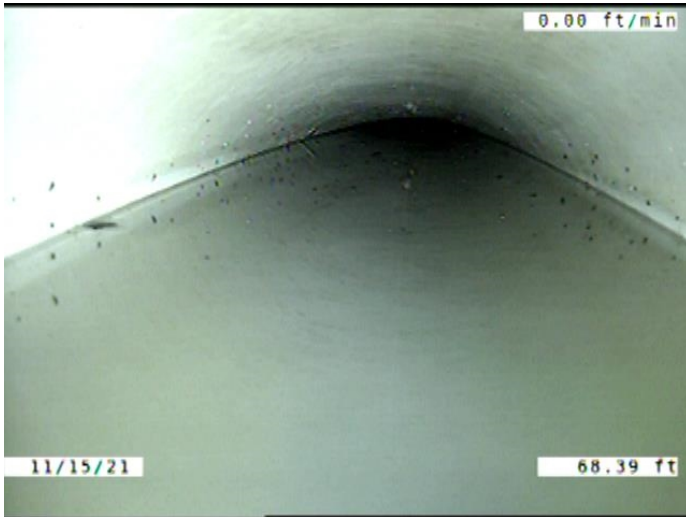
Code:	MSA
Description:	Miscellaneous Survey Abandoned
Distance (ft):	68.4
Structural Grade:	0
O&M Grade:	0
Clock Start/From:	
Clock To:	
1st Value:	
2nd Value:	
Value Percent:	
Continuous Index:	
Within 8" of Joint:	NO
Remarks:	M-605-061
