Profile/Photo Observation Report

Date:	11/15/2021	Weather:		Coding:	PACP 7.0
Pipe Length (ft):	80.0	Owner:	City of Hobart	Pre Clean:	Heavy Cleaning
P.O.#:	YES502259	Surveyor:	S. Bucklin	PSR:	P-605-061-059
Customer:	City of Hobart	Clean Date:	11/14/2021	Shape:	C

Street:	South Lake Park Avenue	Flow Control:	Not Controlled
City:	Hobart, IN	Year Renewed:	
Location:	Local rural streets with light traffic, t	Tape/Media #:	
Purpose:	Routine Assessment	Dia/Height:	12"
Use:	Sanitary Sewage Pipe	Material:	VCP
Drain Area:		Lining:	None
Category:	NA		
Comment:			
Location Details:		Direction of Survey:	Downstream
US MH:	M-605-059	DS MH:	M-605-061
		Total Length Surveyed (ft):	68.4

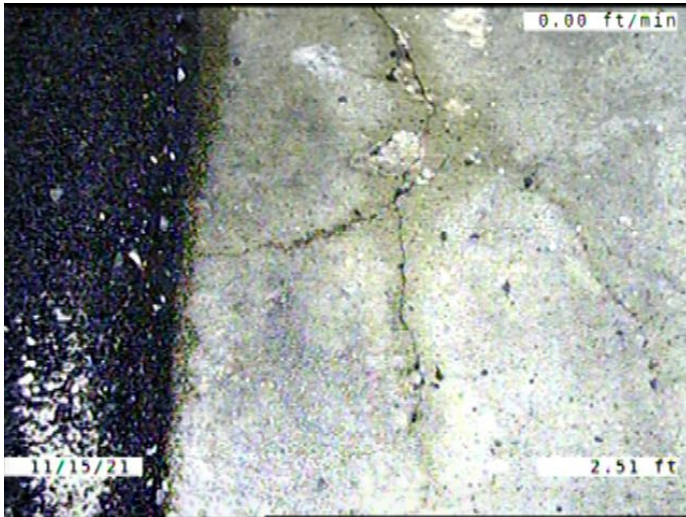
Code: **FM**
 Description: **Fracture Multiple**

Distance (ft): **2.5**
 Structural Grade: **4**
 O&M Grade: **0**
 Clock Start/From: **4**
 Clock To: **5**
 1st Value:
 2nd Value:
 Value Percent:
 Continuous Index:
 Within 8" of Joint: **YES**
 Remarks:

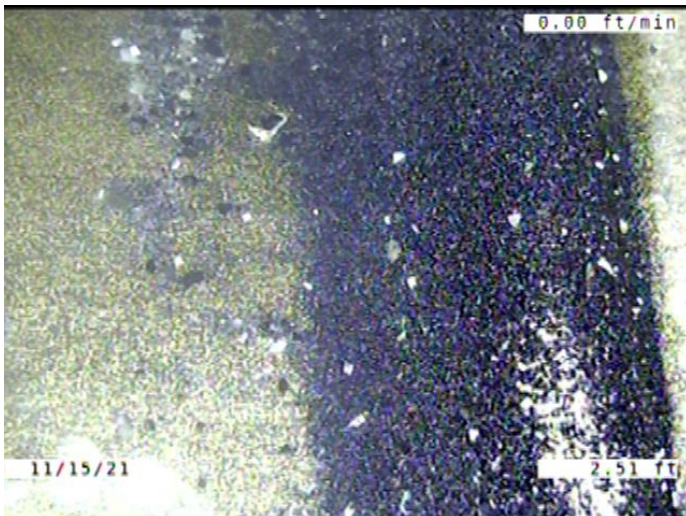
Code: **DSF**
 Description: **Deposits Settled Fine**

Distance (ft): **2.5**
 Structural Grade: **0**
 O&M Grade: **2**
 Clock Start/From: **5**
 Clock To: **7**
 1st Value:
 2nd Value:
 Value Percent: **5.000**
 Continuous Index: **S01**
 Within 8" of Joint: **YES**
 Remarks:

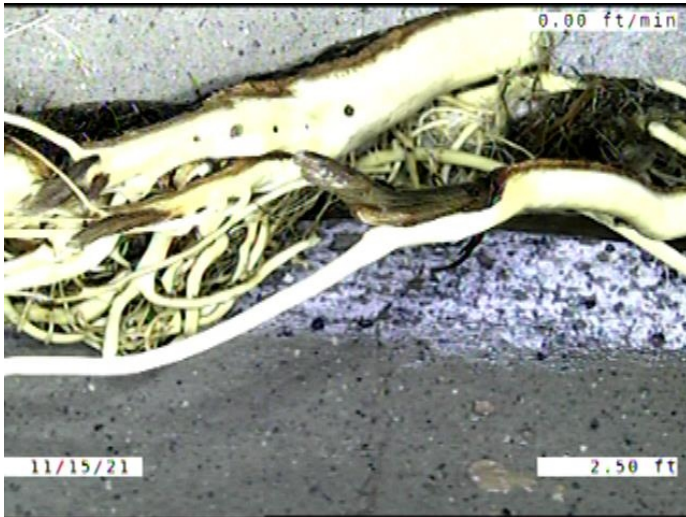
Code: **RMJ**
 Description: **Roots Medium Joint**

Distance (ft): **2.5**
 Structural Grade: **0**
 O&M Grade: **3**
 Clock Start/From: **8**
 Clock To: **3**
 1st Value:
 2nd Value:
 Value Percent: **5.000**
 Continuous Index:
 Within 8" of Joint: **YES**
 Remarks:

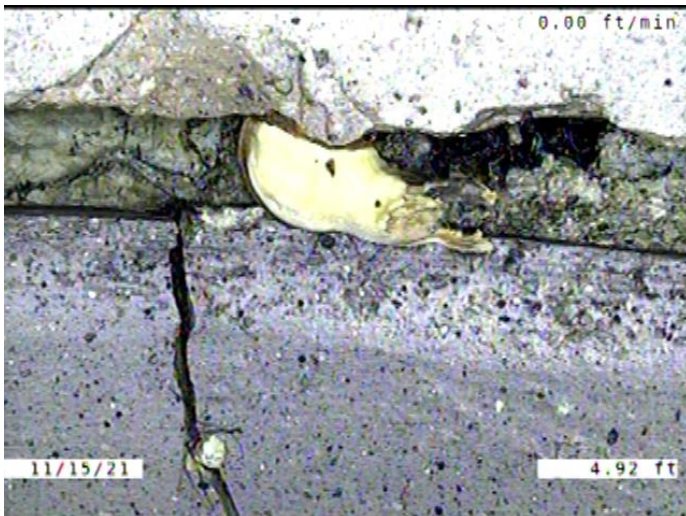
Code: **RFJ**
 Description: **Roots Fine Joint**

Distance (ft): **4.9**
 Structural Grade: **0**
 O&M Grade: **1**
 Clock Start/From: **9**
 Clock To: **1**
 1st Value:
 2nd Value:
 Value Percent:
 Continuous Index:
 Within 8" of Joint: **YES**
 Remarks:

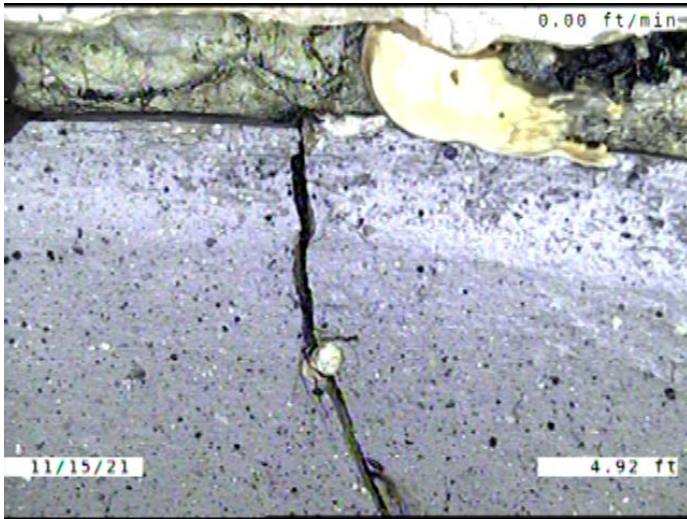
Code: **B**
 Description: **Broken**

Distance (ft): **4.9**
 Structural Grade: **4**
 O&M Grade: **0**
 Clock Start/From: **8**
 Clock To: **4**
 1st Value:
 2nd Value:
 Value Percent:
 Continuous Index:
 Within 8" of Joint: **YES**
 Remarks:

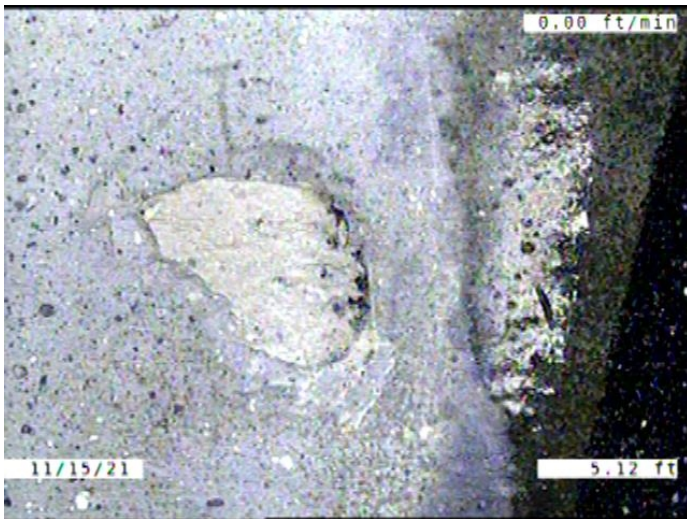
Code: **SSS**
 Description: **Surface Damage Surface Spalling**

Distance (ft): **5.1**
 Structural Grade: **2**
 O&M Grade: **0**
 Clock Start/From: **7**
 Clock To: **8**
 1st Value:
 2nd Value:
 Value Percent:
 Continuous Index:
 Within 8" of Joint: **YES**
 Remarks:

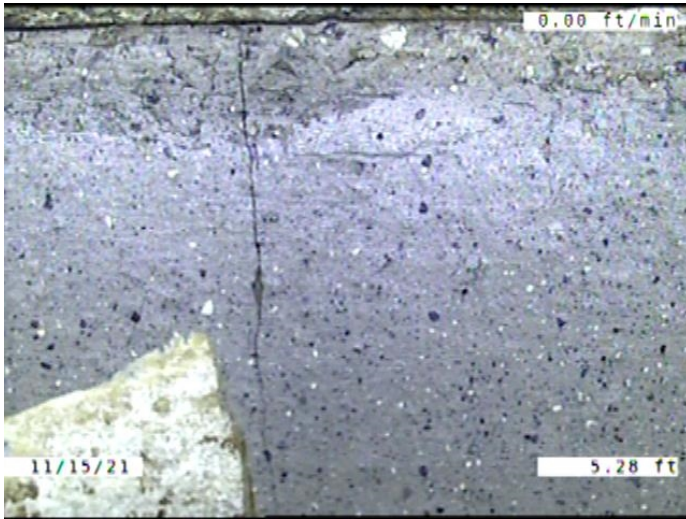
Code: **CL**
Description: **Crack Longitudinal**

Distance (ft): **5.3**
Structural Grade: **2**
O&M Grade: **0**
Clock Start/From: **12**
Clock To:
1st Value:
2nd Value:
Value Percent:
Continuous Index:
Within 8" of Joint: **YES**
Remarks:

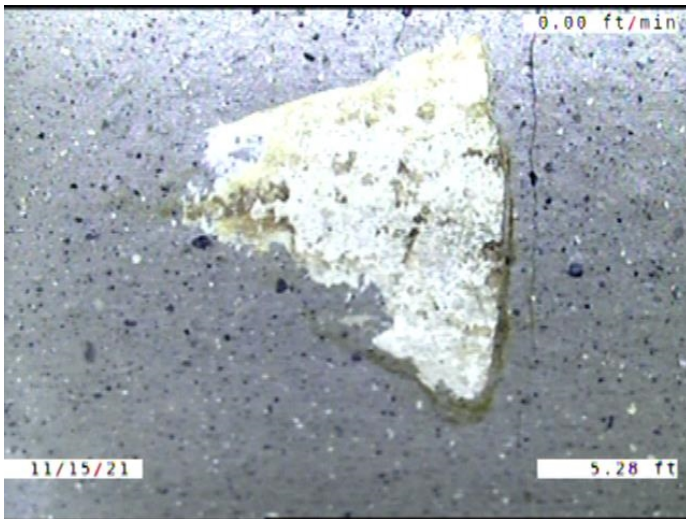
Code: **DAE**
Description: **Deposits Attached Encrustation**

Distance (ft): **5.3**
Structural Grade: **0**
O&M Grade: **2**
Clock Start/From: **11**
Clock To: **12**
1st Value:
2nd Value:
Value Percent: **5.000**
Continuous Index:
Within 8" of Joint: **YES**
Remarks:

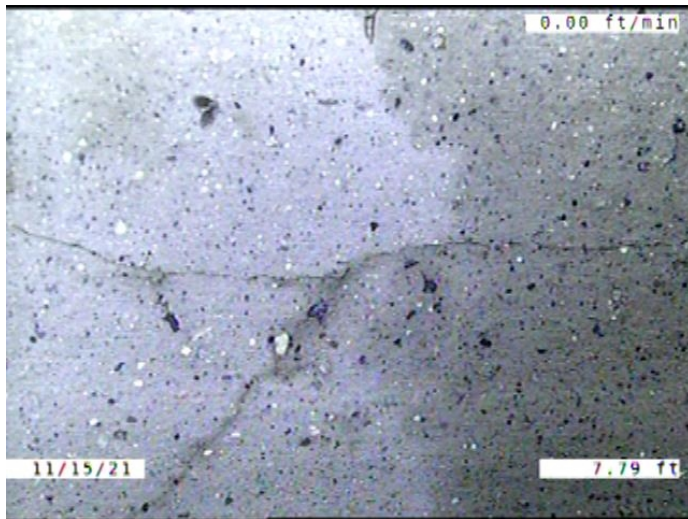
Code: **CM**
Description: **Crack Multiple**

Distance (ft): **7.8**
Structural Grade: **3**
O&M Grade: **0**
Clock Start/From: **8**
Clock To: **12**
1st Value:
2nd Value:
Value Percent:
Continuous Index:
Within 8" of Joint: **YES**
Remarks:

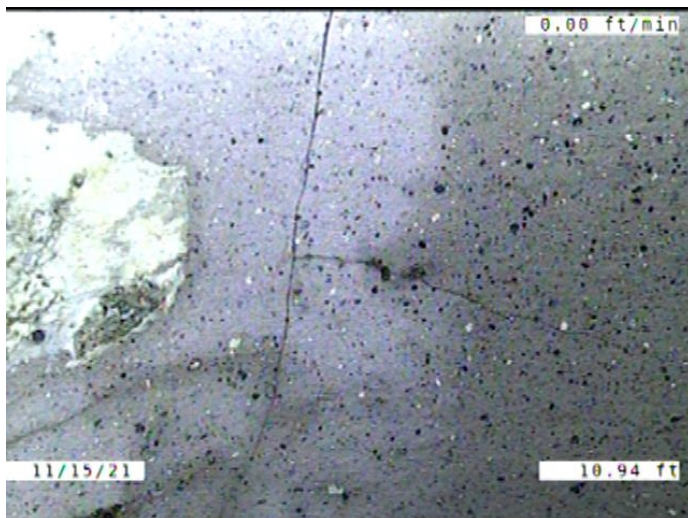
Code: **CM**
Description: **Crack Multiple**

Distance (ft): **10.9**
Structural Grade: **3**
O&M Grade: **0**
Clock Start/From: **8**
Clock To: **11**
1st Value:
2nd Value:
Value Percent:
Continuous Index:
Within 8" of Joint: **YES**
Remarks:

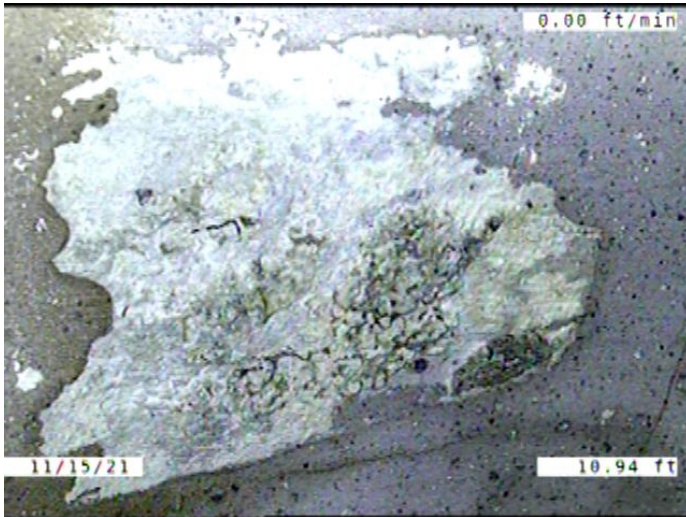
Code: **DAE**
 Description: **Deposits Attached Encrustation**

Distance (ft): **10.9**
 Structural Grade: **0**
 O&M Grade: **2**
 Clock Start/From: **8**
 Clock To: **10**
 1st Value:
 2nd Value:
 Value Percent: **5.000**
 Continuous Index:
 Within 8" of Joint: **YES**
 Remarks:

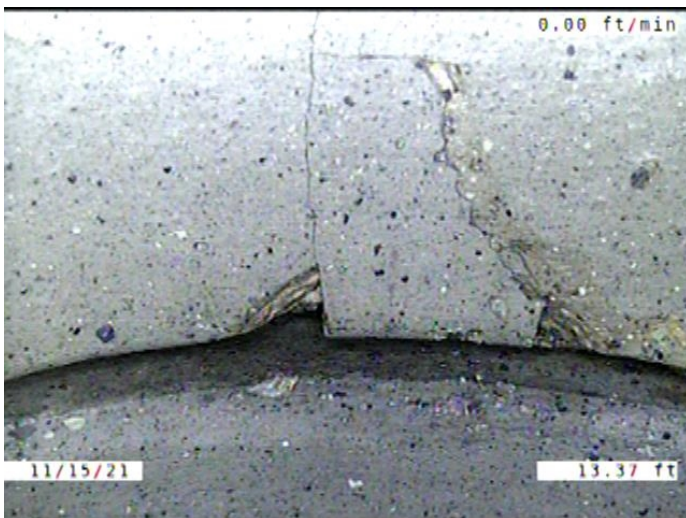
Code: **CM**
 Description: **Crack Multiple**

Distance (ft): **13.4**
 Structural Grade: **3**
 O&M Grade: **0**
 Clock Start/From: **10**
 Clock To: **11**
 1st Value:
 2nd Value:
 Value Percent:
 Continuous Index:
 Within 8" of Joint: **YES**
 Remarks:

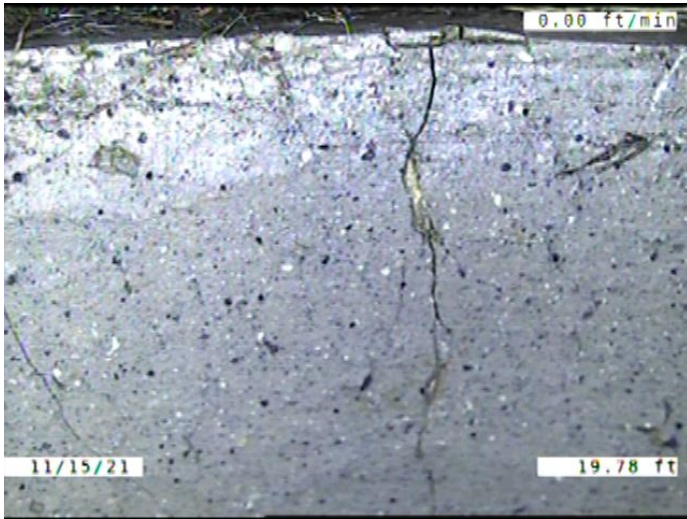
Code: **CM**
 Description: **Crack Multiple**

Distance (ft): **19.8**
 Structural Grade: **3**
 O&M Grade: **0**
 Clock Start/From: **9**
 Clock To: **3**
 1st Value:
 2nd Value:
 Value Percent:
 Continuous Index:
 Within 8" of Joint: **YES**
 Remarks:

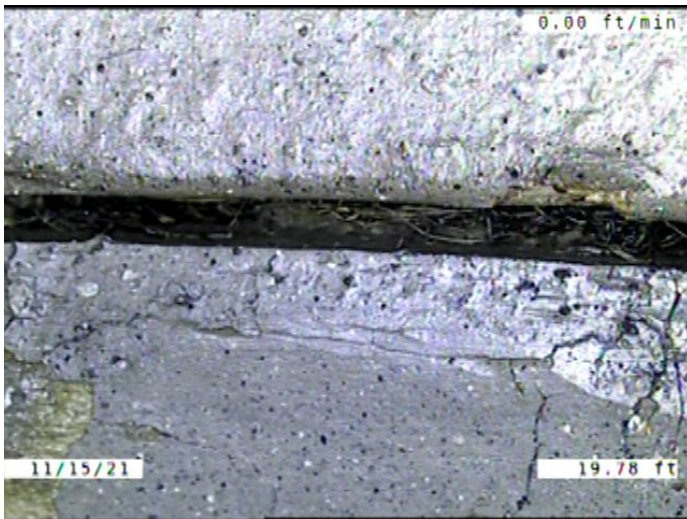
Code: **RFJ**
 Description: **Roots Fine Joint**

Distance (ft): **19.8**
 Structural Grade: **0**
 O&M Grade: **1**
 Clock Start/From: **9**
 Clock To: **4**
 1st Value:
 2nd Value:
 Value Percent:
 Continuous Index:
 Within 8" of Joint: **YES**
 Remarks:

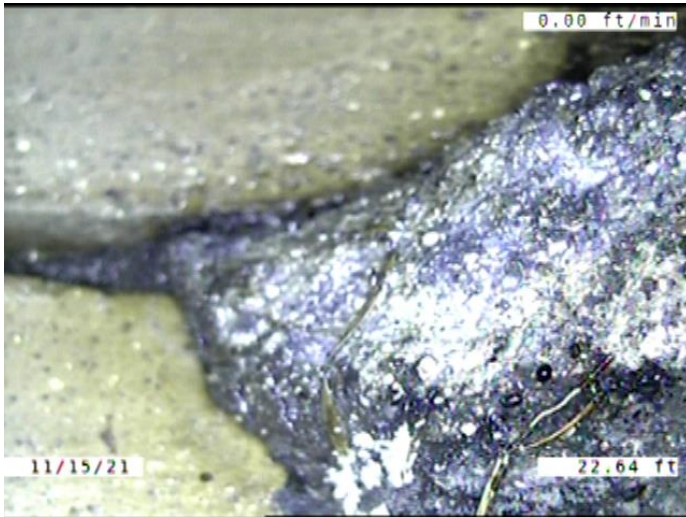
Code: **DAE**
 Description: **Deposits Attached Encrustation**

Distance (ft): **22.6**
 Structural Grade: **0**
 O&M Grade: **2**
 Clock Start/From: **4**
 Clock To: **8**
 1st Value:
 2nd Value:
 Value Percent: **5.000**
 Continuous Index:
 Within 8" of Joint: **YES**
 Remarks:

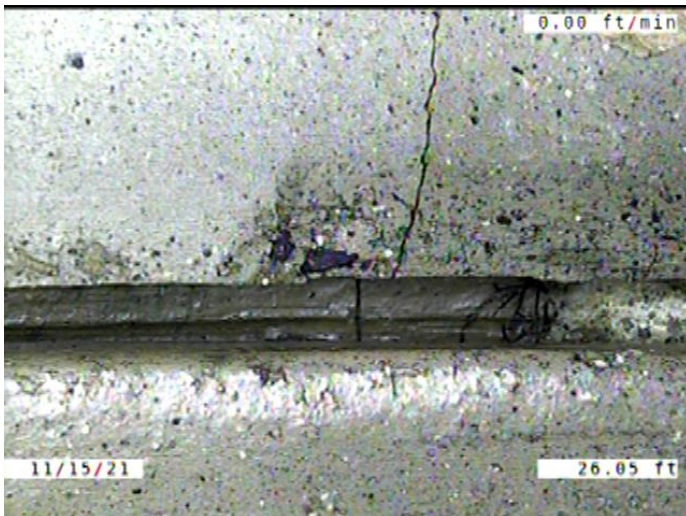
Code: **CM**
 Description: **Crack Multiple**

Distance (ft): **26.0**
 Structural Grade: **3**
 O&M Grade: **0**
 Clock Start/From: **2**
 Clock To: **3**
 1st Value:
 2nd Value:
 Value Percent:
 Continuous Index:
 Within 8" of Joint: **YES**
 Remarks:

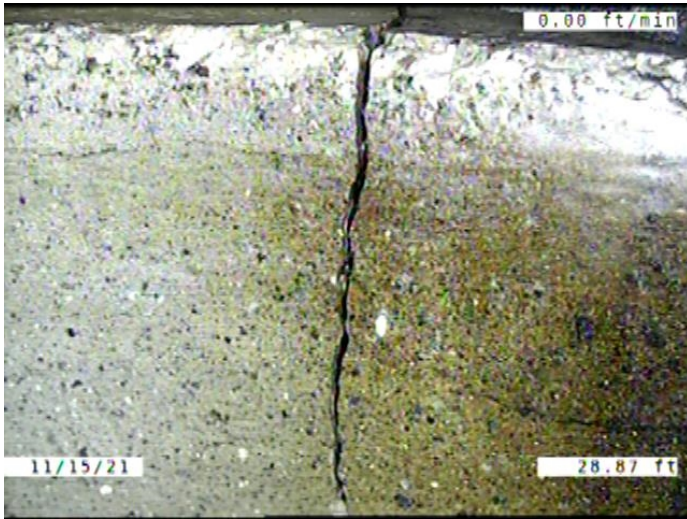
Code: **FM**
 Description: **Fracture Multiple**

Distance (ft): **28.9**
 Structural Grade: **4**
 O&M Grade: **0**
 Clock Start/From: **1**
 Clock To: **4**
 1st Value:
 2nd Value:
 Value Percent:
 Continuous Index:
 Within 8" of Joint: **YES**
 Remarks:

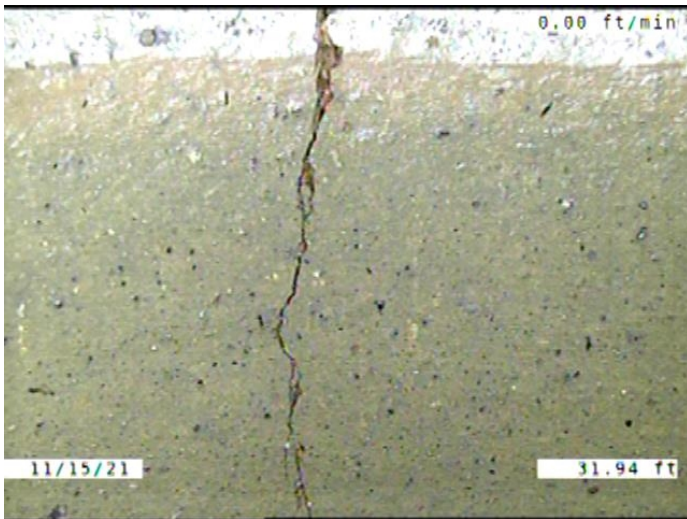
Code: **CL**
 Description: **Crack Longitudinal**

Distance (ft): **31.9**
 Structural Grade: **2**
 O&M Grade: **0**
 Clock Start/From: **11**
 Clock To:
 1st Value:
 2nd Value:
 Value Percent:
 Continuous Index:
 Within 8" of Joint: **YES**
 Remarks:

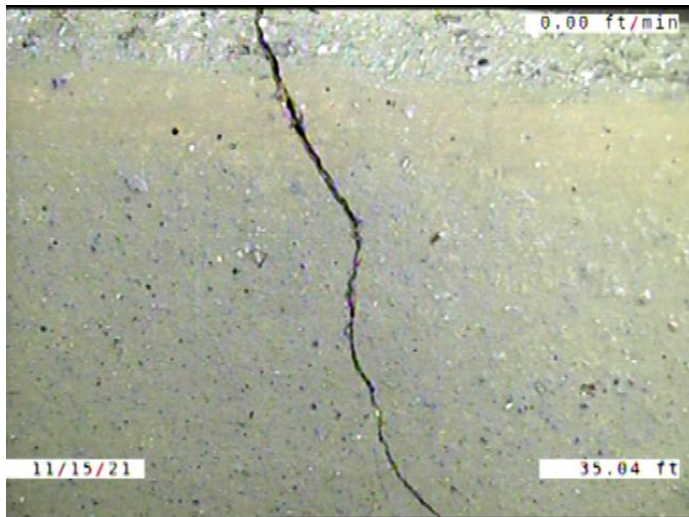
Code: **FM**
 Description: **Fracture Multiple**

Distance (ft): **35.0**
 Structural Grade: **4**
 O&M Grade: **0**
 Clock Start/From: **12**
 Clock To: **12**
 1st Value:
 2nd Value:
 Value Percent:
 Continuous Index:
 Within 8" of Joint: **YES**
 Remarks:

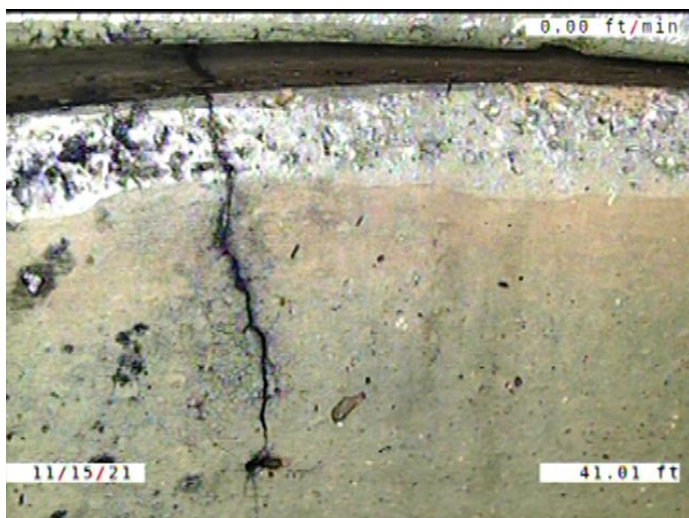
Code: **CL**
 Description: **Crack Longitudinal**

Distance (ft): **41.0**
 Structural Grade: **2**
 O&M Grade: **0**
 Clock Start/From: **9**
 Clock To:
 1st Value:
 2nd Value:
 Value Percent:
 Continuous Index:
 Within 8" of Joint: **YES**
 Remarks:

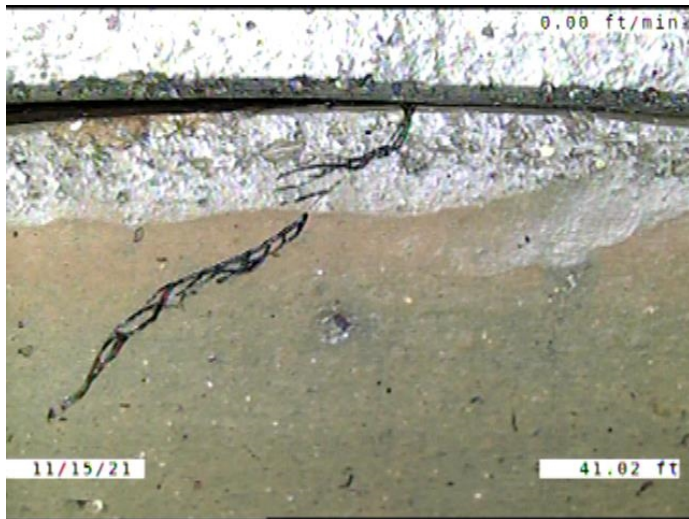
Code: **RFJ**
 Description: **Roots Fine Joint**

Distance (ft): **41.0**
 Structural Grade: **0**
 O&M Grade: **1**
 Clock Start/From: **11**
 Clock To:
 1st Value:
 2nd Value:
 Value Percent:
 Continuous Index:
 Within 8" of Joint: **YES**
 Remarks:

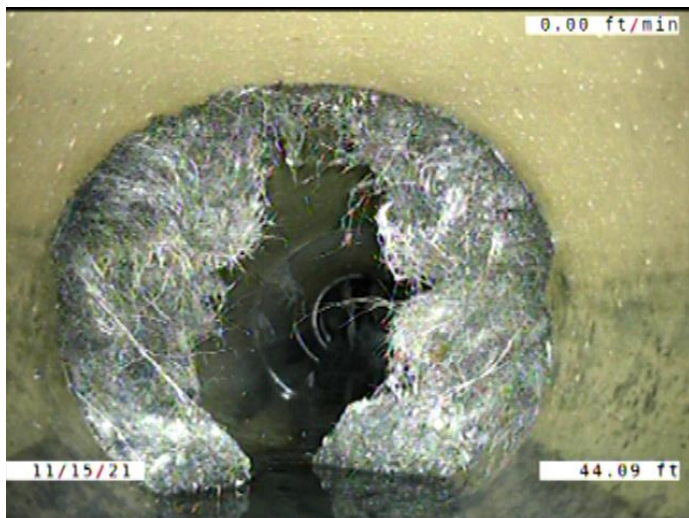
Code: **RBJ**
 Description: **Roots Ball Joint**

Distance (ft): **44.1**
 Structural Grade: **0**
 O&M Grade: **4**
 Clock Start/From: **7**
 Clock To: **5**
 1st Value:
 2nd Value:
 Value Percent: **70.000**
 Continuous Index:
 Within 8" of Joint: **YES**
 Remarks:

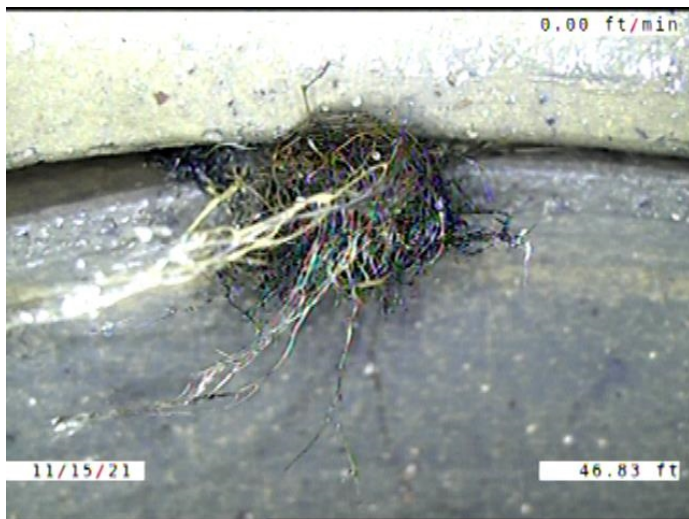
Code: **RFJ**
 Description: **Roots Fine Joint**

Distance (ft): **46.8**
 Structural Grade: **0**
 O&M Grade: **1**
 Clock Start/From: **10**
 Clock To:
 1st Value:
 2nd Value:
 Value Percent:
 Continuous Index:
 Within 8" of Joint: **YES**
 Remarks:

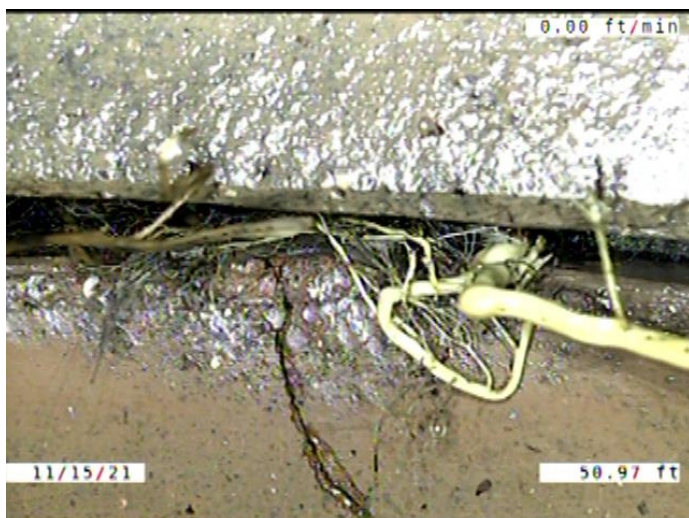
Code: **RFJ**
 Description: **Roots Fine Joint**

Distance (ft): **51.0**
 Structural Grade: **0**
 O&M Grade: **1**
 Clock Start/From: **12**
 Clock To: **2**
 1st Value:
 2nd Value:
 Value Percent:
 Continuous Index:
 Within 8" of Joint: **YES**
 Remarks:

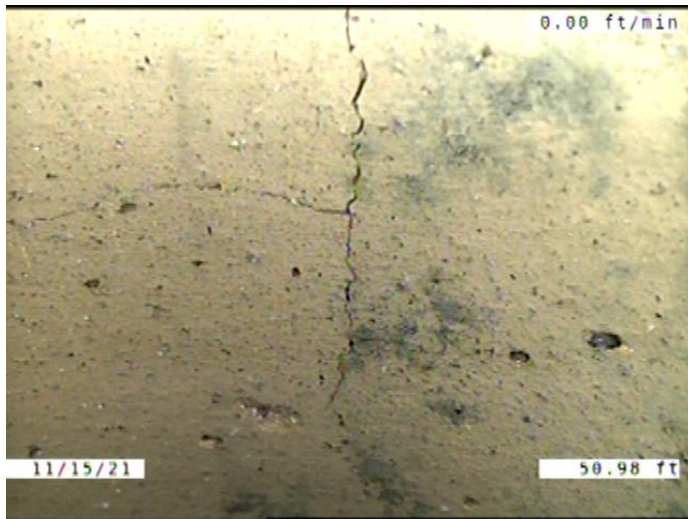
Code: **CM**
 Description: **Crack Multiple**

Distance (ft): **51.0**
 Structural Grade: **3**
 O&M Grade: **0**
 Clock Start/From: **12**
 Clock To: **3**
 1st Value:
 2nd Value:
 Value Percent:
 Continuous Index:
 Within 8" of Joint: **YES**
 Remarks:

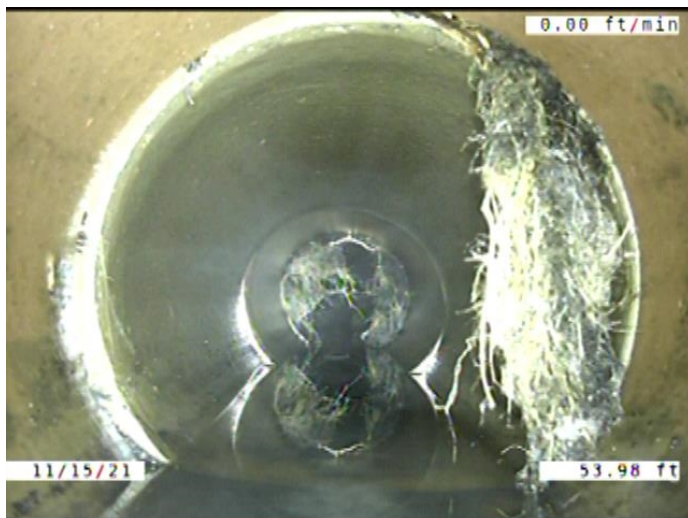
Code: **RMJ**
 Description: **Roots Medium Joint**

Distance (ft): **54.0**
 Structural Grade: **0**
 O&M Grade: **3**
 Clock Start/From: **9**
 Clock To: **4**
 1st Value:
 2nd Value:
 Value Percent: **10.000**
 Continuous Index:
 Within 8" of Joint: **YES**
 Remarks:

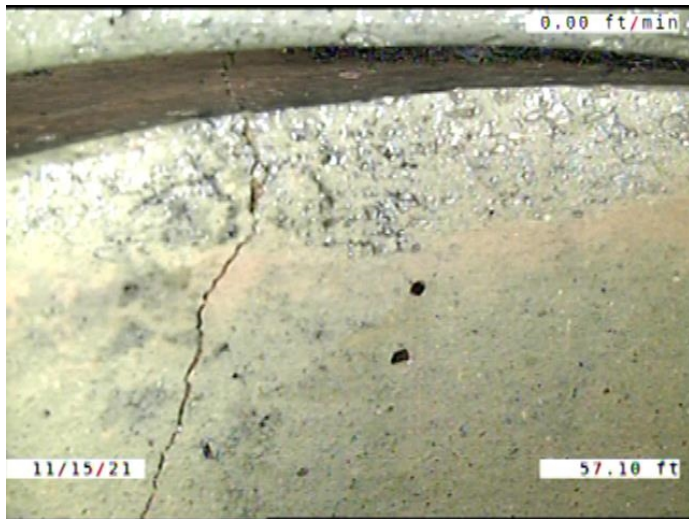
Code: **CS**
 Description: **Crack Spiral**

Distance (ft): **57.1**
 Structural Grade: **2**
 O&M Grade: **0**
 Clock Start/From: **8**
 Clock To: **10**
 1st Value:
 2nd Value:
 Value Percent:
 Continuous Index:
 Within 8" of Joint: **YES**
 Remarks:

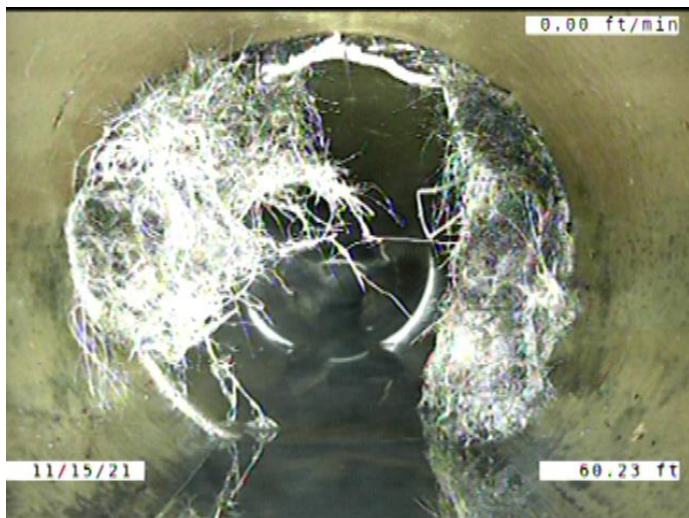
Code: **RMJ**
 Description: **Roots Medium Joint**

Distance (ft): **60.2**
 Structural Grade: **0**
 O&M Grade: **3**
 Clock Start/From: **8**
 Clock To: **5**
 1st Value:
 2nd Value:
 Value Percent: **50.000**
 Continuous Index:
 Within 8" of Joint: **YES**
 Remarks:

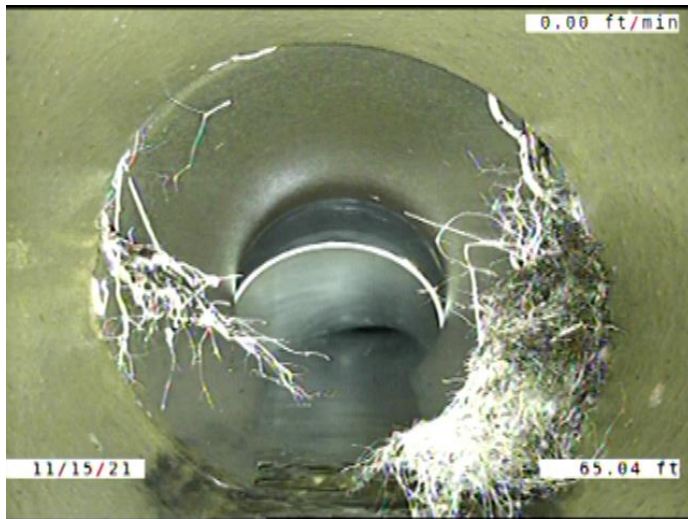
Code: **RMJ**
 Description: **Roots Medium Joint**

Distance (ft): **65.0**
 Structural Grade: **0**
 O&M Grade: **3**
 Clock Start/From: **8**
 Clock To: **5**
 1st Value:
 2nd Value:
 Value Percent: **15.000**
 Continuous Index:
 Within 8" of Joint: **YES**
 Remarks:

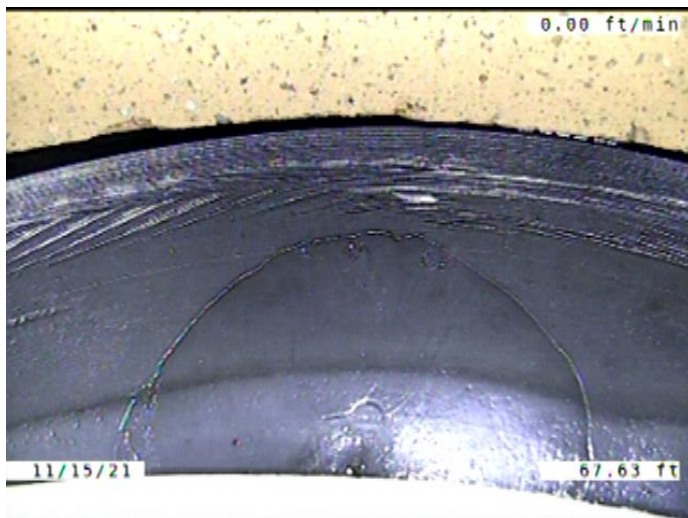
Code: **JOLD**
 Description: **Joint Offset Large Defective**

Distance (ft): **67.6**
 Structural Grade: **4**
 O&M Grade: **0**
 Clock Start/From:
 Clock To:
 1st Value:
 2nd Value:
 Value Percent:
 Continuous Index:
 Within 8" of Joint: **NO**
 Remarks:

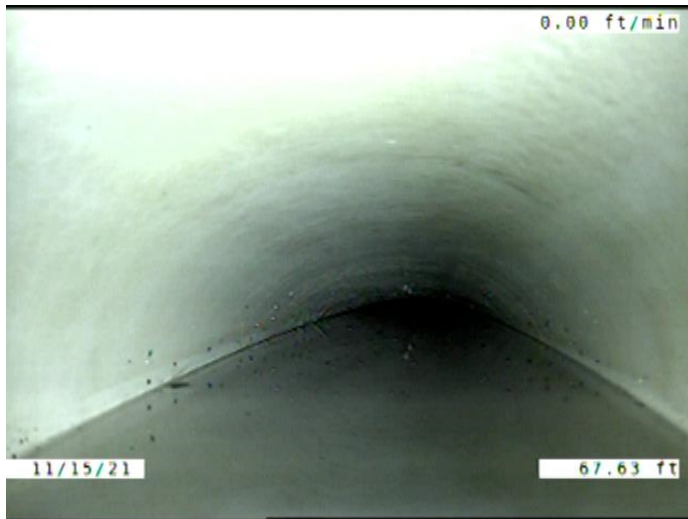
Code: **DSF**
Description: **Deposits Settled Fine**

Distance (ft): **67.6**
Structural Grade: **0**
O&M Grade: **2**
Clock Start/From: **5**
Clock To: **7**
1st Value:
2nd Value:
Value Percent: **5.000**
Continuous Index: **F01**
Within 8" of Joint: **YES**
Remarks:

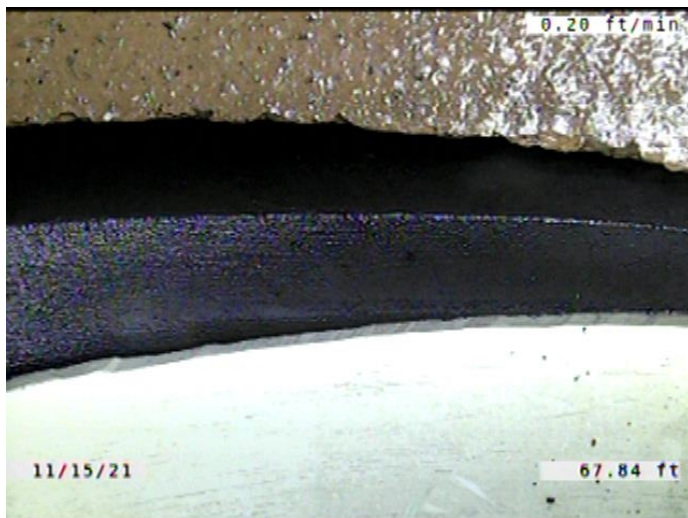
Code: **MMC**
Description: **Miscellaneous Material Change**

Distance (ft): **67.8**
Structural Grade: **0**
O&M Grade: **0**
Clock Start/From:
Clock To:
1st Value:
2nd Value:
Value Percent:
Continuous Index:
Within 8" of Joint: **NO**
Remarks: **VCP TO PVC**
