Profile/Photo Observation Report

Date:	11/14/2021	Weather:		Coding:	PACP 7.0
Pipe Length (ft):	331.8	Owner:	City of Hobart	Pre Clean:	Heavy Cleaning
P.O.#:	YES502259	Surveyor:	S. Bucklin	PSR:	P-604-001-061
Customer:	City of Hobart	Clean Date:	11/14/2021	Shape:	C

Street:	South Lake Park Avenue	Flow Control:	Not Controlled
City:	Hobart, IN	Year Renewed:	
Location:	Local rural streets with light traffic, t	Tape/Media #:	
Purpose:	Routine Assessment	Dia/Height:	10"
Use:	Sanitary Sewage Pipe	Material:	VCP
Drain Area:		Lining:	Cured-In-Place Pipe
Category:	NA		
Comment:

Location Details:		Direction of Survey:	Downstream
US MH:	M-605-061	DS MH:	M-604-001
		Total Length Surveyed (ft):	331.8

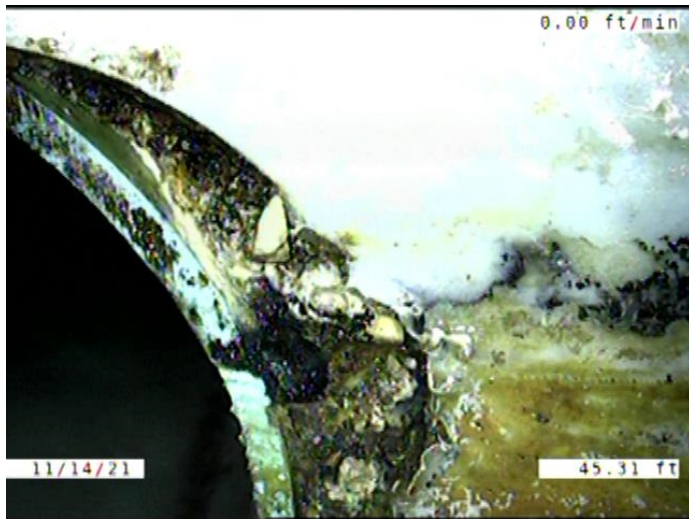
Code:	DAE
Description:	Deposits Attached Encrustation
Distance (ft):	45.3
Structural Grade:	0
O&M Grade:	2
Clock Start/From:	1
Clock To:	5
1st Value:	
2nd Value:	
Value Percent:	5.000
Continuous Index:	
Within 8" of Joint:	YES
Remarks:

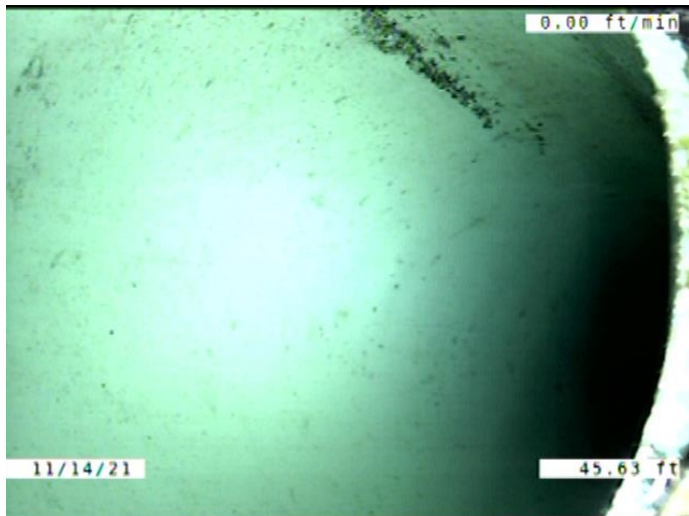
Code:	TBI
Description:	Tap Break-in Intruding
Distance (ft):	45.6
Structural Grade:	0
O&M Grade:	2
Clock Start/From:	2
Clock To:	
1st Value:	4.000
2nd Value:	1.000
Value Percent:	
Continuous Index:	
Within 8" of Joint:	YES
Remarks:

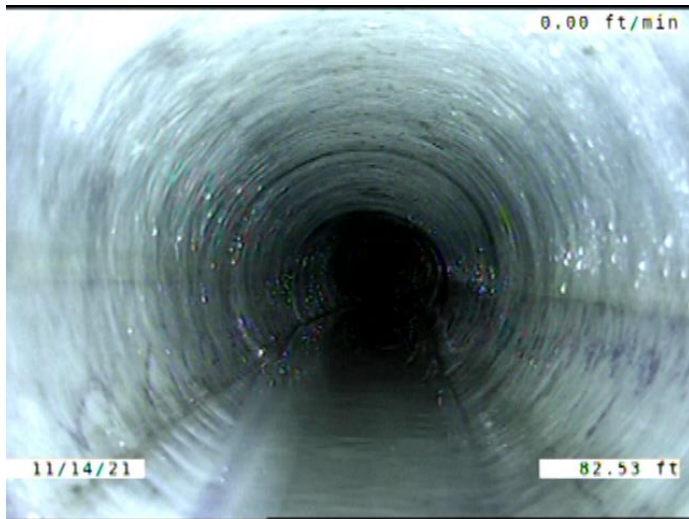
Code: **MWLS**
Description: **Miscellaneous Water Level Sag**

Distance (ft): **82.5**
Structural Grade: **2**
O&M Grade: **0**
Clock Start/From:
Clock To:
1st Value:
2nd Value:
Value Percent: **10.000**
Continuous Index: **S01**
Within 8" of Joint: **NO**
Remarks:

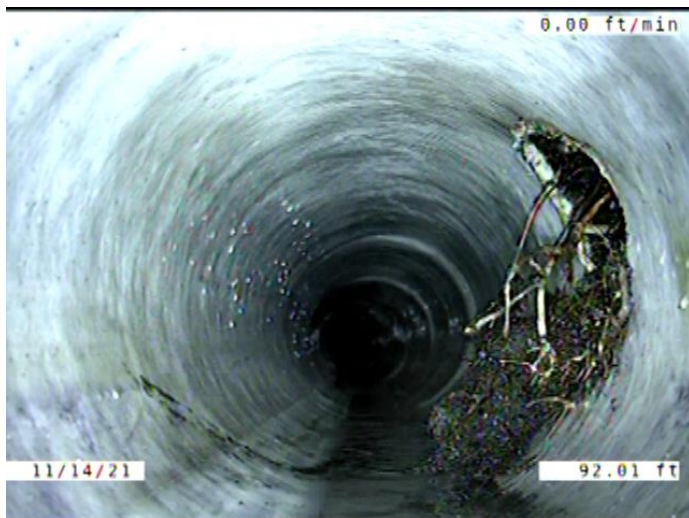
Code: **RML**
Description: **Roots Medium Lateral**

Distance (ft): **92.0**
Structural Grade: **0**
O&M Grade: **3**
Clock Start/From: **2**
Clock To: **3**
1st Value:
2nd Value:
Value Percent: **5.000**
Continuous Index:
Within 8" of Joint: **NO**
Remarks:

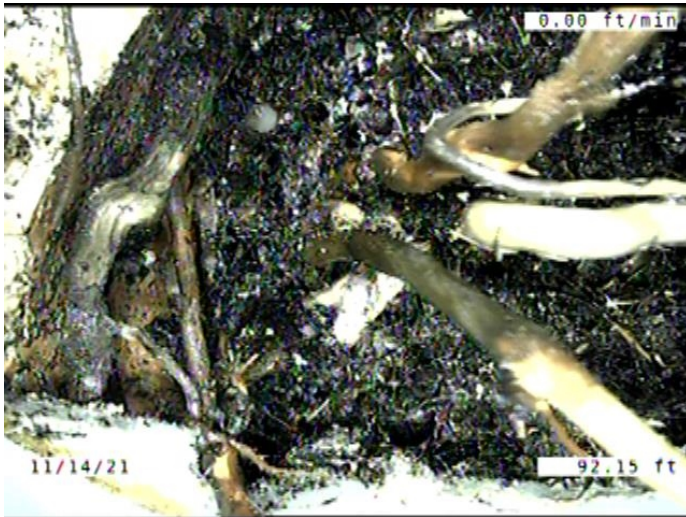
Code:	TBD
Description:	Tap Break-in/Hammer Defective
Distance (ft):	92.1
Structural Grade:	0
O&M Grade:	3
Clock Start/From:	2
Clock To:	
1st Value:	4.000
2nd Value:	
Value Percent:	
Continuous Index:	
Within 8" of Joint:	YES
Remarks:	LOOKS TO BE 100% PLUGGED WITH ROOTS

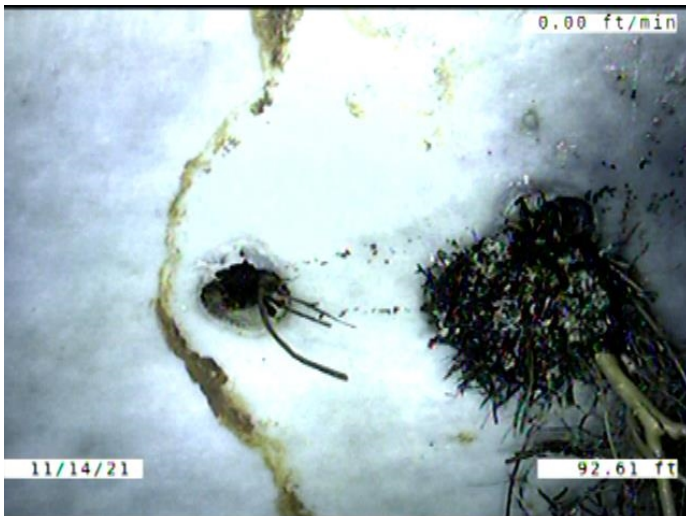
Code:	H
Description:	Hole
Distance (ft):	92.6
Structural Grade:	5
O&M Grade:	0
Clock Start/From:	2
Clock To:	3
1st Value:	
2nd Value:	
Value Percent:	
Continuous Index:	
Within 8" of Joint:	NO
Remarks:

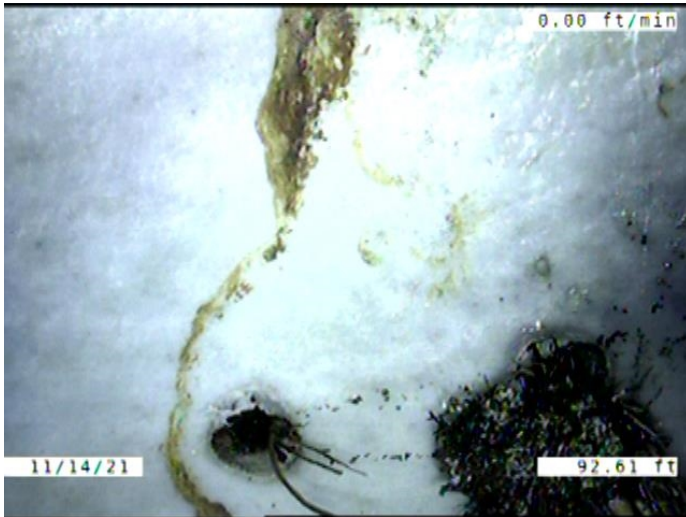
Code: **ISB**
 Description: **Infiltration Stain Barrel**

Distance (ft): **92.6**
 Structural Grade: **0**
 O&M Grade: **1**
 Clock Start/From: **2**
 Clock To: **5**
 1st Value:
 2nd Value:
 Value Percent:
 Continuous Index:
 Within 8" of Joint: **NO**
 Remarks:

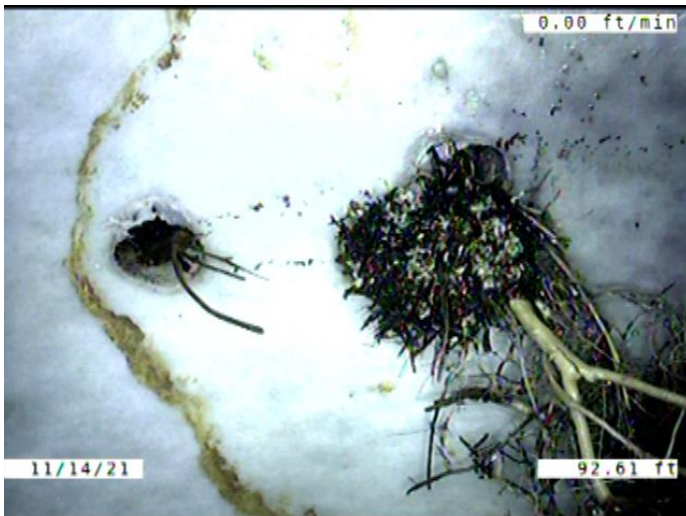
Code: **RFB**
 Description: **Roots Fine Barrel**

Distance (ft): **92.6**
 Structural Grade: **0**
 O&M Grade: **2**
 Clock Start/From: **2**
 Clock To: **3**
 1st Value:
 2nd Value:
 Value Percent:
 Continuous Index:
 Within 8" of Joint: **NO**
 Remarks:

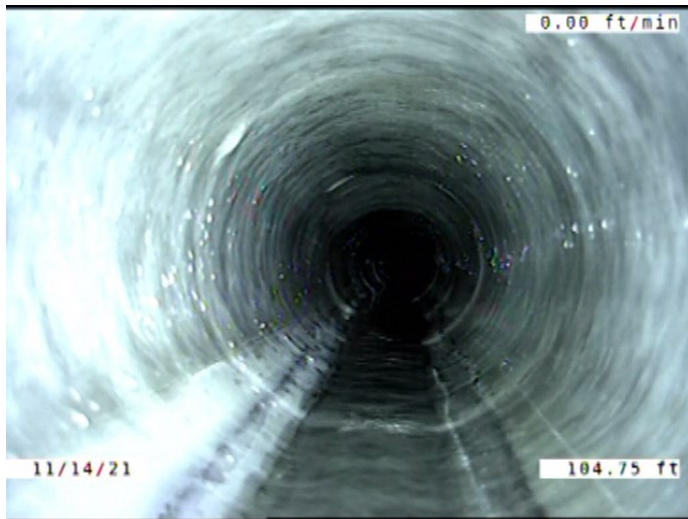
Code: **MWLS**
 Description: **Miscellaneous Water Level Sag**

Distance (ft): **104.7**
 Structural Grade: **2**
 O&M Grade: **0**
 Clock Start/From:
 Clock To:
 1st Value:
 2nd Value:
 Value Percent: **10.000**
 Continuous Index: **F01**
 Within 8" of Joint: **NO**
 Remarks:

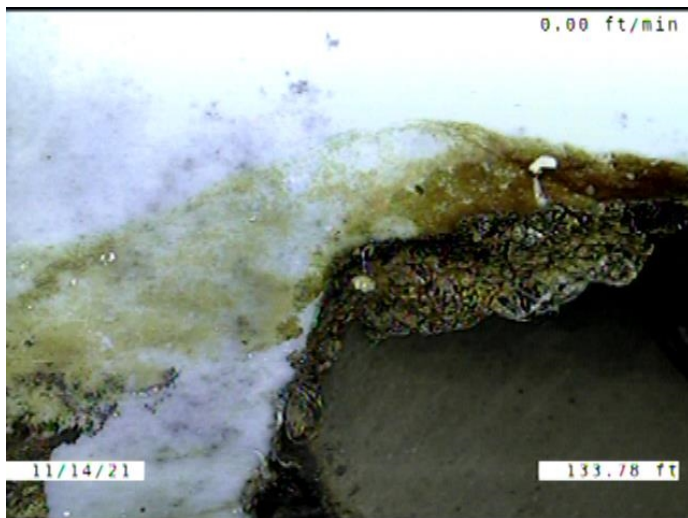
Code: **DAE**
 Description: **Deposits Attached Encrustation**

Distance (ft): **133.8**
 Structural Grade: **0**
 O&M Grade: **2**
 Clock Start/From: **8**
 Clock To: **5**
 1st Value:
 2nd Value:
 Value Percent: **5.000**
 Continuous Index:
 Within 8" of Joint: **YES**
 Remarks:

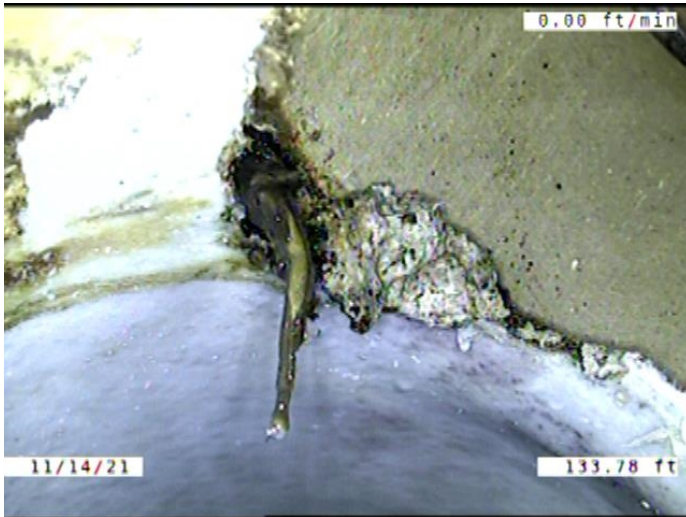
Code: **RFC**
 Description: **Roots Fine Connection**

Distance (ft): **133.8**
 Structural Grade: **0**
 O&M Grade: **1**
 Clock Start/From: **1**
 Clock To:
 1st Value:
 2nd Value:
 Value Percent:
 Continuous Index:
 Within 8" of Joint: **NO**
 Remarks:

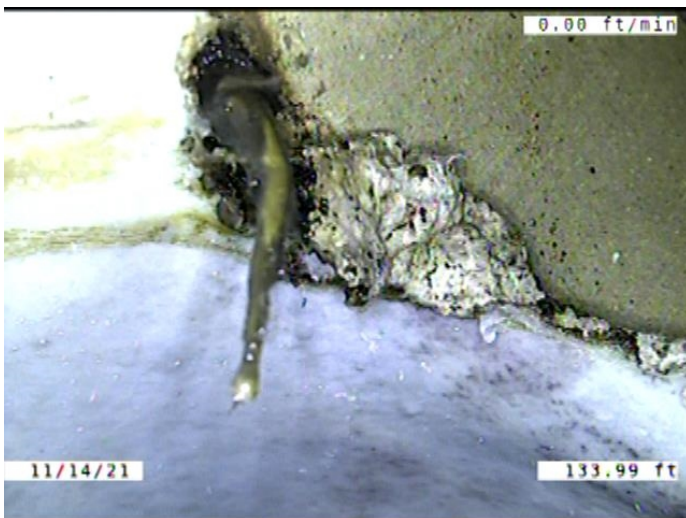
Code: **IWC**
 Description: **Infiltration Weeper Connection**

Distance (ft): **134.0**
 Structural Grade: **0**
 O&M Grade: **2**
 Clock Start/From: **1**
 Clock To:
 1st Value:
 2nd Value:
 Value Percent:
 Continuous Index:
 Within 8" of Joint: **NO**
 Remarks:

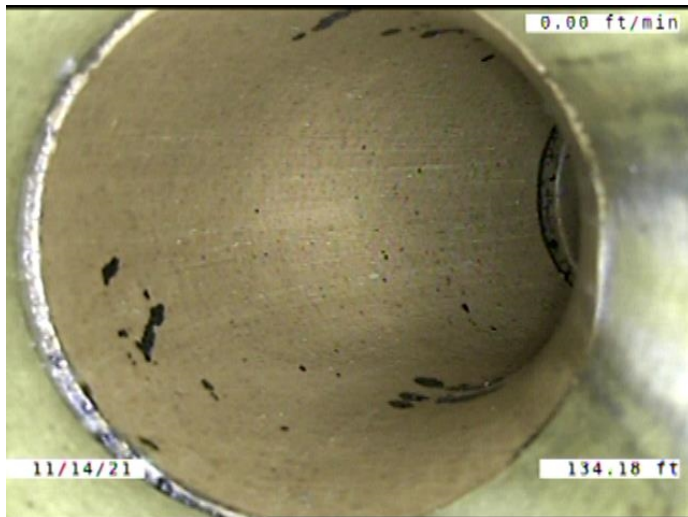
Code: **TB**
 Description: **Tap Break-in/Hammer**

Distance (ft): **134.2**
 Structural Grade: **0**
 O&M Grade: **0**
 Clock Start/From: **2**
 Clock To:
 1st Value: **4.000**
 2nd Value:
 Value Percent:
 Continuous Index:
 Within 8" of Joint: **YES**
 Remarks: **CONSTANTLY RUNNING WATER**

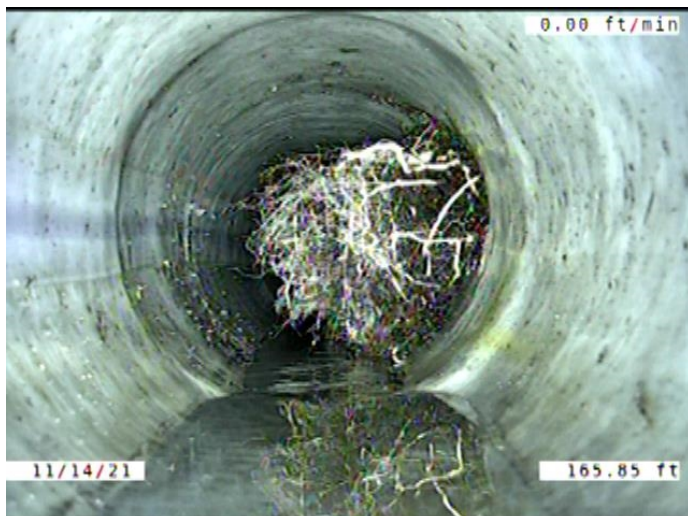
Code: **RBC**
 Description: **Roots Ball Connection**

Distance (ft): **165.8**
 Structural Grade: **0**
 O&M Grade: **4**
 Clock Start/From: **1**
 Clock To: **3**
 1st Value:
 2nd Value:
 Value Percent: **75.000**
 Continuous Index:
 Within 8" of Joint: **NO**
 Remarks:

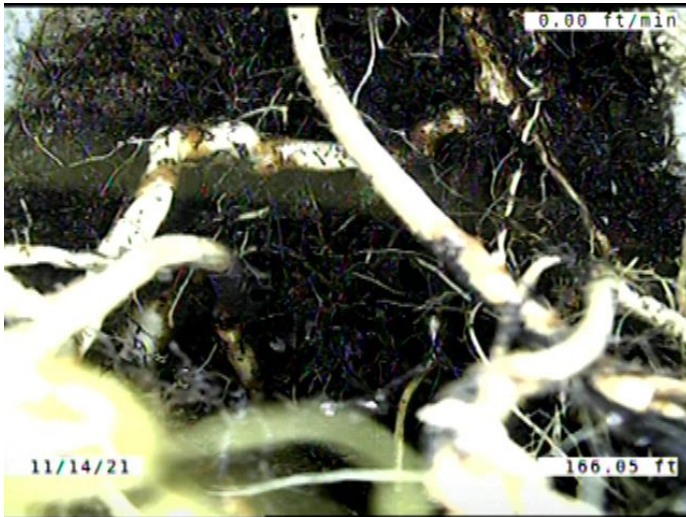
Code:	TBD
Description:	Tap Break-in/Hammer Defective
Distance (ft):	166.0
Structural Grade:	0
O&M Grade:	3
Clock Start/From:	2
Clock To:	
1st Value:	4.000
2nd Value:	
Value Percent:	
Continuous Index:	
Within 8" of Joint:	YES
Remarks:	LOOKS TO BE 100% PLUGGED WITH ROOTS

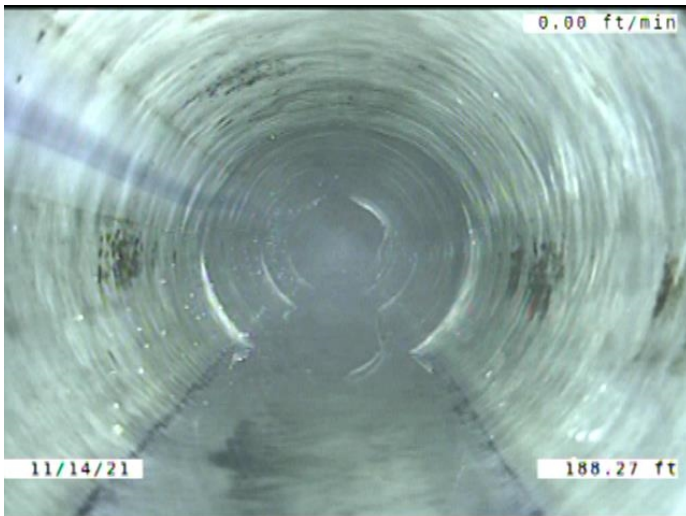
Code:	MWLS
Description:	Miscellaneous Water Level Sag
Distance (ft):	188.3
Structural Grade:	2
O&M Grade:	0
Clock Start/From:	
Clock To:	
1st Value:	
2nd Value:	
Value Percent:	10.000
Continuous Index:	
Within 8" of Joint:	NO
Remarks:

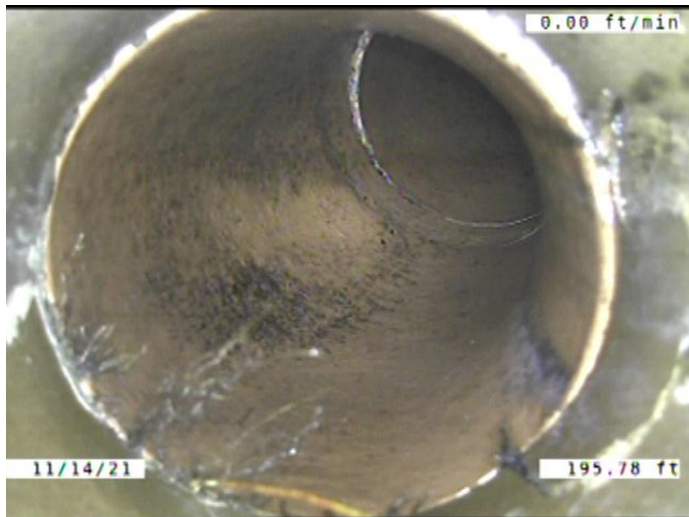
Code: **TB**
 Description: **Tap Break-in/Hammer**

Distance (ft): **195.8**
 Structural Grade: **0**
 O&M Grade: **0**
 Clock Start/From: **2**
 Clock To:
 1st Value: **4.000**
 2nd Value:
 Value Percent:
 Continuous Index:
 Within 8" of Joint: **YES**
 Remarks: **ROOTS GROWING OUT OF THE JOINT**

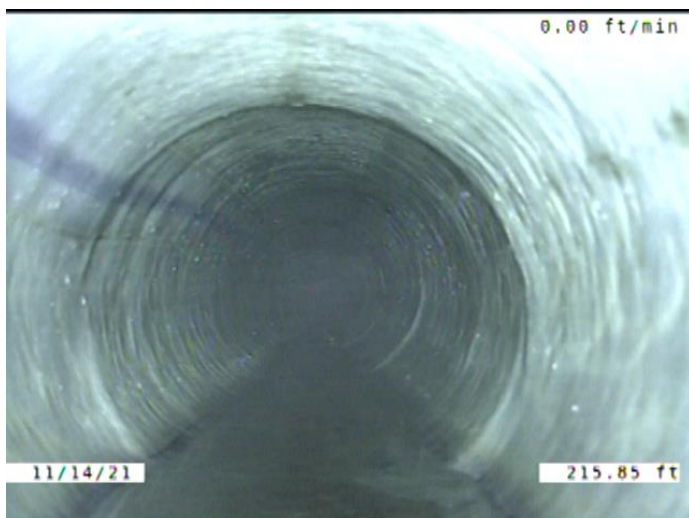
Code: **MWLS**
 Description: **Miscellaneous Water Level Sag**

Distance (ft): **215.8**
 Structural Grade: **2**
 O&M Grade: **0**
 Clock Start/From:
 Clock To:
 1st Value:
 2nd Value:
 Value Percent: **5.000**
 Continuous Index:
 Within 8" of Joint: **NO**
 Remarks:

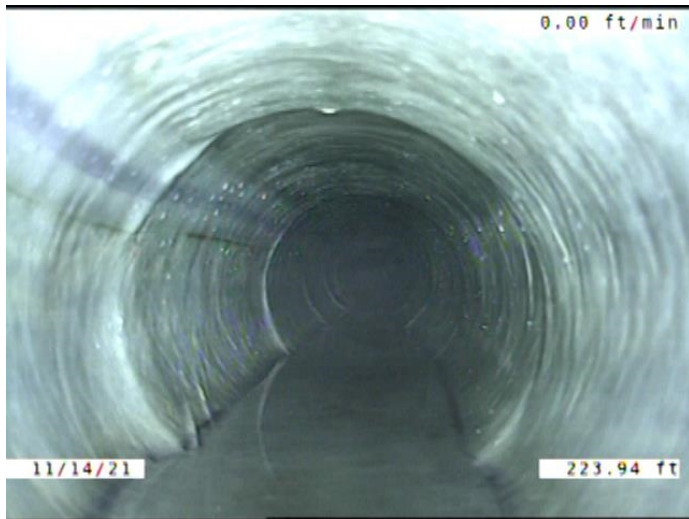
Code: **MWLS**
Description: **Miscellaneous Water Level Sag**

Distance (ft): **223.9**
Structural Grade: **2**
O&M Grade: **0**
Clock Start/From:
Clock To:
1st Value:
2nd Value:
Value Percent: **5.000**
Continuous Index: **S02**
Within 8" of Joint: **NO**
Remarks:

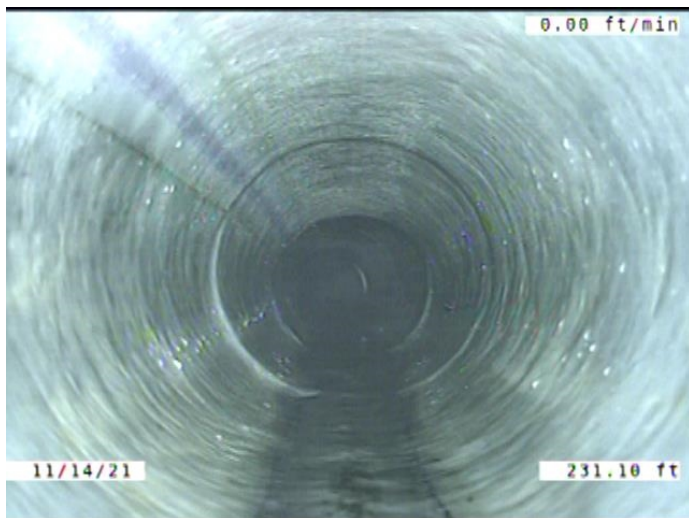
Code: **MWLS**
Description: **Miscellaneous Water Level Sag**

Distance (ft): **231.1**
Structural Grade: **2**
O&M Grade: **0**
Clock Start/From:
Clock To:
1st Value:
2nd Value:
Value Percent: **5.000**
Continuous Index: **F02**
Within 8" of Joint: **NO**
Remarks:

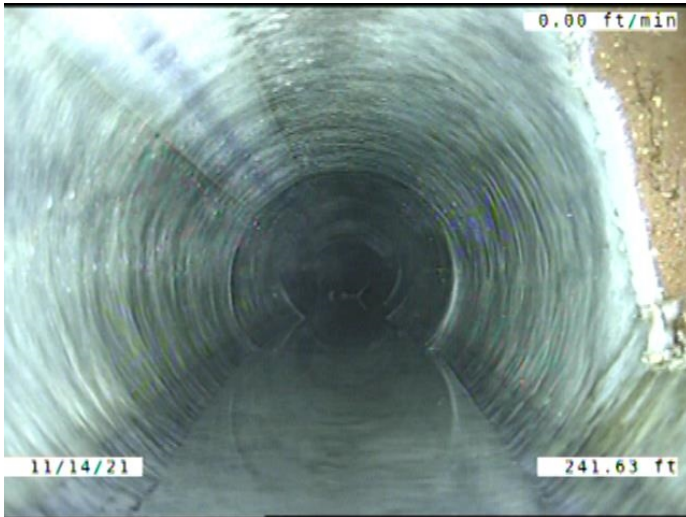
Code: **MWLS**
 Description: **Miscellaneous Water Level Sag**

Distance (ft): **241.6**
 Structural Grade: **2**
 O&M Grade: **0**
 Clock Start/From:
 Clock To:
 1st Value:
 2nd Value:
 Value Percent: **5.000**
 Continuous Index: **S03**
 Within 8" of Joint: **NO**
 Remarks:

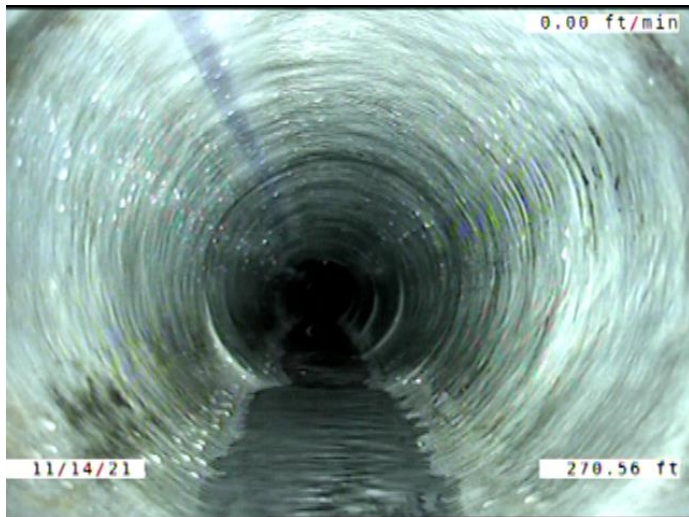
Code: **MWLS**
 Description: **Miscellaneous Water Level Sag**

Distance (ft): **270.6**
 Structural Grade: **2**
 O&M Grade: **0**
 Clock Start/From:
 Clock To:
 1st Value:
 2nd Value:
 Value Percent: **5.000**
 Continuous Index: **F03**
 Within 8" of Joint: **NO**
 Remarks:

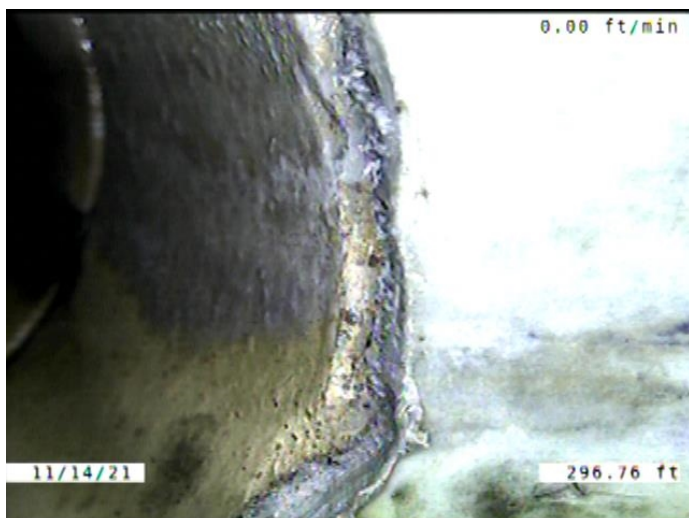
Code: **B**
 Description: **Broken**

Distance (ft): **296.8**
 Structural Grade: **4**
 O&M Grade: **0**
 Clock Start/From: **12**
 Clock To: **2**
 1st Value:
 2nd Value:
 Value Percent:
 Continuous Index:
 Within 8" of Joint: **YES**
 Remarks:
