Profile/Photo Observation Report

Date:	11/15/2021	Weather:		Coding:	PACP 7.0
Pipe Length (ft):	79.1	Owner:	City of Hobart	Pre Clean:	Heavy Cleaning
P.O.#:	YES502259	Surveyor:	S. Bucklin	PSR:	P-605-060-061
Customer:	City of Hobart	Clean Date:	11/14/2021	Shape:	C

Street:	South Lake Park Avenue	Flow Control:	Not Controlled
City:	Hobart, IN	Year Renewed:	
Location:	Local rural streets with light traffic, t	Tape/Media #:	
Purpose:	Routine Assessment	Dia/Height:	8"
Use:	Sanitary Sewage Pipe	Material:	VCP
Drain Area:		Lining:	None
Category:	NA		
Comment:			
Location Details:		Direction of Survey:	Upstream
US MH:	M-605-061	DS MH:	M-605-060
		Total Length Surveyed (ft):	79.1

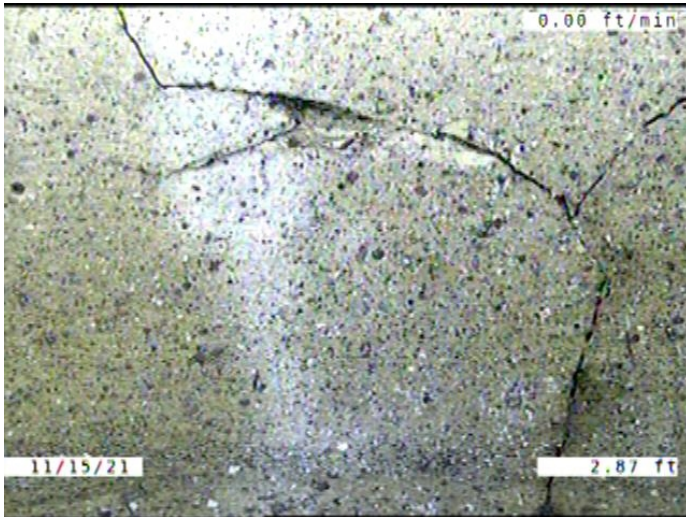
Code: **FM**
 Description: **Fracture Multiple**

Distance (ft): **2.9**
 Structural Grade: **4**
 O&M Grade: **0**
 Clock Start/From: **8**
 Clock To: **1**
 1st Value:
 2nd Value:
 Value Percent:
 Continuous Index:
 Within 8" of Joint: **YES**
 Remarks:

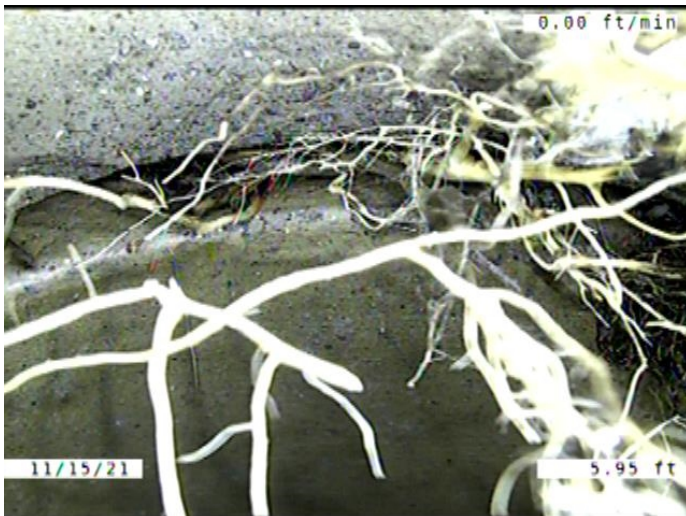
Code: **RMJ**
 Description: **Roots Medium Joint**

Distance (ft): **5.9**
 Structural Grade: **0**
 O&M Grade: **3**
 Clock Start/From: **9**
 Clock To: **2**
 1st Value:
 2nd Value:
 Value Percent: **5.000**
 Continuous Index:
 Within 8" of Joint: **YES**
 Remarks:

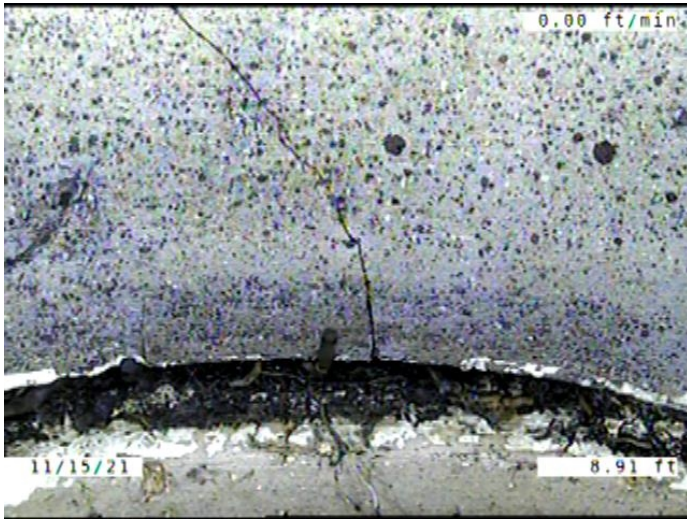
Code: **CM**
 Description: **Crack Multiple**

Distance (ft): **8.9**
 Structural Grade: **3**
 O&M Grade: **0**
 Clock Start/From: **10**
 Clock To: **12**
 1st Value:
 2nd Value:
 Value Percent:
 Continuous Index:
 Within 8" of Joint: **YES**
 Remarks:

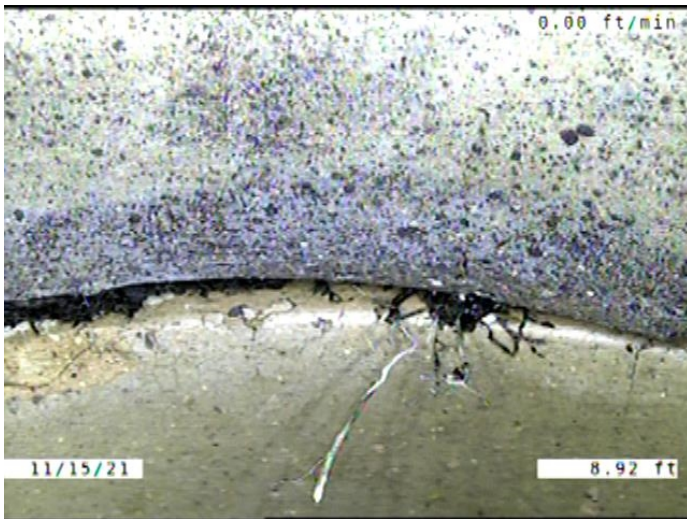
Code: **RFJ**
 Description: **Roots Fine Joint**

Distance (ft): **8.9**
 Structural Grade: **0**
 O&M Grade: **1**
 Clock Start/From: **9**
 Clock To: **3**
 1st Value:
 2nd Value:
 Value Percent:
 Continuous Index: **S01**
 Within 8" of Joint: **YES**
 Remarks:

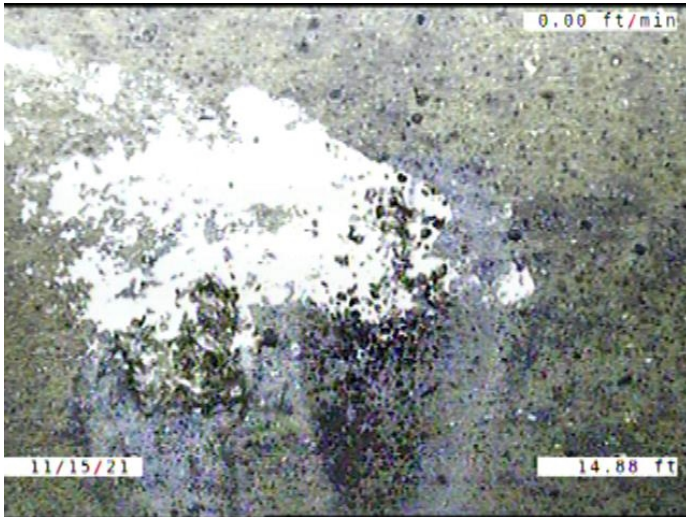
Code: **DAE**
 Description: **Deposits Attached Encrustation**

Distance (ft): **14.9**
 Structural Grade: **0**
 O&M Grade: **2**
 Clock Start/From: **8**
 Clock To: **9**
 1st Value:
 2nd Value:
 Value Percent: **5.000**
 Continuous Index:
 Within 8" of Joint: **YES**
 Remarks:

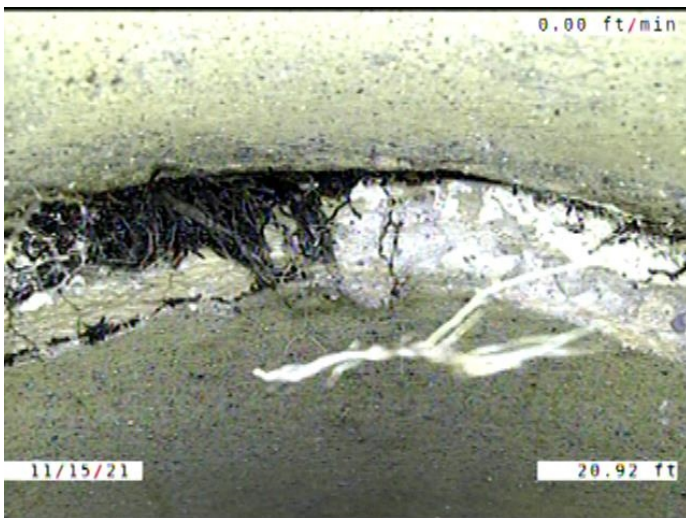
Code: **JOM**
 Description: **Joint Offset Medium**

Distance (ft): **20.9**
 Structural Grade: **3**
 O&M Grade: **0**
 Clock Start/From:
 Clock To:
 1st Value:
 2nd Value:
 Value Percent:
 Continuous Index:
 Within 8" of Joint: **NO**
 Remarks:

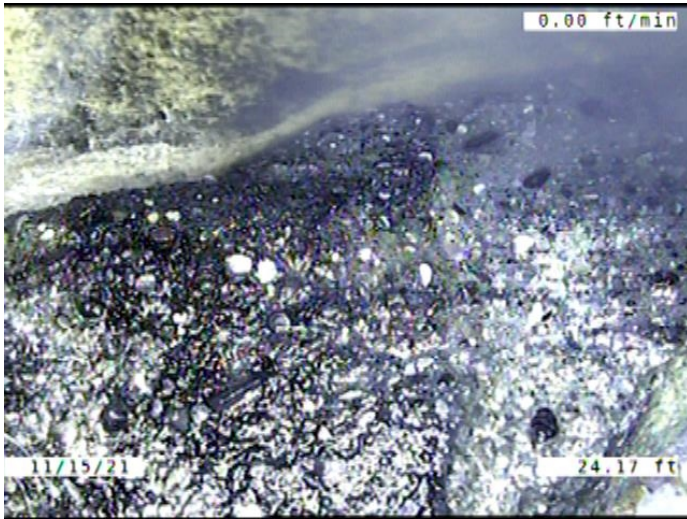
Code: **DAE**
 Description: **Deposits Attached Encrustation**

Distance (ft): **24.2**
 Structural Grade: **0**
 O&M Grade: **2**
 Clock Start/From: **4**
 Clock To: **8**
 1st Value:
 2nd Value:
 Value Percent: **5.000**
 Continuous Index:
 Within 8" of Joint: **YES**
 Remarks:

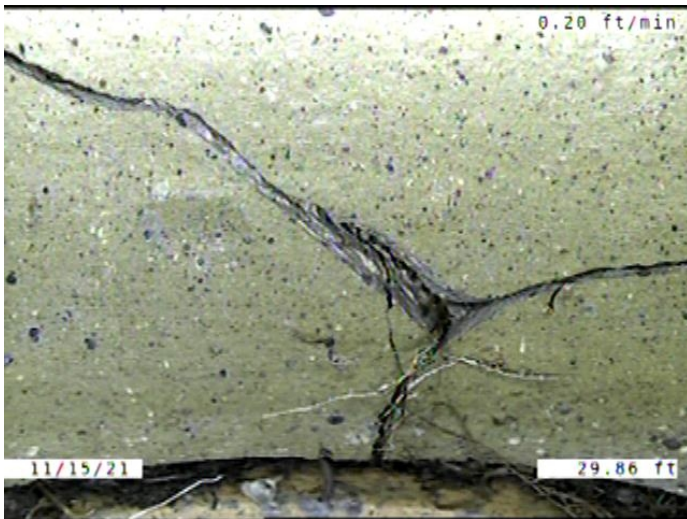
Code: **B**
 Description: **Broken**

Distance (ft): **29.9**
 Structural Grade: **4**
 O&M Grade: **0**
 Clock Start/From: **12**
 Clock To: **12**
 1st Value:
 2nd Value:
 Value Percent:
 Continuous Index:
 Within 8" of Joint: **YES**
 Remarks:

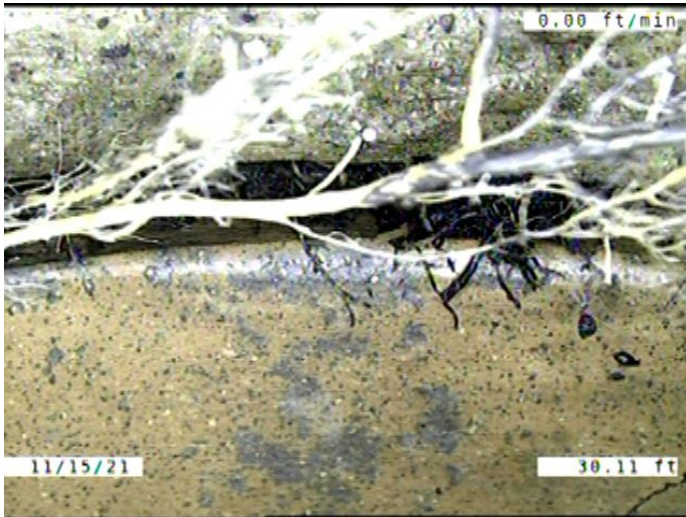
Code: **RMJ**
 Description: **Roots Medium Joint**

Distance (ft): **30.1**
 Structural Grade: **0**
 O&M Grade: **3**
 Clock Start/From: **8**
 Clock To: **4**
 1st Value:
 2nd Value:
 Value Percent: **5.000**
 Continuous Index:
 Within 8" of Joint: **YES**
 Remarks:

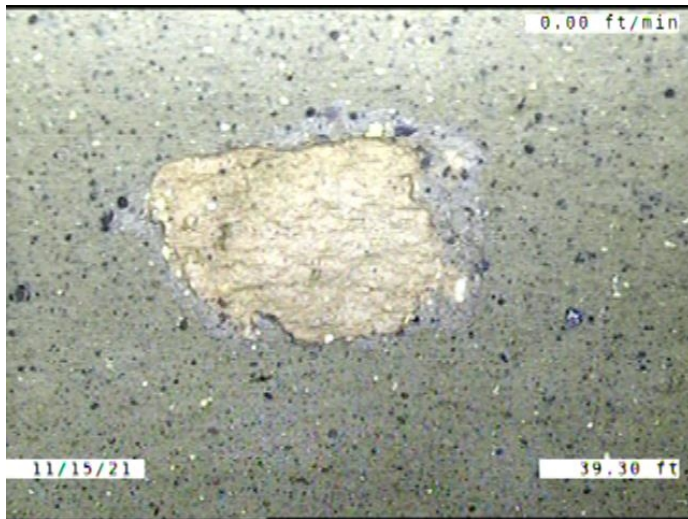
Code:	SSS
Description:	Surface Damage Surface Spalling
Distance (ft):	39.3
Structural Grade:	2
O&M Grade:	0
Clock Start/From:	12
Clock To:	
1st Value:	
2nd Value:	
Value Percent:	
Continuous Index:	
Within 8" of Joint:	NO
Remarks:

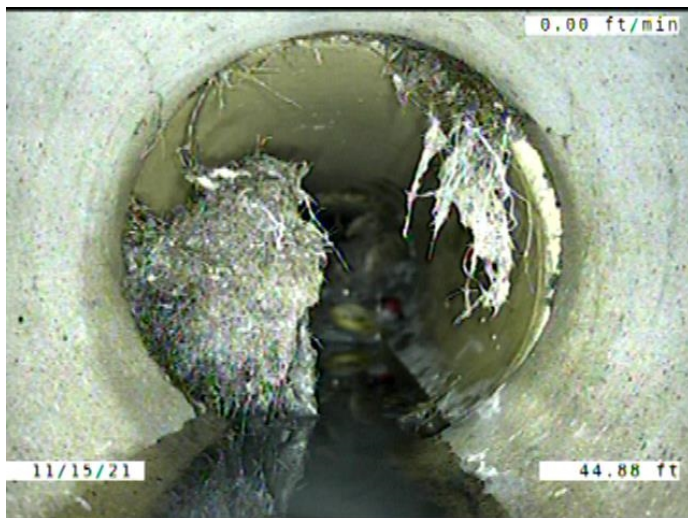
Code:	RMJ
Description:	Roots Medium Joint
Distance (ft):	44.9
Structural Grade:	0
O&M Grade:	3
Clock Start/From:	7
Clock To:	2
1st Value:	
2nd Value:	
Value Percent:	30.000
Continuous Index:	
Within 8" of Joint:	YES
Remarks:

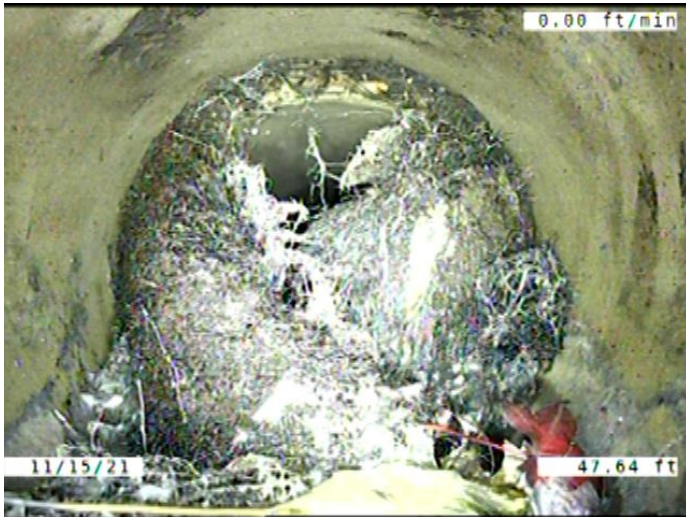
Code: **RBJ**
 Description: **Roots Ball Joint**

Distance (ft): **47.6**
 Structural Grade: **0**
 O&M Grade: **4**
 Clock Start/From: **12**
 Clock To: **12**
 1st Value:
 2nd Value:
 Value Percent: **95.000**
 Continuous Index:
 Within 8" of Joint: **YES**
 Remarks:

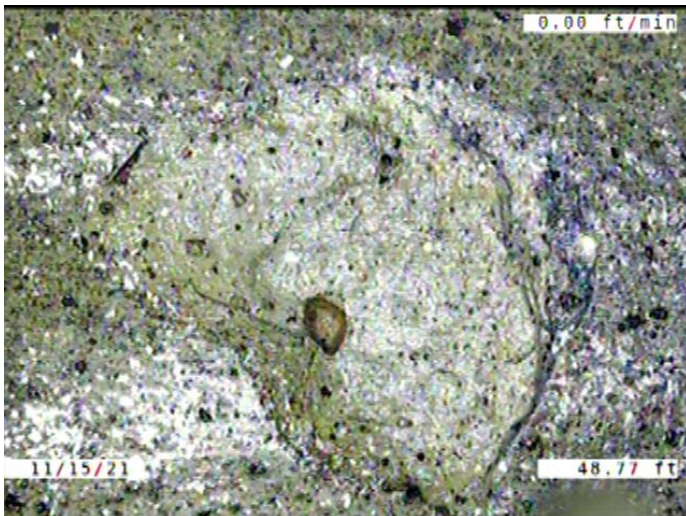
Code: **SSS**
 Description: **Surface Damage Surface Spalling**

Distance (ft): **48.8**
 Structural Grade: **2**
 O&M Grade: **0**
 Clock Start/From: **3**
 Clock To:
 1st Value:
 2nd Value:
 Value Percent:
 Continuous Index:
 Within 8" of Joint: **NO**
 Remarks:

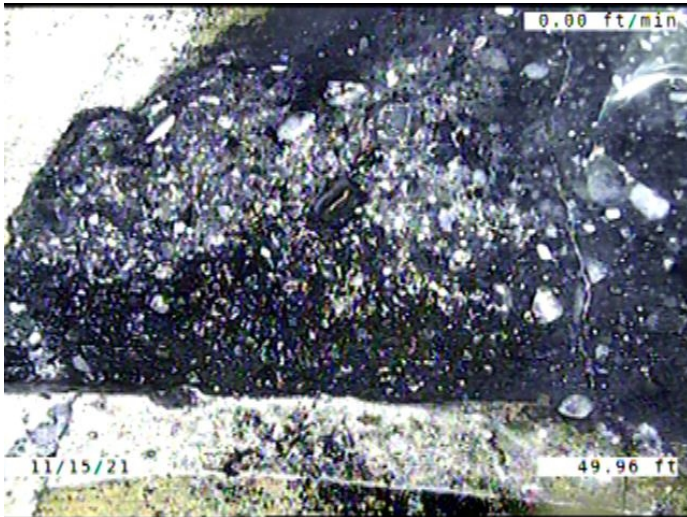
Code: **DAE**
 Description: **Deposits Attached Encrustation**

Distance (ft): **50.0**
 Structural Grade: **0**
 O&M Grade: **2**
 Clock Start/From: **4**
 Clock To: **8**
 1st Value:
 2nd Value:
 Value Percent: **5.000**
 Continuous Index:
 Within 8" of Joint: **YES**
 Remarks:

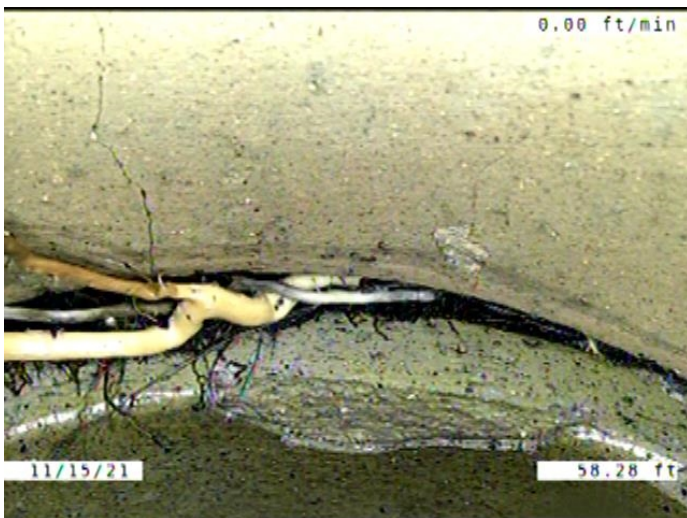
Code: **RMJ**
 Description: **Roots Medium Joint**

Distance (ft): **58.3**
 Structural Grade: **0**
 O&M Grade: **3**
 Clock Start/From: **8**
 Clock To: **4**
 1st Value:
 2nd Value:
 Value Percent: **5.000**
 Continuous Index:
 Within 8" of Joint: **YES**
 Remarks:

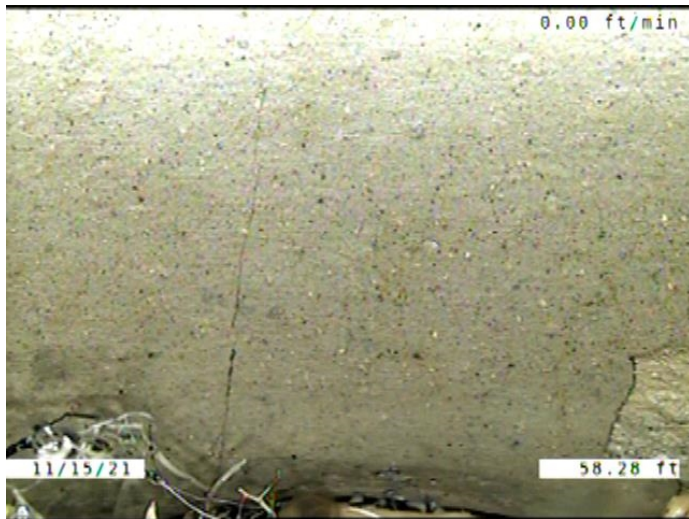
Code: **CM**
 Description: **Crack Multiple**

Distance (ft): **58.3**
 Structural Grade: **3**
 O&M Grade: **0**
 Clock Start/From: **10**
 Clock To: **2**
 1st Value:
 2nd Value:
 Value Percent:
 Continuous Index:
 Within 8" of Joint: **YES**
 Remarks:

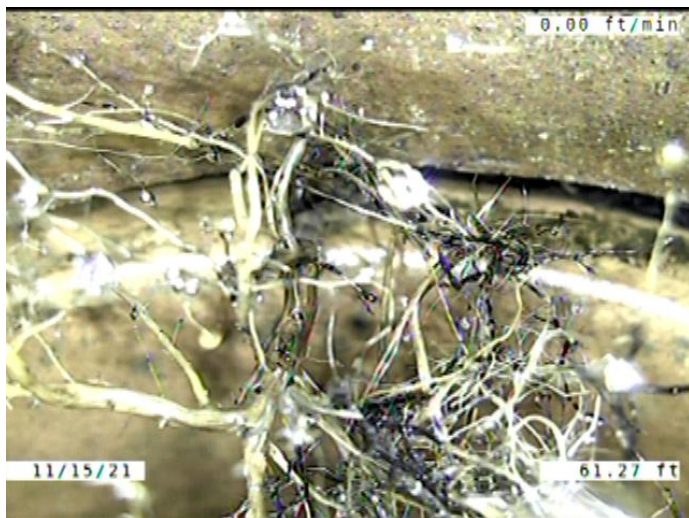
Code: **RMJ**
 Description: **Roots Medium Joint**

Distance (ft): **61.3**
 Structural Grade: **0**
 O&M Grade: **3**
 Clock Start/From: **10**
 Clock To: **1**
 1st Value:
 2nd Value:
 Value Percent: **5.000**
 Continuous Index:
 Within 8" of Joint: **YES**
 Remarks:

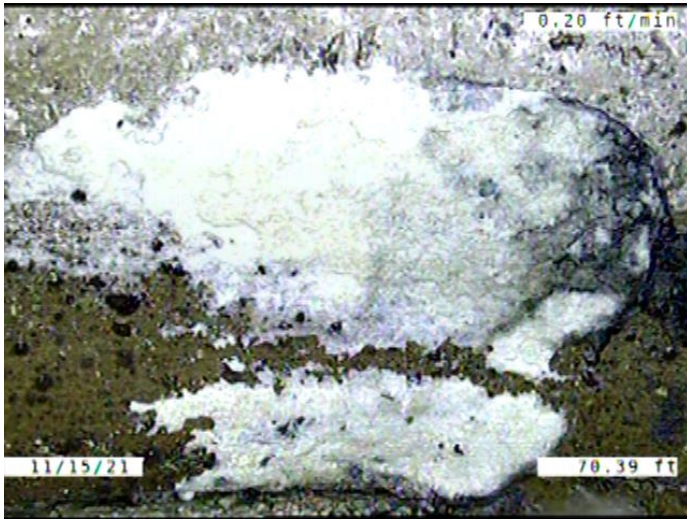
Code: **DAE**
Description: **Deposits Attached Encrustation**

Distance (ft): **70.4**
Structural Grade: **0**
O&M Grade: **2**
Clock Start/From: **10**
Clock To:
1st Value:
2nd Value:
Value Percent: **5.000**
Continuous Index:
Within 8" of Joint: **NO**
Remarks:

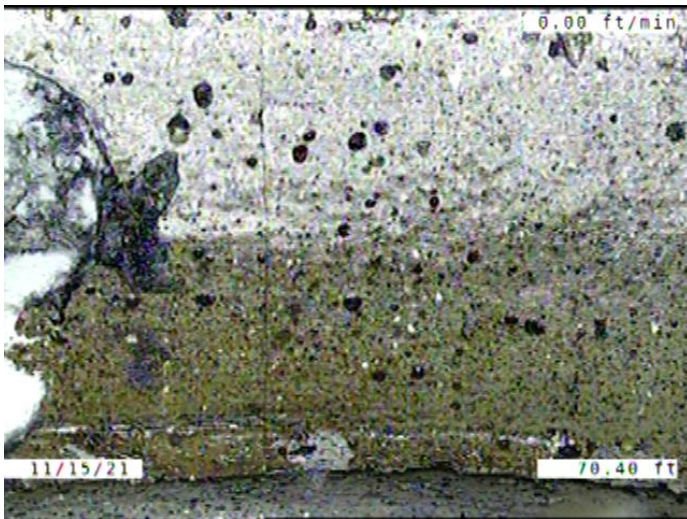
Code: **CL**
Description: **Crack Longitudinal**

Distance (ft): **70.4**
Structural Grade: **2**
O&M Grade: **0**
Clock Start/From: **11**
Clock To:
1st Value:
2nd Value:
Value Percent:
Continuous Index:
Within 8" of Joint: **YES**
Remarks:

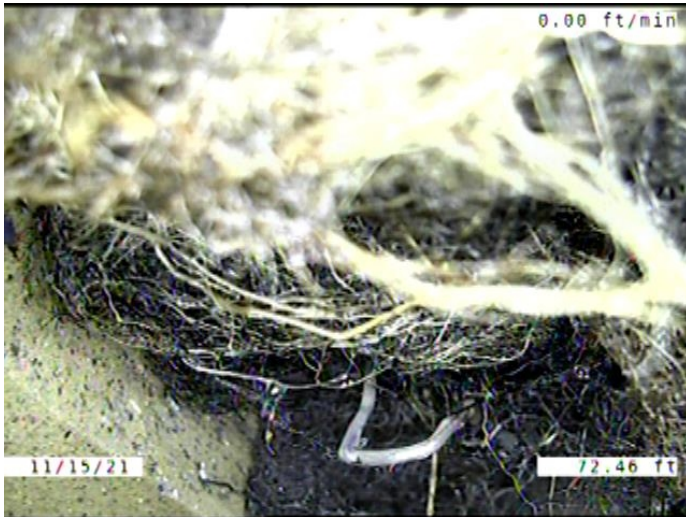
Code: **RMC**
 Description: **Roots Medium Connection**

Distance (ft): **72.5**
 Structural Grade: **0**
 O&M Grade: **3**
 Clock Start/From: **1**
 Clock To: **3**
 1st Value:
 2nd Value:
 Value Percent: **10.000**
 Continuous Index:
 Within 8" of Joint: **NO**
 Remarks:

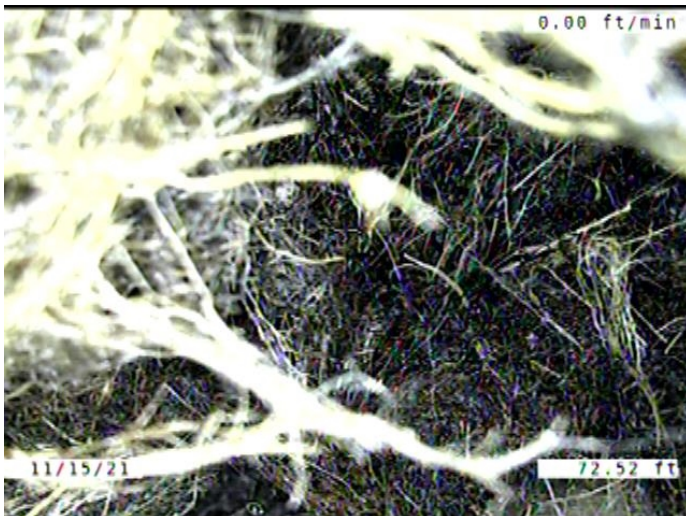
Code: **TFD**
 Description: **Tap Factory Defective**

Distance (ft): **72.5**
 Structural Grade: **0**
 O&M Grade: **3**
 Clock Start/From: **2**
 Clock To:
 1st Value: **4.000**
 2nd Value:
 Value Percent:
 Continuous Index:
 Within 8" of Joint: **YES**
 Remarks: **LOOKS TO BE 100% PLUGGED WITH ROOTS**

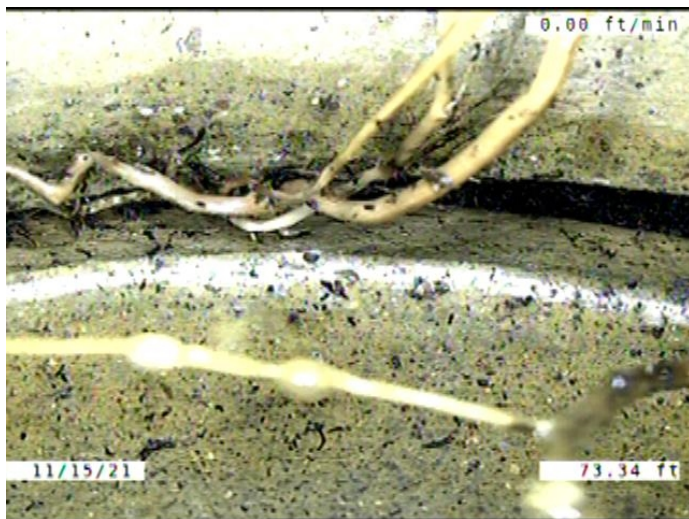
Code: **RMJ**
 Description: **Roots Medium Joint**

Distance (ft): **73.3**
 Structural Grade: **0**
 O&M Grade: **3**
 Clock Start/From: **10**
 Clock To: **2**
 1st Value:
 2nd Value:
 Value Percent: **5.000**
 Continuous Index:
 Within 8" of Joint: **YES**
 Remarks:

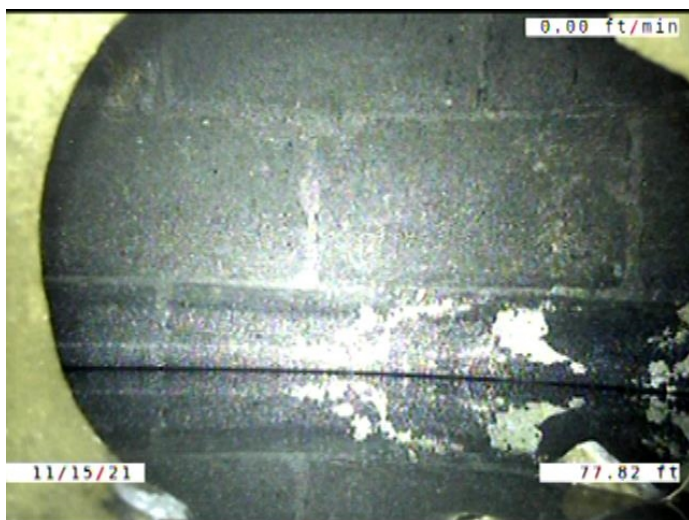
Code: **RFJ**
 Description: **Roots Fine Joint**

Distance (ft): **77.8**
 Structural Grade: **0**
 O&M Grade: **1**
 Clock Start/From: **9**
 Clock To: **3**
 1st Value:
 2nd Value:
 Value Percent:
 Continuous Index: **F01**
 Within 8" of Joint: **YES**
 Remarks:
