Profile/Photo Observation Report

Date:	11/15/2021	Weather:		Coding:	PACP 7.0
Pipe Length (ft):	79.1	Owner:	City of Hobart	Pre Clean:	Heavy Cleaning
P.O.#:	YES502259	Surveyor:	S. Bucklin	PSR:	P-605-060-061
Customer:	City of Hobart	Clean Date:	11/14/2021	Shape:	C

Street:	South Lake Park Avenue	Flow Control:	Not Controlled
City:	Hobart, IN	Year Renewed:	
Location:	Local rural streets with light traffic, t	Tape/Media #:	
Purpose:	Routine Assessment	Dia/Height:	8"
Use:	Sanitary Sewage Pipe	Material:	VCP
Drain Area:		Lining:	None
Category:	NA		
Comment:			
Location Details:		Direction of Survey:	Upstream
US MH:	M-605-061	DS MH:	M-605-060
		Total Length Surveyed (ft):	79.1

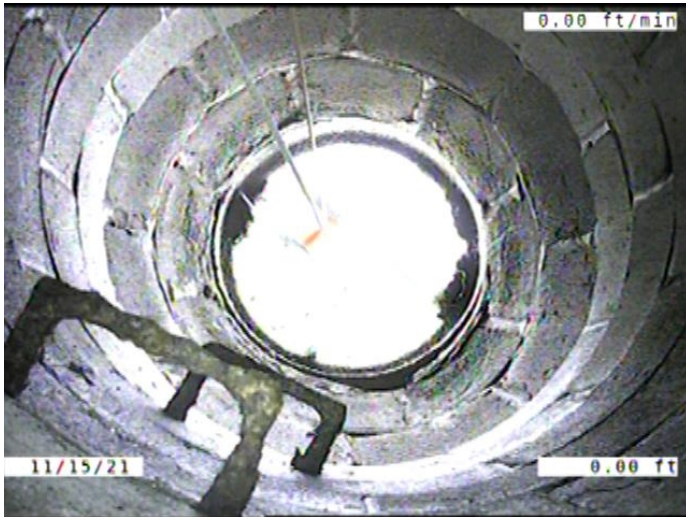
Code: **AMH**
 Description: **Manhole**

Distance (ft): **.0**
 Structural Grade: **0**
 O&M Grade: **0**
 Clock Start/From:
 Clock To:
 1st Value:
 2nd Value:
 Value Percent:
 Continuous Index:
 Within 8" of Joint: **NO**
 Remarks: **M-605-060**

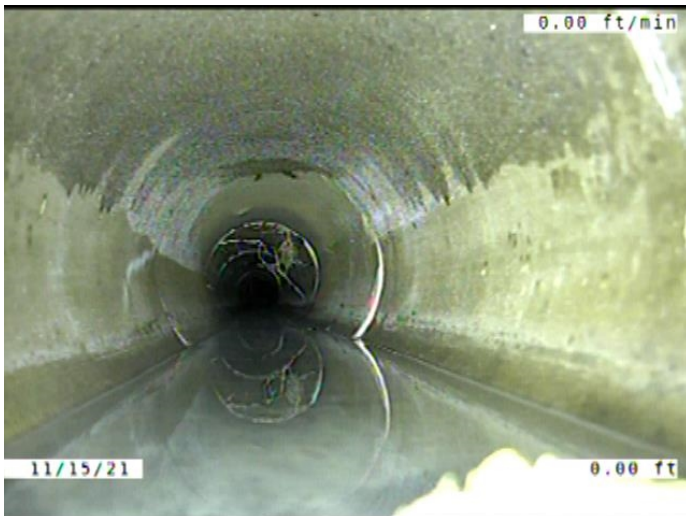
Code: **MWL**
 Description: **Miscellaneous Water Level**

Distance (ft): **.0**
 Structural Grade: **0**
 O&M Grade: **0**
 Clock Start/From:
 Clock To:
 1st Value:
 2nd Value:
 Value Percent: **5.000**
 Continuous Index:
 Within 8" of Joint: **NO**
 Remarks:

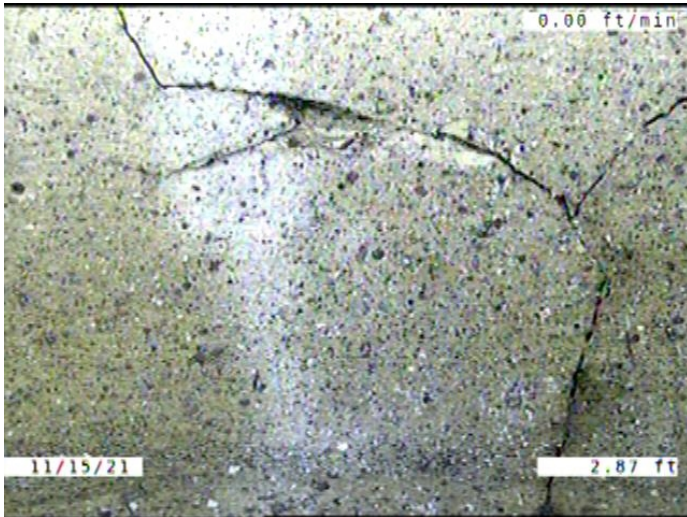
Code: **FM**
 Description: **Fracture Multiple**

Distance (ft): **2.9**
 Structural Grade: **4**
 O&M Grade: **0**
 Clock Start/From: **8**
 Clock To: **1**
 1st Value:
 2nd Value:
 Value Percent:
 Continuous Index:
 Within 8" of Joint: **YES**
 Remarks:

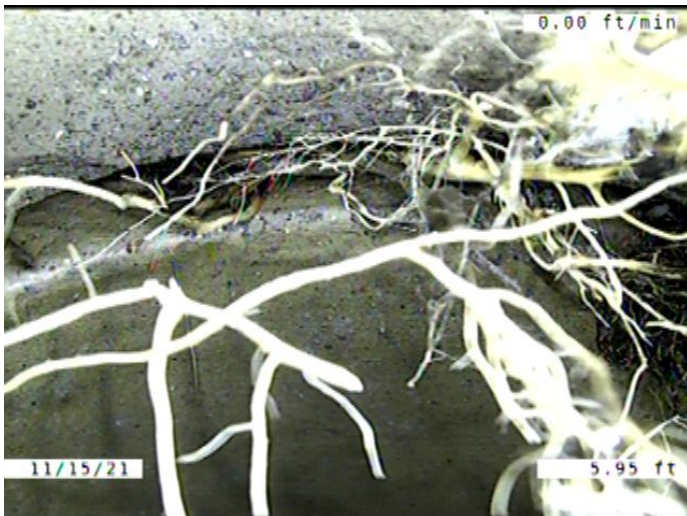
Code: **RMJ**
 Description: **Roots Medium Joint**

Distance (ft): **5.9**
 Structural Grade: **0**
 O&M Grade: **3**
 Clock Start/From: **9**
 Clock To: **2**
 1st Value:
 2nd Value:
 Value Percent: **5.000**
 Continuous Index:
 Within 8" of Joint: **YES**
 Remarks:

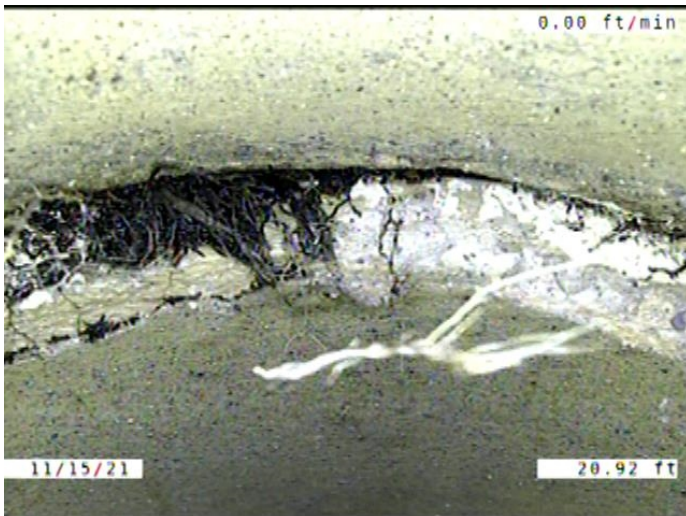
Code: **JOM**
 Description: **Joint Offset Medium**

Distance (ft): **20.9**
 Structural Grade: **3**
 O&M Grade: **0**
 Clock Start/From:
 Clock To:
 1st Value:
 2nd Value:
 Value Percent:
 Continuous Index:
 Within 8" of Joint: **NO**
 Remarks:

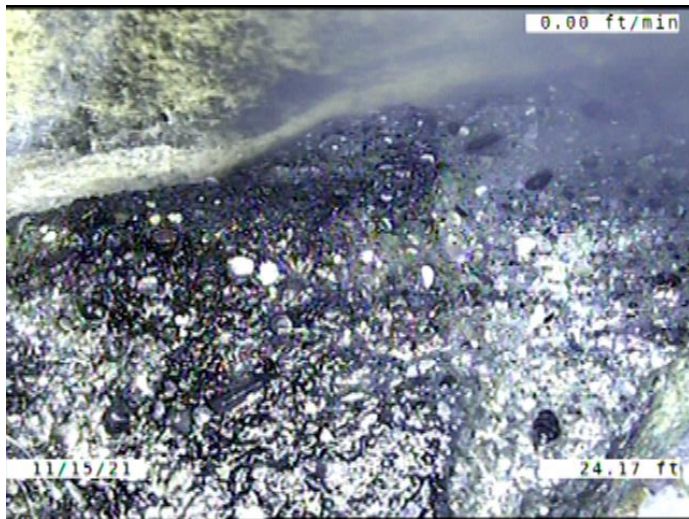
Code: **DAE**
 Description: **Deposits Attached Encrustation**

Distance (ft): **24.2**
 Structural Grade: **0**
 O&M Grade: **2**
 Clock Start/From: **4**
 Clock To: **8**
 1st Value:
 2nd Value:
 Value Percent: **5.000**
 Continuous Index:
 Within 8" of Joint: **YES**
 Remarks:

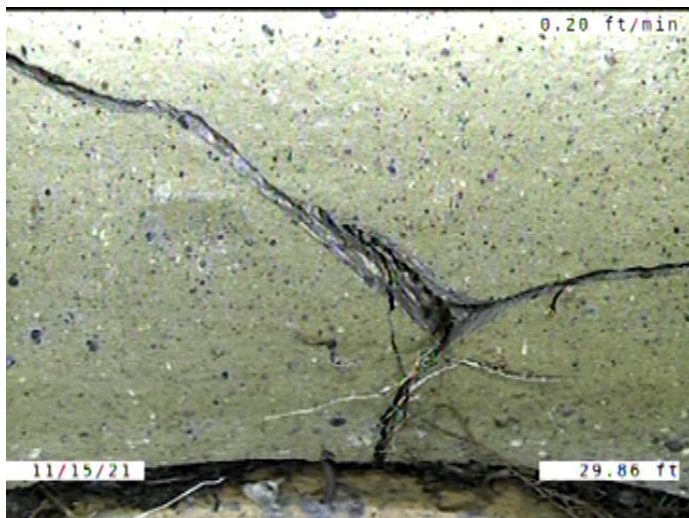
Code: **B**
 Description: **Broken**

Distance (ft): **29.9**
 Structural Grade: **4**
 O&M Grade: **0**
 Clock Start/From: **12**
 Clock To: **12**
 1st Value:
 2nd Value:
 Value Percent:
 Continuous Index:
 Within 8" of Joint: **YES**
 Remarks:

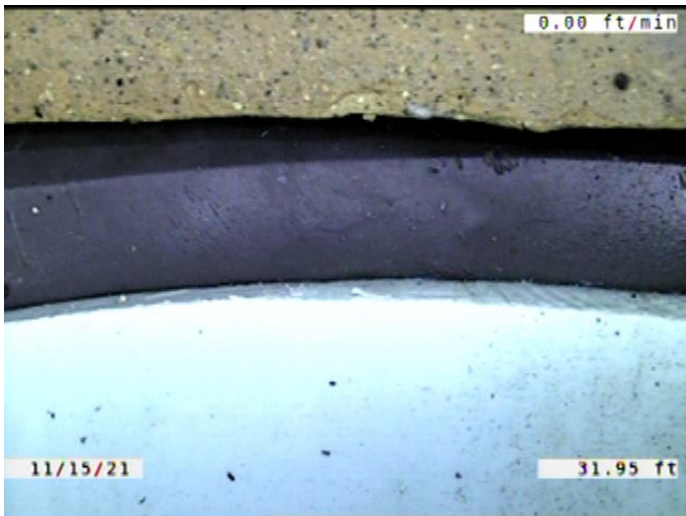
Code: **MMC**
 Description: **Miscellaneous Material Change**

Distance (ft): **31.9**
 Structural Grade: **0**
 O&M Grade: **0**
 Clock Start/From:
 Clock To:
 1st Value:
 2nd Value:
 Value Percent:
 Continuous Index:
 Within 8" of Joint: **NO**
 Remarks: **VCP TO PVC**

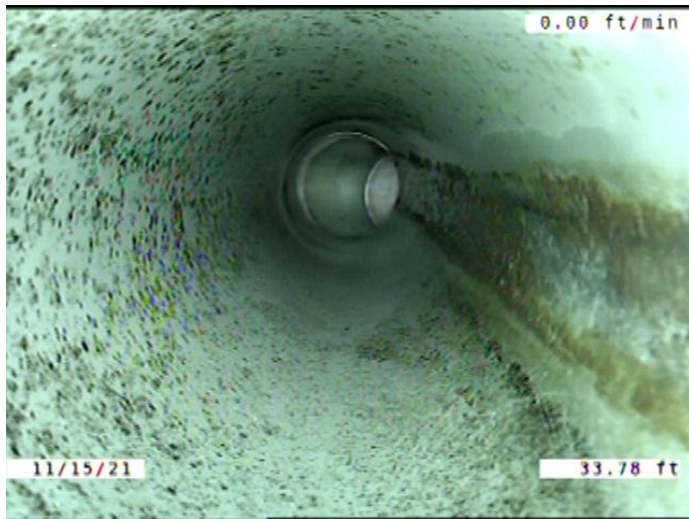
Code: **TF**
 Description: **Tap Factory**

Distance (ft): **33.8**
 Structural Grade: **0**
 O&M Grade: **0**
 Clock Start/From: **1**
 Clock To:
 1st Value: **4.000**
 2nd Value:
 Value Percent:
 Continuous Index:
 Within 8" of Joint: **YES**
 Remarks:

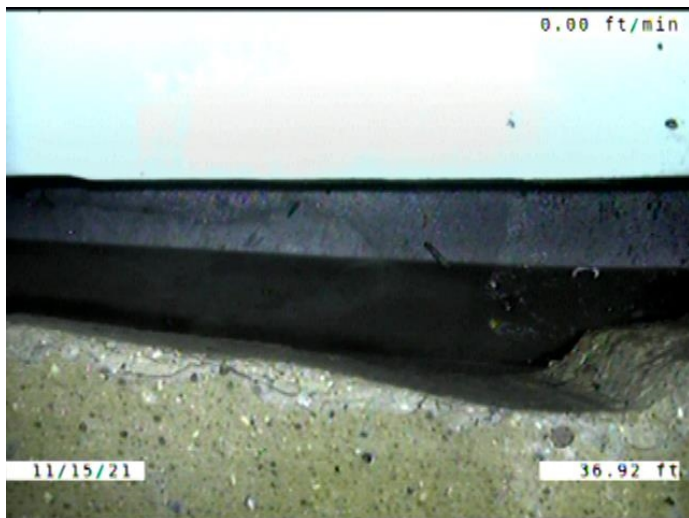
Code: **MMC**
 Description: **Miscellaneous Material Change**

Distance (ft): **36.9**
 Structural Grade: **0**
 O&M Grade: **0**
 Clock Start/From:
 Clock To:
 1st Value:
 2nd Value:
 Value Percent:
 Continuous Index:
 Within 8" of Joint: **NO**
 Remarks: **PVC TO VCP**

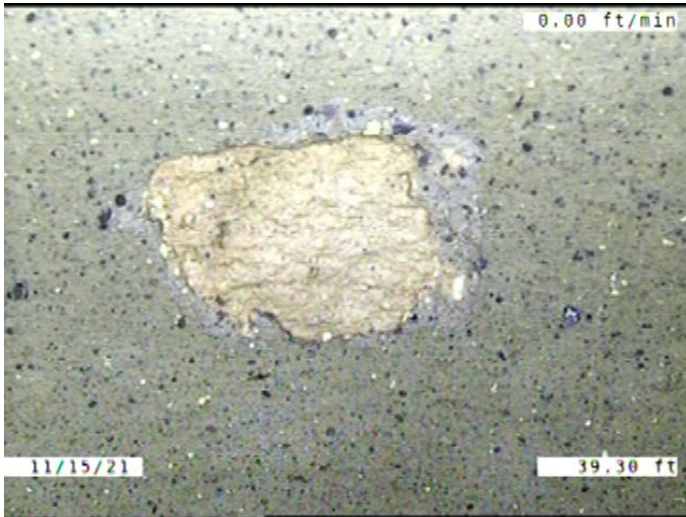
Code:	SSS
Description:	Surface Damage Surface Spalling
Distance (ft):	39.3
Structural Grade:	2
O&M Grade:	0
Clock Start/From:	12
Clock To:	
1st Value:	
2nd Value:	
Value Percent:	
Continuous Index:	
Within 8" of Joint:	NO
Remarks:

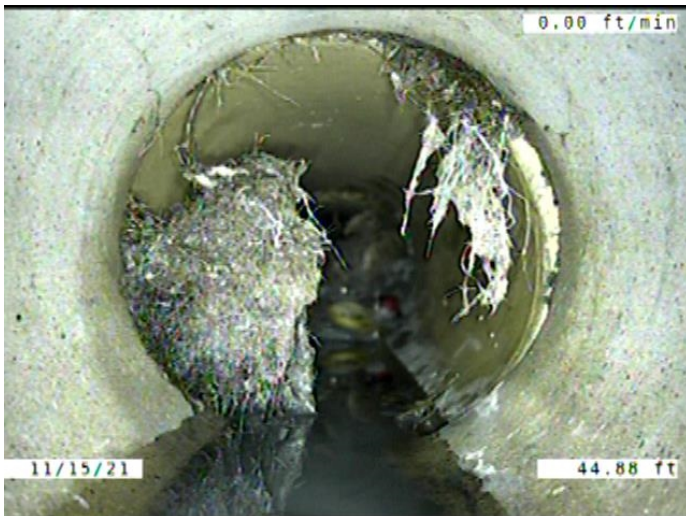
Code:	RMJ
Description:	Roots Medium Joint
Distance (ft):	44.9
Structural Grade:	0
O&M Grade:	3
Clock Start/From:	7
Clock To:	2
1st Value:	
2nd Value:	
Value Percent:	30.000
Continuous Index:	
Within 8" of Joint:	YES
Remarks:

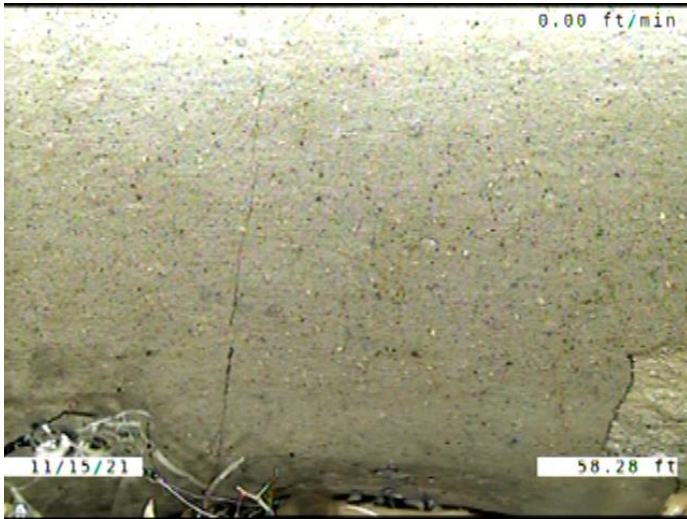
Code: **CM**
Description: **Crack Multiple**

Distance (ft): **58.3**
Structural Grade: **3**
O&M Grade: **0**
Clock Start/From: **10**
Clock To: **2**
1st Value:
2nd Value:
Value Percent:
Continuous Index:
Within 8" of Joint: **YES**
Remarks:

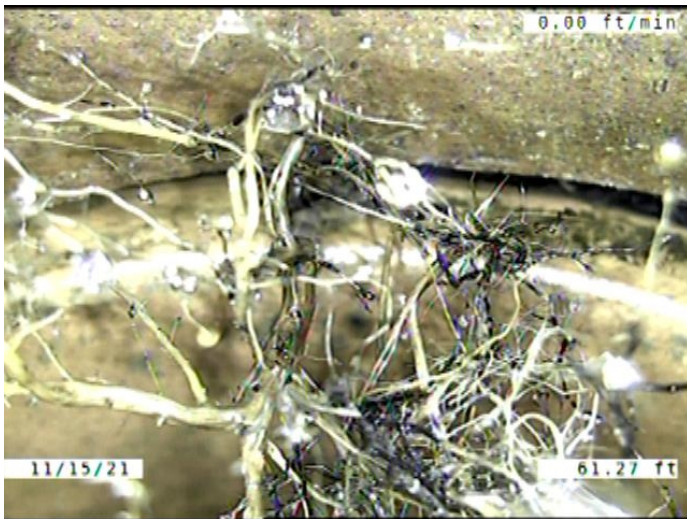
Code: **RMJ**
Description: **Roots Medium Joint**

Distance (ft): **61.3**
Structural Grade: **0**
O&M Grade: **3**
Clock Start/From: **10**
Clock To: **1**
1st Value:
2nd Value:
Value Percent: **5.000**
Continuous Index:
Within 8" of Joint: **YES**
Remarks:

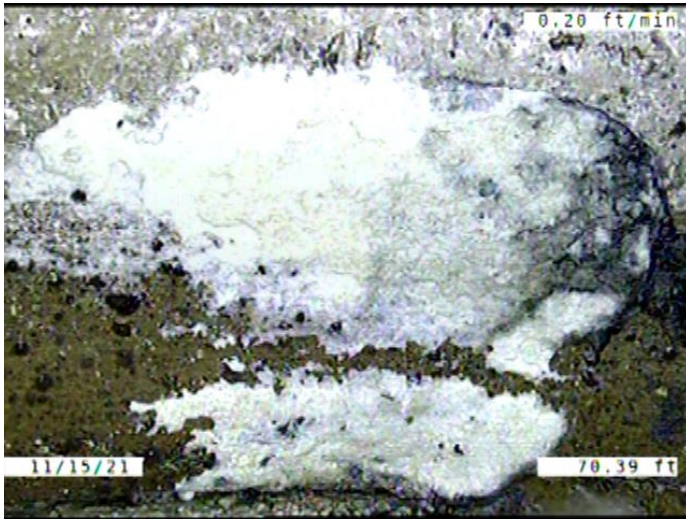
Code: **DAE**
 Description: **Deposits Attached Encrustation**

Distance (ft): **70.4**
 Structural Grade: **0**
 O&M Grade: **2**
 Clock Start/From: **10**
 Clock To:
 1st Value:
 2nd Value:
 Value Percent: **5.000**
 Continuous Index:
 Within 8" of Joint: **NO**
 Remarks:

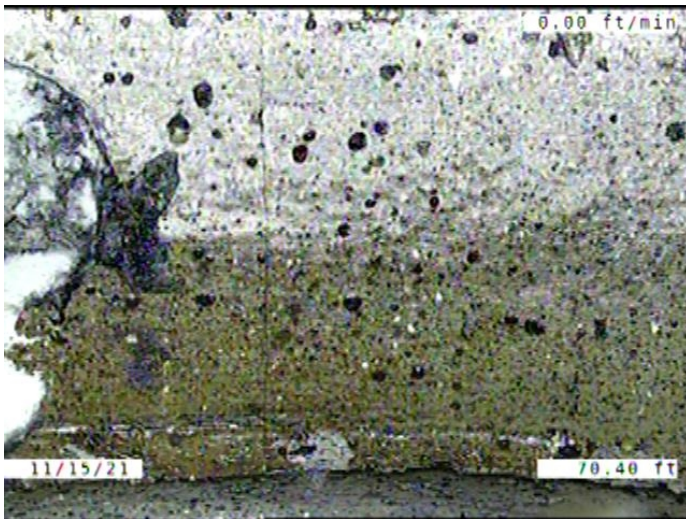
Code: **CL**
 Description: **Crack Longitudinal**

Distance (ft): **70.4**
 Structural Grade: **2**
 O&M Grade: **0**
 Clock Start/From: **11**
 Clock To:
 1st Value:
 2nd Value:
 Value Percent:
 Continuous Index:
 Within 8" of Joint: **YES**
 Remarks:

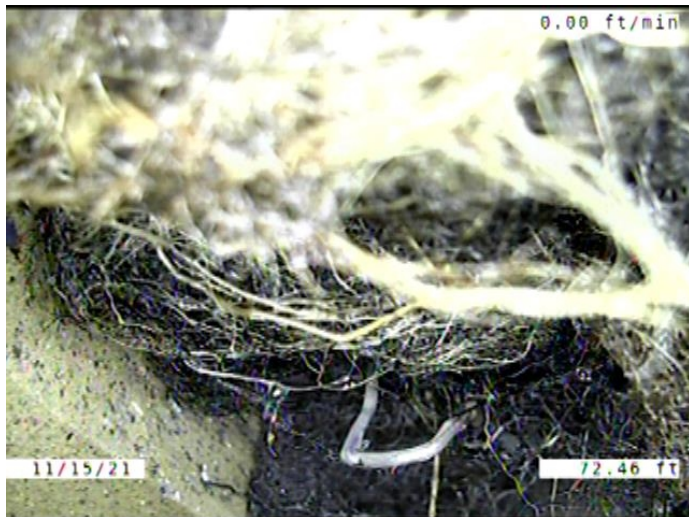
Code: **RMC**
 Description: **Roots Medium Connection**

Distance (ft): **72.5**
 Structural Grade: **0**
 O&M Grade: **3**
 Clock Start/From: **1**
 Clock To: **3**
 1st Value:
 2nd Value:
 Value Percent: **10.000**
 Continuous Index:
 Within 8" of Joint: **NO**
 Remarks:

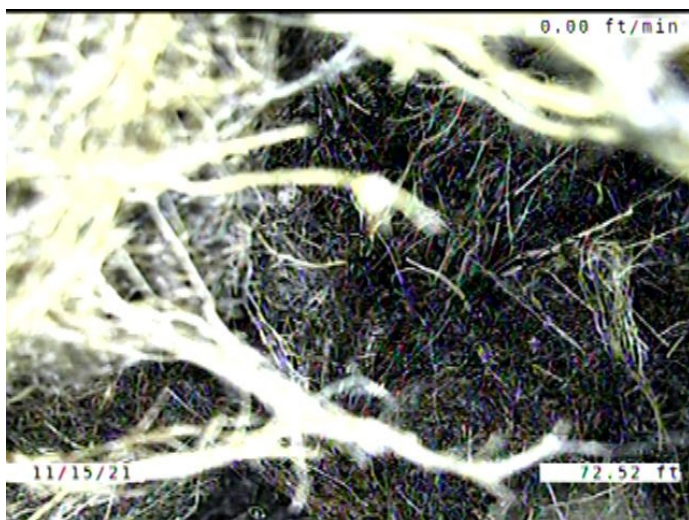
Code: **TFD**
 Description: **Tap Factory Defective**

Distance (ft): **72.5**
 Structural Grade: **0**
 O&M Grade: **3**
 Clock Start/From: **2**
 Clock To:
 1st Value: **4.000**
 2nd Value:
 Value Percent:
 Continuous Index:
 Within 8" of Joint: **YES**
 Remarks: **LOOKS TO BE 100% PLUGGED WITH ROOTS**

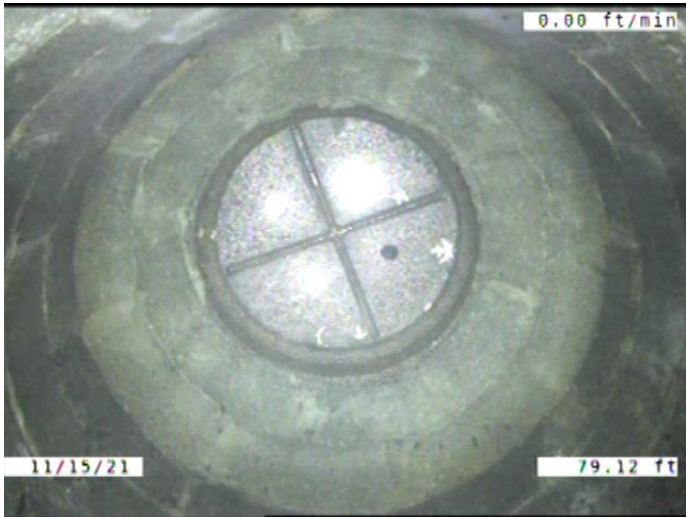
Code:	AMH
Description:	Manhole
Distance (ft):	79.1
Structural Grade:	0
O&M Grade:	0
Clock Start/From:	
Clock To:	
1st Value:	
2nd Value:	
Value Percent:	
Continuous Index:	
Within 8" of Joint:	NO
Remarks:	M-605-061
